# Visual recovery of desert pavement surfaces following impacts from vehicle and foot traffic in the Ross Sea region of Antarctica

TANYA A. O'NEILL<sup>1</sup>, MEGAN R. BALKS<sup>1</sup> and JERÓNIMO LÓPEZ-MARTÍNEZ<sup>2</sup>

**Abstract:** Sites of past human activity were investigated to assess the visual recovery of the desert pavement following impacts from human trampling and vehicle traffic. Visually disturbed and nearby control sites were assessed using comparative photographic records, a field-based Visual Site Assessment, and Desert Pavement Recovery Assessment. Sites included: vehicle and walking tracks at Marble Point and Taylor Valley; a campsite, experimental treading trial site, and vehicle tracks in Wright Valley; and vehicle and walking tracks at Cape Roberts. The time since last disturbance ranged from three months to over 50 years. This investigation also attempted to determine what has the greatest lasting visual impact on soil surfaces in the Ross Sea region: dispersed trafficking or track formation? Walking tracks remained visible in the landscape (due to larger clasts concentrating along track margins) long after the desert pavement surface had recovered. H

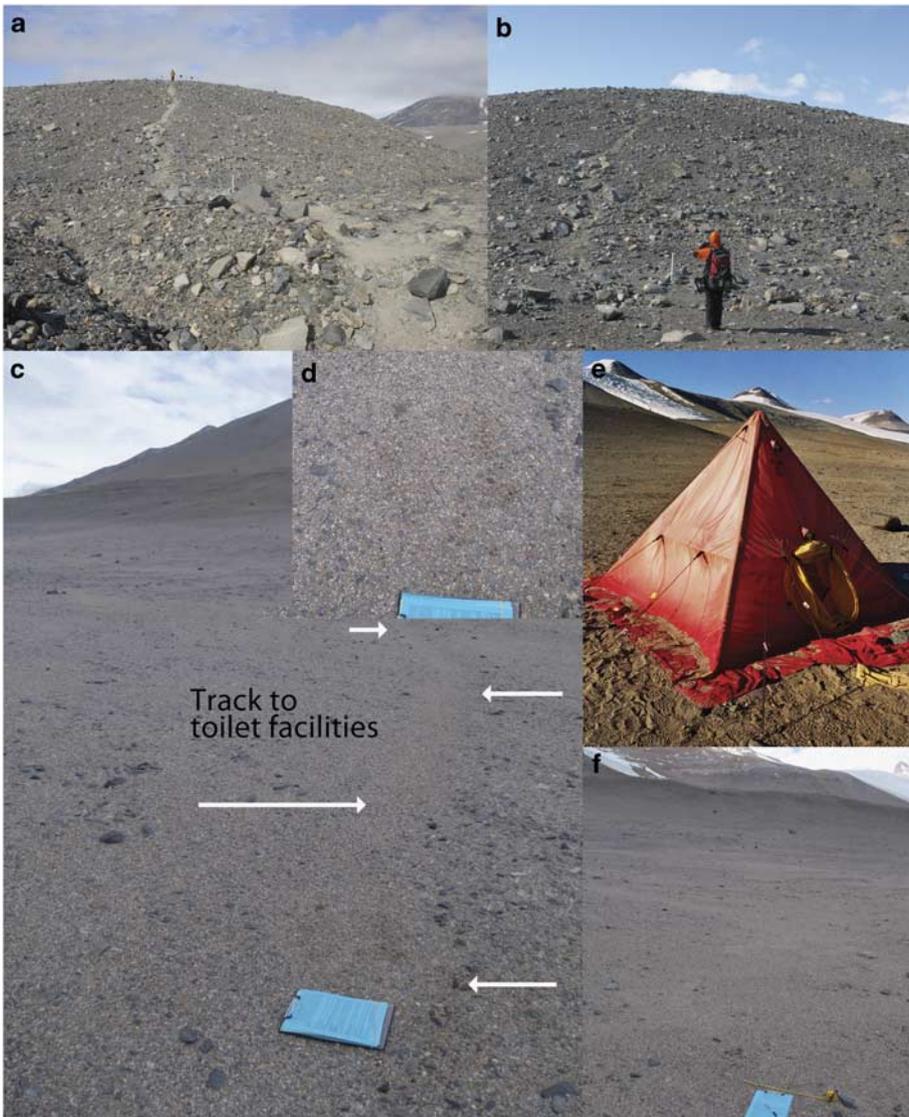
**Fig. 2.** Taylor Valley Visitor Zone and Loop moraine sites. **a.** Taylor Valley Visitor Zone, walking track from the helicopter landing site to the hilltop lookout, 2006/07 season, after 96 tourist visitors. Picture: Jana Newman. **b.** Walking track from the helicopter landing site to the hilltop lookout, December 2009, before first tourist group of the season. **c.** Loop moraine 2004/05 walking track to toilet, track margin visible (white arrows), after five years recovery, December 2009. **d.** Recovery of the desert pavement on the track surface, after five years. **e.** Loop moraine tent site, December 2004. Picture: Fiona Shanhun. **f.** Loop moraine tent site, five years later, December 2009.

At the Loop moraine campsite, the 2004/05 walking track between the tents and toilet facilities had abundant disturbed surface stones, and distinct surface texture change (Table IV). The ground surface had an indentation effect, the result of sorting of rock material and compaction of the inner part of the track (Fig. 2c & d). The walking track had a moderate colour contrast between the track and the adjacent undisturbed material, which is probably the result of the larger, and darker, dolerite rocks having moved to the outer margins of the track due to foot traffic (Fig. 2c). The visibly disturbed area was about 450 m<sup>2</sup> (300 m long x 1.5 m wide), and the foot track was clearly evident five years after the disturbance.

In contrast, at the Loop moraine campsite, the impacts around the tent site, caused by widespread random trampling (Fig. 2e), were undetectable (Fig. 2f). There were no visibly disturbed stones, no impressions of rocks removed, no boot imprints and no visible surface colour difference. In less than five years the desert pavement at the tent site showed visual recovery to pre-disturbance condition (Fig. 2e & f) and was visually indistinguishable

from the tent site to the toilet) would enhance the visual aesthetics by eliminating unnatural surface irregularities, and facilitate the visible recovery of previously disturbed desert pavement. Larger stones, such as those used to pin down tents at the Loop moraine campsite, must however, be replaced in original orientations with salt coated surfaces down and polished or weathered surfaces up, preferably in the indentations from which they were removed. The redistribution of disturbed rocks from vehicle and walking track margins was an effective means of remediation at the former Vanda station site (MRI of 90%), but needs to be undertaken with an understanding of the rock material's natural position in the environment.

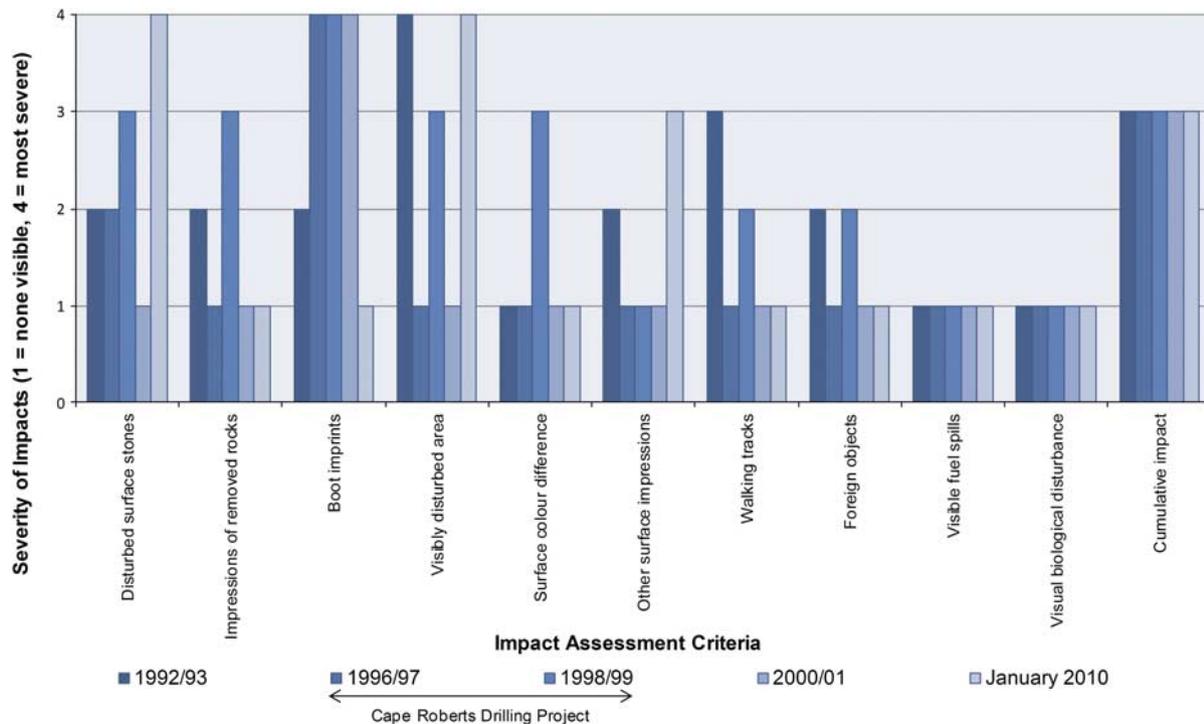
**Fig. 4.** Visual Site Assessment of Cape Roberts Project (CRP) “Northern Plot” monitoring site, pre-CRP (1992/93, after Campbell & Keys 1993), during CRP (1996/97 and 1998/99, after Waterhouse 2001), after remediation (2000/01, after Cowie 2001), and ten years after remediation (January 2010). Note: January 2010 control scores are not shown, however, each impact assessment criteria scored a one.

At the “Northern Plot” VSAs showed the site was overall in better condition in 2010 than in the pre-CRP baseline assessment in 1992/93 (Fig. 4). This probably reflects effective site cleanup and restoration in 1999/2000 and 2000/01. The Cape Roberts sites had been disturbed on numerous occasions prior to the commencement of the Cape Roberts Drilling Project. In 2010 there was an improvement in four impact assessment criteria, including, a decrease in impressions of removed rocks, boot imprints, presence of foreign objects, and evidence of formed walking tracks. Four criteria remained the same, and the evidence of cumulative impact remained consistent at  $> 100 \text{ m}^2$ . Mid-project 1996/97 and 1998/99 VSAs showed an increase in impressions of removed rocks, evidence of walking tracks, and foreign objects over the duration of the drilling project. The abundance of disturbed surface stones, and other surface impressions, shows only partial recovery to baseline 1992/93 condition (Fig. 4), with rehabilitation probably an ongoing process. The “Northern Plot” had an MRI of 88% (Table V).

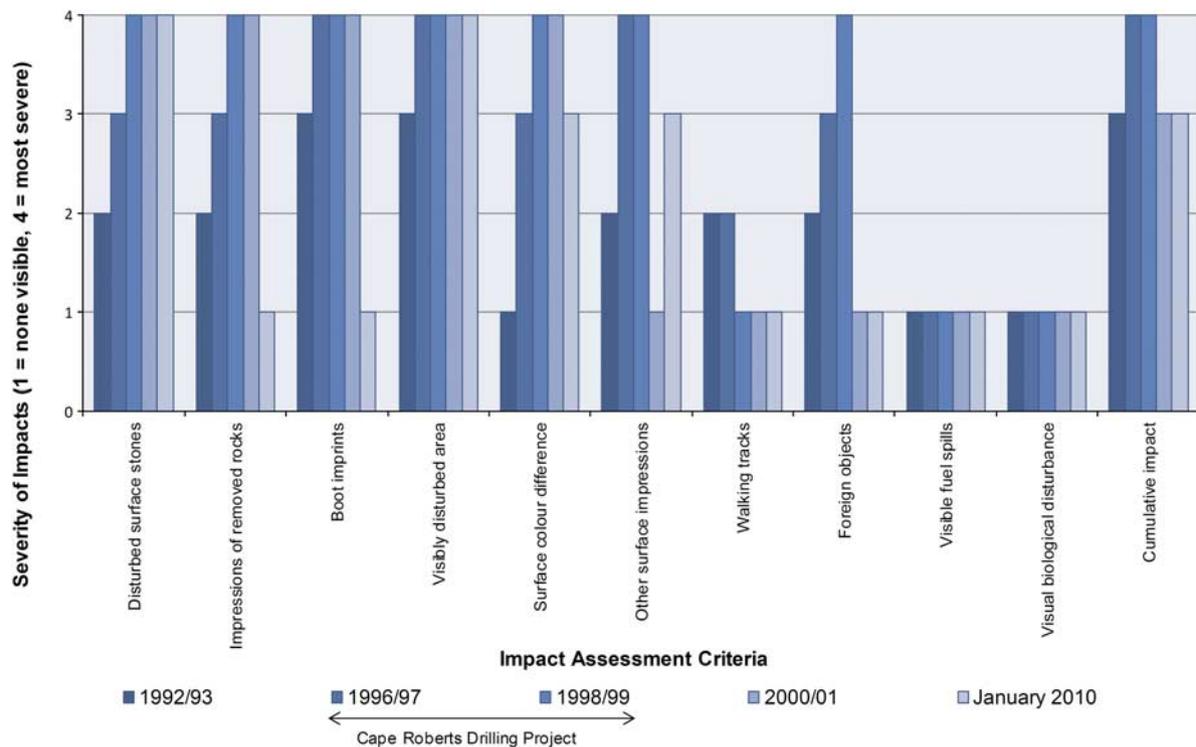
**Fig. 5.** Visual Site Assessment of Cape Roberts Project (CRP) “Southern Plot” monitoring site, pre-CRP (1992/93, after Campbell & Keys 1993), during CRP (1996/97 and 1998/99, after Waterhouse 2001), after remediation (2000/01, after Cowie 2001), and ten years after remediation (January 2010). Note: January 2010 control scores are not shown, however, each impact assessment criteria scored a one.

Visual impacts were consistently greater at the “Southern Plot” as it was the site where most vehicle and walking tracks were concentrated, and the location of the fuel rack and huts. The “Southern Plot” showed deterioration in some of the criteria re-assessed in 2010. There was a decline in four impact assessment criteria, including an increase in abundance of disturbed surface stones, and visibly disturbed areas, and evidence of other surface impressions, such as Hagglund vehicles tracks and helicopter skid marks (Fig. 5). Three impact assessment criteria remained the same, such as the extent of cumulative impact which remained consistent at  $> 100 \text{ m}^2$ , and four showed an improvement beyond the 1992/93 baseline assessment (impressions of removed rocks, boot imprints, evidence of walking tracks, and foreign objects). The surface colour contrast between the impacted site and the surrounding undisturbed material showed the greatest increase in the first few years of the project. Both the visibly disturbed area and cumulative impacts increased rapidly at the beginning of the CRP (see 1996/97 and 1998/99 VSAs, Fig. 5), and remained “severe” over the duration of the project. The 2010 assessment showed no obvious evidence of post-CRP environmental monitoring soil sampling pits, nor visible evidence of the removal of contaminated sand and gravel that was taken during remediation (Waterhouse 2001).
