Surface Roughening of Platinum Wire
An Electrochemical and Mechanical Approach

A thesis

Masters of Engineering

The University of Waikato

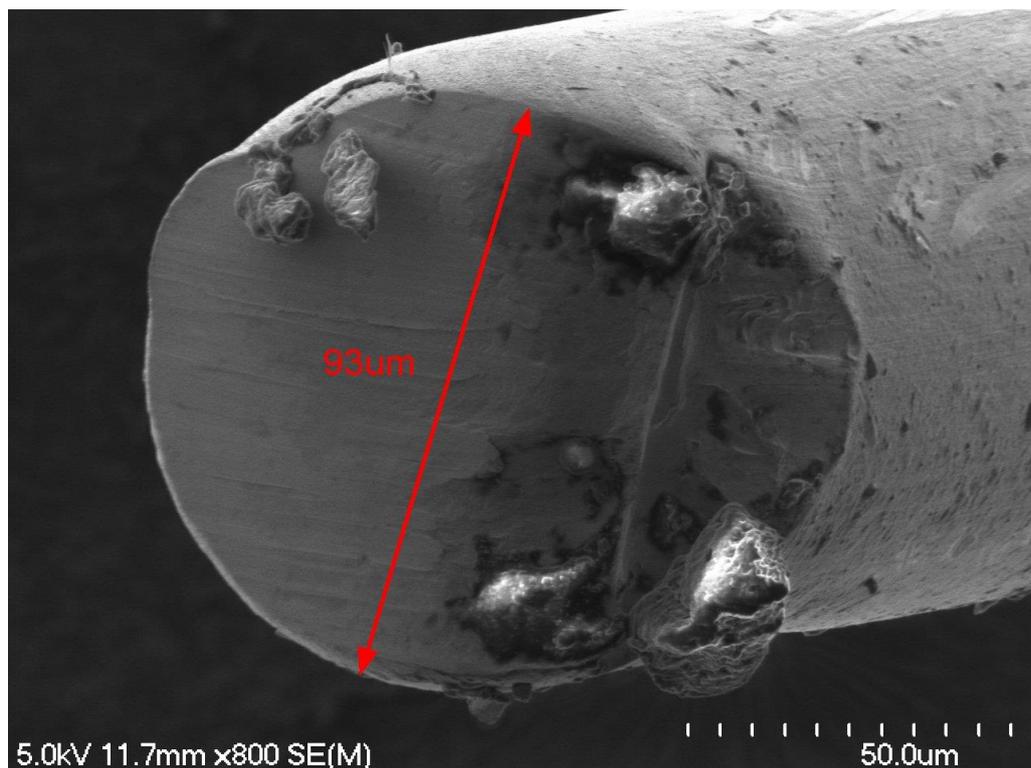
The real cross sectional area was measured by using a calibrated micrograph of a sample of the wire. An untreated sample of the wire was analysed using ImageJ, an image processing program.

Figure 1 - Untreated Platinum Wire, 800x magnification

The final diameter of the wire was measured at 93 micrometres. This gives a cross sectional area of:

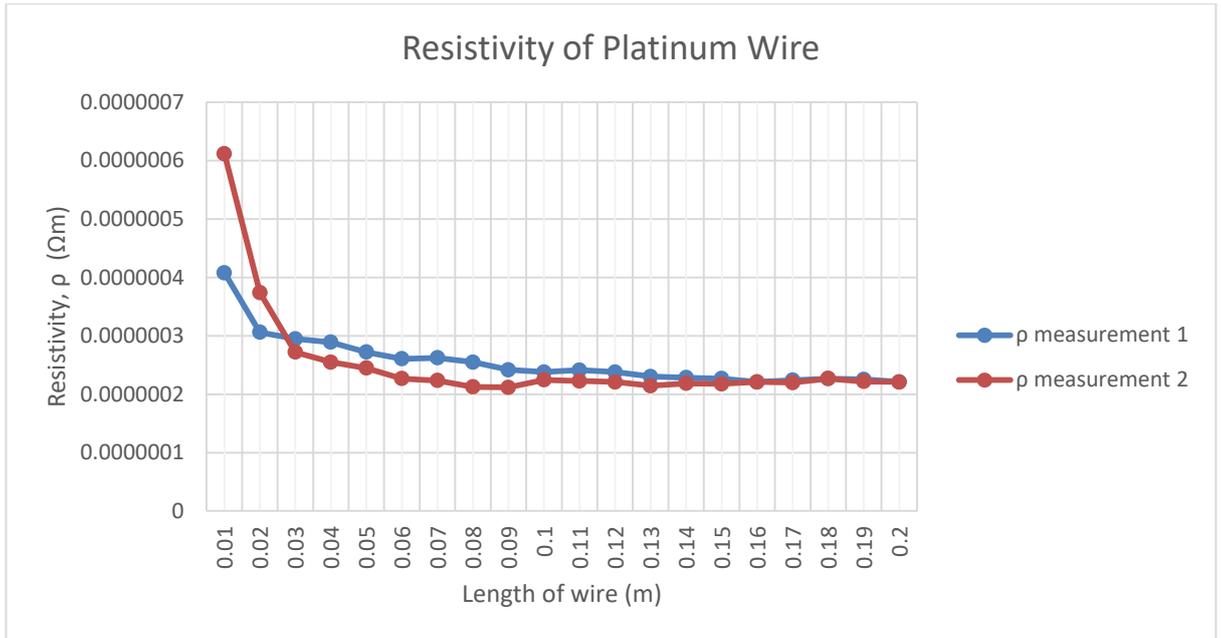
Figure 2- Platinum wire resistance measurements

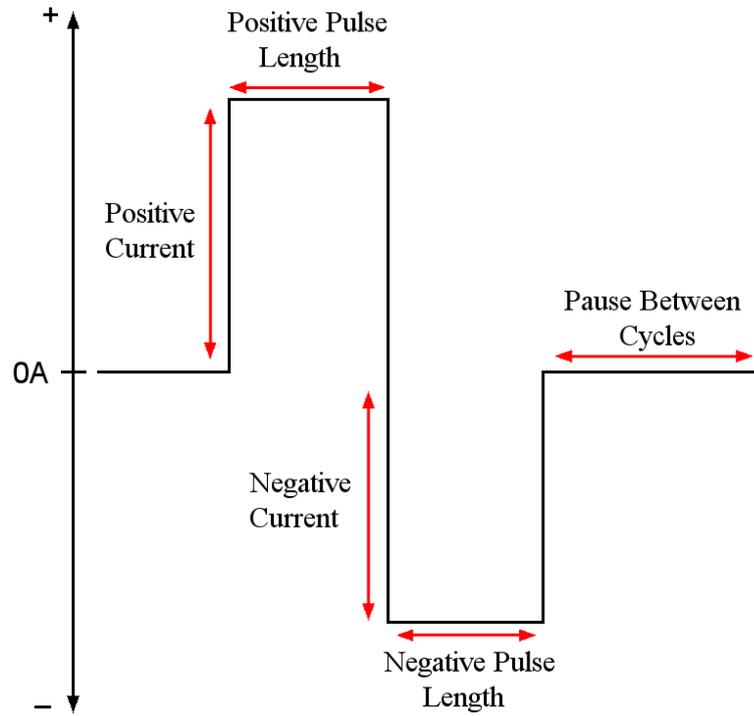
The largest variable in the treatment of the platinum wire is the applied electric current. The applied electric pulses are square waves with a pause between pulse cycles. The pause allows the deposited material to stabilize and any ions that are left over in the solution to diffuse evenly. The general shape is shown below.

Figure 3 - Otteniser pulse shape

The Otteniser allows for parameters to be set for all of the pulse durations and magnitudes by using the GUI.

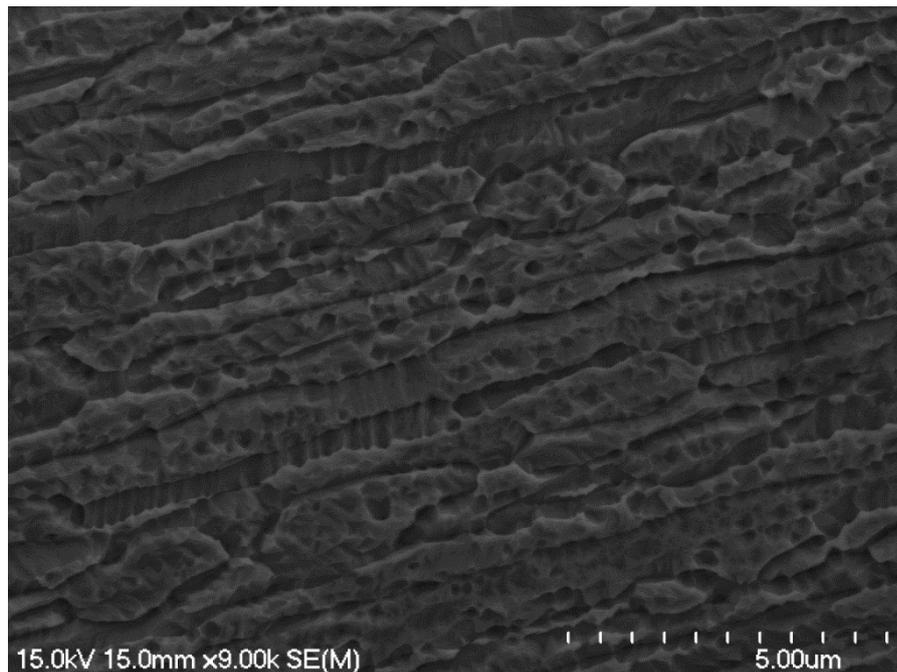
It has been shown that a frequency of about 1 kHz gives the most desirable surface texture⁽⁴⁾. To that end, a set of tests was carried out to determine suitable pulse duration. Tests at frequencies of 1 kHz showed that the corrosion step was not long enough and that the corrosion was shallow and resulted in a rough surface and a shallow treatment.

Figure 4 - Platinum surface, 1 KHz treatment

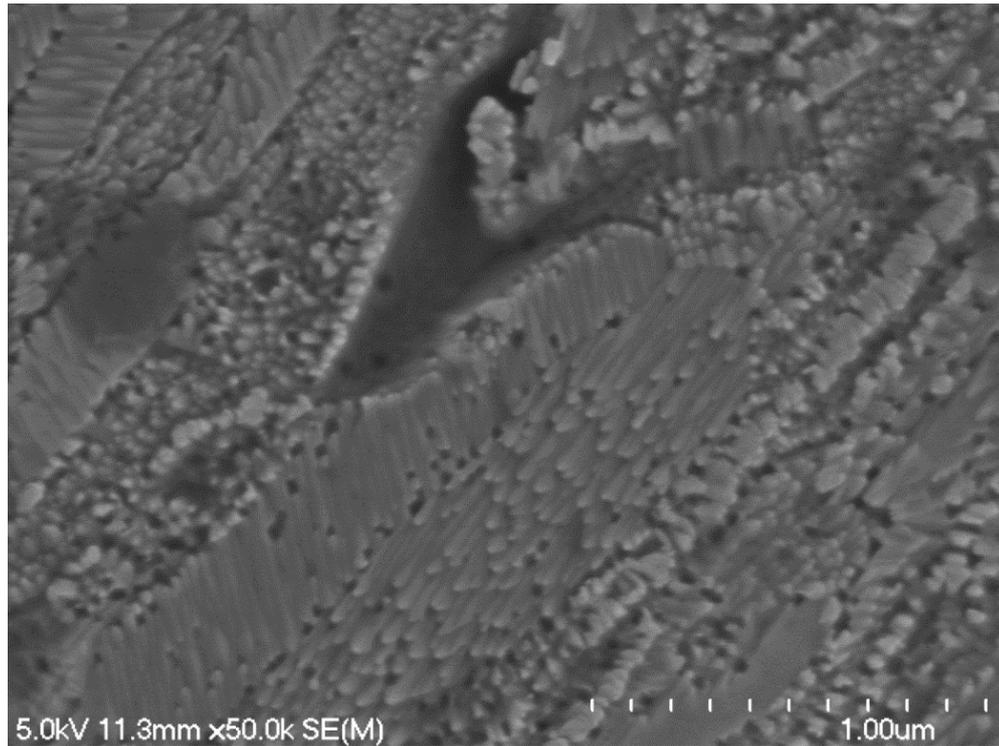
When the frequency was turned below 500Hz, the corrosion was deeper but the growth on the surface was textured in an undesirable way. The growth followed the crystallographic orientation of the substrate grain.

Figure 5- Platinum surface, 500Hz treatment showing the different orientations of the growth

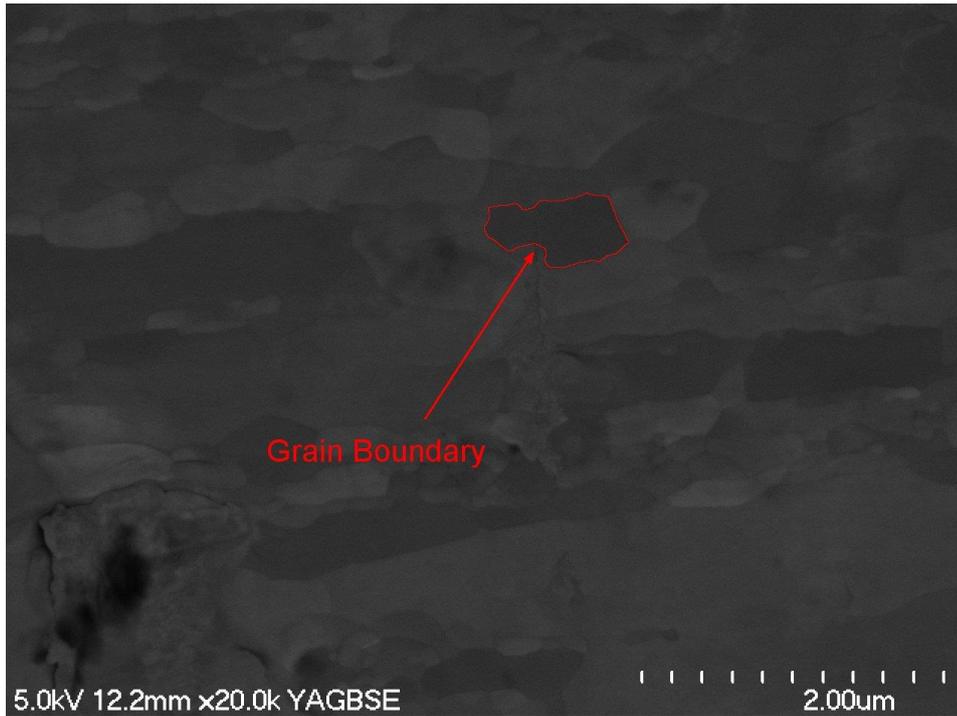
Figure 6-Grain boundaries on untreated platinum wire

In the end, a frequency of 704.2 Hz was chosen which translates to positive and negative pulse duration each of 0.71ms. At this frequency, corrosion was deeper than the high frequency tests and followed the grain boundaries. The deposition also resulted in a desirable porous structure. A test that was stopped before the surface was fully modified clearly shows the corrosion along grain boundaries. This shows the preferential corrosion paths illustrated by figures 6 and 7.

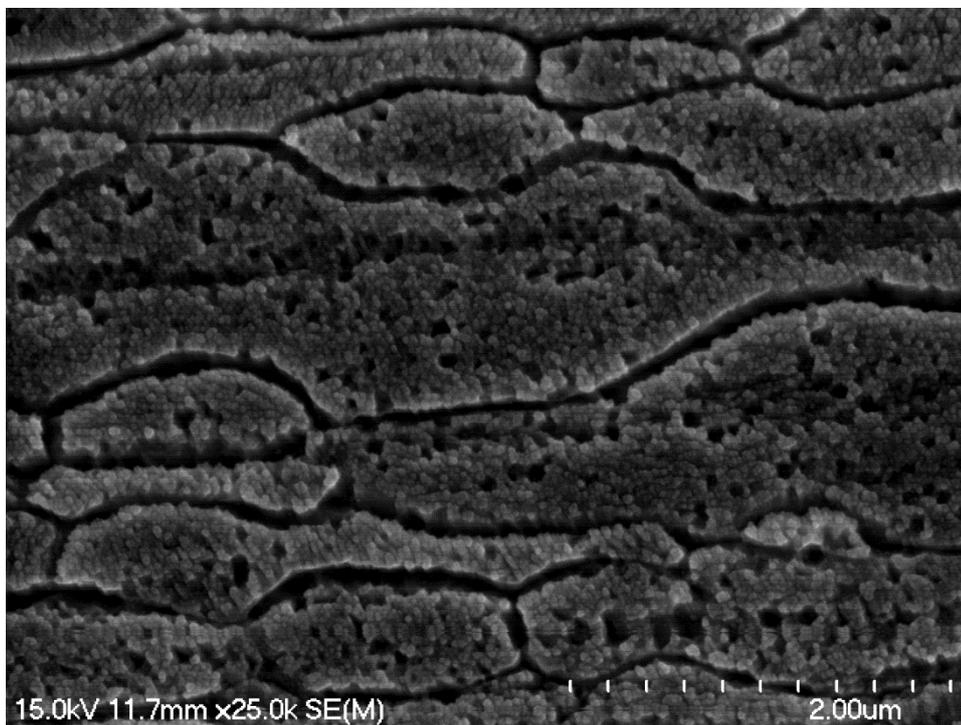
Figure 7- A test to show the corrosion of grain boundaries in platinum wire

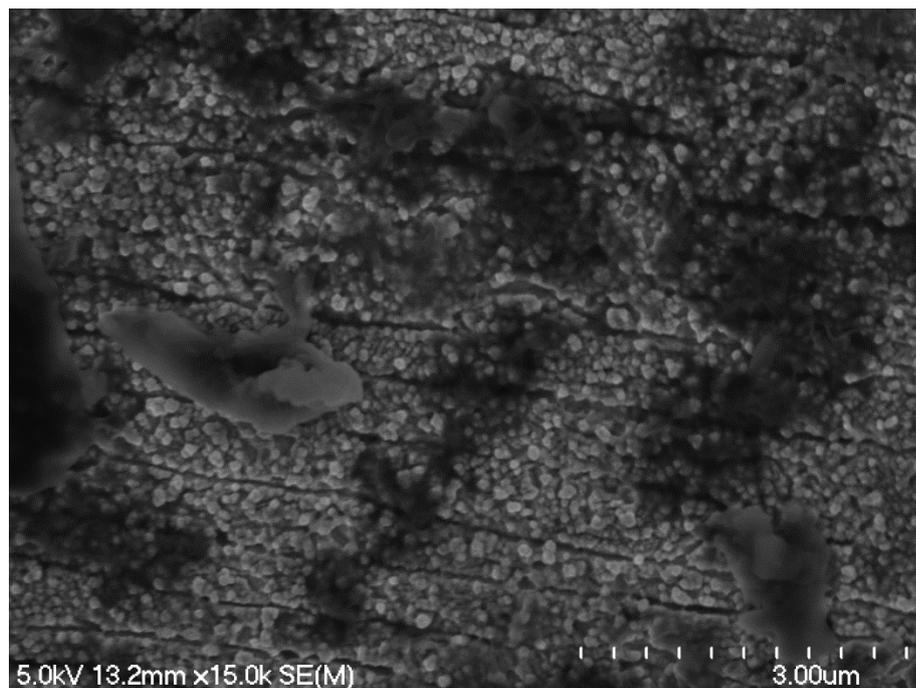
When 190mA was used, the deposited material was porous and looked fine, however, the depth of treatment was limited. A picture below shows the favourable porous morphology, but the underlying corrosion grain boundary corrosion crevices can still be seen in some places, suggesting that the treatment depth was limited.

Figure 8- Oxidised platinum wire at 190mA

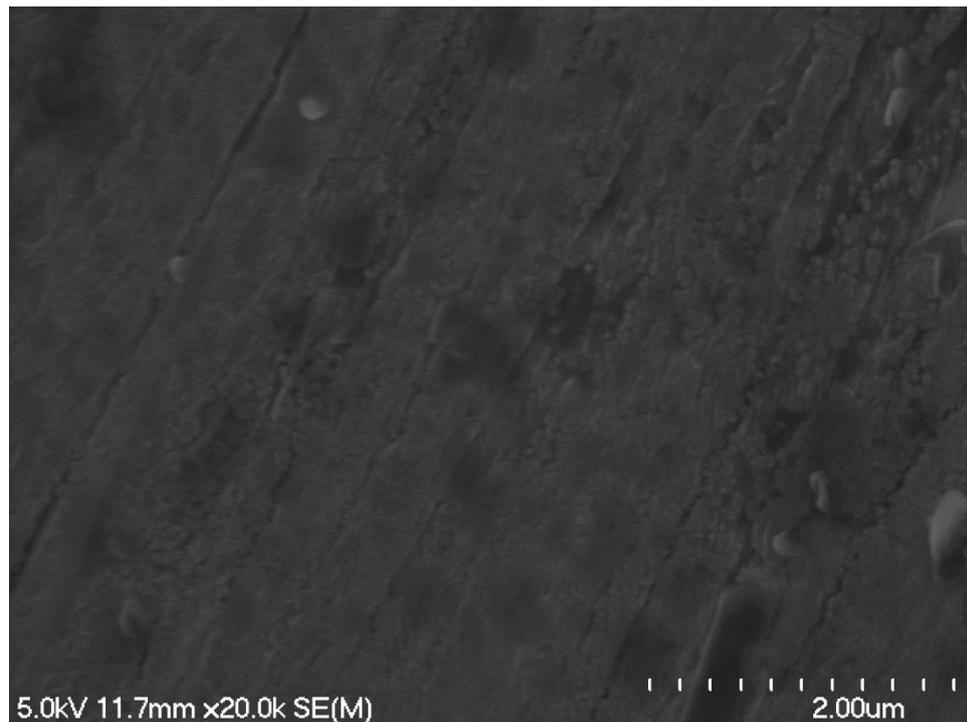
The corrosion step worked as expected and mirrored regular galvanic corrosion. This means that the corrosion preferentially attacked the high energy facets but also corroded the other faces as well. Along with the typical galvanic corrosion, there was evidence of blistering in the platinum wire. This damage can be seen as deep as 10 microns deep inside the wire.

Figure 9 – Cross section of a treated wire showing internal cracking

Blistering is an effect of the large amount of hydrogen gas that is evolved during the Ottenisation process. Some of the hydrogen gas migrates into the corroded material instead of being expelled out into the electrolyte solution. This hydrogen gas builds up and creates voids and internal cracks within the wire. These blisters are unseen from the surface and mechanically weaken the material by reducing the effective cross sectional area.

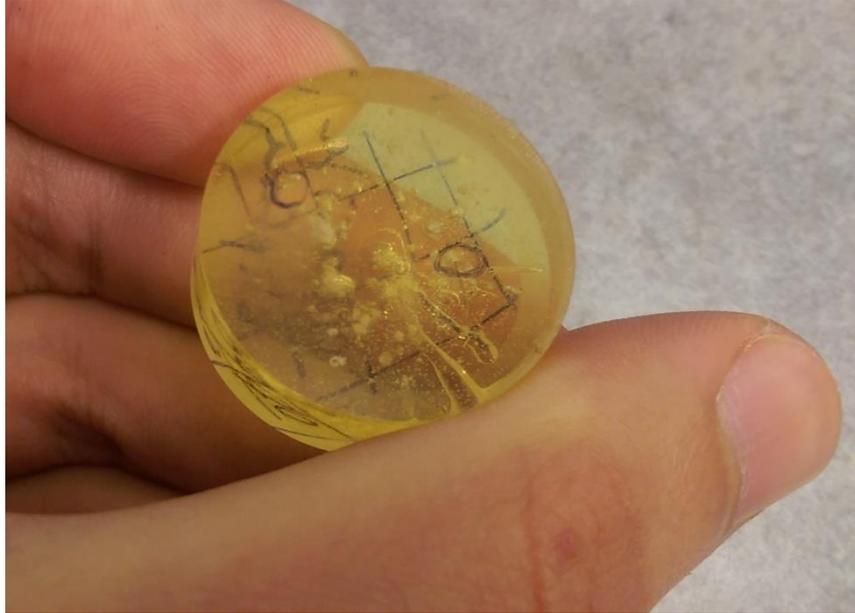
11). To get a clean cross section of the wire two different methods were used. The first was to fix the wire in a resin that hardens and then use increasingly higher grit sand paper to eventually diamond paste to whittle down the wire until a clean cross section can be seen.

Figure 10 – Resin with imbedded platinum wire samples

The samples embedded into the resin required a coating of platinum to be imaged in the SEM. This layer made discerning between the porous coat and the substrate difficult. The fractured sample had enough undamaged edge to analyse, and therefore were used more often.

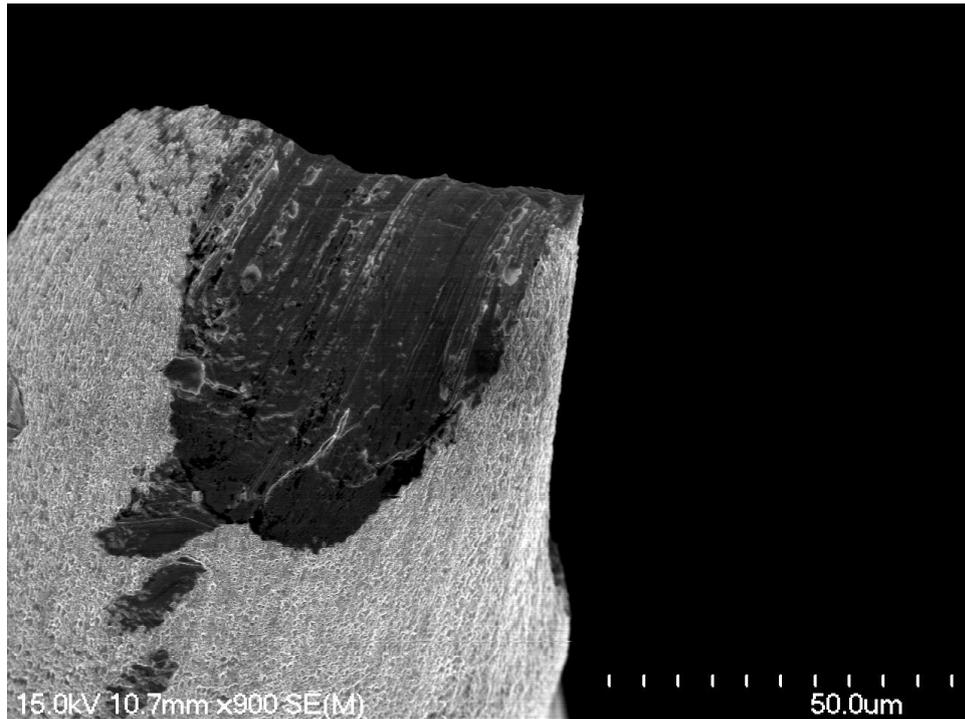
The second method is to mechanically fracture the wire by deformation. The fracture requires clamp points in order to initiate the deformation. The clamp points flatten the texture that is formed on the surface. This suggests that the growths are fragile and susceptible to mechanical wear and tear.

Figure 11 - Deformation from cutting a wire with scissors

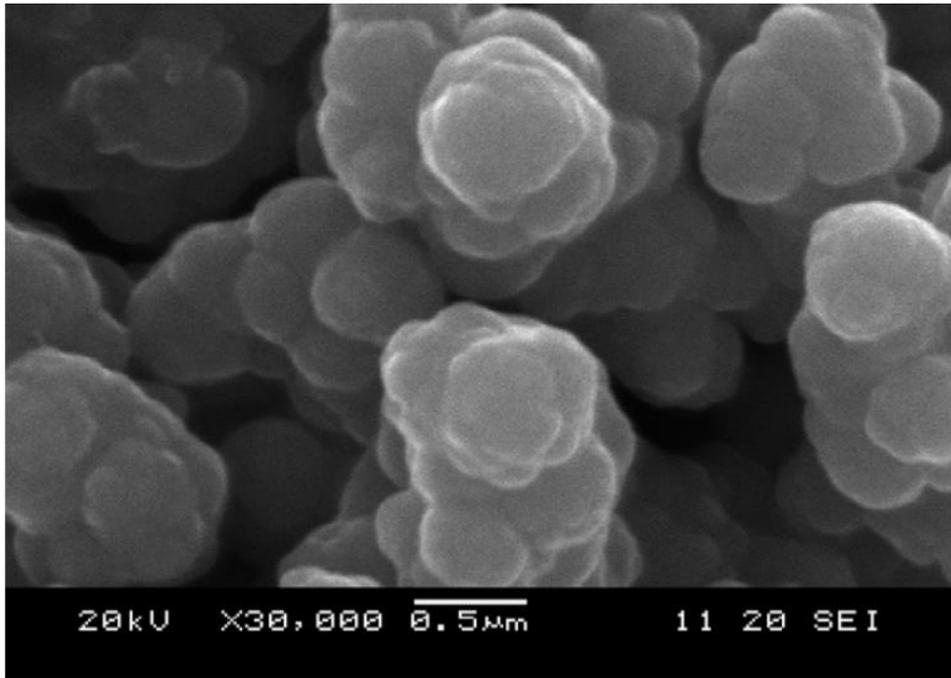
The microstructure of the resulting product reflects the structure that is found deposited on the counter electrode in regular electrochemical corrosion of platinum in sulphuric acid⁽⁶⁾.

Figure 12- Platinum deposition micrograph taken from Fumihiko Kodero 2007

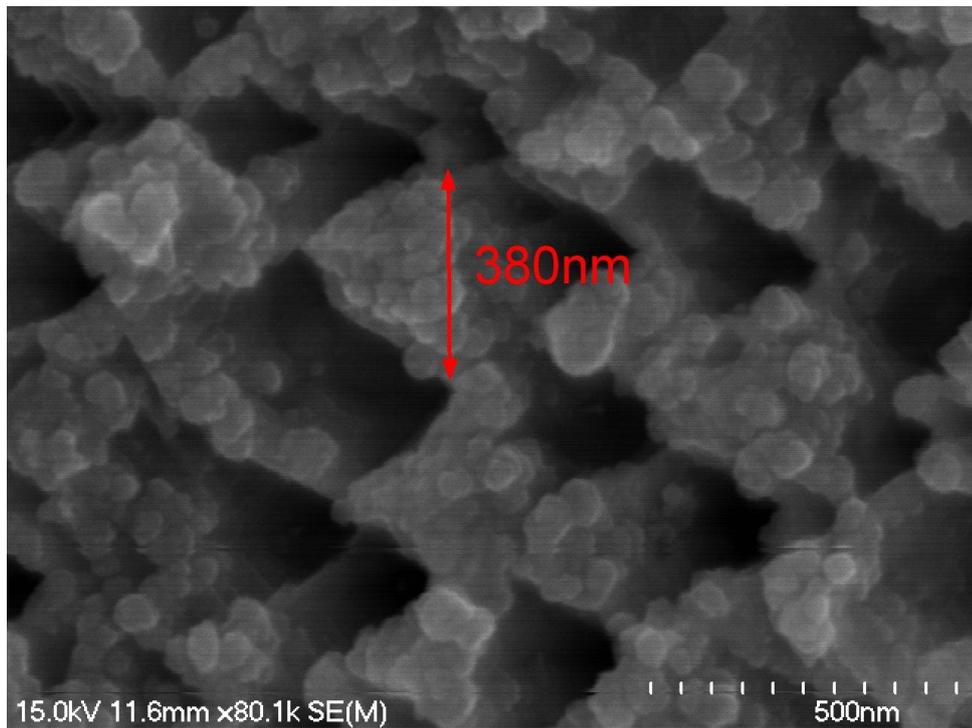
Figure 13- Platinum deposition micrographs from Ottenisation

The coating deposited is symmetrical and repeats predictably along the entire surface of the treated wire.

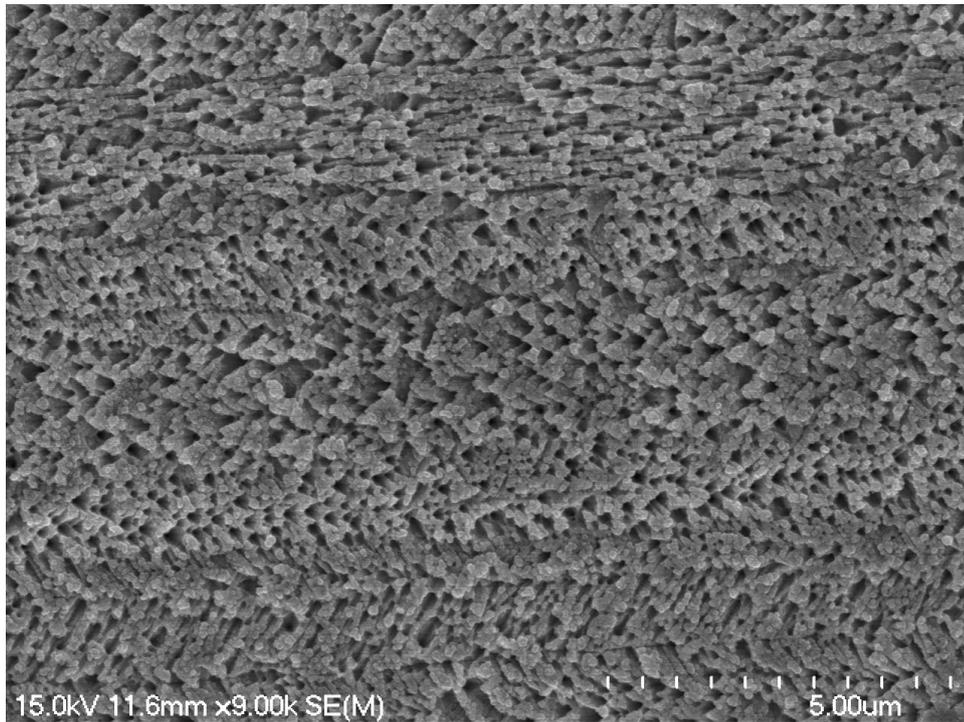
Figure 14-Surface of an Oxidized platinum wire

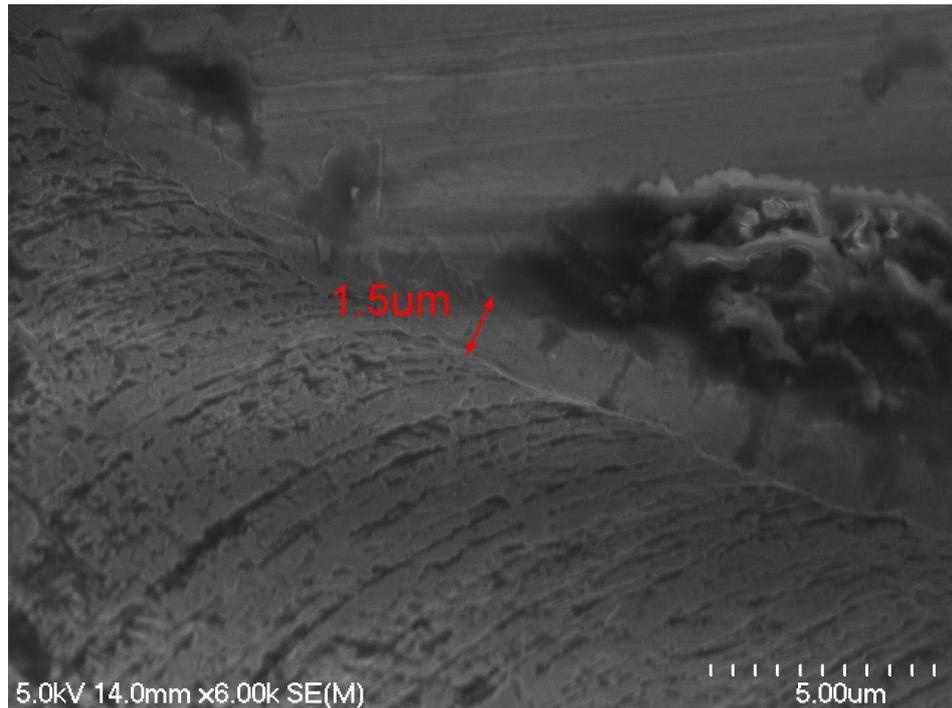
The treatment depth reached a maximum value of about 1.5 micro meters. This depth did not increase even after increasing treatment times. In order to measure this, getting a clear cross section was the most challenging part. A clean fractured surface was the clearest view of the treatment depth. This did come with some drawbacks. Firstly, the wire exhibits ductile fracture. This means that only the part where the fracture begins has a clean edge to image.

Secondly, the wire had to be held firmly in order to be fractured. This caused the surface to be flattened as can be seen. This means that the 1.5 micro meter depth might actually be slightly more if the flattened surface texture is taken into account.

Figure 15 - Oxidized platinum wire showing deposited layer thickness

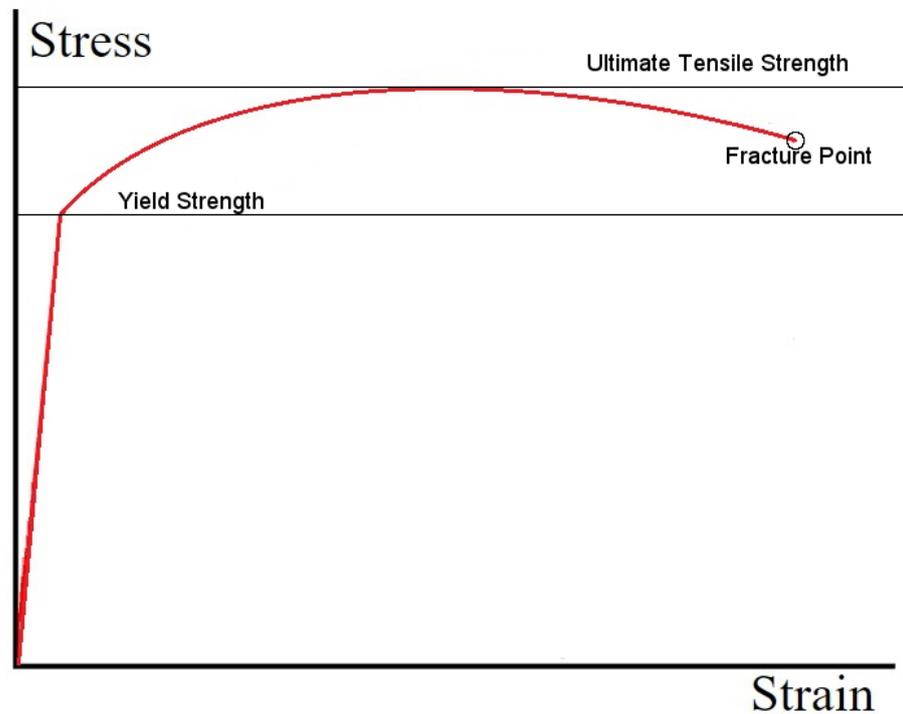
Fatigue cracking is a type of fracture that involves applying a repeating stress to a material. The types of stress applied can be categorised into two regimes of fatigue life: low cycle fatigue and high cycle fatigue. The low cycle fatigue applies a stress that is greater than the yield strength of the material. This type is considered strain controlled and typically fails below 10^4 stress cycles. The high cycle fatigue regime fails at a higher number of cycles while applying a much less than the yield strength.

Figure 16- Typical stress-strain behaviour of a ductile material

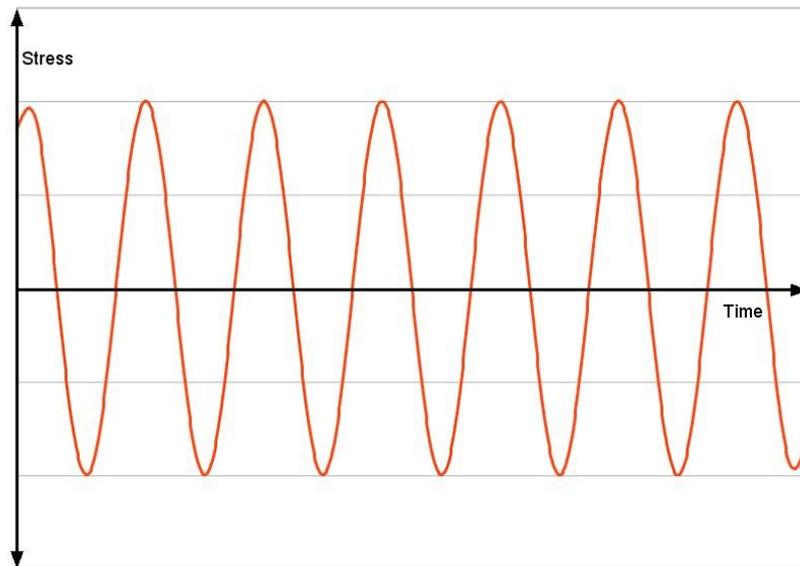
Figure 17- Cyclical fatigue loading

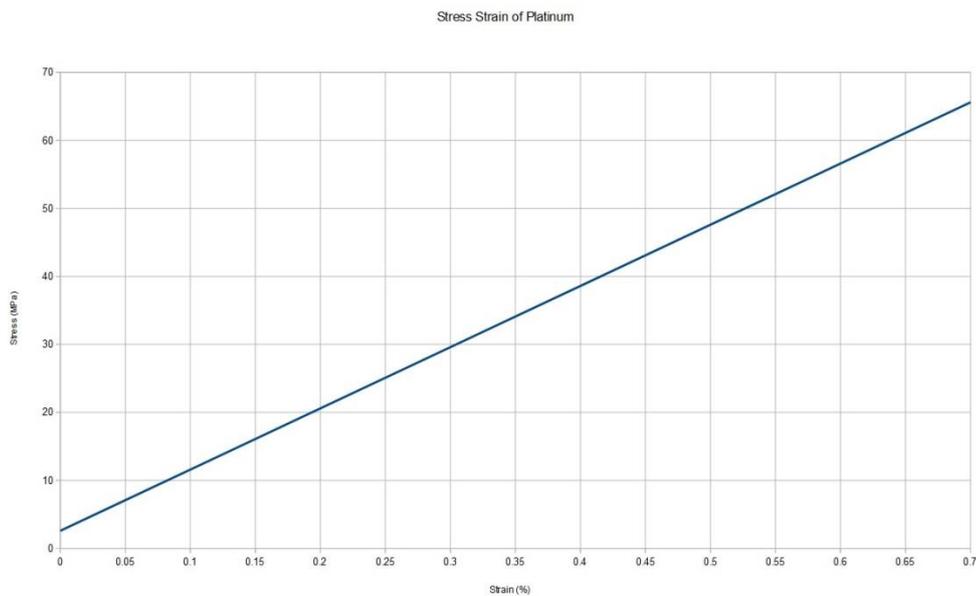
yield strength has to be applied. California Fine Wire does not list yield strength for their material, however other manufactures list platinum with yield strength between 30 and 200 MPa depending on the manufacturing method. From the data available on manufacturing methods it is safe to assume that the yield strength is above 75 MPa. This was later confirmed by tests of greater than 10^4 cycles of under 50 MPa before fracture. A tensile test done by S.J.A. Koh⁽¹³⁾ shows the stress-strain behaviour of platinum in the elastic region.

Figure 18 - Stress-strain behaviour of platinum derived from Koh et.al. experiments

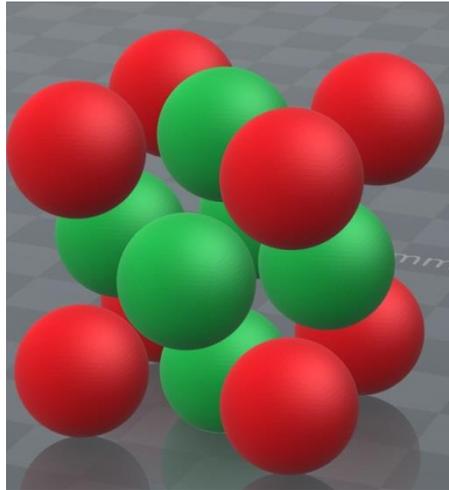
In order to get an idea of the crack and fracture behaviour of platinum, a 0.64mm thick copper wire was used. In addition to being cheaper, the thicker copper is much easier to work with. Platinum is a face centred cubic material (FCC). This is a material that has a cubic shape with a platinum atom at each corner of a cube and one on each face. Below is a representation of an FCC unit cell. The red spheres represent the corner atoms and the green spheres are the atoms on the face of the cell.

Figure 19 - Unit cell of an FCC material

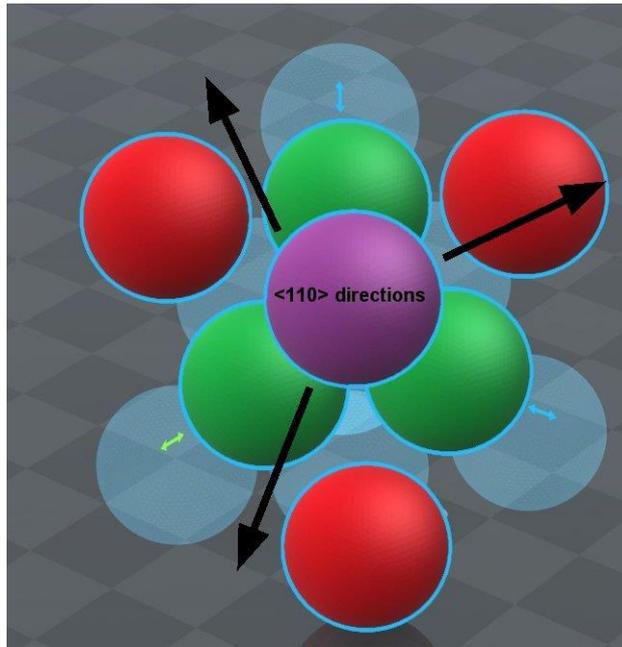
FCC materials have 12 slip systems from 4 {111} planes each with 3 $\langle 110 \rangle$ directions. The image below illustrates this slip using one of the {111} planes. The purple atom rests on top of one of these plane and can slip between the atoms above and below it in the $\langle 110 \rangle$ directions.

Figure 20 - $\langle 110 \rangle$ slip directions

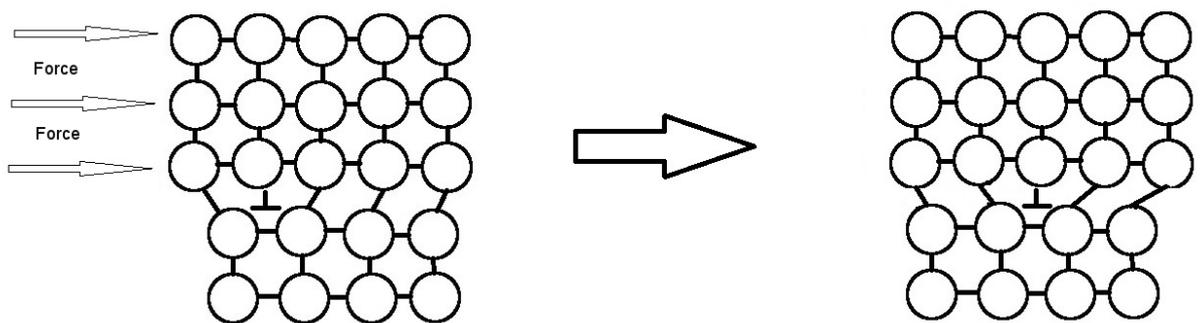
Dislocation movement occurs along the slip planes. This is because atomic movement along slip planes requires relatively low amounts of energy. The way that slip occurs is when an applied stress causes bonds around a dislocation to reform and shift said dislocation. Below is an example of the movement of an edge dislocation.

Figure 21- Model illustrating one form of dislocation movement (edge dislocation)

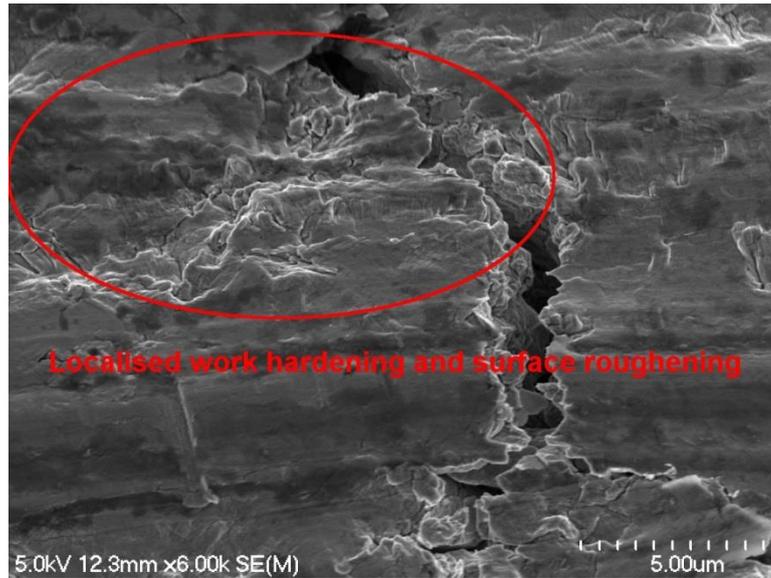
Subsequent dislocations form in the same manner and glide in the same way and are stopped at the same points. These dislocations stack up and form what is called a persistent slip band (PSB). This is an area of high strain concentration. The high volume of dislocations can cross-slip and climb which introduces vacancies, localised work hardening, and surface roughening.

Figure 22 - Micrograph of a micro crack in copper

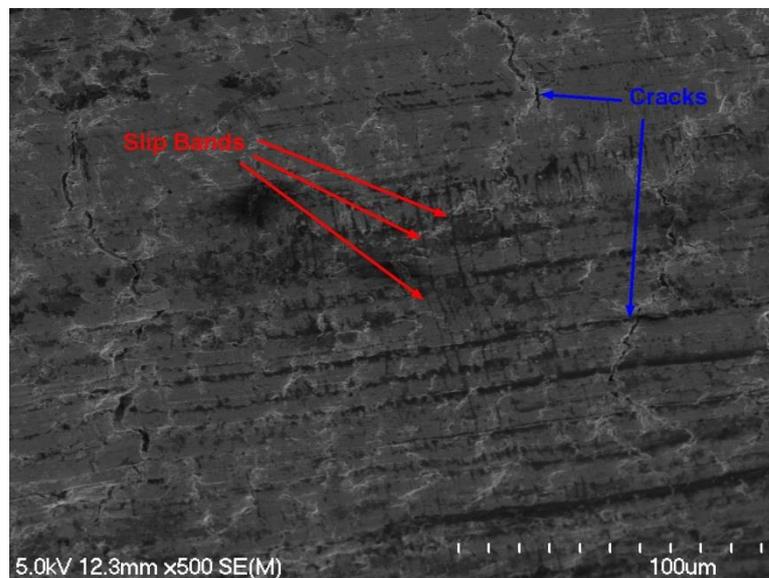
After enough stress is applied, and enough dislocations are stacked on top of each other, these slip bands can break open and form what is known as a crack.

Figure 23- Slip bands formed in a fatigued copper sample

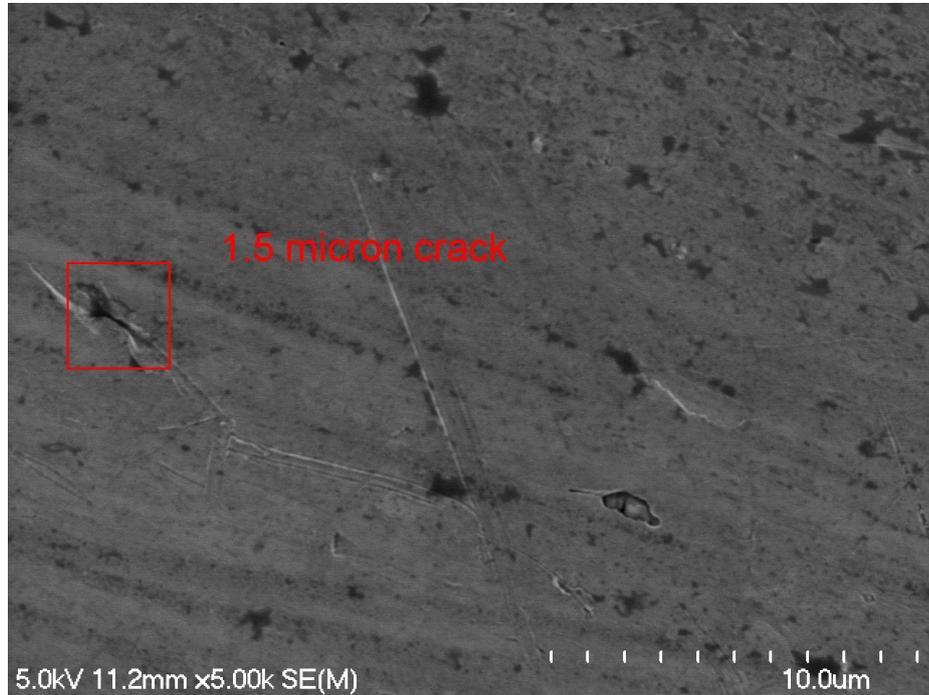
When a platinum sample that was fatigued for 5,000 cycles was put into the SEM, cracks started to be apparent in the surface of the sample on the order of

1 micron in size. These small cracks were used as initial crack sizes for further analysis. When samples were less fatigued, the surface was not obviously cracked.

Figure 24- 5,000 fatigue cycle platinum sample showing crack initiation. 1.5 micron was the largest crack found

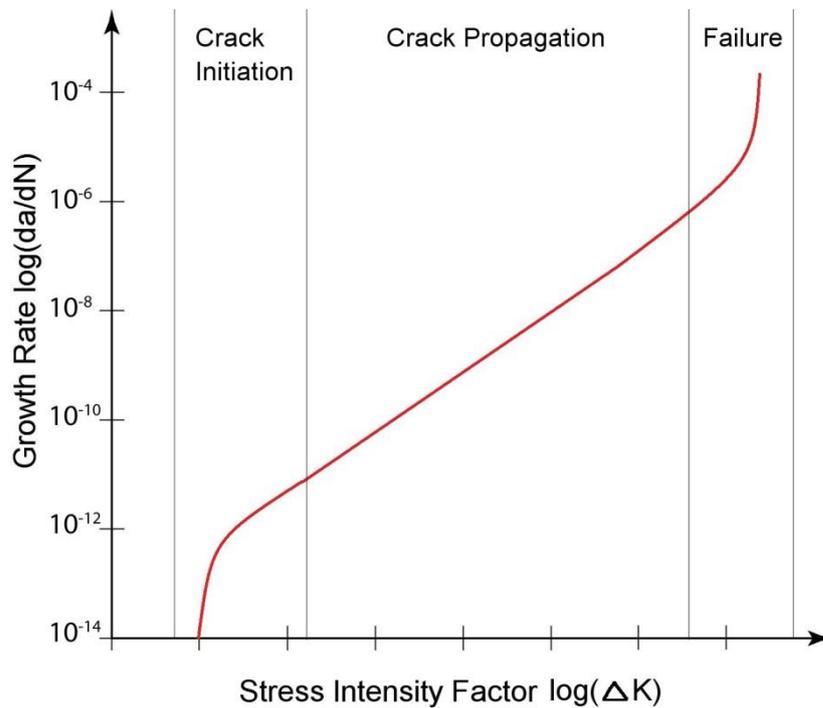
get an order of magnitude idea of how many cycles were needed for failure. The material constant m is dimensionless and generally between 3 and 5. The C value is a little bit trickier and needs to be experimentally determined. It generally varies from 10^{-7} to 10^{-12} MPa and is highly dependent on material, grain structure, and material phase. When the crack growth is plotted in a log-log plot, it has a general shape shown below.

Figure 25- Typical behaviour of fatigue cracking. Log-log plot

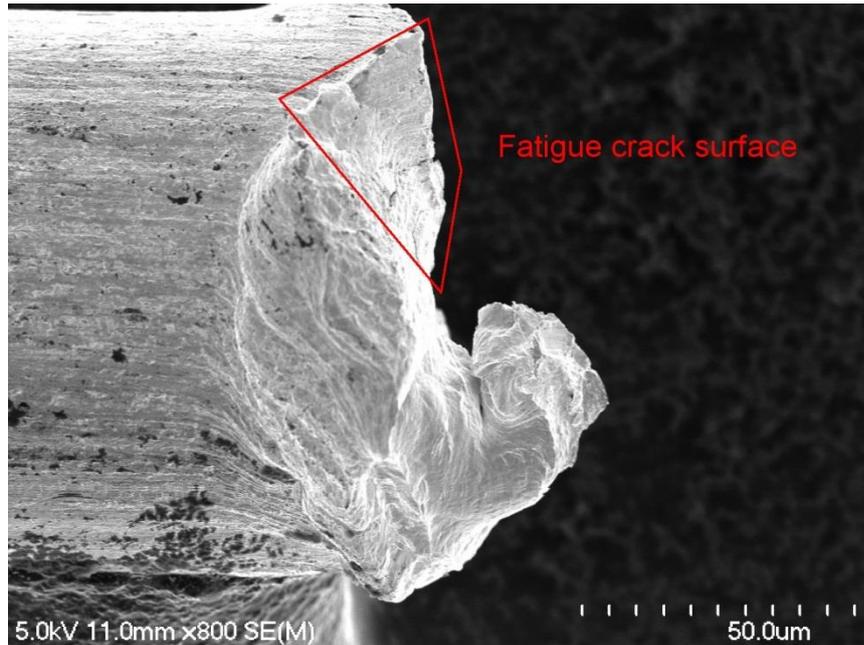
Once a crack has grown to a critical crack size, the material will fracture. This crack size is dependent on the material, its microstructure, and the applied load. The critical crack size for the platinum wire used has to be experimentally determined. In order to do this, a test was run until the material failed and a micrograph was taken to look at the fracture surface.

Figure 26- Ductile failure of a fatigued platinum wire sample

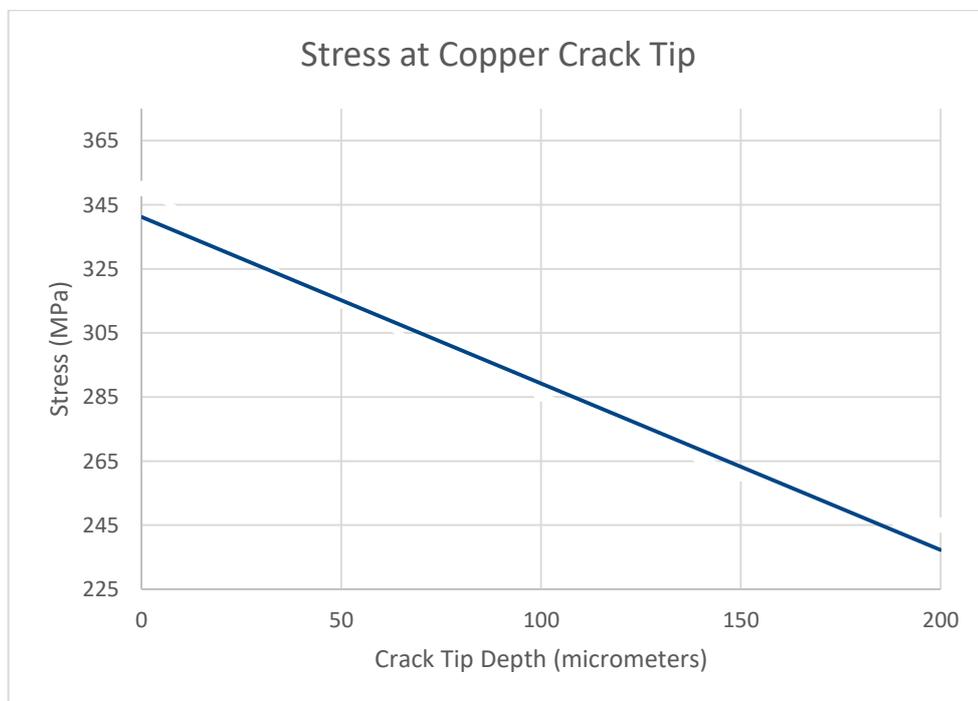
The stress that is applied to the wire at each depth can be plotted using the stress/strain behaviour of the material mapped to the strain at the distance from the neutral axis in a sample undergoing pure bending.

Figure 27 - Model of stress at crack tip in the copper wire

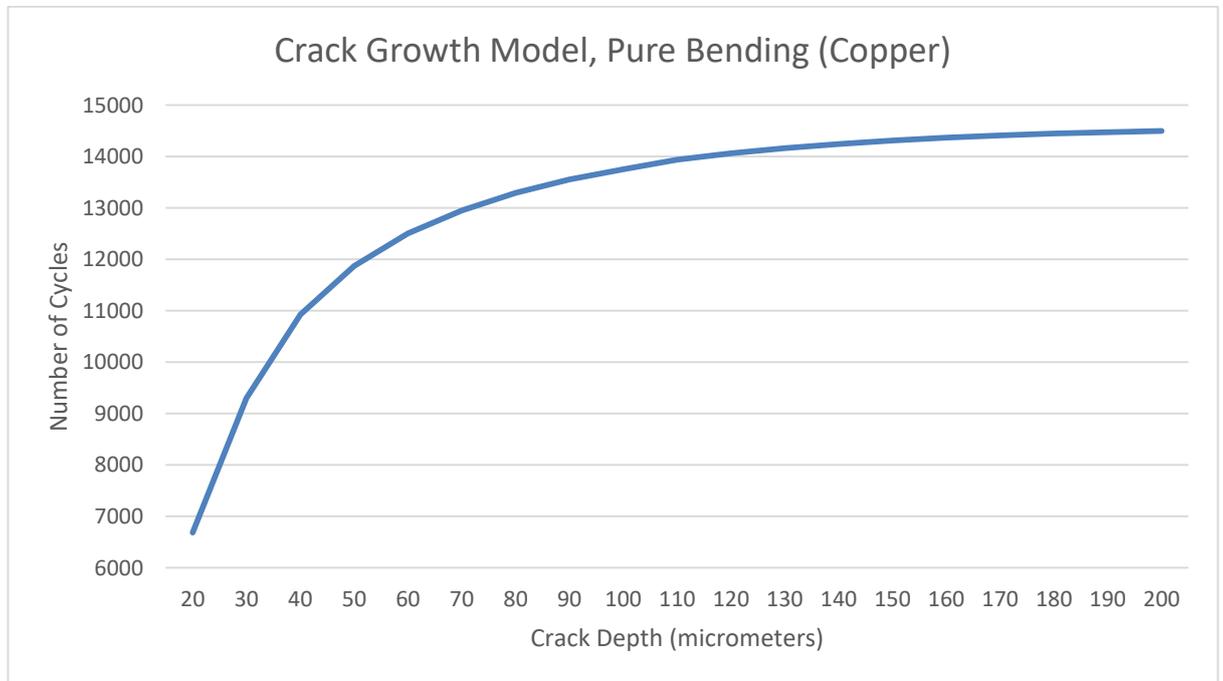
Then using the Paris model, the following crack behaviour can be expected.

Figure 28 - Crack tip depth for copper at 0.5% strain cycles

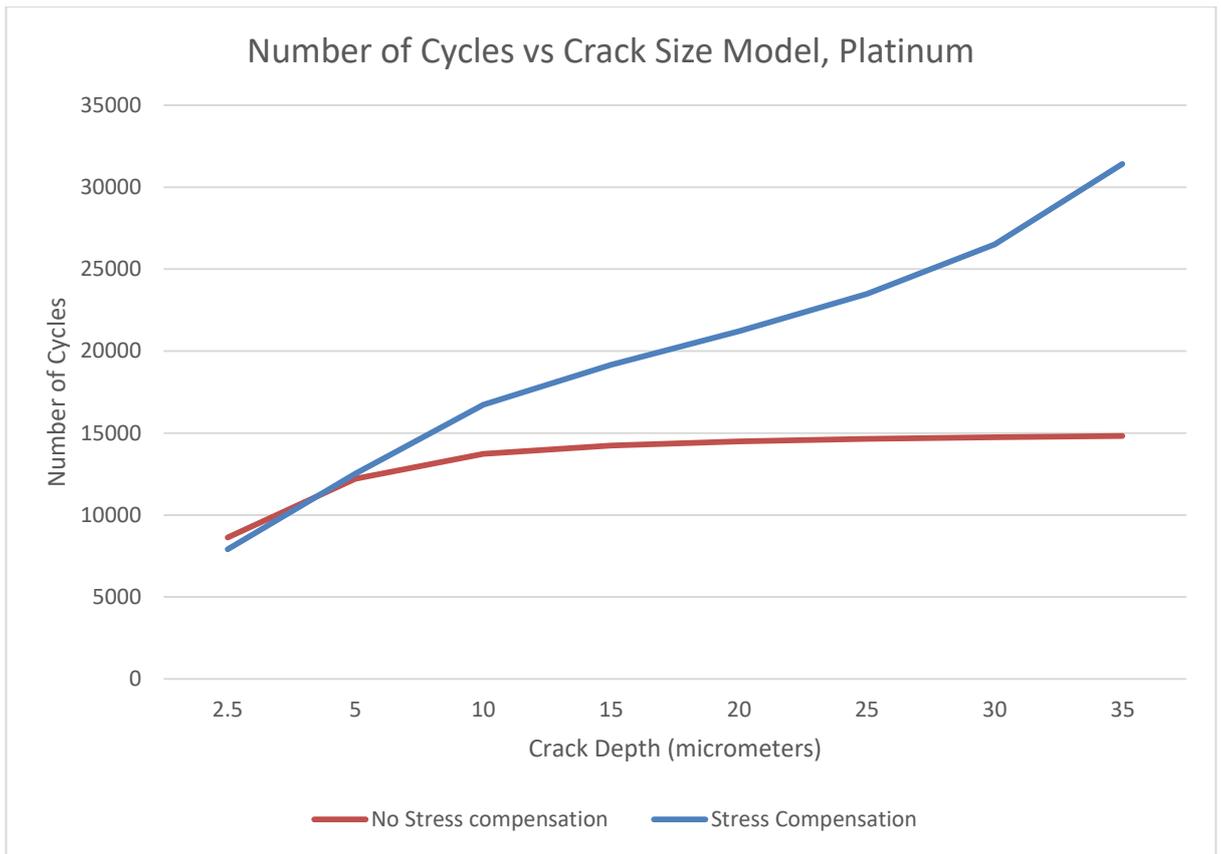
A similar kind of model can be made for the platinum wire. This shows a much more linear behaviour because of the size of the wire. The small diameter means that as the crack grows, the tip reaches the neutral axis very quickly. This causes the amount of strain, and therefore stress, to drop off very quickly which offsets the exponential growth rate. In addition, pure bending has a different effect than plain tensile stresses on the geometric factor, Y .

Figure 29- Crack tip depth for platinum at 0.5% strain cycles

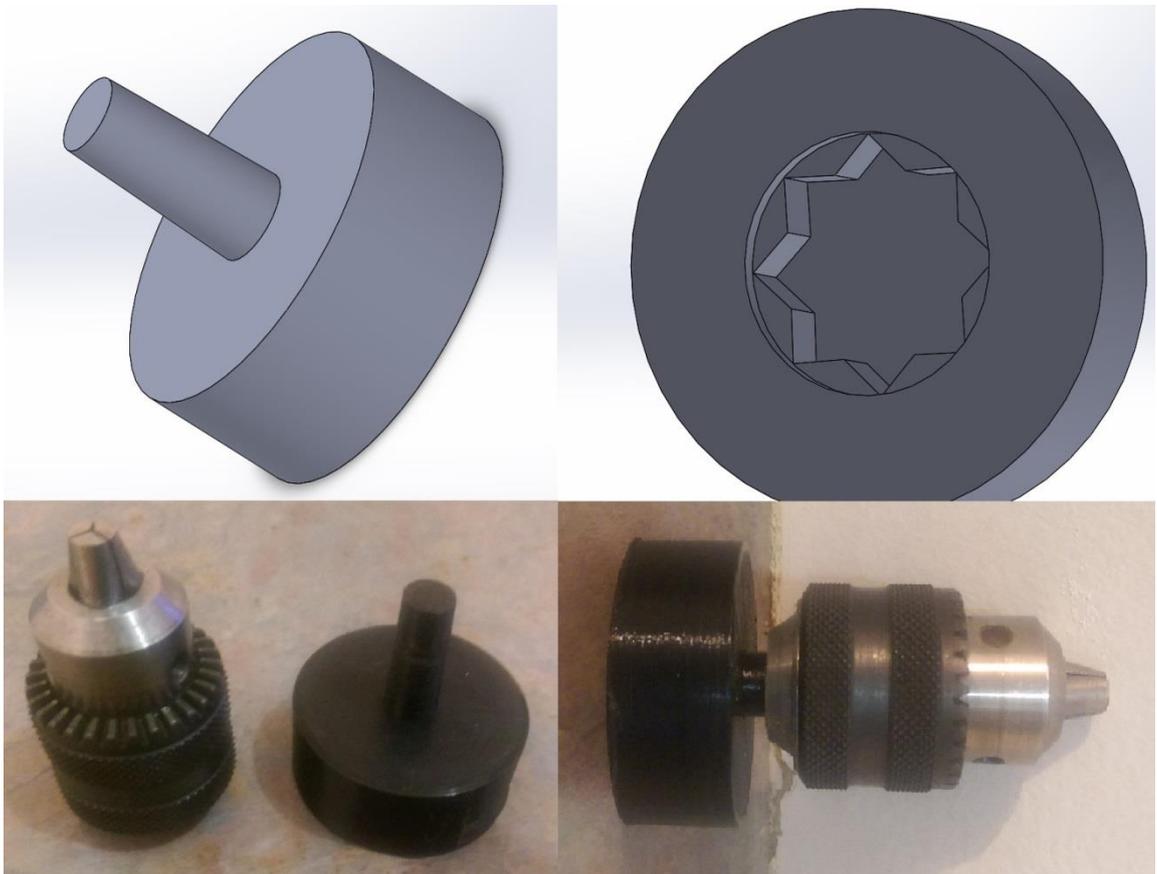
The second part needed is a way to hold the wire. To do this, a high quality drill chuck was found. This drill chuck needed to have the ability to clamp down to 0mm in order to hold a 100 micron wire. An LFA 0-1/4" drill chuck was acquired and found to be able to hold this wire securely. To be able to mount the drill chuck to the motor, a mount was designed in Solid Works and 3D printed.

Figure 30- Drill chuck stand for mounting onto a DC motor, design and the printed part

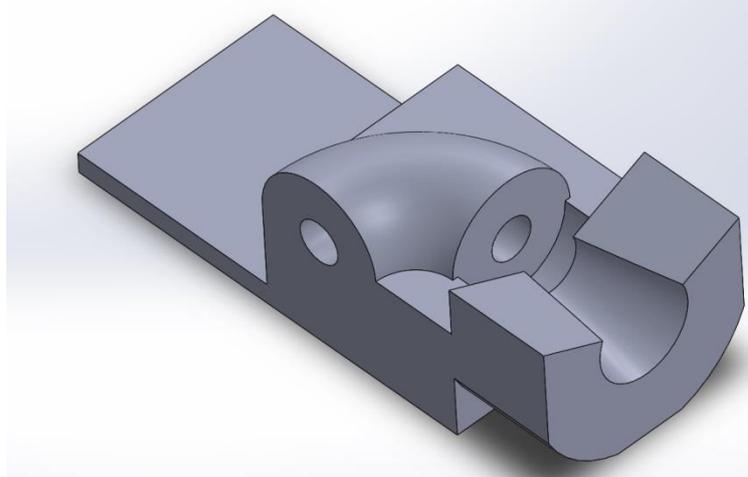
needed. A tube that is bent with the desired radius was used instead. This was also designed in Solid Works and 3D printed.

Figure 31- Stand to hold a wire in a constant bend
