Surface Roughening of Platinum Wire
An Electrochemical and Mechanical Approach

A thesis

Masters of Engineering

The University of Waikato

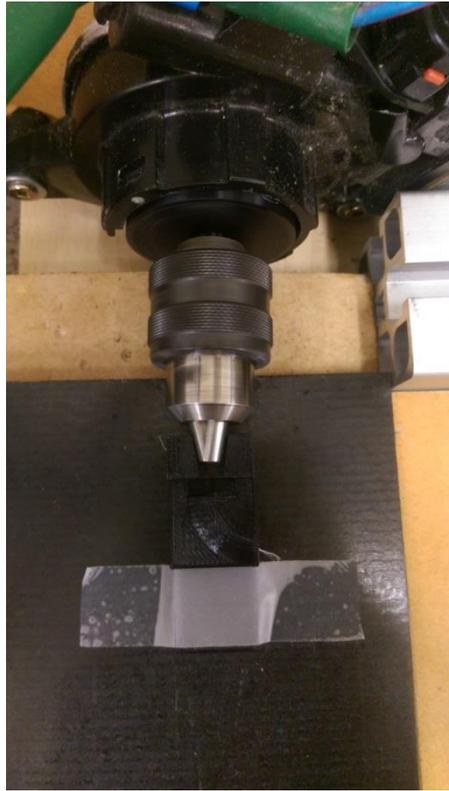
When the test rig is set up, the motor rotates at a constant speed for even extended periods. Run times up to 10 days of continuous operation were completed to test the reliability of the motor and rig as well as to make sure that the motor continued to rotate at a constant speed. The final setup worked without failure for all the tests of both copper and platinum samples.

Figure 32- Test fixture when assembled

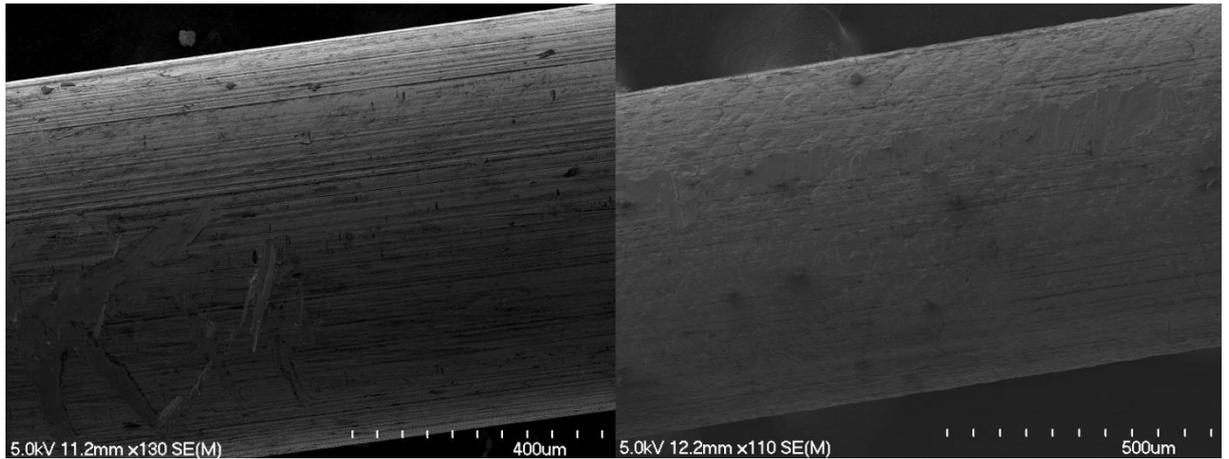
Surface texture of copper after fatiguing was dramatically altered. This is because of the high amount of dislocations and the cracks that accumulate on the surface. The crack density measured was approximately $3\mu\text{m}/100\mu\text{m}^2$ in a sample that was fatigued to failure. This is done by measuring the total length of cracks in a known area.

Figure 33 - Copper wire before (left) and after (right) fatigue

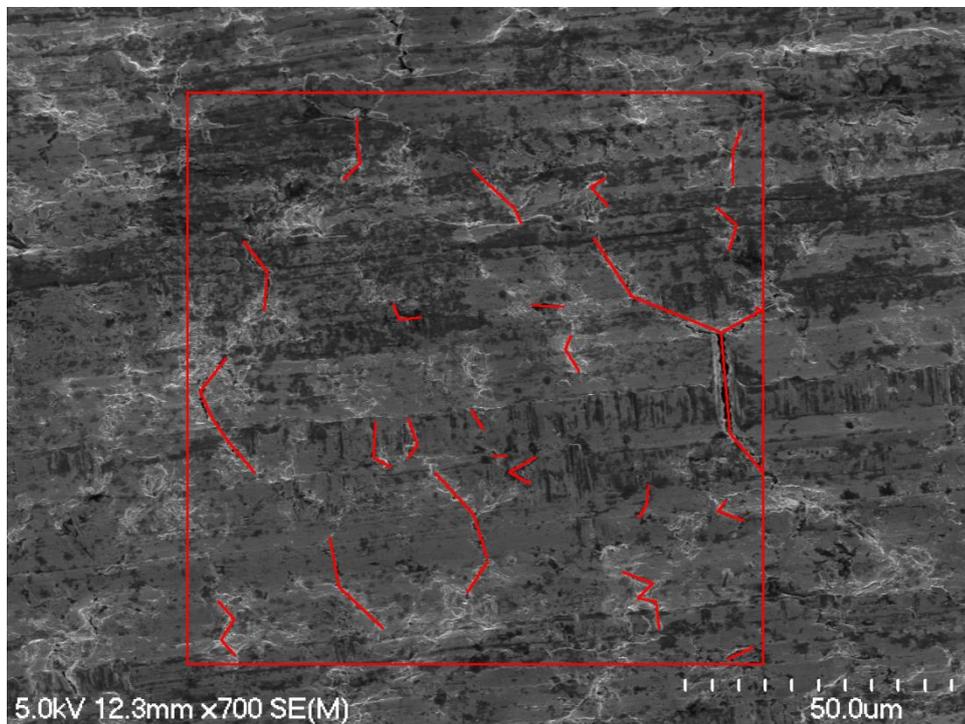
Figure 34- Copper surface after fatigue to failure

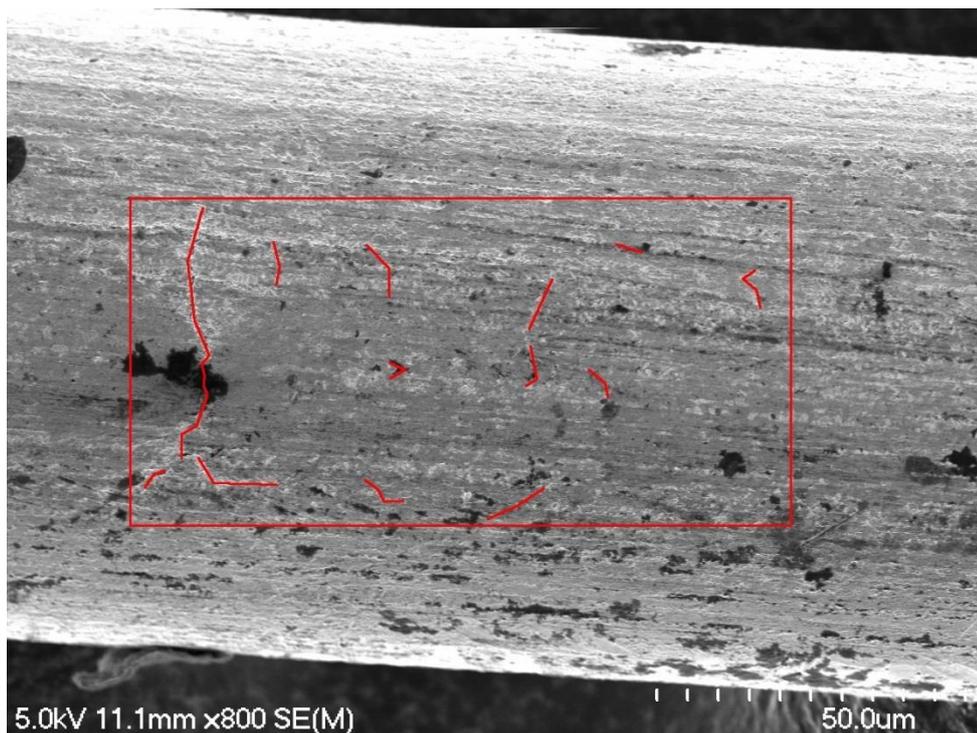
A closer and more comprehensive look was taken at platinum. The crack density was calculated over several areas that were fatigued. The average was found to be about $2.5\mu\text{m}/100\mu\text{m}^2$ in a sample that was fatigued to failure.

Figure 35- Platinum surface of a sample fatigued to failure

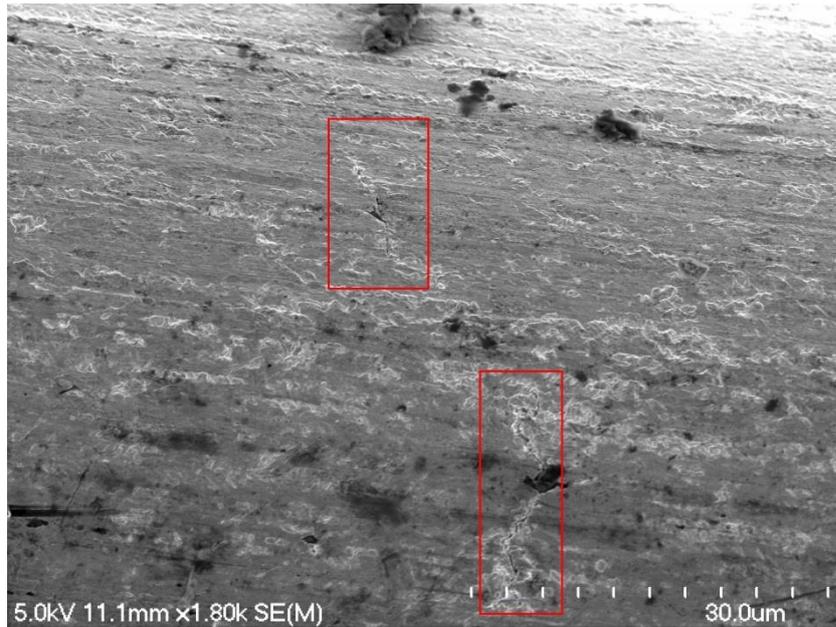
Samples that were run to failure took 31,000 and 32,500 cycles to fail. Two samples underwent 5,000 cycles to look for initial crack sizes. Sets of three tests were done at 7,000, 10,000, 15,000, 20,000, and 25,000 cycles. For analysis, each of the samples had several of the larger cracks measured and averaged in order to determine a crack length.

Figure 36- Example of cracks used for size analysis

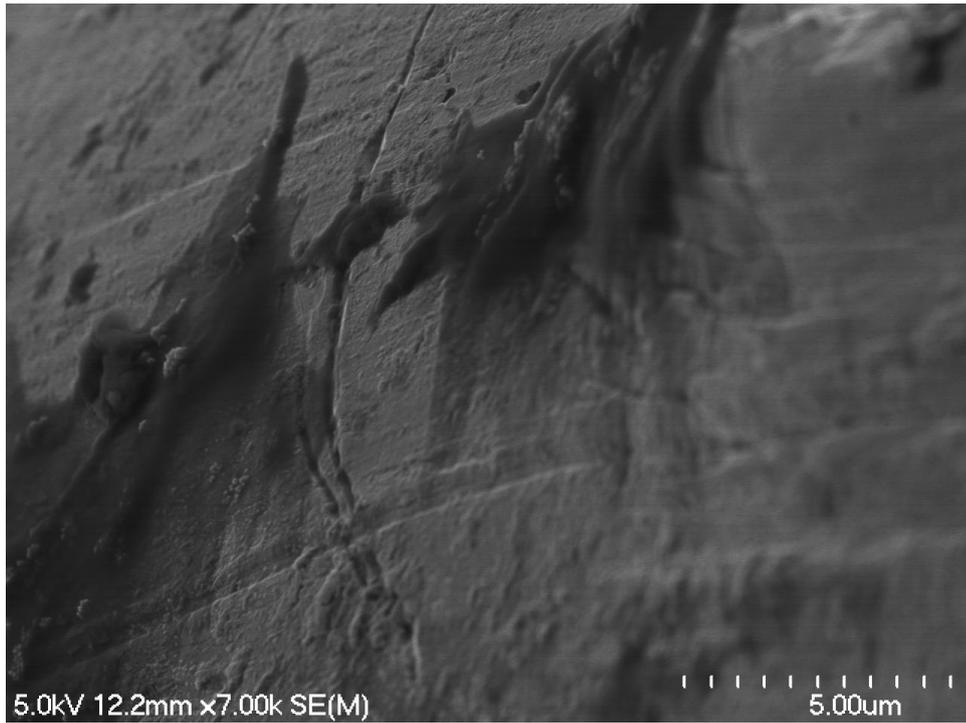
Cross sections of the wires were taken to measure crack depth as well as surface pictures to measure crack length. These measurements showed that the length and depth of any given crack was about the same. This is seen nicely in a sample fatigued to with 20,000 cycles. Below are pictures of both a cross section and a surface crack of the same sample. Both show a crack size of about 15 microns.

Figure 37- Single large crack in 20,000 cycle sample

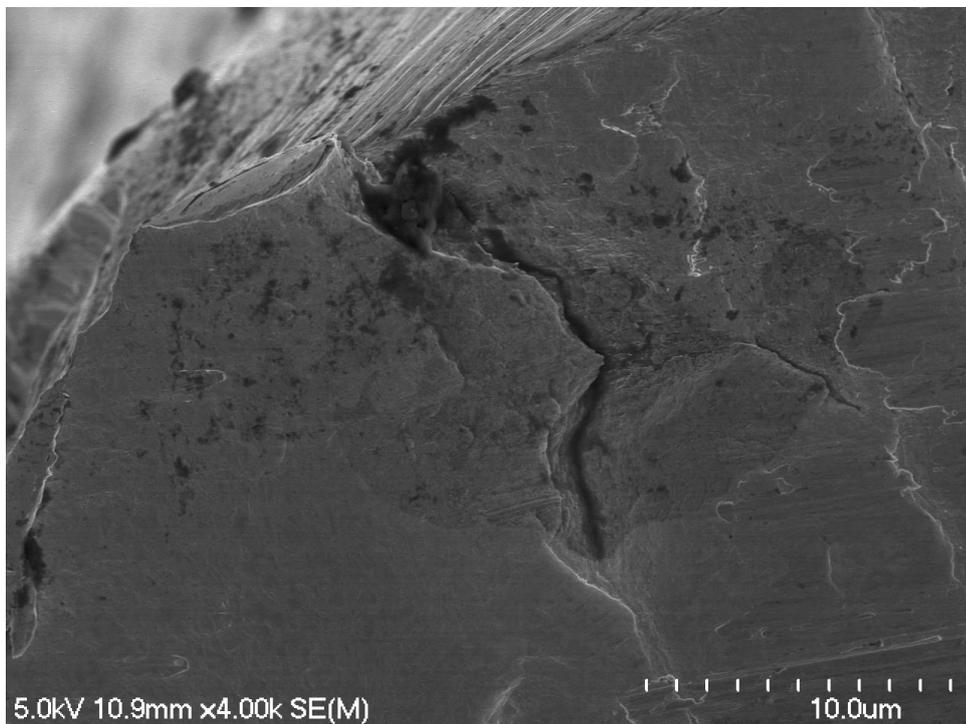
Figure 38- Cross section of a crack in a 20,000 cycle fatigue platinum wire

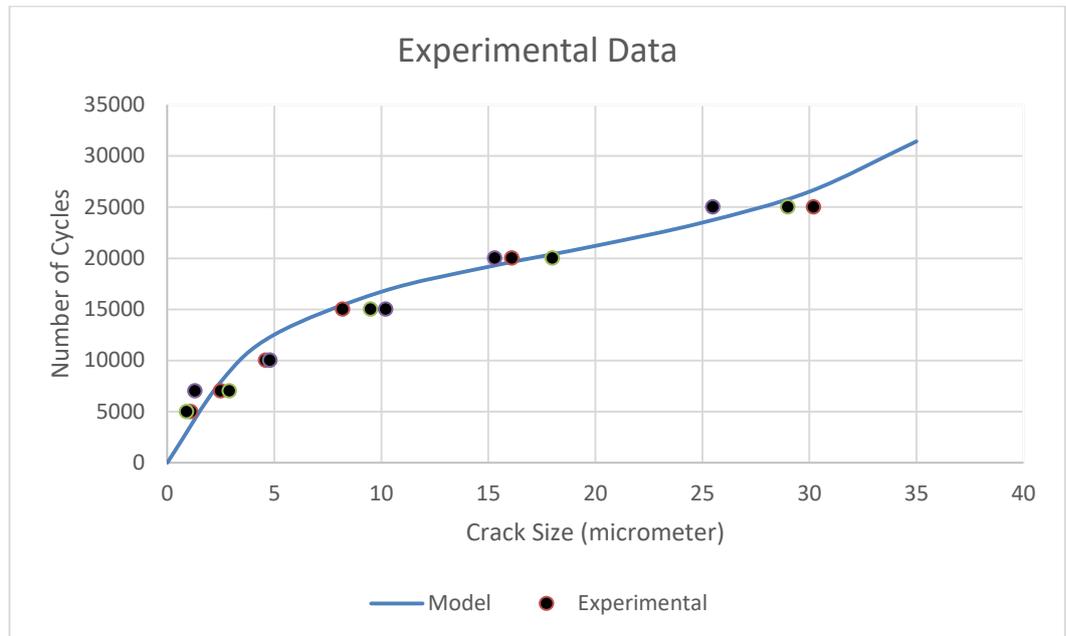
The crack sizes were found to vary from 1 to about 35 microns. The cracks generally seemed to grow in a way that reflected the mathematical model. The results are graphed along with the mathematical model.

Figure 39 - Experimental data plotted on the crack growth model

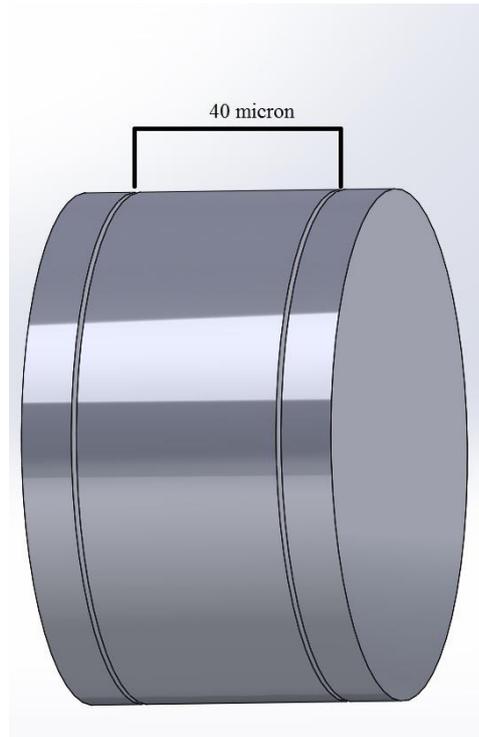
Mechanical fatigue creates surface defects that grow predictably and have a statistically regular density of formation. When crack depths (sizes) of approximately $15\mu\text{m}$ were reached, the density was about $2.5\mu\text{m}/100\mu\text{m}^2$. This translates to a crack that travels the entire circumference every $40\mu\text{m}$ for the $100\mu\text{m}$ thick wire, as illustrated in figure 40. However, this is a statistical interpretation, and the reality is that the cracks do not form in this way.

Figure 40 - Statistical interpretation of crack density

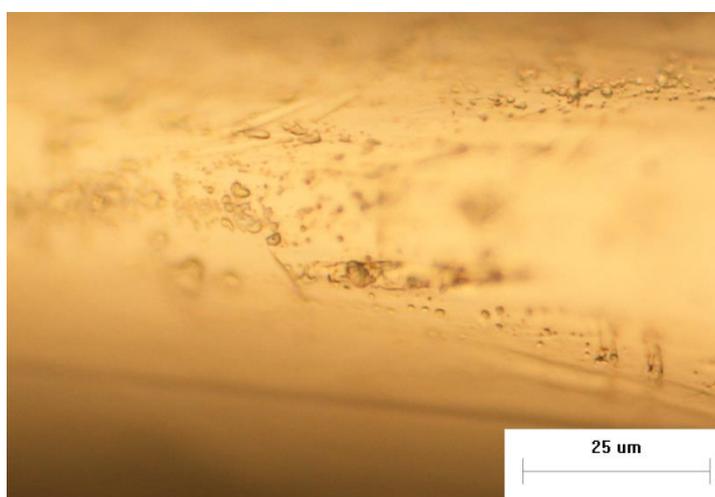
In order to increase the growth size and depth of the electrochemical treatment, a pure pitting experiment was conducted. After the Ottenisation was completed the high roughness was used as initiation points for pitting corrosion. The roughened wire was submerged in a stagnant 3 molar NaCl solution and given a +5V bias. This was left for 24 hours and observed in an optical microscope.

Figure 41 - Pure pitting at the surface of a platinum wire

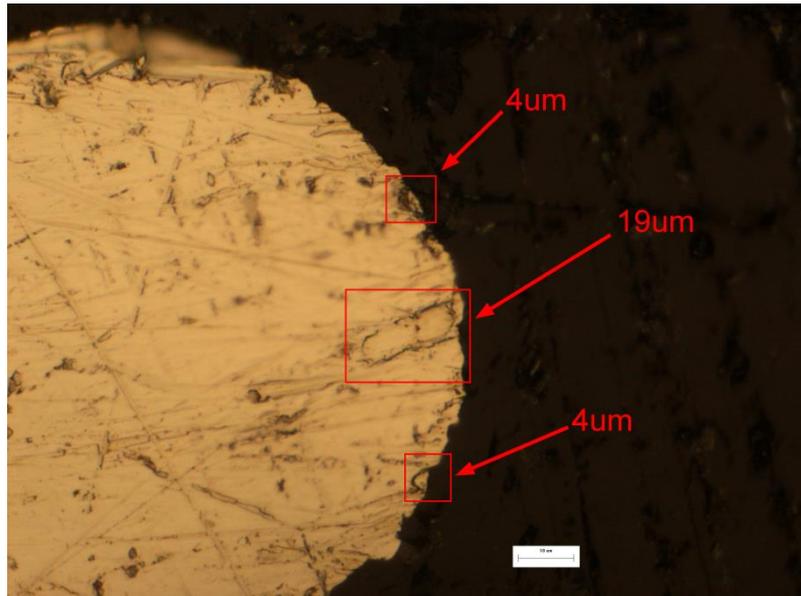
The growth sizes in the Ottenisation-only process were under 1 micron as can be seen earlier in this paper. The pit sizes, when this corrosion step was added, varied from 1 micron to 5 microns in diameter. This can be controlled to be larger or smaller by adjusting the treatment duration. In addition to larger surface textures, the pores can be made much deeper. In the wire shown in figure 7, the pits were observed to reach a depth of 19 microns as seen below.

Figure 42- Cross section of a pitted platinum wire sample
