**Decay Fungi from New Zealand Leaky Buildings:
Isolation, Identification and Preservative Resistance**

A thesis
submitted in partial fulfilment
of the requirements for the Degree of
Doctor of Philosophy in Biological Sciences
at
The University of Waikato
by

2008

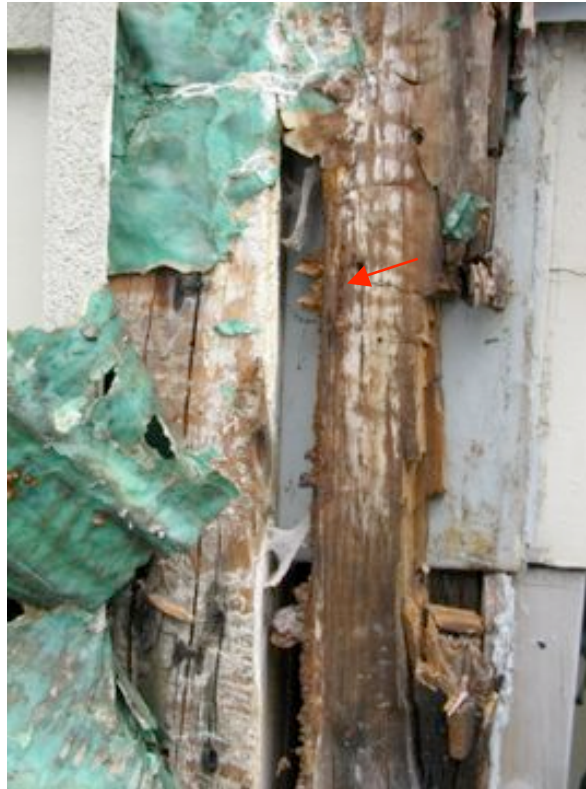
Figure 1.1 *Gloeophyllum sepiarium* fruiting body (arrow) on framing stud and associated white mycelium. Framing timber used was *P. radiata*.

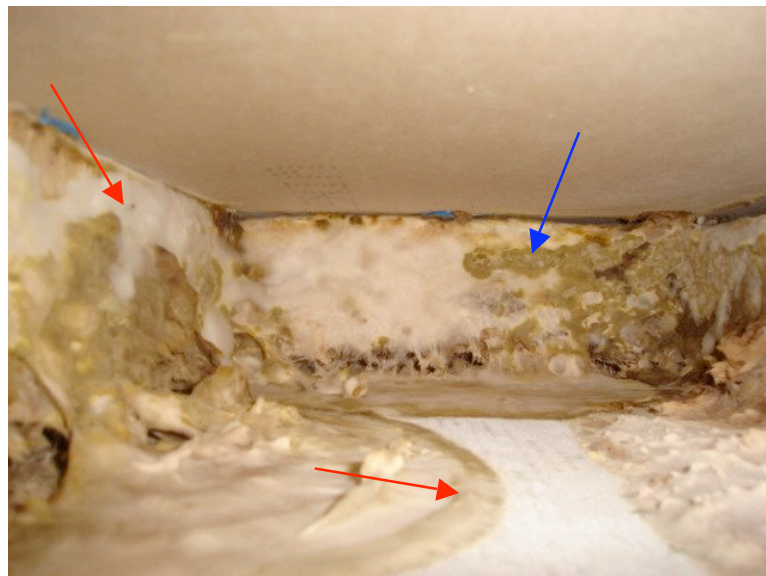
Figure 1.5 Advancement of mycelium (red arrows) in wall cavity and secondary mould growth (blue arrow). Source: Beagle Consultancy Ltd, Rotorua, NZ.

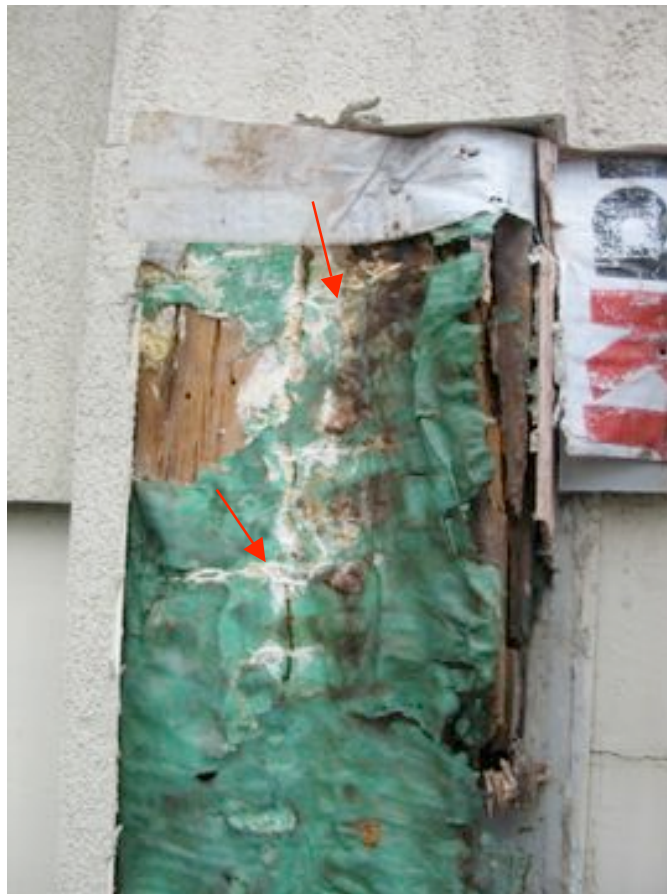
Figure 1.6 Strand formation of a basidiomycete fungus on building paper (arrows).

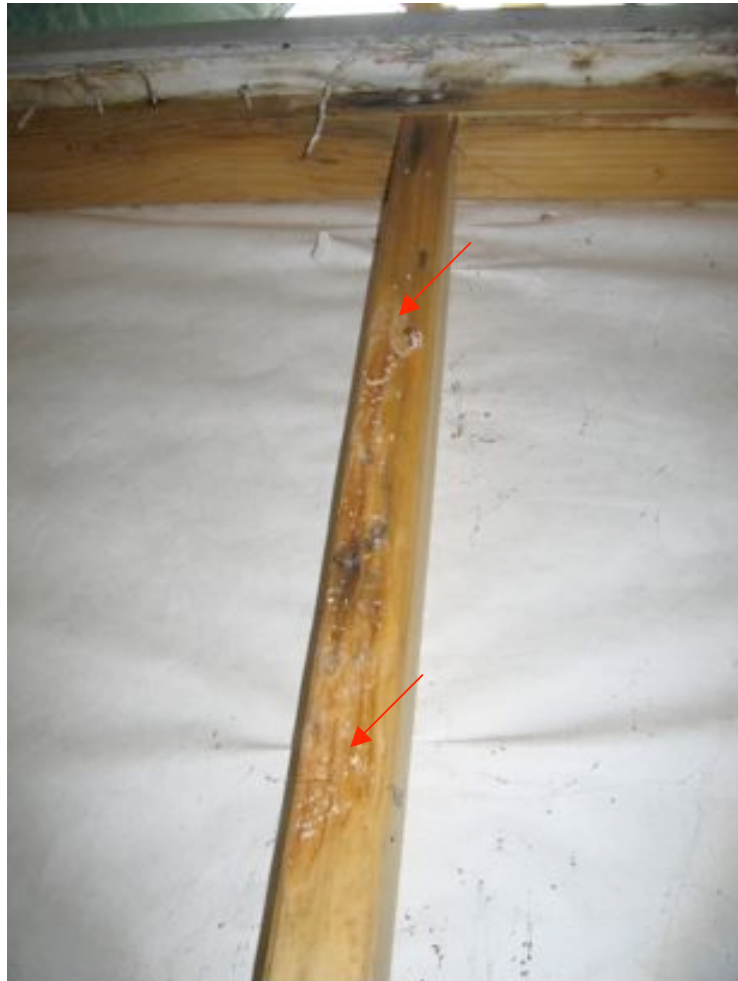
Figure 1.14 *P. radiata* wall stud showing early signs of decay establishment on the surface, indicated through formation of white mycelium (arrows). Source: Prendos Ltd., Auckland, NZ (2007).

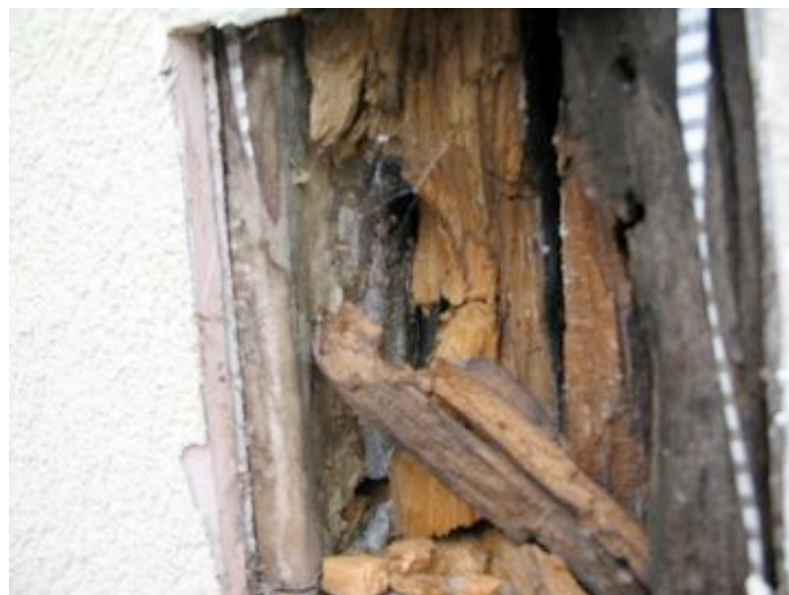
Figure 1.16 Corner wall stud heavily degraded and exploited for nutrients by decay fungi.

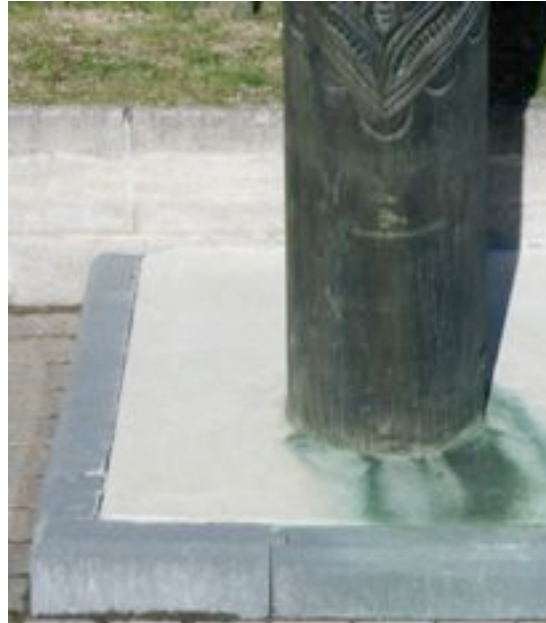
Figure 1.21 Greenish leachate staining the concrete in front of a CCA-treated pole.

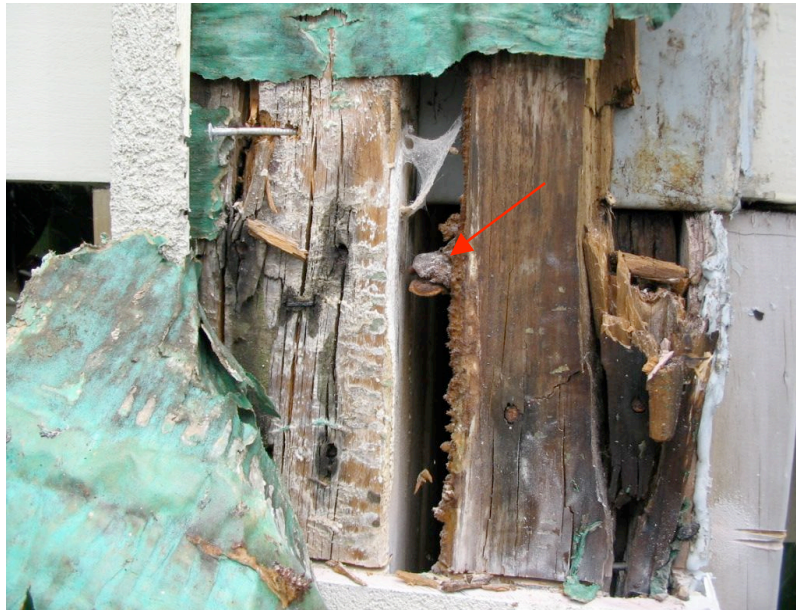
Figure 2.1 Fungal fruiting body *Gloeophyllum sepiarium* growing between two vertical studs (red arrow); detected after exterior wall cladding material was removed.

In addition to identifications by sequencing (Section 2.3.2), thirteen fungal fruiting bodies were identified by traditional morphological examination through combinational use of identification keys and are listed in Table 2.2. Some exemplifying photographs showing the identified fungi *Gloeophyllum sepiarium*, *Lentinus squamosus*, *Serpula lacrymans* and *Phellinus contiguus*, growing on various building materials, are shown in Figures 2.1 to 2.4. Further, Figure 2.5 outlines the difficulty to analyse a “dark” fruiting body due to its unnatural appearance, thought to belong to *Gloeophyllum sp.* but the molecular investigation couldn’t reveal a positive identification since no PCR amplification of extracted DNA was achieved.

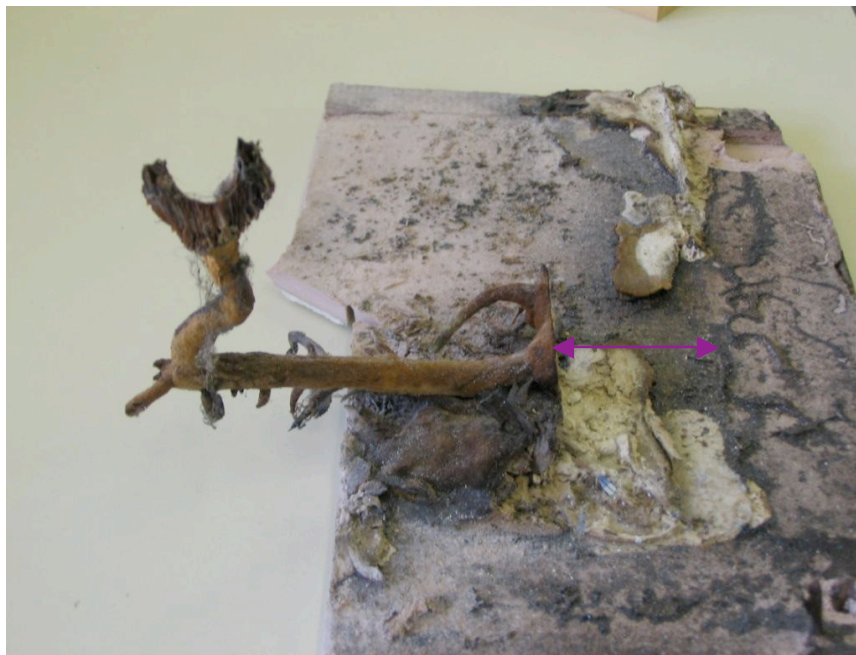
Figure 2.2 Fungal fruiting body *Lentinus squamosus* detected behind monolithic cladding material. Note: Magenta arrowheads indicating the original positioning of the wall framing (Courtesy of Beagle Consultancy Ltd., Rotorua, NZ).

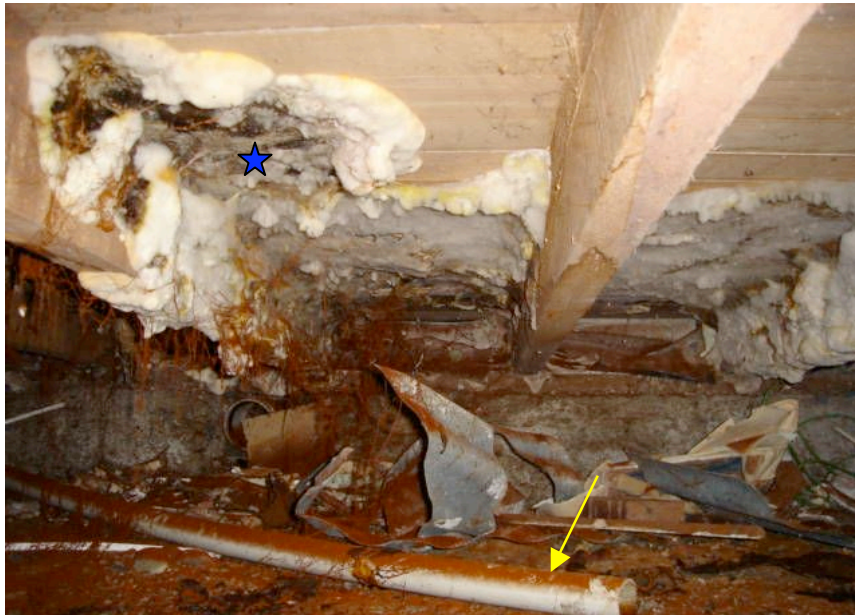
Figure 2.3 Fungal fruiting body *Serpula lacrymans* development under house floorboards (blue star); Red 'dust' on the ground and on various building materials are reproductive spores produced by this fungus (yellow arrow) (Courtesy of AA House Checks Ltd., Christchurch, NZ).

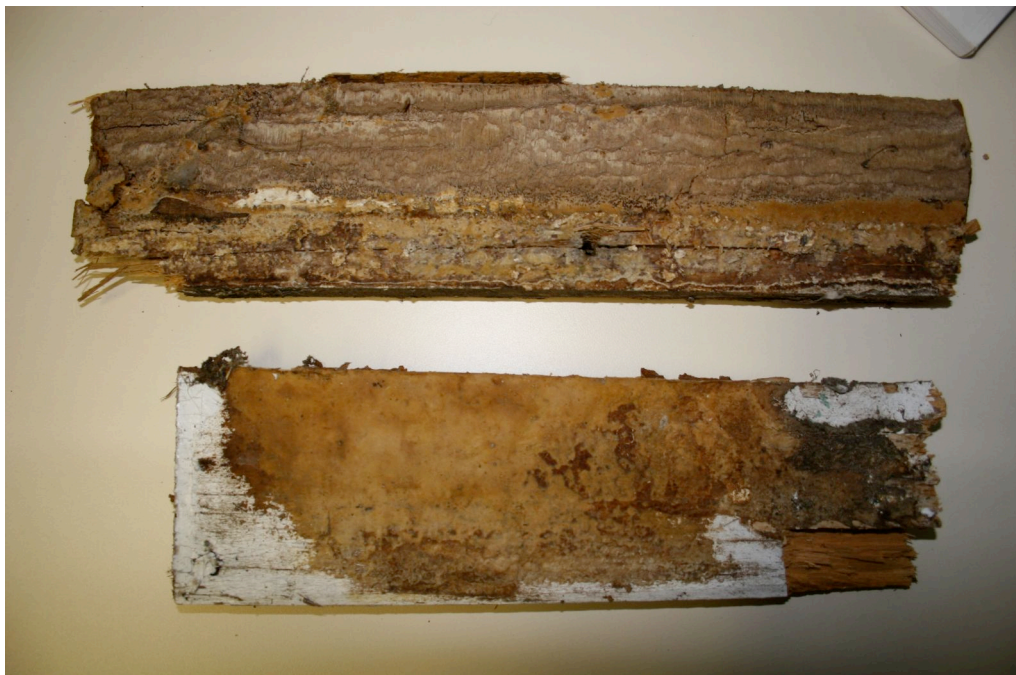
Figure 2.4 *Phellinus contiguus* detected growing on softwood weatherboards made of *Dacrydium cupressinum* Lamb. (rimu) (Courtesy of Ian Dickie, Landcare Research, Southbridge, NZ).

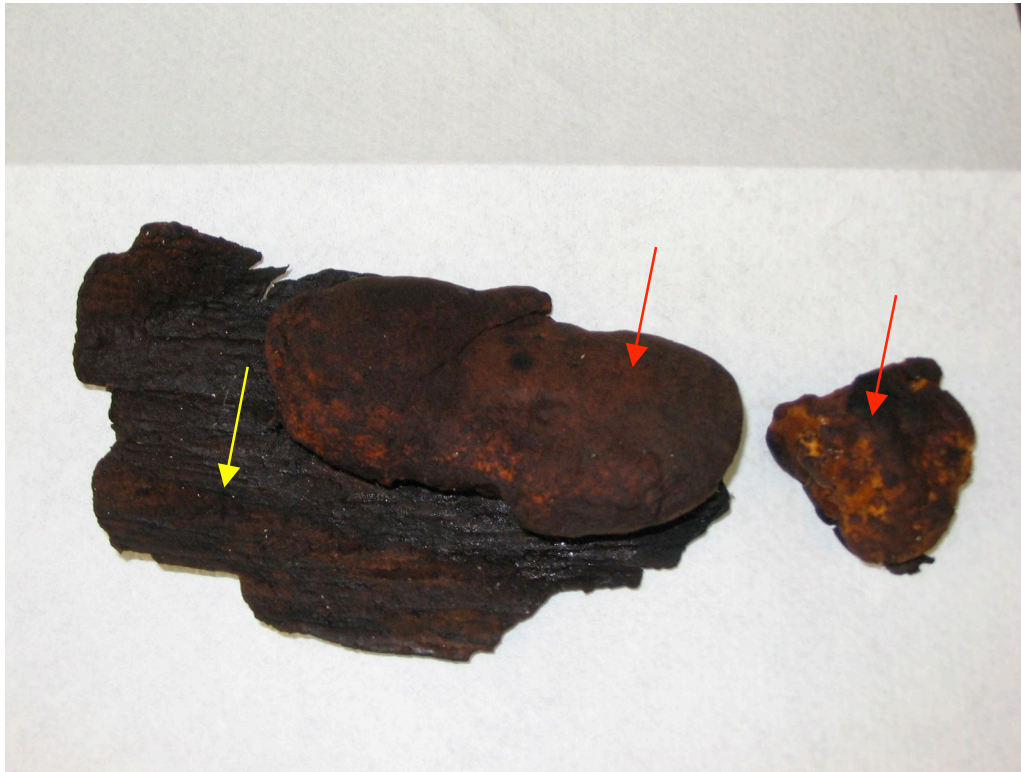
Figure 2.5 “Dark” fungal fruiting body samples (red arrows) without any prominent identification features; already detached from the framing timber but still connected with a thick and tough fungal mycelium mat (yellow arrow) (Courtesy of Beagle Consultancy Ltd., Rotorua, NZ).

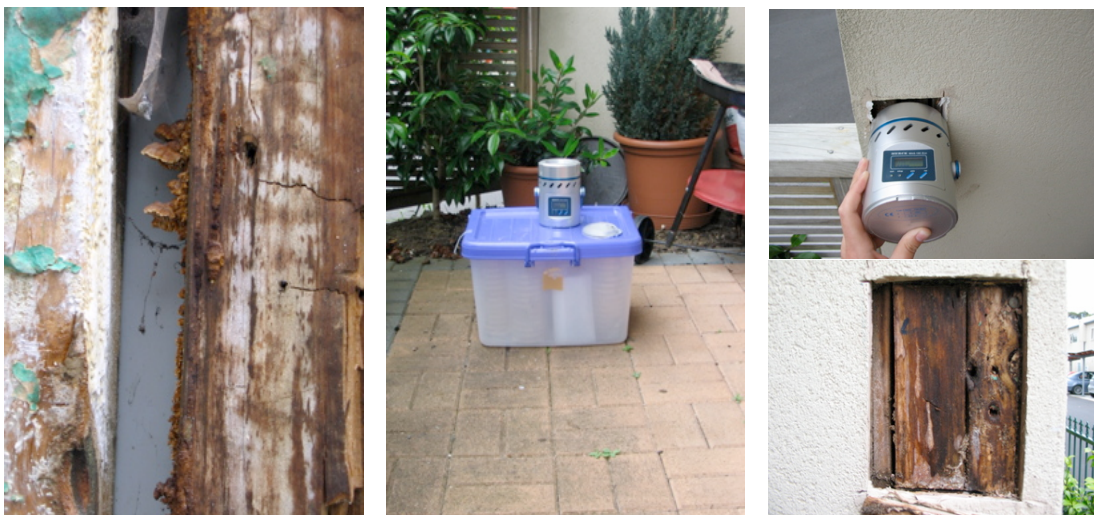
Figure 4.1 Left: *Gloeophyllum sepiarium* fruiting body on framing stud and associated white mycelium. Centre: outside sampling ground level. Right, upper: sampling within wall cavity. Right, lower: decayed and damp wall framing.
