Impact of Repair Joints in Fencing Wire on Data Communications: How to Receive Radio and Block Data using No. 8 Wire

Abstract—Modern electric fences have remote controls and remote monitors that communicate with the energizer through the active fence wire. This manuscript looks at the impact of repair joints on the data communications between energizer and remotes. We report measurements of nonlinear rust-induced characteristics in joints and we draw conclusions about their effects in the context of an electric fence carrying data communications signals. We furthermore demonstrate how their nonlinear characteristics can cause mixing and detection effects that could account for radio reception.

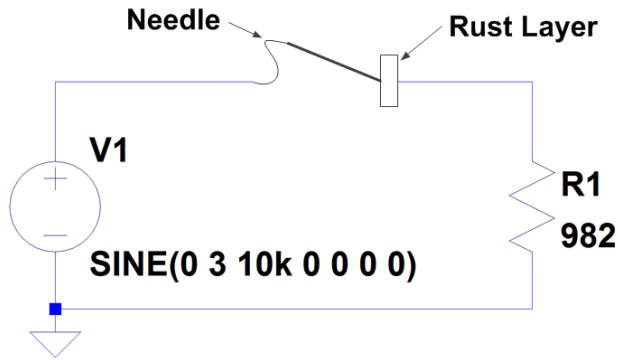
Fig. 1. Schematic of test circuit. A sinewave of 3 V peak at a frequency of 10kHz is shown (simulator notation).

In order to investigate the impedance characteristics of rusty steel contact an arrangement resembling a “cat’s whisker” was constructed with a rusty bar and a needle. The schematic diagram appears in figure 1, and a photograph of the setup appears in figure 2. A signal generator was used to produce sine and triangle waves at a frequency of 10 kHz with varying amplitudes. A Tektronix TBS1062 oscilloscope was used to sample the voltage and current waveforms. By dragging the needle across the rust layer and applying more or less pressure, the quality of the connection could be varied. Mostly the joint would appear either as an open or a short circuit. Nevertheless, the oscilloscope would sometimes display a distorted waveform when a certain rust layer thickness was achieved. This method is delicate and it could take a significant period of time to achieve a joint that was neither completely isolated nor fully conducting, but the outcome was repeatable.

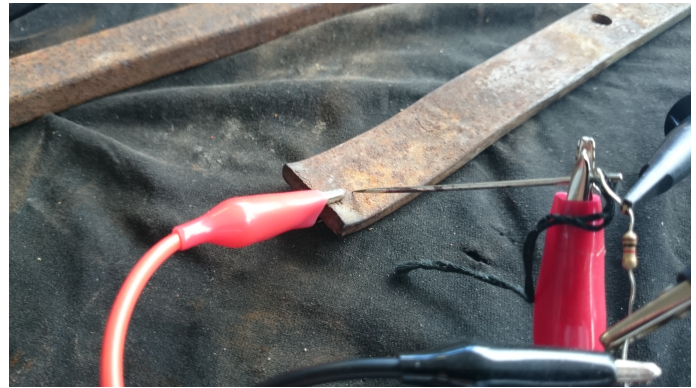
Fig. 2. Photo showing experimental setup of Rust Joint

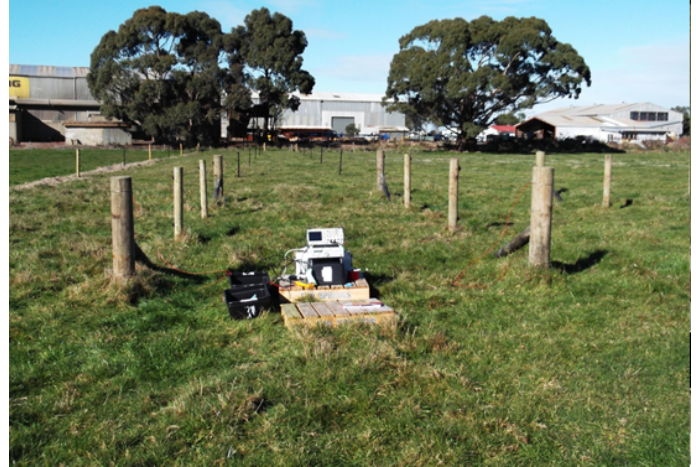
Fig. 4. The fence constructed for testing the impact of various components on the energizer communications system
