Evaluating the potential of historic sheep dips as point sources of trace element and organochlorine pollutants

A thesis
submitted in partial fulfilment
of the requirements for the Degree
of
Master of Science in Earth Sciences
at the
University of Waikato

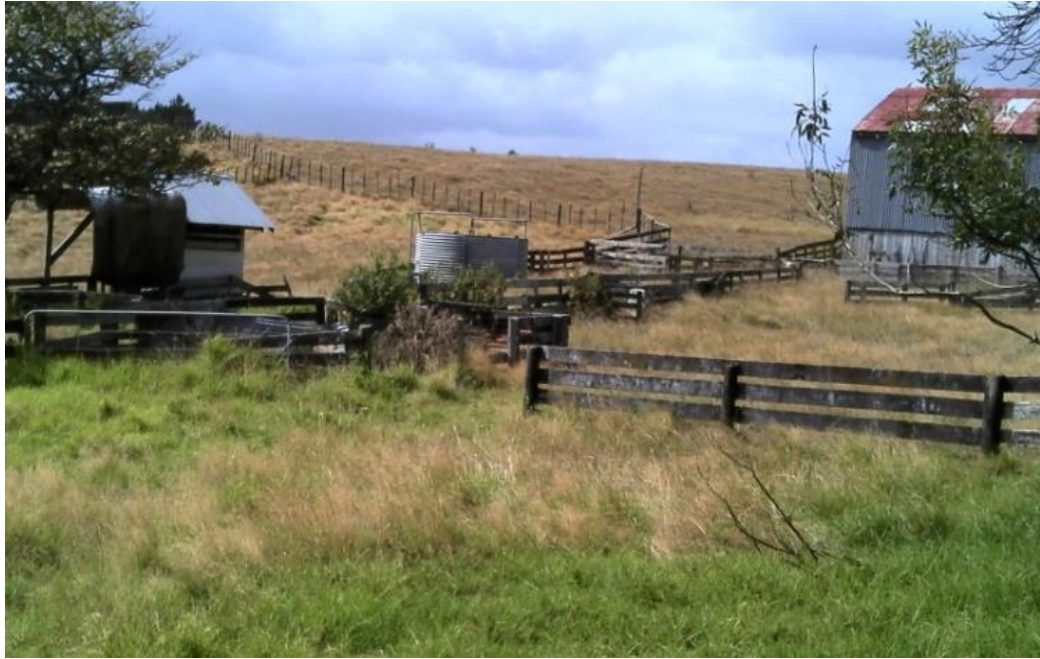
Figure 1-1 Remnants of a sheep shower, last used in about 1965. Showing the holding pens on the bottom right fenced area, drip zone uphill of the power sprayer and the old shearing shed. Photo taken 14 March 2013

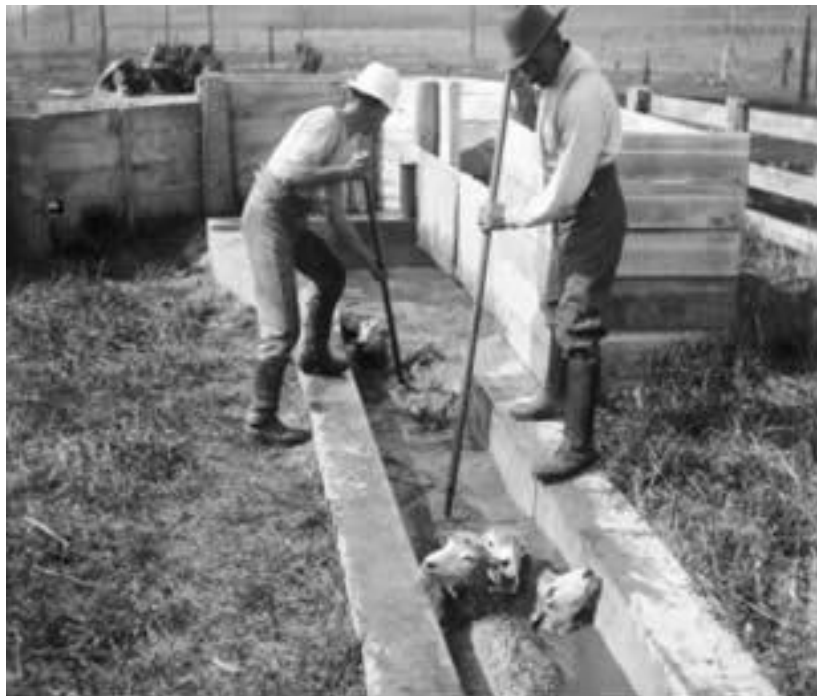
Figure 2-1 Dipping in Levin on 2 March 1906. Photo showing the holding pens in the background and a solid built concrete structure containing dipping chemicals. Source: Adkin Collection, National Library, reproduced from Ministry for the Environment, 2006.

Plunge-type dips (Figure 2-1) were first introduced as a dipping technique in the early to mid-1800s before the introduction of "pot dips" for smaller stock numbers and swim-through dips on large stations (McBride, 2004; Ministry for the Environment, 2006).

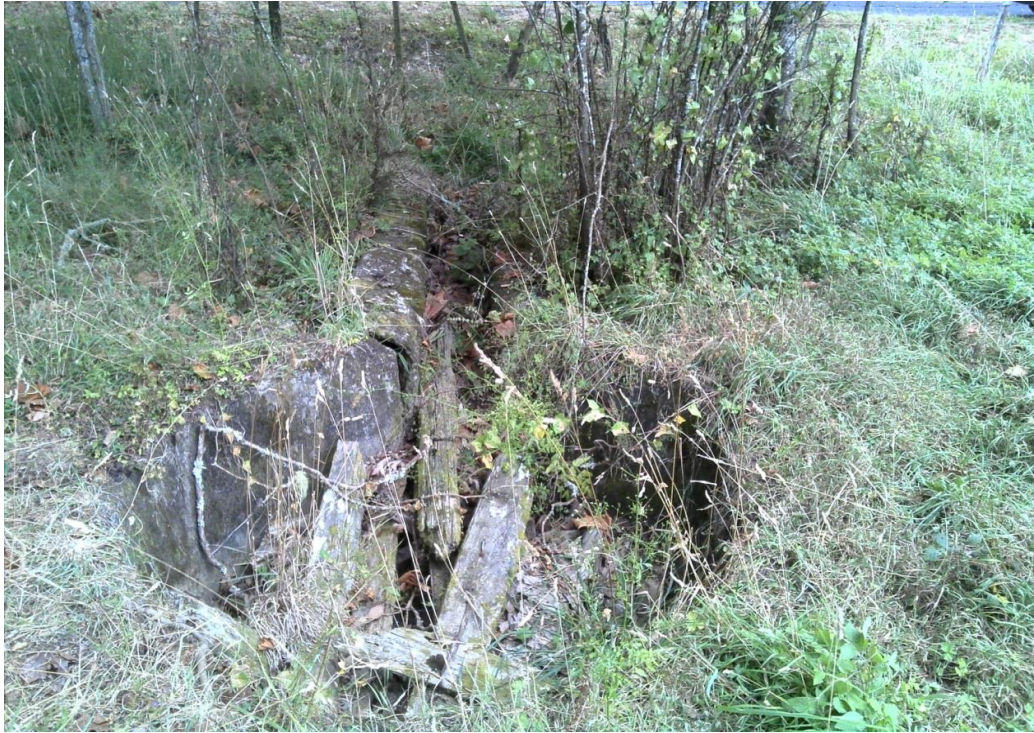
Figure 3-1 Redundant pot bath sheep dip. Last used about 1965. Dip entrance in the foreground and draining pens at the far end of the dip.

Study site A was an old pot bath (Figure 3-1). The dip structure had a 2 metre diameter dip sump which was 1.5 metres deep, and 3 metre drain length. The dip lies east to west with the head facing west and drain exit to the east. The dip structure was solidly built and visible from the adjacent road. Remnants of the dip exit and drip area could be seen from the road though slightly obscured by mature trees growing beside the main drain, the drip area, and the area between the road and the dip.

The former owner reported that he helped his father and elder brothers in the sheep farm dipping sheep when he was in his mid-teens, in the early 1960's. His recollection of the location of the redundant pot dip, the old holding yards, drip area, splash zone and spent chemical disposal patterns fit the physical evidence found onsite. Evidence onsite included the redundant dip superstructure, remnants of concrete, old fence posts, and bits and pieces of old timber lying in the vicinity of the dip. Some old pieces of timber were used to cover the dip to prevent stock falling in (Figure 3-1).

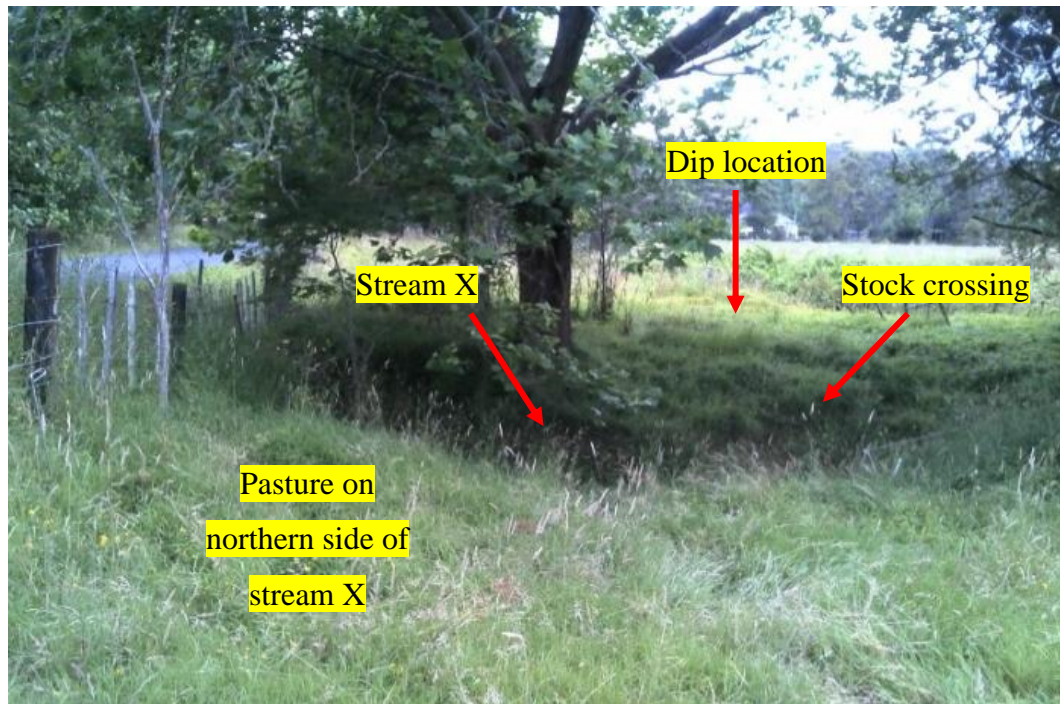
Figure 3-2 Photo taken from the northern paddock in the foreground looking south towards stream X and the dip location on the southern paddock behind the large tree

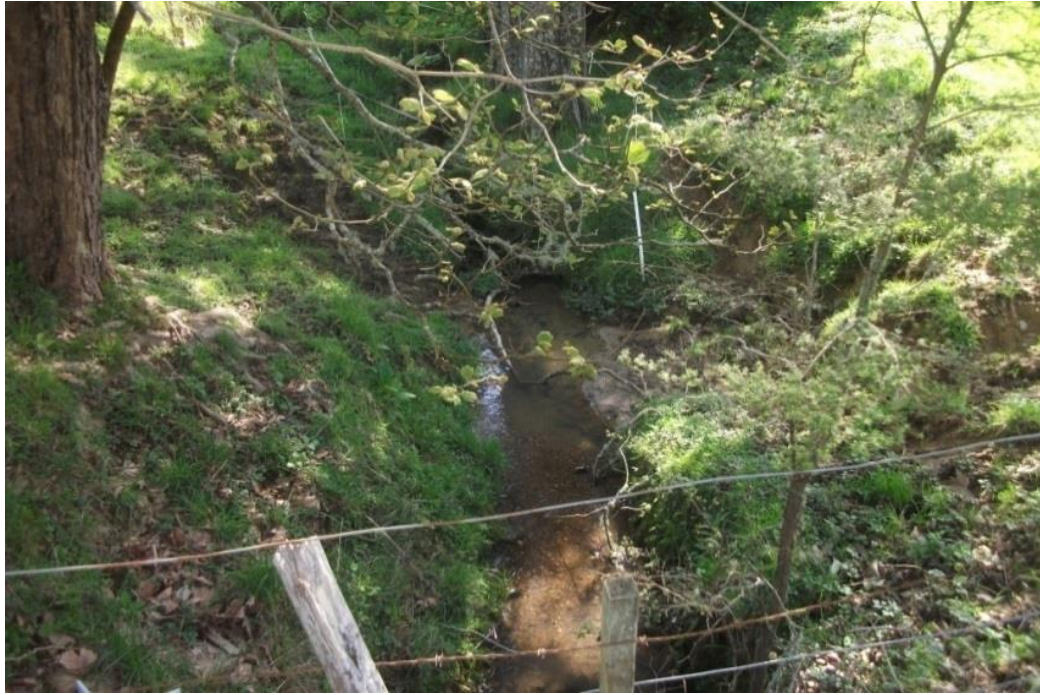
Figure 3-3 Stock crossing showing stream bank erosion extending to the runoff zone on the top right which is a likely source of sediments to stream X.

There were two streams flowing close to the old dip. The closest and smaller, stream X, was located 7 m north of the dip and flows east to west into the larger stream Y. Stream X had a stock crossing (Figure 3-3).

Stream X and the land adjacent to the dip site (to the right of the right of stream X in Figure 3-3), is where the dip solution was probably emptied. Either side of stream X continues to be grazed (Figure 3-2). River bank erosion had occurred on the edge of esplanade reserve fence line which is mid-way between the dip and stream Y and downstream of the confluence of stream X and stream Y. The eroded area cuts into the reserve.

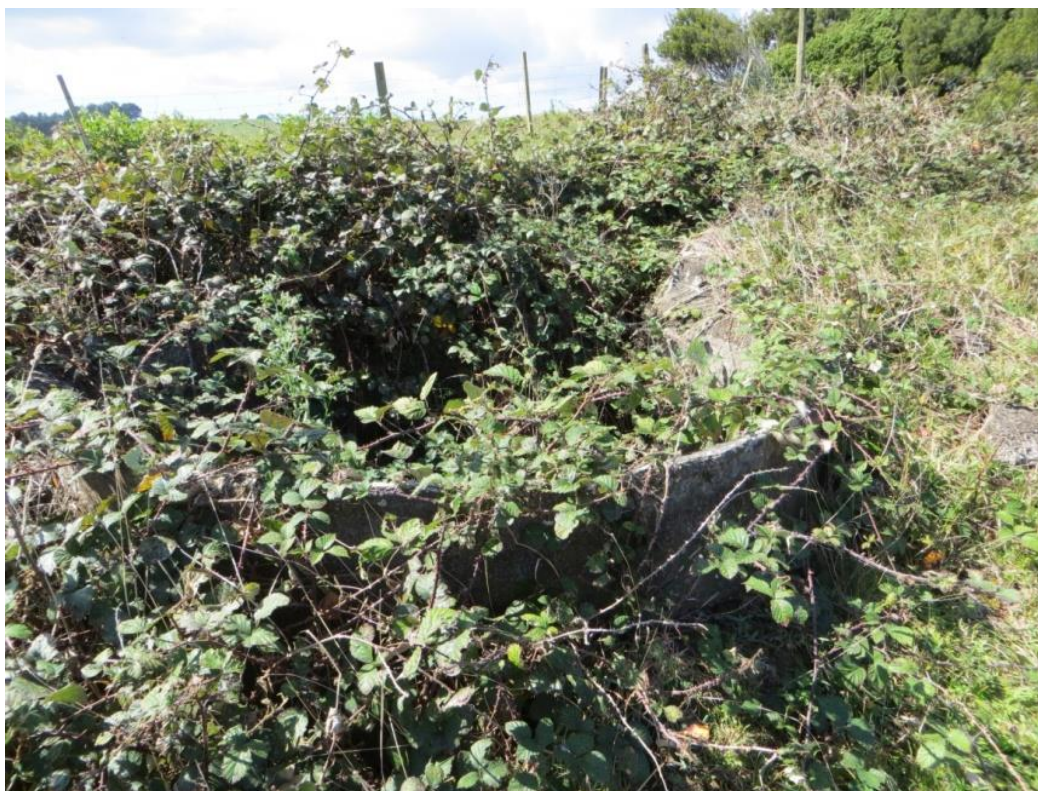
Figure 3-4 Site B, showing the redundant plunge sheep dip with main dip sump in the foreground and draining platform to the left at the far end.

Study site B was an old plunge sheep dip. The main dip sump and draining platform were visible onsite (Figure 3-3). The old sheep dip was located on a 100 m elevation with a steep (>10 degree) south facing slope, currently used as a grazing area. The dip structure had a 2 m diameter sump which was 1.5 m deep. The dip was 8 m long with concrete lead out sides. The dip lies east to west with the main sump facing the downslope gully. The dip had not been filled in. There was a fenced hilltop area 5 m away from the dip exit which was used for grazing. Native bush borders either side of the paddock, east and west of the dip site. The native bush located on the eastern side was fenced off from stock.

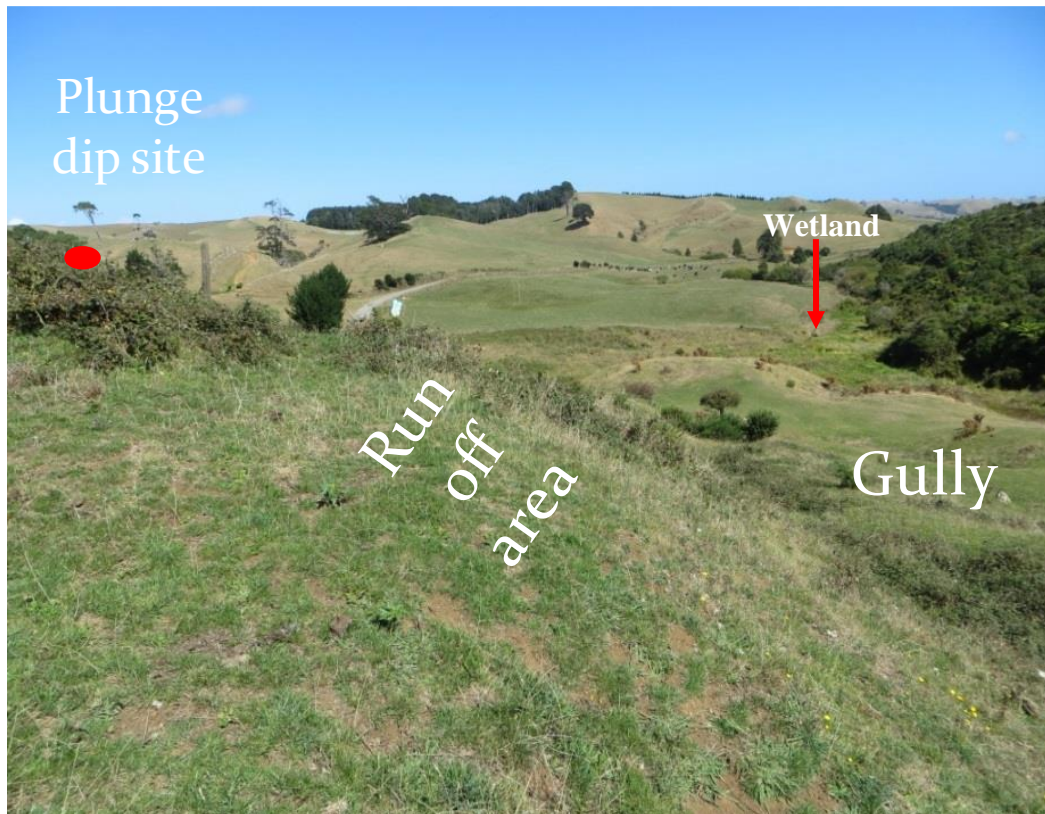
Figure 3-5 Study site B showing the potential discharge pathway

Land on which site B was located had been in the same ownership since the day the old plunge dip was last used in the early 1960's. The landowner showed us the location of the dip and provided information regarding the dips historical use. Site B had little historical information on chemical disposal patterns therefore professional judgement was used in determining the experimental design and sampling plan. The old dip has the potential to discharge contaminants onto land and gully (Figure 3-4).

Land and gully directly downslope of the dip site is where it is probable that the spent dip solution was emptied. The 5 m wide gully runs north to south on the west side the dip site and leads to a stock water supply and a small stream downhill. According to the landowner the gully was widened sometime before 1900 to be used as a track for cross country horse carts (Figure 3-5). The stock water supply was cut into the true left side of the gully 90 m downhill from the dip site. Adjacent to the stream was a wetland which has formed largely from a natural spring that leads into the stream.

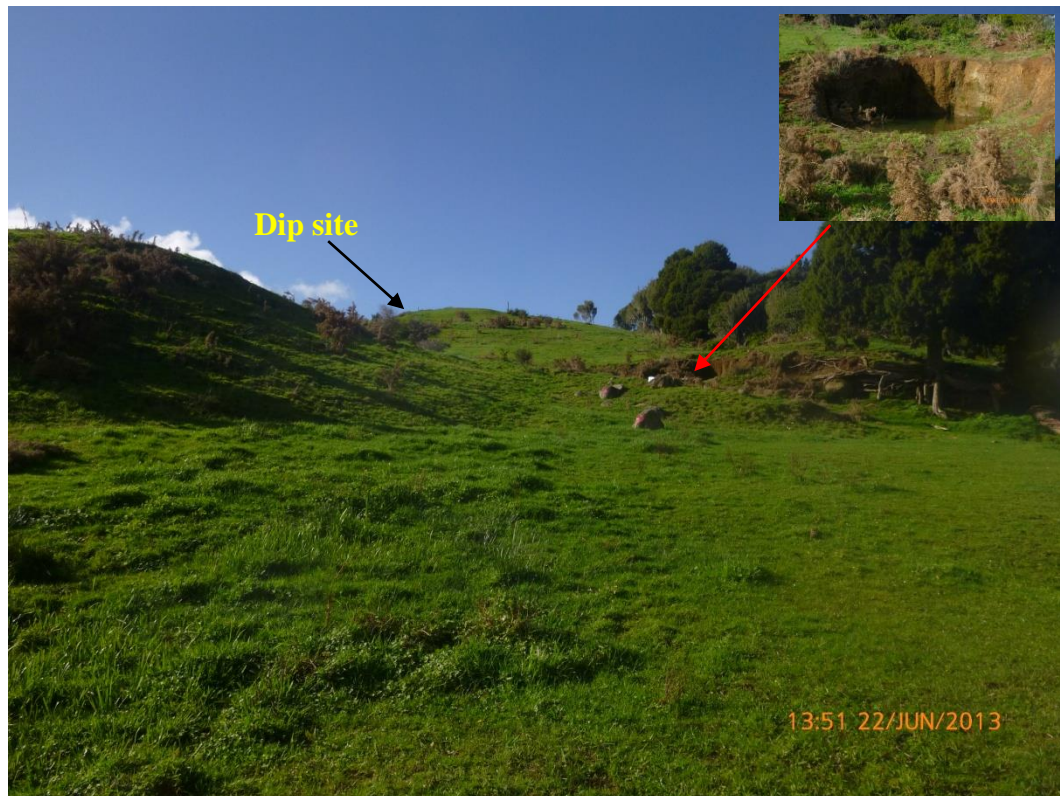
**Figure 3-6 Site B, looking uphill from the end of the gully in the foreground.
Insert: Stock water supply**

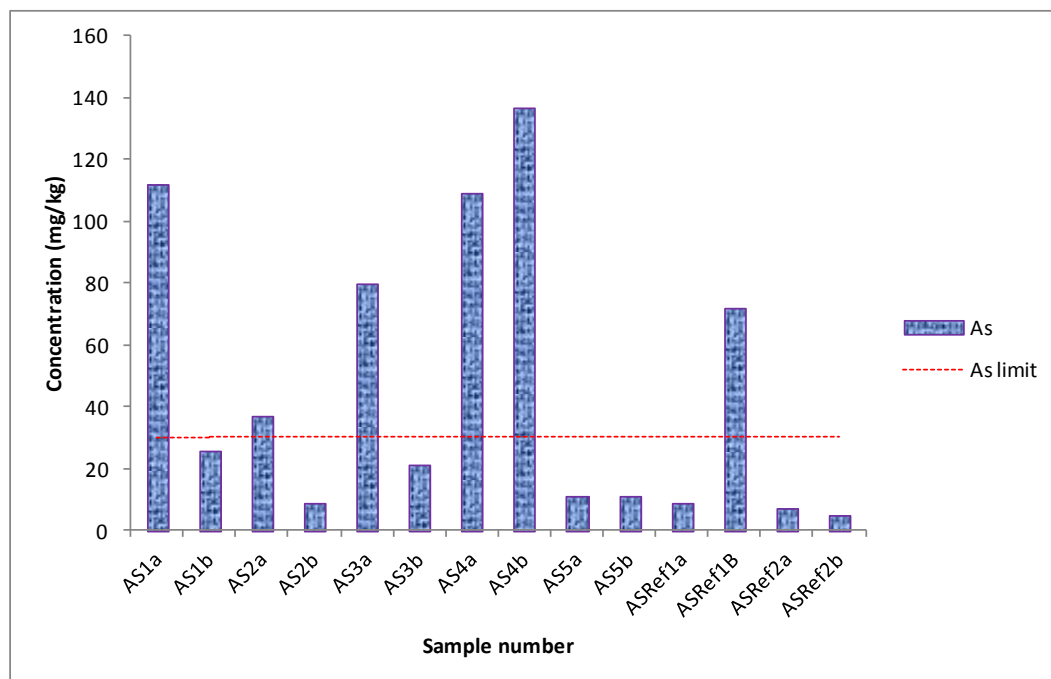
Figure 4-3 Arsenic concentration with respect to the Ministry for the Environment and Ministry of Health (1997) guideline value of 30 mg/kg for agriculture and residential land uses.

Arsenic concentrations on the reference soil samples ranged from 5 to 72 mg/kg. Three reference samples were consistent with background levels of soil arsenic ranging from 1 – 25 mg/kg in the Waikato region (Taylor and Kim, 2009) and the environmental guideline level of 30 mg/kg (Ministry for the Environment and Ministry of Health, 1997) for agricultural land and land for lifestyle blocks. A 10 – 20 cm depth reference sample taken 20 m north of the dip site and across stream X (ASRef#1b) had 72 mg/kg As which is above the environmental guideline limit of 30 mg/kg (Ministry for the Environment and Ministry of Health, 1997).

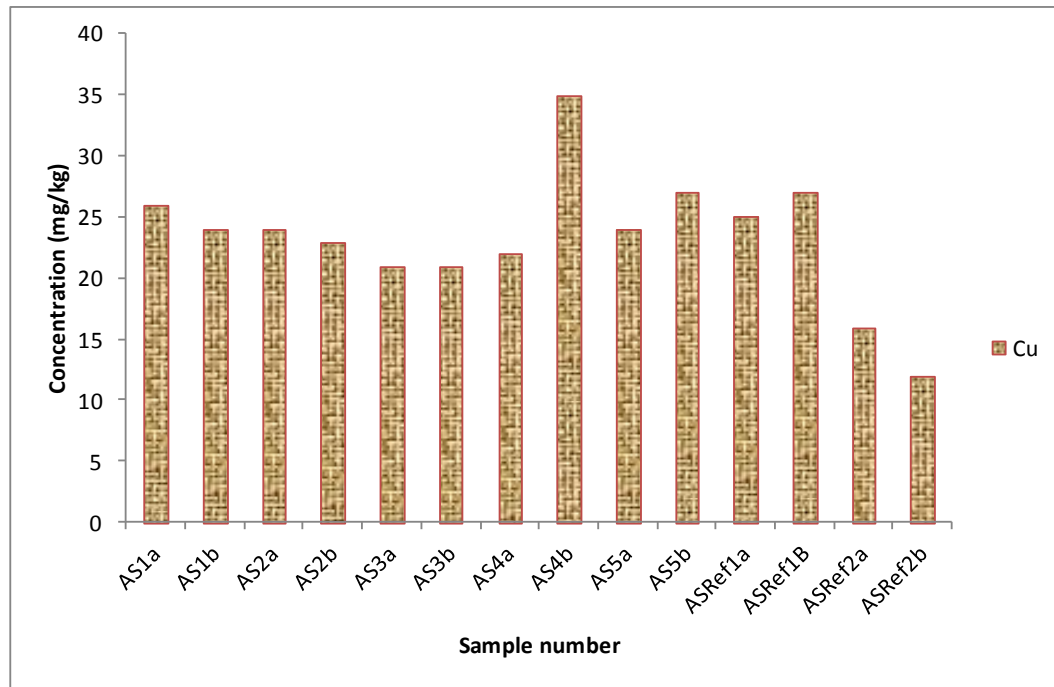
Figure 4-4 Copper concentrations showing levels well below the soil acceptance level of 370 mg/kg (Cavanagh, 2004a).

Copper concentrations ranged from 12 mg/kg to 30 mg/kg (Figure 4-4). Concentrations of copper were all below the soil acceptance level of 370 mg/kg (Cavanagh, 2004a) and background levels 38 to 380 mg/kg for the protection of livestock on agricultural land associated with contaminated sites (Ministry for the Environment and Ministry of Health, 1997). The lowest detected concentration of 12 mg/kg was the deep sample from a reference site located across the road (ASRef2b) and the highest detected concentration of 35 mg/kg was from the deep sample adjacent to the dip site (AS4b).

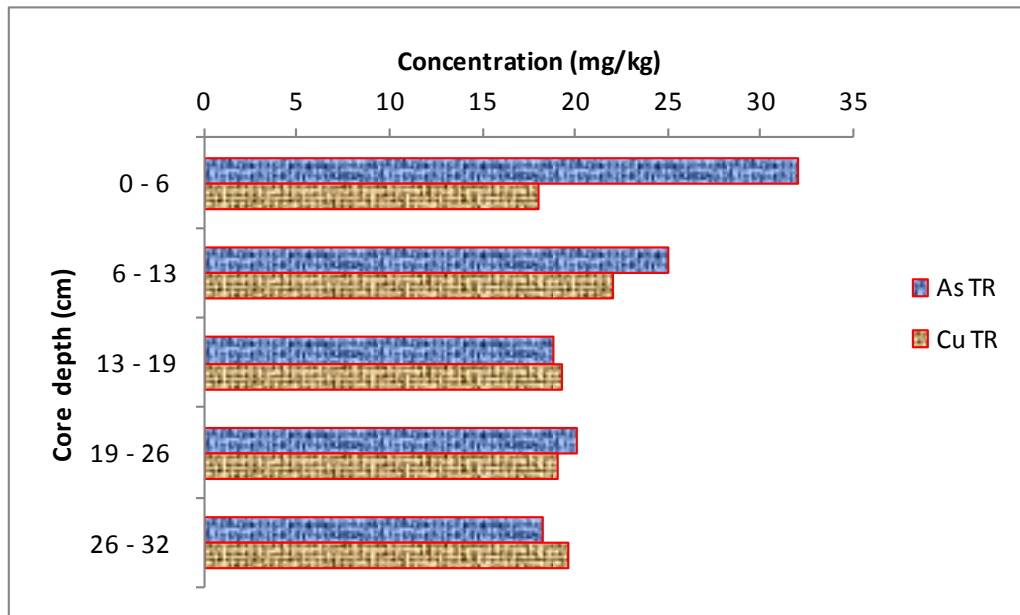
Figure 4-5 Total recoverable As and Cu in discharge zone sediment core ASSED3.

Extent and distribution of arsenic and copper residues in the discharge samples are shown on Figure 4-5. Arsenic levels were highest near the surface. On the other hand copper levels were uniform in the entire sediment core.

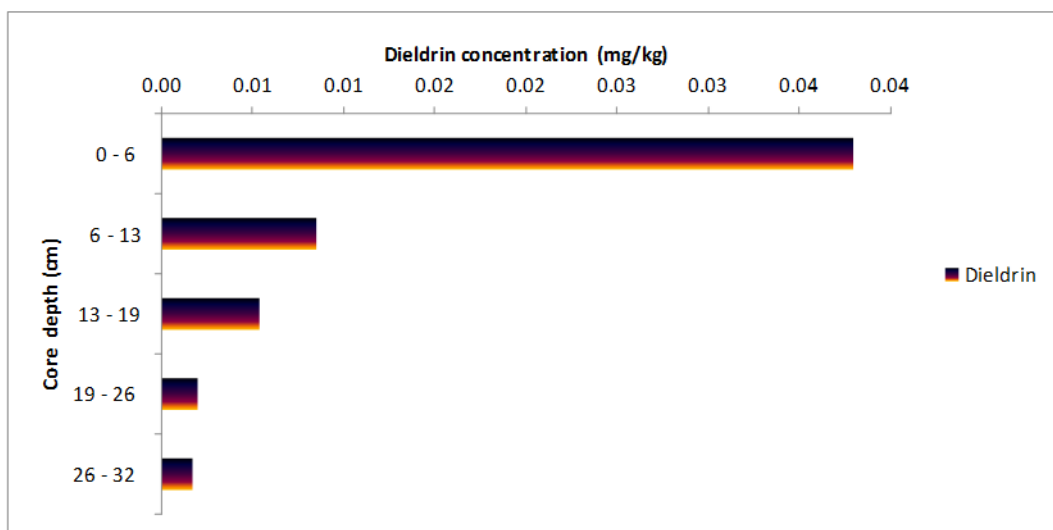
Figure 4-6 Extent and distribution of dieldrin in stream sediment core ASED3. Other cores had no detectable organochlorines.

Three organochlorine pesticides were detected in all the five discharge zone sediment samples located downstream of the dip site (ASED3). All remaining samples were below detection limit. Dieldrin concentrations ranged from 0.0017 mg/kg to 0.038 mg/kg. All five sediment samples were well above the interim sediment quality guideline low (ISQG-Low) limit of 0.00002 mg/kg for dieldrin (Ministry for the Environment, 2006). Dieldrin concentrations on the surface samples down to 13 cm core depth were well above the interim sediment quality guideline higher limit (ISQG-High) of 0.008 mg/kg (Ministry for the Environment, 2006). The levels of dieldrin depict a decreasing trend with increasing core depth (Figure 4.6).

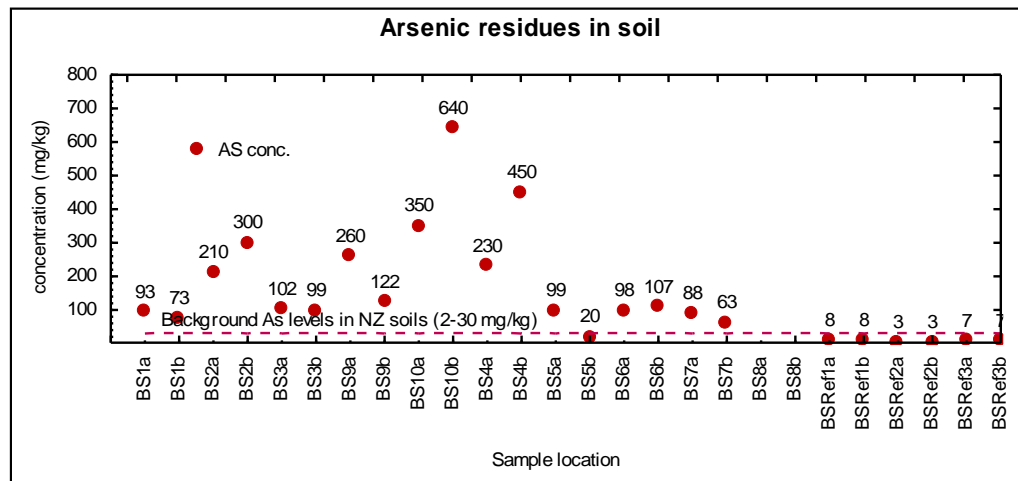
Figure 4-7 Residual arsenic concentrations in soil showing the extent and distribution relative to the environmental guideline limit of 30 mg/kg (Ministry for the Environment and Ministry of Health, 1997).

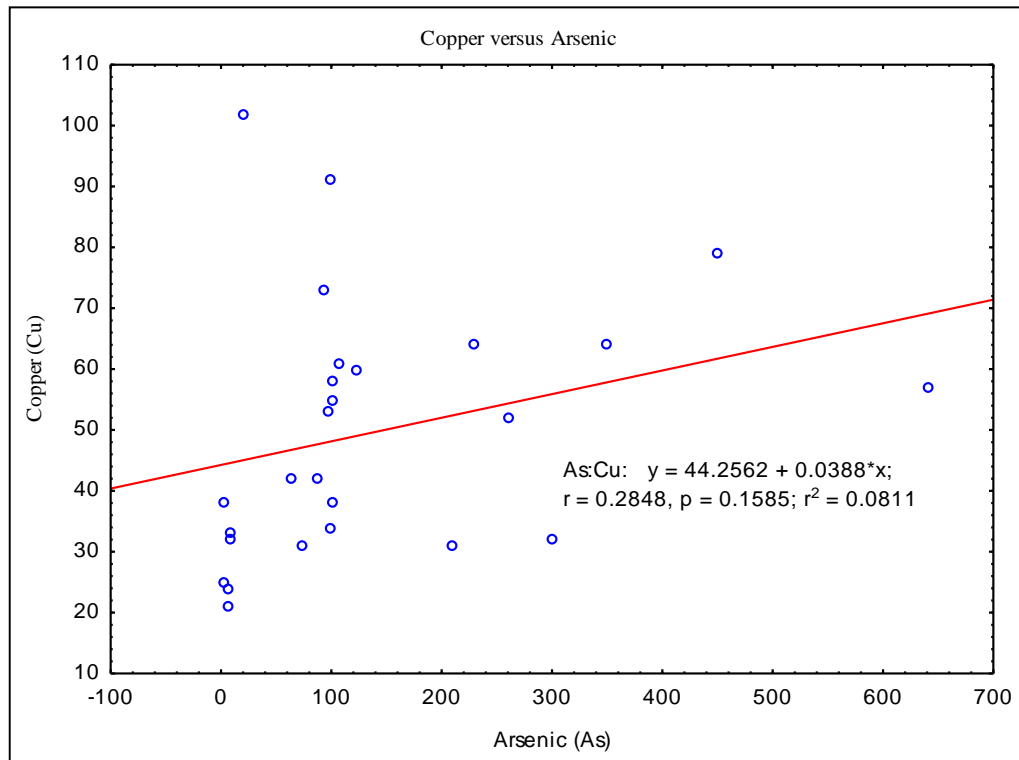
Figure 4-8 Plot showing the extent of copper and arsenic concentrations at Site B.

Concentrations of copper and arsenic had a statistical regression r^2 value of 0.0811, ($P = 0.158$) indicative of low precision which means that there were no relationship in terms of the extent of contamination at Site B (Figure 4-8).

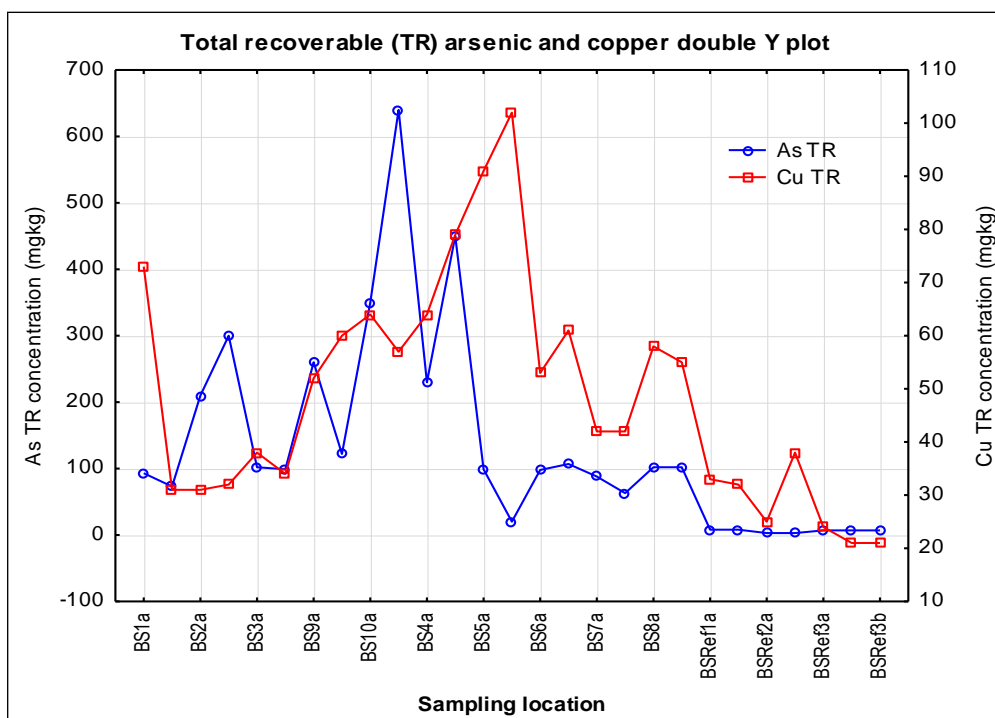
Figure 4-9 Arsenic and copper based dipping chemical.

Despite the difference in the extent of concentrations between copper and arsenic at Site B, a relationship between arsenic and copper in terms distribution patterns was observed. Copper appeared to be trending higher with high arsenic or low with low to moderate arsenic concentration (Figure 4-9). This relationship may suggest that a likely dipping chemical used at Site B was copper arsenate which was a widely used sheep dipping chemical in New Zealand.

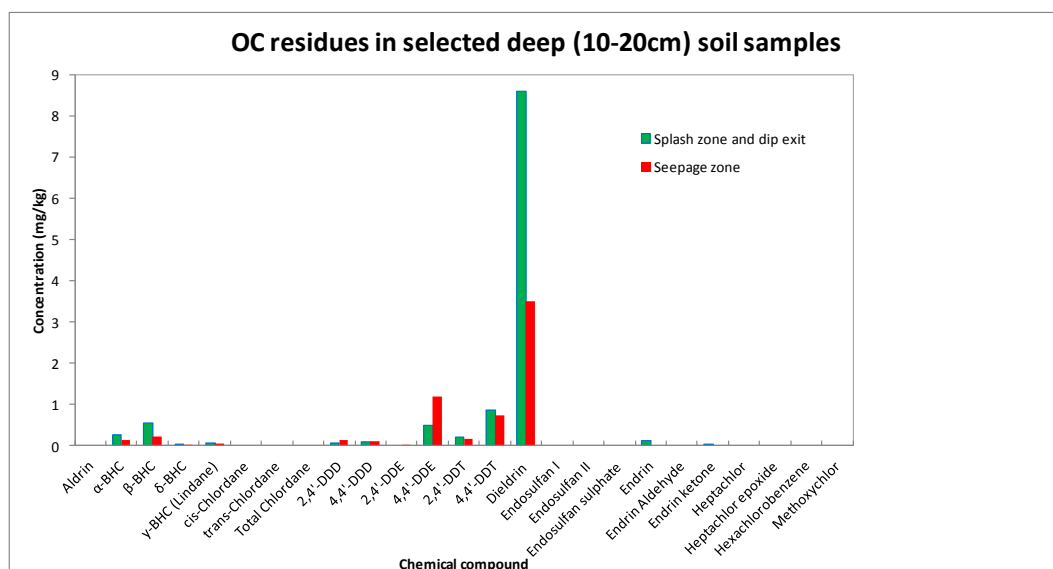
Figure 4-10 Detectable organochlorine pesticides in soil samples BS10b and BS4b.

DDT including DDT metabolites (DDE and DDD) was found in both surface and deep samples at varying concentrations. 2,4'-DDD and 4,4'-DDD had 0.017 to 0.145 mg/kg from sites around the dip and gully. 2,4'-DDE and 4,4'-DDE had 0.016 to 1.200 mg/kg. All ten samples had 4,4'-DDE. Only BS4b had 2,4'-DDE. 2,4'-DDT and 4,4'-DDT with levels ranging from 0.018 to 0.880 mg/kg. 4,4'-DDT was present on all samples analysed. 2,4'-DDT was detected on three samples. Pesticide endrin and endrin ketone was detected on sample BS10b at 0.127 mg/kg and 0.039 mg/kg concentrations respectively. Dieldrin was detected on all ten samples except BS7a. Concentrations of dieldrin range from 0.021 to 8.60 mg/kg. Organochlorine residues detected had non-formal distribution patterns around and away from the sheep dip. Elevated residues levels were found at the splash, the drip area, and the discharge zone along the gully line (Figure 4-10).

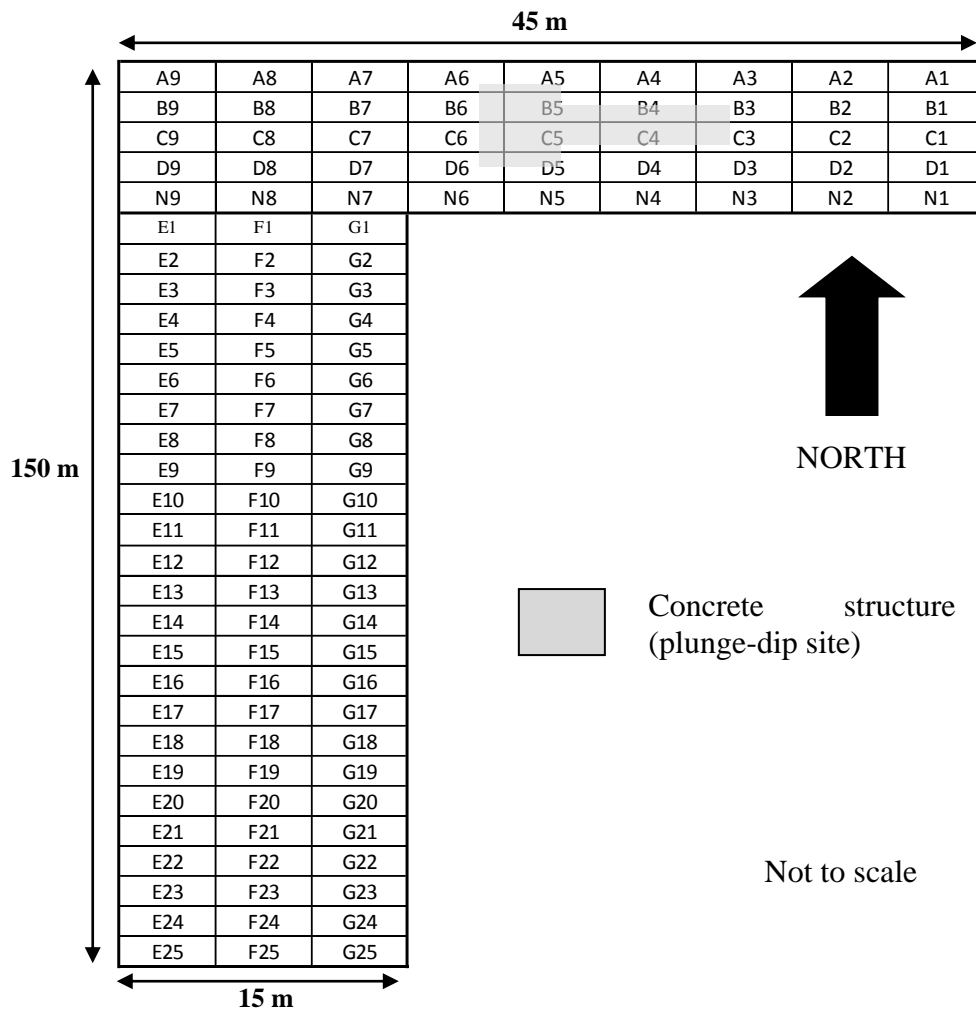
Figure 5-2 Grid layout for systematic sampling at Site B showing sample locations.

The second part of the site B sampling plan covered the area at the top of the gully which is west of the dip site and downhill to the end of the gully. Grid lines ran north to south. Sampling for the second part commenced at the top of the gully from the southern end of part one and completed at the bottom of the hill, 112 m from the dip site. Soil samples for site B were collected using a 5 x 5 m grid. The total area sampled was 1500 m² which produced 120 soil samples.

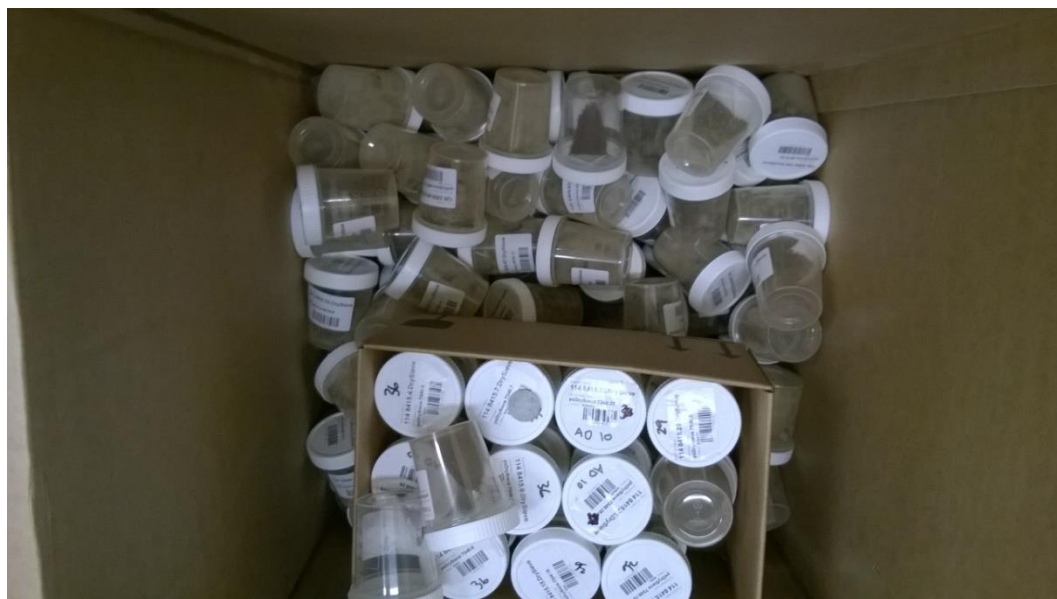
Figure 5-3 Air dried (2 - 5% moisture content) and 2 mm sieved samples for XRF analysis.

The first step in preparation of soil and sediment analysis was for all samples to be dried and sieved. Soil and sediment samples were air dried in a 35°C oven and 2 mm sieved at Hill Laboratories Ltd (Figure 5-3).

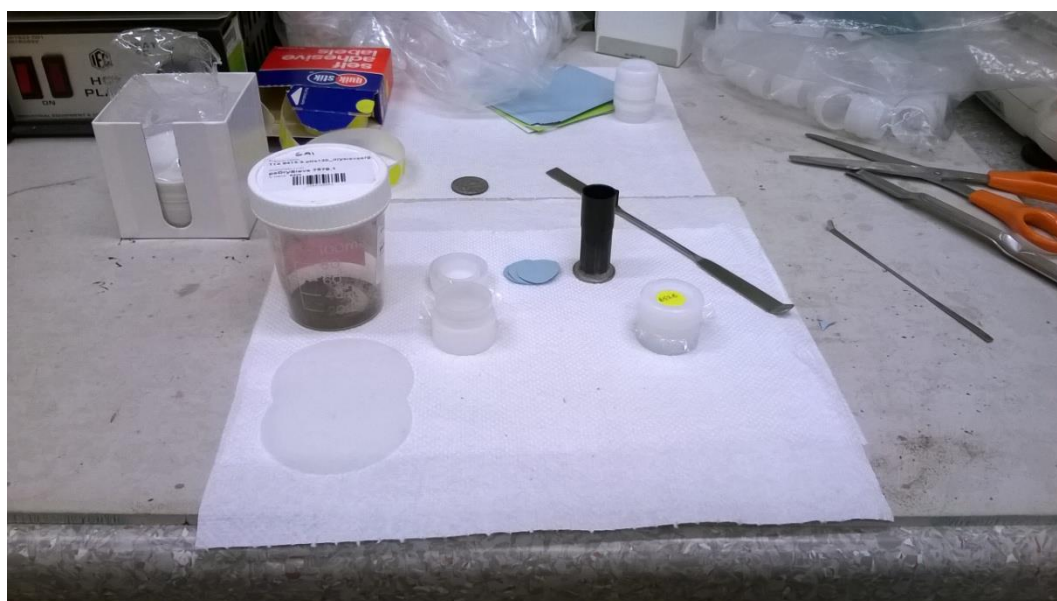
Figure 5-4 Sub-sampled 2 mm fraction is prepared into an XRF sample container for elemental analysis.

A homogenous sub-sample of the < 2 mm fraction was placed into a white plastic sample container (Figure 5-4) to which a thin layer of membrane film cover the bottom and the top covered with a thin layer of paper, cotton wool, and capped. Sample labels were transferred onto the sub-sample containers. Prepared batches were then transferred to the instrument room for testing on the XRF. Detection limit for arsenic on the XRF was < 5 mg/kg dry weight (Appendix II).

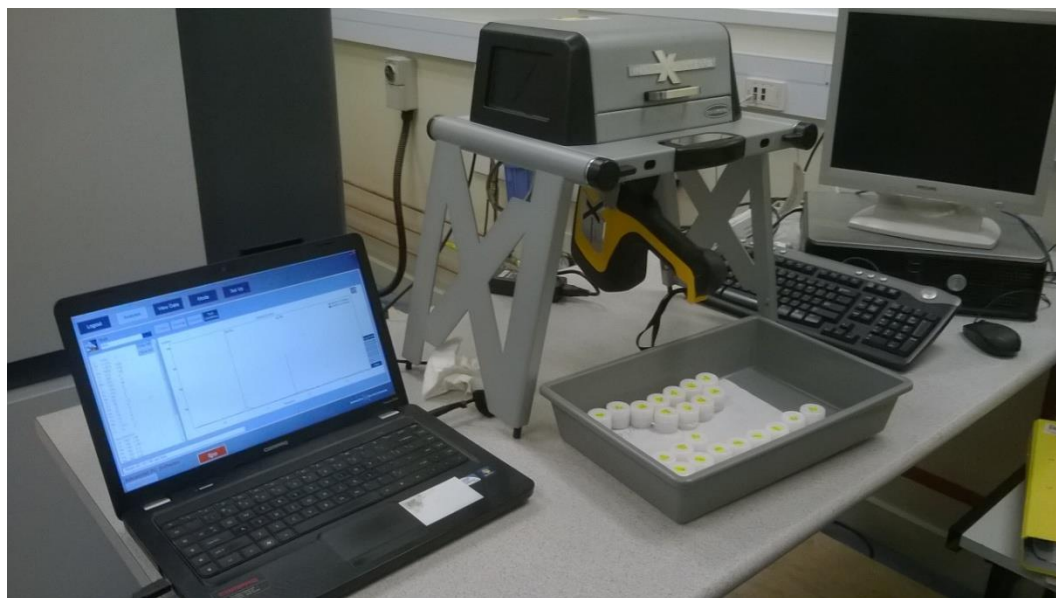
Figure 5-5 Laboratory setup of the handheld XRF showing the standard operational setup of the four main components (laptop, samples, bench-top, and XRF).

Laboratory setup of the pXRF instrument was undertaken where a bench-top stand was used to minimise radiation exposure to the operator and supervising lab staff (Figure 5-5). Operating the pXRF safely and effectively was paramount in the lab analysis method.

- to begin, the bench-top was unfolded and the bench-top adapter screwed in to the pXRF, making sure the contact points between the adapter and the pXRF were positioned correctly
- safety warning selected as the power source was switched on
- “Innov-X Delta Advanced PC Software” installed into the laptop computer, switched on, and connected via USB to the back of the bench-top to start up the device then;
- a pre-set username and password was entered to access start up menu, then
- a calibration check using the supplied 316 stainless steel “coin” was undertaken

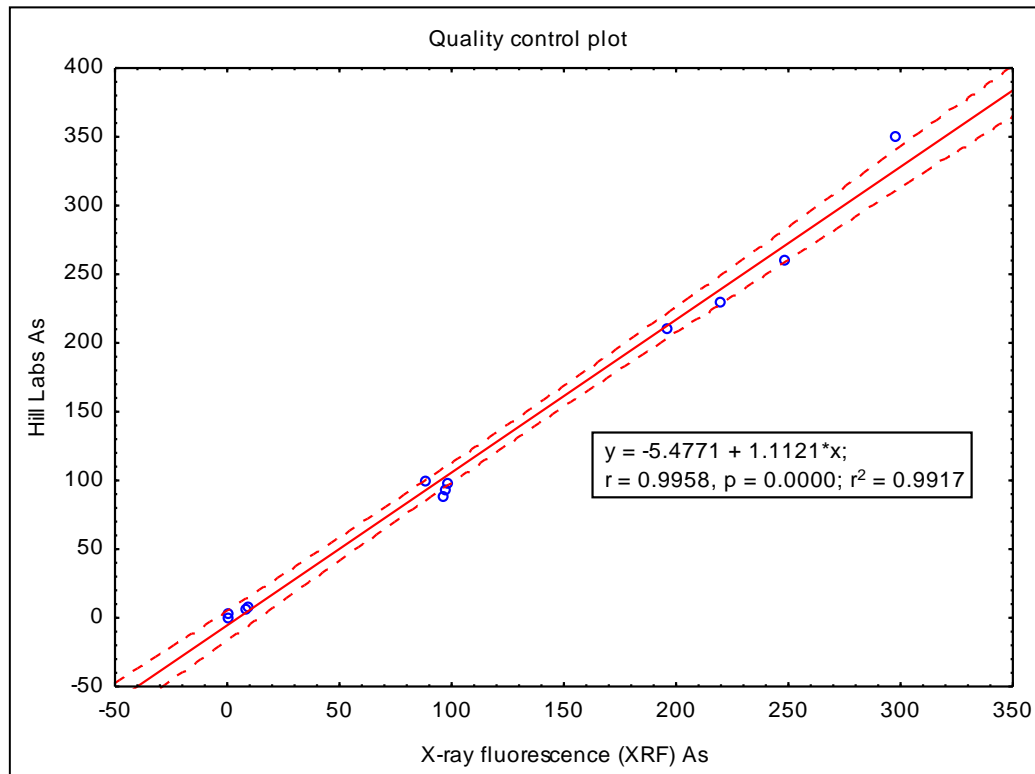
Figure 5-6 Comparative data analysis showing high precision and accuracy in sample preparation and experimental methods.

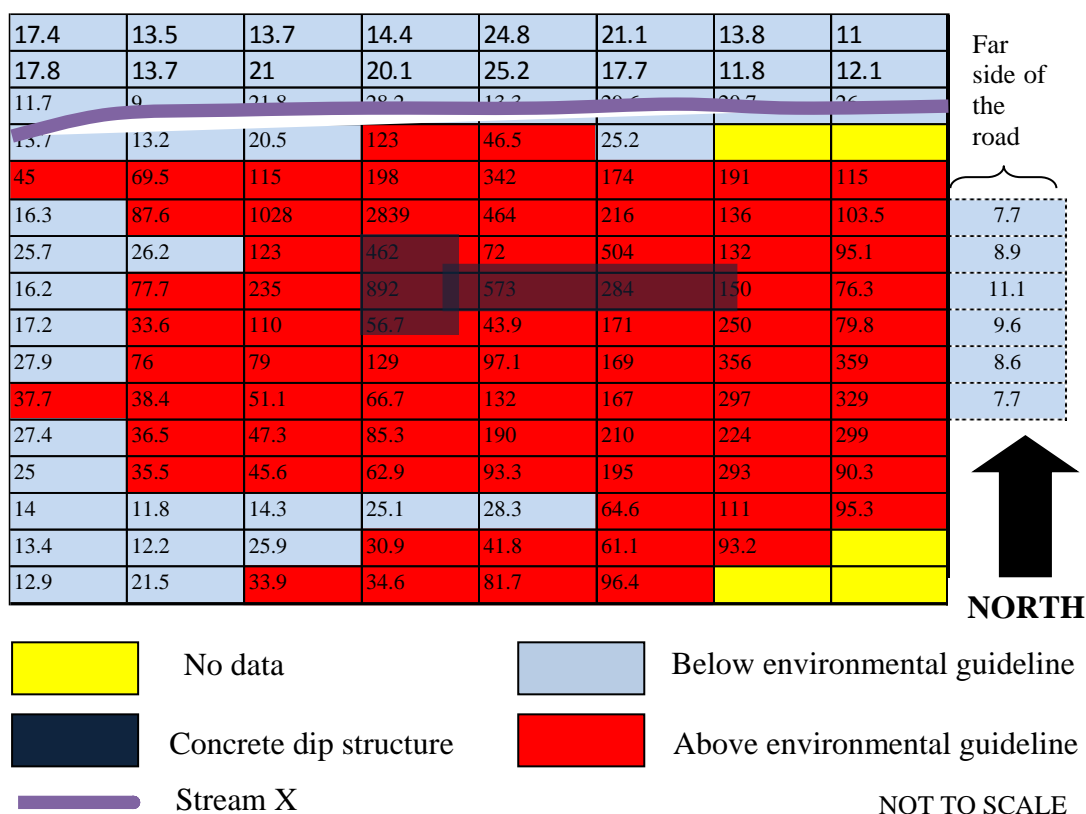
Figure 5-7 Phase II arsenic concentrations within the grid at Site A (in mg/kg).

From the 129 soil samples analysed from Site A 76 had concentrations above background levels of arsenic in New Zealand soils, 30 mg/kg. The minimum arsenic concentration was 7 mg/kg and the maximum 2,839 mg/kg. Samples closer to the dip had elevated levels compared to samples from across stream X on the northern paddock and across the road to the east and uphill (Figure 5-7).

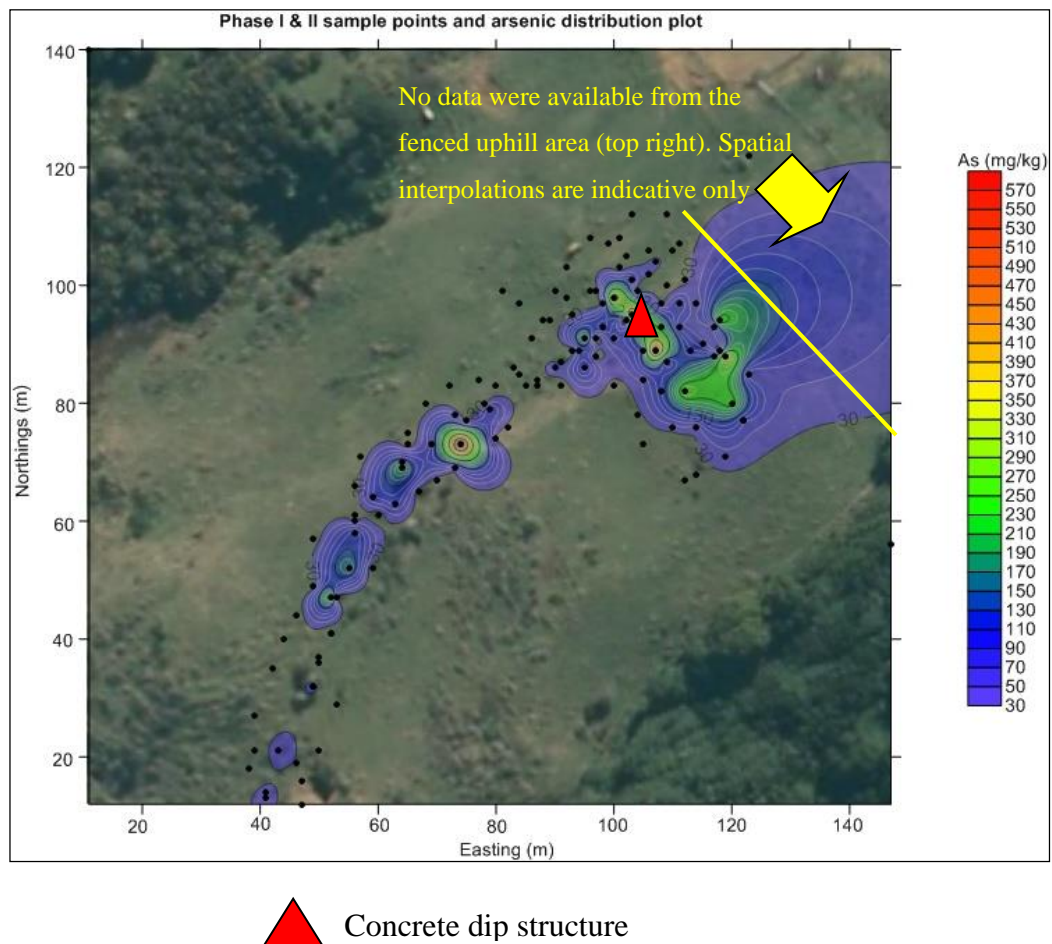
Figure 5-8 Phase I & II spatial plot showing the distribution of arsenic in relation to samples above and below guideline (not included in colour overlay level of 30 mg/kg (Ministry for the Environment and Ministry of Health, 1997)).

Elevated arsenic was detected at sample site G9 (30.1 mg/kg) which was the site that was furthest from the sheep dip at Site B. In phase I the average concentration around this sample point was 56.5 mg/kg. Sample site G9 was on a 91 m elevation, mid-gully, and 100 m downhill from the sheep dip, and 10 m uphill from the stock water supply.
