Sensitive pyroclastic soils in the Bay of Plenty, New Zealand: microstructure to failure mechanisms

Keywords: sensitive soil; tephra; halloysite; microstructure

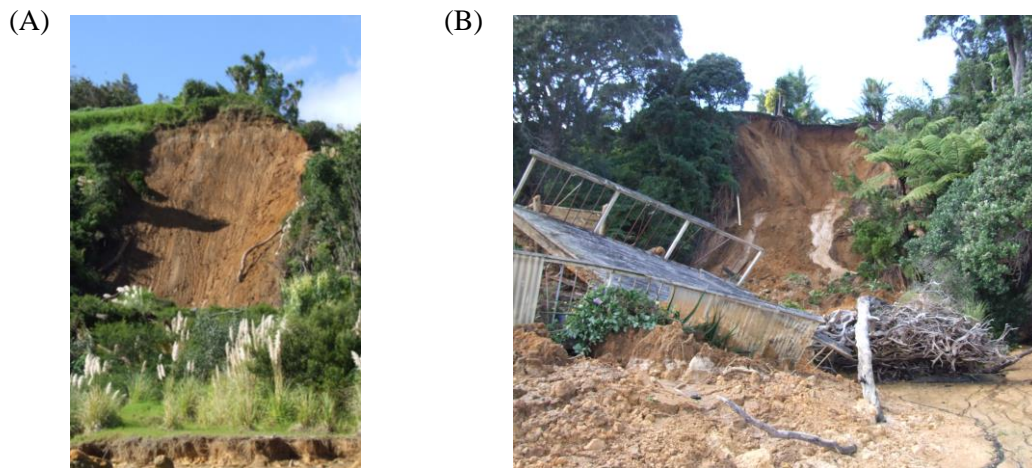
Figure 1. Translational (A) and flow-slide (B) landslides initiated following the passage of Cyclone Debbie on 4/5 April 2017. Although translational failures can denude large areas of the slope, flow-slides cause greater excursion into the slope and hence pose greater risk.

Sensitive soils have been known to pose a landslide hazard at Omokoroa and in the wider Bay of Plenty for some time. These sensitive soils create flow-slides with long runout, and failures that regress back into the slope over long time intervals. Recognition of halloysite as the key clay mineral in the Pahoia Tephra sequence that hosts the failure surface of these flow-slides allows us to predict and understand the basic physical characteristics of the soils; most notably inactive clay minerals with high liquidity indexes which are characteristic features of sensitive soils globally. Remoulded halloysite samples are also known to have distinctive responses to pH, and cation type and concentration (Theng and Wells, 1995). These responses allow for the possibility of slope improvement by means of cation manipulation, an avenue being investigated by Robertson *et al.* (this volume), but any treatment needs to be targeted to known characteristics of halloysite.

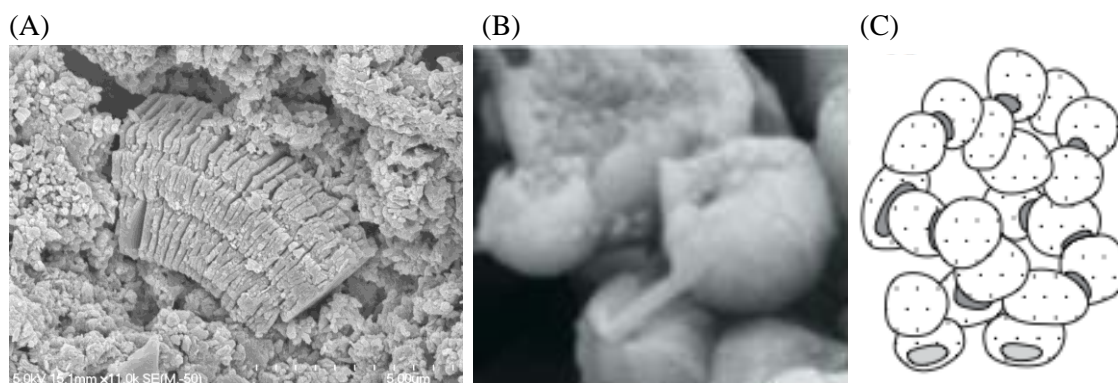
Figure 2. Scanning electron micrographs of (A) book and (B) mushroom-cap morphologies of halloysite. (C) Inferred framework network of mushroom cap clay minerals. Image credits: (A) Helen Turner, (B) and (C) from Kluger *et al.* (2017).

Recently we have recognised two more morphologies of halloysite in Bay of Plenty sensitive soils: books (Cunningham *et al.*, 2016) and mushroom-caps (Kluger *et al.*, 2017). The book morphology (Figure 2A) mimics a common morphology of kaolinite, and may have been responsible for mis-identification of halloysite clays in the Bay of Plenty in previous work. The mushroom-cap morphology (Figure 2B) is recognised from the same location at Bramley Drive as the spheres described by Smalley *et al.* (1980). With improved SEM technology, we identify these spheres as incomplete: individual halloysite spheroids are typically ~250–400 nm in diameter with openings ~80–160 nm in diameter on one side, giving the “mushroom-cap” appearance. We infer that the spheroids observed are composed of concentrically stacked 1:1 layers, reminiscent of the structure of an onion. A complete silanol layer, as comprises the outer sphere surface, carries a net negative charge. In the openings, ends of both silanol and aluminol sheets are exposed, giving a neutral or weakly positive overall charge. Electrostatic or van der Waals forces lead to attraction between the negatively charged convex surfaces of the silanol sheets and the weak positive charges of the concave openings, allowing the individual minerals to aggregate into a network of connected particles in the undisturbed state (Figure 2C). The attractions are short-range however, and detachment by remoulding allows a disaggregation, giving the material a low remoulded strength. While the various halloysite morphologies occur mixed throughout the profile; the mushroom-caps are most abundant in the highly sensitive layers, whereas tubular halloysite is more abundant in the upper, less sensitive materials.

By looking more deeply at the structure of the clay minerals, identifying mushroom-cap shaped halloysite spheroids as dominant in the most sensitive soil layers allows us to recognise the nature of the framework of the soil, and hence infer mechanisms for breakdown of the structure. Little cohesion or friction softening is recognised in static triaxial testing; this follows from the nature of the clay minerals – spheres will not inherently realign as might be expected with platy minerals, their friction will be similar before and after; cohesion will presumably be lost, but limited cohesion exists in the undisturbed condition due to only weak attractive forces being able to develop between the outer and broken segments of the mushroom caps. We infer that excess pore pressure gradients initiate the separation of mushroom caps, leading to brittle shear surface evolution. Dramatic particle rearrangement on detachment of the weakly bonded spheroids leads to release of further pore water along the shear zone, enhancing pressure gradients and hence propagation of failure progressively to form discrete shear surfaces.

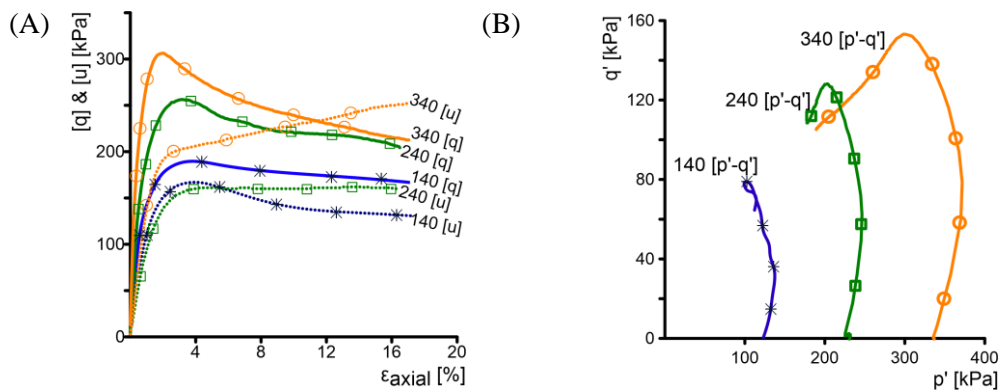
Figure 3. (A) Deviator stress versus axial strain, and (B) effective stress path plots for static triaxial tests (from Mills and Moon, 2016)

samples were stored in their tubes in sealed chambers until immediately before testing. Testing followed standard NZ procedures (NZS4402 (1986)), with the exception of the rate of stress application where a high rate of 0.5 mm min^{-1} was chosen following the model of Gylland *et al.* (2013). B values greater than 95 % were achieved during saturation, and isotropic consolidation stresses of $140\text{--}340 \text{ kN m}^{-2}$ were applied to bracket field overburden stresses. Test results are summarised in Table 2 and plotted in Figure 3.

Samples failed at axial strains of 3.2 % or less, and exhibited significant strain softening post-failure as expected for sensitive soils. Pore water pressures climbed sharply on application of axial stress, then dropped or plateaued post-failure in the samples tested at lower effective confining stresses ($\sigma_c = 140$ & 240 kN m^{-2}), but continued to increase after failure in the sample at the highest confining stress ($\sigma_c = 340 \text{ kN m}^{-2}$). Effective stress path plots show contractive behaviour, particularly at the higher confining stresses.

Strength parameters derived from these tests are included in Table 2. The values are in keeping with commonly reported values for the strength of halloysite-rich soils (Table 1) and show relatively low cohesion and high friction angle in undisturbed (peak) conditions. Residual cohesion is similar to the undisturbed value, and the friction angle undergoes only a small change post-failure. Strain softening of effective cohesion values and friction angles is thus limited, indicating that pore water pressure changes post-failure are key to the significant strain softening observed.

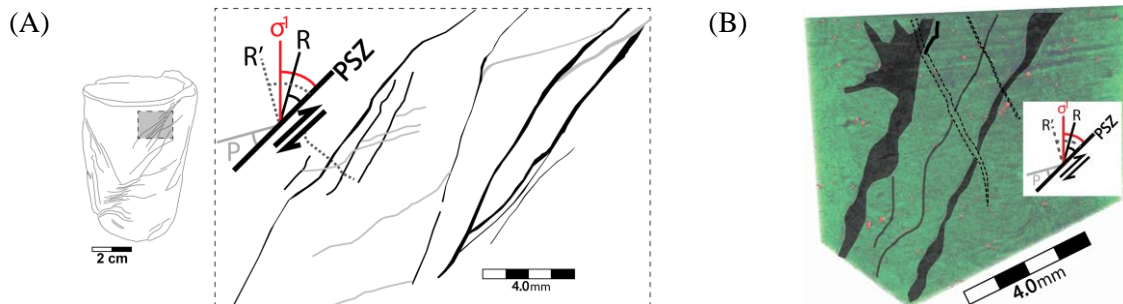
Figure 4. Thin section (A) and microCT section (B) of failure surfaces (from Mills, 2016).

Following strength testing, thin section description and computerised x-ray tomography (CT) of the failed cores were undertaken to examine the fracture surfaces developed during stress application. Thin sections were prepared by cutting surfaces oriented vertically on the failed core; these were air-dried slowly under ambient laboratory conditions, and impregnated with resin

before following normal thin section preparation procedures. Small (10 mm inside diameter) core samples were taken normal to the macroscopic shear surface for micro-CT scans which were undertaken using a Bruker Skyscan 2000 Micro-CT at the University of Auckland.

Thin section samples (tested at 240 and 340 kN m⁻²) show multiple principal shear zones evidenced by zones of particle reorientation up to 1.0 mm wide that have distinct boundaries with the surrounding matrix material (Figure 4A). The shear zones are continuous across the full length of the thin sections, and commonly show branching and coalescence, most notably around weathered zones or particle concentrations. As well, minor shears that are not continuous are commonly observed. A portion of the micro-CT scan image (sample tested at 355 kN m⁻² effective stress) is shown in Figure 4B. A matrix of clays is indicated in green, dense particles are red colours, and shear zones are highlighted with pale green, black and pink annotations. All angles are measured with respect to the angle of the macroscopic principal shear (PDS) identified on the failed core. Two small shear zones 0.05–0.1 mm thick and spaced 2–3 mm apart are apparent in the core. These are most closely oriented to the direction expected for Reidel R shears, and are linked by antithetic R' shears. Reorientation of particles within these shear zones is not apparent, but the clay matrix within the shears is notably denser than in the surrounding matrix.

Overall, we observe brittle failure occurring along multiple shear zones oriented approximately as expected for Riedel shears, with some antithetic (R') shears observed linking the principal shear zones. Clay minerals are densified in the shear zones compared with the matrix density, and larger grains are reoriented to parallel the shear zone.

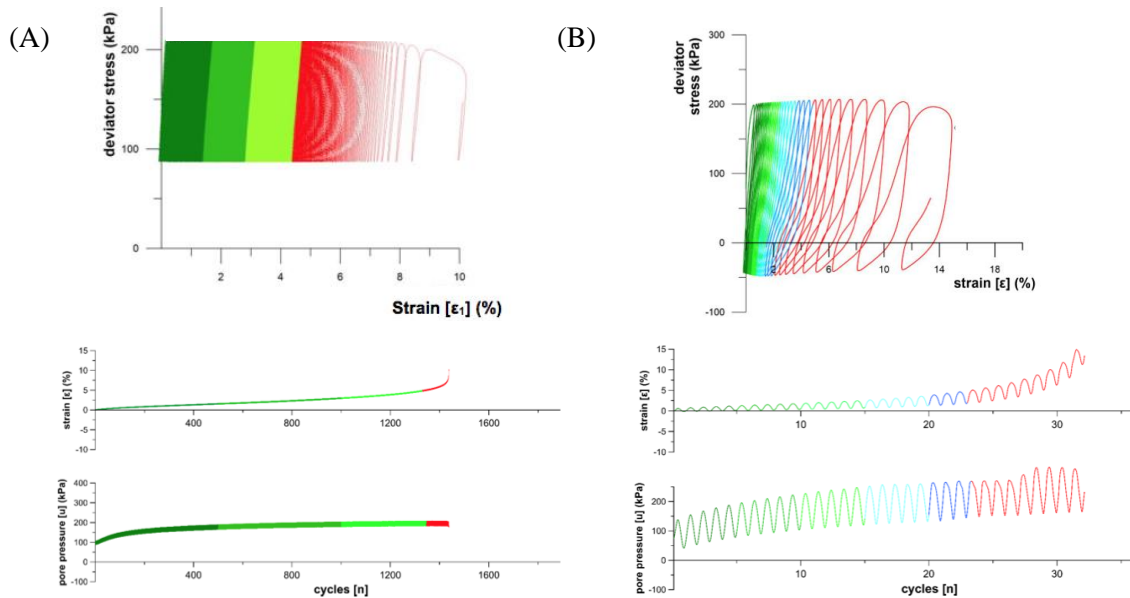
Figure 5. Cyclic triaxial test results for two samples. (A) 75 kN m⁻² average applied stress, 30 kN m⁻² cyclic stress; (B) 40 kN m⁻² applied average stress, 60 kN m⁻² cyclic stress (from Mills, 2016)

Figure 5A shows the test results for one sample tested at with high average shear stress of $\tau_{av}=75$ kN m⁻² and low cyclic shear stress of $\tau_{cyc}=30$ kN m⁻², meaning that the sample remains in compression throughout the test. Notable is that the hysteresis loops remain relatively unaffected by loading cycles for most of the test, then the sample fails suddenly over a few cycles (failure in this case is defined as 5 % single amplitude axial strain). Pore water pressure rises sharply as the stress is initially increased, then remains high throughout the test. By contrast, Figure 5B shows the results of a test run with average shear stress of $\tau_{av}=40$ kN m⁻² and cyclic stress of $\tau_{cyc}=60$ kN m⁻² (ie. the sample experienced extension for part of each loading cycle). Both samples described develop compressional strain and increased pore water pressure throughout, but in the second test

the hysteresis loops develop a much more distorted shape (decreased stiffness), especially in the extensional regime, as the sample approaches failure; post-failure the pore water pressure increases and the stiffness decreases markedly.

The sudden increase in axial strain and the decrease in stiffness observed in the cyclic triaxial tests is in keeping with the sensitive nature of the soils where brittle failure and considerable post-failure strain softening are observed in the static compression testing presented above. The development of pore water pressure during loading is inferred to play a significant role in the development of failure in these materials.
