The Change in the Horizontal Position of the Dune Toe and Vegetation Line on Beaches Within the Waikato Region

A thesis
submitted partial fulfilment
of the requirements for the degree
of
Master of Science (Research) in Earth Sciences
at
The University of Waikato
by
Celeste Jade Davies-Calway

2020

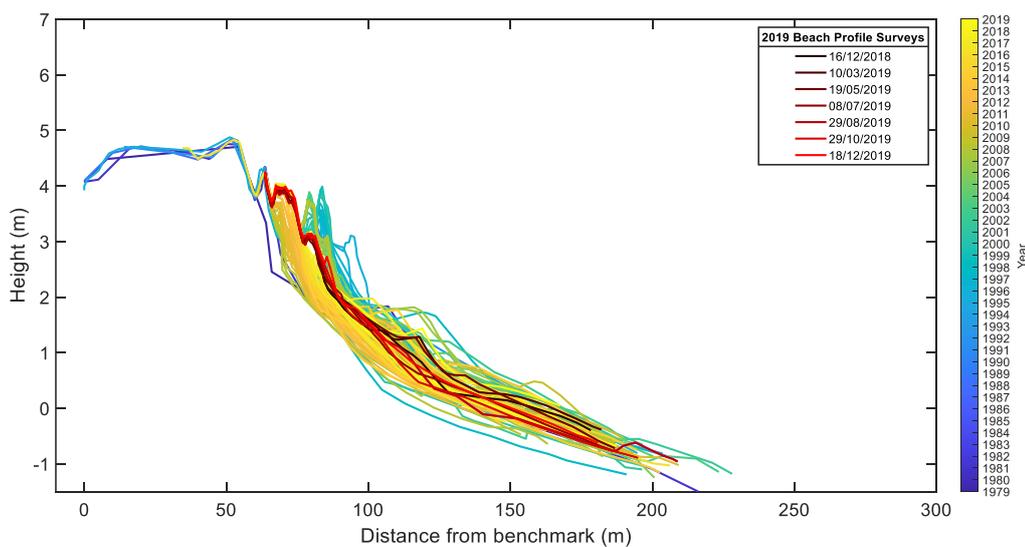
Figure 3.37. Historic Beach Profiles at CCS14, Matarangi Beach. Beach profiles from 1979 to 2019. The 2019 field survey beach profiles are shown in red.

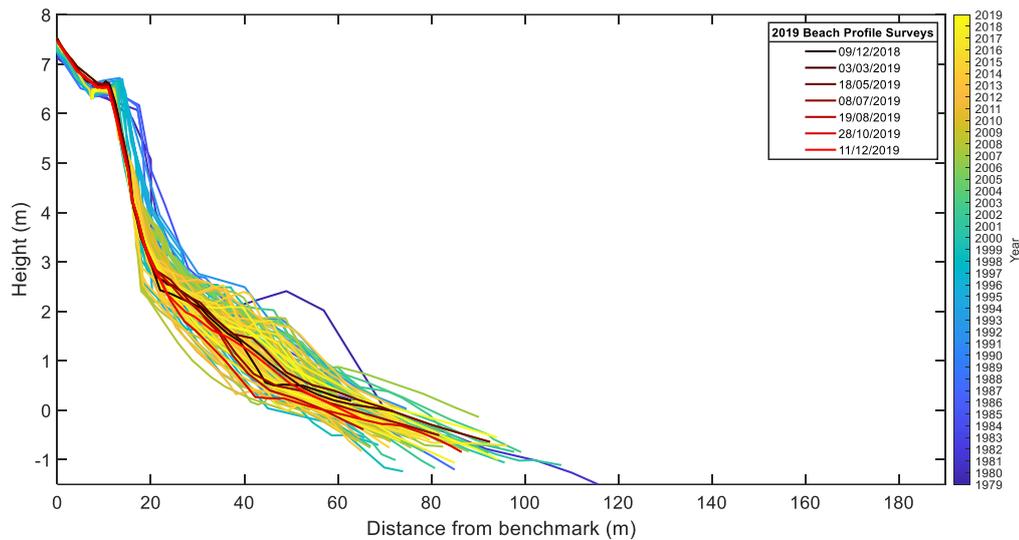
Figure 3.38. Historic beach profiles at CCS11, Whangapoua Beach. Beach profiles from 1979 to 2019. The 2019 field survey beach profiles are shown in red.

The inflection point of the dune toe where the steep slope of the sand dune meet the lower angled beach was also shown in the historic beach profiles (Figure 3.38). How the dune toe moved with the lower beach face was shown, where changes in the lower beach face cause changes to the dune toe but to a lower magnitude, where at CCS12 (Figure 3.39), the dune toe moved landward and then seaward again.

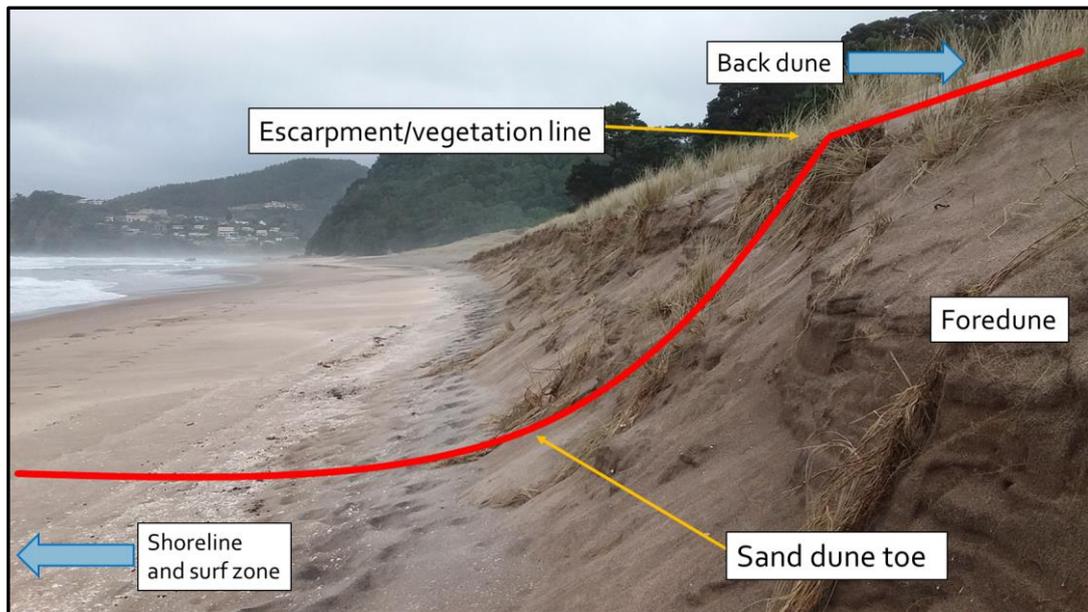
Figure 4.1. A diagram showing what is defined as the dune toe and vegetation line when there is an escarpment present.

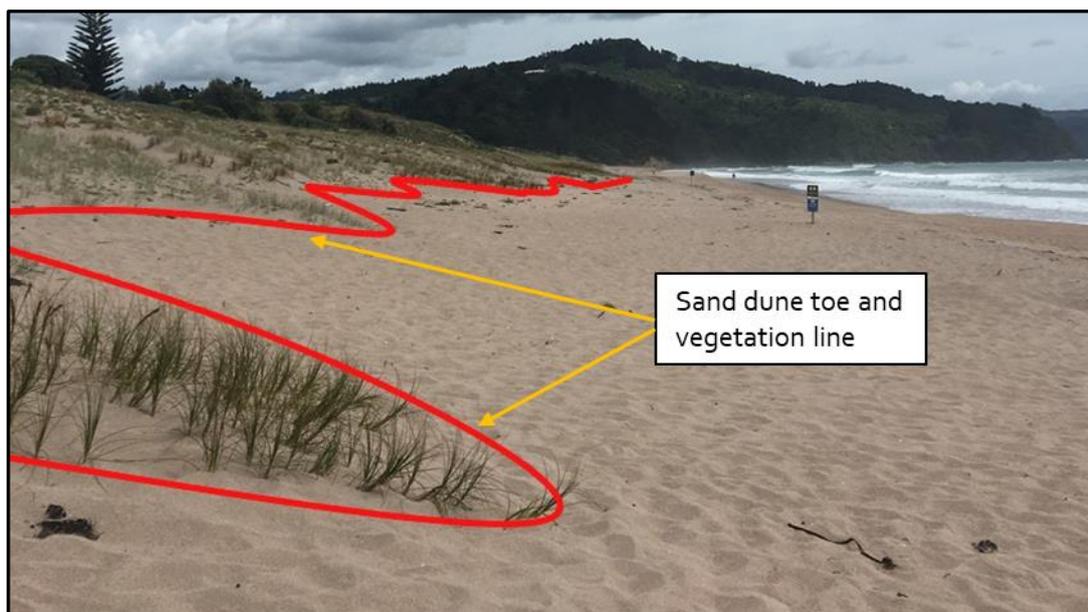
Figure 4.2. A diagram showing what is defined as the dune toe or vegetation line when there is no escarpment present.

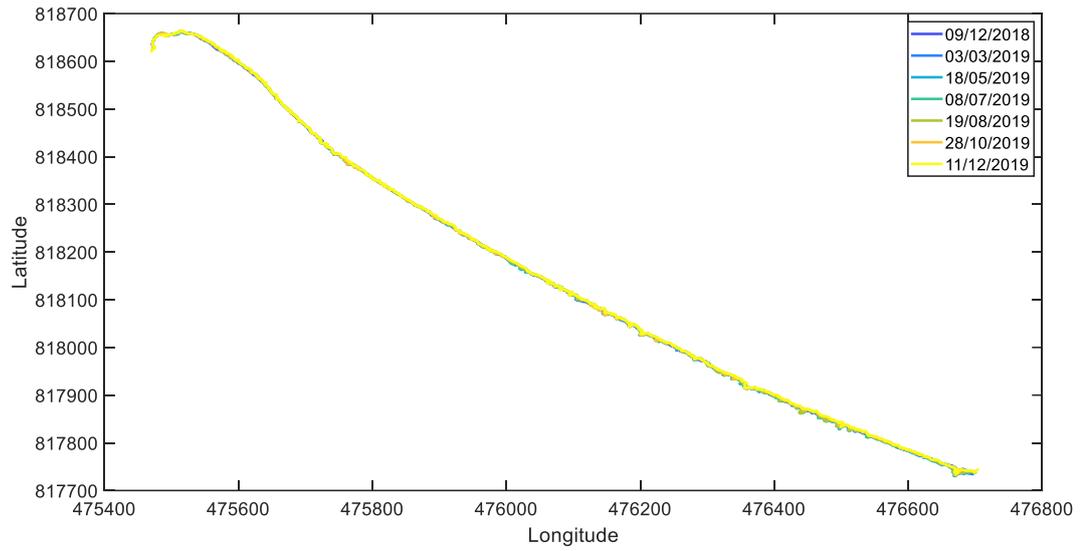
Figure 4.7. The coordinate position of the alongshore dune toe, Whangapoua Beach. Field surveys were taken 9th December 2018, 3rd March 2019, 18th May 2019, 8th July 2019, 19th August 2019, 28th October 2019 and 11th December 2019.

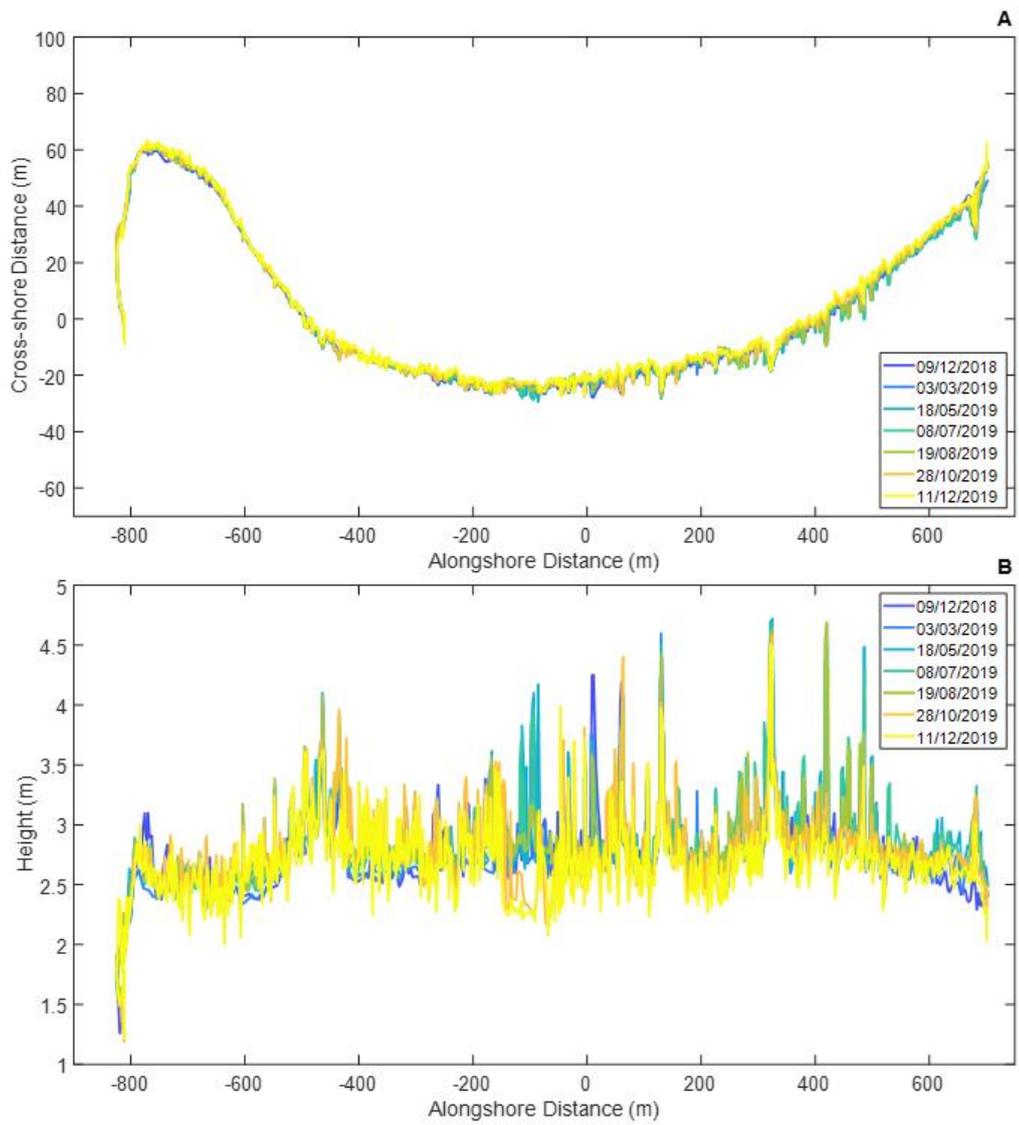
Figure 4.8. The cross-shore distance of the dune toe (A) and the height of the dune toe (B), Whangapoua Beach. Field surveys were taken 9th December 2018, 3rd March 2019, 18th May 2019, 8th July 2019, 19th August 2019, 28th October 2019 and 11th December 2019.

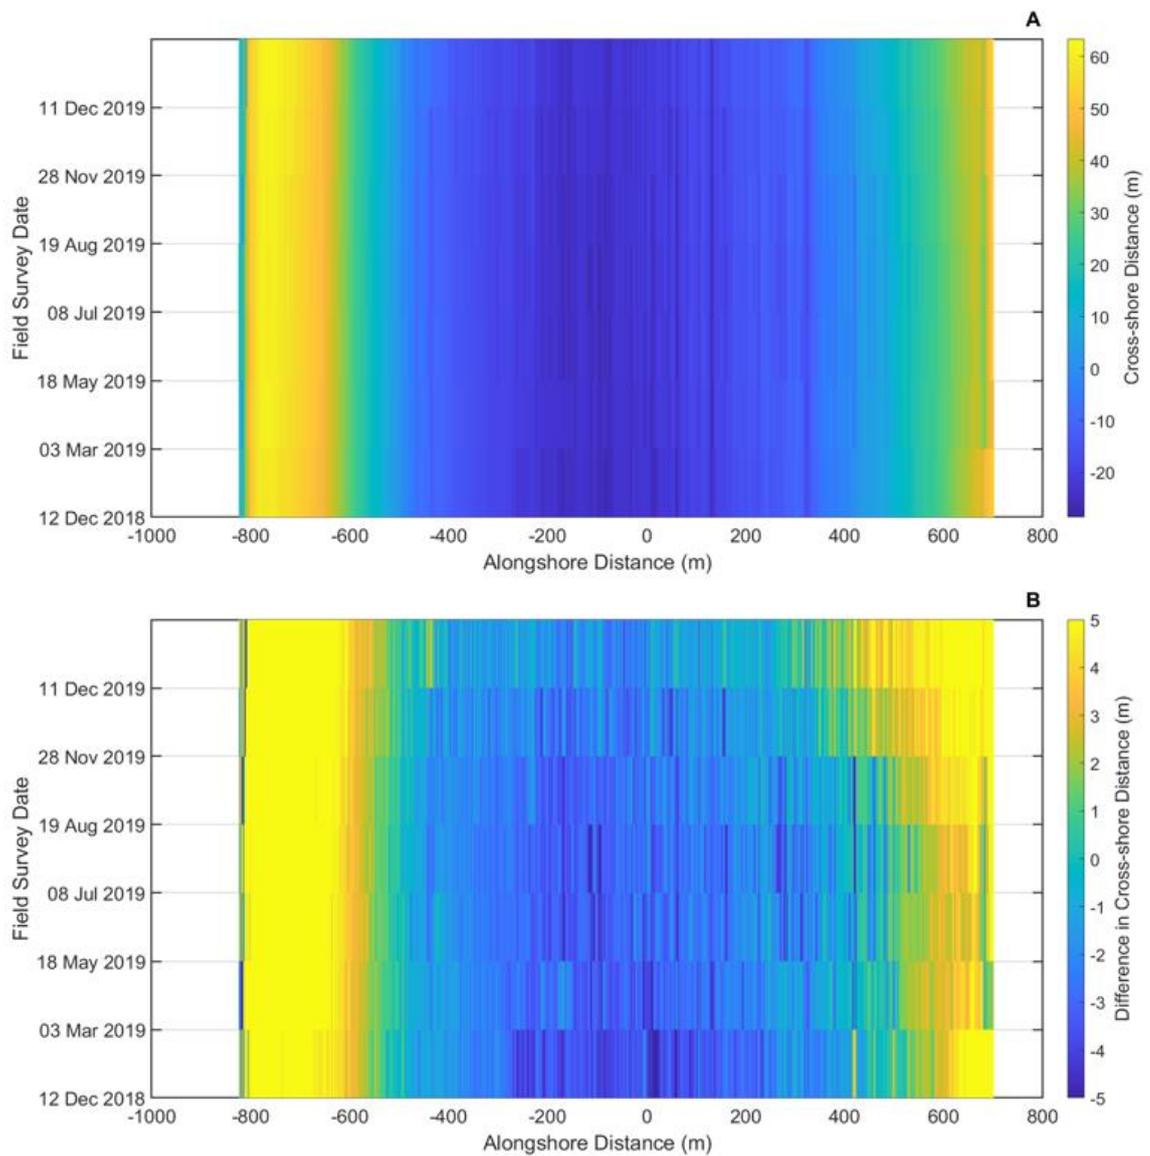
Figure 4.9. The horizontal position of the dune toe (A) and the difference of cross-shore distance of the dune toe from the mean horizontal position of the dune toe (B), Whangapoua Beach. Each bar represents a field survey of the dune toe and the colour of each bar represents the cross-shore position of the horizontal dune toe (A) and the difference of cross-shore distance from the mean horizontal dune toe position. Field surveys were taken 9th December 2018, 3rd March 2019, 18th May 2019, 8th July 2019, 19th August 2019, 28th October 2019 and 11th December 2019.

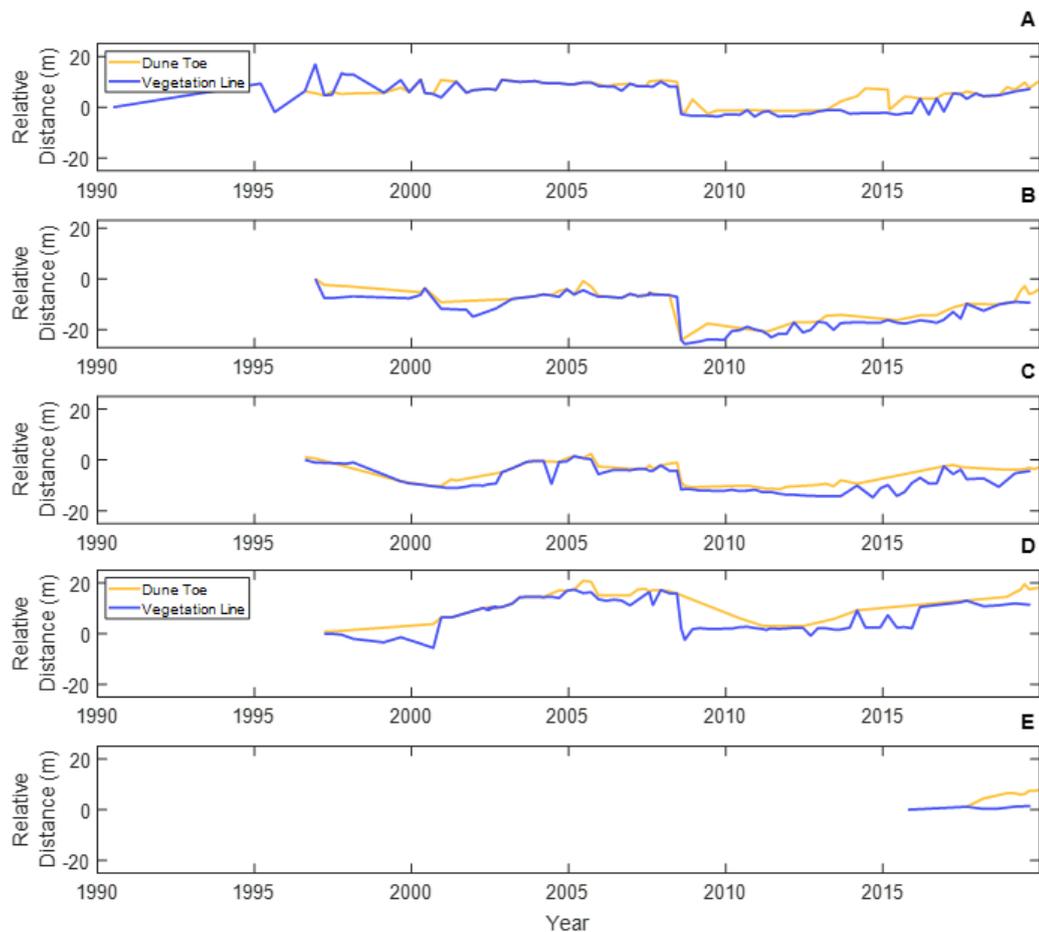
Figure 4.10. The change in relative horizontal distance of the vegetation line and dune toe, Matarangi Beach. The vegetation line (purple line) and dune toe (orange line) for at the beach profile sites of CCS13 (A), CCS14 (B), CCS15 (C), CCS16 (D) and CCS17 (E). Note the y-axis is shifted in panel B.

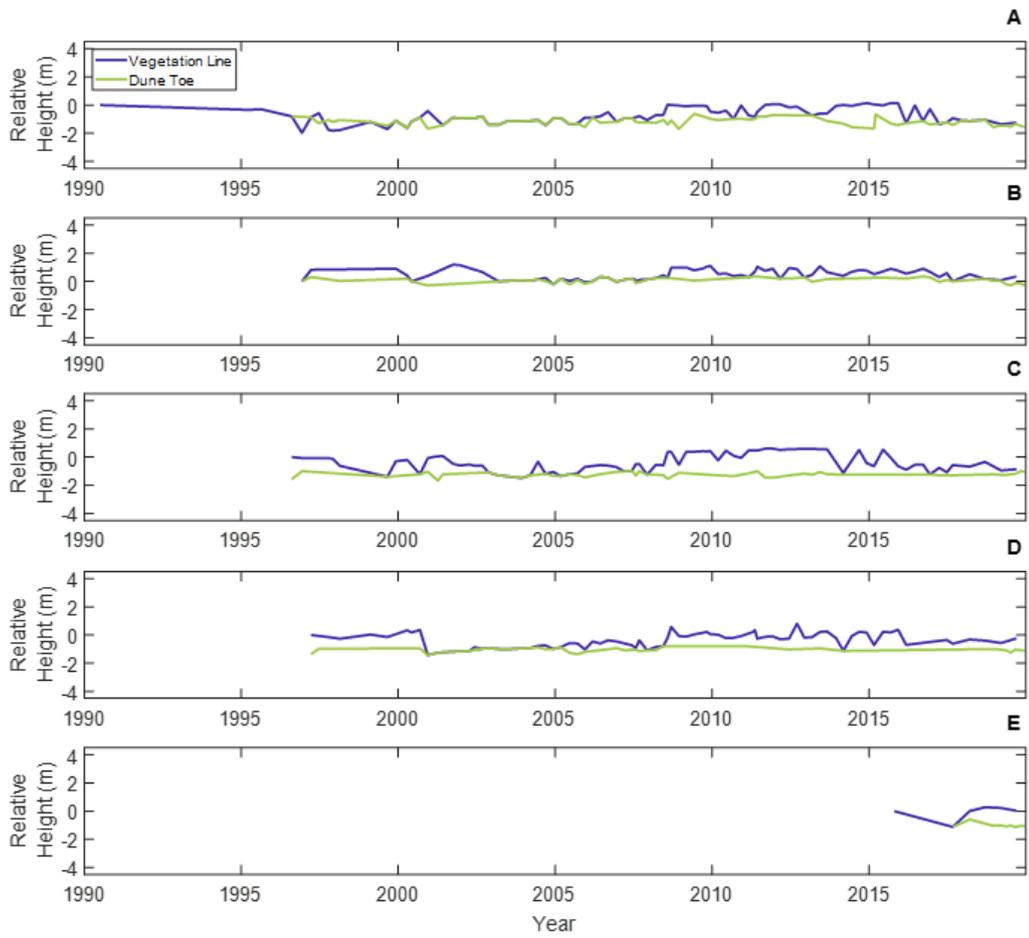
Figure 4.11. The change in relative height of the vegetation line and dune toe, Matarangi Beach. The vegetation line (blue line) and dune toe (green line) for at the beach profile sites of CCS13 (A), CCS14 (B), CCS15 (C), CCS16 (D) and CCS17 (E).

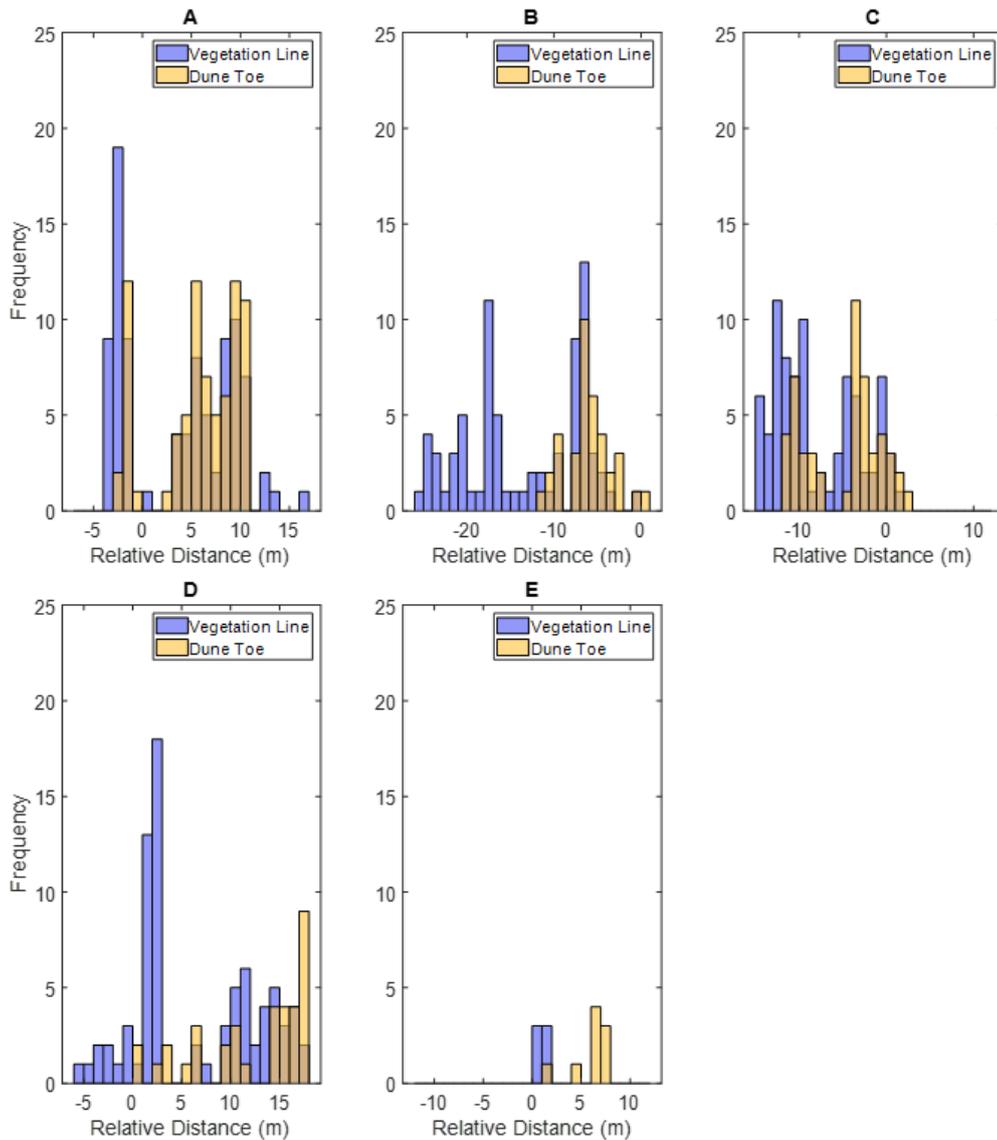
Figure 4.12. The distribution of relative horizontal distance position of the vegetation line and dune toe, Matarangi Beach. The vegetation line (purple line) and dune toe (orange line) for at the beach profile sites of CCS13 (A), CCS14 (B), CCS15 (C), CCS16 (D) and CCS17 (E). Note the shifted x-axis in panel A, B, C and D, and the different scale x-axis in panel B.

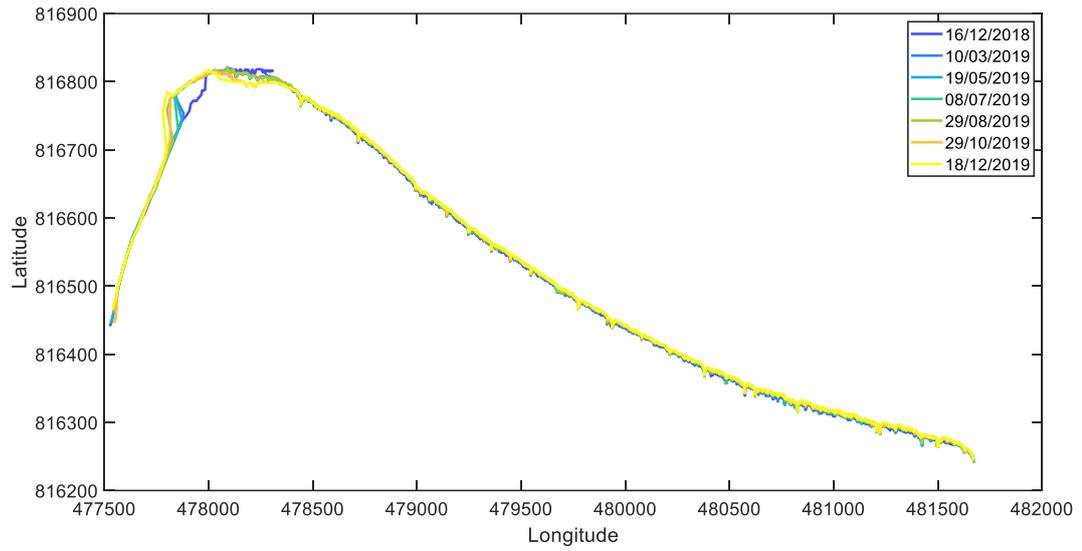
Figure 4.13. The coordinate position of the alongshore dune toe, Matarangi Beach. Field surveys were taken 16th December 2018, 10th March 2019, 19th May 2019, 8th July 2019, 29th August 2019, 29th October 2019 and 18th December 2019.

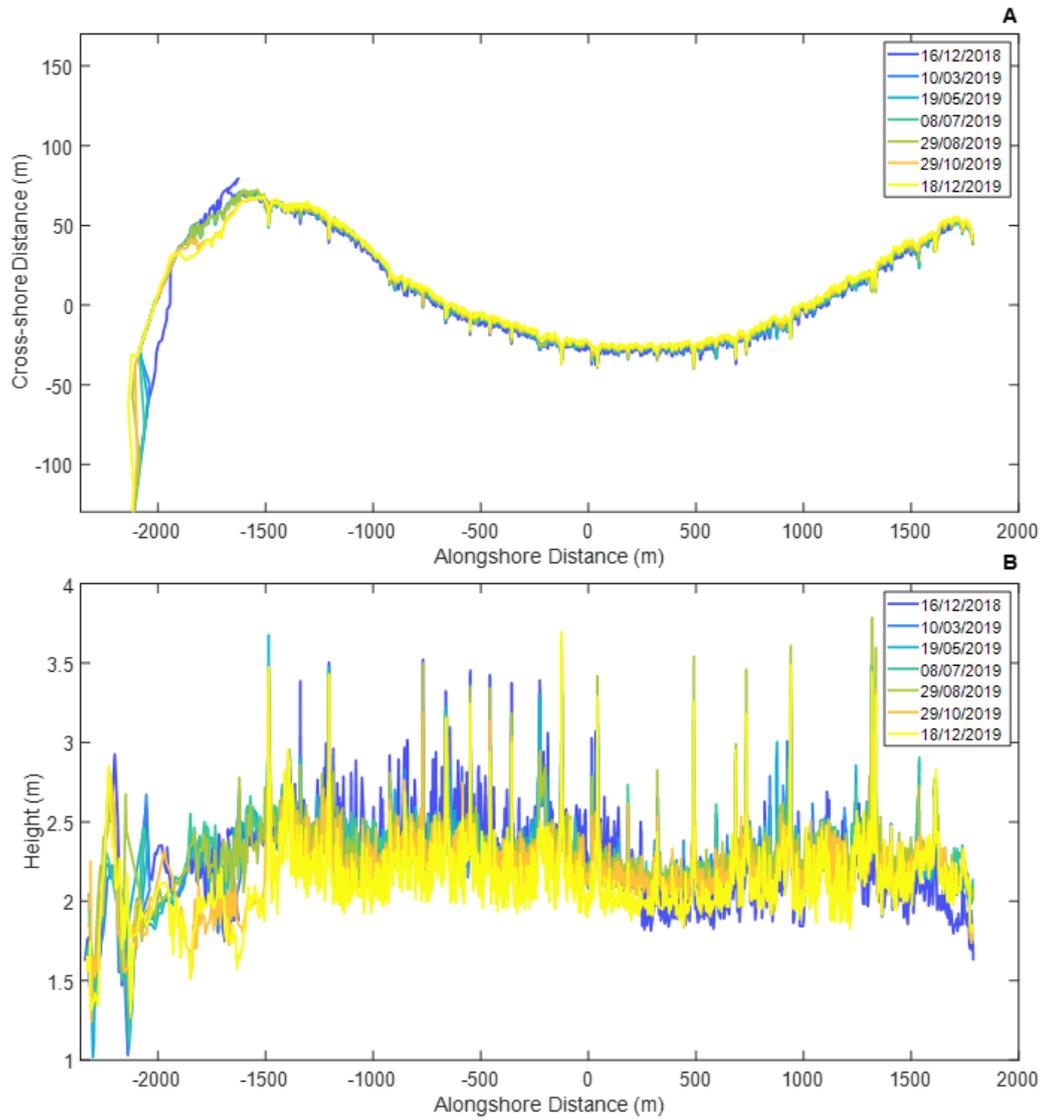
Figure 4.14. The cross-shore distance of the dune toe (A) and the height of the dune toe (B), Matarangi Beach. Field surveys were taken 16th December 2018, 10th March 2019, 19th May 2019, 8th July 2019, 29th August 2019, 29th October 2019 and 18th December 2019.

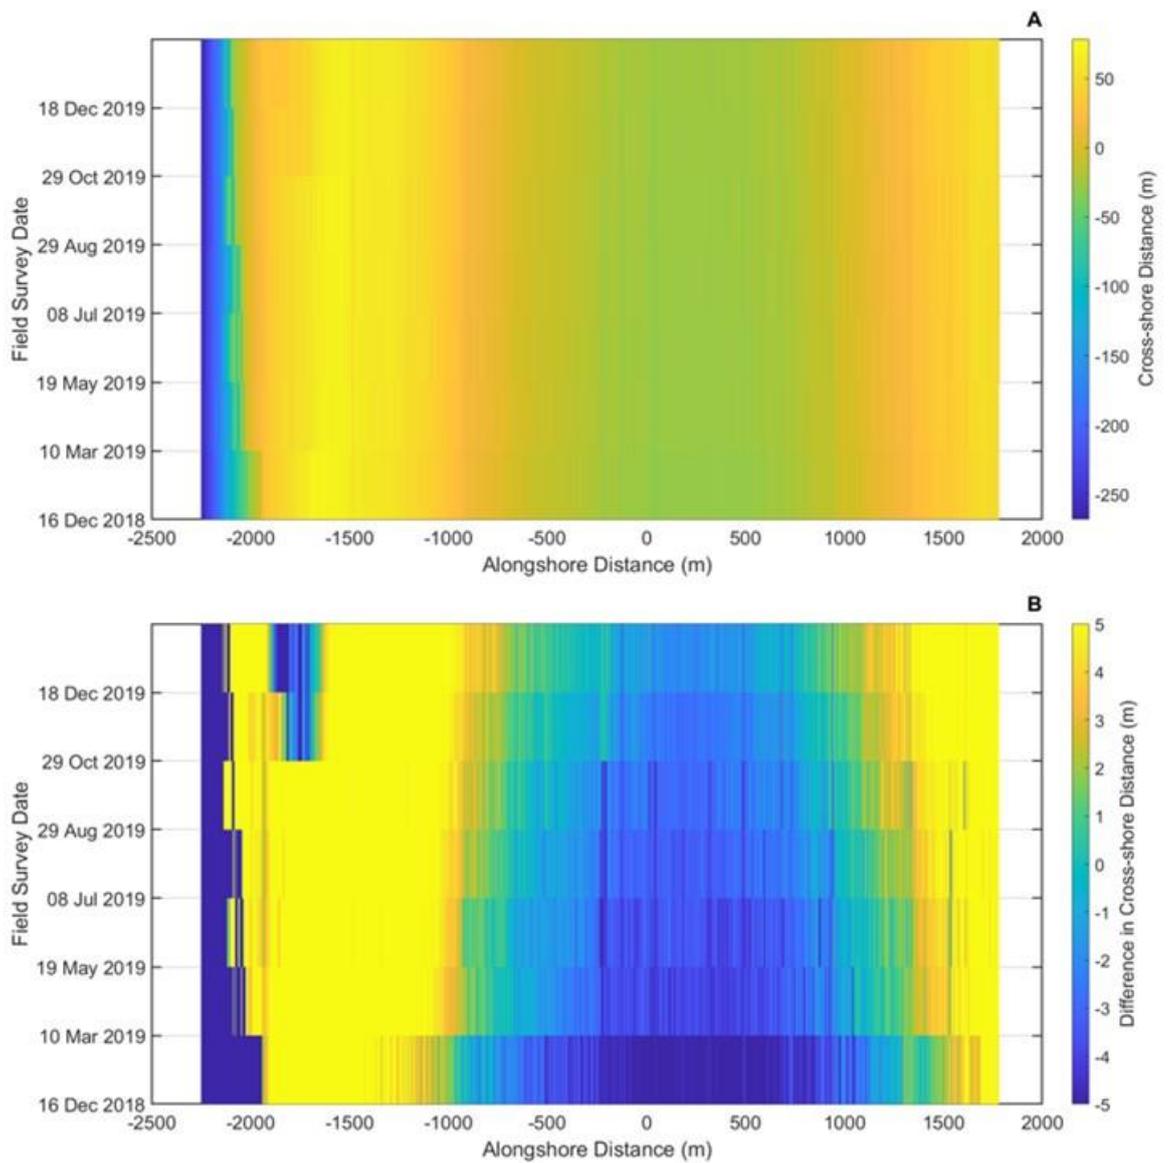
Figure 4.15. The horizontal position of the dune toe (A) and the difference of cross-shore distance of the dune toe from the mean horizontal position of the dune toe (B), Matarangi Beach. Each bar represents a field survey of the dune toe and the colour of each bar represents the cross-shore position of the horizontal dune toe (A) and the difference of cross-shore distance from the mean horizontal dune toe position. Field surveys were taken 16th December 2018, 10th March 2019, 19th May 2019, 8th July 2019, 29th August 2019, 29th October 2019 and 18th December 2019.

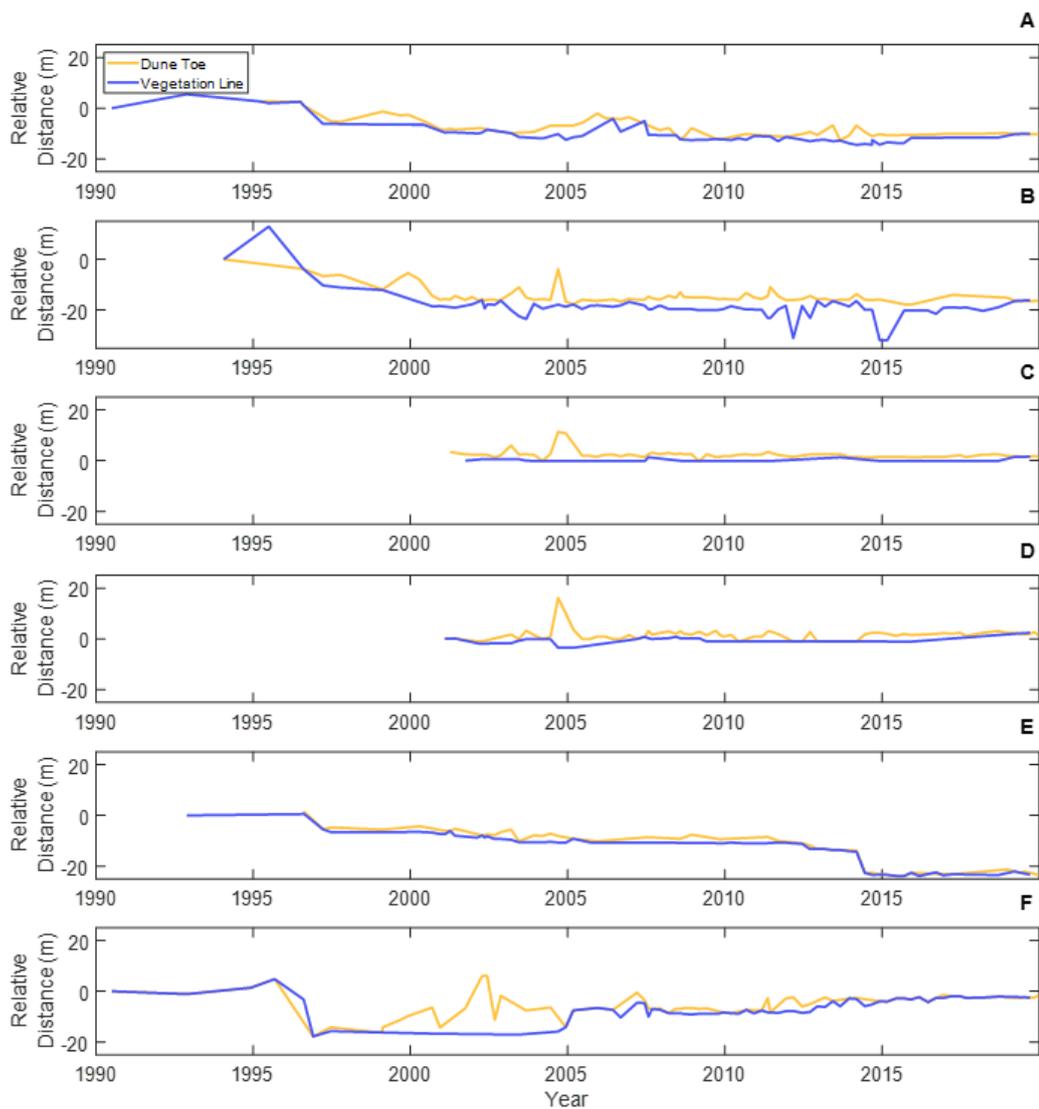
Figure 4.16. The change in relative horizontal distance of the vegetation line and dune toe, Buffalo Beach. The vegetation line (purple line) and dune toe (orange line) for at the beach profile sites of CCS24 (A), CCS25 (B), CCS25-2 (C), CCS25-3 (D), CCS25-1 (E) and CCS26 (F). Note the shifted x-axis in panel B.

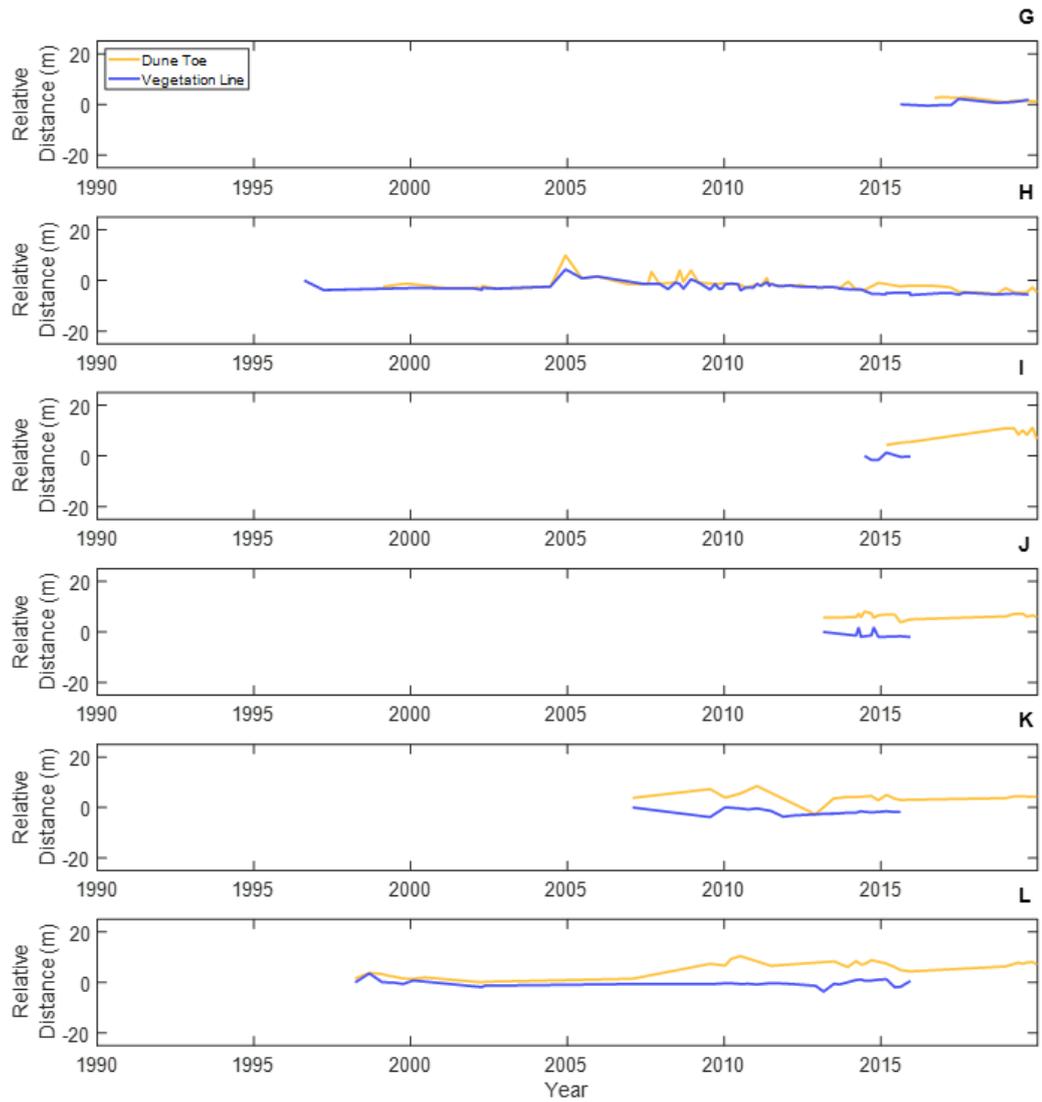
Figure 4.17. The change in relative horizontal distance of the vegetation line and dune toe, Buffalo Beach. The vegetation line (purple line) and dune toe (orange line) for at the beach profile sites of CCS26/1 (G), CCS27 (H), CCS27/10 (I), CCS27/8 (J), CCS27/6 (K) and CCS27/2 (L).

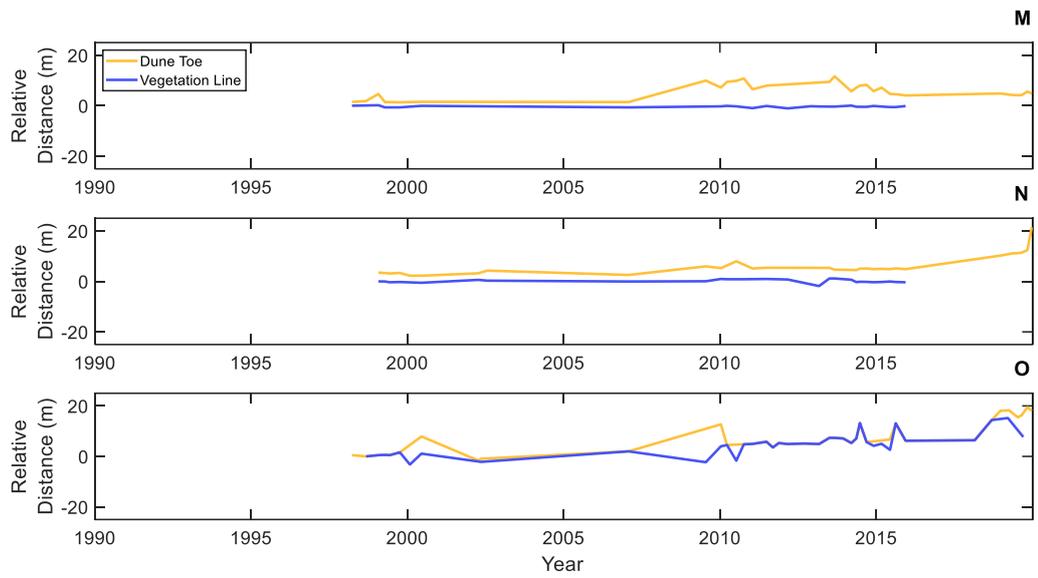
Figure 4.18. The change in relative horizontal distance of the vegetation line and dune toe, Buffalo Beach. The vegetation line (purple line) and dune toe (orange line) for at the beach profile sites of CCS27/3 (M), CCS27/4 (N), CCS27/5 (O).

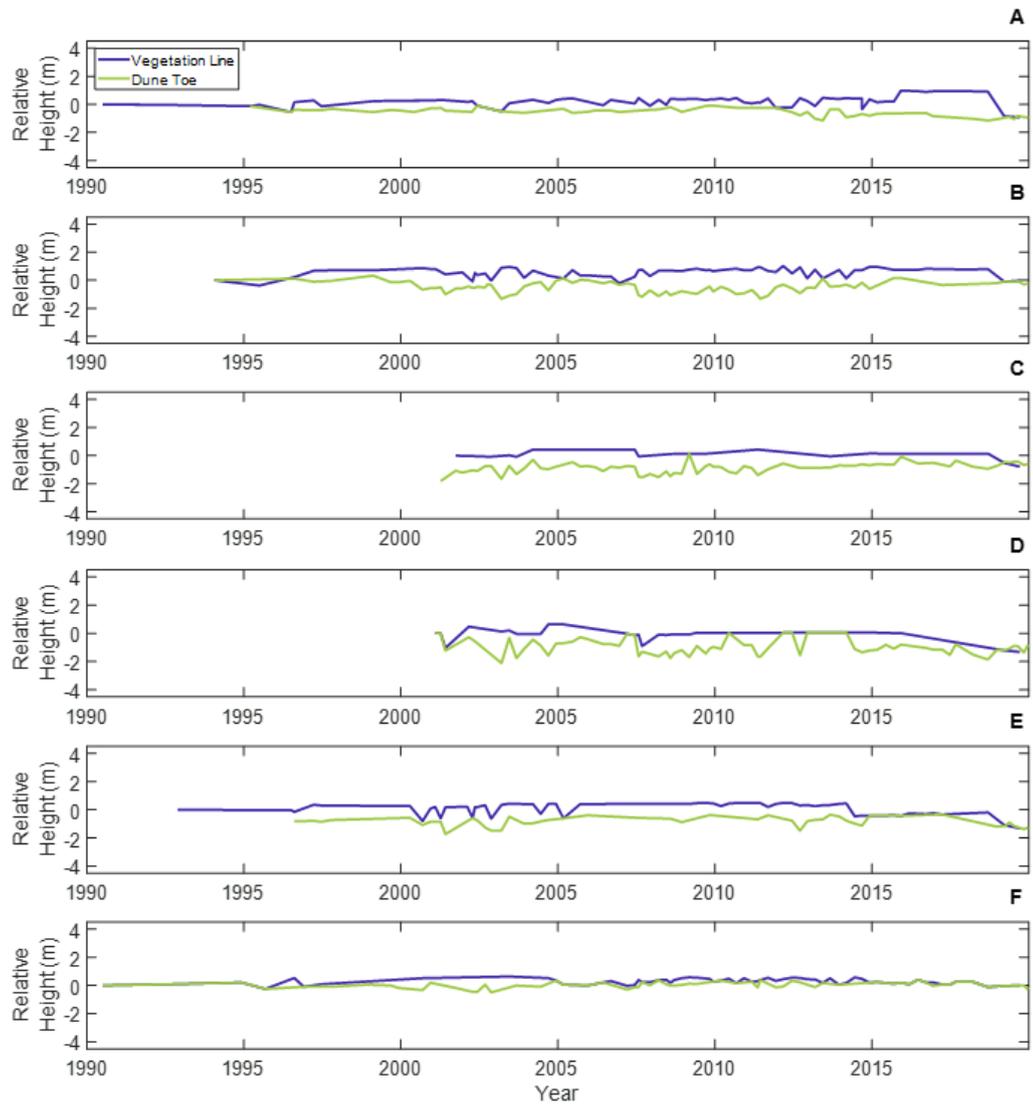
Figure 4.19. The change in relative height of the vegetation line and dune toe, Buffalo Beach. The vegetation line (blue line) and dune toe (green line) for at the beach profile sites of CCS24 (A), CCS25 (B), CCS25-2 (C), CCS25-3 (D), CCS25-1 (E) and CCS26 (F).

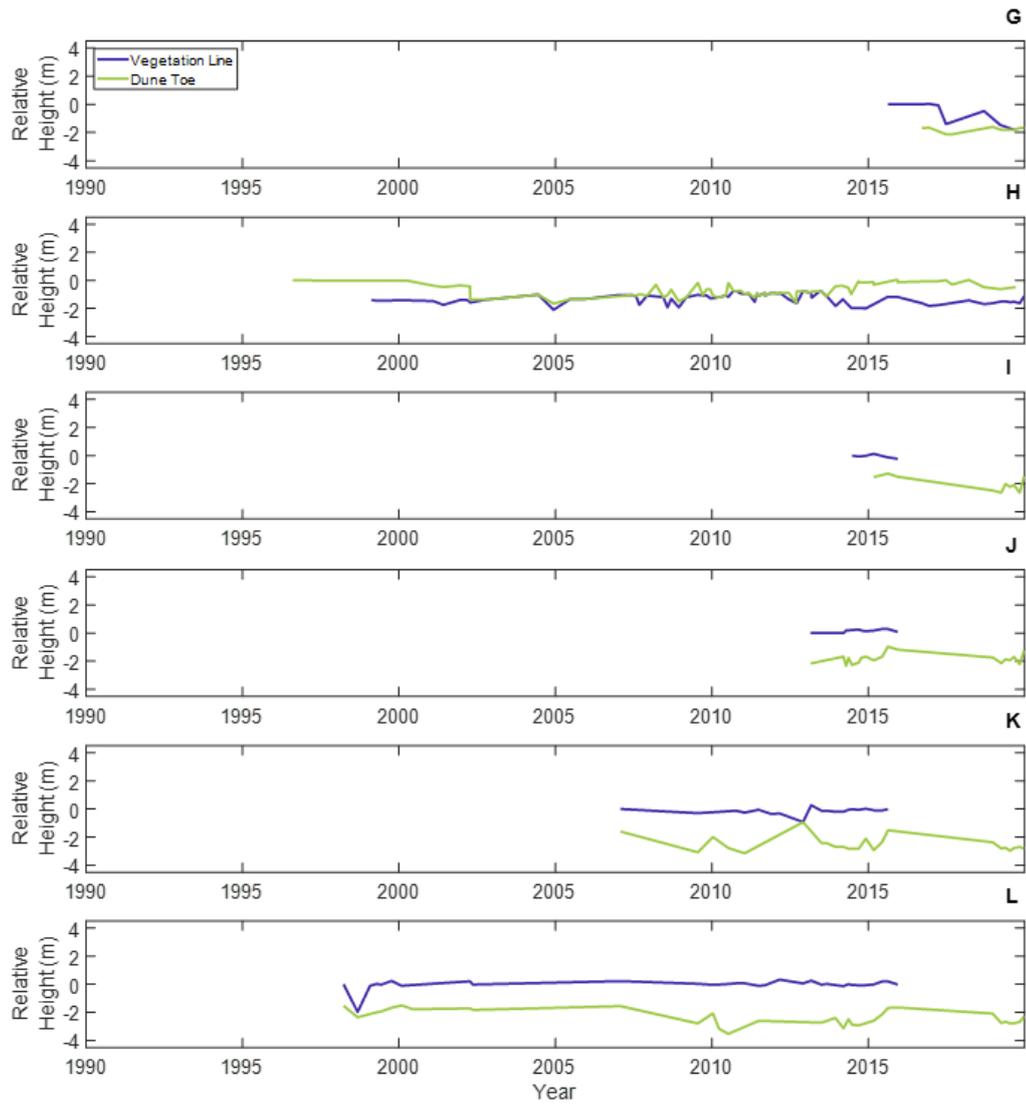
Figure 4.20. The change in relative height of the vegetation line and dune toe, Buffalo Beach. The vegetation line (blue line) and dune toe (green line) for at the beach profile sites of CCS26/1 (G), CCS27 (H), CCS27/10 (I), CCS27/8 (J), CCS27/6 (K) and CCS27/2 (L).

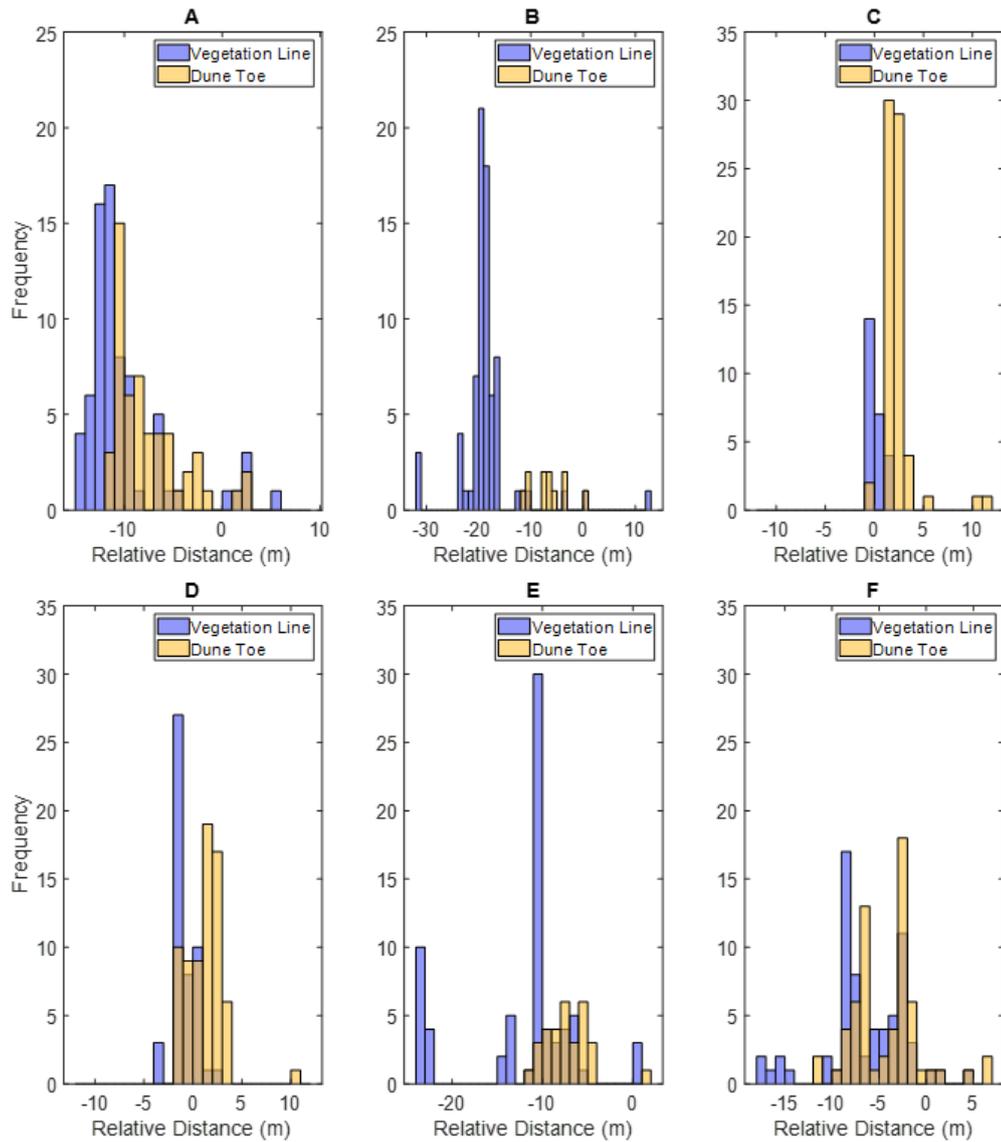
Figure 4.22. The distribution of relative horizontal distance position of the vegetation line and dune toe, Buffalo Beach. The vegetation line (purple line) and dune toe (orange line) for at the beach profile sites of CCS24 (A), CCS25 (B), CCS25-2 (C), CCS25-3 (D), CCS25-1 (E) and CCS26 (F). Note the x-axis is shifted in panel A, B, C, D, E and F, and the x-axis scale is different in panel B, E and F.

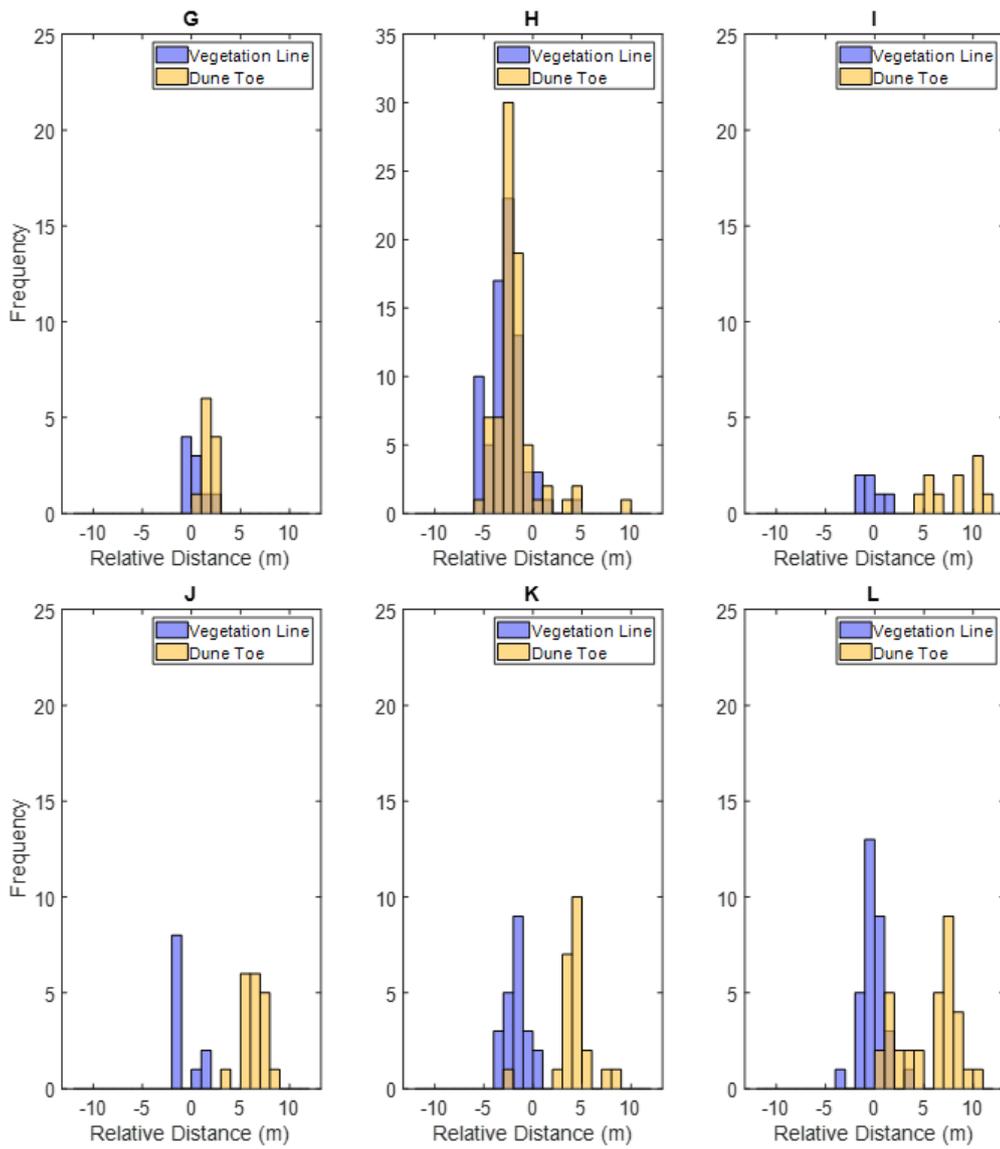
Figure 4.23. The distribution of relative horizontal distance position of the vegetation line and dune toe, Buffalo Beach. The vegetation line (purple line) and dune toe (orange line) for at the beach profile sites of CCS26/1 (G), CCS27 (H), CCS27/10 (I), CCS27/8 (J), CCS27/6 (K) and CCS27/2 (L). Note the x-axis is shifted in panel H.

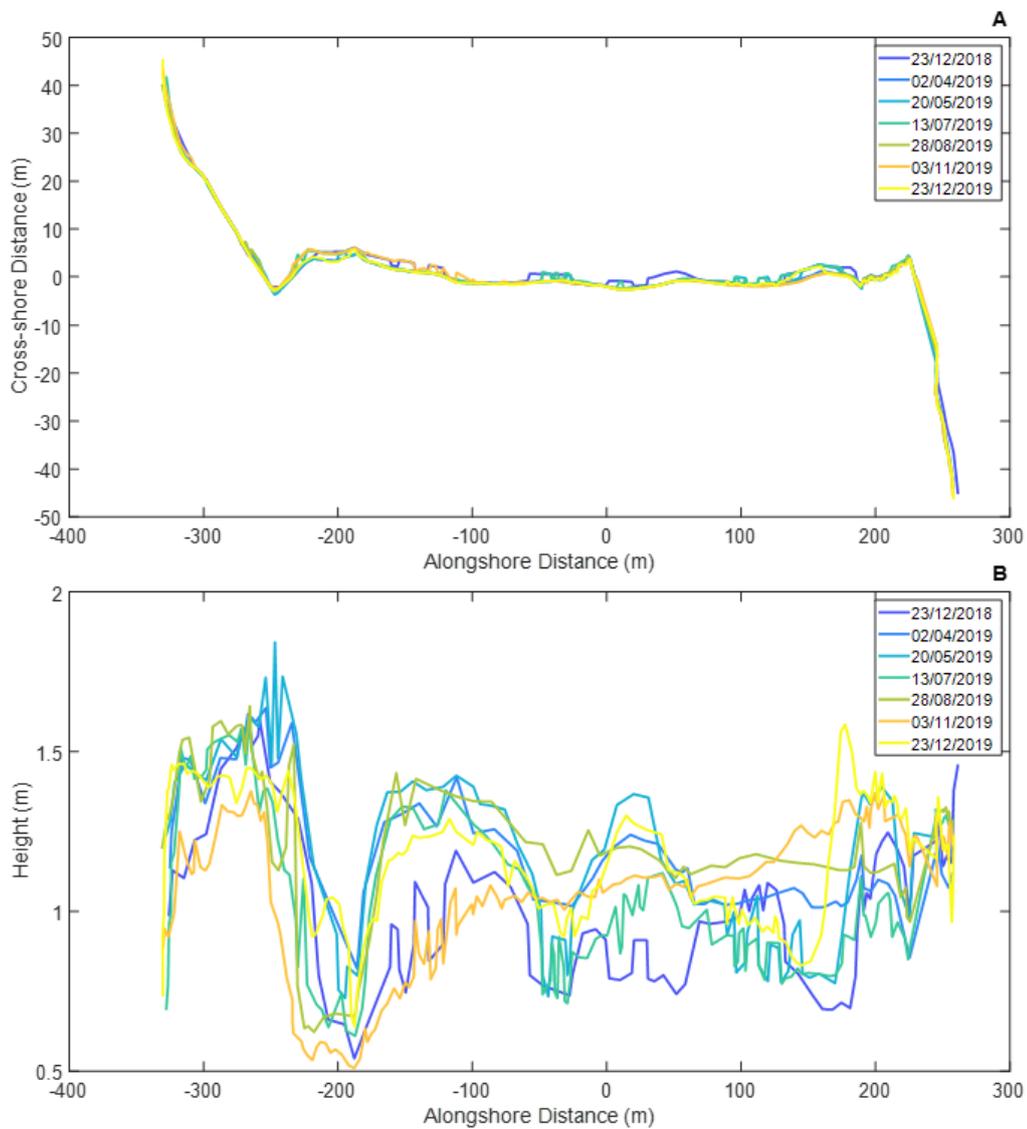
Figure 4.26. The cross-shore distance of the dune toe (A) and the height of the dune toe (B), Buffalo Beach. Field surveys were taken 23rd December 2018, 2nd April 2019, 20th May 2019, 13th July 2019, 28th August 2019, 3rd November 2019 and 23rd December 2019.
