The Change in the Horizontal Position of the Dune Toe and Vegetation Line on Beaches Within the Waikato Region

A thesis
submitted partial fulfilment
of the requirements for the degree
of
Master of Science (Research) in Earth Sciences
at
The University of Waikato
by
Celeste Jade Davies-Calway

2020

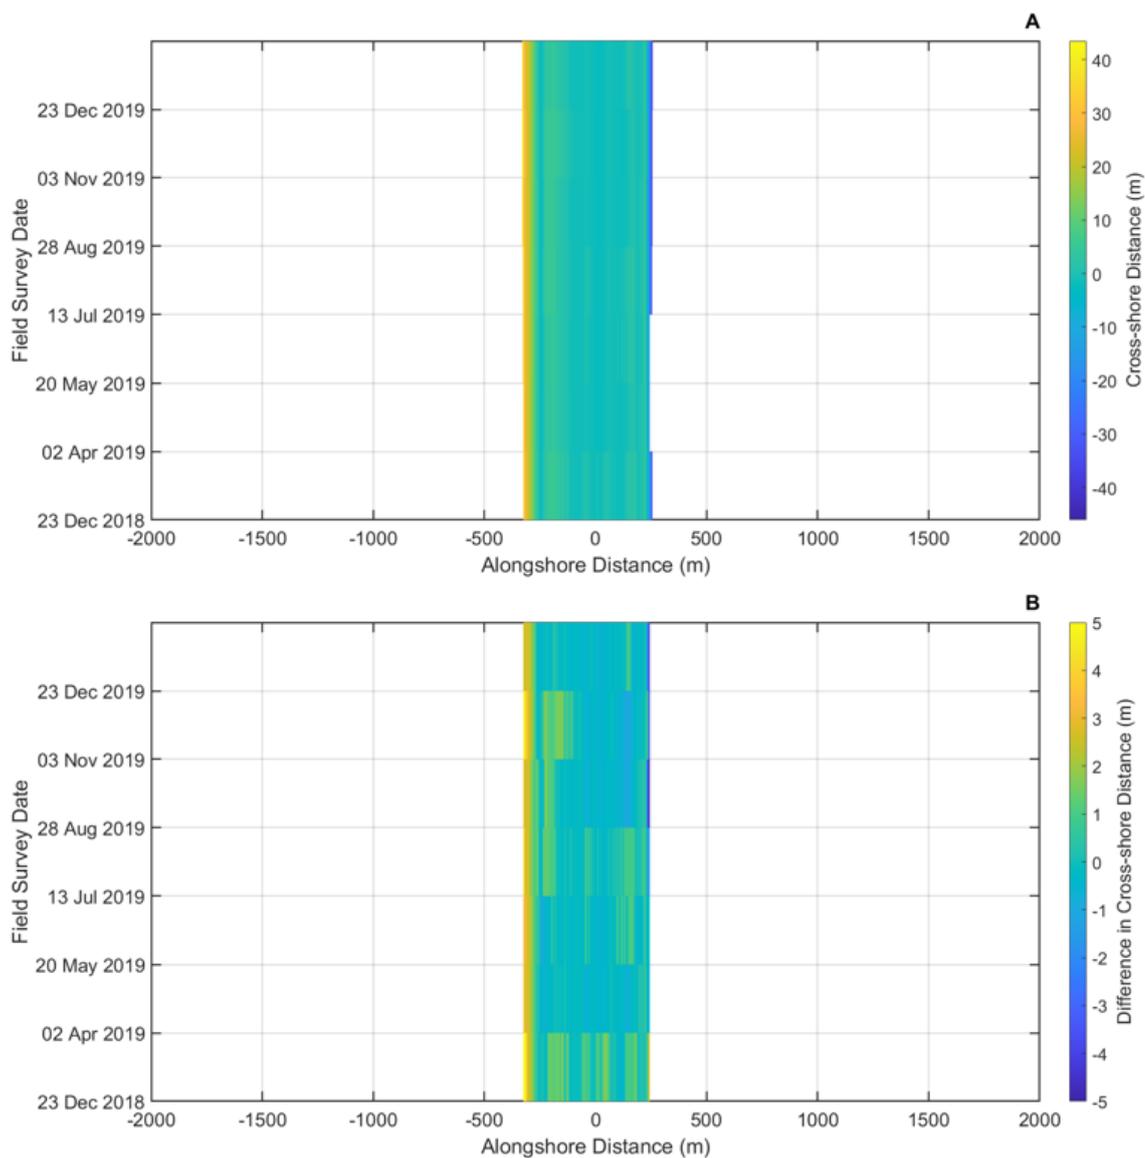
Figure 4.27. The horizontal position of the dune toe (A) and the difference of cross-shore distance of the dune toe from the mean horizontal position of the dune toe (B), Buffalo Beach. Each bar represents a field survey of the dune toe and the colour of each bar represents the cross-shore position of the horizontal dune toe (A) and the difference of cross-shore distance from the mean horizontal dune toe position. Field surveys were taken 23rd December 2018, 2nd April 2019, 20th May 2019, 13th July 2019, 28th August 2019, 3rd November 2019 and 23rd December 2019.

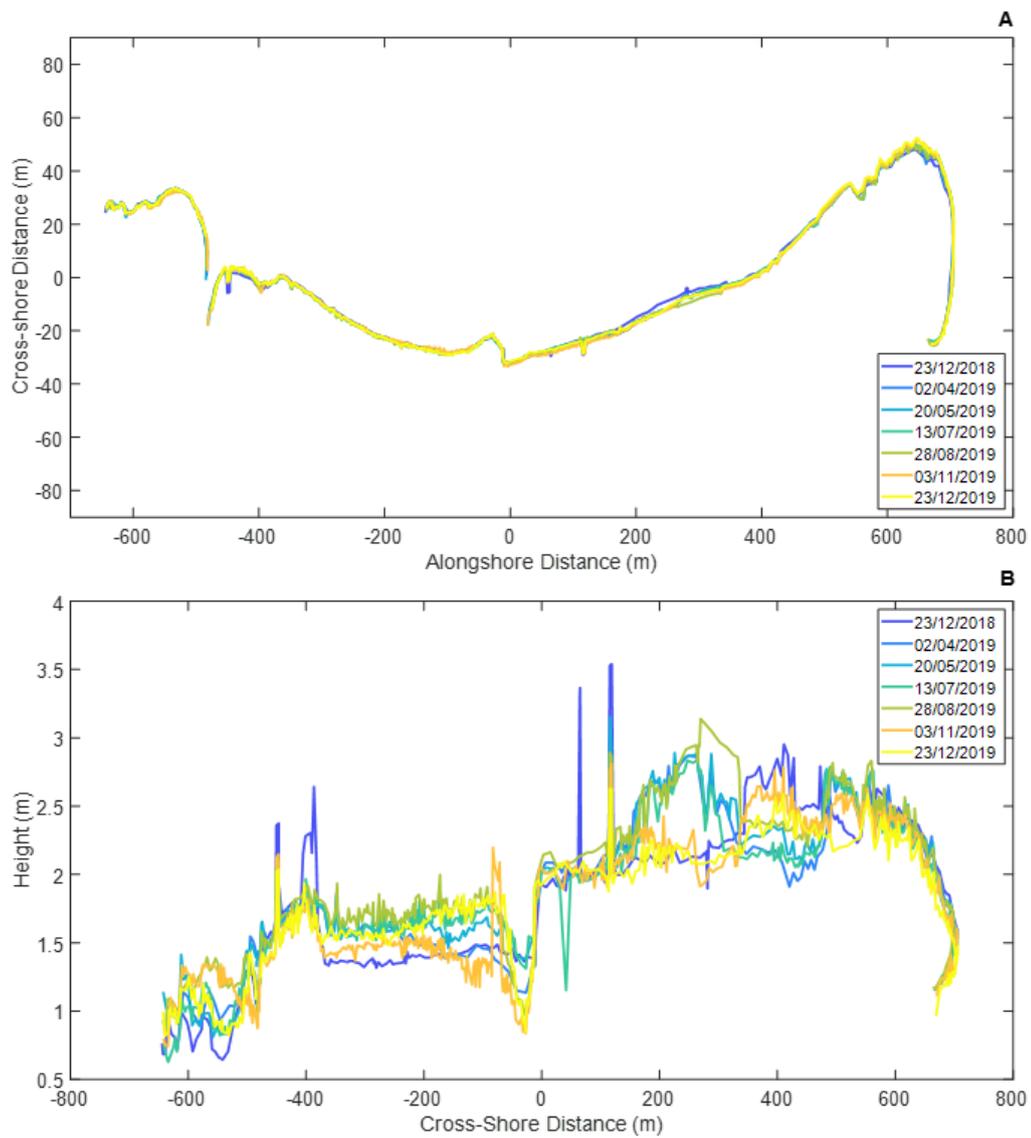
Figure 4.28. The cross-shore distance of the dune toe (A) and the height of the dune toe (B), Buffalo Beach. Field surveys were taken 23rd December 2018, 2nd April 2019, 20th May 2019, 13th July 2019, 28th August 2019, 3rd November 2019 and 23rd December 2019.

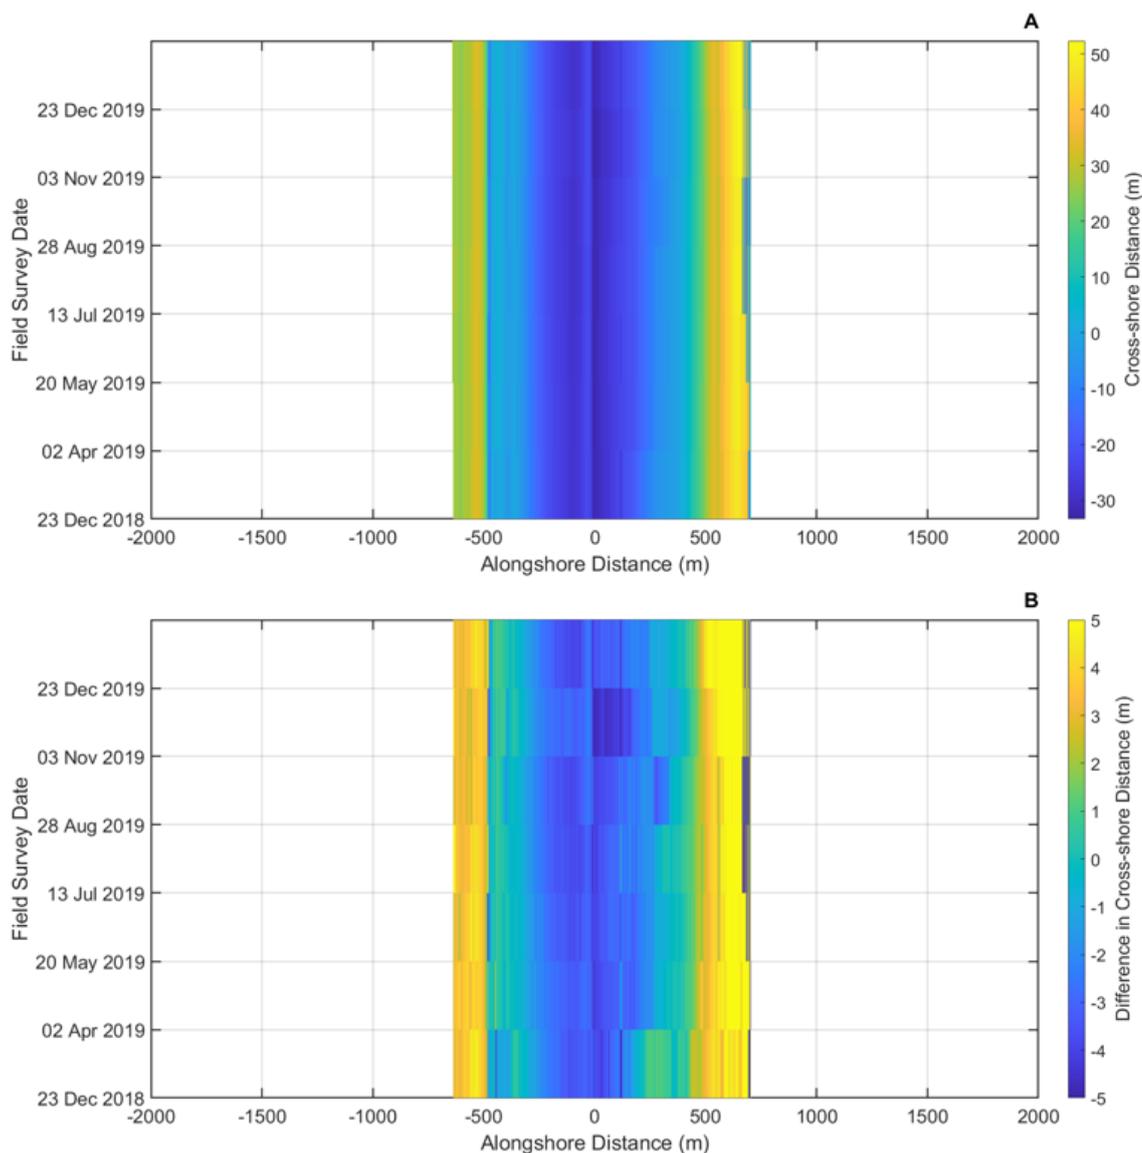
Figure 4.29. The horizontal position of the dune toe (A) and the difference of cross-shore distance of the dune toe from the mean horizontal position of the dune toe (B), Buffalo Beach. Each bar represents a field survey of the dune toe and the colour of each bar represents the cross-shore position of the horizontal dune toe (A) and the difference of cross-shore distance from the mean horizontal dune toe position. Field surveys were taken 23rd December 2018, 2nd April 2019, 20th May 2019, 13th July 2019, 28th August 2019, 3rd November 2019 and 23rd December 2019.

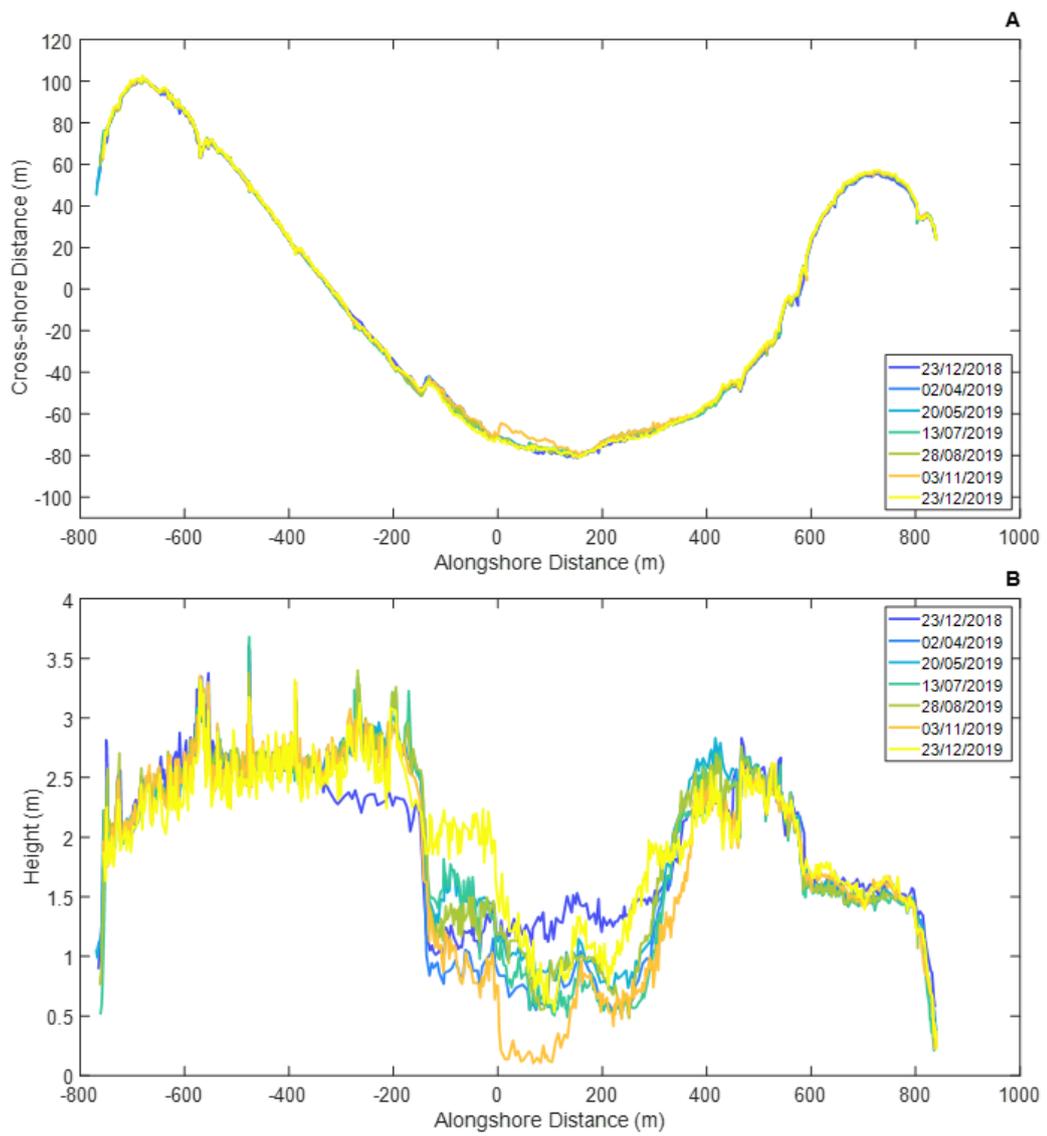
Figure 4.30. The cross-shore distance of the dune toe (A) and the height of the dune toe (B), Buffalo Beach. Field surveys were taken 23rd December 2018, 2nd April 2019, 20th May 2019, 13th July 2019, 28th August 2019, 3rd November 2019 and 23rd December 2019.

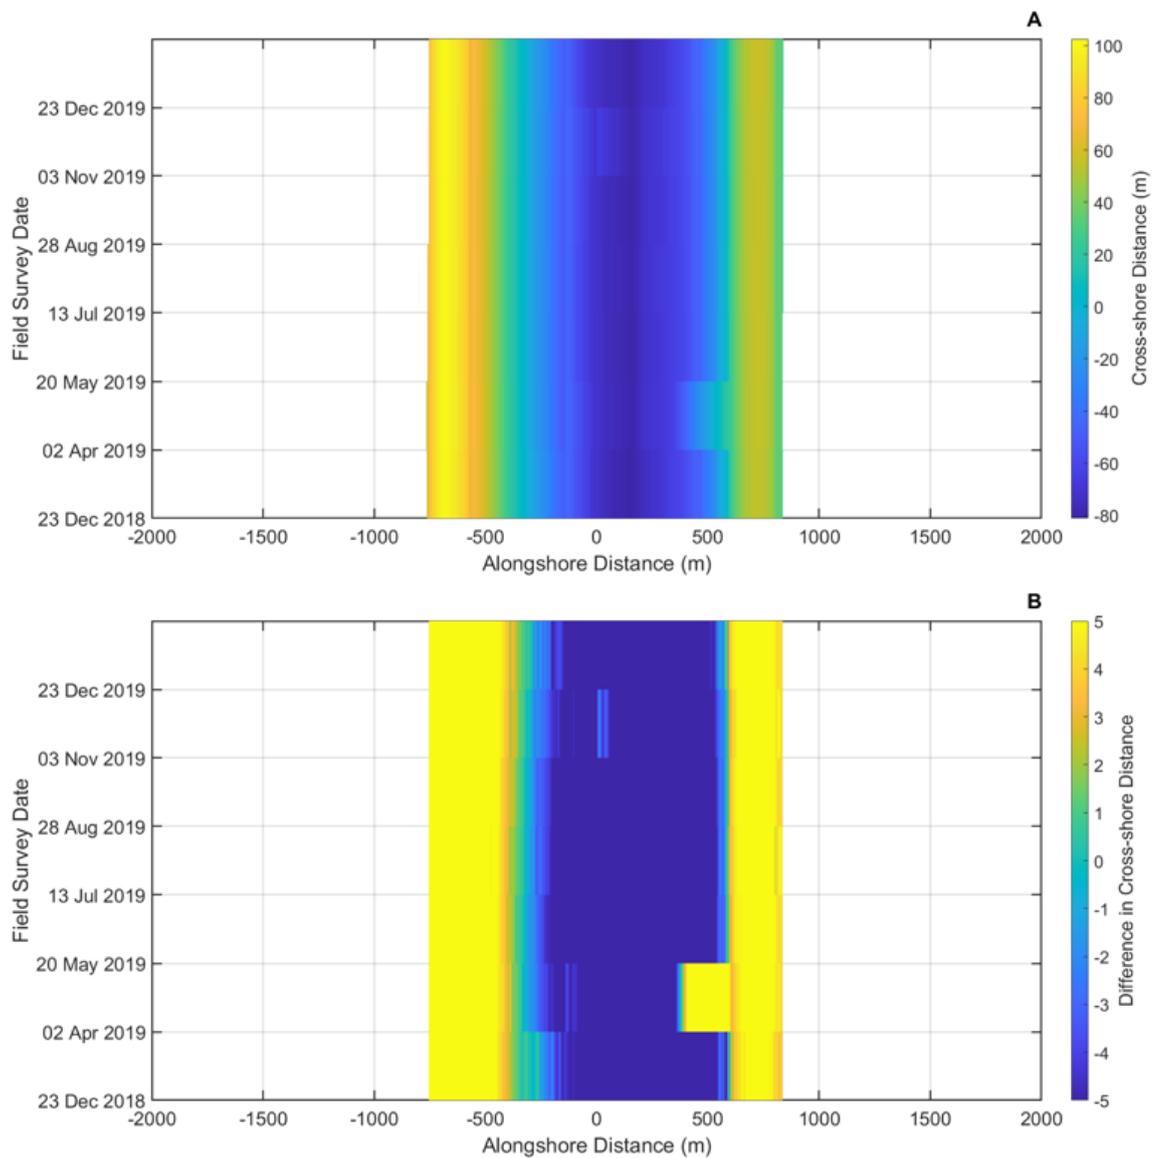
Figure 4.31. The horizontal position of the dune toe (A) and the difference of cross-shore distance of the dune toe from the mean horizontal position of the dune toe (B), Buffalo Beach. Each bar represents a field survey of the dune toe and the colour of each bar represents the cross-shore position of the horizontal dune toe (A) and the difference of cross-shore distance from the mean horizontal dune toe position. Field surveys were taken 23rd December 2018, 2nd April 2019, 20th May 2019, 13th July 2019, 28th August 2019, 3rd November 2019 and 23rd December 2019.

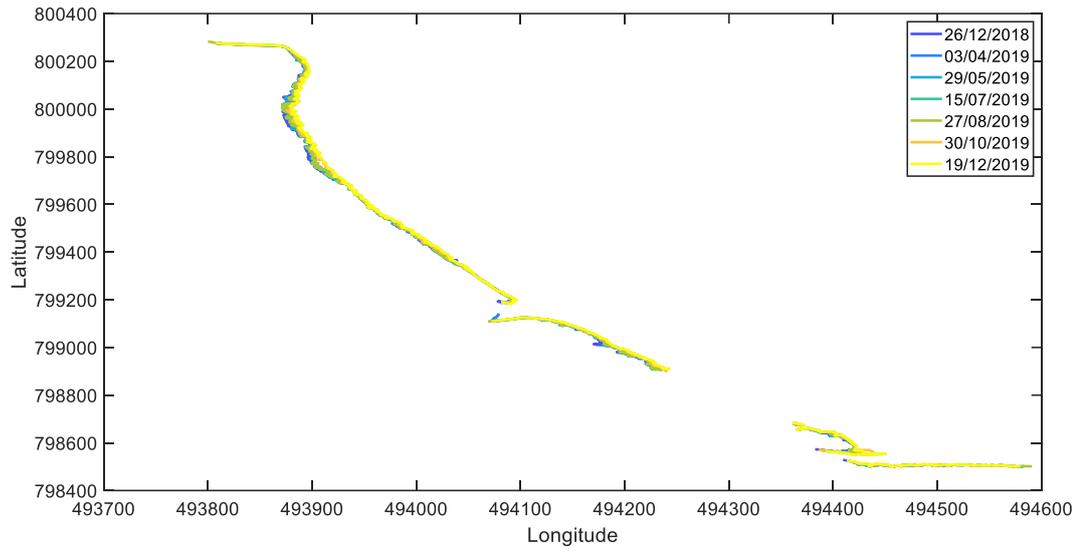
Figure 4.35. The coordinate position of the alongshore dune toe, Hot Water Beach. Field surveys were taken 16th December 2018, 3rd April 2019, 29th May 2019, 15th July 2019, 27th August 2019, 30th October 2019 and 19th December 2019.

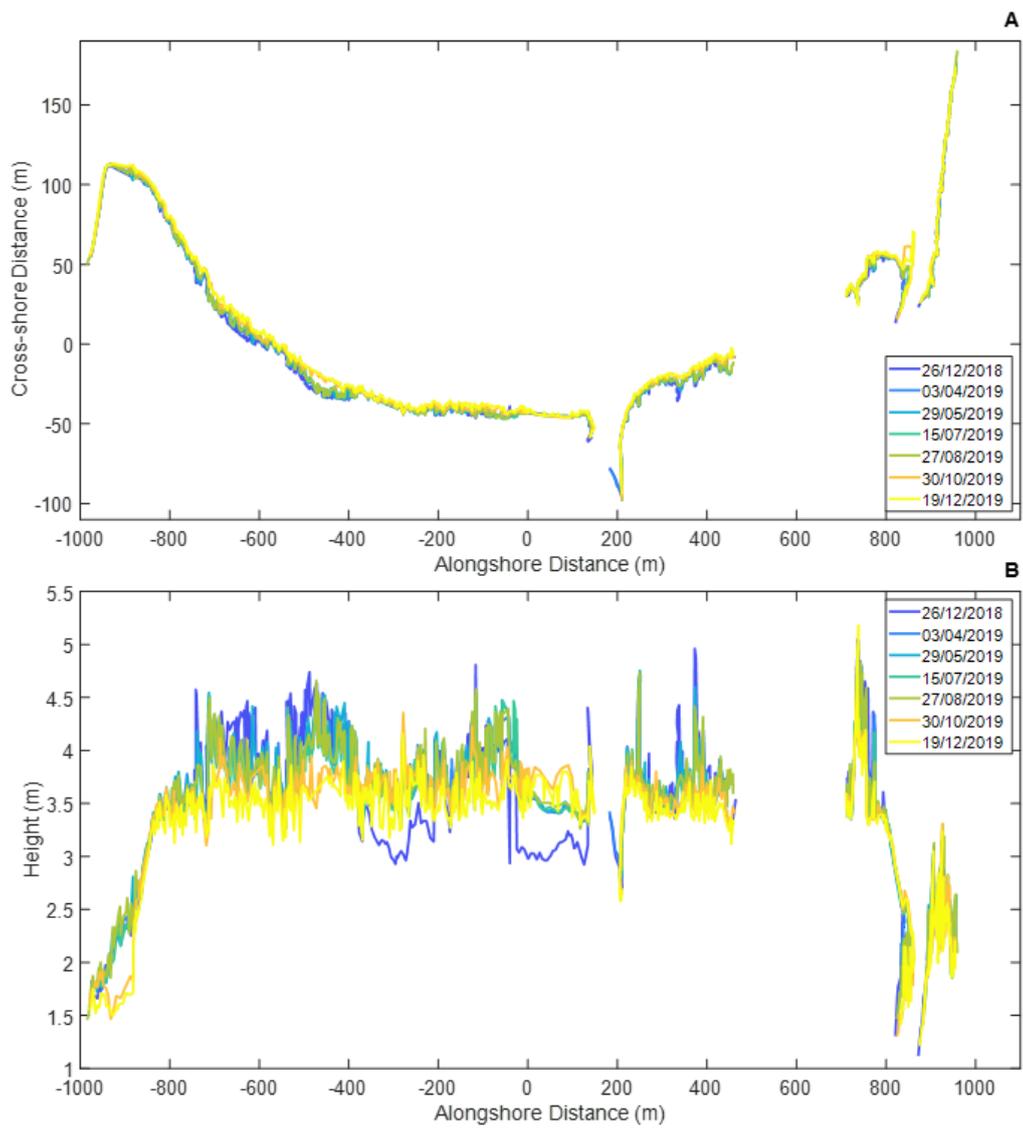
Figure 4.36. The cross-shore distance of the dune toe (A) and the height of the dune toe (B), Hot Water Beach. Field surveys were taken 16th December 2018, 3rd April 2019, 29th May 2019, 15th July 2019, 27th August 2019, 30th October 2019 and 19th December 2019.

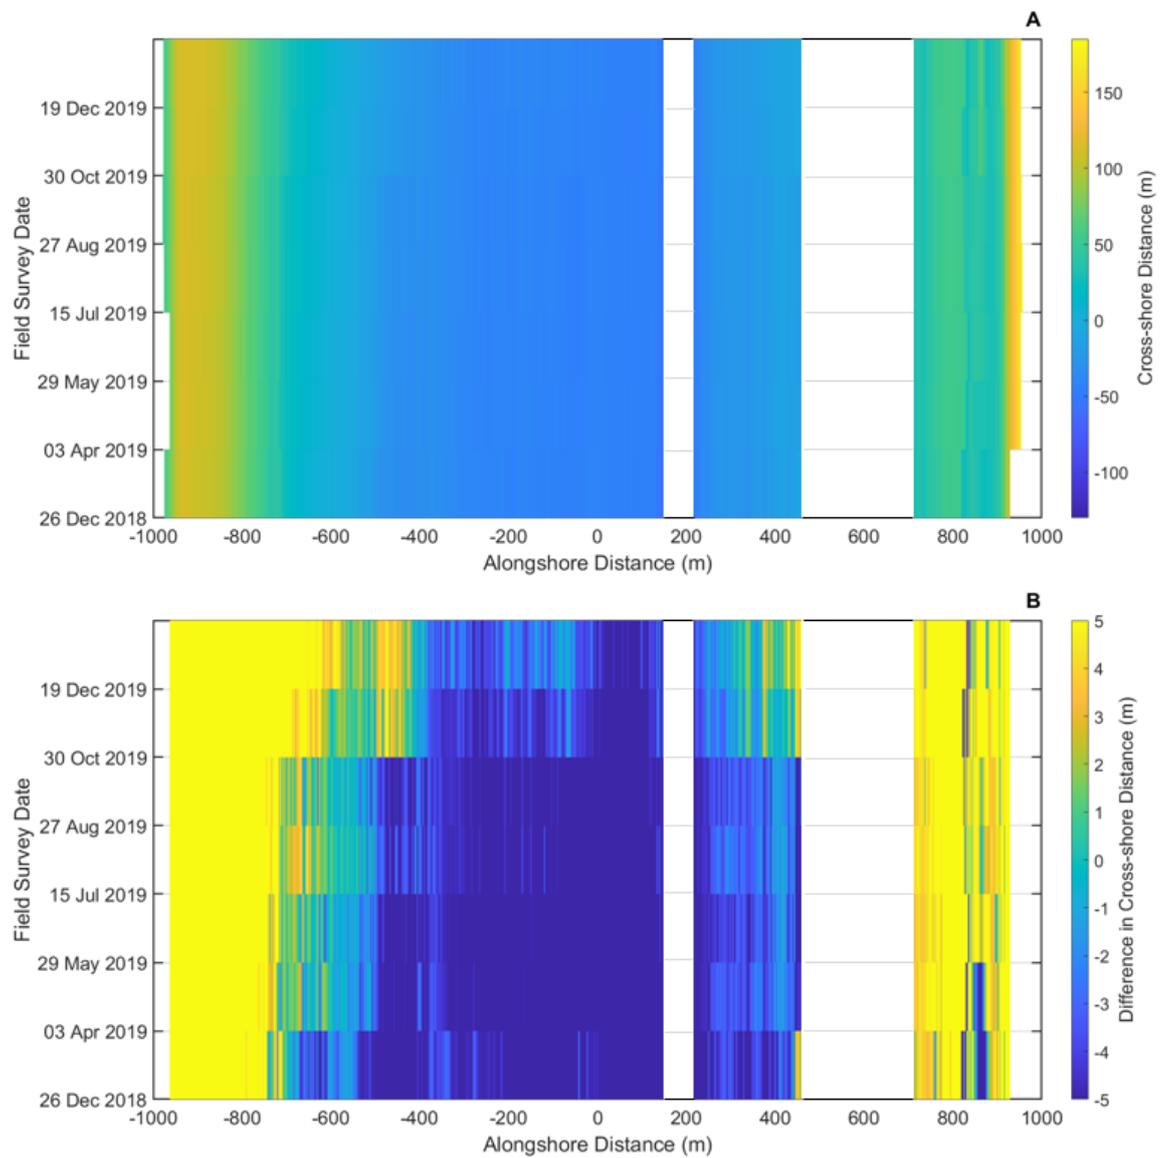
Figure 4.37. The horizontal position of the dune toe (A) and the difference of cross-shore distance of the dune toe from the mean horizontal position of the dune toe (B), Hot Water Beach. Each bar represents a field survey of the dune toe and the colour of each bar represents the cross-shore position of the horizontal dune toe (A) and the difference of cross-shore distance from the mean horizontal dune toe position. Field surveys were taken 16th December 2018, 3rd April 2019, 29th May 2019, 15th July 2019, 27th August 2019, 30th October 2019 and 19th December 2019.

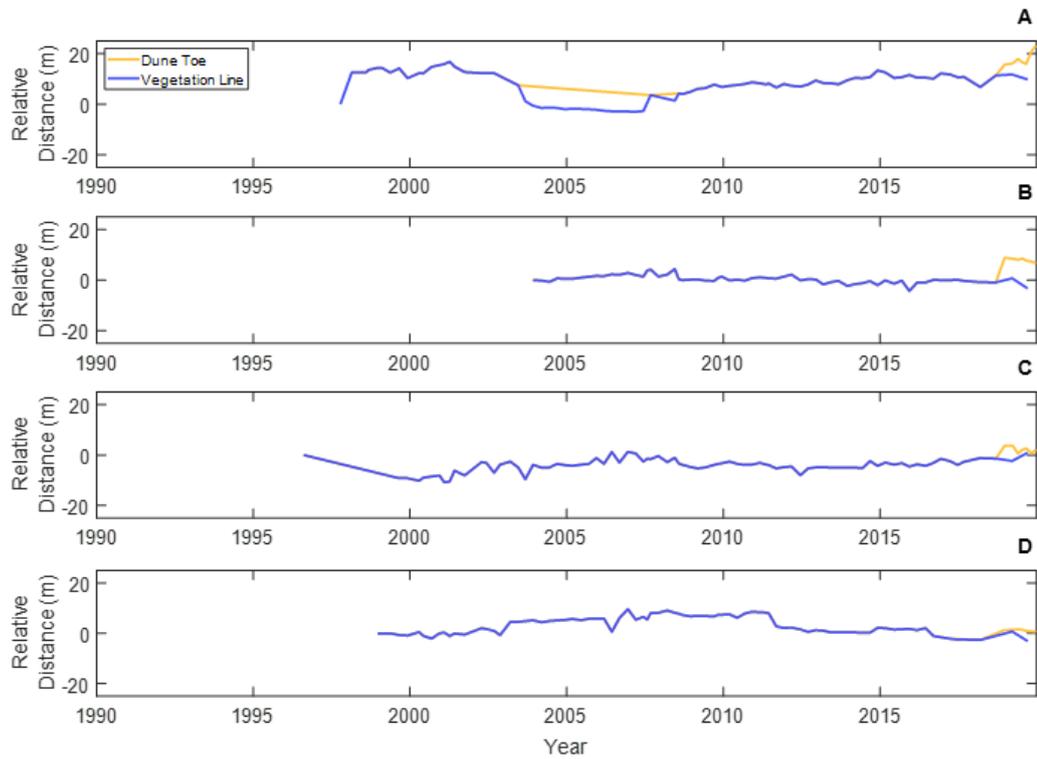
Figure 4.38. The change in relative horizontal distance of the vegetation line and dune toe, Tairua Beach. The vegetation line (purple line) and dune toe (orange line) for at the beach profile sites of CCS36 (A), CCS36-2 (B), CCS36-1 (C) and CCS37 (D).

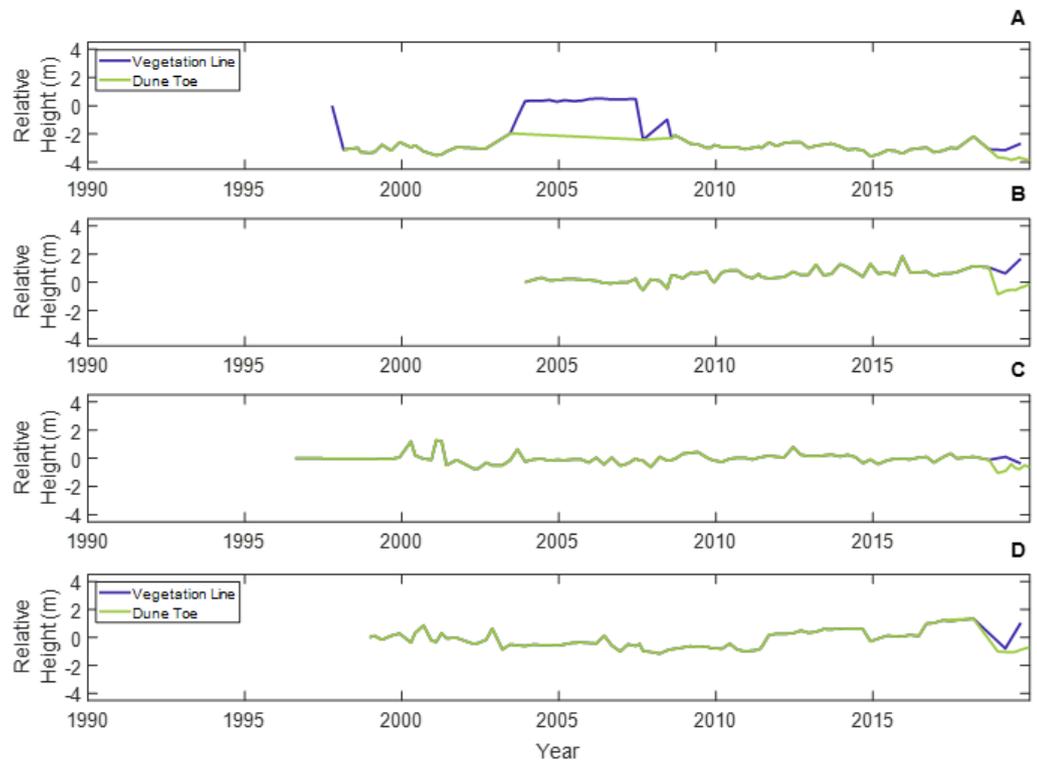
Figure 4.39. The change in relative height of the vegetation line and dune toe, Tairua Beach. The vegetation line (blue line) and dune toe (green line) for at the beach profile sites of CCS36 (A), CCS36-2 (B), CCS36-1 (C) and CCS37 (D).

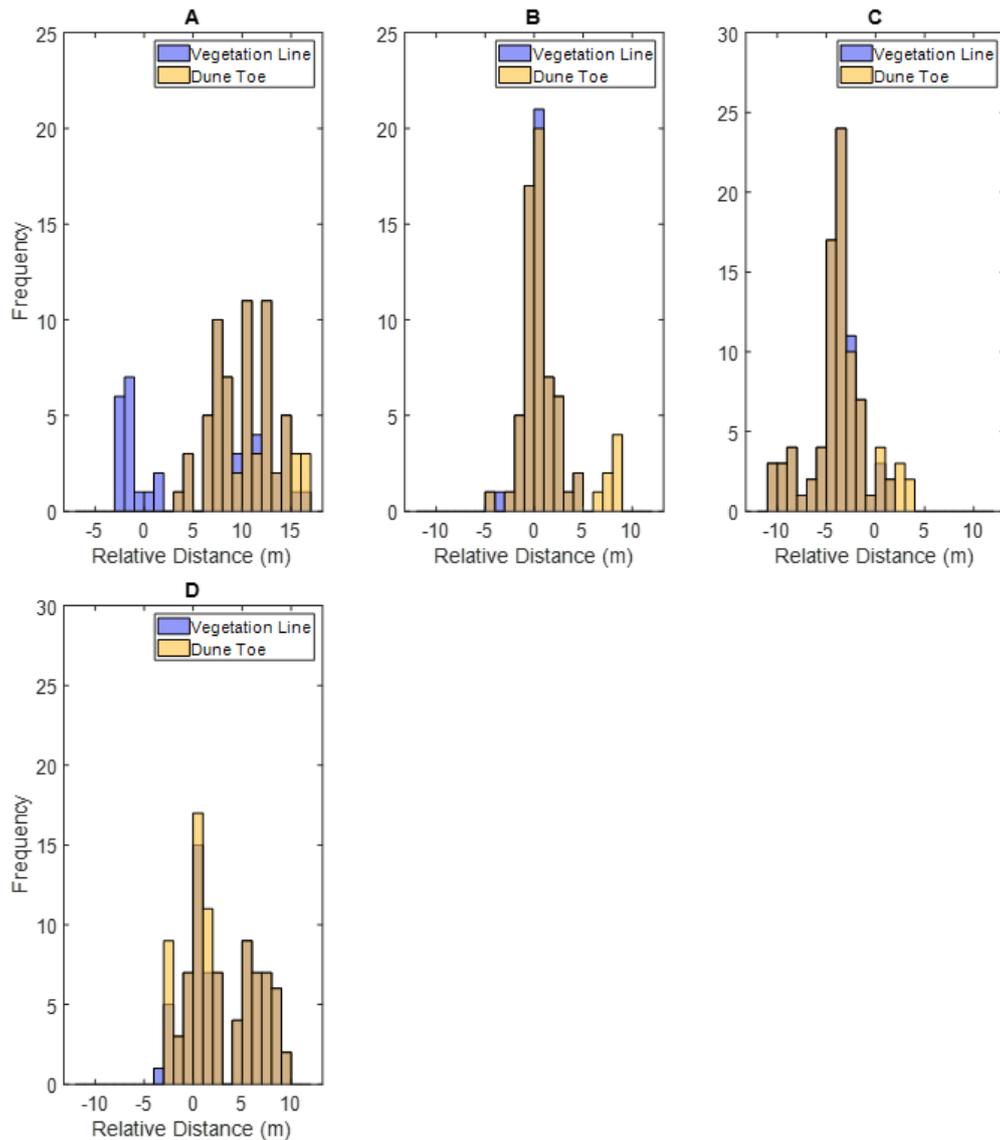
Figure 4.40. The distribution of relative horizontal distance position of the vegetation line and dune toe, Tairua Beach. The vegetation line (purple line) and dune toe (orange line) for at the beach profile sites of CCS36 (A), CCS36-2 (B), CCS36-1 (C) and CCS37 (D). Note the x-axis is shifted in panel A and C.

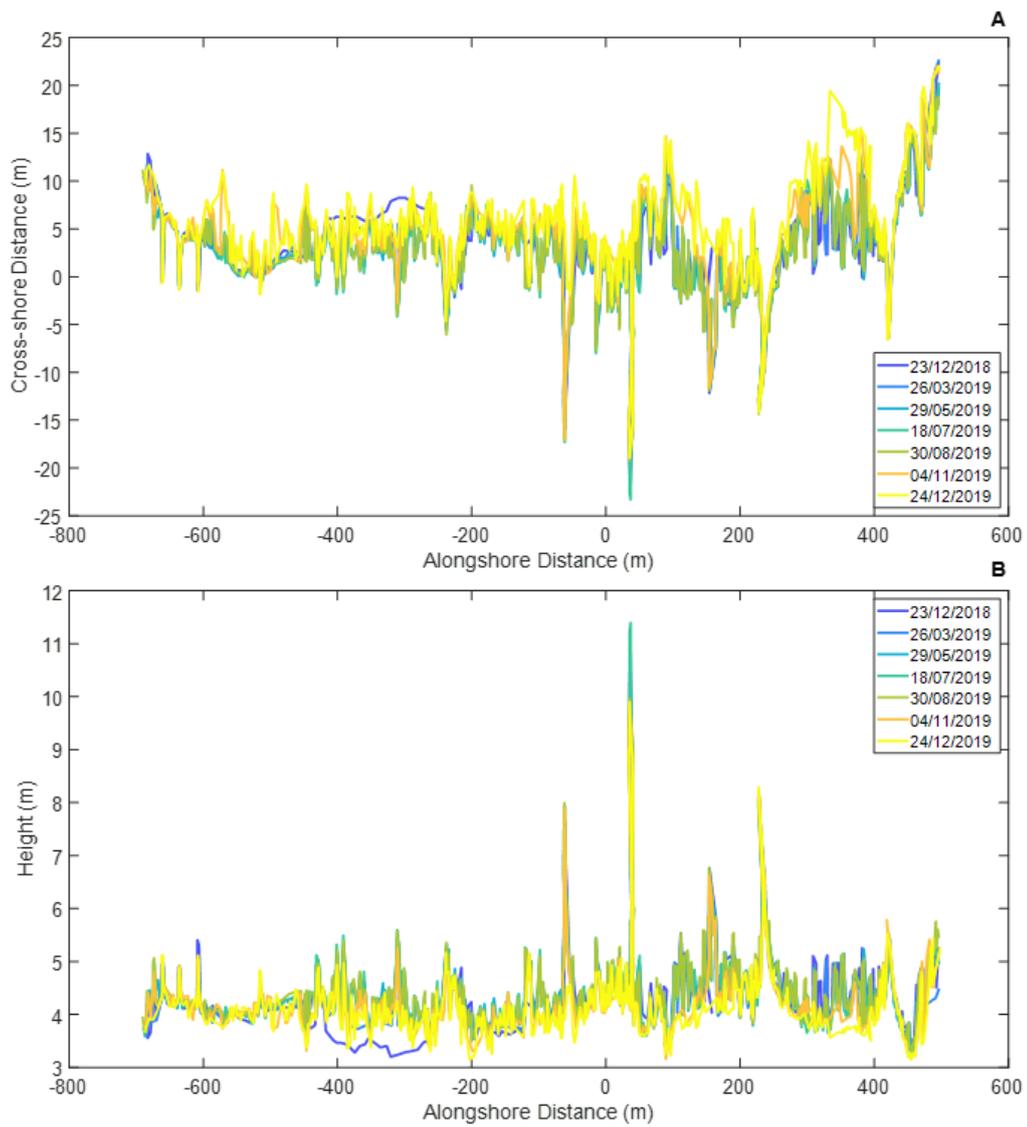
Figure 4.42. The cross-shore distance of the dune toe (A) and the height of the dune toe (B), Tairua Beach. Field surveys were taken 23rd December 2018, 26th March 2019, 29th May 2019, 18th July 2019, 30th August 2019, 4th November 2019 and 24th December 2019.

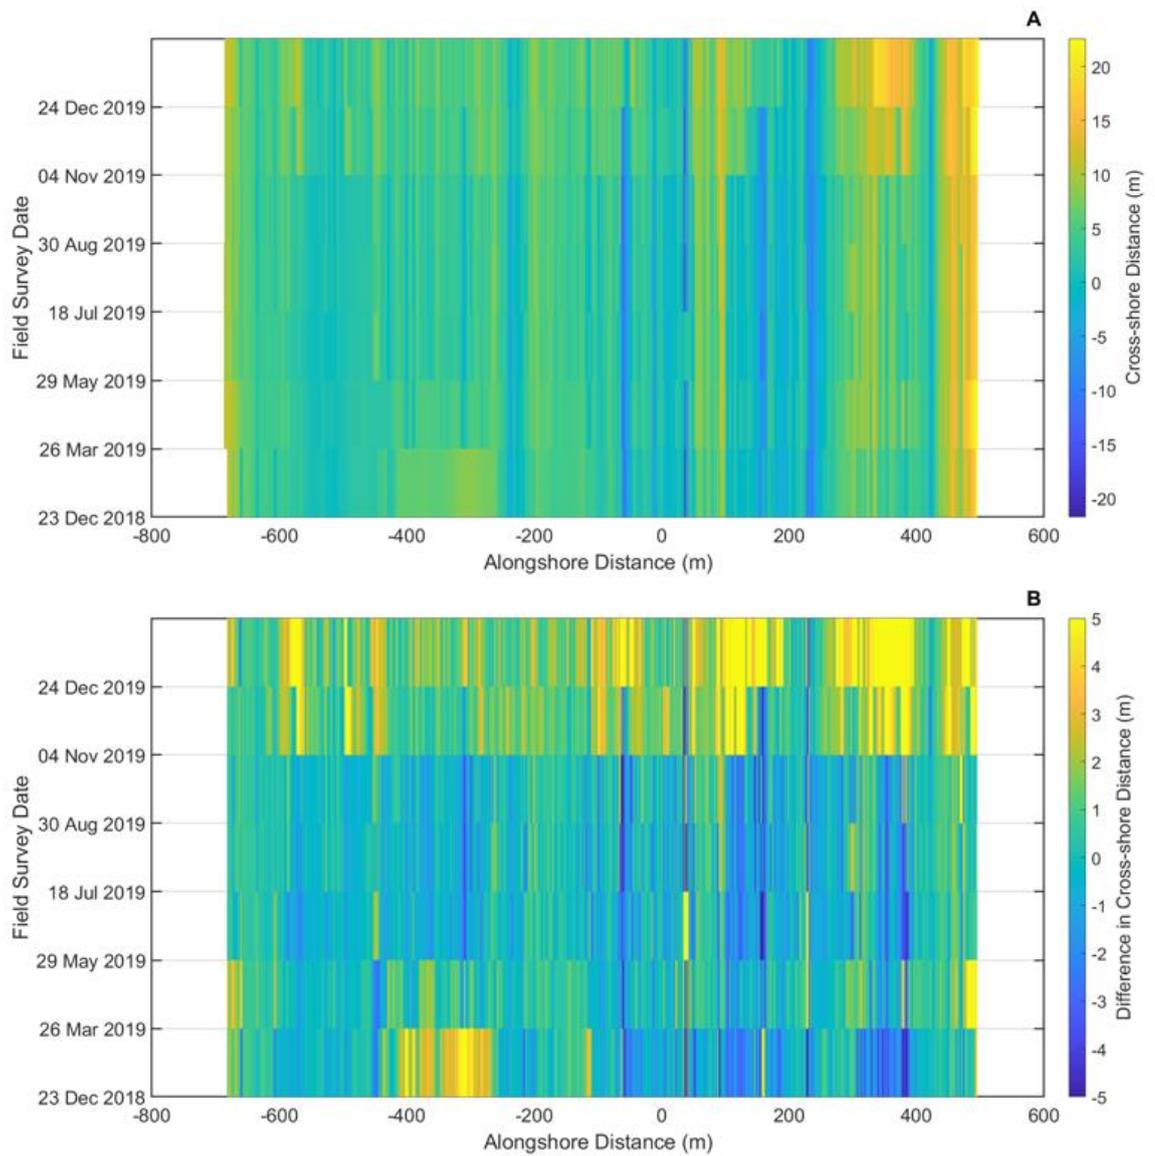
Figure 4.43. The horizontal position of the dune toe (A) and the difference of cross-shore distance of the dune toe from the mean horizontal position of the dune toe (B), Tairua Beach. Each bar represents a field survey of the dune toe and the colour of each bar represents the cross-shore position of the horizontal dune toe (A) and the difference of cross-shore distance from the mean horizontal dune toe position. Field surveys were taken 23rd December 2018, 26th March 2019, 29th May 2019, 18th July 2019, 30th August 2019, 4th November 2019 and 24th December 2019.

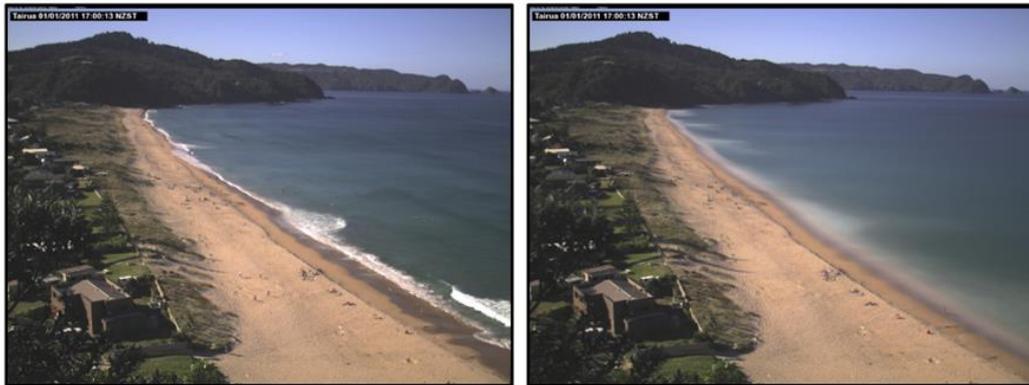
Figure 5.1. An example of one of the images that are captured, as part of the “CamEra” network, of Tairua Beach. Figure two. An example of one of the averaged ‘time exposure’ images for one hour at Tairua Beach.

A coloured 760 by 570 pixel image for before October 2009 or 1500 by 2020 pixel image for after October 2009 was produced every daylight hour. Assuming that the dune toe does not change over a short time scale, one image per month, from the 20-year dataset, was selected for analysis. Care was taken to avoid the use of images that were taken in foggy weather conditions, or at certain times of the day (normally at the very start and end of each day) where there was large shadowing on the beach area, or in certain light levels were avoided, so that the vegetation line could be found more easily. Images that had smudges or sea spray on the camera lenses were also avoided, along with objects present that obscured the

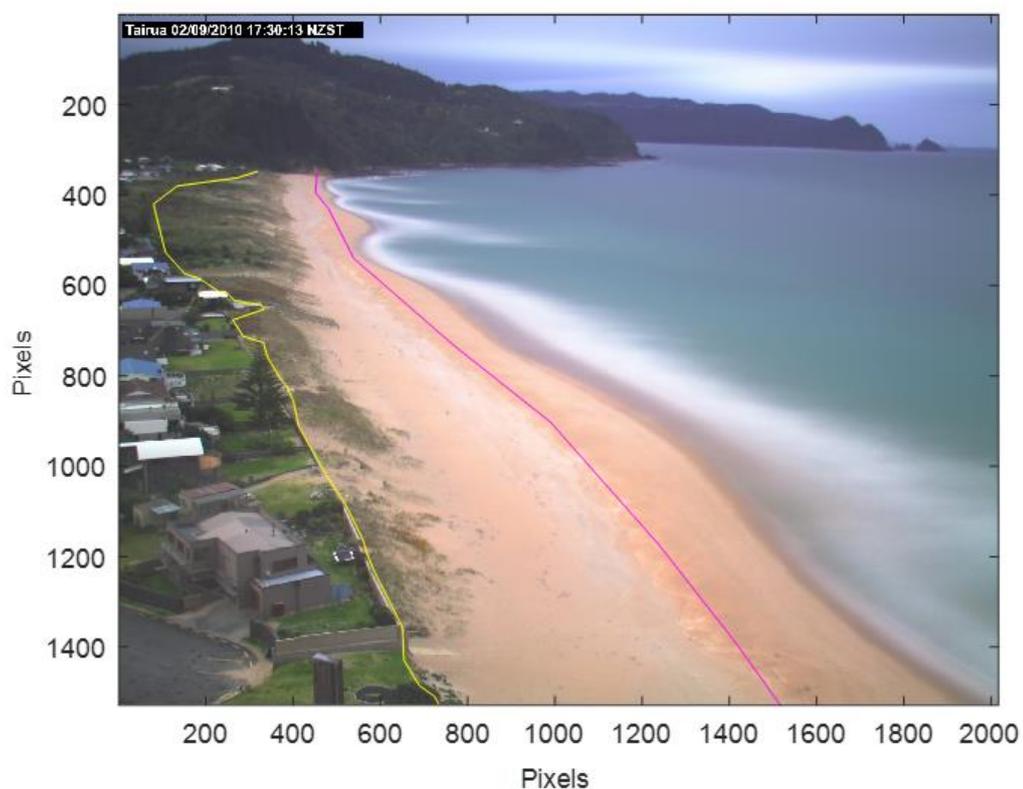
Figure 5.2. Image showing where the masked area of the dunes and beach is situated. Pixels of interest were within the horizontal transects between the first boundary (yellow line) and second boundary (pink line) shown on the image.

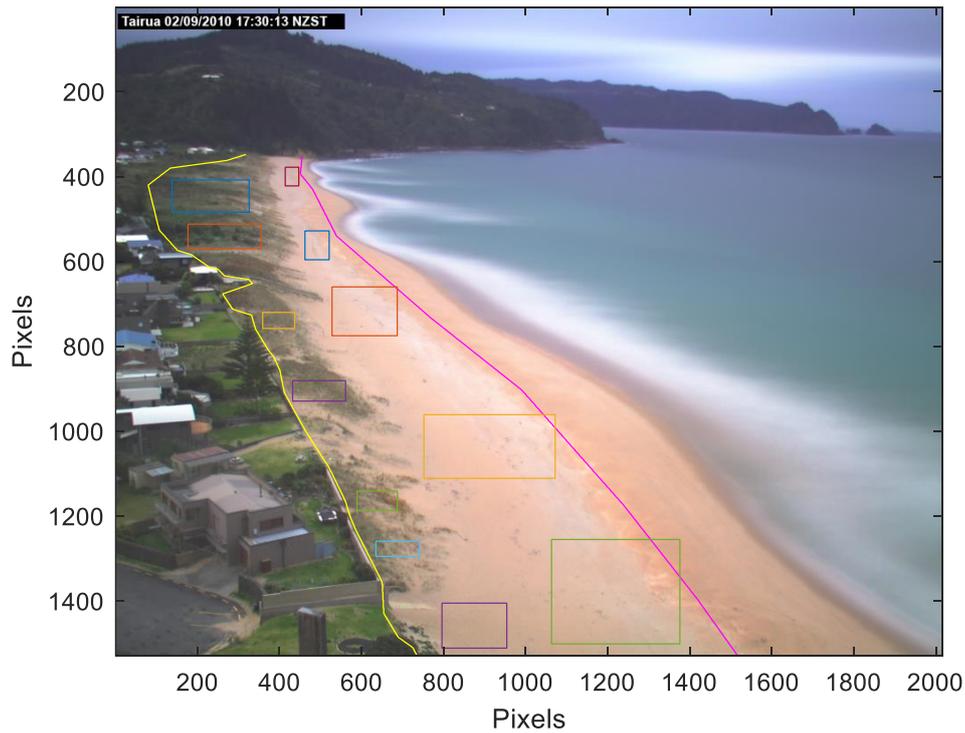
Figure 5.4. An example of samples taken from the image to determine thresholds for classification which represented the dune area and sand area (coloured squares) within the masked area (yellow and pink lines).

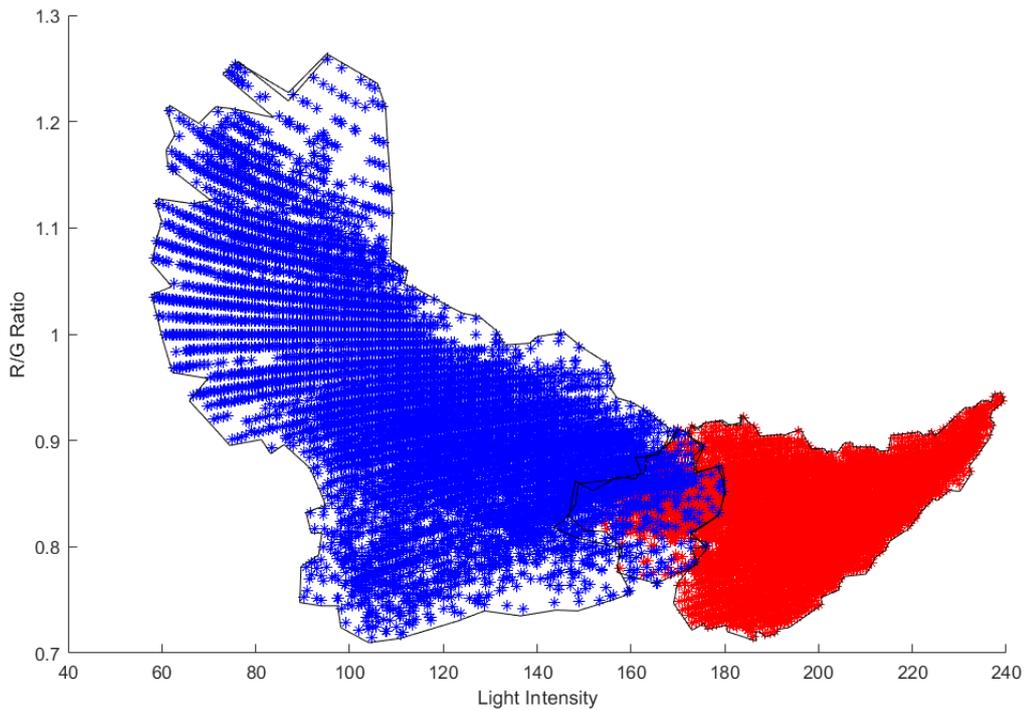
Figure 5.5. The green-light to red-light ratio against the light intensity of red, green and blue light, for the sample of pixels from the image. The blue dots represented the sample of pixels from the vegetated dune area and the red dots represented the sample of pixels from the sand area of the beach.

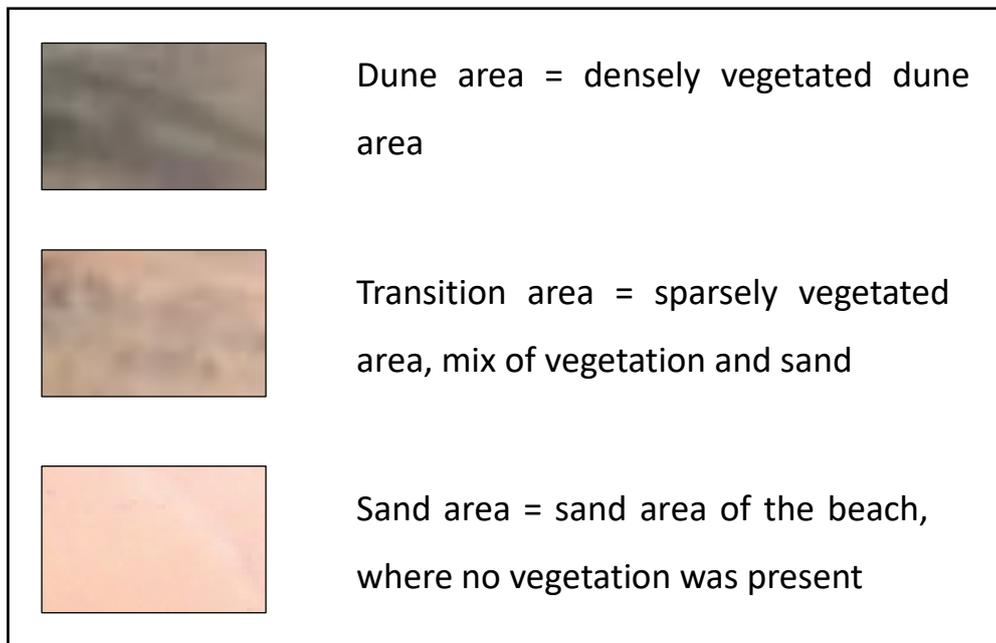
Figure 5.6. A visual example from an image which showed the three classes of 'dune' area, 'transition' area and 'sand' area.

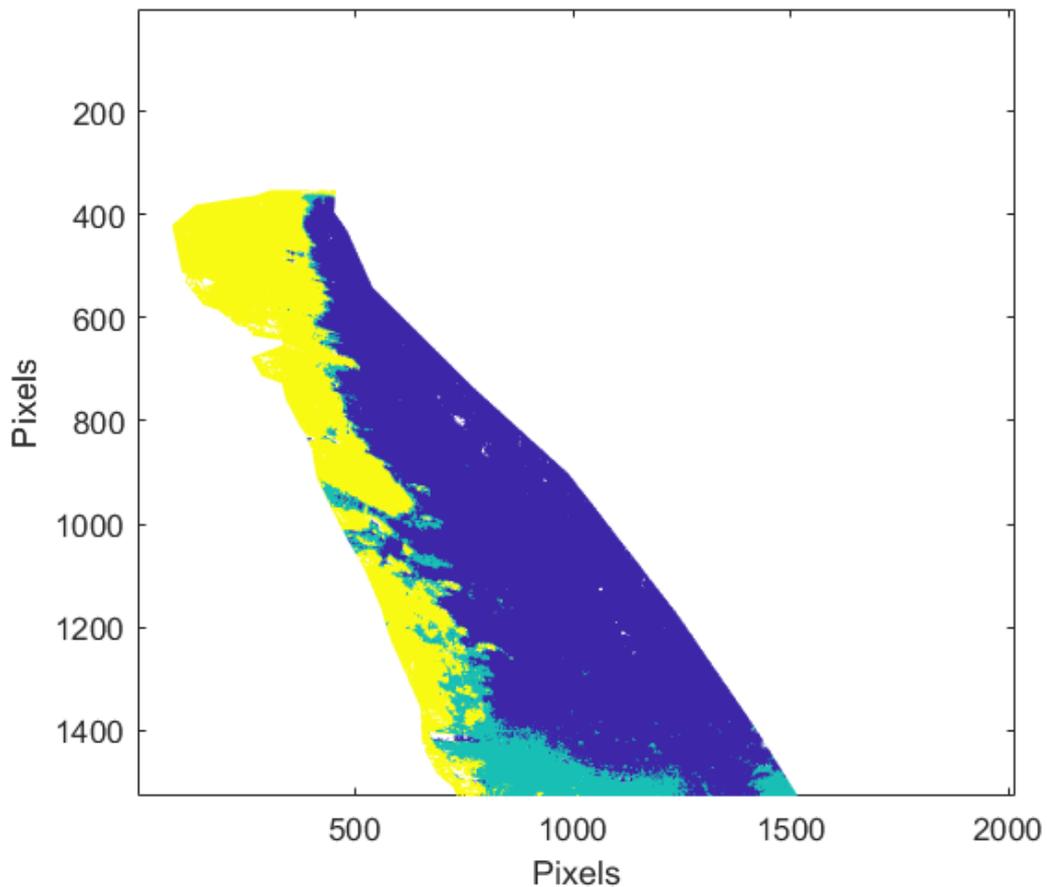
Each pixel within the mask of the image was classified, by searching each horizontal line of pixels within the image for colour characteristics that matched the threshold conditions. Each class was allocated a number (dune area = 3, transition zone = 2, and sand area = 1) and each pixel within the mask, was allocated a number based on whether the thresholds for one of the three classes were met (pixels that did not meet the thresholds for any of the classes were allocated 0). The number for each pixel was stored and plotted (Figure 5.7).

Figure 5.7. The class of pixels within the masked area of the image. The three classes were the dune area (yellow), transition area (green) and sand area (purple).

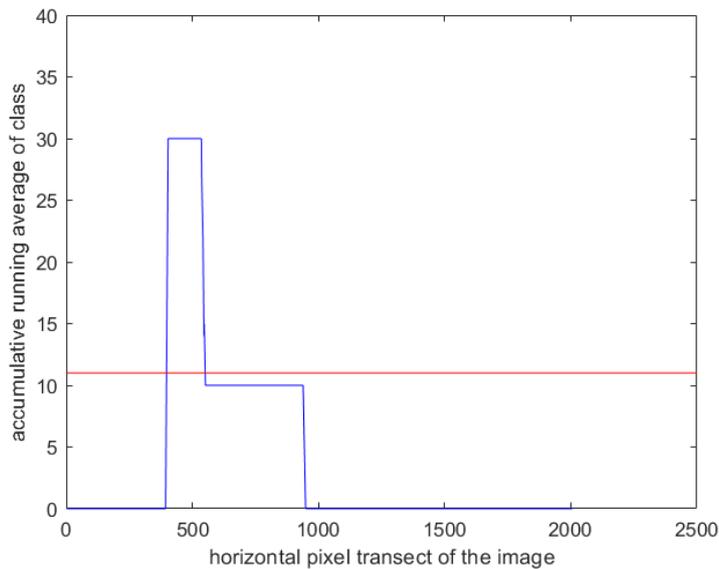
Figure 5.8. The cumulative running average of the class of pixels for one horizontal transect (blue) and the threshold (11) for the position of the vegetation line (red).

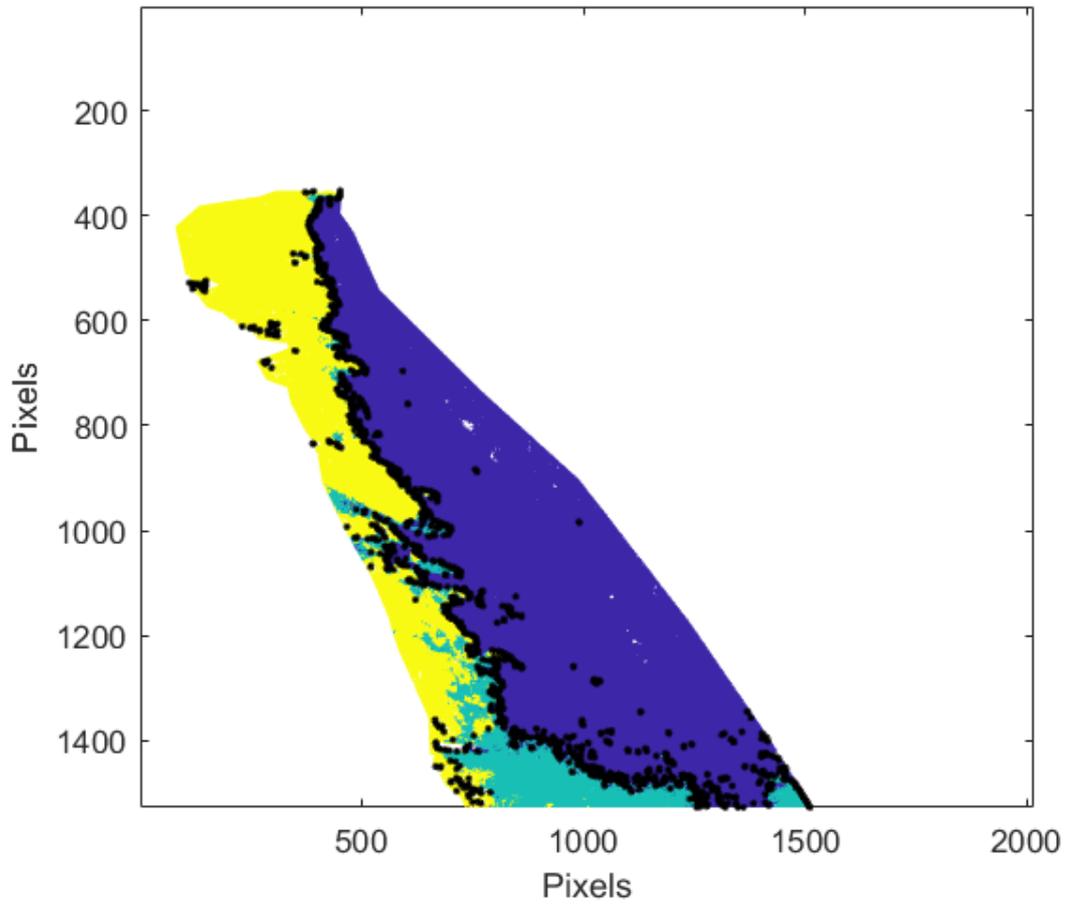
Figure 5.9. The class of pixels within the masked area of the image and the potential vegetation line position (black dots). The three classes are dune (yellow), transition (green) and sand (purple).
