The Change in the Horizontal Position of the Dune Toe and Vegetation Line on Beaches Within the Waikato Region

A thesis
submitted partial fulfilment
of the requirements for the degree
of
Master of Science (Research) in Earth Sciences
at
The University of Waikato
by
Celeste Jade Davies-Calway

2020

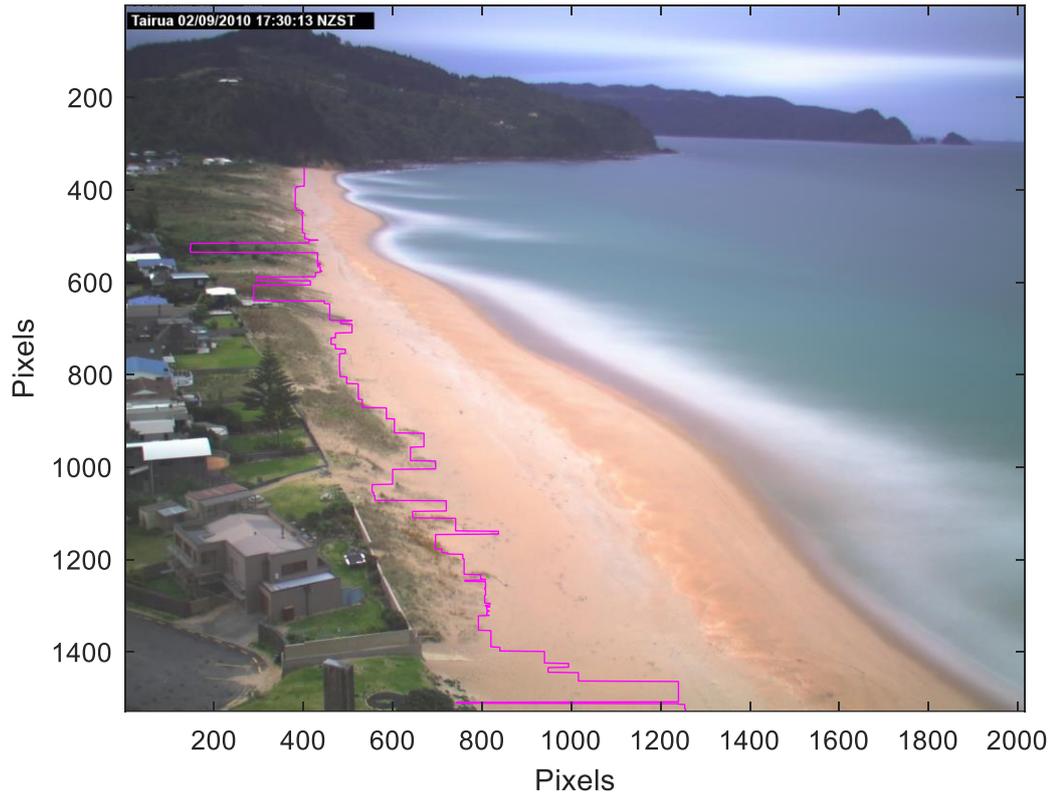
Figure 5.10. The running mode of the potential vegetation line position (magenta line).

In order to smooth the resulting vegetation line, the running mode was calculated using 40 pixel lines (Figure 5.10). Finally, the nearest point to the running mode, was then found and determined to be the position of the vegetation line (Figure 5.11 & Figure 5.12). A small amount of manual editing was necessary in order to correct anomalies in the resulting vegetation line in order to improve the quality of the data.

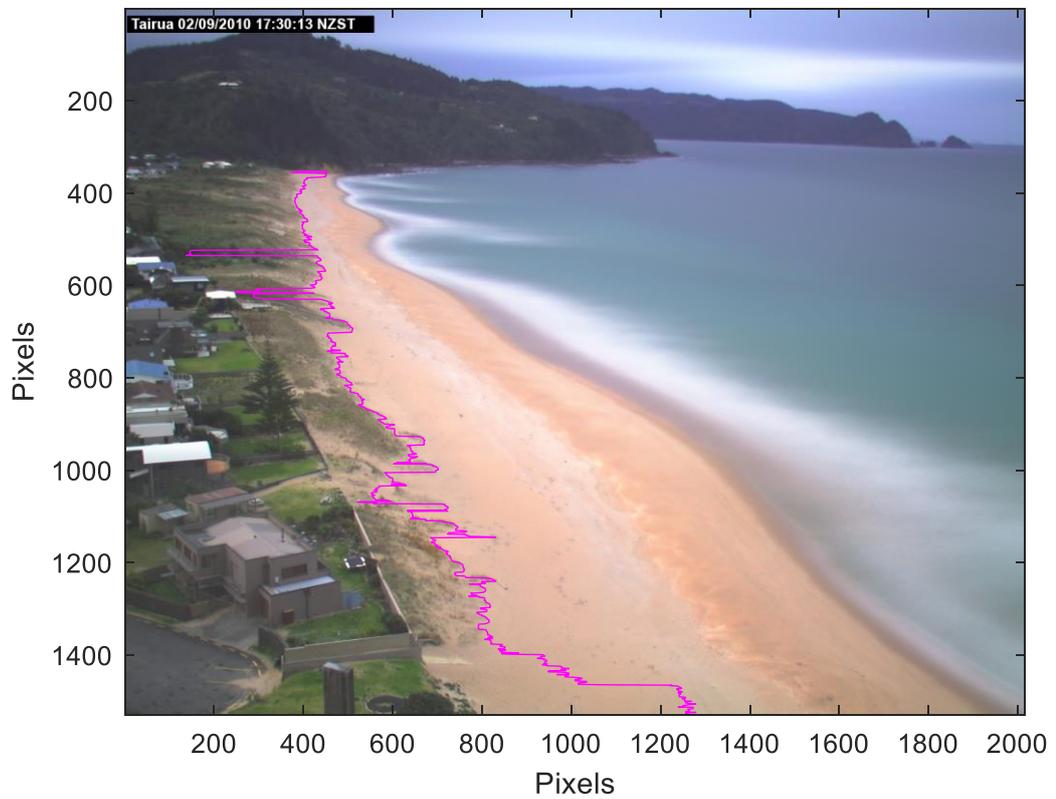
Figure 5.11. The generated vegetation line (magenta line), before manual editing.

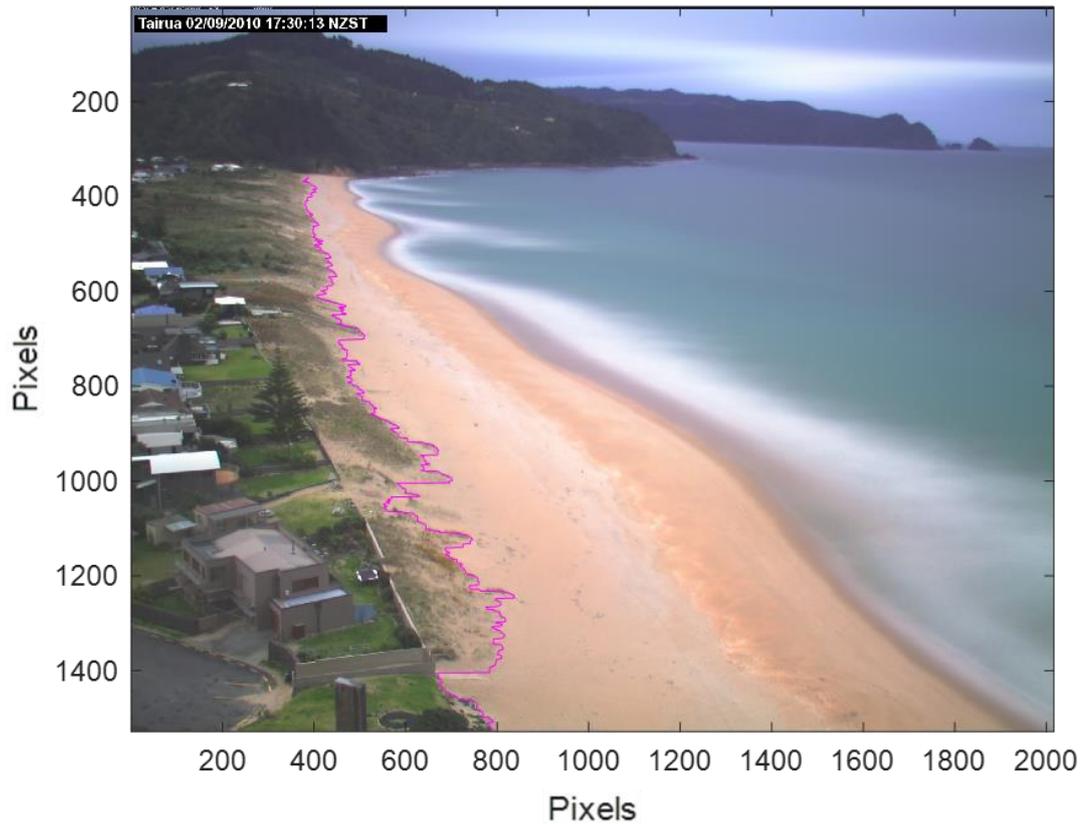
Figure 5.12. The final vegetation line (magenta line), after manual editing.

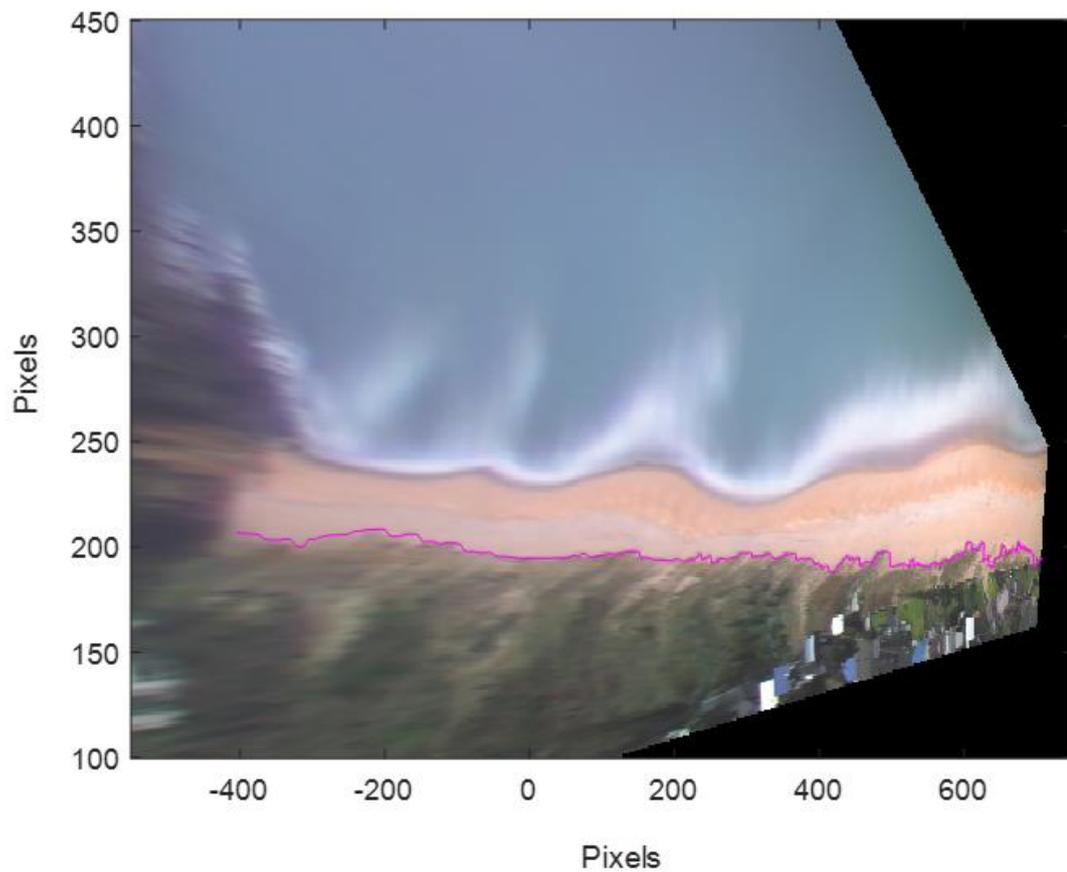
Figure 5.13. The rectified image, showing the final vegetation line (magenta line).

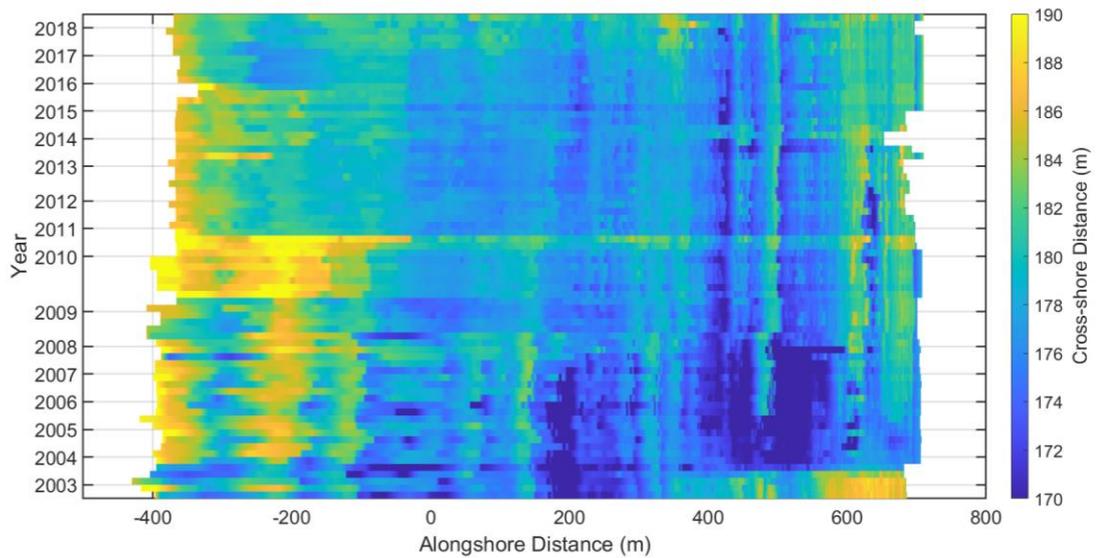
Figure 5.14. The horizontal position of the vegetation line throughout time, from 2002 to 2019, yellow shows areas that are seaward and dark blue areas are landward.

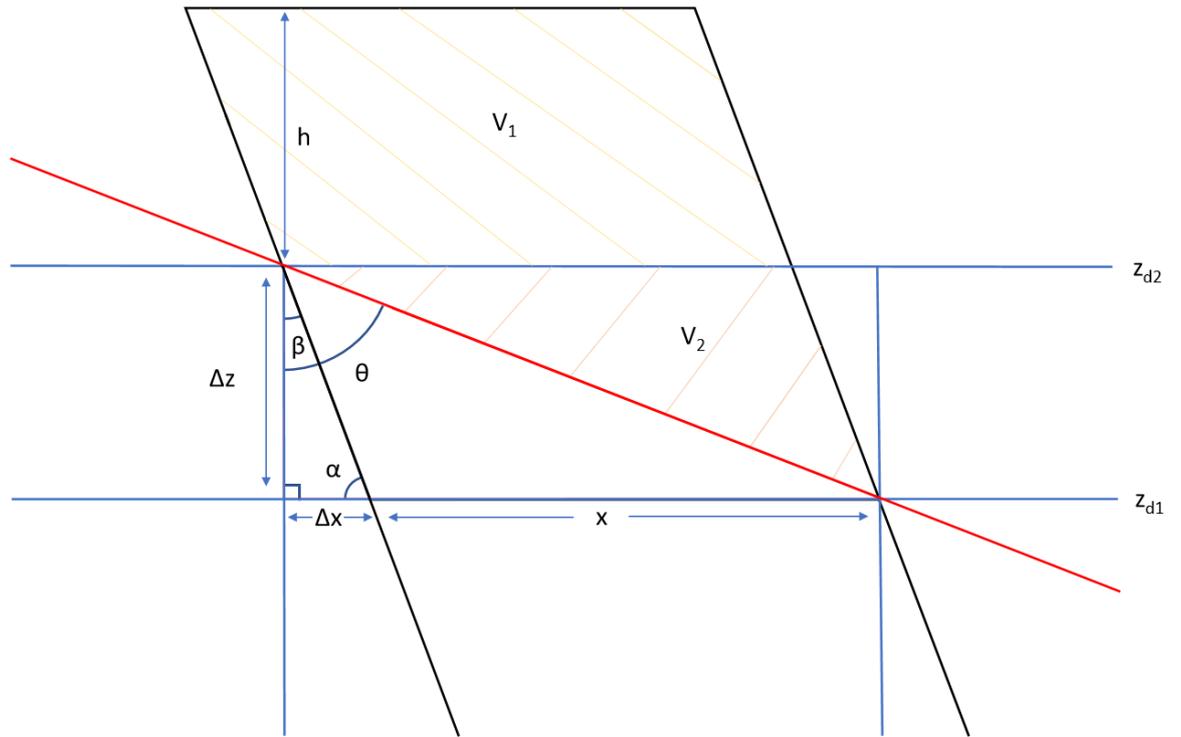
Figure 6.1. A diagram showing how the new dune toe position was determined. The variables used are shown in equations 6 to 17.

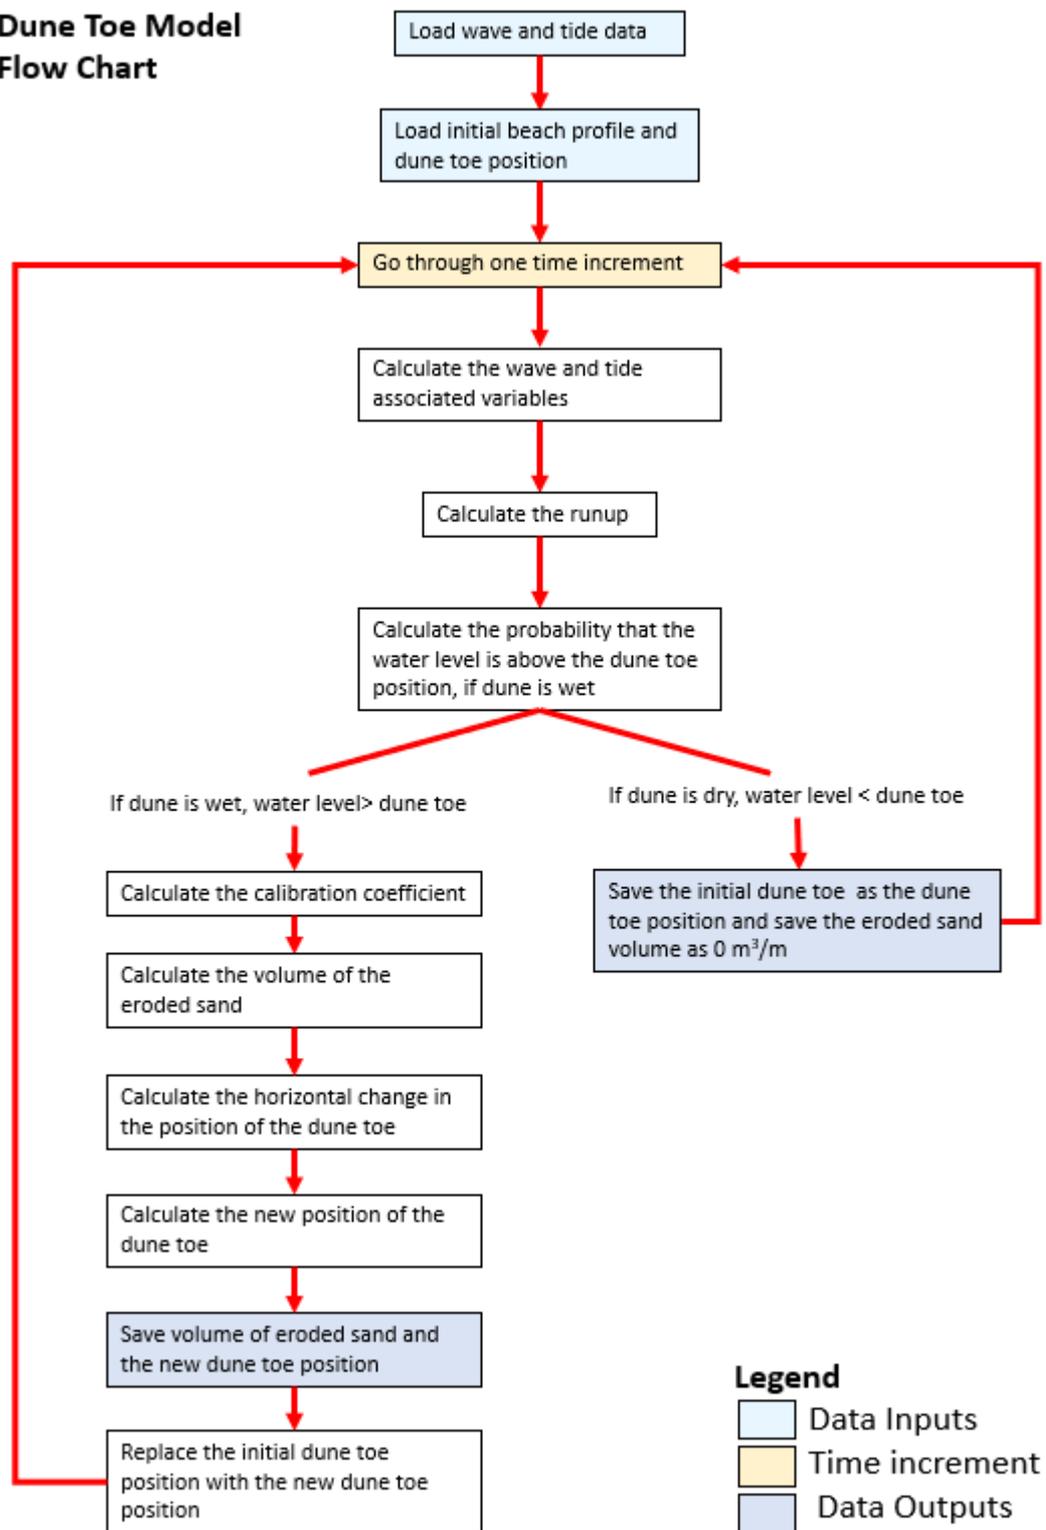
Dune Toe Model Flow Chart

Figure 6.2. A schematic showing how the model is run for every time increment, the arrows shows the order of the equations calculated for the model. The light blue shaded boxes show the data inputs, the orange shaded box shows the time increment for each model run and the dark blue boxes show the data outputs for each time increment of the model run.

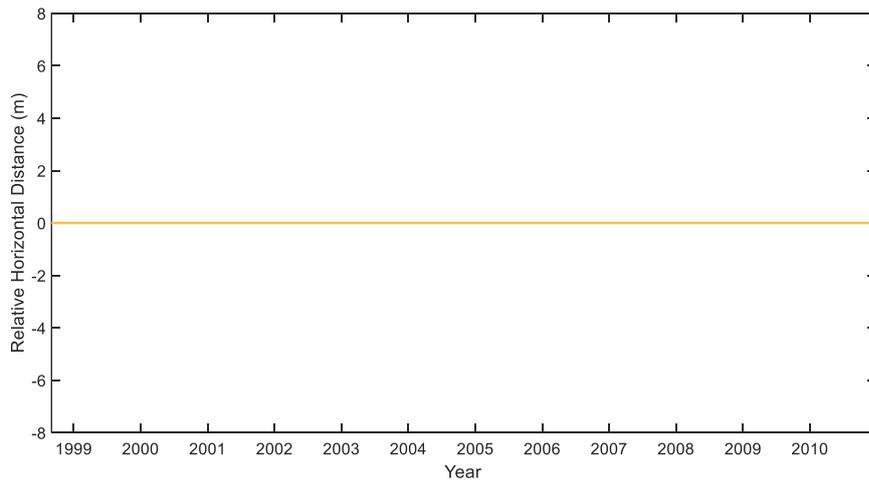
Figure 6.6. The predicted change in the horizontal position of the dune toe from the model between 1998 and 2011.

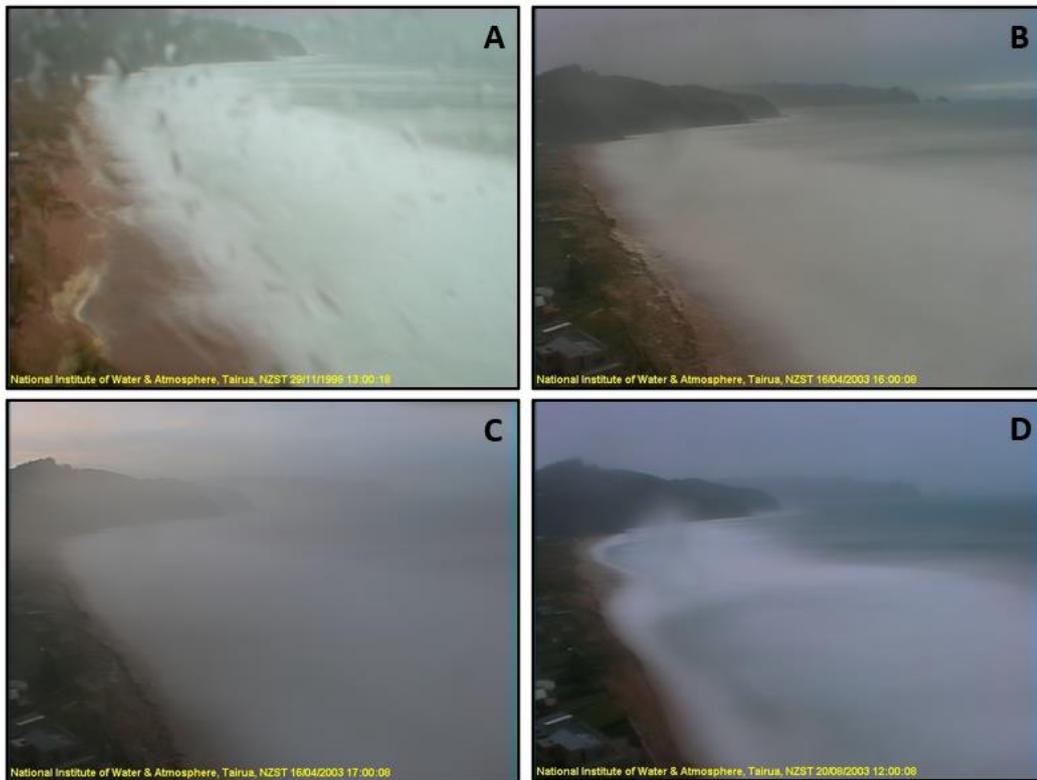
Figure 6.12. Examples of when water reached the vegetation line/dune toe at Tairua Beach. The imagery was taken 29th November 1998 (A), 16th April 2003 (B), 16th April 2003 (C) and 20th August 2003 (D).

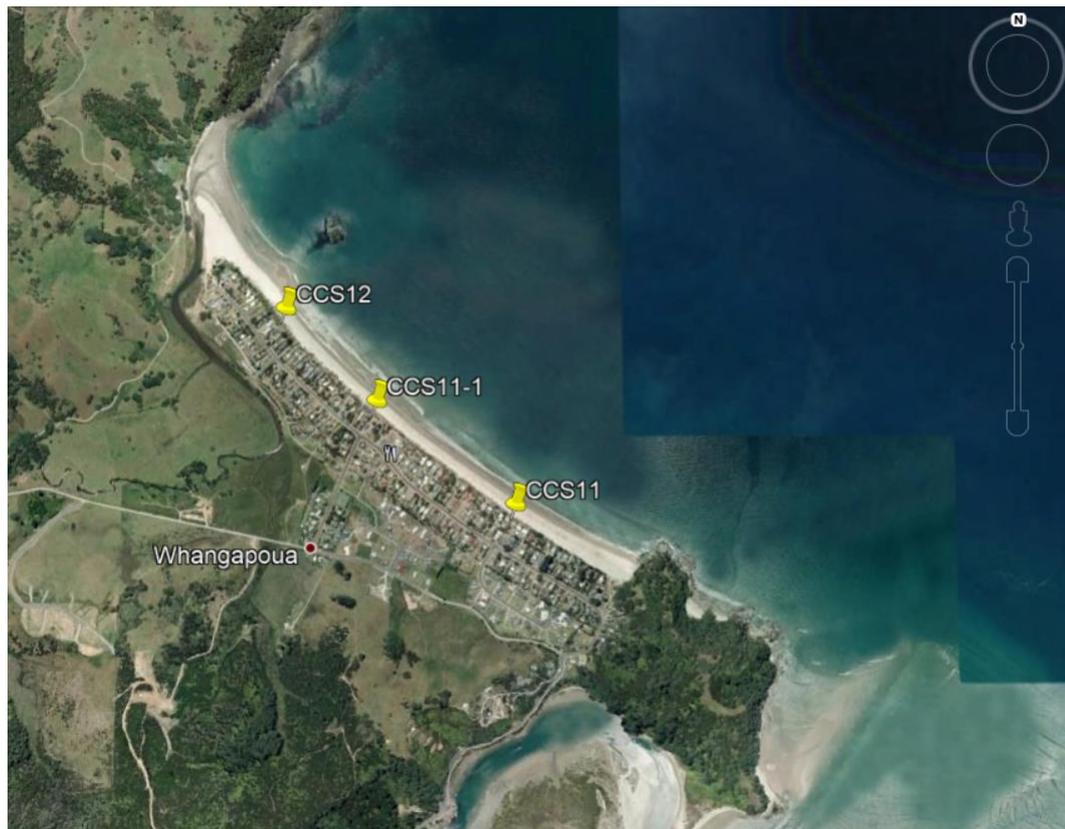
Figure A.1. Beach profile sites, Whangapoua Beach of CCS12, CCS11-1 and CCS11.

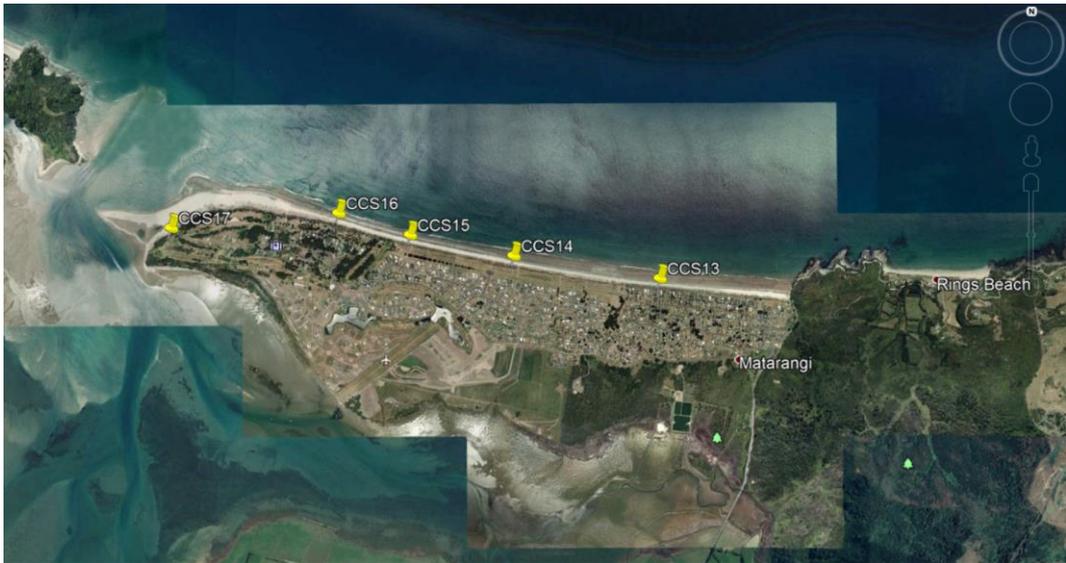
Figure A.2. Beach profile sites, Matarangi Beach of CCS13, CCS14, CCS15, CCS16 and CCS17.

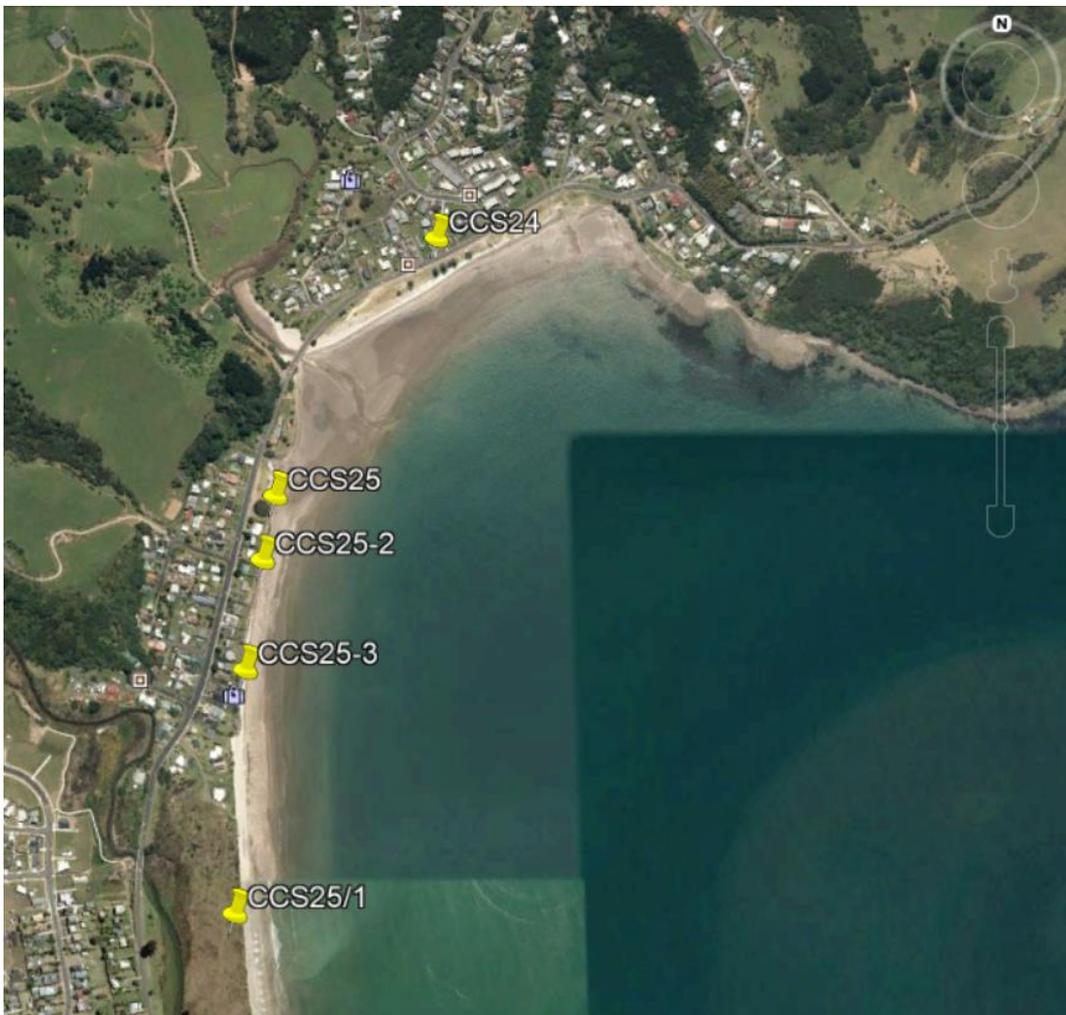
Figure A.3. Beach profile sites, North Buffalo Beach of CCS24, CCS25, CCS25-2, CCS25-3 and CCS25/1.

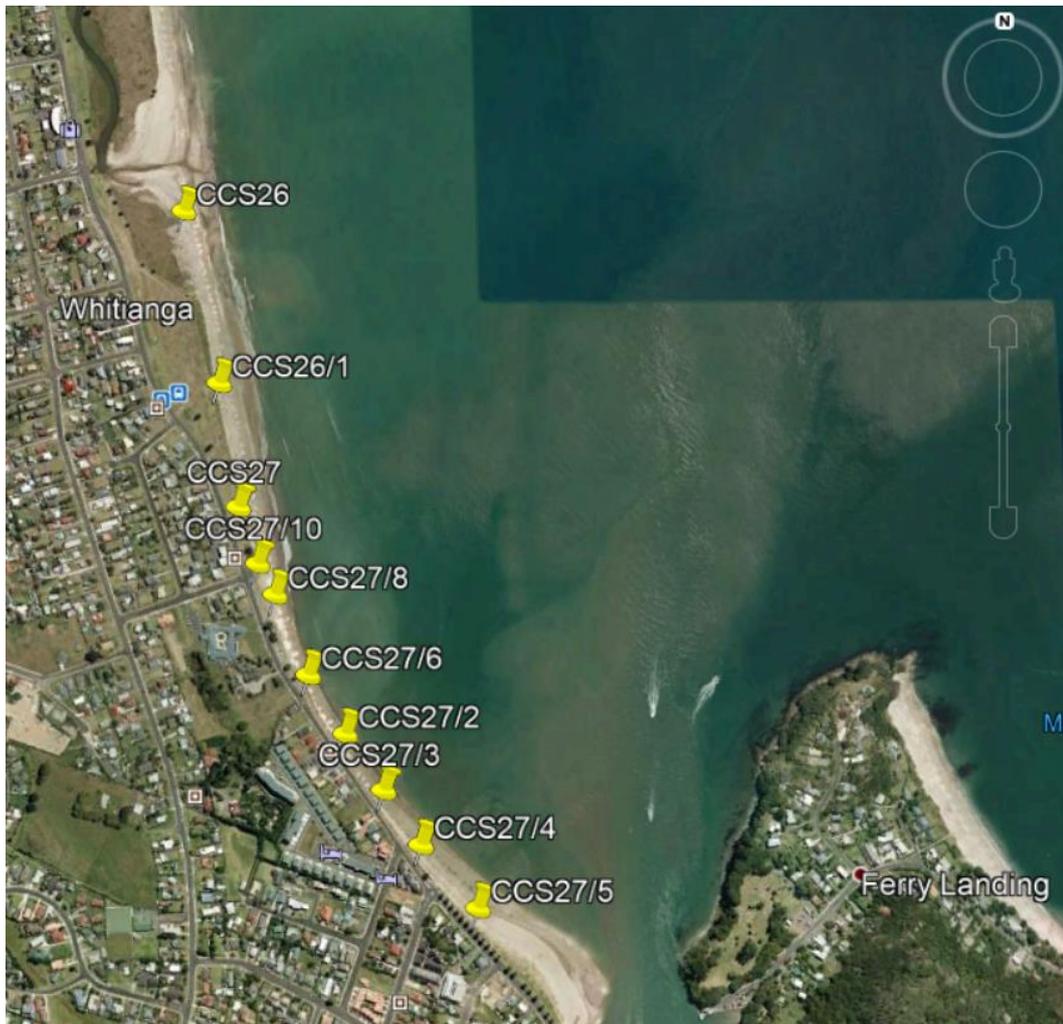
Figure A.4. Beach profile sites, South Buffalo Beach of CCS26, CCS26/1, CCS27, CCS27/10, CCS27/8, CCS27/6, CCS27/2, CCS27/3, CCS27/4 and CCS27/5.

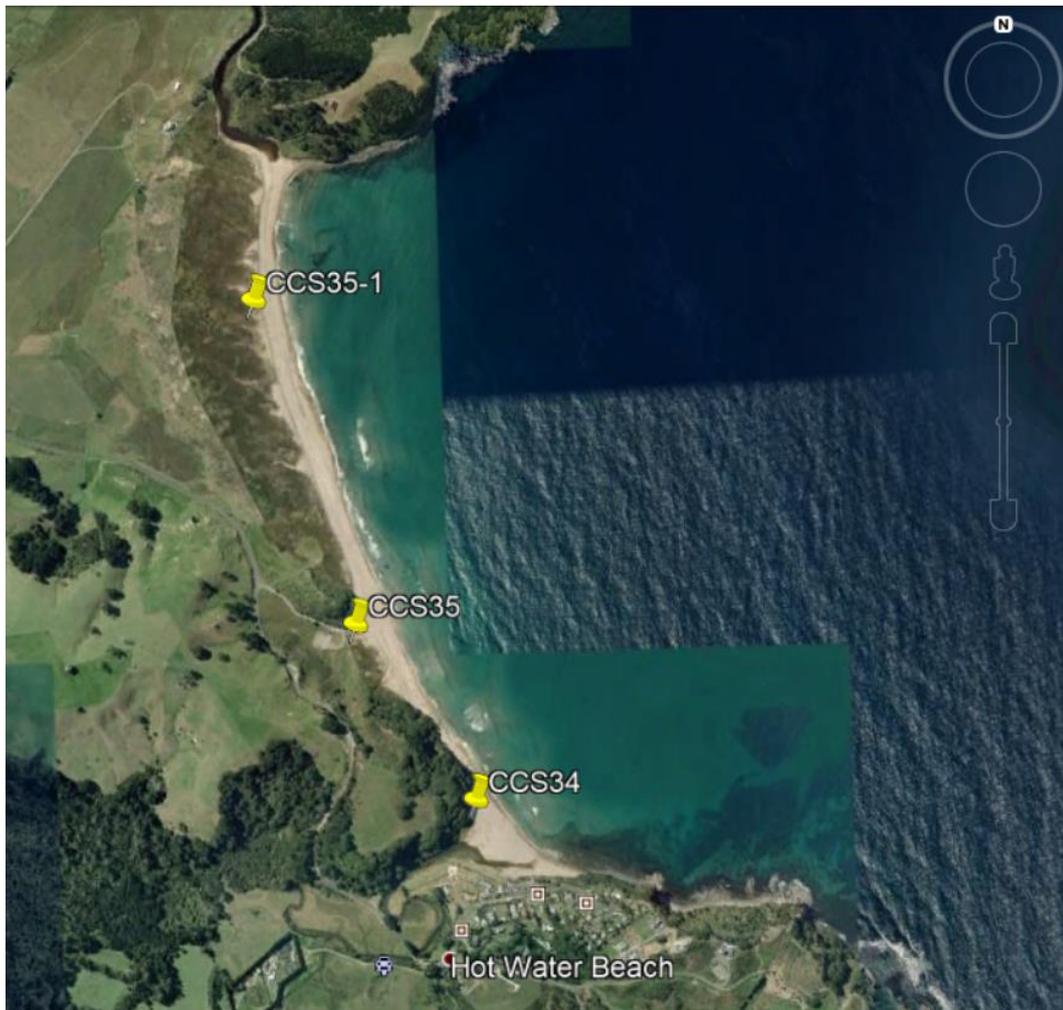
Figure A.4. Beach profile sites, Hot Water Beach of CCS34, CCS35 and CCS35-1.

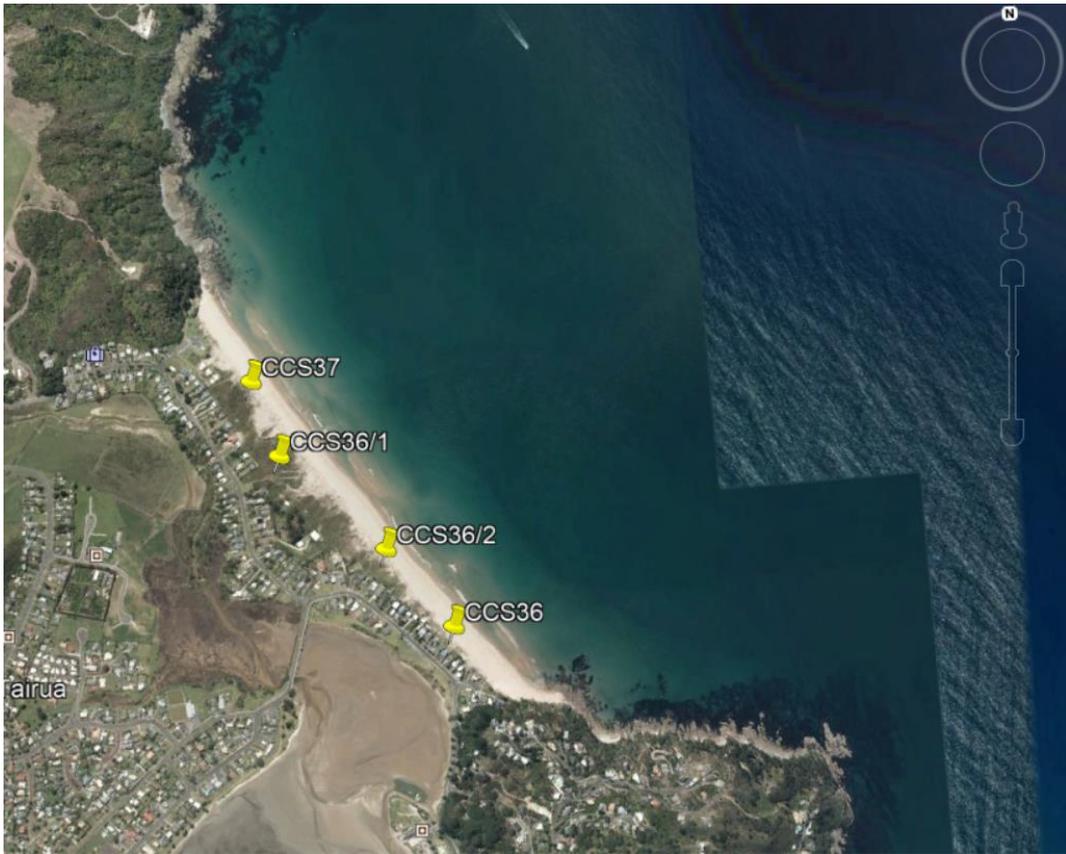
Figure A.5. Beach profile sites, Tairua Beach of CCS37, CCS36/1, CCS36/2 and CCS36.
