Sensitive Soils of the Puketoka Formation, Hamilton, New Zealand

A thesis submitted in partial fulfilment
of the requirements for the degree
of
Master of Science (Research) (Earth Sciences)
at
The University of Waikato
by
Emily Charlotte Kitchen

2021

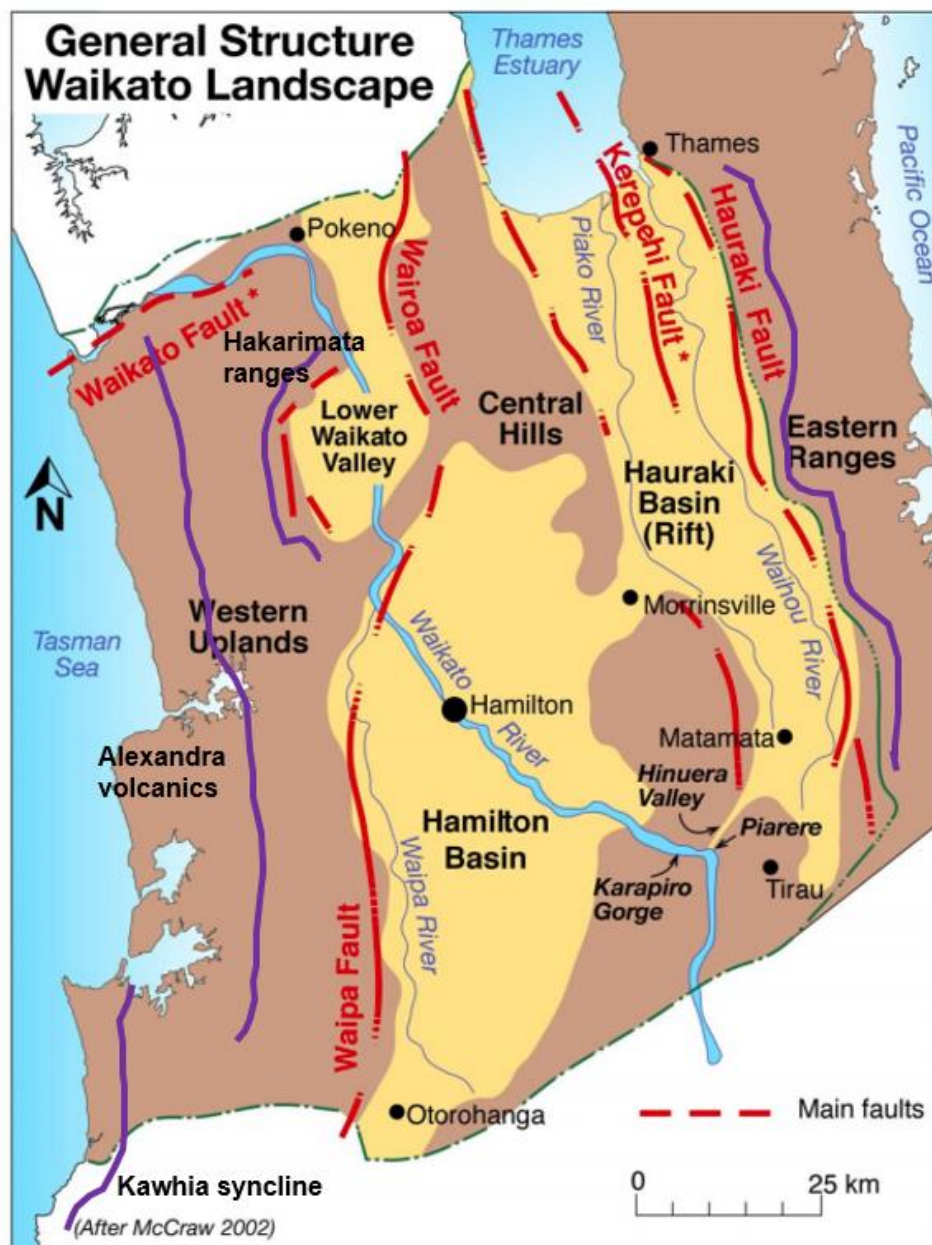
Figure 2.1. Schematic of the Hamilton Basin, detailing the general basin structure. The purple lines indicate the mountain ranges of the region, as described above (Lowe, 2010).

The Hamilton Basin is an oval shaped depression that is greater than 80 kilometres in length running from north to south, and over 40 kilometres wide (Selby & Lowe, 1992). The basin is bounded in nearly all directions by various mountain ranges, except to the south (**Figure 2.1**). The Hakirimata and Taupiri Ranges bound the basin to the north, the Pakaroa Ranges to the east, and the Alexandra Volcanics and Kawhia Syncline (Western Uplands) to the west of the basin (Selby and Lowe, 1992). In the southern direction, the basin floor material rises and connects with the land of the King Country Plateaux (Selby & Lowe, 1992). The Hamilton Basin was initially produced around 5 million years ago (Ma) as a direct result of normal faulting that produces tectonic features including the Hauraki Graben across the now defined Waikato Region (Selby & Lowe, 1992). The Waikato River runs through the Hamilton Basin and is responsible for much of the more recent landscape development (McCraw, 2011).

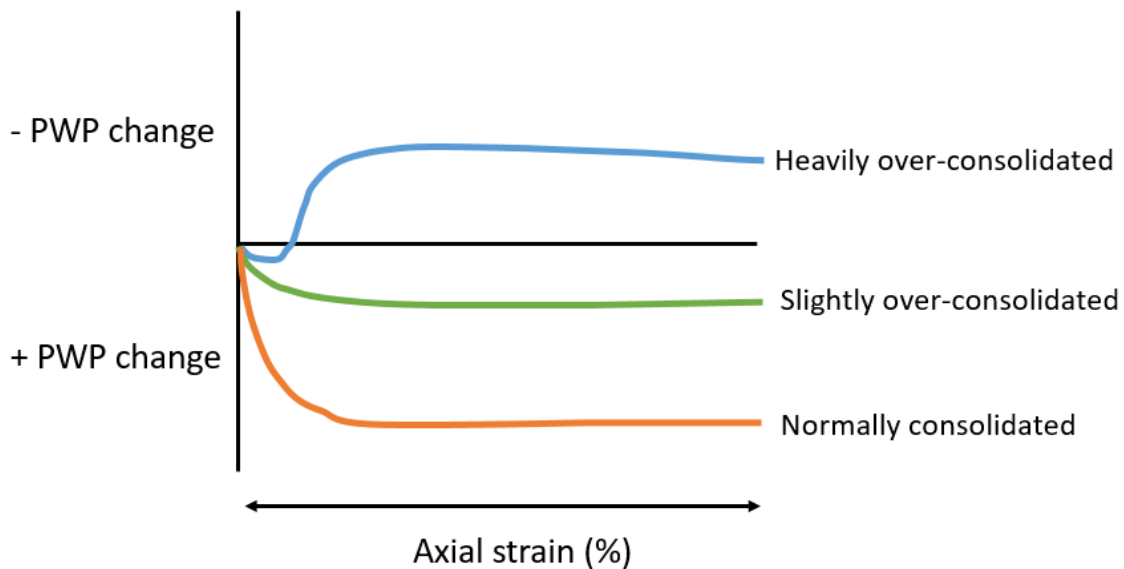
Figure 2.11. Graph summarising the response of pore water pressure (PWP) changes in response to changes in axial strain (%), relating to the degree of consolidation within clay materials (after Tan, 2010).

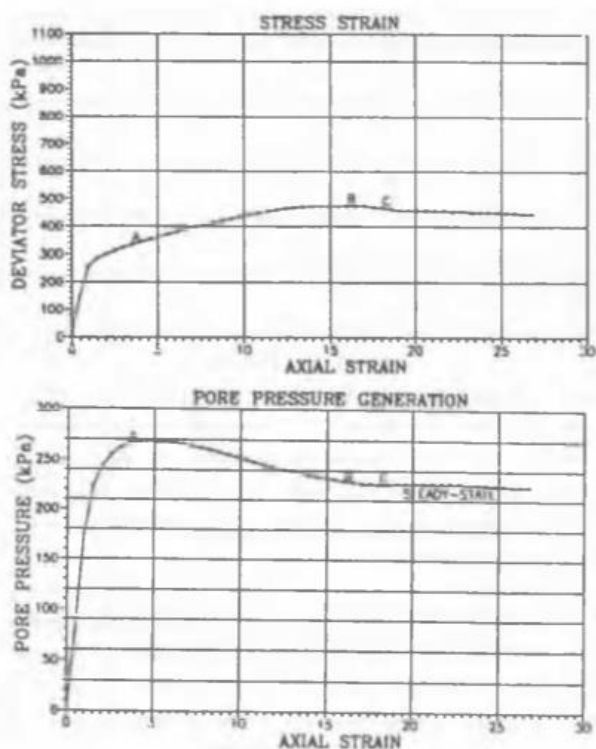
Figure 2.14. Graphs summarising the deviator stress and pore water pressure (kPa) response of a material in relation to axial strain for a shear band failure (Konrad & Sawitzki, 1994).

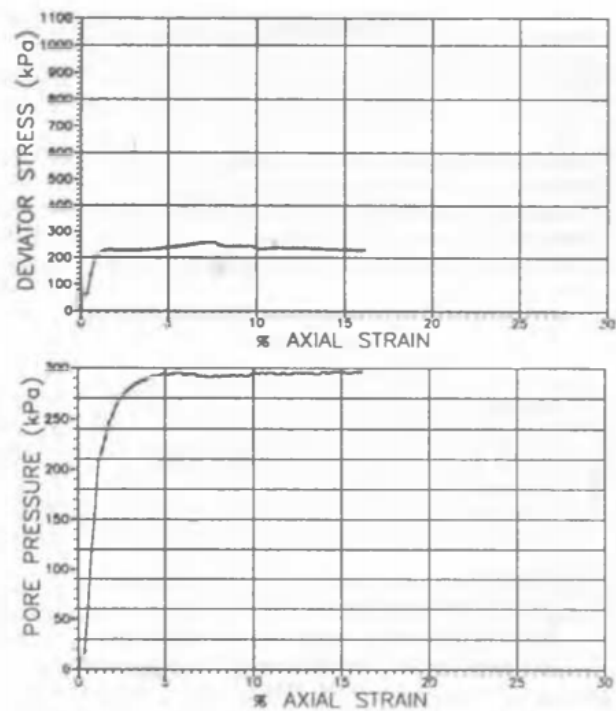
Figure 2.15. Graphs summarising the deviator stress and pore water pressure (kPa) response of a material in relation to axial strain for a barrel failure (Konrad & Sawitzki, 1994).

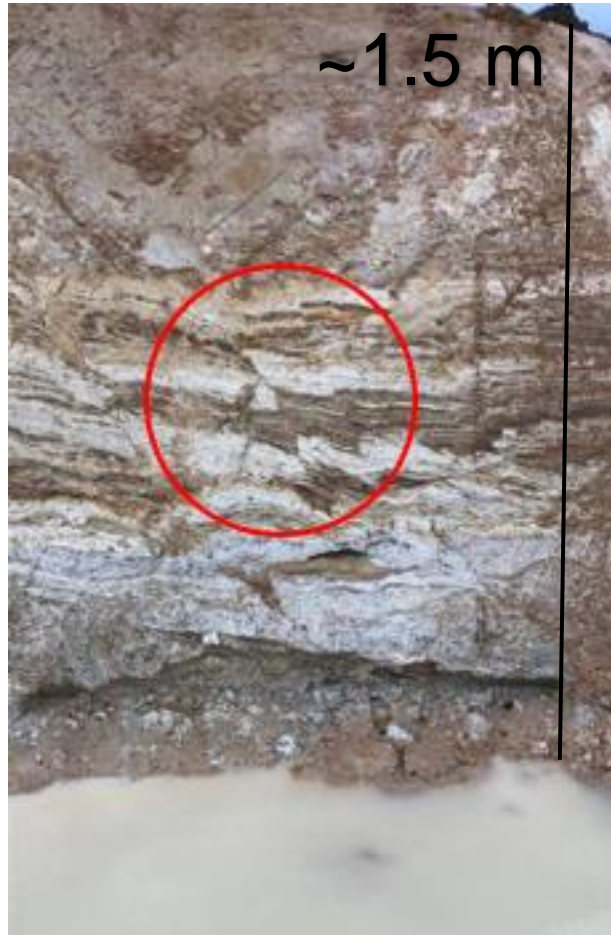
Figure 4.3. Image showing evidence of the faulting found within the Dixon Road Roundabout site cuttings, which could pose an issue to the sensitive sediments within the site if seismic activity were to occur. Note the bedding of the layers observed, separated by dark brown layers (Lethborg, 24th July 2020).

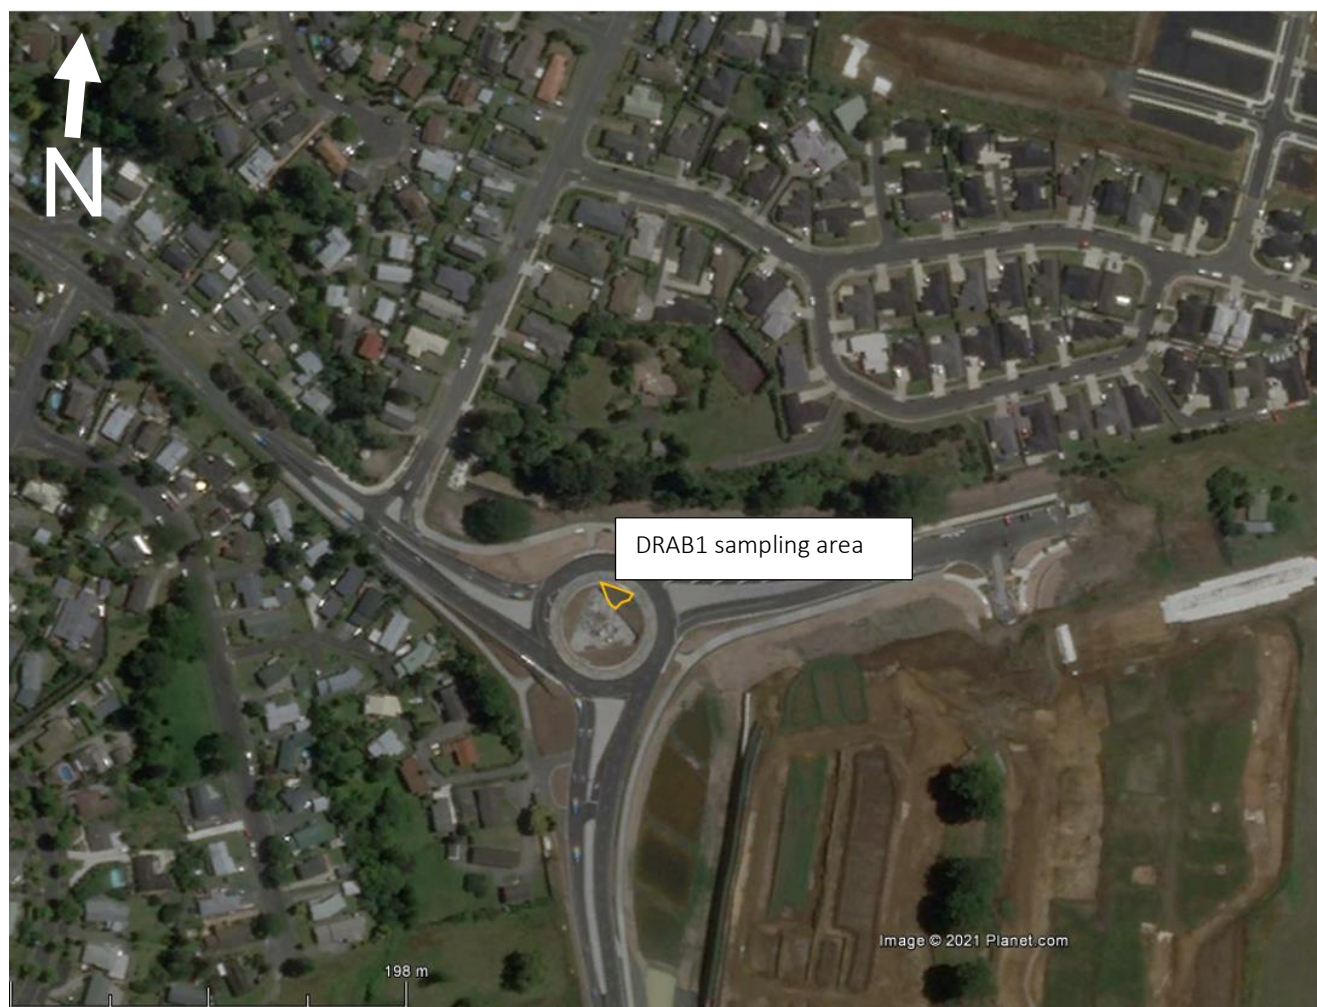
Figure 4.4. Google Earth image showing the approximate location of sampling for the Dixon Road Roundabout (DRAB1) site, in relation to the now constructed roundabout (Google Earth, 2021).

The site showed an extensive number of layers due to the ~10m cuts made in order to accommodate future underpass installations. **Figure 4.4** shows the approximate location of the samples taken for the Dixon Road Roundabout site, hereafter referred to as DRAB1.

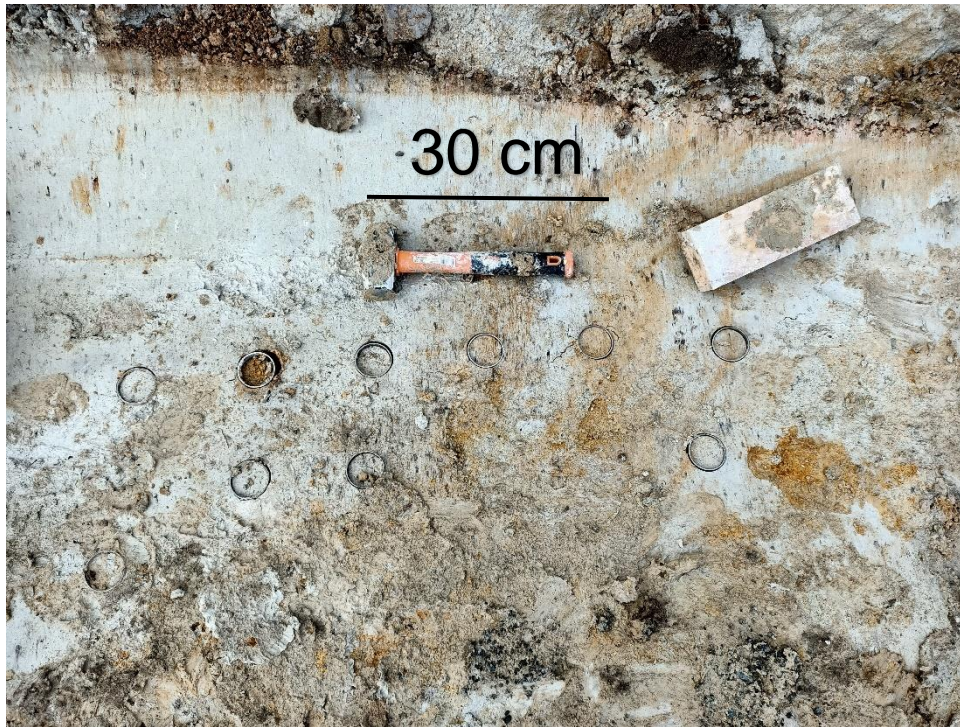
Figure 4.6. Figure showing ten of the twelve triaxial cores hammered into the cleared bench of Puketoka Formation material (30cm mallet for scale) (Kitchen, 2021).

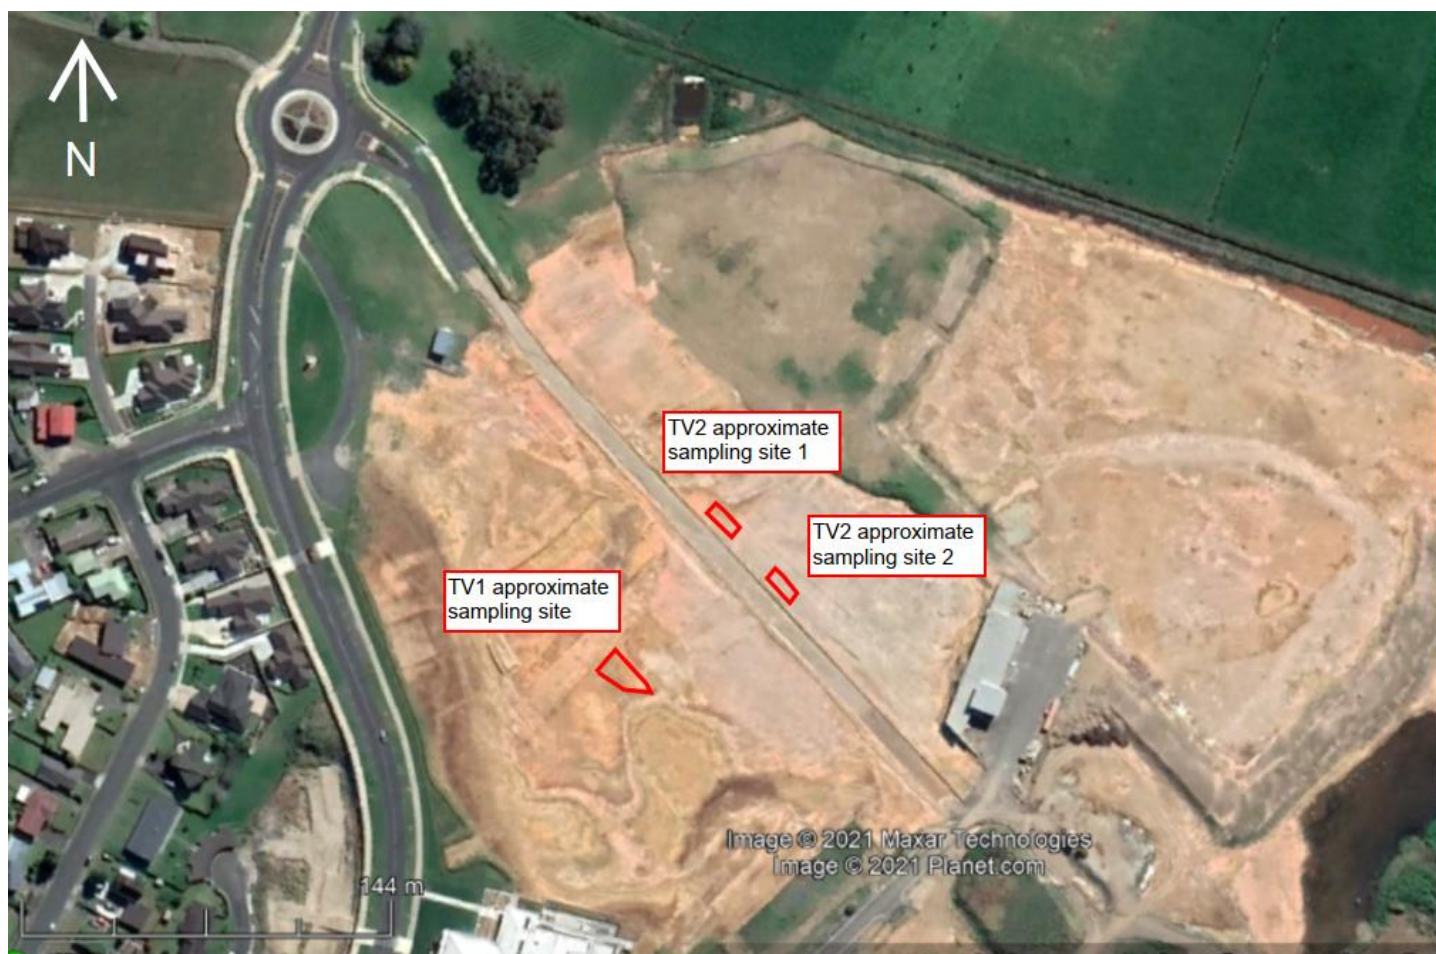
Figure 4.7. Annotated map showing the sampling areas within the Temple View site, where TV1 and TV2 materials were sampled from (Google Earth, 2021).

Two areas were sampled from within the Temple View site (referred to as TV1 and TV2) in order to capture some of the variance seen within the site (**Figure 4.7**).

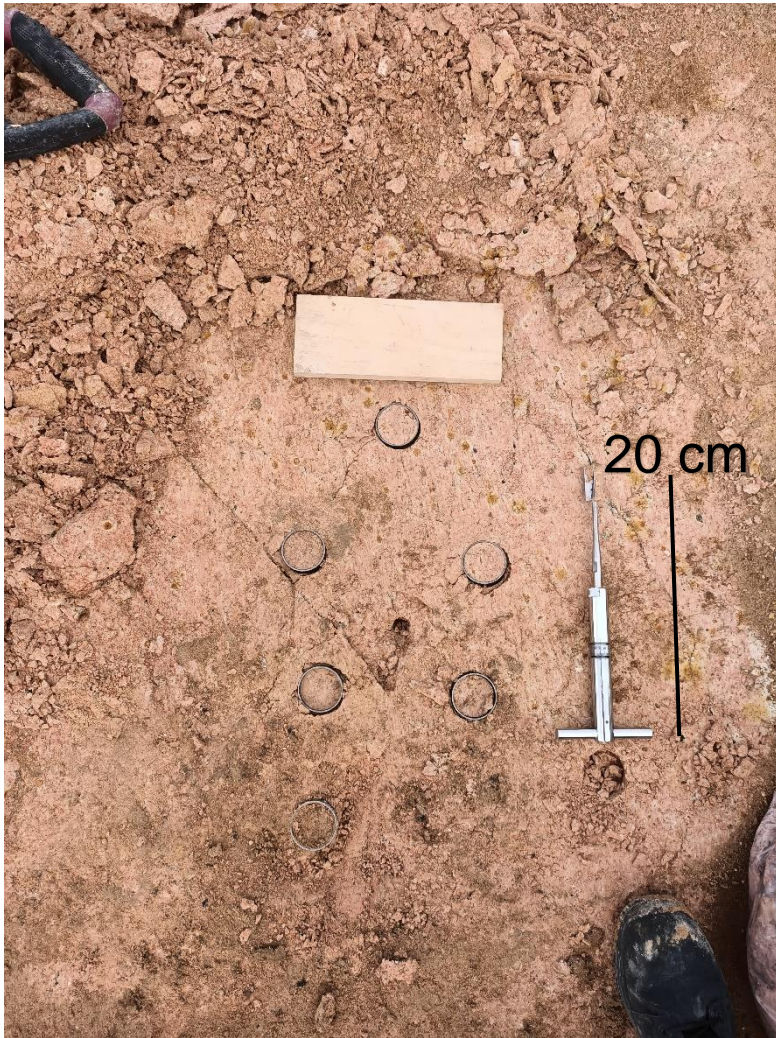
Figure 4.9. Image showing the level platform scraped prior to triaxial core extraction of the upper Puketoka Formation materials (20 cm shear vane to scale).

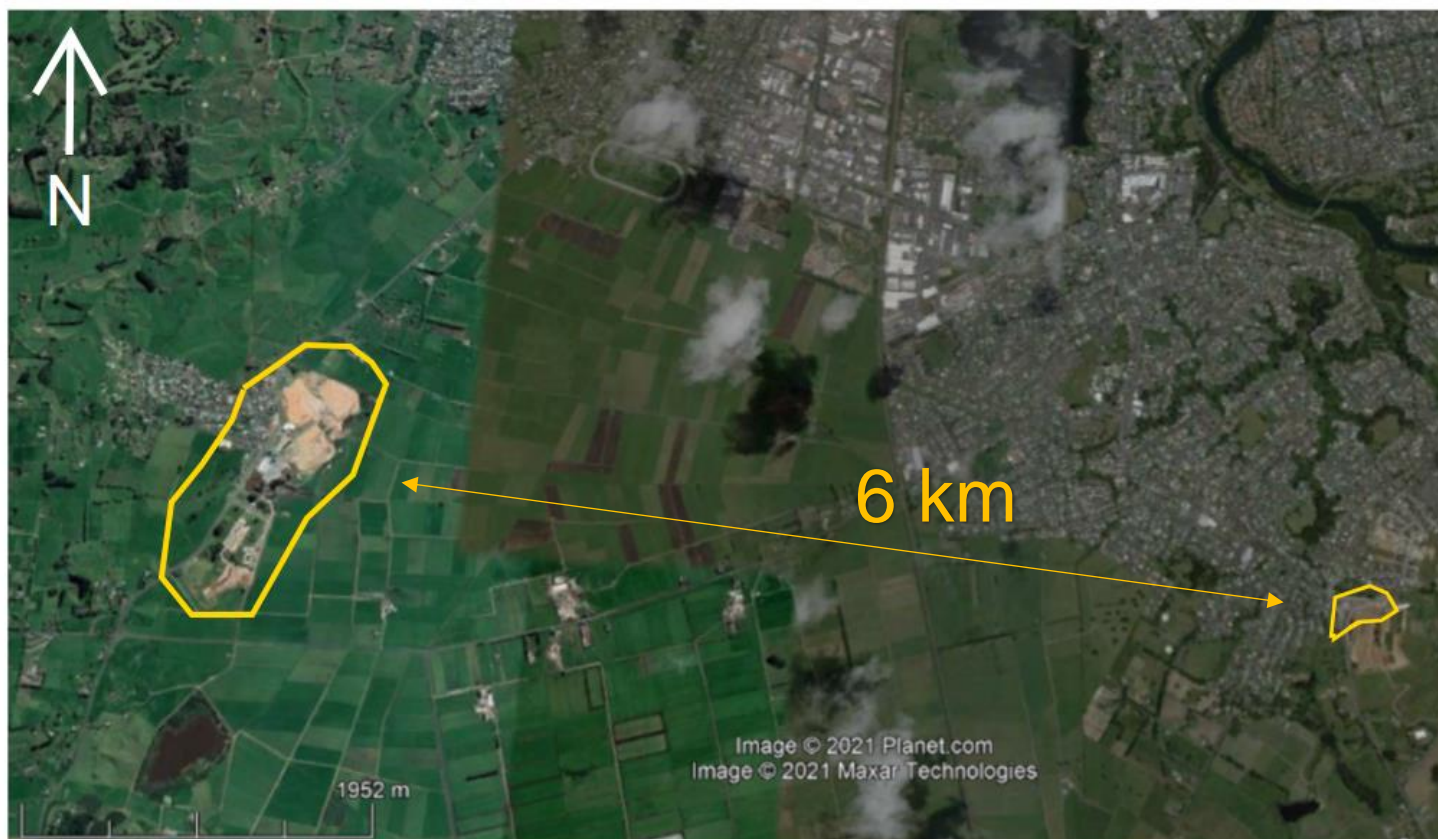
Figure 4.11. Google earth image comparing the locations of the two sites sampled for this study. The large outline indicates the Temple View site, and the smaller outline indicates the Dixon Road Roundabout site (Google Earth, 2021).

The two sites used within this study are located around 6 kilometres away from one another, therefore provide some potential level of variability in the extent of the Puketoka Formation. **Figure 4.11** compares the locations to one another.

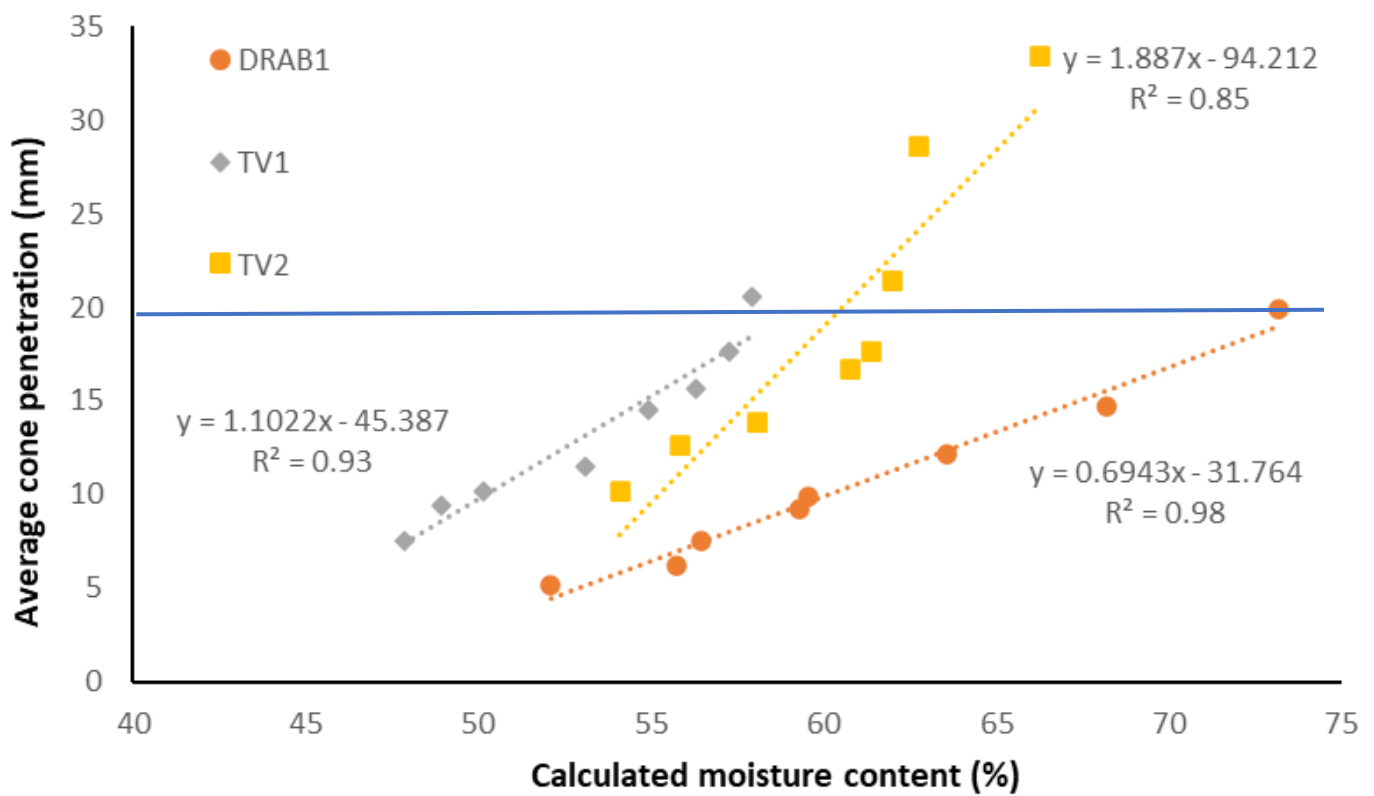
Figure 5.1. Graph showing the relationship between the average cone penetration (mm) and the moisture content (%) for the soils of this study. The blue line indicates penetration at 20 mm.

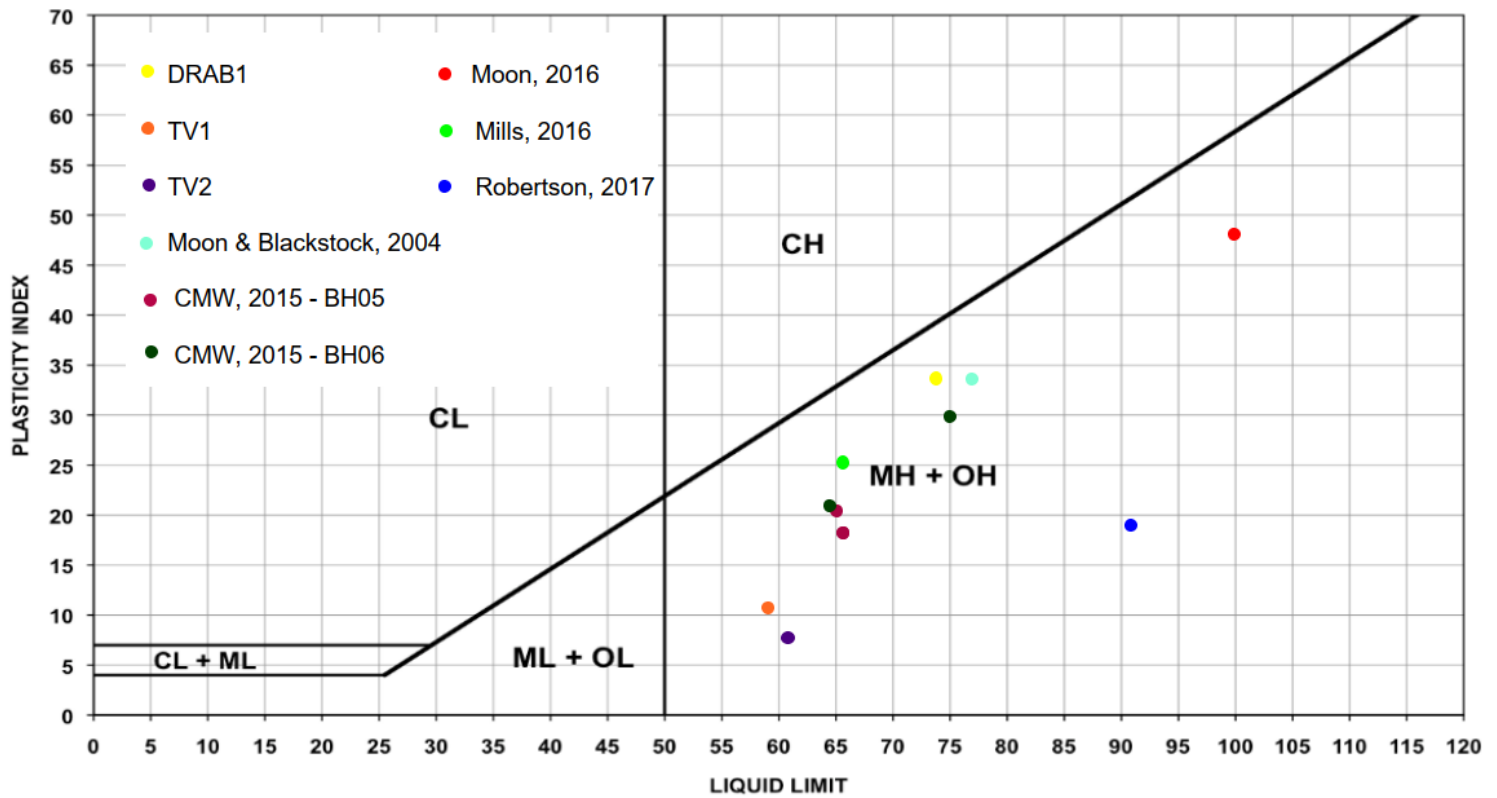
Figure 5.2. Graph summarising the Atterberg limits results for tests completed on DRAB1, TV1 and TV2 samples, in addition to results of previous studies (Casagrande, 1948).

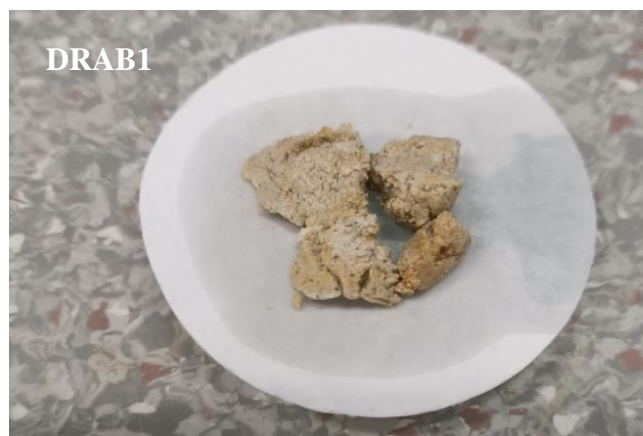
Figure 6.9. Image showing the results of the Fieldes and Perrott NaF test for allophane. The lack of pink colouration upon the paper indicates absence of allophane after 5 minutes of exposure.

Due to the incredibly small nature of allophane, it is x-ray amorphous (Lowe et al., 2012). Therefore, qualitative testing was needed. The NaF test, developed by Fieldes and Perrott, was conducted for all three samples, and the results found no presence of allophane within either site after 1 minute, 3 minutes and 5 minutes of exposure to NaF (**Figure 6.8** and **6.9**).

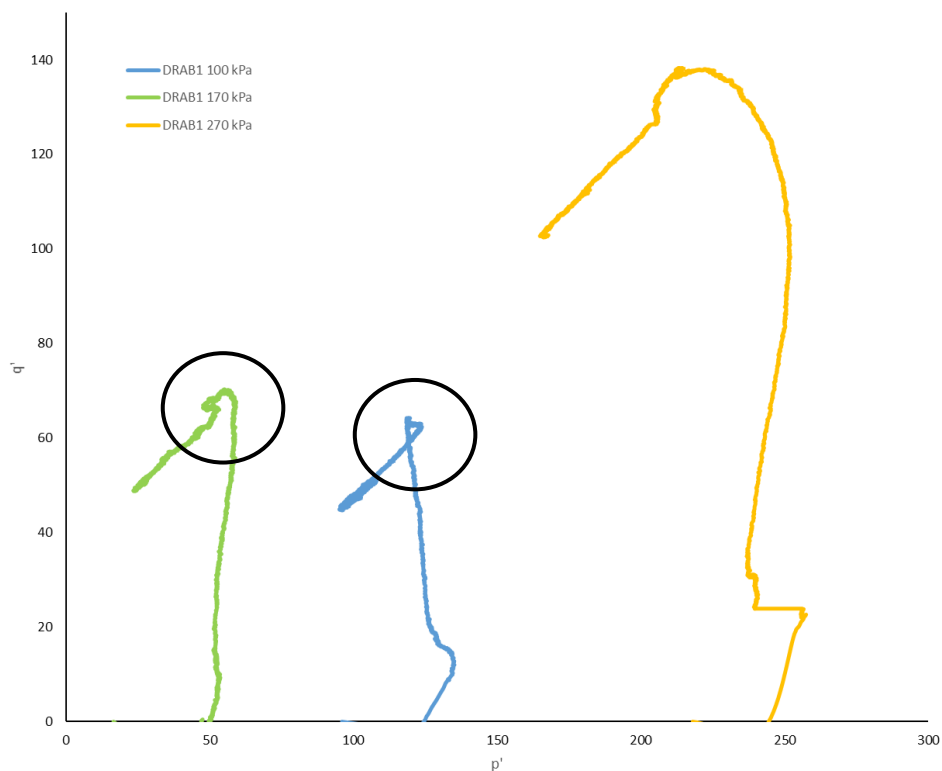
Figure 7.3. Graph summarising the p' versus q' response for DRAB1 failed triaxial cores, at differing confining pressures. Black circles indicate the correction made by the materials, after travelling above the critical state line.

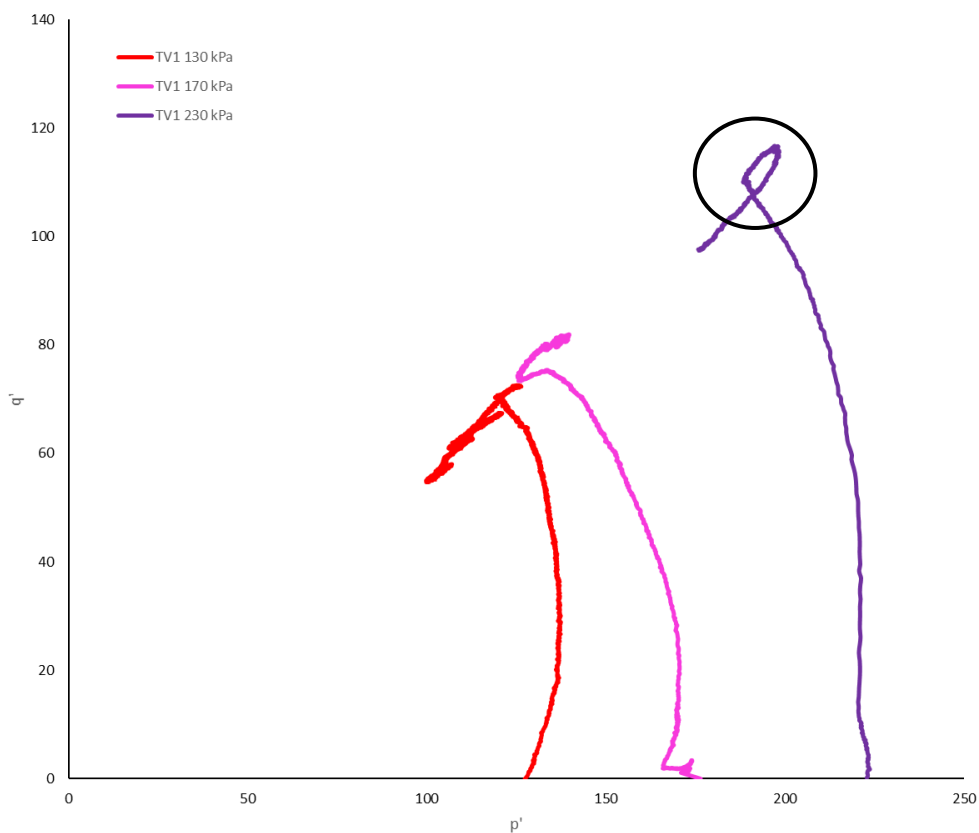
Figure 7.4. Graph summarising the p' vs q' response of the TV1 triaxial cores at differing confining pressures. The black circle indicates the correction of the material following travel above the critical state line to the yield point.

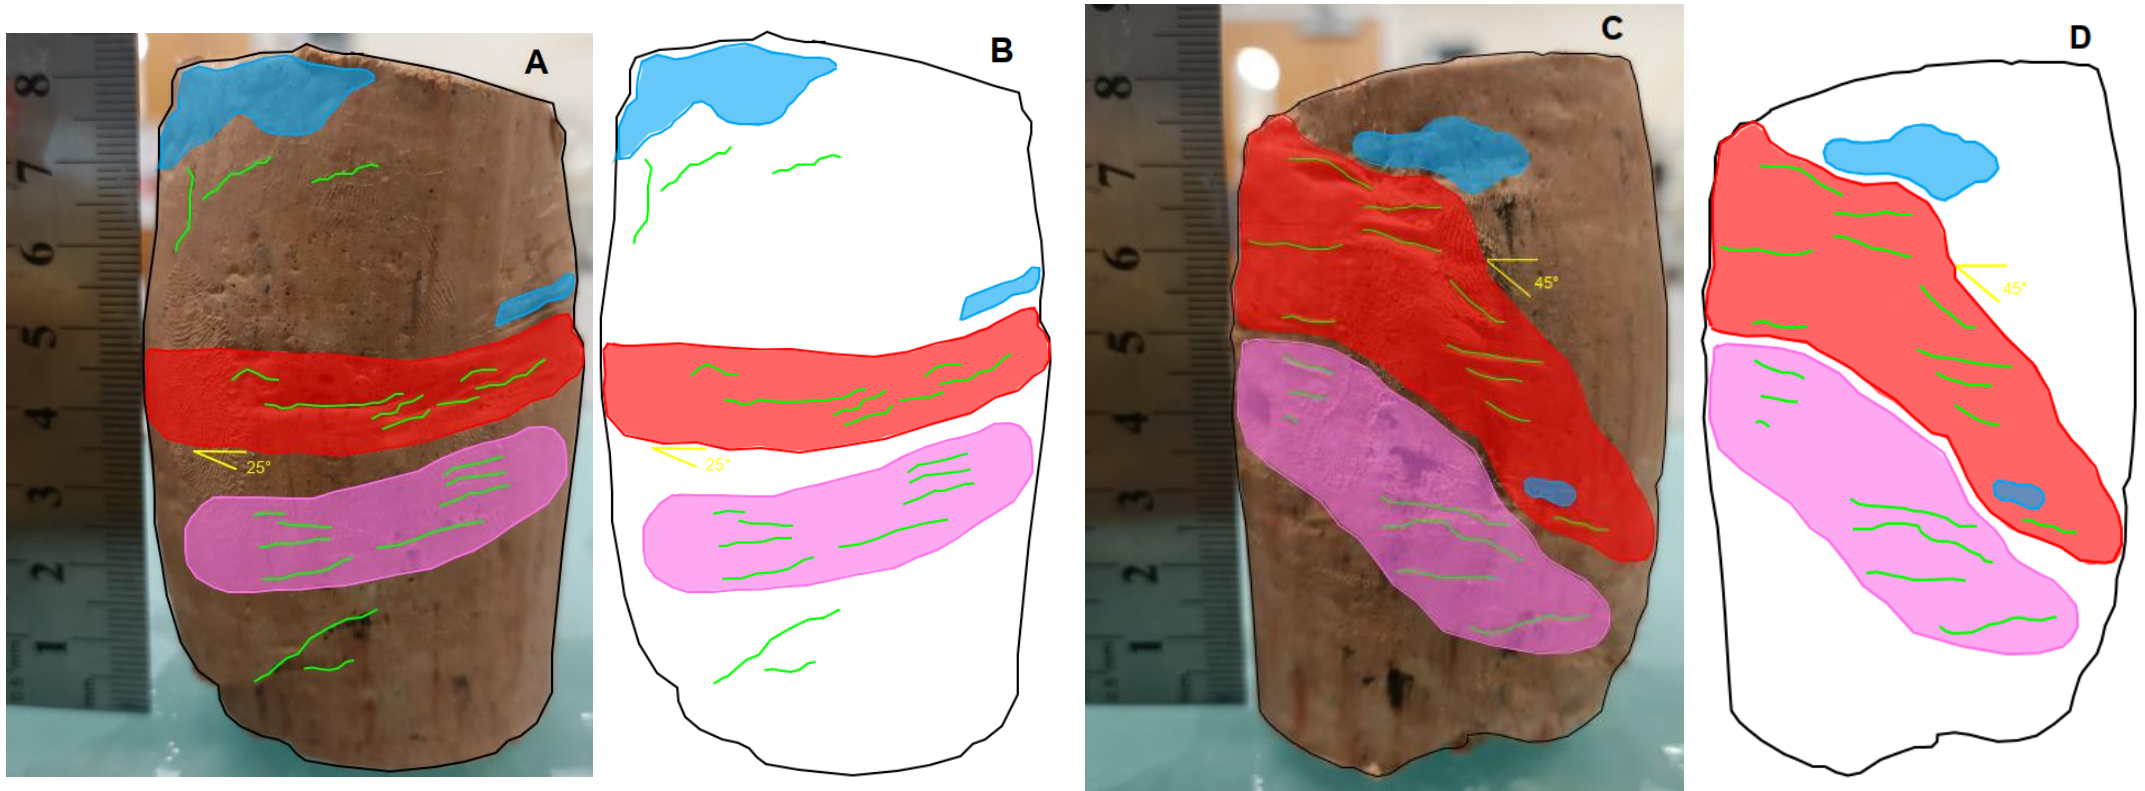
Figure 7.11. Annotated images of plane 1, overlain on an image of the soil core (A) and blank (B), and plane 4 (C) and (D), of the failed TV1 triaxial core, at 230 kPa confining pressure.

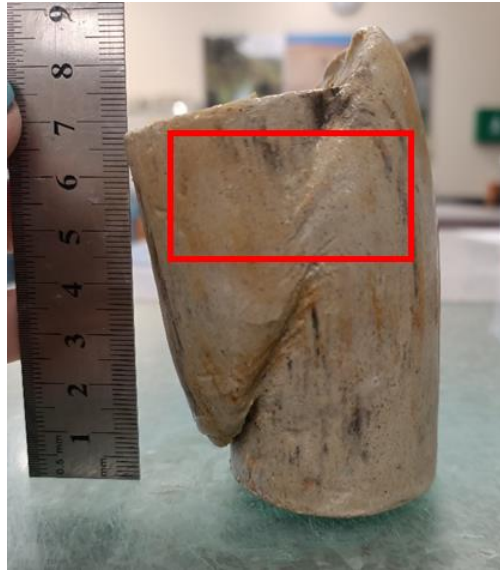
Figure 7.13. Image depicting the location on the core where the thin section was taken from, adjacent to the failure surface.

The thin section produced for the 270 kPa sample was taken adjacent to the failure surface (**Figure 7.13**). The shears were not prominent, with the overall thin section having few fracture zones visible. The large main PSZ shear was connected to the conjugate shears by several small lateral shears. These shears had a measured angle of between 30 and 40° . These measured angles did not closely match the calculated angle values for Riedel shear propagations detailed in **Figure 7.12**, A). The shears were infilled with a dark substance, potentially hematite, as observed in **Figure 7.16**, image B.

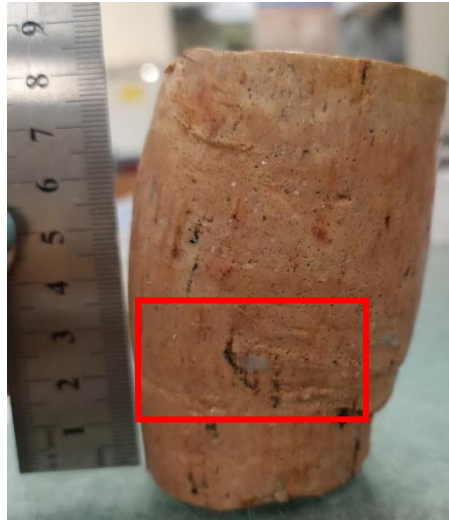
Figure 7.14. Image showing the location the 130 kPa thin section, adjacent to the failure surface.

The thin section produced for the 130 kPa confining pressure was taken adjacent to the failure surface (**Figure 7.14**). This thin section was found to exhibit more visible shears, compared with the DRAB1 270 kPa sample (**Figure 7.17**). One PSZ zone could be seen propagating across the sample, with two conjugate shear zones connected by R' shears. The interaction between these shears had a measured angle of $\sim 50 - 60^\circ$. The measured angles were in agreement with the calculated Riedel shear propagations detailed on **Figure 7.12, B**). One conjugate shear passes through a highly weathered, high relief cristobalite crystal (**Figure 7.17, B**). Infilling of the fracture within the crystal was also observed. There is a lower degree of shear infilling compared to the DRAB1 270 kPa sample (image B), bottom left corner).

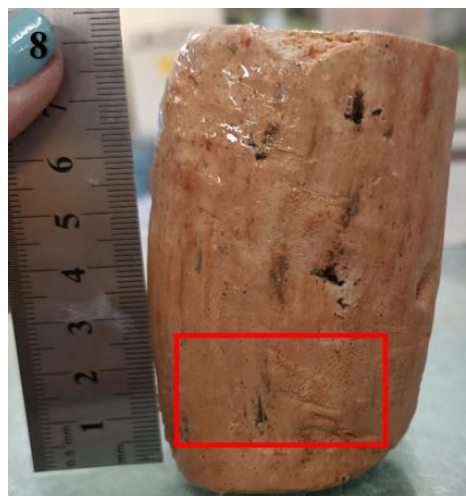
Figure 7.15. Image showing the location of the thin section taken from the TV1 230 kPa thin section, adjacent to the failure surface.

The TV1 230 kPa thin section was taken adjacent to the failure surface (**Figure 7.15**) produced shows the main hypothesised PSZ propagating laterally across the sample (**Figure 7.18**) but did not show any infilling with dark material, unlike DRAB1 270 kPa and TV1 130 kPa samples. The shear zones within the TV1 230 kPa sample were not developed enough to accurately define and measure the Riedel shear propagation zones and interactions between different shear types. Therefore, only the main identified shear zone within the sample is marked on **Figure 7.18**.

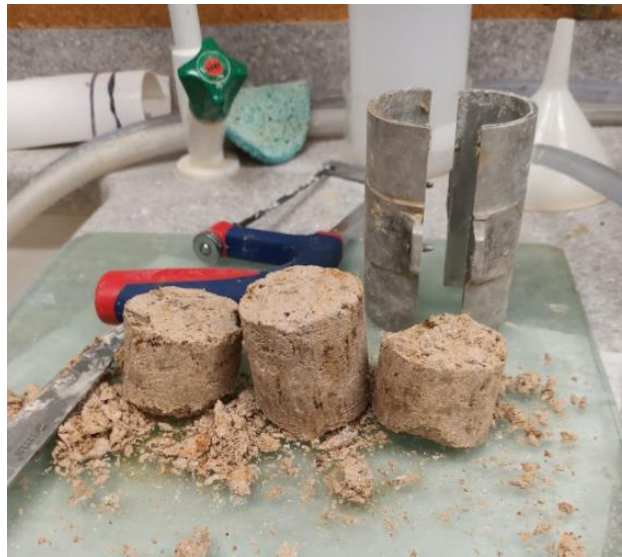
Figure 7.19. Image showing the condition of the TV2 cores during extraction. The granular nature of the cores in addition to the moisture content disallowed successful core extraction and trimming.

The time of year the cores were collected and the depth of testing influenced the quality of the samples obtained. The TV2 samples collected were too dry to be used for triaxial testing, crumbling when cut (**Figure 7.19**).

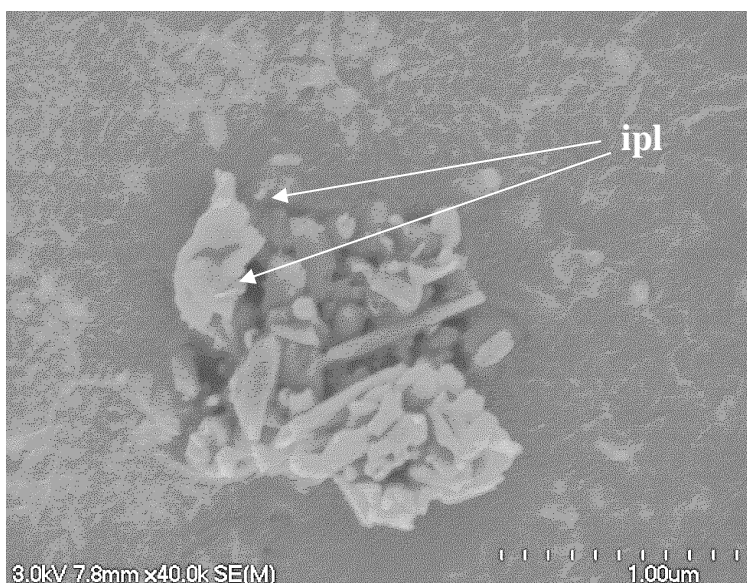
Figure 8.9. SEM image showing the presence of irregularly shaped plates within TV1, denoted by ipl. The plates range between 0.3 and 0.6 µm in TV1. Due to the limitations of the SEM it is challenging to determine the depth and true shape of the plates.

Plate morphologies were also present within all three samples analysed (**Figure 8.5 to 8.9**). Plates appeared to be less abundant than the tubules identified, but the abundances appeared to be similar in all three samples analysed, with differing shapes. The plates appear to either be hexagonal or irregularly shaped in DRAB1 (**Figure 8.5, 8.6, and 8.7**). Plates that are hexagonal in shape normally associated with halloysite. The plates appeared to be more irregular in shape for TV1 and TV2 (**Figure 8.8 and 8.9**). The sizes of the plates varied in all three samples. (Dixon, 1989; Wyatt, 2009). The plates tended to be edge to edge (EE) and face to face (FF) in contact in all three samples.

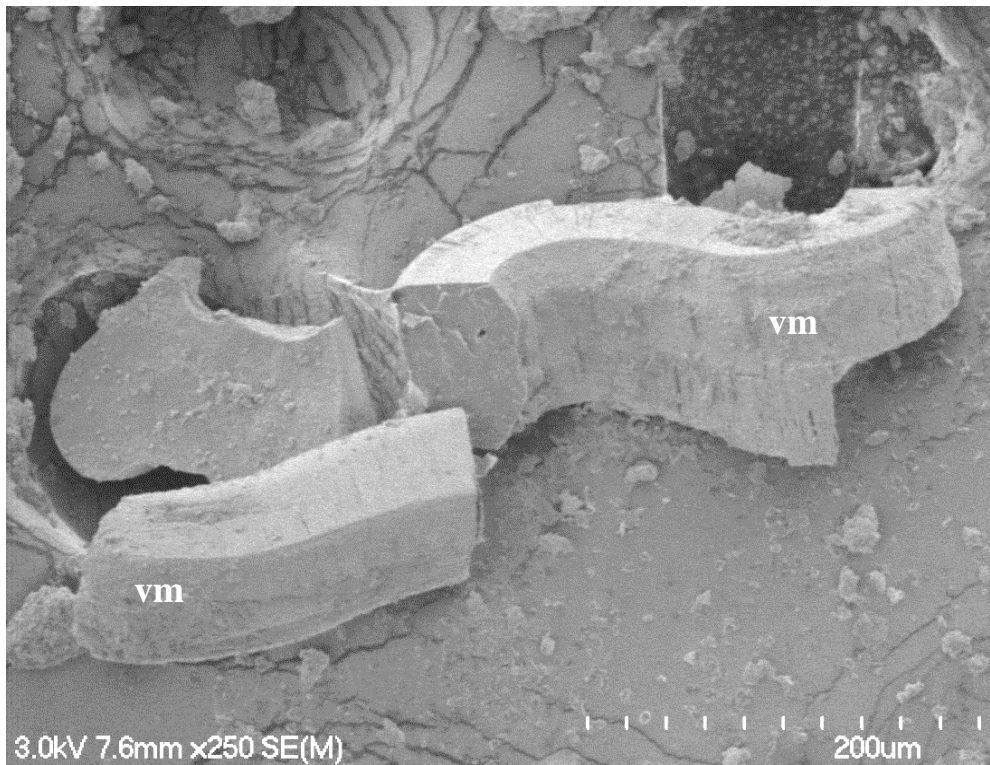
Figure 8.15. SEM image depicting the presence of two vermiform book (vm) forms radiating away from one another at a common point in TV2. The books range from 200 to 250 μm in size, and display face to edge contacts.

Whilst the identification of singular plates occurred in all three samples, stacked plates in a vermiform arrangement (books) were only observed in TV1 and TV2 and were seemingly absent within DRAB1. TV2 had the greatest observed abundance. The books observed were identified to be blocky and square to vermicular curved books, varying in size between 75 and 250 μm in length, and 0.5 to 100 μm in diameter (**Figure 8.14**, **8.15** and **8.16**). Book formations were identified within Tauranga sensitive soils in Wyatt’s 2009 study, and in the pyroclastic soil materials studied across Tauranga in Arthur’s 2010 study (**chapter 2**). I hypothesise the books identified in TV2 are kaolinite, observed on the XRD bulk and clay graphs (**chapter 6**).

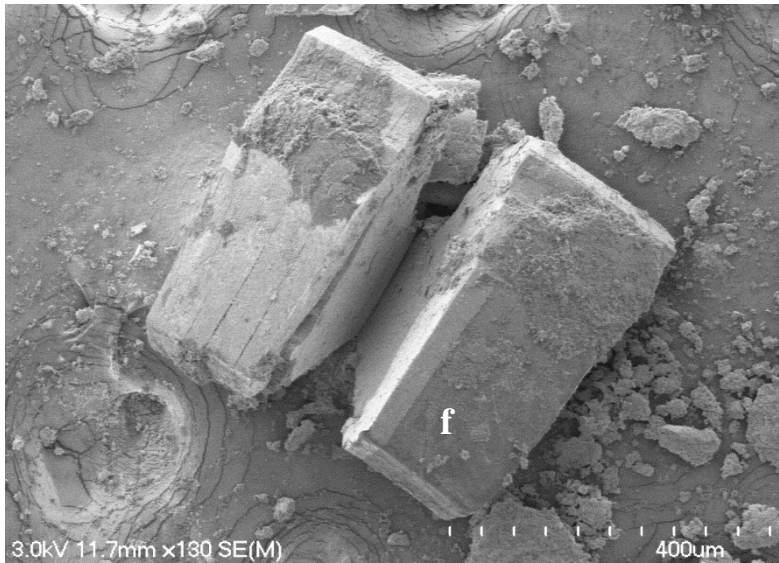
Figure 8.34. SEM image showing a hypothesised feldspar (f) grain identified within the more granular portion of the TV1 sample. This grain is extremely large in size (458 μm), and appears to have split down the middle as a result of sample preparation.

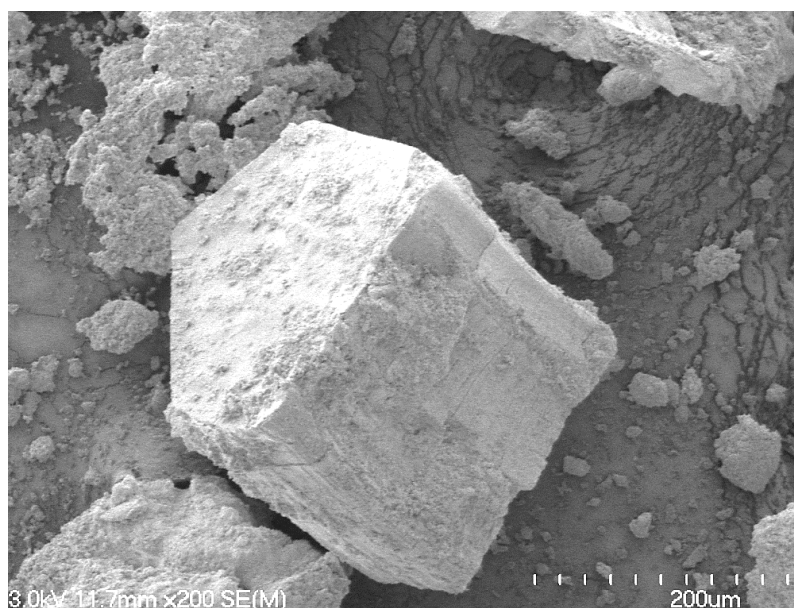
Figure 8.36. SEM image depicting a large, blocky grain identified within the more cohesive portion of the TV1 sample. The grain is 180 μm in diameter, and appears to be foliated, similar to the book formations identified in TV1 and TV2. The grain is also finely covered in grain coatings across the exposed surfaces. This grain is hypothesised to be micaceous.

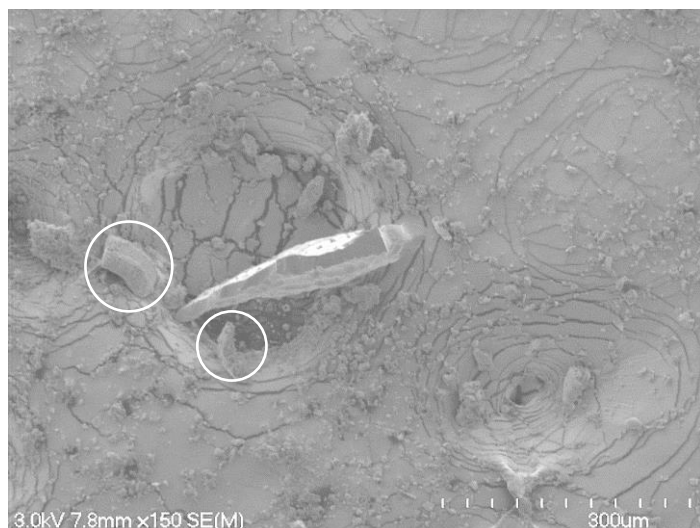
Figure 8.50. SEM image showing a large grain of slightly weathered volcanic glass (wvg), 313 μm in length and μm in diameter. Note the presence of small clay-sized microaggregates upon the surface of the grain (highlighted by white circles) and the presence of potential vermicular book formations to the left of the image (denoted by white circles). These were isolated from one another.

TV2 tended to have more grains isolated from the clay-sized groundmass compared with TV1 and DRAB1, indicative of the more granular nature of TV2 (**Figure 8.48** to **8.52**). These grains were relatively clean on the exposed surfaces, with only small amounts of surface matrix materials present upon the grains (**Figure 8.49**). The main grains observed appeared to be angular volcanic glass that had experienced differing degrees of weathering, and subangular quartz crystals (**Figure 8.50** and **8.51**). These crystals and glass tended to represent the silt and sand-sized grain fraction. Some grains were found to be embedded within the clay-sized matrix, particularly in the more cohesive portions of the sample (**Figure 8.53**).

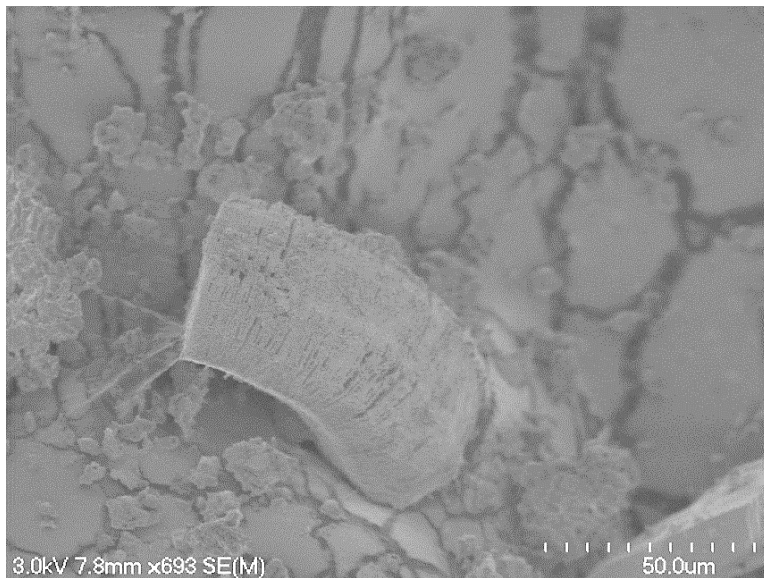
Figure 8.59. SEM image showing another example of the vermiform book formations analysed within the TV2 samples. This book formation measured 82.1 μm in length and 41 μm in diameter.

Halloysite book formations were common in TV2, and were found most frequently in these samples, as compared to DRAB1 and TV1. The book formations were generally vermicular in shape, and both fully formed and partially formed formations could be observed (**Figure 8.58, 8.59, 8.60** and **8.61**).

The books were typically observed isolated from one another and were commonly seen radiating from small amounts of clay-sized groundmass surrounding some portions of the base of the formations (**Figure 8.58, 8.59, 8.60 and 8.61**). The books also tended to have some grain coatings upon them and experienced some defoliation at the edges of individual platy layers (**Figure 8.62**).

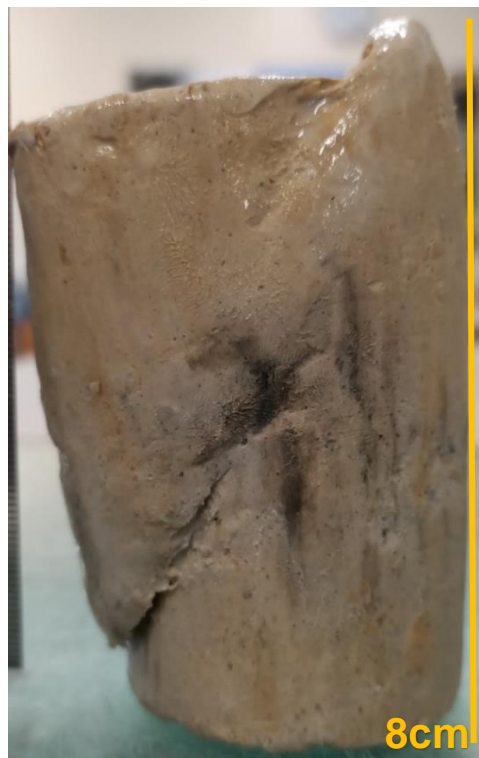
Figure 9.1. Image showing the extent of strain localisation (shear band formation) occurring within areas of manganese concentrations within a failed triaxial core sample (DRAB1 130 kPa).

Strain softening, contractive failure (SSC) is discussed in detail in **chapter 2**. SSC failures generally result in strain localisation related with the formation of shear bands within the soil material. Shear bands were observed in the form of deformed soil material in many of the samples of this study (**chapter 5**). The formation of shear bands usually occurs near an area of weakness within the soil, such as where material changes occur, concentrations of particular materials, and where material properties differ (Gylland, 2013a; Mills, 2016). This was observed in multiple samples tested throughout the course of this study (**Table 9.2**), particularly with manganese concentrations identified within the soils (**Figure 9.1**).
