SUCCESS STORIES AND THE WAY FORWARD

Rohan Wells

ABSTRACT

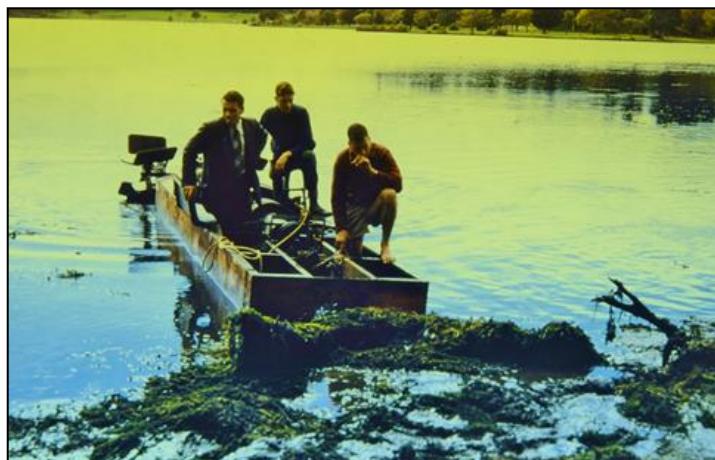
The photo above is a weed harvester – probably the first one in New Zealand. With continual refinement, they got bigger and more efficient. **Slide 2** The Lakeland steel harvester, manufactured in Rotorua, was the biggest harvester we have had in New Zealand. It was used on the Rotorua Lakes to remove water net (*Hydrodictyon*). It was used to clear a passage for the Lakeland Queen tourist boat to get out onto the lake. Water net infestations spread quickly and, unlike the macrophytes, only one cell (possibly spores) is all that is required for propagation. It spread quickly, even appearing in bird baths. It was like trying to contain foot and mouth. The techniques used for containing oxygen weeds are often inappropriate for algae.

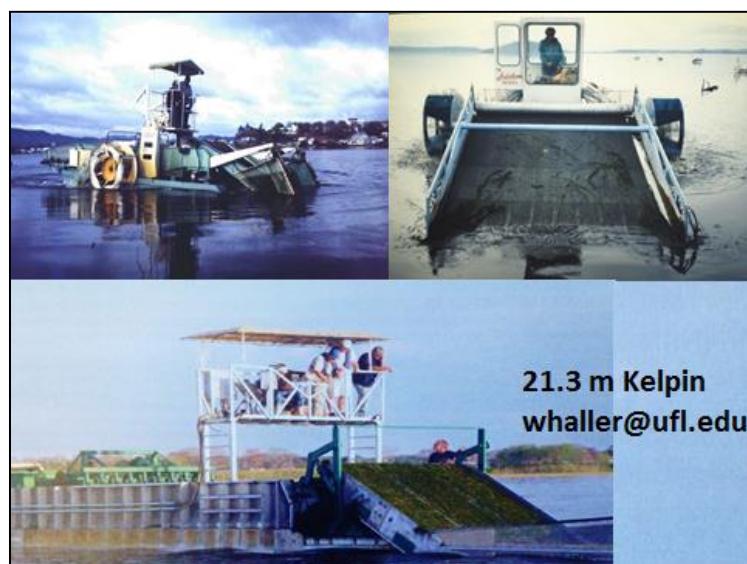
Slide 3

In Florida weed harvesting of topped out hydrilla collected about 22 tonnes per hectare. It was taking too long and cost too much to be viable. **Slide 3** is a 21 metre Kelpin monster harvester which cuts to 3 metres deep. Cutting the hydrilla at a time of the year when the

weeds are at their lowest quantity reduced the harvesting required to 1 tonne per hectare. Cutting it right to the bottom prevented a weed problem throughout the year. So changing the strategy produced a cost effective solution, in Orange Lake (3 m deep with a flat bottom).

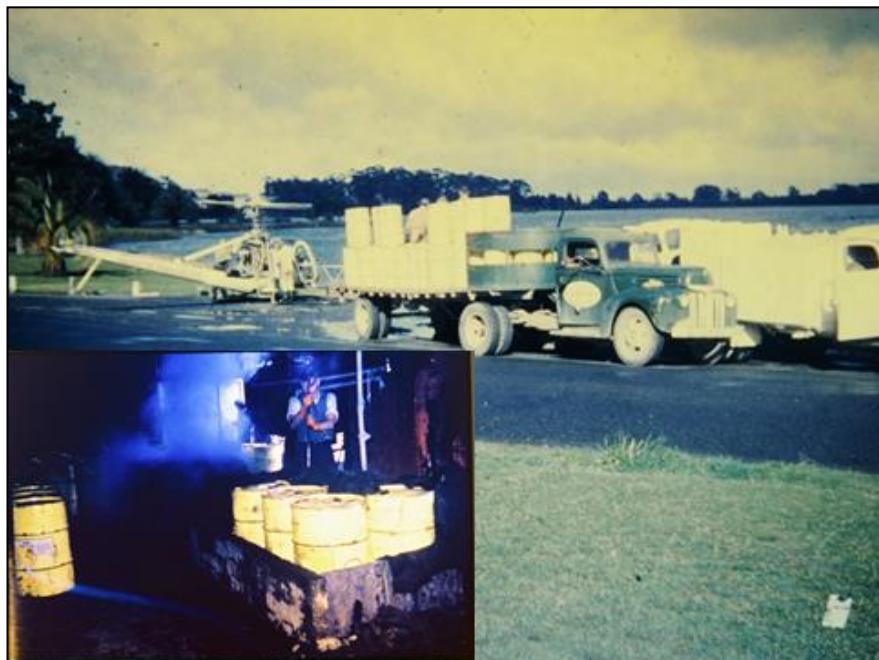
Slide 4

At Hamilton Lake in the 1950s, the agricultural engineers came up with a chemical solution, sodium arsenite. It had been used in the USA since 1929 and was a common herbicide. It was also a health tonic and used for medicinal purposes. In **Slide 4** the guy who is opening up the tanks has no protective gear, three people were hospitalised and he was probably one of them.

In 1959 low level helicopter flying applied 5.5 tonnes sodium arsenite to Lake Rotoroa, Hamilton which was successful, i.e. no weed for five years but also no plants in the lake for five years. Then the weed problem re-surfaced, probably from a re-introduction. Sodium arsenite treatment cost about \$0.5M in today's terms and arsenic levels still remain high in sediments and plants. It was tried in the Rotorua Lakes but was not effective with the target 10ppm concentrations not achieved; most likely due to dispersion.

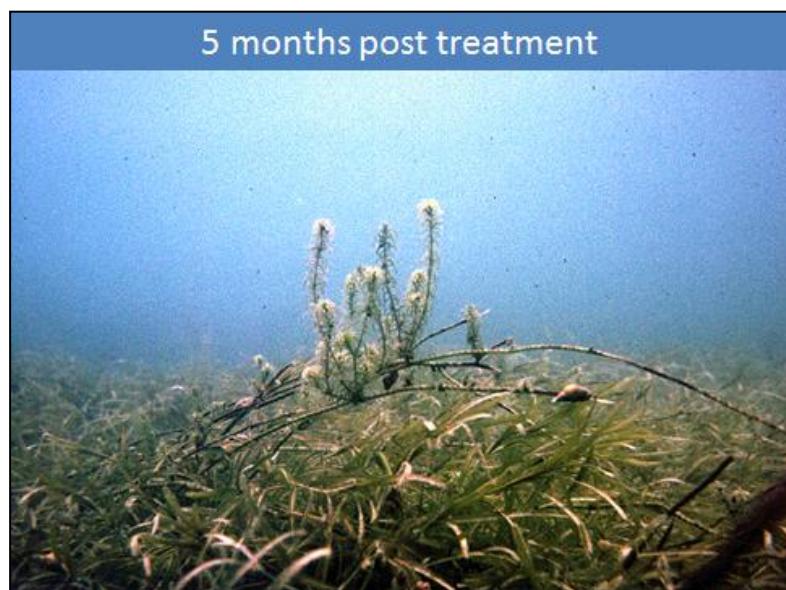
Slide 5

NIWA has worked on further refining herbicide formulations, some of which have been adopted by chemical manufacturers and applicators with incorporation into consent conditions for weed control. Today Aquagel is accepted as a useful additive that helps better target weeds growing in water below the surface. Diquat has been very effective. In Lake Okataina, hornwort was 8 m tall at its initial invasion site; but after diquat treatment no hornwort shoots were found at this site. In diquat trials, five months post spray, the tall-growing native species are left intact to become the dominant plant (**Slide 5**). Diquat is deactivated by sediment and it is ineffective on shoot buds located on basal stems and root crowns, so ultimately plants like *lagarosiphon* do recover.

5 months post treatment

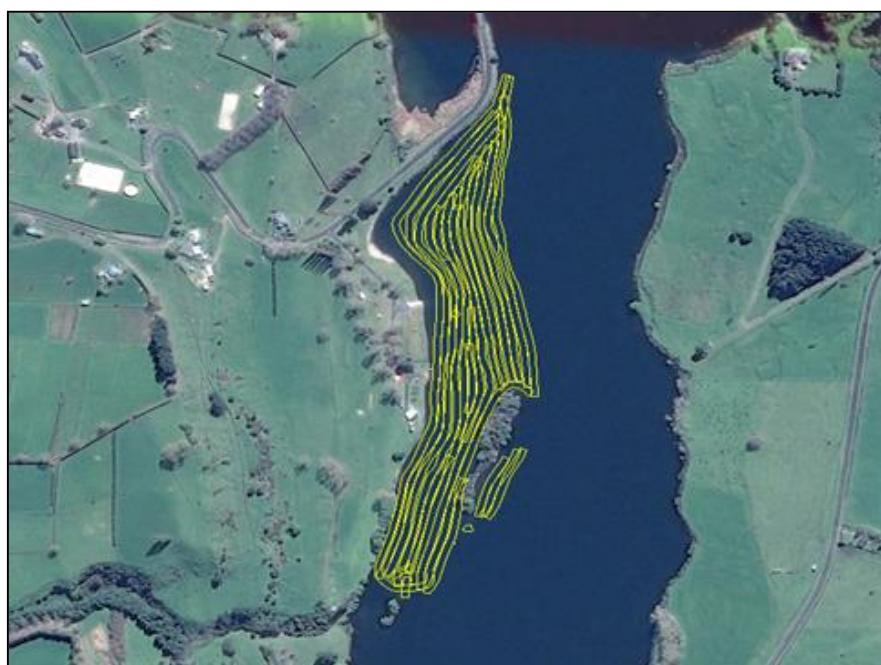
Slide 6

Technology developments like GPS provide better targeting, tracking and recording of the work done (**Slide 6**). Sonar developments now enable good records to be made.

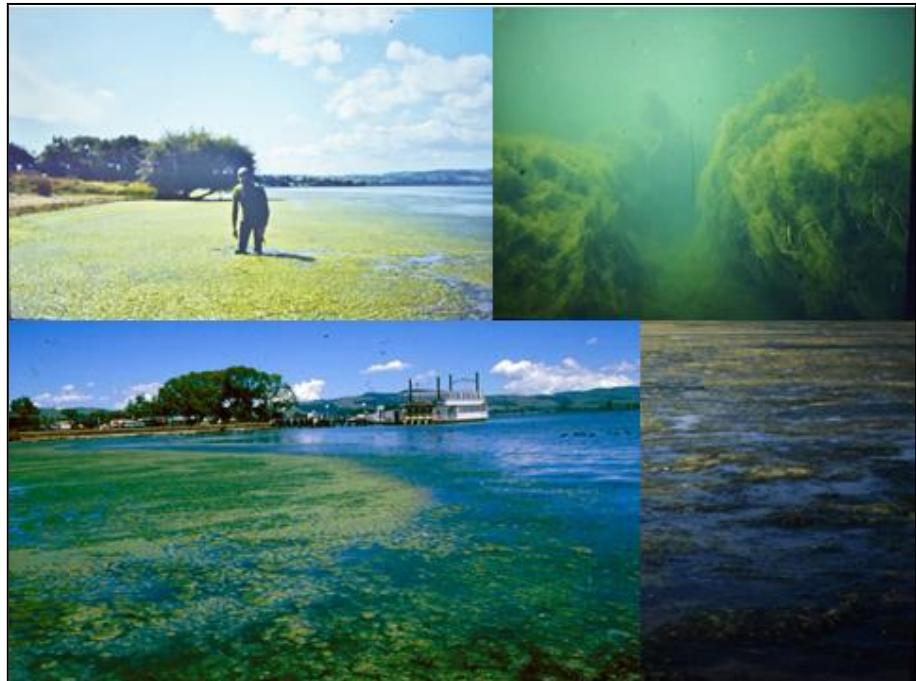
Slide 8

Considering water net again (**Slide 8**); NIWA was driven to look at all sorts of ways of overcoming this problem. Copper based algicides seemed to be the only effective control. But copper accumulates because it does not break down. The answer for Lake Rotorua proved to be habitat manipulation. After investigating the habitat of the water net, we

found that it was growing on the egeria. Egeria was targeted with diquat and once the water net had lost its habitat, and with no protection from water movement, it was dissipated very rapidly. Then the big harvester for the Lakeland Queen was no longer required!

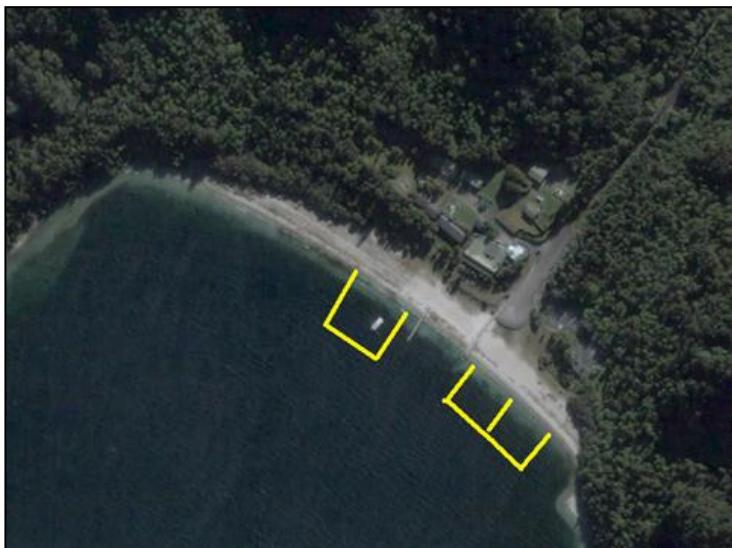
At Lake Okataina (left) we prepared plots on the waterfront for comparison of alternative control measures; a diquat treated plot, a suction dredged plot and a harvested plot cut to the sediment level. We compared the vegetation post treatment and also looked at invertebrates. Native species ended up dominating in all treatments. Invertebrate abundance levels compared with the controls were less, however the same species were present in all three test

plots but more were in the herbicide treated plot than in the suction dredged and cut plots.

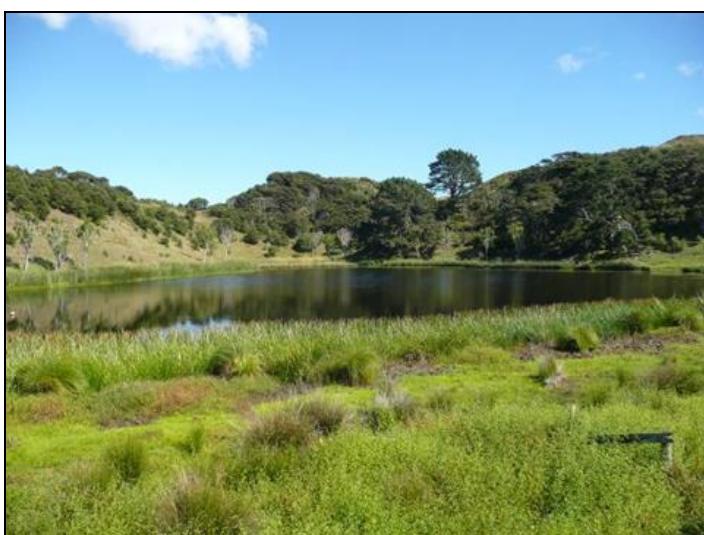
One treatment in Lake Phoebe (right) killed a dense lagarosiphon band; it is now 2½ years since the treatment and it is now an all native vegetation lake. Auckland Council is looking at eradication of about 16 sites on South Kaipara Head so more information about its use will become available in the future.

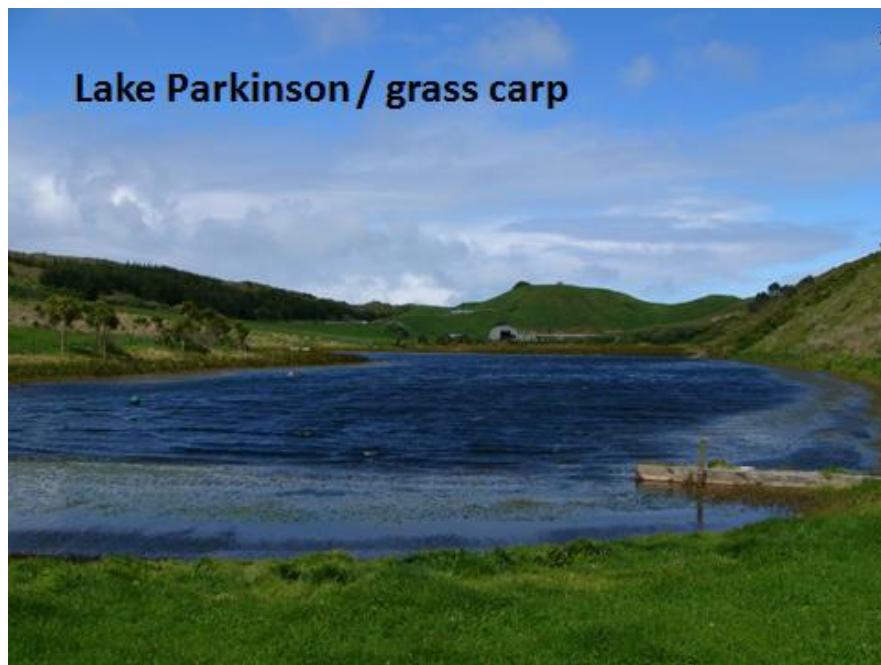
Slide 11

Northland is using grass carp strategically, for hornwort and egeria. They have been put in Lake Swan (which had hornwort and egeria) as it was a threat to very high value lakes in the immediate vicinity **Slide 11**.

Lake Parkinson / grass carp

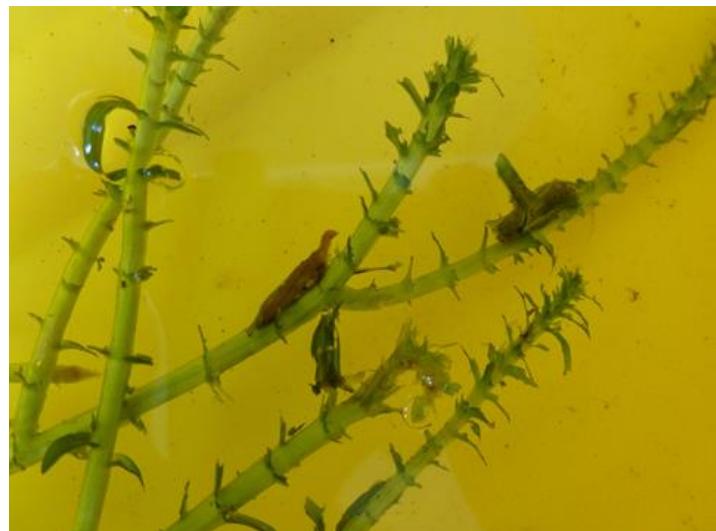
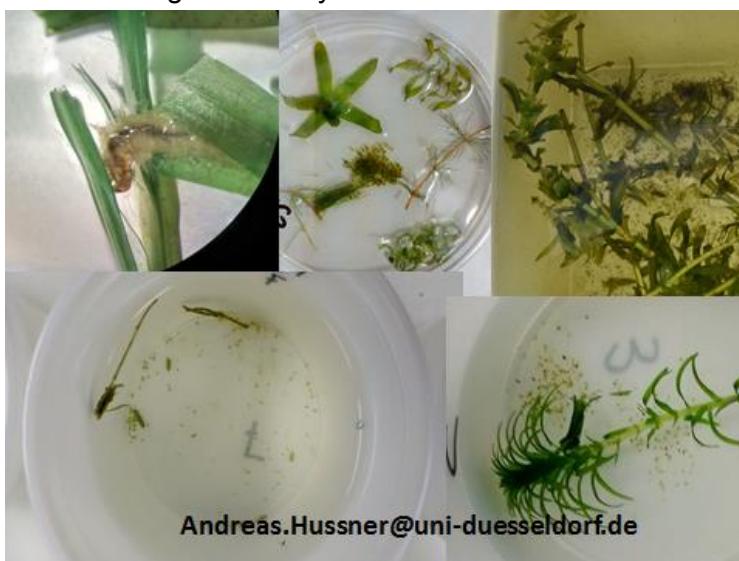
Choice feeding experiments showed that it found egeria and hydrilla very acceptable (below). But hornwort was the preferred species and the consumption rates were up to 4 times body weight per day. This is a revelation, we have an insect bio-control agent already in New
