**RISK ANALYSIS ASSOCIATED WITH  
FLANK FAILURE FROM  
PUTAUAKI, BAY OF PLENTY,  
NEW ZEALAND**

**Master of Science in Earth Science**

**The University of Waikato**

University of Waikato  
2007

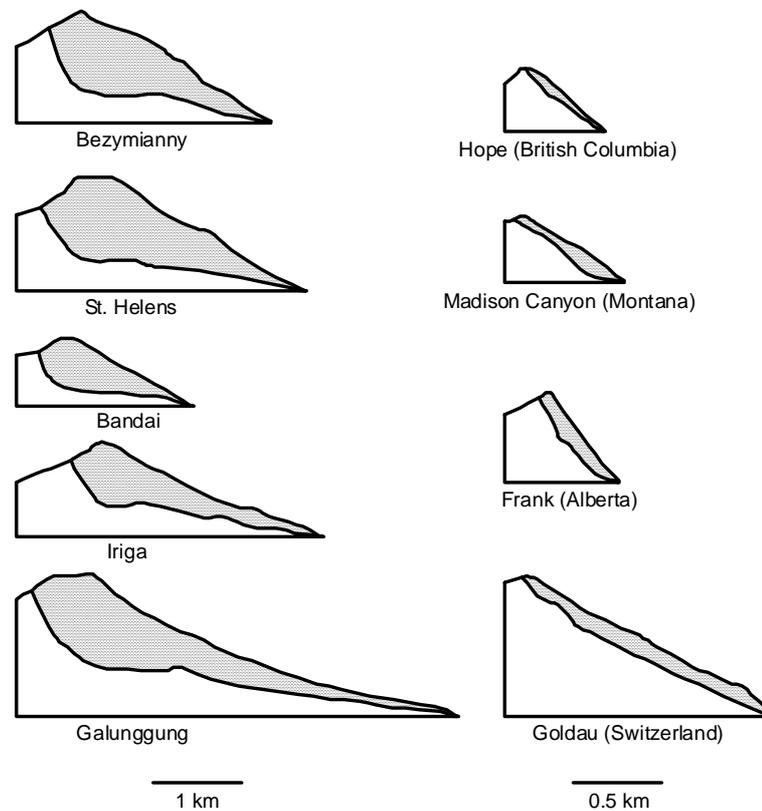
Figure 2.1 – Cross-sections of volcanic landslides (left column) as compared to non-volcanic landslides (right column, drawn at 2x scale). Shaded portion indicates volume removed by slope failure. Vertical scale equals horizontal scale. Adapted from Siebert (1999)

The failure surfaces of volcanic landslides are typically more deeply seated than their non-volcanic counterparts and not as influenced by stratigraphic dip slopes (Figure. 2.1). Their greater depth may be attributed in part to the presence of large amounts of weakly indurated pyroclastic and altered material (Reid *et al.* 2000; Siebert 2002). Smaller-volume volcanic landslides without associated eruptions, for example Yasour Volcano, southwest Pacific, 1975, tend to form shallow depressions on the flanks of volcanoes. This is in contrast to the large amphitheatres of large volume volcanic landslides which often extend into the core of the volcano and contain the central vent (Siebert 1984).

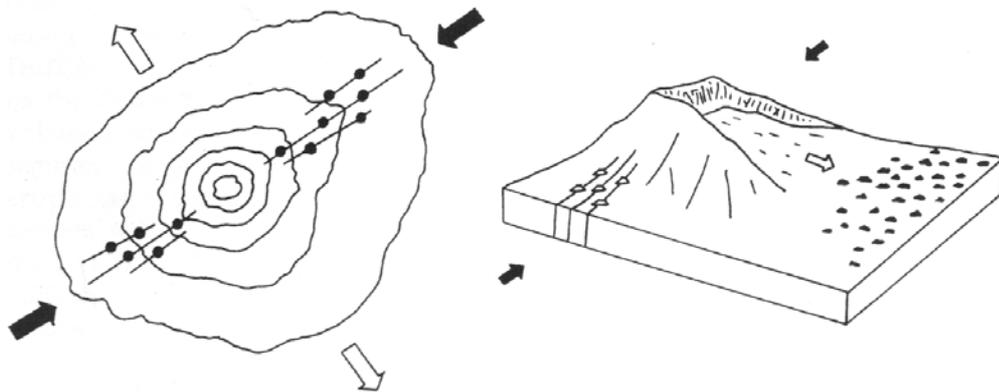
Figure 2.2 – Schematic illustrating the direction of proposed dilational stresses associated with the intrusion of dykes within the volcano edifice. It is thought that intruding dykes promote collapse in a direction perpendicular to that of intrusion orientation. Black arrows indicate orientation of dyke intrusion. White arrows indicate likely direction of collapse. Adapted from Siebert (1984).

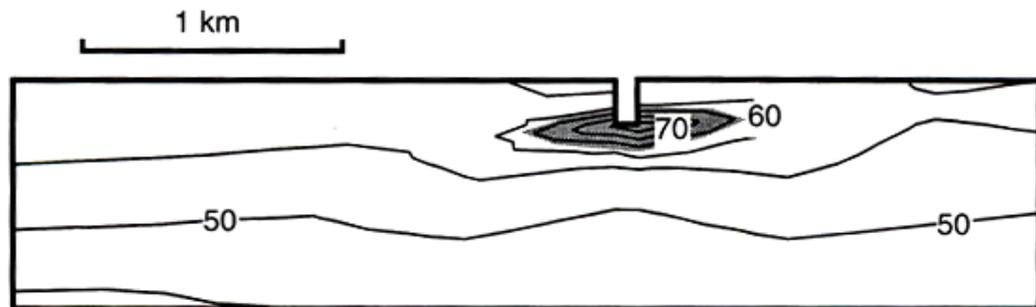
Figure 2.3 – Schematic illustrating shear stress distribution in relation to morphological changes on the volcano flanks. The image above shows how shear stresses increase near the base of the canyon where the highest values are located. Values in MPa. Sourced from Hürlimann *et al.* (2002).

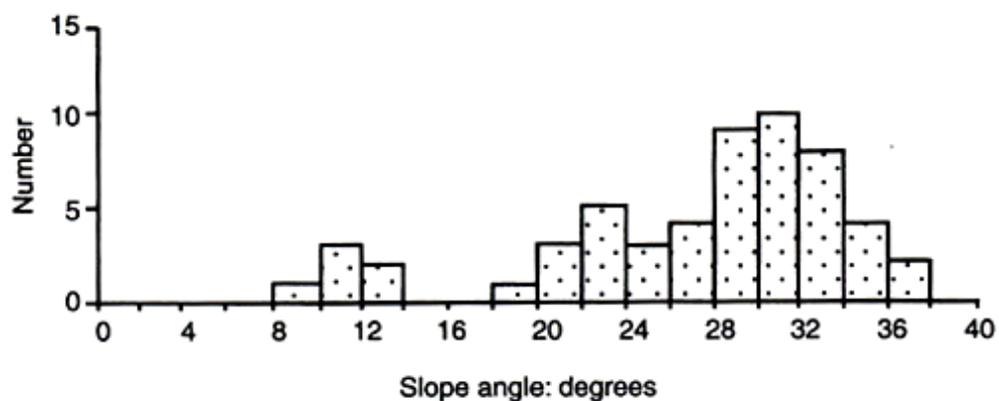
Figure 2.4 – Slope angle of Quaternary volcanoes that have undergone major slope failure ( $n = 55$ ). Sourced from Siebert (1999).

Slope angle also contributes to failure at volcanoes, more so on steep flanked stratovolcanoes than low-angle shield volcanoes. Figure 2.4 shows a possible correlation between slope angle and the frequency of major slope failure for Quaternary volcanoes which have undergone major slope failure. Landslides appear most likely on slope angles between 20 – 36°.

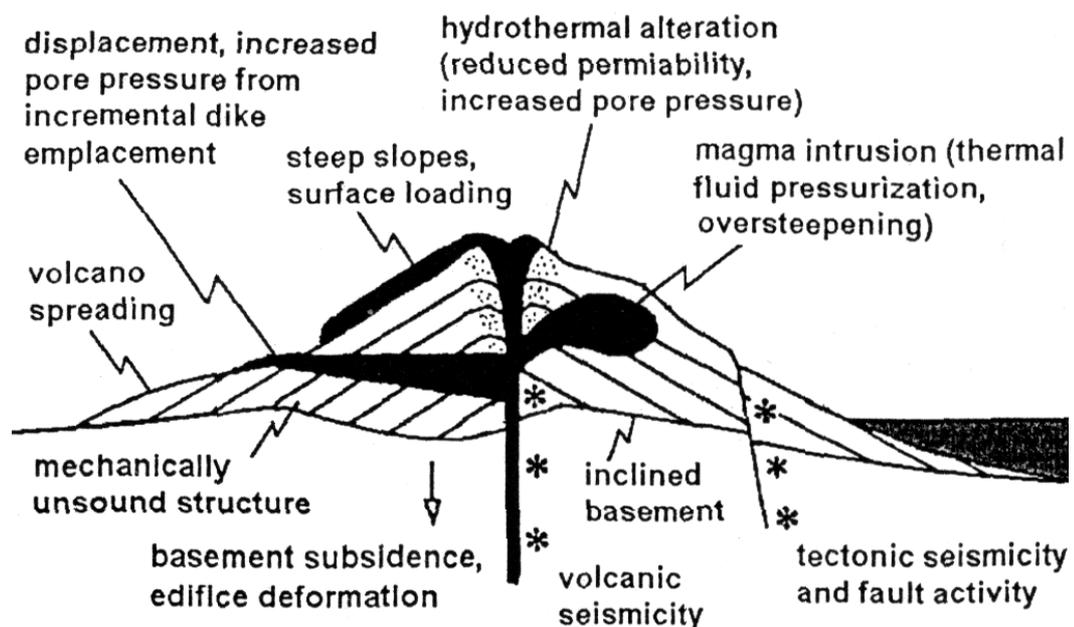
Figure 2.5 – Factors contributing to the inherent instability of volcanoes. Sourced from Siebert (2002).

It is highly likely that the inherent instability of volcanoes is attributable to a combination of events or circumstances rather than any single process (Figure 2.5). While a final factor may ‘trigger’ a volcanic landslide, it is never the sole cause. Magmatic intrusions at Bezymianny Volcano, Kamchatka in 1956 and Mount St Helens, Washington in 1980 produced major deformation (Voight *et al.* 1983; Siebert 2002), while earthquakes precipitated edifice failure (Siebert 2002). Active hydrothermal and magmatic systems both had an influence on the collapse of Nevado de Colima, Mexico (Stoopes & Sheridan 1992). Voight & Elsworth (1997) concluded that intense, variably-oriented jointing, and hydrothermal alteration is particularly significant in reducing shear strength of volcanic slopes. However, it is the superposition of subsequent factors, such as pore water pressure enhancement, that cause this gradually weakened material to fail. The large population of volcanoes meeting slope angle criteria, for example, that have not to this point undergone failure, suggests that a triggering mechanism is required to initiate failure (Siebert 1996).

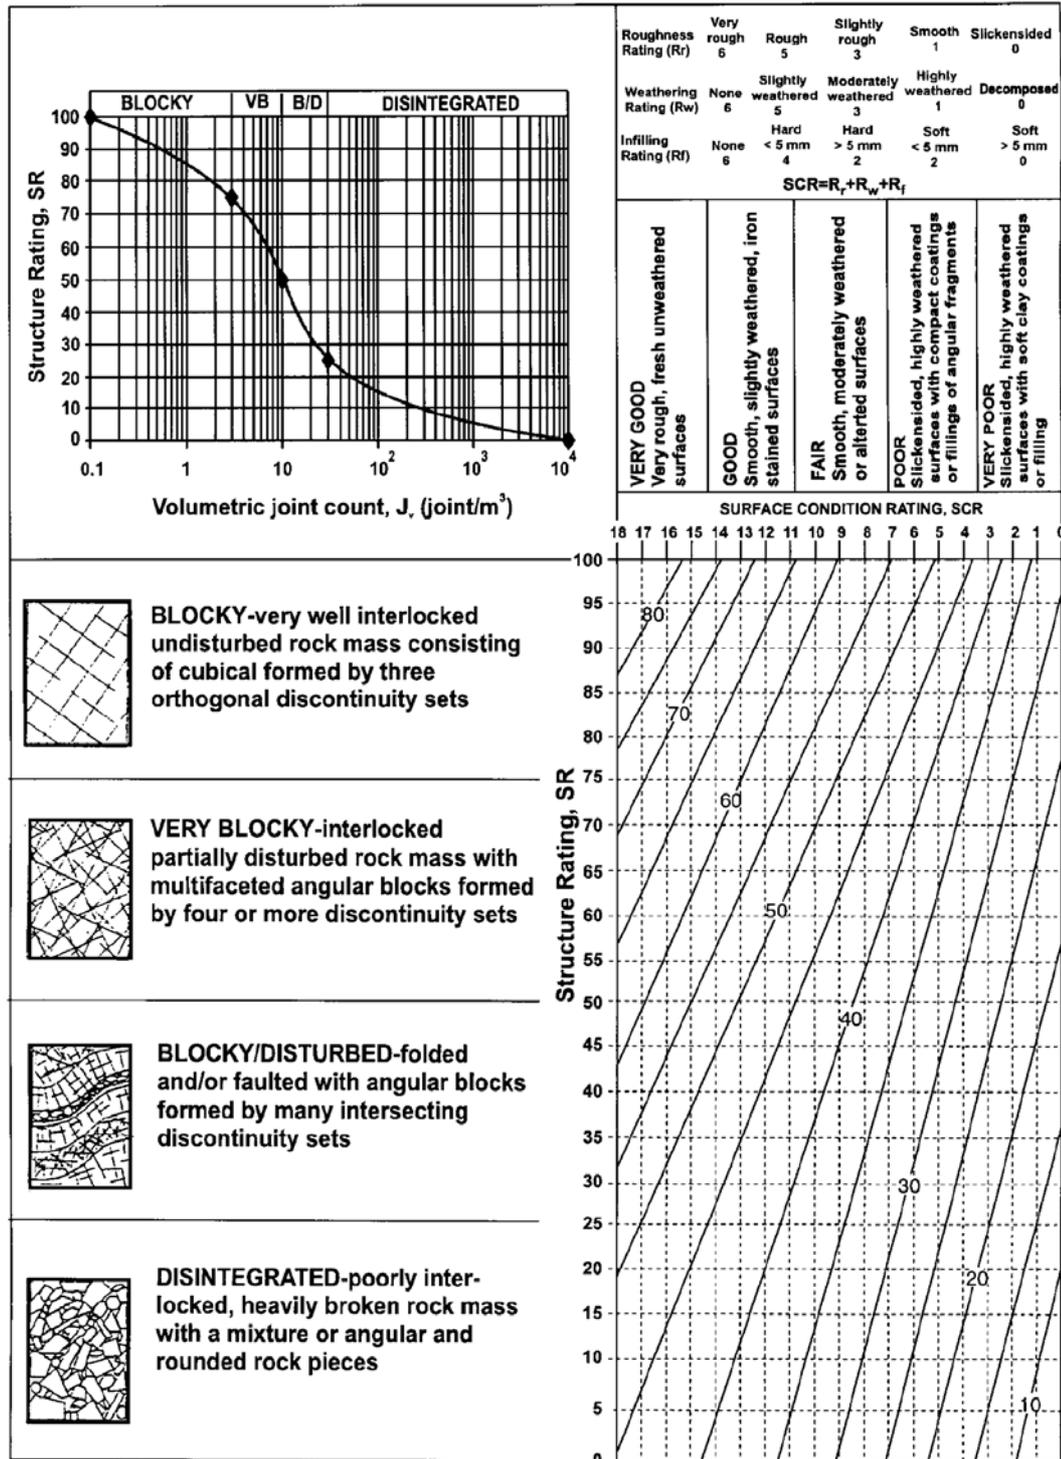
Figure 2.7 – The modified GSI classification scheme. Sourced from Sonmez & Ulusay (1999).

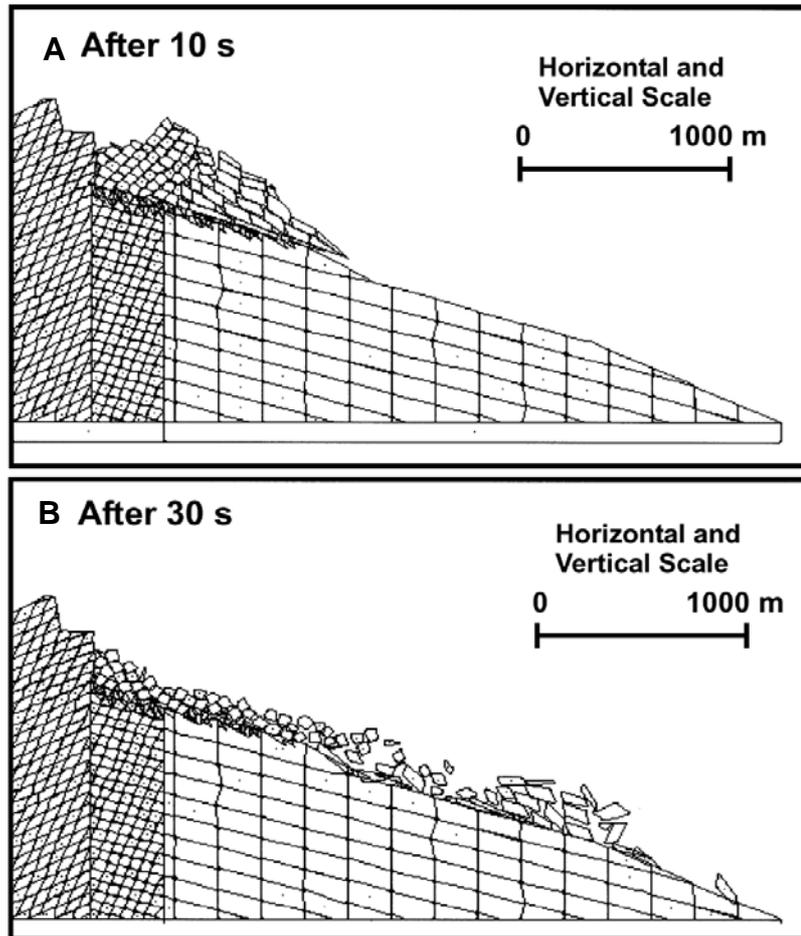
Figure 2.8 – Modelled failure of a volcanic cone using a two dimensional distinct element model. (A) At 10 seconds after failure initiation; and (B) at 30 seconds after failure initiation, intact block begins to disaggregate into smaller pieces. Shaded regions indicate differing lithologies. Sourced from Zimbelman *et al.*(2004)

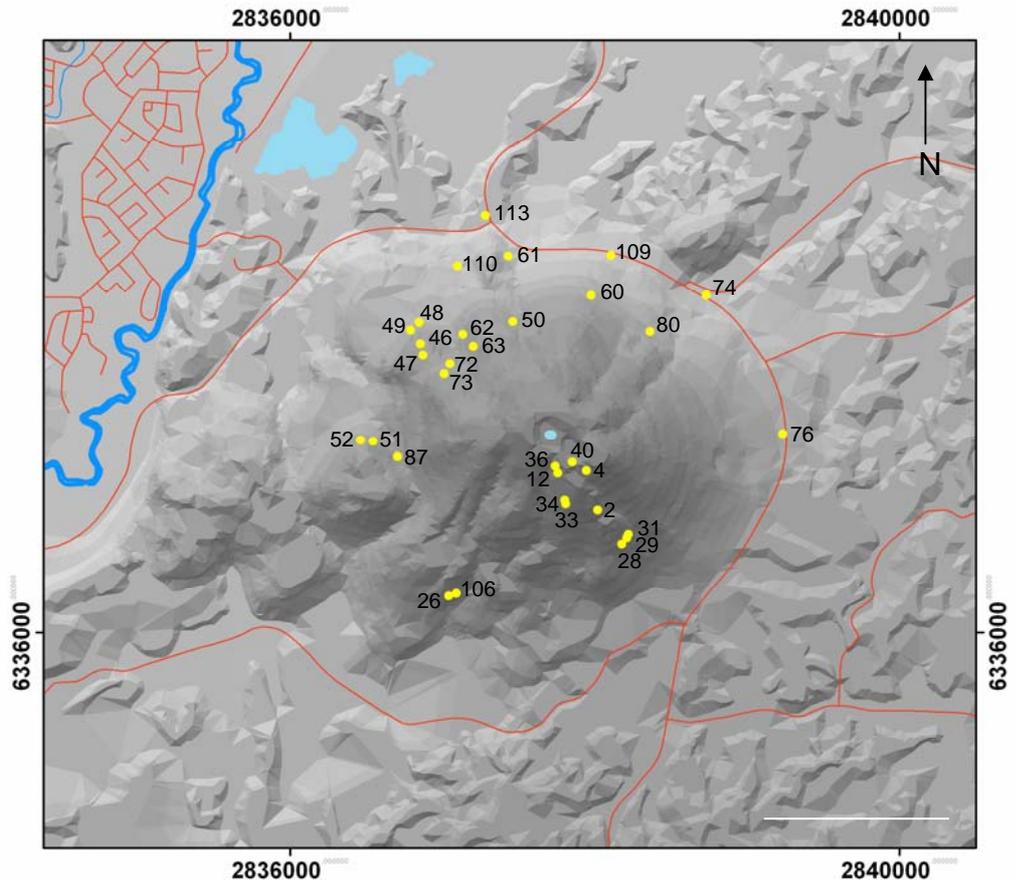
Figure 3.1 – DEM indicating location of rock mass strength measurements (yellow markers). Numbers indicate site numbers. White bar represents 1 km.

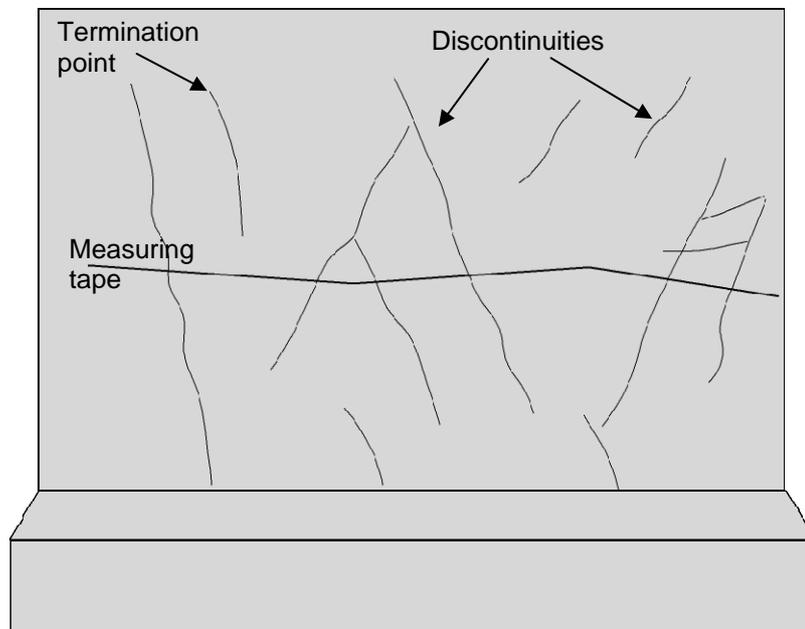
Figure 3.2 – Schematic diagram of a scanline survey. Adapted from Brady & Brown (2004)

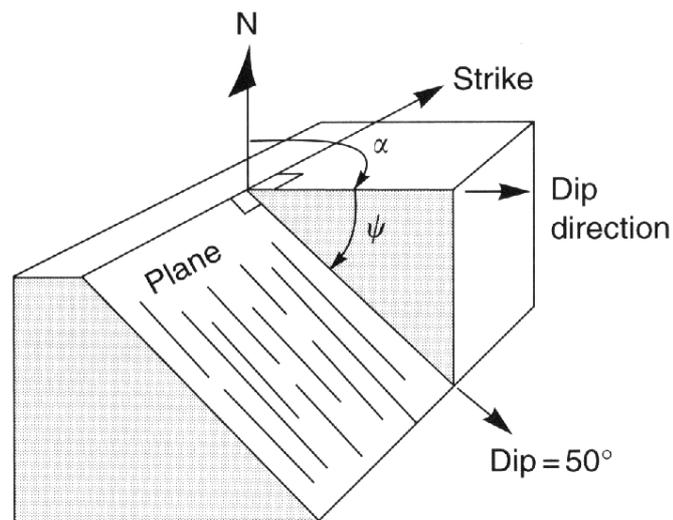
Figure 3.3 – Schematic illustrating dip and dip direction of a discontinuity. Discontinuity dip is defined as the maximum inclination of a discontinuity to the horizontal in degrees. Dip direction is defined as the direction of the horizontal trace of the line of dip measured clockwise from north. Sourced from Wyllie & Mah (2004)

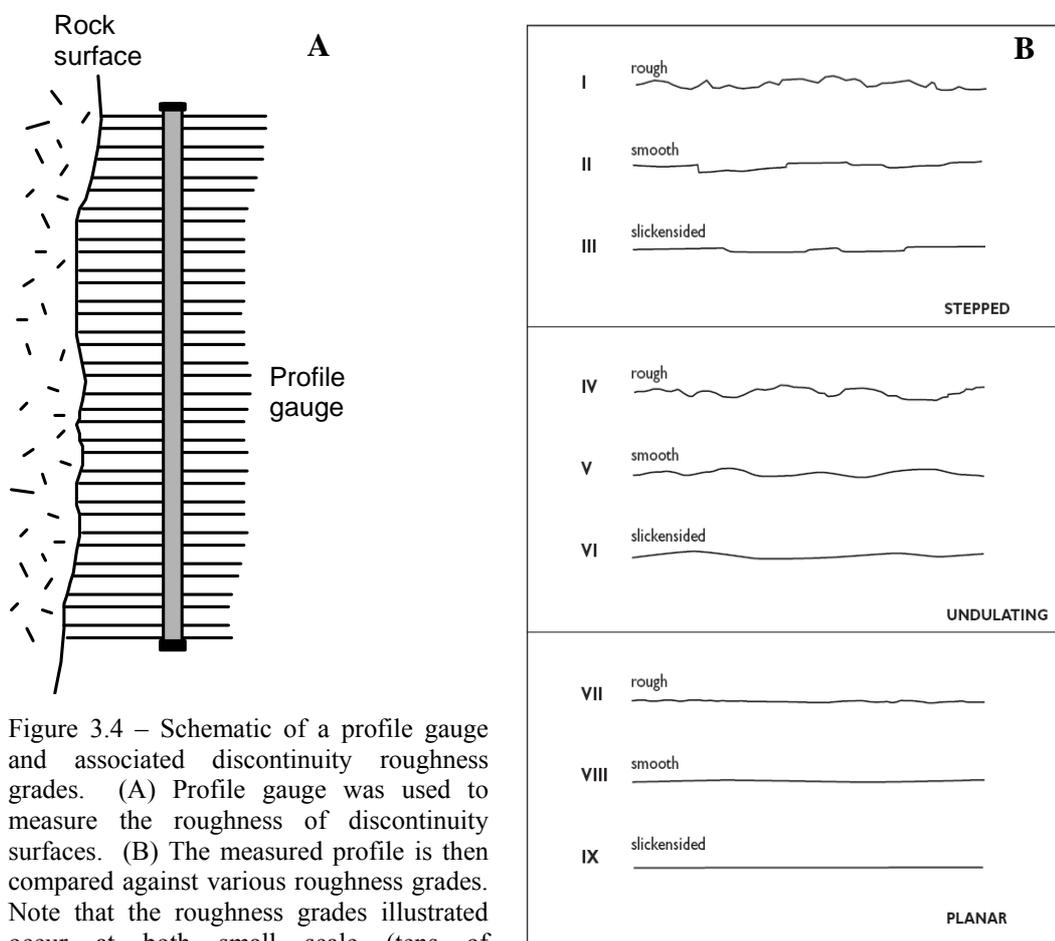
Figure 3.4 – Schematic of a profile gauge and associated discontinuity roughness grades. (A) Profile gauge was used to measure the roughness of discontinuity surfaces. (B) The measured profile is then compared against various roughness grades. Note that the roughness grades illustrated occur at both small scale (tens of millimetres) and large scale (several metres). Adapted from Bradshaw (2004).

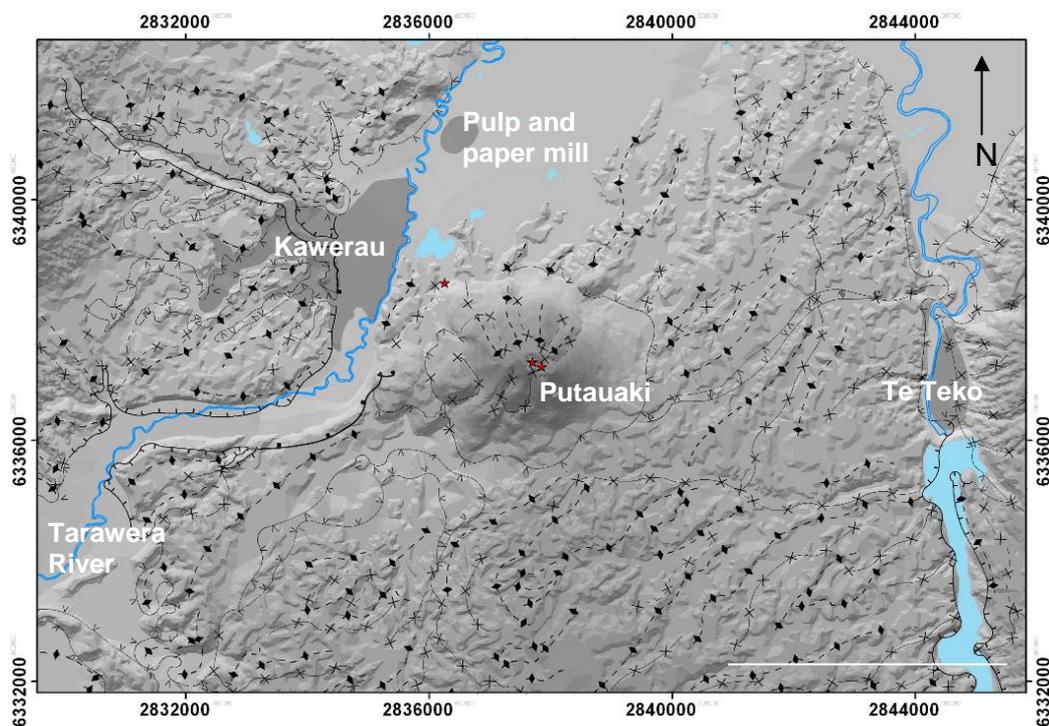
Figure 4.1 – Major geomorphological features of Putauaki and the surrounding landscape. Also shown are the Tarawera River, the townships of Kawerau and Te Teko, and the pulp and paper mill. White line represents 4 km. Geomorphological symbols from Cooke & Doornkamp (1990).

In plan view, Putauaki is a roughly circular feature (Figure 4.1), its circumference measuring approximately 10 km. Its volume has been reported as being approximately 1.61 km<sup>3</sup> (Duncan 1970). Putauaki consists of two primary features including Main Dome (approximately 6 ka) and Main Cone (approximately 4 ka) (Nairn 1995) (Figure 4.2). The summit of Main Cone is a prominent feature standing approximately 820 m a.s.l., thus protruding some 740 m above the surrounding landscape. Main Cone displays an average slope angle of 36° nearer to its summit, which lessens to approximately 32° closer to the base of the cone (Figure 4.2). According to Siebert (1984), both these angles coincide well with the average slope angles of volcanoes which have undergone major

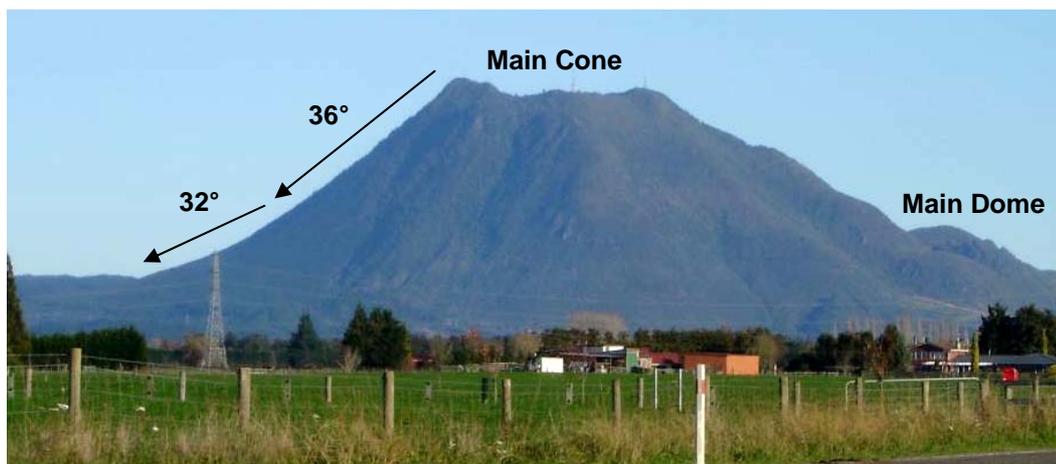
Figure 4.2 – Putauaki viewed from the north-west. Putauaki is a prominent feature on an otherwise subdued landscape. Arrows represent slope angles of Main Cone. The flanks of Putauaki show little evidence of significant erosion. The irregular topography of rounded ridges and poorly developed valleys attest to the young age of Putauaki. Note the non-dissected draped appearance of the eastern (left in figure) flank. A step-like morphology is apparent on the western (right in figure) flank. The summit of Main Dome can be seen in the background behind the western flank.

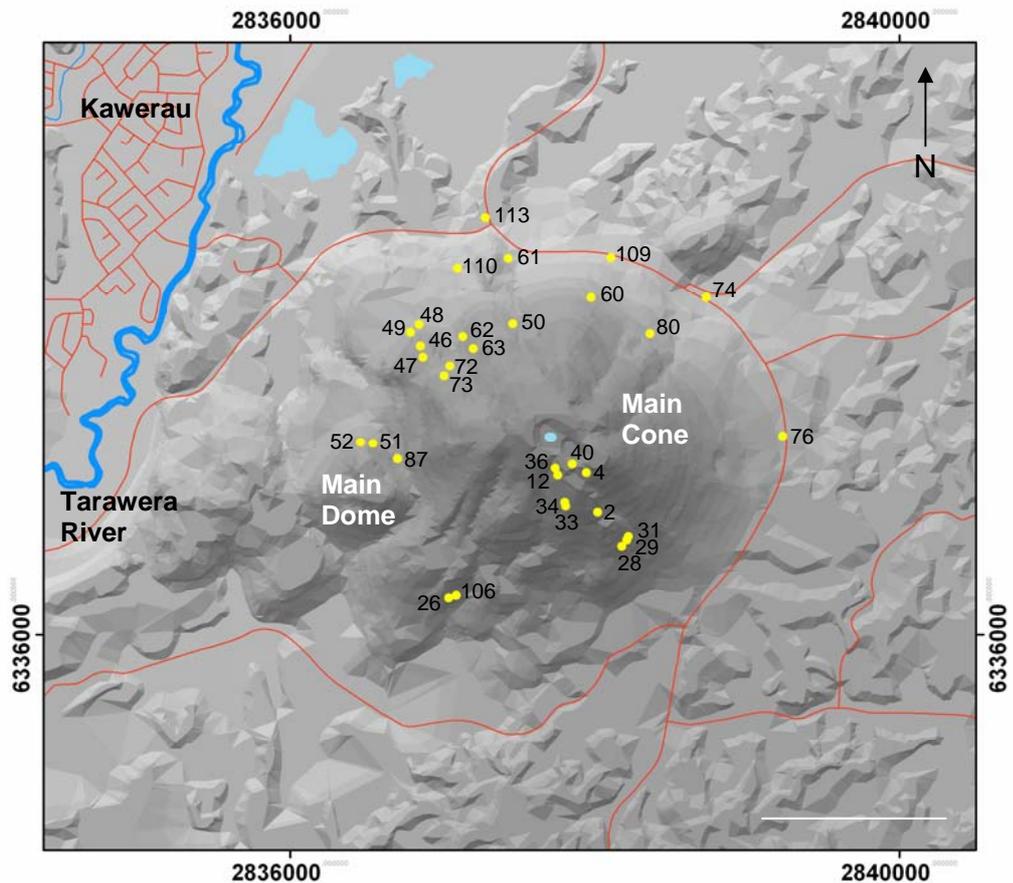
Figure 4.3 – DEM showing location of rock mass description sites (yellow markers). Numbers indicate site numbers. White bar represents 1 km.

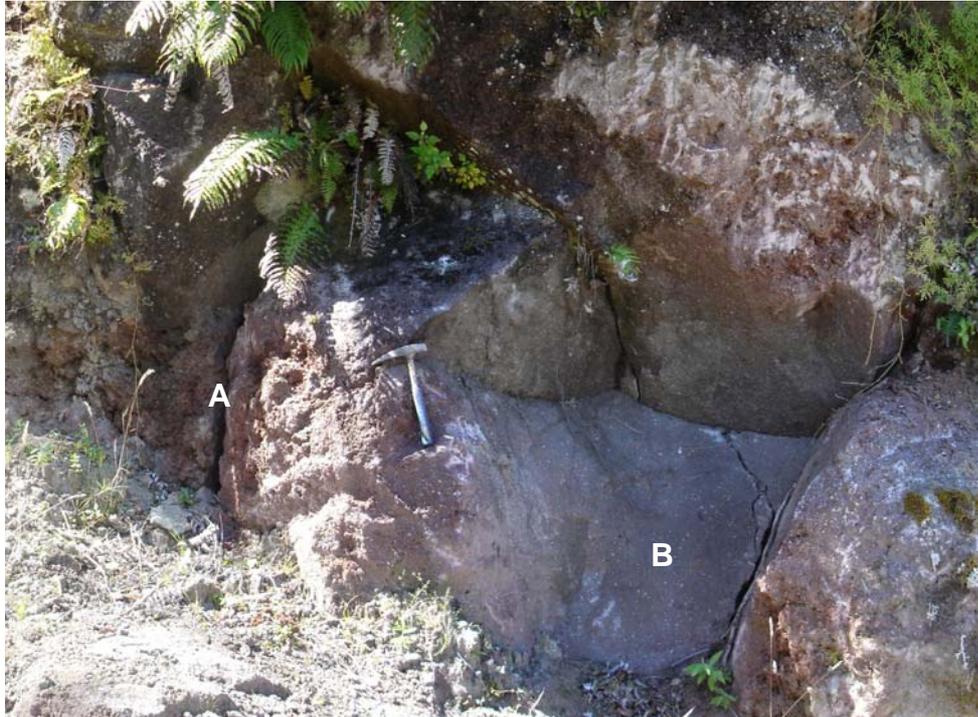
Figure 4.5 – Indurated andesite outcrop exhibiting a scoriaceous surface structure (indicated by ‘A’) that is absent deeper within the rock mass. In the above a figure a loose block has dislodged (indicated by ‘B’) exposing the non-scoriaceous interior of this rock mass. The pinkish tinge of this unit is presumed to be the result of oxidation. Photo taken at site 34. Geological hammer for scale.

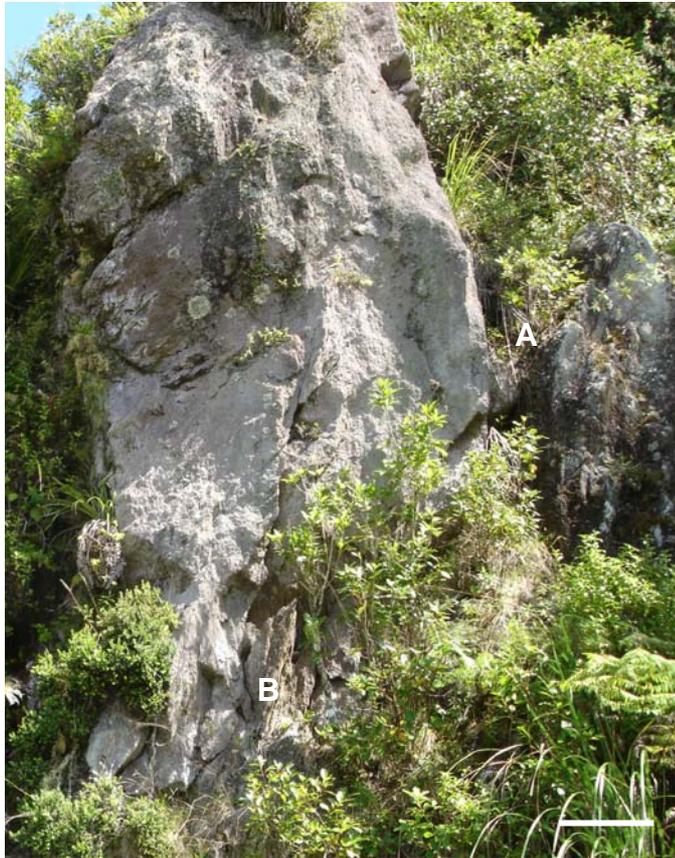
Figure 4.6 – Indurated andesite outcrop exhibiting wide discontinuity spacing. The relaxed state of the discontinuities produces some extremely wide apertures as seen in the upper right of the figure where shrubbery is growing within the discontinuity (indicated by ‘A’). Note the slaty habit of the indurated andesite displayed nearer the base of the outcrop (indicated by ‘B’). Photo taken at site 29. White bar represents 1 m.

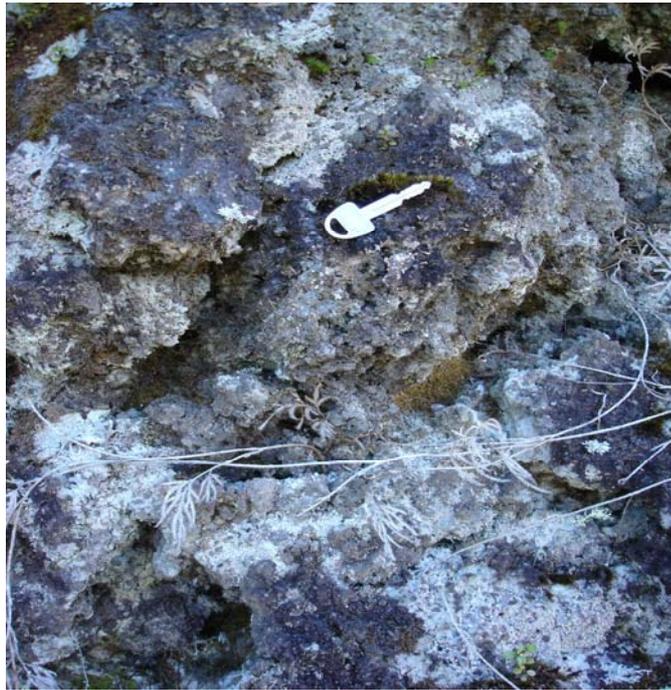
Figure 4.7 – Scoriaceous andesite outcrop exhibiting a scoriaceous texture. Photo taken at site 2. Key for scale.

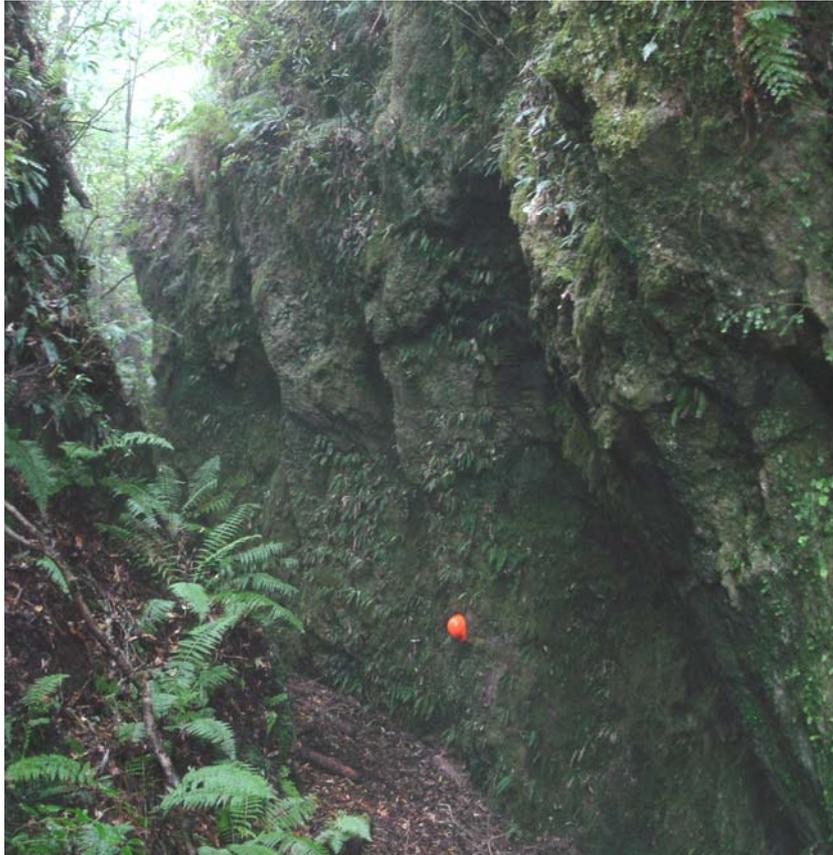
Figure 4.8 – Discontinuity sets in the scoriaceous andesite. Major discontinuity sets are very apparent; however, the sub-canopy location and associated blankets of moss-like vegetation mean a clean view of minor discontinuities is difficult. Note the canyon-like location of the outcrop. Photo taken at site 33. Safety helmet for scale.

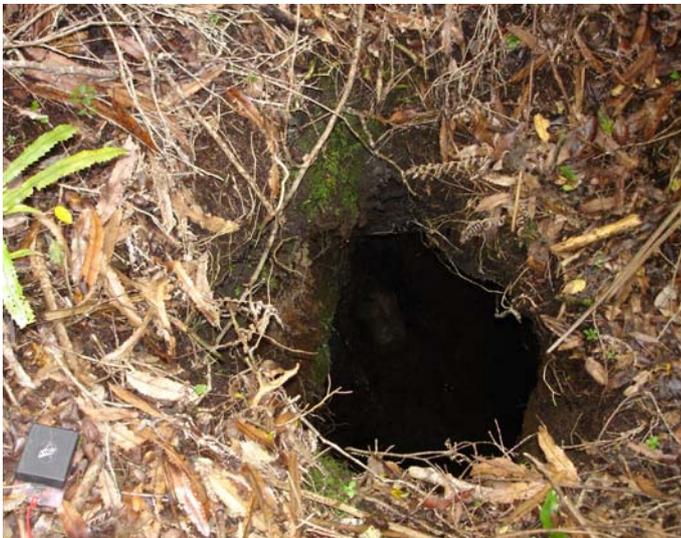
Figure 4.9 – A tomo in the scoriaceous andesite. These cavities are a common feature of the scoriaceous andesite, thought to represent internal collapse of voids within the rock mass. Forest detritus commonly obstructs the full extent of these cavities. Photo taken at site 2. Silva compass for scale.

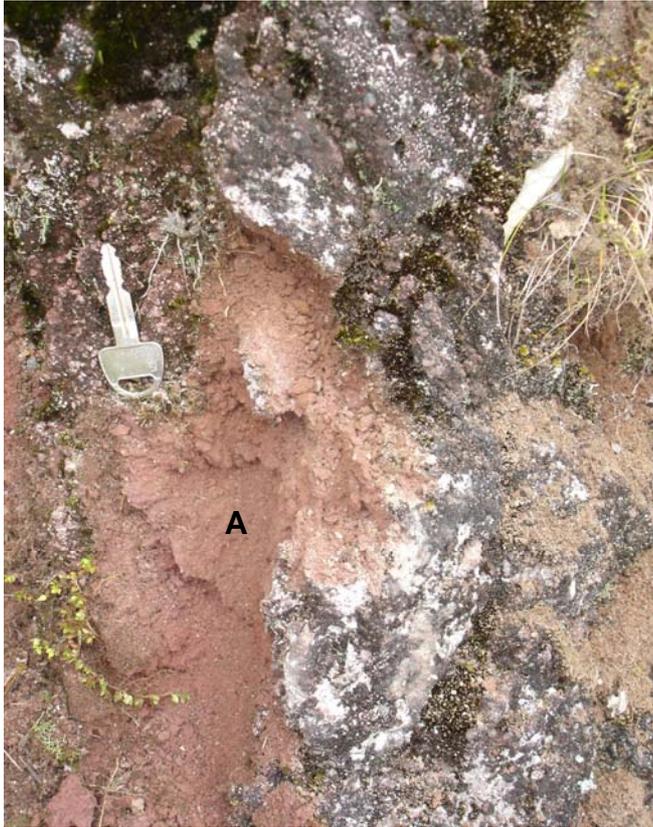
Figure 4.10 – Altered andesite outcrop exhibiting a readily disaggregated nature. The nature of this lithotechnical unit is evidence of its weak field strength. Weathered surfaces of the altered andesite appear grey, while freshly exposed surfaces appear reddish (as indicated by ‘A’). Photo taken at site 40. Key for scale.

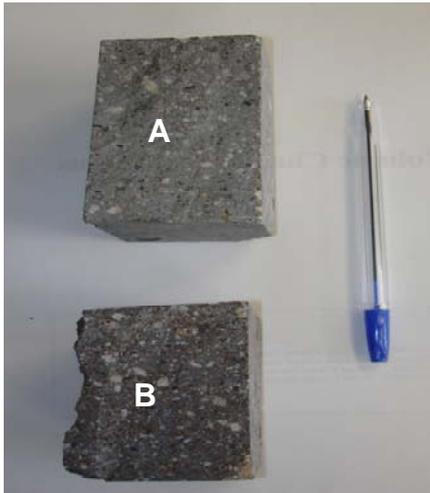
Figure 4.11 – (A) Light grey colour characteristic of the indurated dacite. (B) A sample of indurated andesite which exhibits a much darker colour. The relatively light colour of the indurated dacite aids field identification of this unit. Pen for scale.

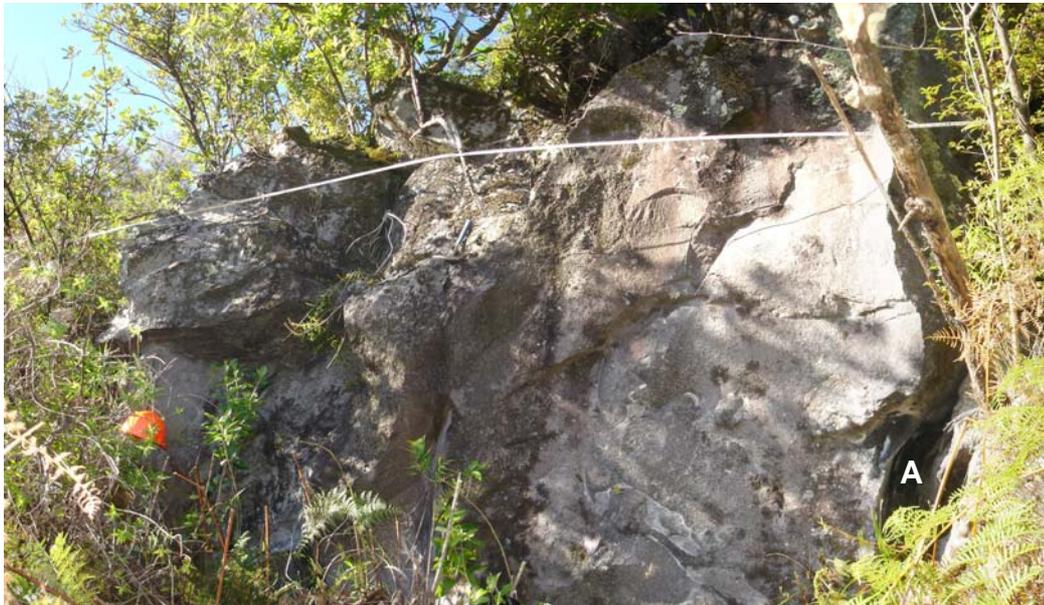
Figure 4.12 – Indurated dacite outcrop exhibiting very wide discontinuity apertures (as shown by ‘A’ in the lower right of the above figure). Photo taken at site 52. Safety helmet for scale.

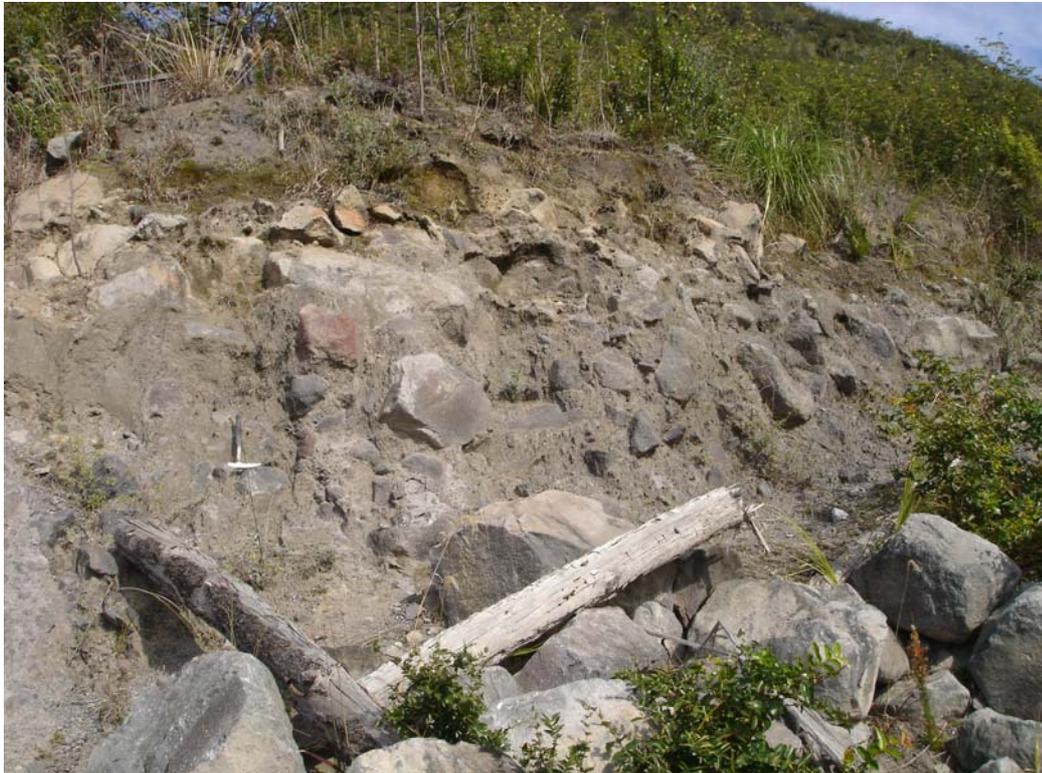
Figure 4.13 – Block and ash flow deposit. The block and ash flow is very poorly sorted containing constituents ranging in size from fine sand to boulders. The deposit is loosely packed, fallen blocks regularly littering the bases of outcrops. Blocks appear matrix supported. Photo taken at site 109. Geological hammer for scale.

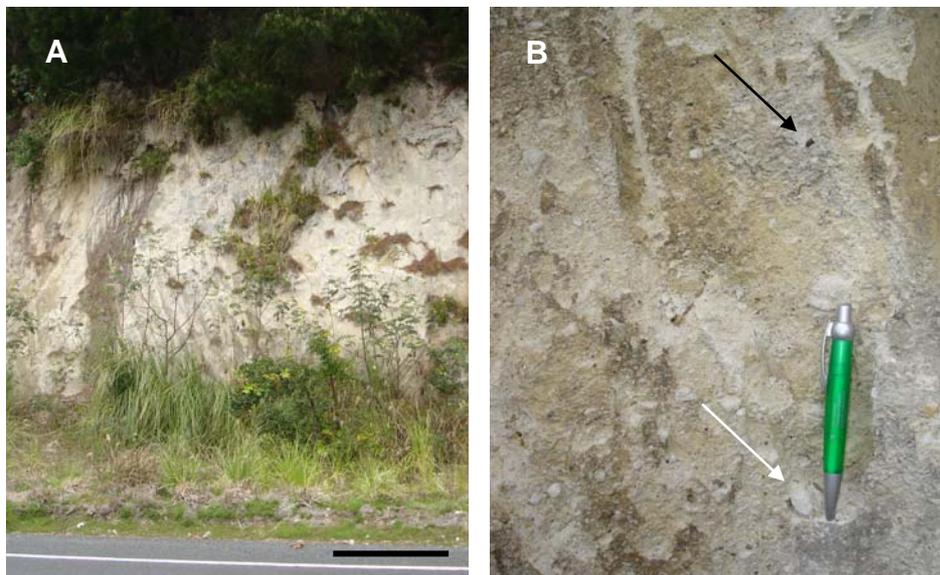
Figure 4.14 – (A) Matahina Ignimbrite outcrop. (B) Lithics (black arrow) and pumice clasts (white arrow) combined makeup approximately 20 % of the Matahina Ignimbrite. Black bar represents 2 m. Photo taken at site 113. Pen for scale.

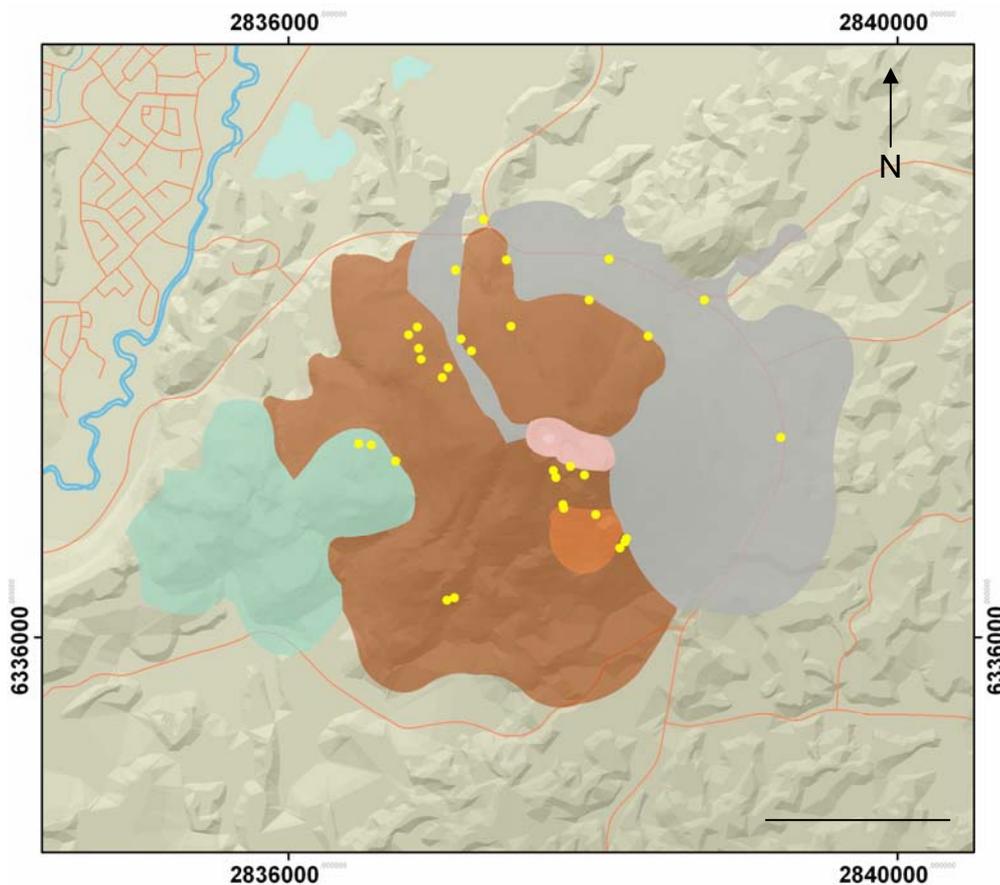
Figure 4.15 – DEM indicating location and approximate boundaries of each lithotechnical unit. Black line represents 1 km.

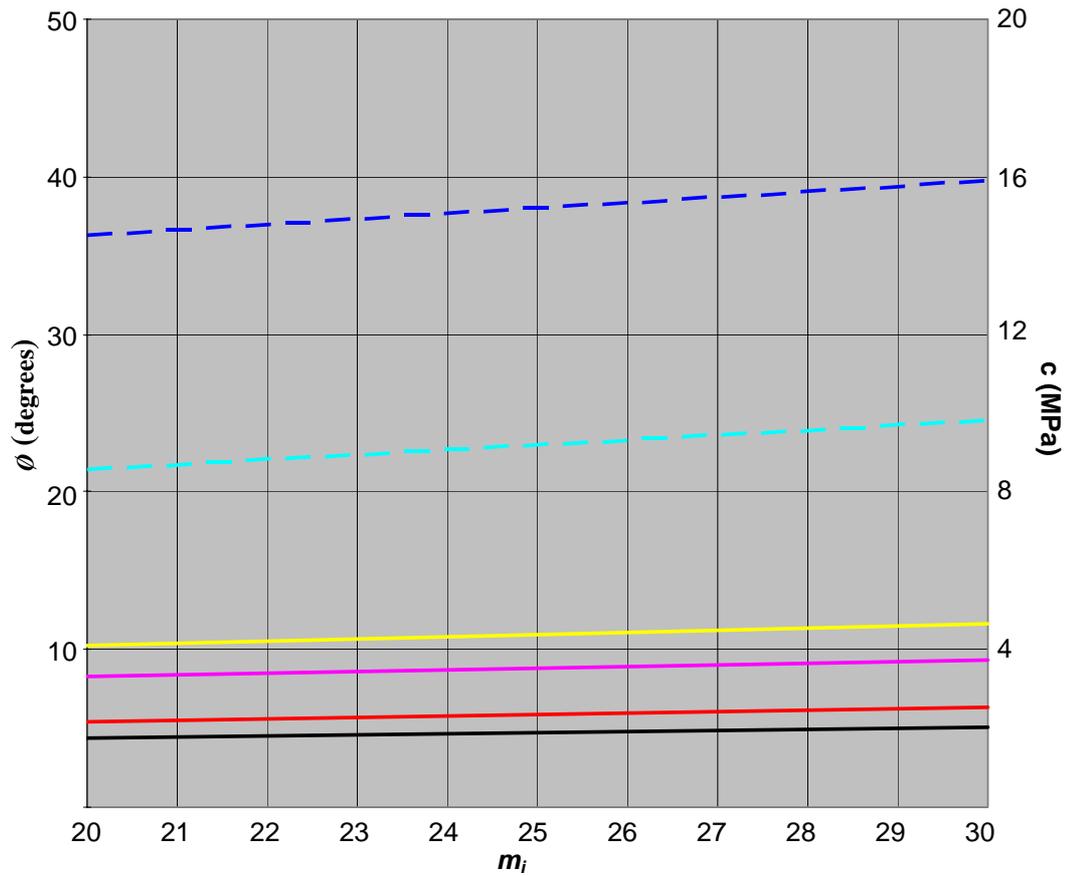
Figure 5.1 – Graph showing the effect of changing PLCN,  $m_i$  and D, on  $c$  (solid lines) and  $\phi$  (dashed lines) for indurated andesite. Lines A – H represent combinations of PLCN and D as indicated by their respective label. Refer Appendix O for the effects of changing PLCN,  $m_i$  and D, on  $c$  and  $\phi$  for all hard rocks.

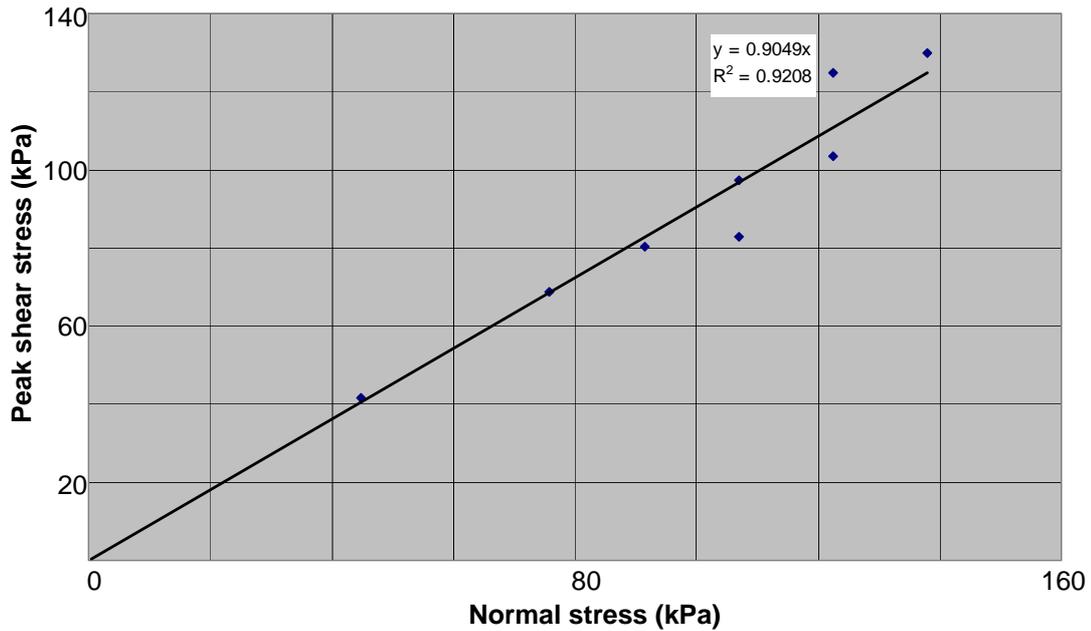
Figure 5.2 – Graph of peak shear stress versus normal stress for the block and ash flow. Refer Appendix P for complete direct shear data.

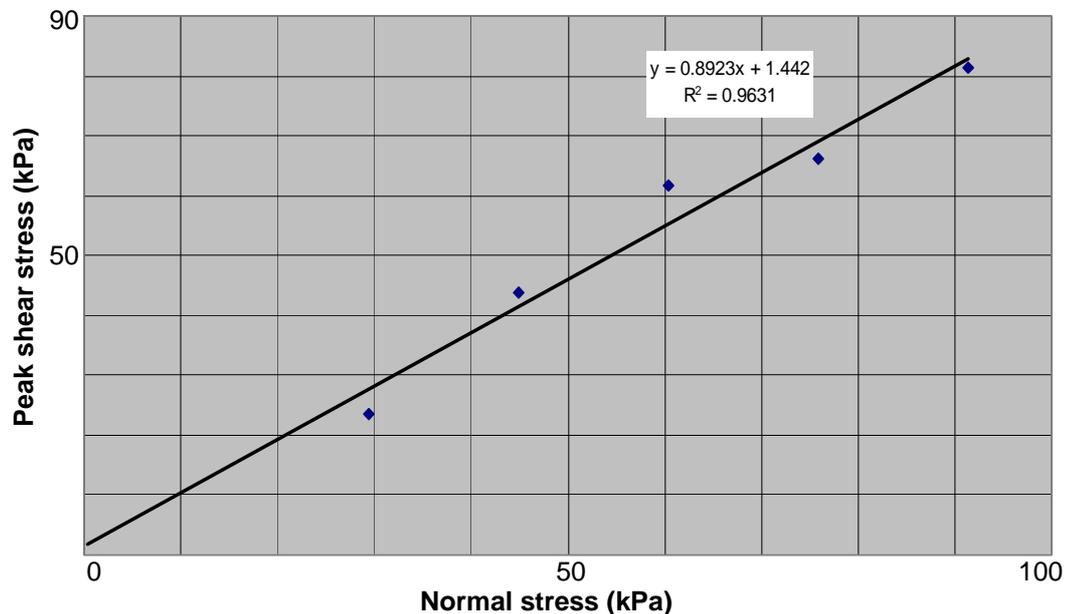
Figure 5.3 – Graph of peak shear stress versus normal stress for the Matahina Ignimbrite. Refer Appendix P for complete direct shear data.

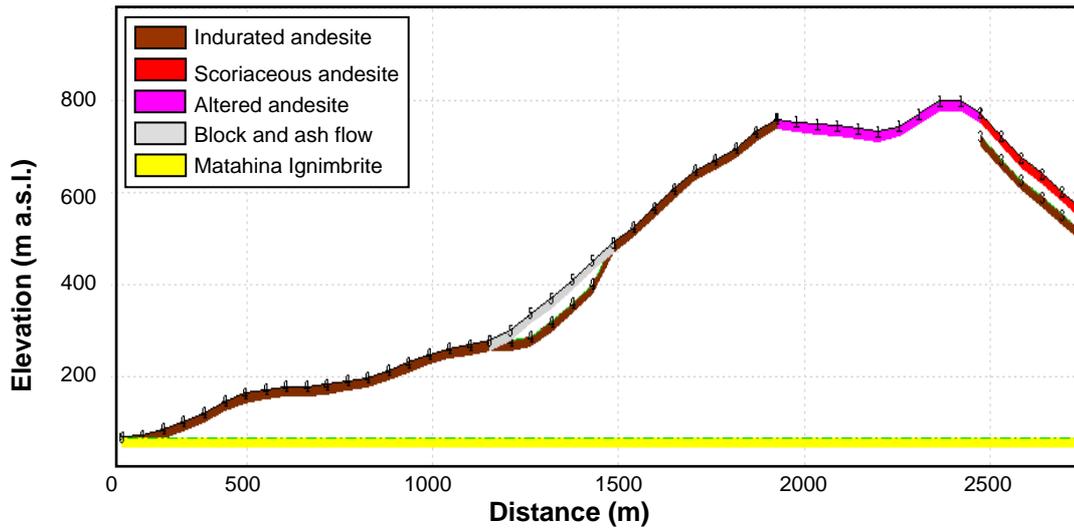
Figure 6.1 – Galena™ model of slope profile 4. The slope profile is constructed using a right handed x/y co-ordinate system allowing the slope surface to rise to the right. Material profiles are defined via lines made up of a series of x/y co-ordinate pairs; these lines represent the upper surface of the material profile. Galena™ recognises that the area below each line consists of the defined material for that line.

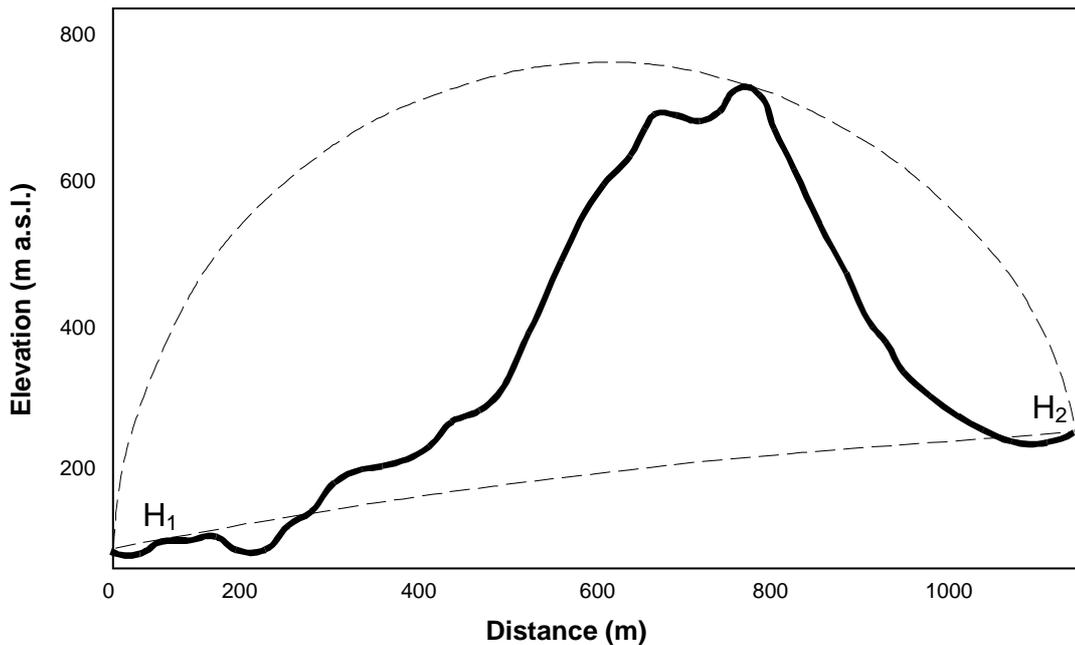
Figure 6.2 – Schematic illustrating the Dupuit approximation for estimating the form of an asymmetrical watertable. This version of the equation is applied to situations whereby the watertable elevation on either side of the profile is at different heights ( $H_1$  and  $H_2$ ). Upper and lower dashed lines represent watertable elevations of 100 % and 0 % respectively. Bold line represents profile of run-line 4 – 4a.
