**RISK ANALYSIS ASSOCIATED WITH  
FLANK FAILURE FROM  
PUTAUAKI, BAY OF PLENTY,  
NEW ZEALAND**

**Master of Science in Earth Science**

**The University of Waikato**

University of Waikato  
2007

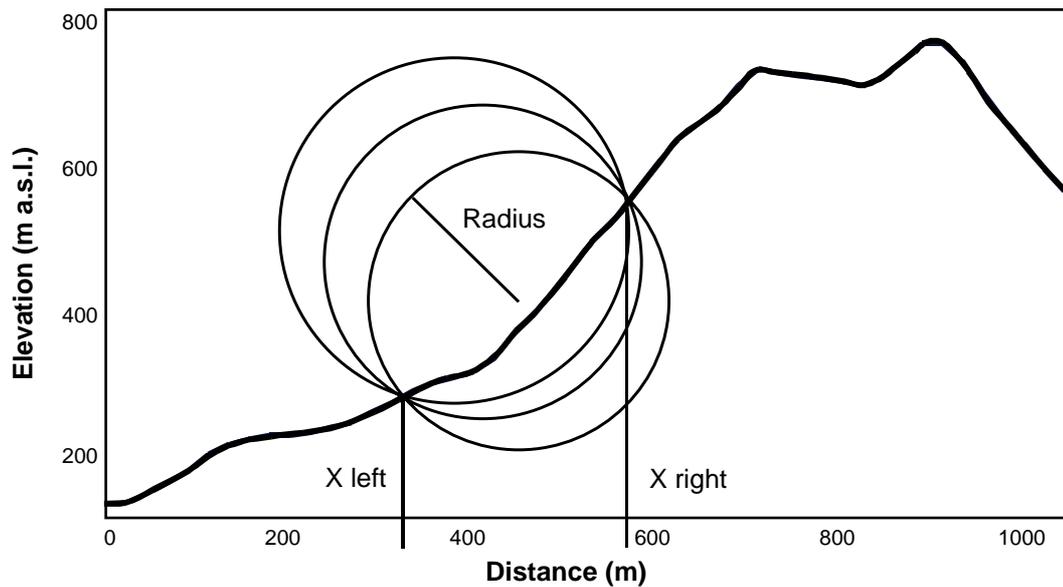
Figure 6.3 – Schematic illustrating how Galena™ models failure surfaces using x-left, x-right and radius parameters. This describes the x co-ordinate for the left and right intercepts of the failure surface with the slope surface, together with a radius. Shown are three different failure surfaces utilising the same x left and x-right co-ordinates. The radius is the differentiating factor. Bold line represents profile 4.

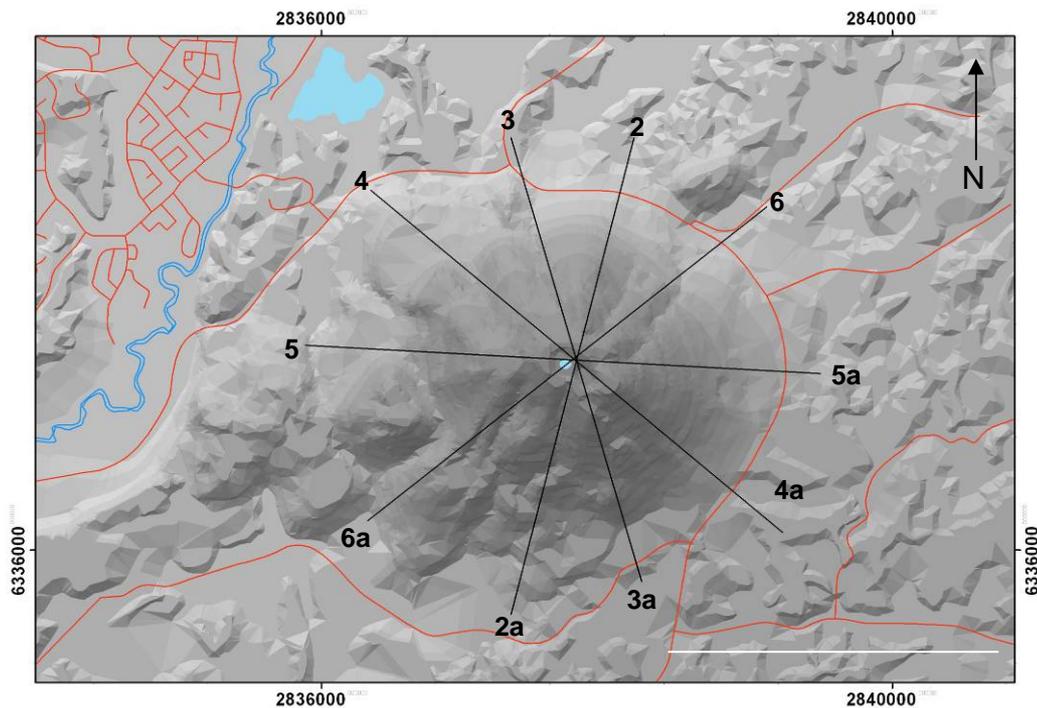
Figure 6.4 – DEM indicating location of run-lines. Numbers indicate run-line number. White line represents 2 km.

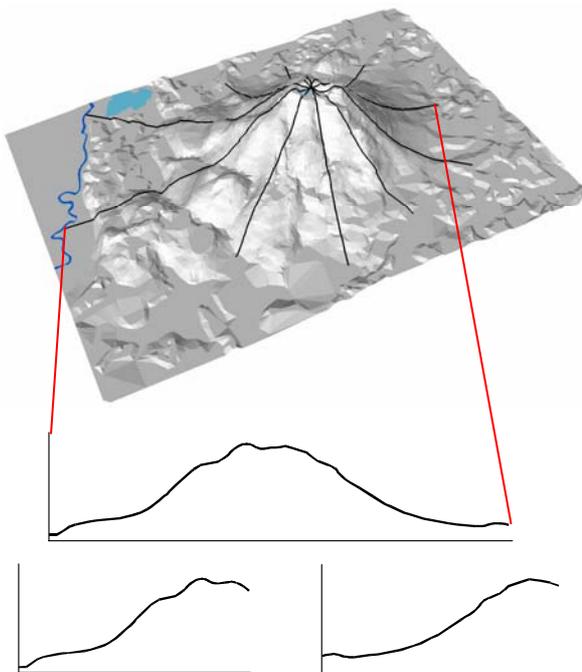
Figure 6.5 – Schematic illustrating the division of run-lines into slope profiles. Each run-line was divided in two producing a total of 10 slope profiles. This allows each slope profile to be modelled rising to the right in Galena™. Note that although only one run-line is shown as being divided in two, all five run-lines were divided. Slope profiles shown in figure pullout are those of run-line 5 – 5a.

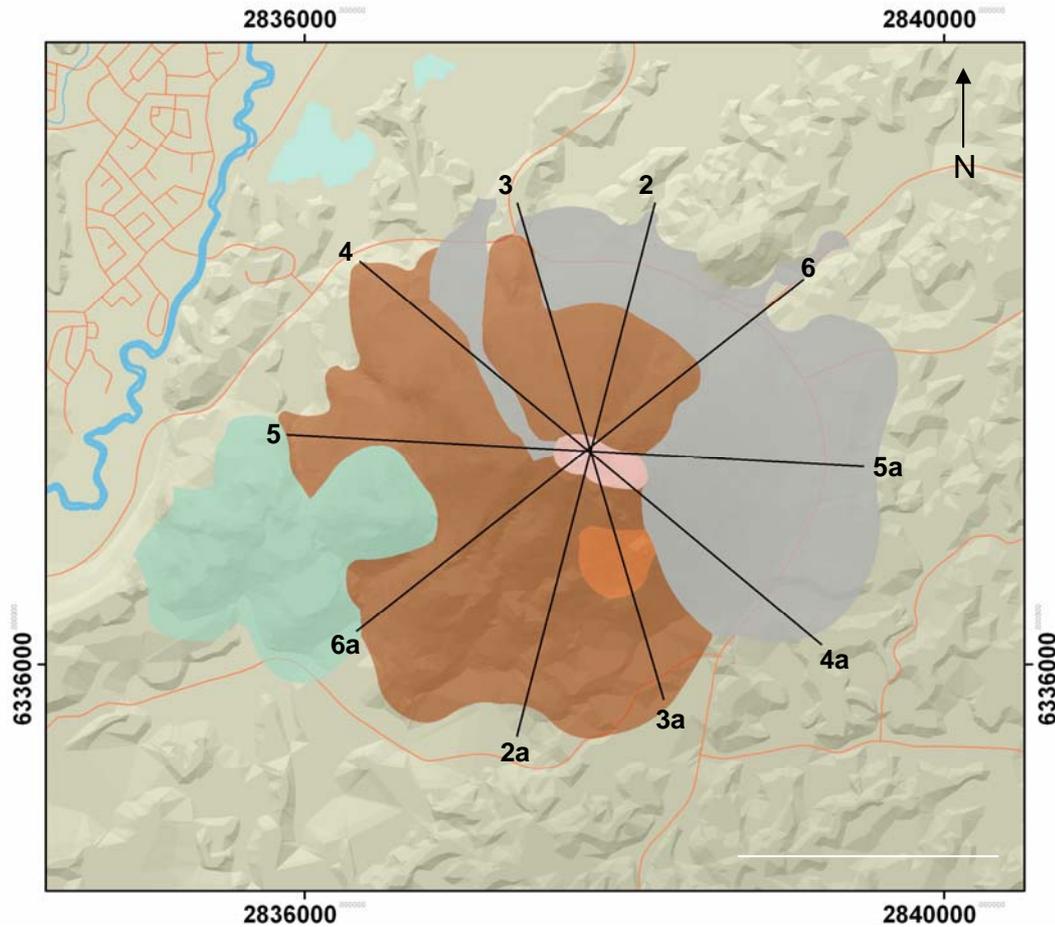
Figure 6.6 – DEM indicating location of run-lines relative to the boundaries of each lithotechnical unit. Boundaries of lithotechnical units are defined in Chapter 4. Numbers indicate run-line number. White line represents 2 km.

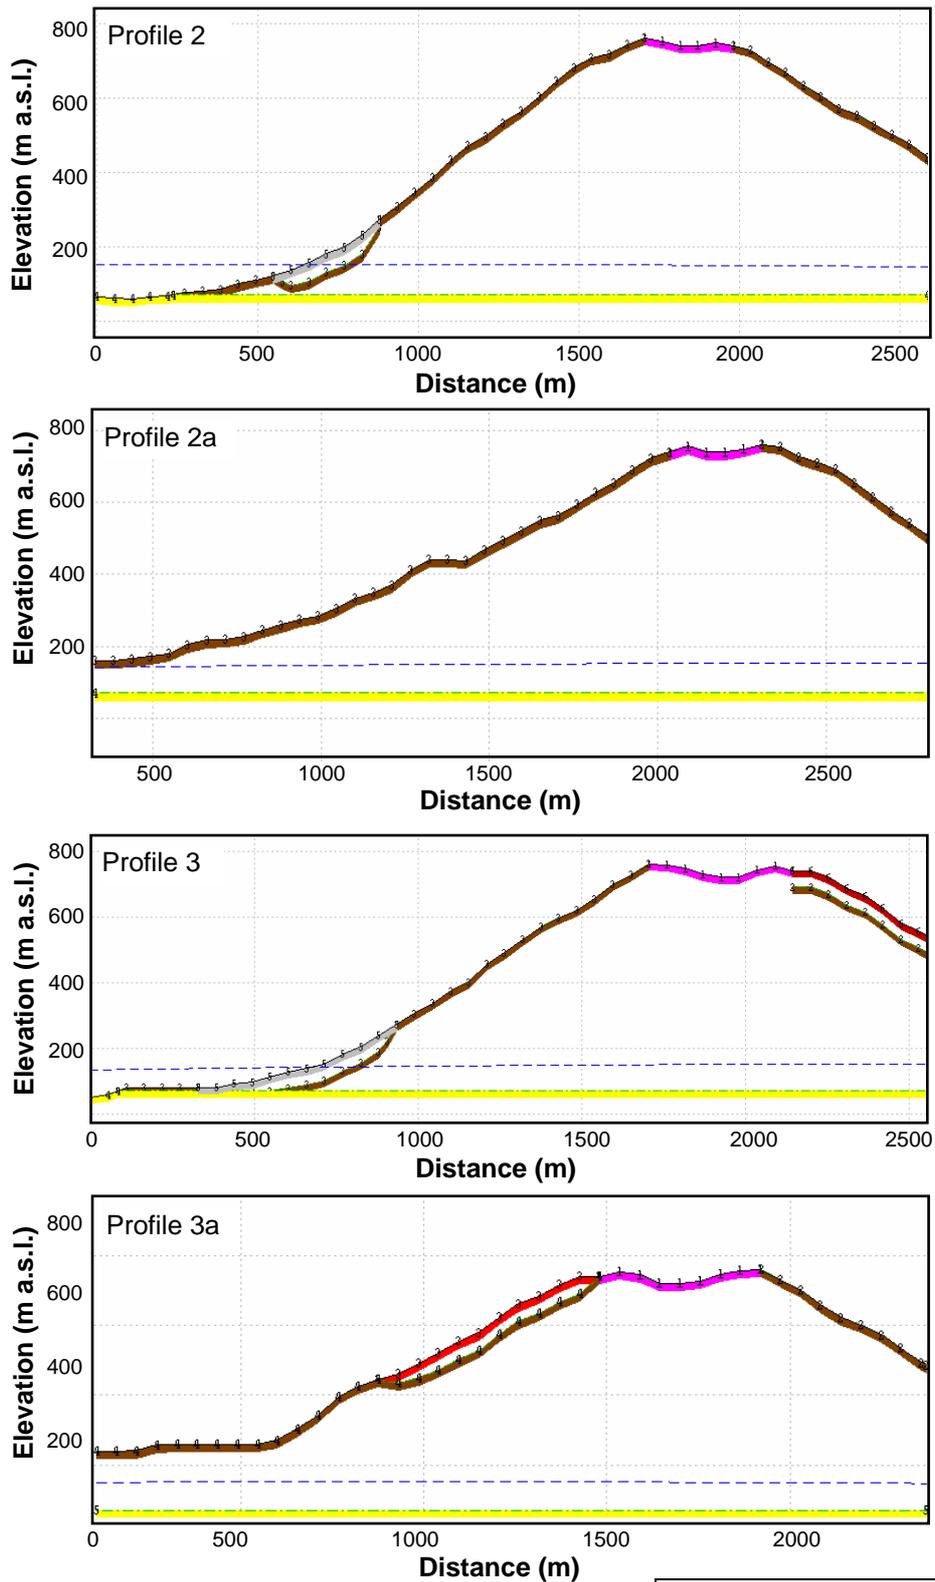
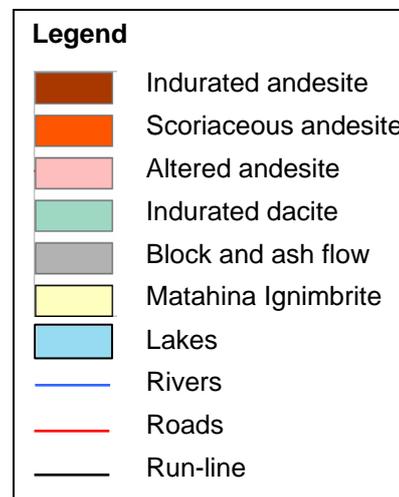
Figure 6.7a – Galena™ models of slope profiles 2, 2a, 3, and 3a showing subsurface stratigraphy. All slope profiles are shown with a watertable elevation of 20%.

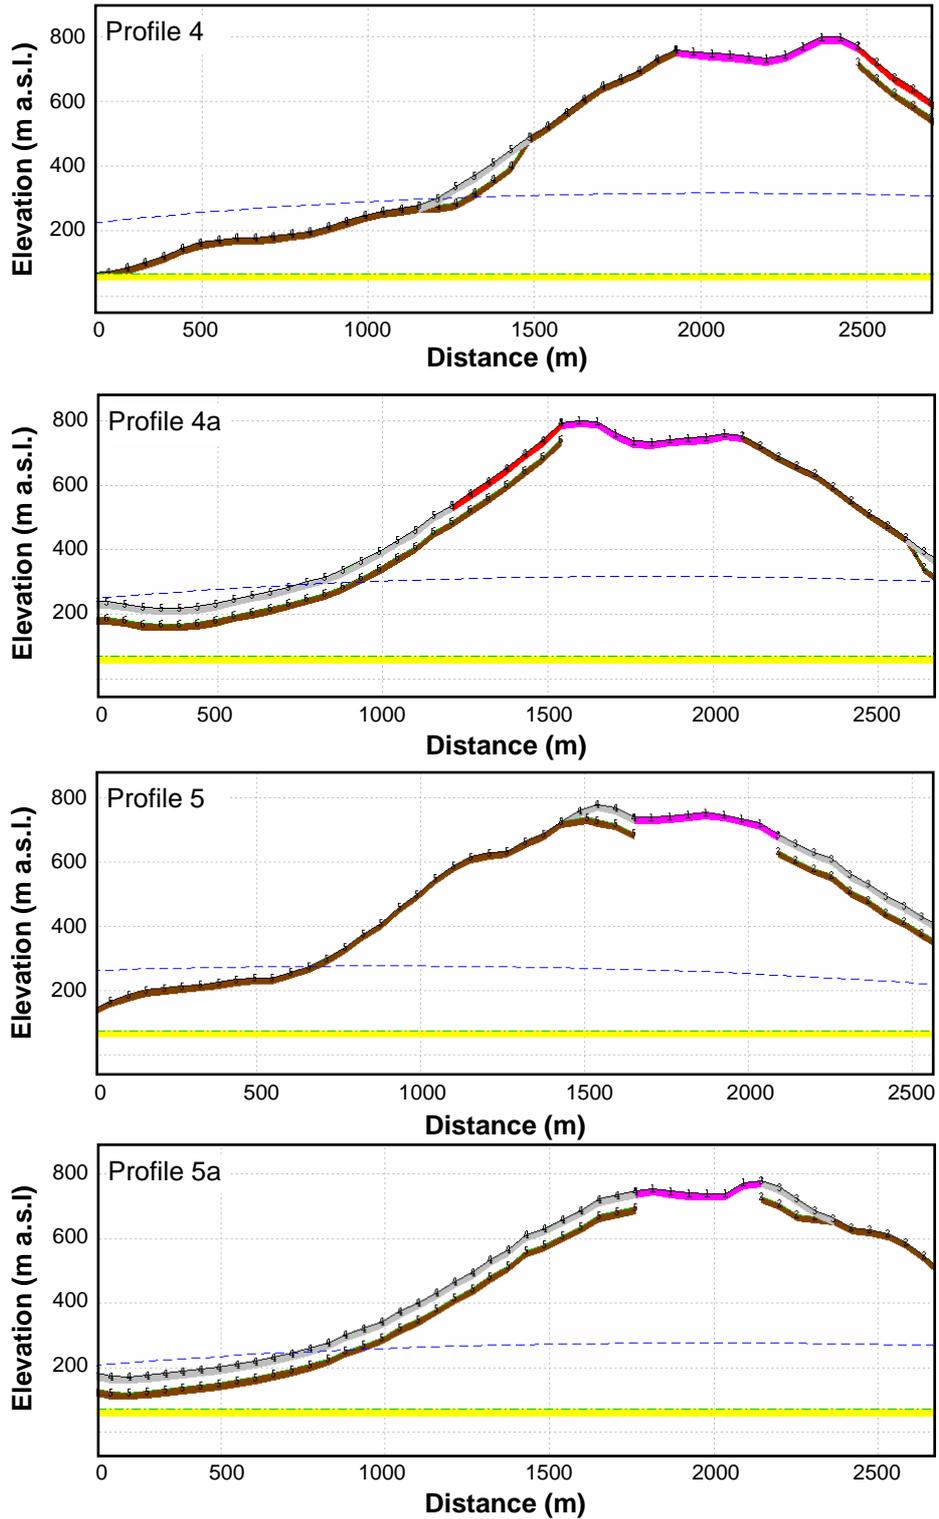
Figure 6.7b – Galena™ models of slope profiles 4, 4a, 5, and 5a showing subsurface stratigraphy. All slope profiles are shown with a watertable elevation of 20 %. Model legend is same as that for Figure 6.7a

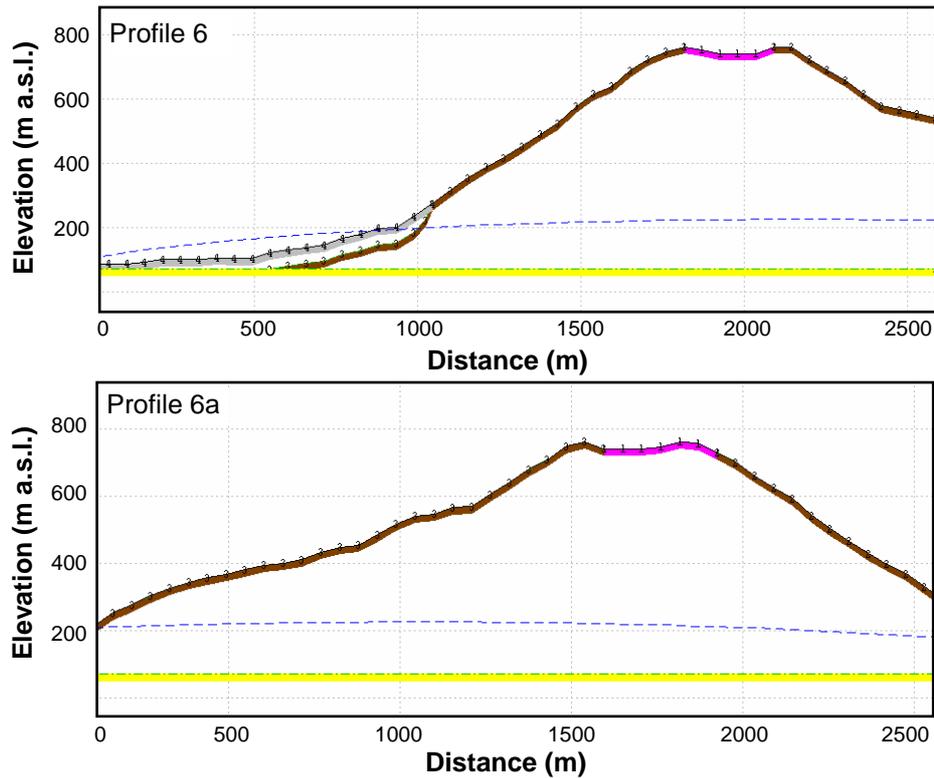
Figure 6.7c – Galena™ models of slope profiles 6 and 6a showing subsurface stratigraphy. All slope profiles are shown with a watertable elevation of 20 %. Model legend is same as that for Figure 6.7a

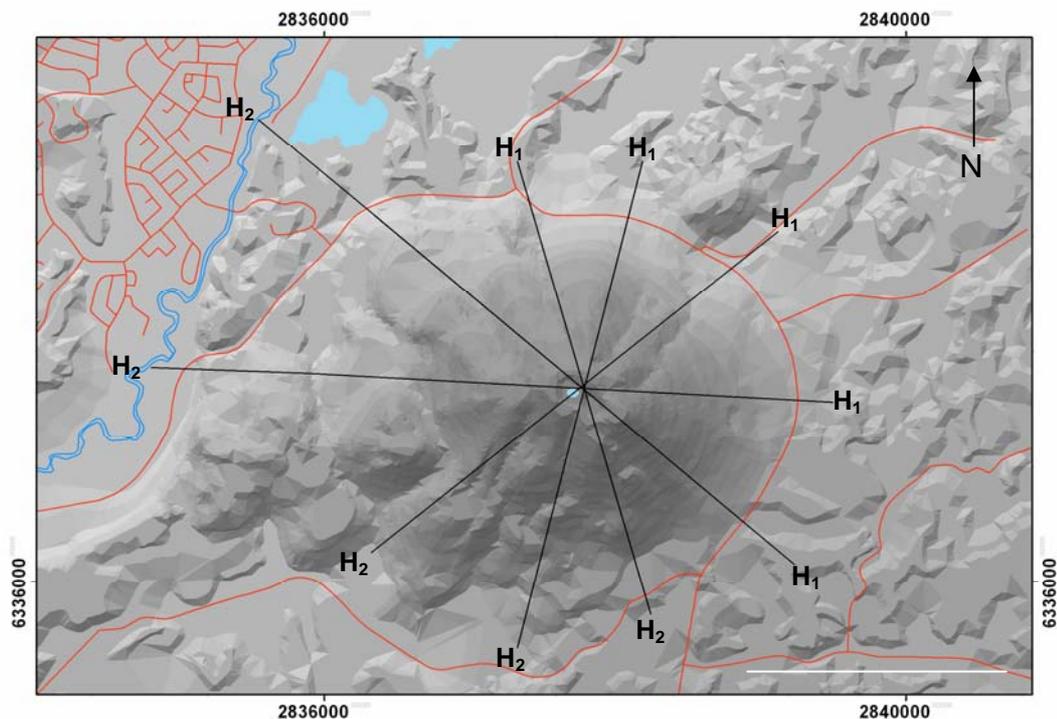
Figure 6.8 – Location of  $H_1$  and  $H_2$  parameters for each slope profile.  $H_1$  and  $H_2$  were interpreted as the heights at each end of the profile's respective run-line. Map legend is same as that for Figure 6.4. White line represents 2 km.

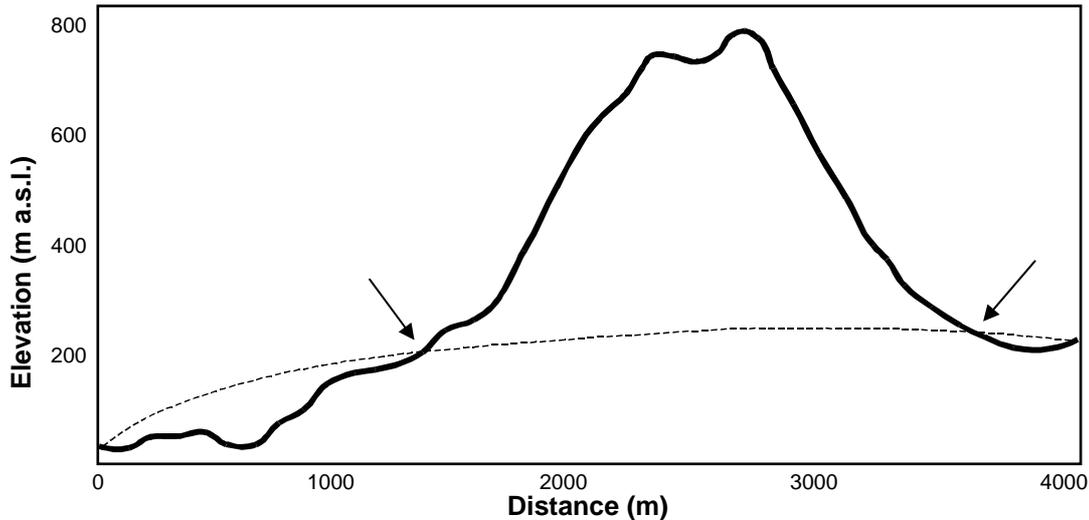
Figure 6.9 – Realistic watertable elevation for Putauaki is estimated to be 15 % (dashed line). For most slope profiles, a watertable of this elevation lays approximately 230 m a.s.l. coinciding with the lower flank. Assuming a 15 % watertable elevation, arrows indicate the maximum elevation at which seepage faces would be expected. Bold line represents profile of run-line 4 – 4a.

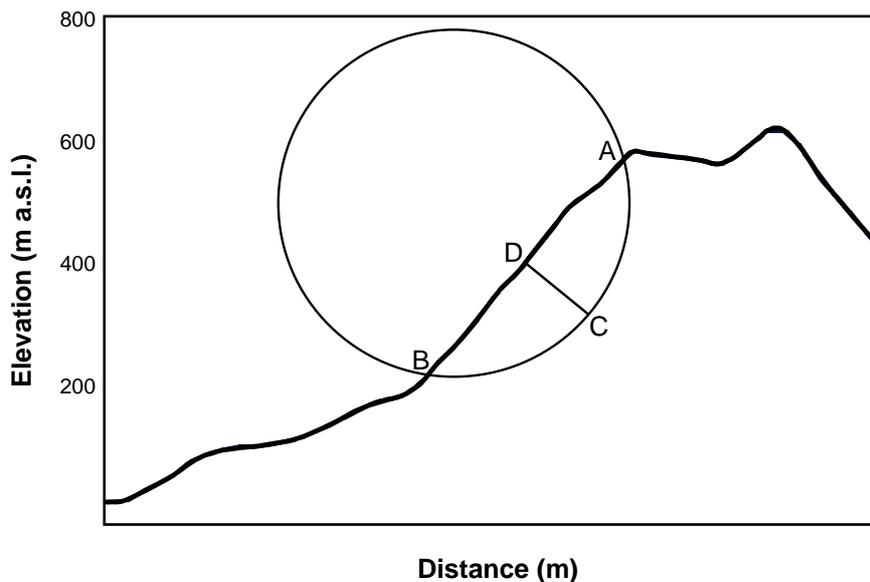
Figure 6.10 – Calculation of the segment area of  $F_{\min}$ . Arc AB represents  $F_{\min}$ . Chord length is measured as the straight line distance between the uppermost and lowermost points of  $F_{\min}$  (straight line distance from A – B). Segment height is measured as the maximum depth of  $F_{\min}$  (distance from C – D). Bold line represents profile 4.

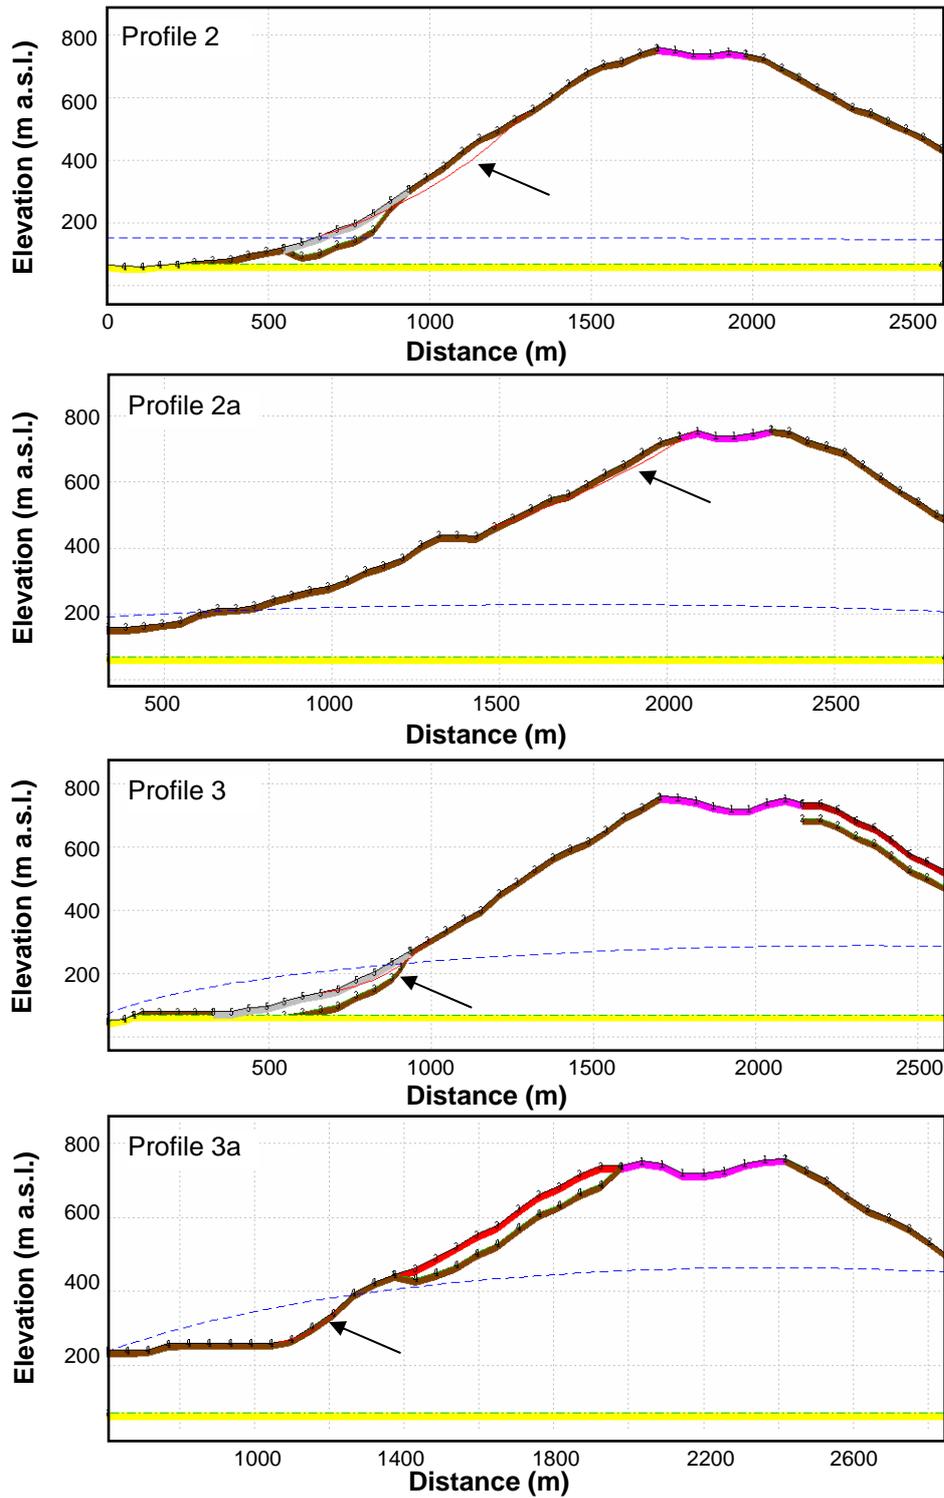
Figure 6.11 – Galena™ models of slope profiles 2, 2a, 3 and 3a showing position of  $F_{min}$ . All four of these profiles exhibited only small scale failure. All slope profiles are shown with a watertable elevation of 20 %. Arrow indicates location of failure scarp for small scale failure.

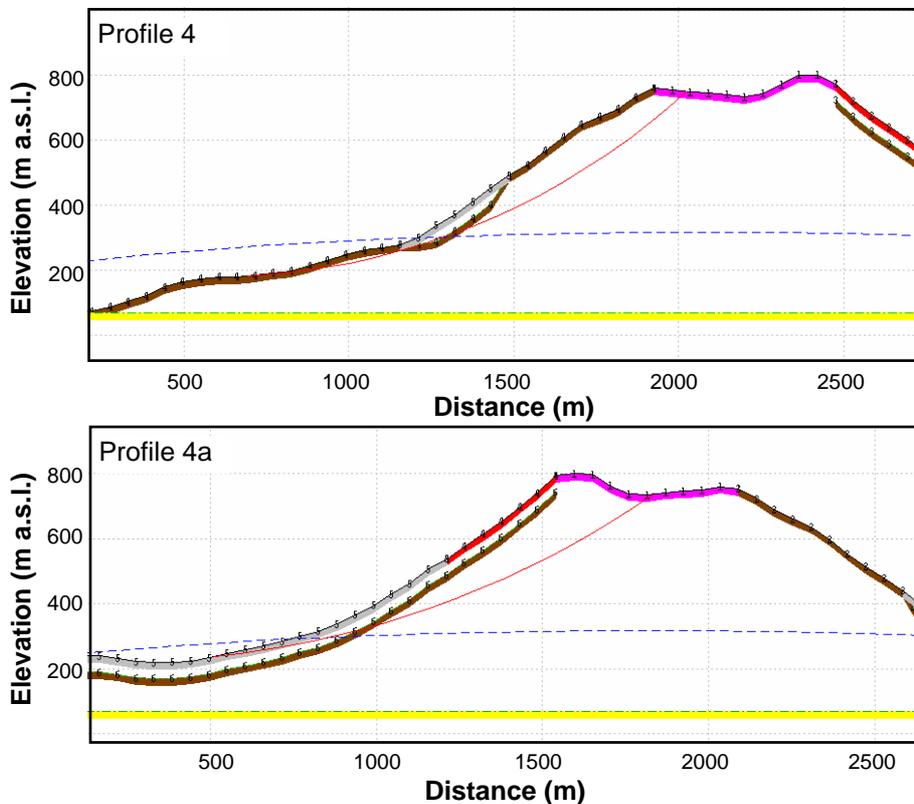
Figure 6.12a - Galena™ models of slope profiles 4 and 4a showing position of  $F_{\min}$ . Both of these profiles exhibited large scale failure. All slope profiles are shown with a watertable elevation of 20 %. Model legend is same as that for Figure 6.11.

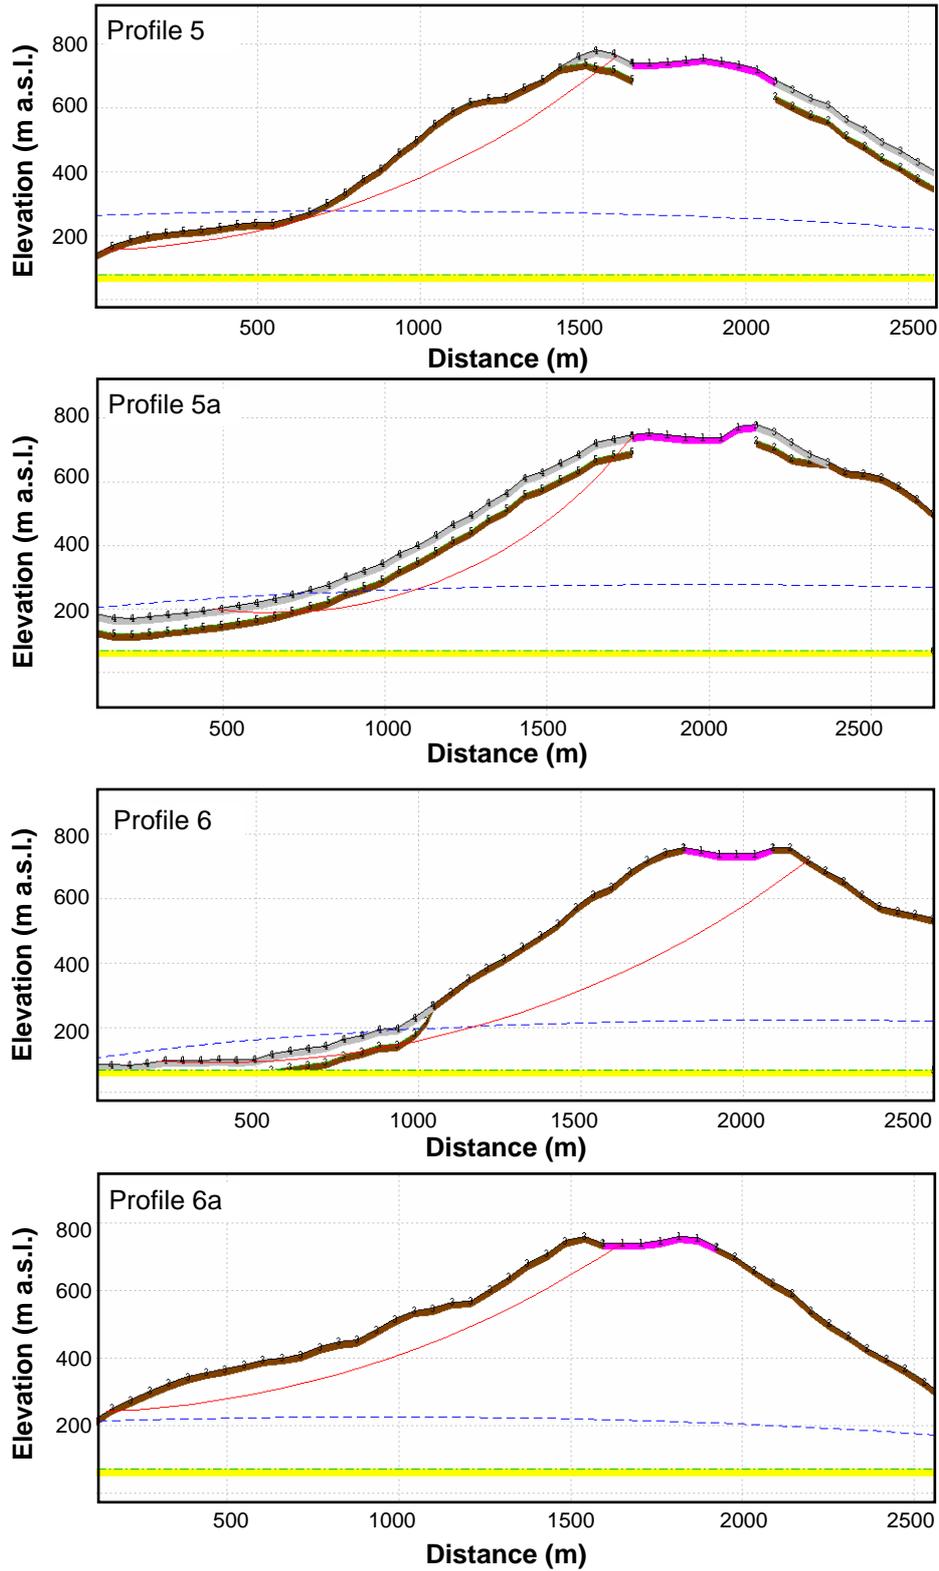
Figure 6.12b - Galena™ models of slope profiles 5, 5a, 6, and 6a showing position of  $F_{min}$ . All four of these profiles exhibited large scale failure. All slope profiles are shown with a watertable elevation of 20%. Model legend is same as that for Figure 6.11.

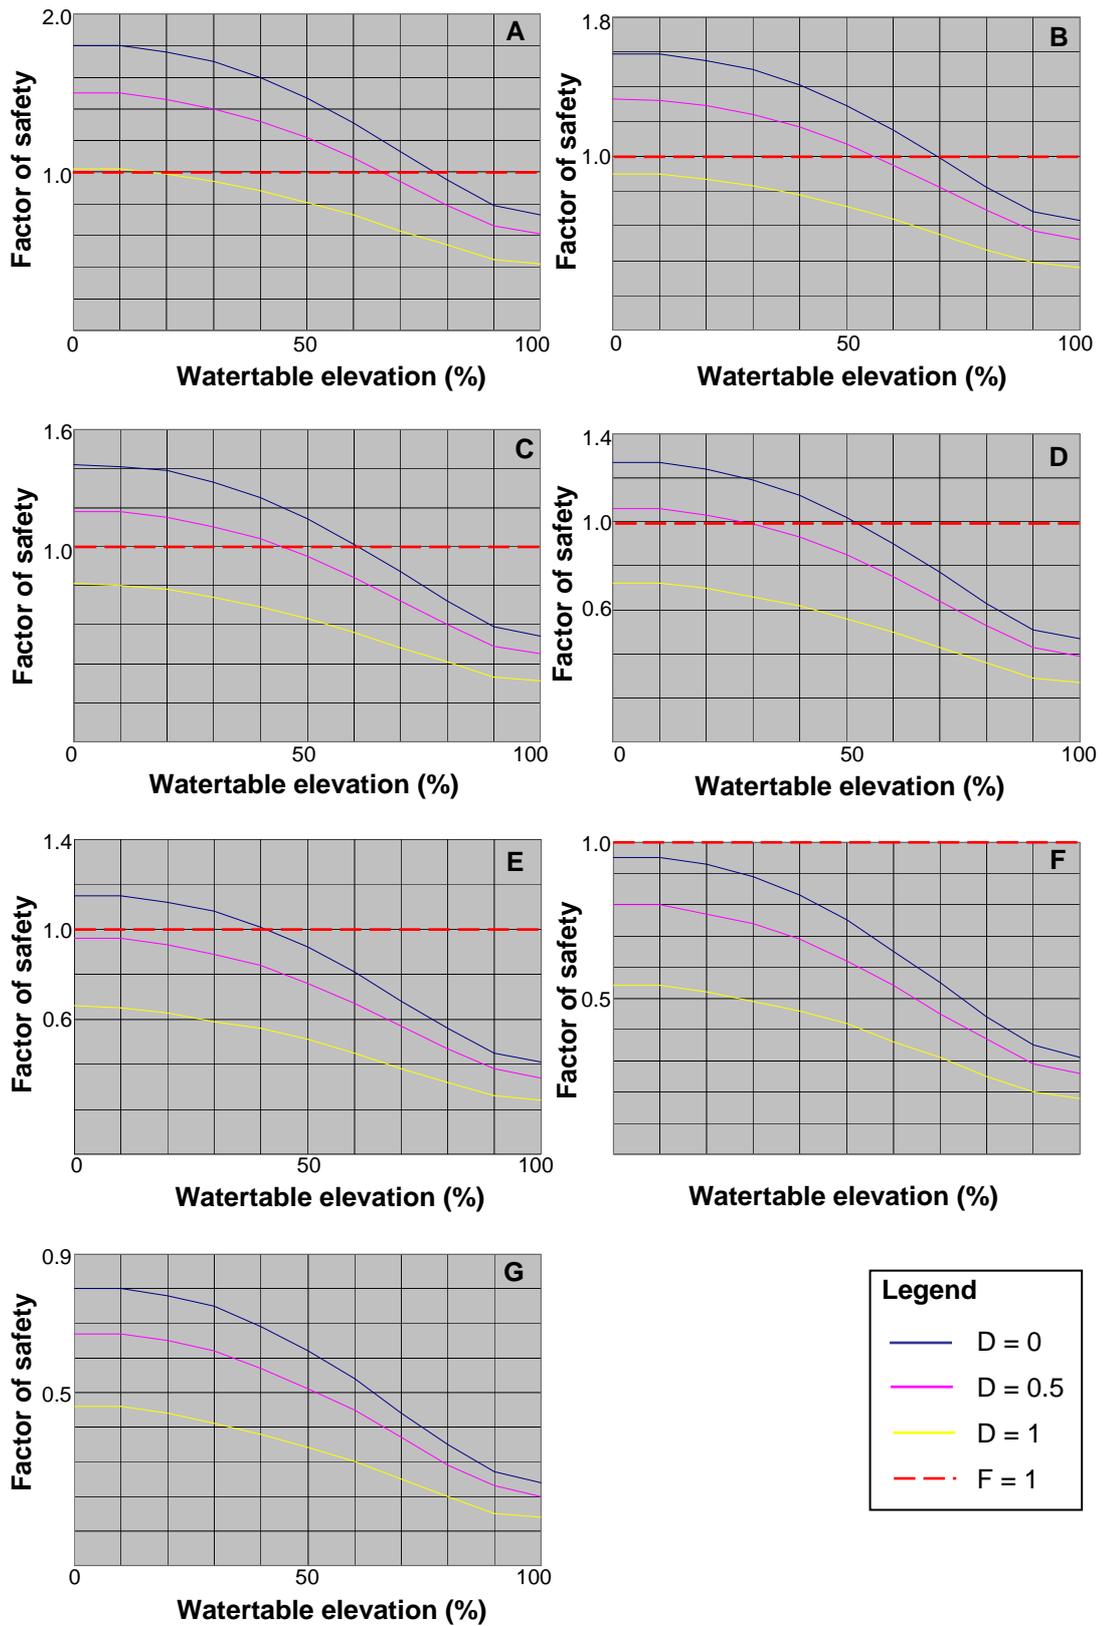
Figure 6.13 – Graphs of F (y-axis) against watertable elevation (x-axis) at earthquake forces ranging from 0 – 0.2 g in 0.05 g increments (graphs A – E), and 0.2 – 0.4. g in 0.1 g increments (graphs E – G). Watertable elevation is measured in % slope saturation. Graphs correspond to profile 4a. F = 1.0 represented by red dashed line.

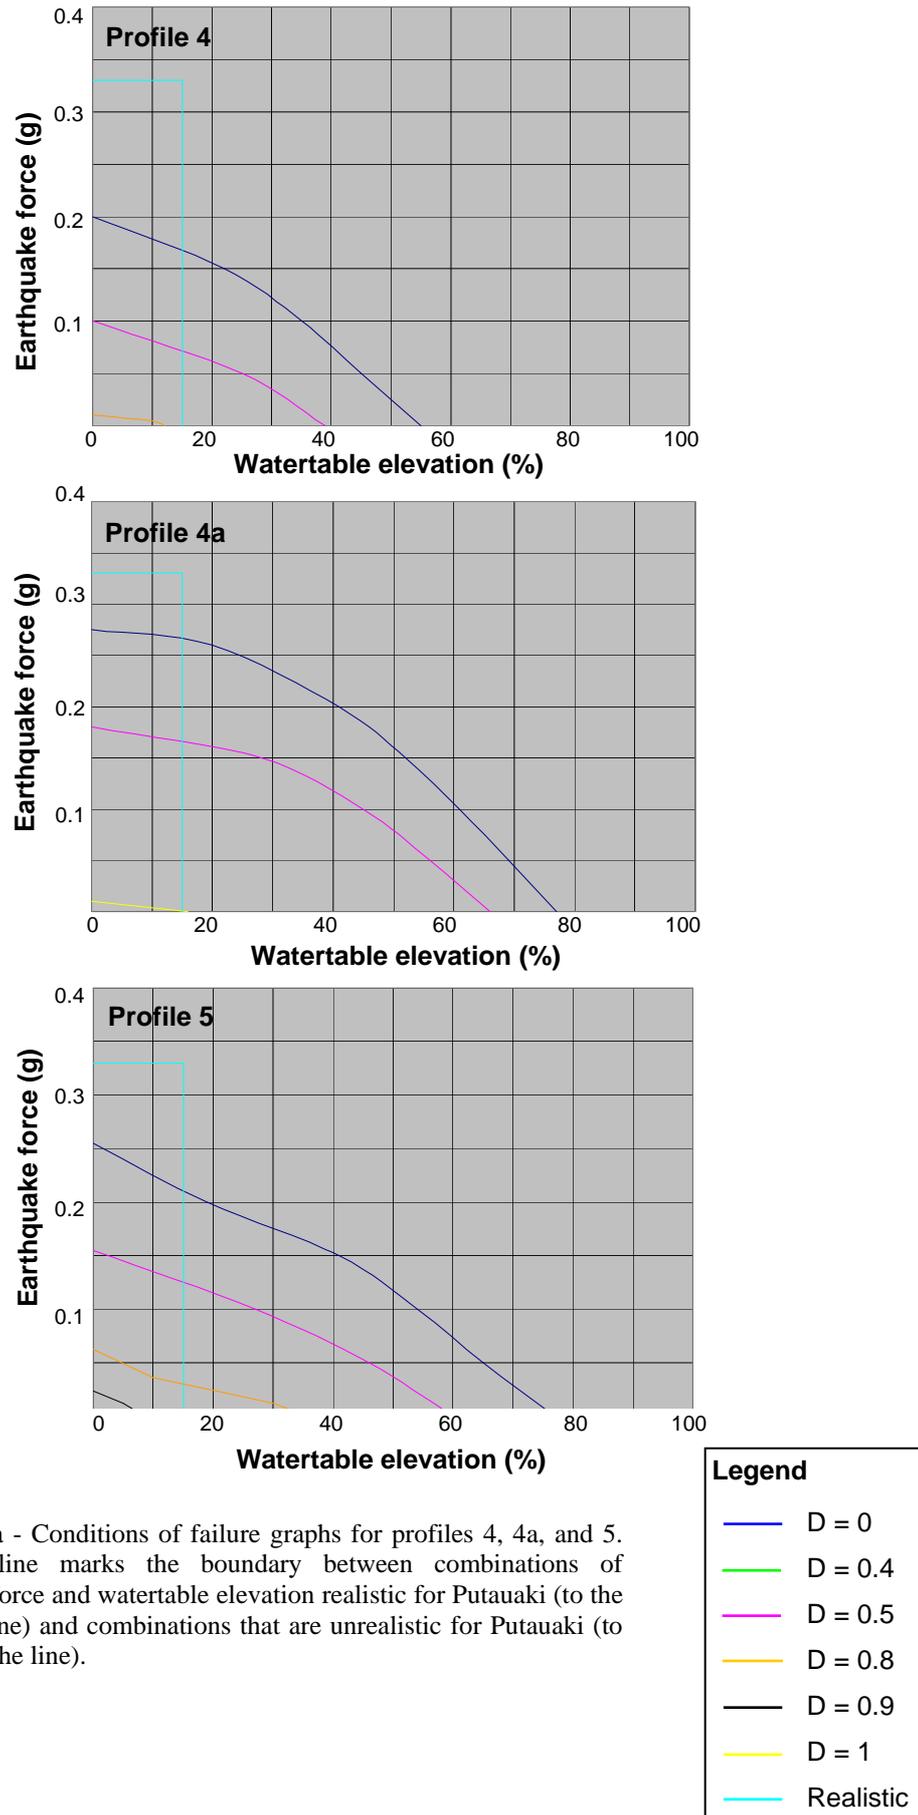
Figure 6.14a - Conditions of failure graphs for profiles 4, 4a, and 5. 'Realistic' line marks the boundary between combinations of earthquake force and watertable elevation realistic for Putauaki (to the left of the line) and combinations that are unrealistic for Putauaki (to the right of the line).

The conditions of failure graph for profile 4 shows that the line representing  $F = 1.0$  at a  $D$  of 1.0 does not plot on the graph (Figure 6.14a). A value of  $D = 0.8$  is the highest level of disturbance that manages to plot on this graph, meaning that as long as  $D$  is  $> 0.8$ , profile 4 cannot achieve stable conditions irrespective of

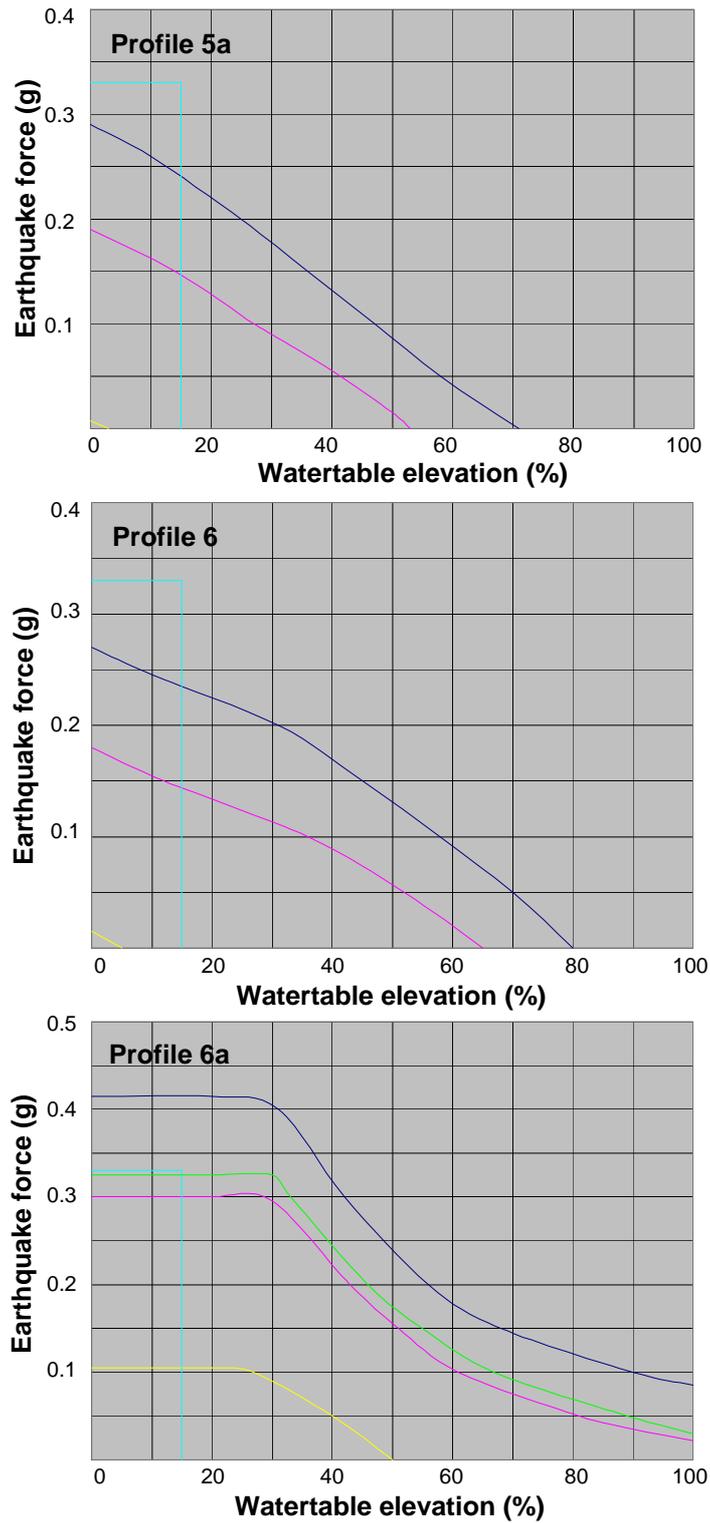
Figure 6.14b - Conditions of failure graphs for profiles 5a, 6 and 6a. 'Realistic' line marks the boundary between combinations of earthquake force and watertable elevation realistic for Putauaki (to the left of the line) and combinations that are unrealistic for Putauaki (to the right of the line). Graph legend same as that for Figure 6.14a.

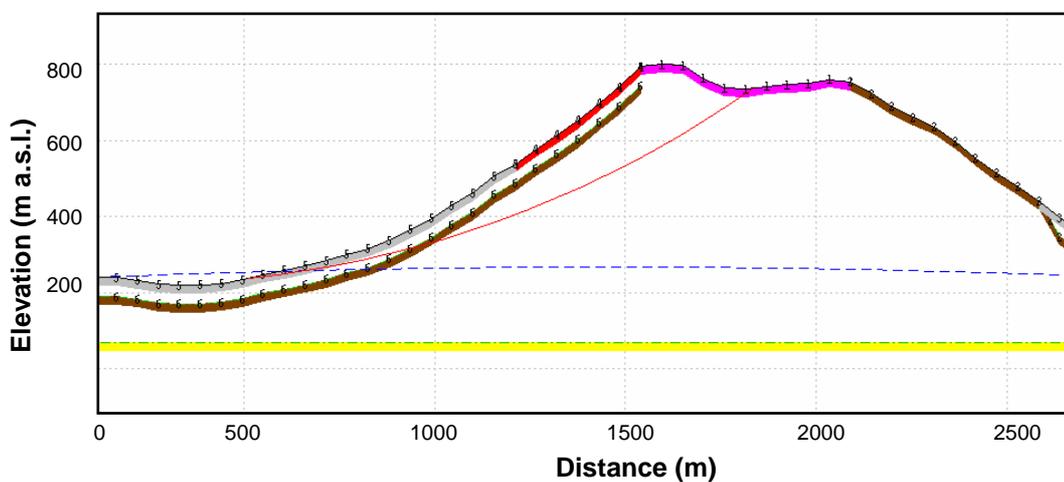
Figure 6.15 – Galena™ model of profile 4a indicating a 12 % watertable elevation. Note how watertable elevation must be  $> 12\%$  to impinge upon  $F_{\min}$ .

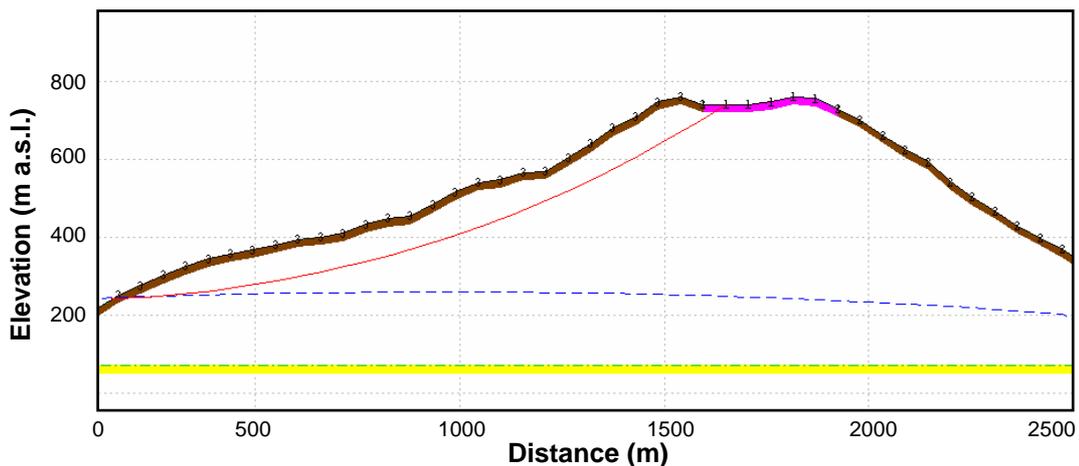
Figure 6.16 - Galena™ model of profile 6a indicating a  $25\%$  watertable elevation. Watertable elevation must be  $> 25\%$  to impinge upon  $F_{\min}$ . Graph legend same as that for Figure 6.15.

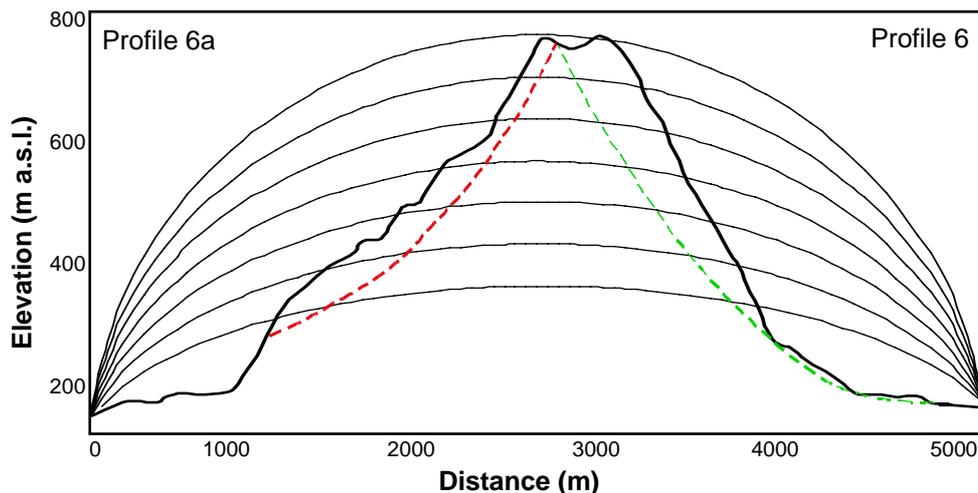
Figure 6.17 – Profile of run-line 6 – 6a with watertable heights ranging from 30 % (lowermost ellipse) to 90 % (uppermost ellipse) in 10% intervals.  $F_{\min}$  of profile 6 and 6a indicated by the green and red dashed line respectively.

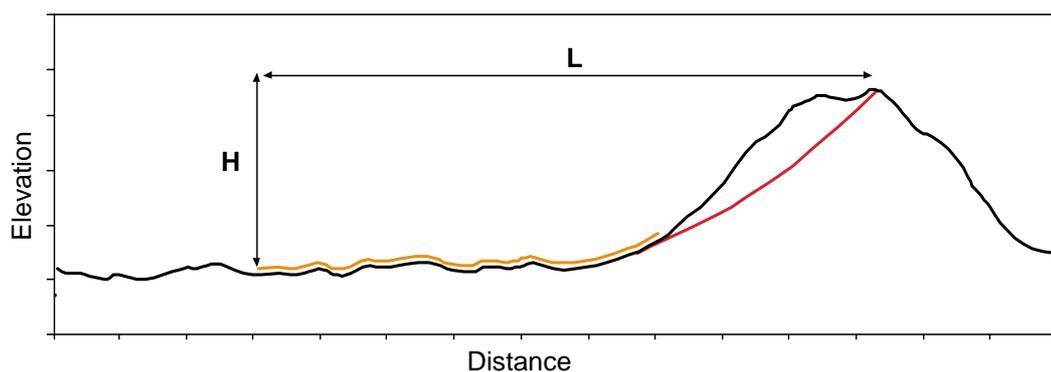
Figure 7.1 – Schematic representation of the procedure used to calculate the H/L ratio of a potential landslide. H/L ratios are calculated as the distance from the top of the prefailure surface to the distal end of the landslide deposit. Red line represents failure surface. Brown line represents landslide deposit.

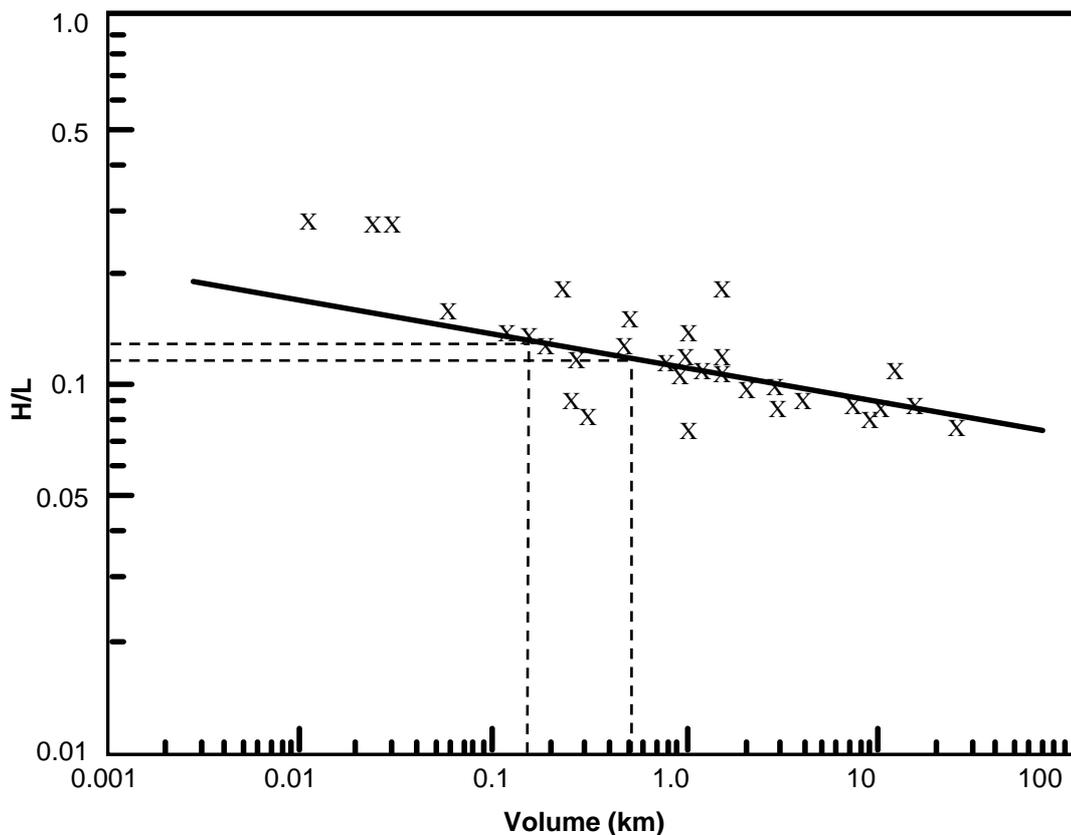
Figure 7.2 – Log-log relationship between ratio of fall height (H) and travel distance (L) to volume of debris-avalanche deposits ( $n = 32$ ). Dashed lines indicate approximate range of H/L ratios applicable for landslides sourced from Putauaki. Sourced from Siebert (1984).
