**Post-Disposal Monitoring of
the Auckland Marine Disposal Ground**

for Coastal Resources Ltd.

Permit no. 555

February 2011

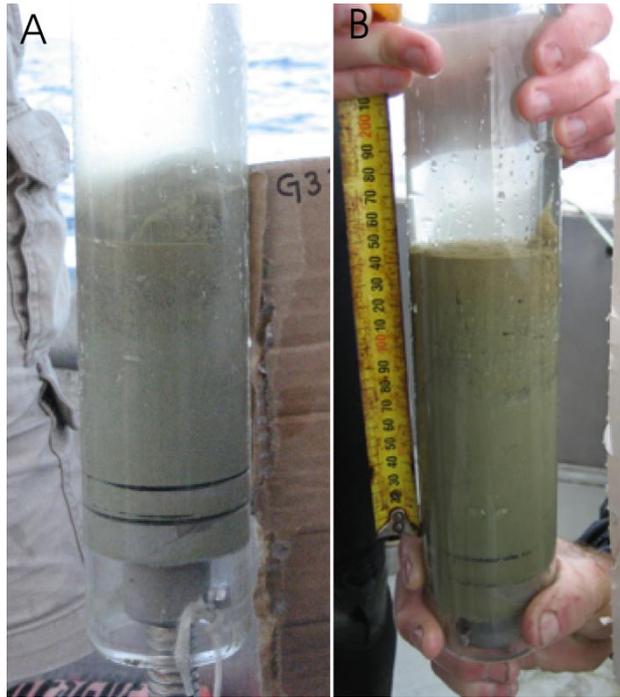
Figure 1.3 Photos of sediment cores retrieved (A) prior to disposal and (B) following disposal. These samples were collected from location G3, but are typical of the majority of samples collected at the disposal site both before and after disposal.

Pre-disposal site cores, as well as pre-disposal control cores indicate that the shelf in this area is uniformly overlain with a brown to olive green mud that is loose and fluffy at the surface and somewhat more consolidated to a depth of +/- 12 cm. Biological activity is evident at most sample locations to a depth of approximately 5 – 7 cm, but no samples showed evidence of macrofaunal type invertebrates.

Post-disposal cores in a general sense appeared much the same as those collected prior to disposal operations. The exceptions were at H2, the location of hopper release, and at a site 250 m east of that location. Location H2 appeared to have the most significant quantity of the disposed material while a much smaller amount seems to have reached the site 250 m east. No black mud was observed in samples collected at the site 250 m west of H2.

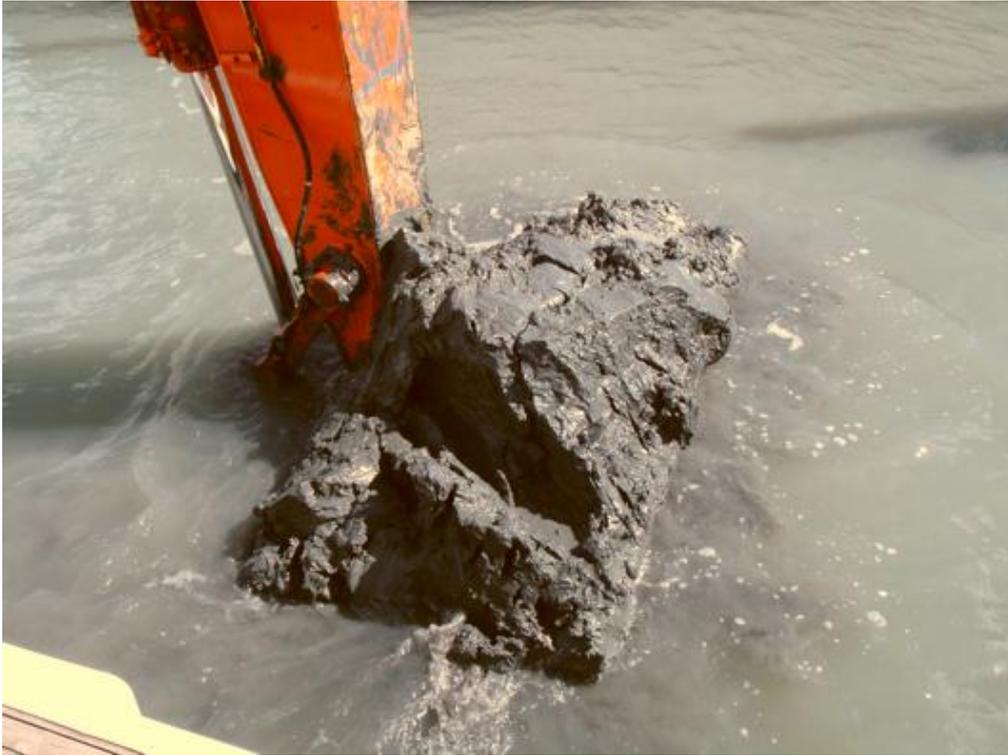
Figure 1.5 Black anoxic mud being dredged from a Pine Harbour Marina berth (end of March 2010) (photo: Bryna Flaim).

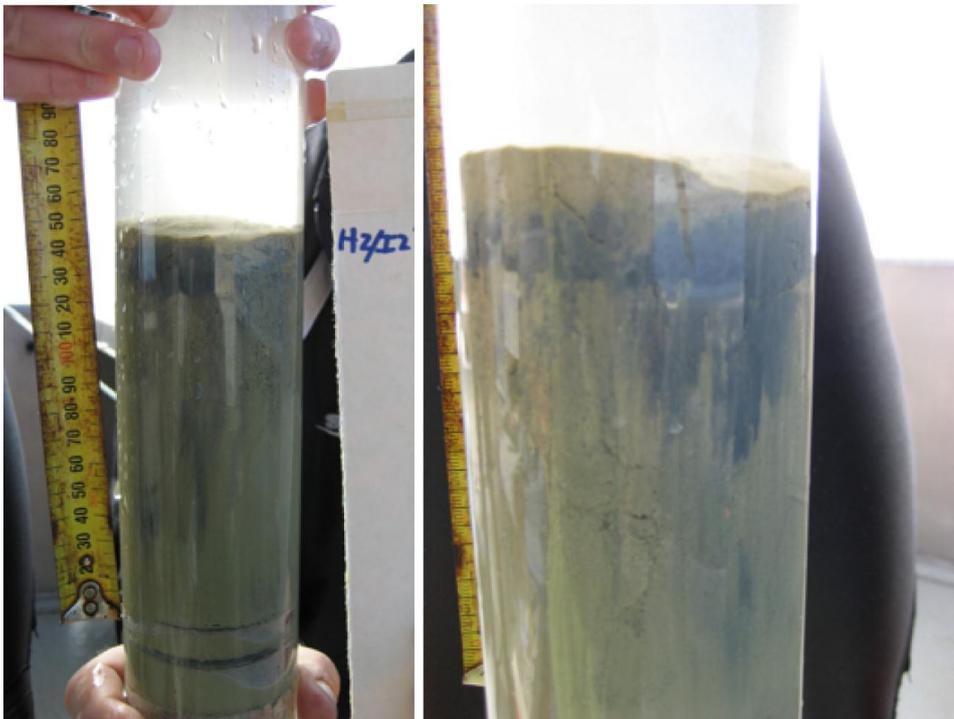
The cores retrieved from the location 250 m east of H2 (referred to as H2-I2) consisted of the same black mud observed in cores from H2 (Figure 1.6). However, the quantity was significantly less than that at H2. The clumps prevalent in the H2 cores were not apparent at H2-I2. Accordingly, a larger percent of the black mud in the H2-I2 core had become oxidised because the majority of the material was close to the surface of the core.

Figure 1.6 Photo of sediment core with a small amount of black disposal mud retrieved from location H2-I2 (250 m east of the actual disposal location) June 2010 following the trial disposal in (includes close-up view).

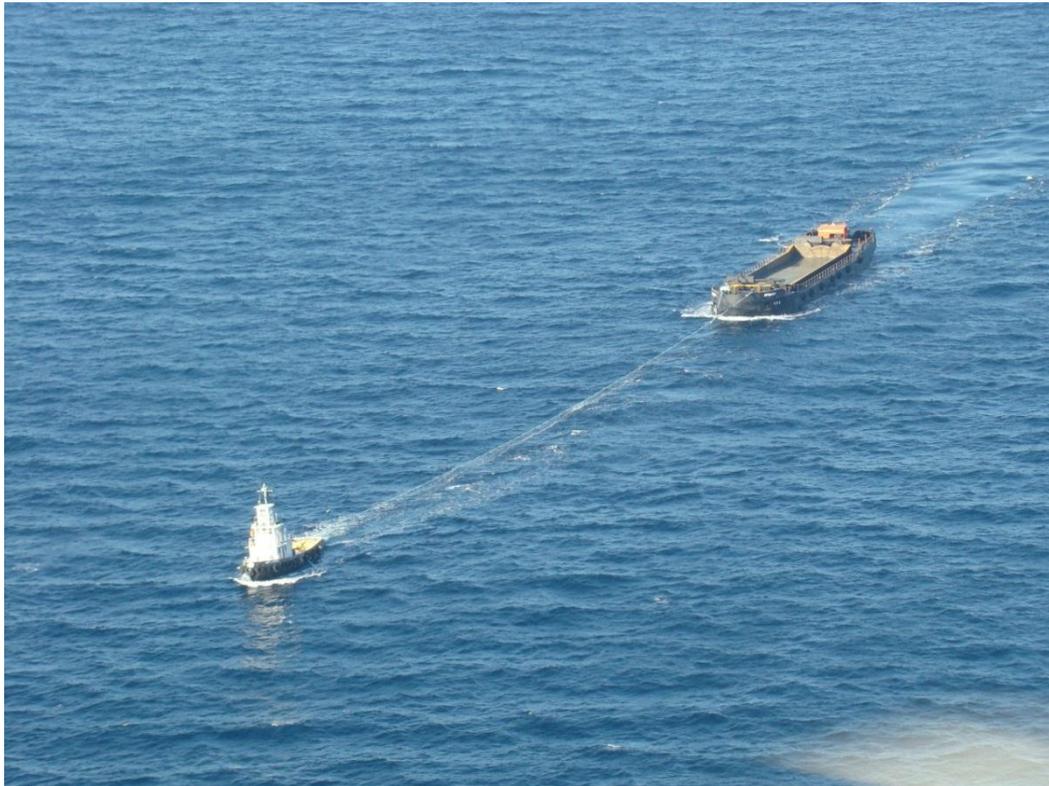
Figure 2.2 Aerial photo of the tug MV Mina Campbell towing the split hull hopper ‘Groper’ to the disposal site for the second disposal on March 20, 2010 (photo: Terry Healy).

Disposal of the $\sim 4800 \text{ m}^3$ of dredged material was undertaken in 9 loads (averaging $\sim 540 \text{ m}^3$ per load) using a towed split hull hopper (Figure 2.2). The

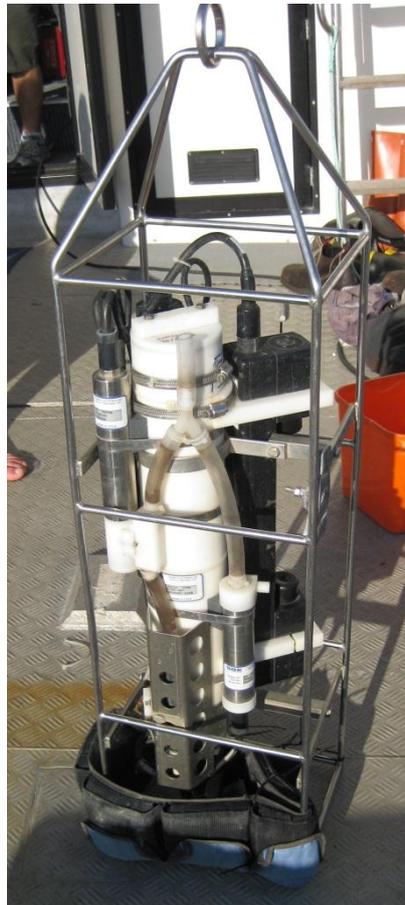
On each of the four plume monitoring surveys, a “SeaBird” CTD profiler was deployed near the disposal release location immediately following completion of plume monitoring (as the vessel must be stationary for deployment). This device includes sensors which record conductivity (from which salinity can be inferred), temperature, and density with respect to depth (Figure 3.5). Two to three profiles were recorded during each survey in locations relevant to plume locations observed during the monitoring portion of each survey. It should be noted that often the plume itself was significantly diluted and dispersed by the time the CTD profile was recorded, but stratification of the water column, if present, would be detectable regardless of the presence of the plume. CTD profile locations visited after each survey are listed in Table 3.2.

Figure 3.5 “Sea Bird” CTD profiler used to record conductivity, temperature and density at the site following completion of each of the four plume monitoring surveys.

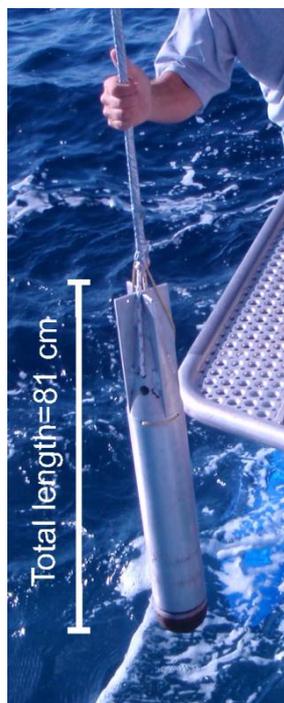
The geomechanical strength of the site sediment was assessed using the dynamic penetrometer *Nimrod* (Figure 4.2). This device is a portable probe capable of recording small scale vertical changes in sediment strength through the possibility of variable tip geometries (flat cylinder, hemisphere, or cone), the ability for true free-fall along with high-speed data acquisition, and the inclusion of four accelerometers varying in range and resolution (Stark et al. 2009a). Deployed by hand, *Nimrod* penetrates the seafloor after free-fall through the water column. Sensors measure deceleration and pressure over time after penetration of the seafloor allowing for the calculation of velocity and penetration depth (Stark et al. 2009a). Although vertical variation in sediment properties such as strength and density can be inferred through the deceleration-depth profiles, the impact velocity and in consequence the deceleration, is also influenced by water column effects (e.g. currents) and other deployment factors (e.g. tether drag) (Stoll et al. 2007; Stark and Wever 2008). Given these uncertainties, it has been considered more useful to assess bearing capacity and undrained shear strength (Aubeny and Shi, 2006; Stoll et al 2007; Stark et al. 2009b). Deceleration after the probe contacts the seafloor is proportional to the resistive force of the sediment which is dependent on its undrained shear strength (Stoll and Akal 1999). Following that principle, an approach first introduced by Dayal and Allen (1975) and advanced by Aubeny and Shi (2006) was used to determine the undrained shear strength from the deceleration profile at locations across the proposed site.

Figure 4.2 *Nimrod* being readied for a free-fall deployment (assembled with hemispherical tip).

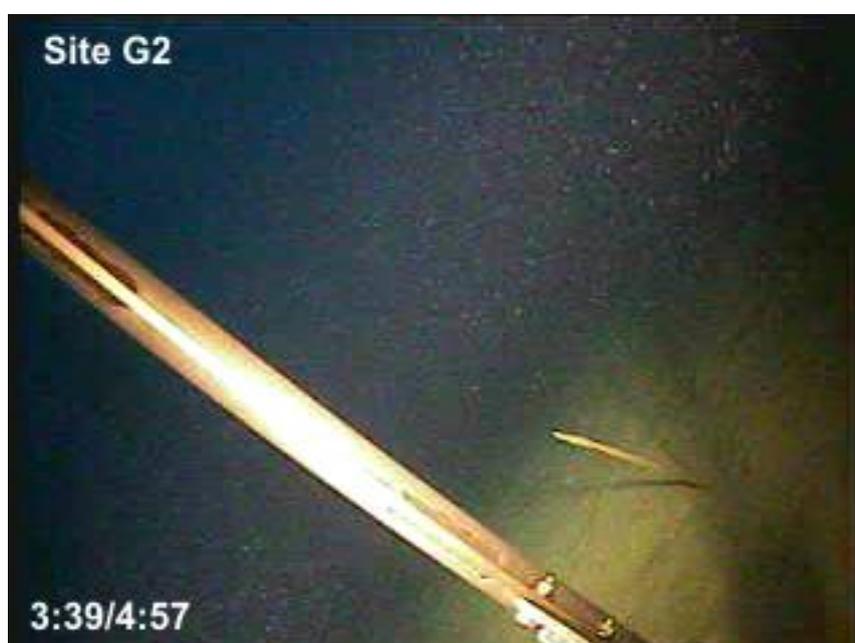
Underwater video footage did not record any pelagic organisms and very few epibenthic organisms were observed. One sessile organism, most likely a Sea Pen (Order Pennatulacea), was observed in the footage recorded at Site G2 (Figure 5.2), but other than that, the only evidence of epibenthic activity were some tracks in the seafloor which along with relatively common worm burrows, contributed to the ‘micro-relief’ described in Report 6.

Figure 5.2 A sessile benthic invertebrate (most likely a Sea Pen-Order Pennatulacea) recorded in underwater footage at location G2 of the disposal site in June 2010.

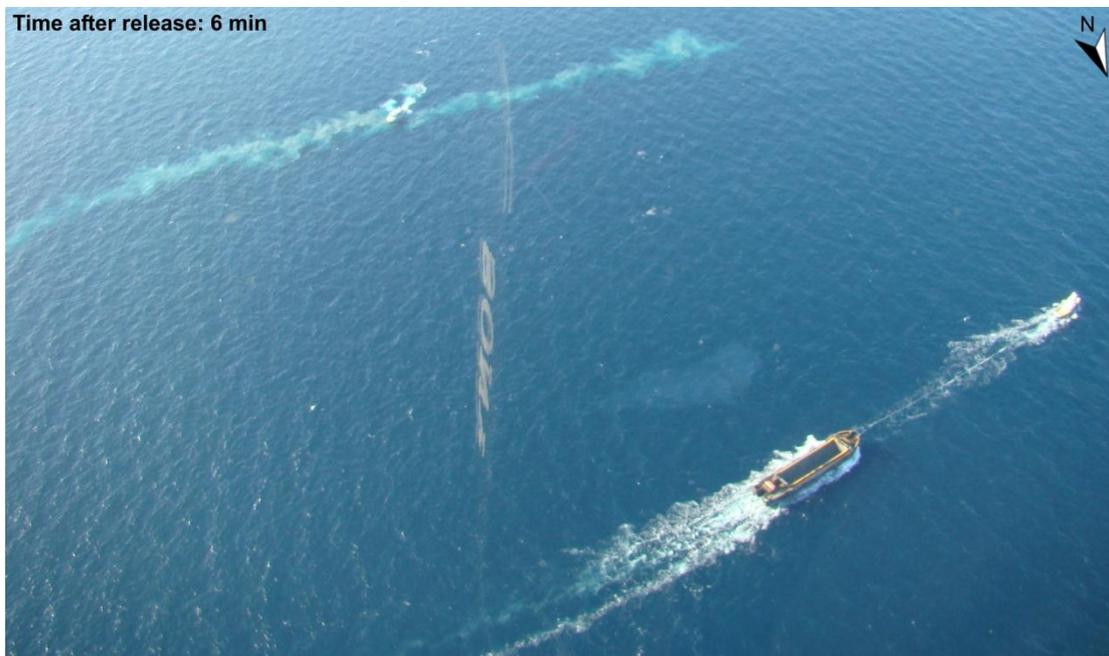
Figure 6.4 Aerial photo of surface plume 6 minutes after disposal of dredged material at the site on March 20 2010 (photo: Terry Healy).

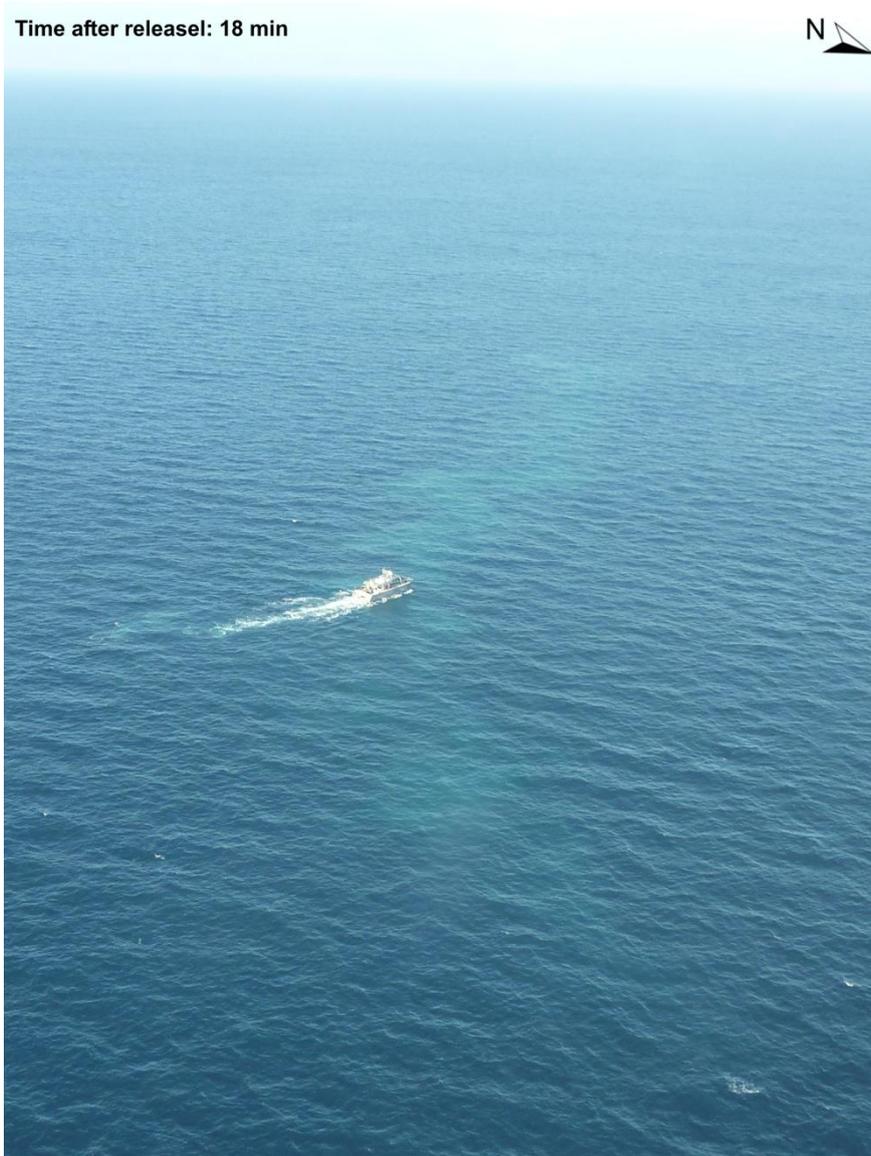
Time after release: 18 min

Figure 6.5 Aerial photo of surface plume 18 minutes after disposal of dredged material at the site on March 20 2010 (photo: Simon Male).

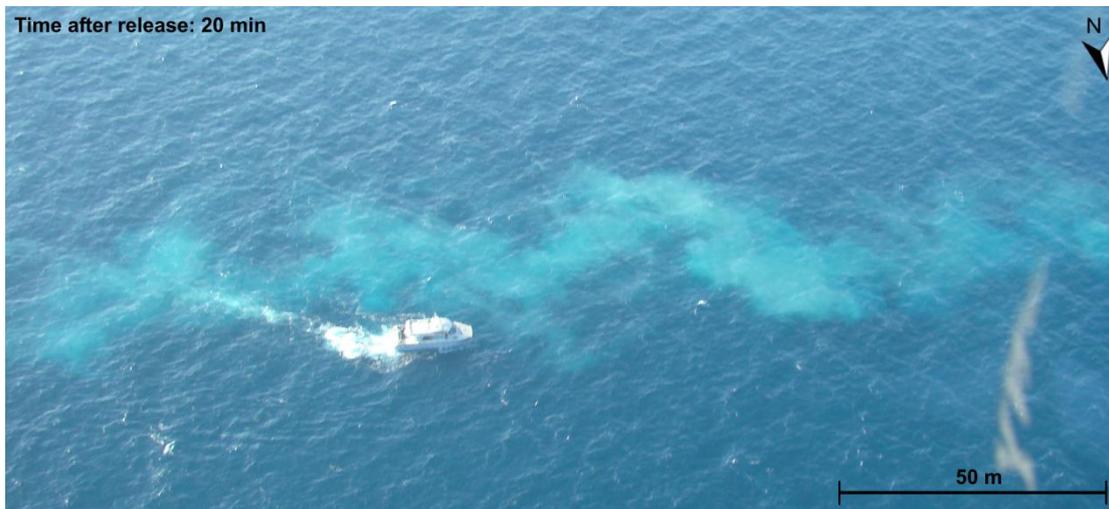
The visibility of the plume was dependant on both its concentration and the glare from the sun on the water surface. In the photo taken after 18 min, the plume appeared only faintly and already looked much dispersed (Figure 6.5). However, Figure 6.6 shows that while having clearly undergone dilution through dispersion compared to photos taken earlier, the plume was still quite visible after 20 min.

The length of the plume was estimated in photographs that were taken close to overhead ('bird's-eye-view'), the reason being that the perspective of the photograph skews the scale when the view is from a low side angle. A reasonably accurate scale was applied to Figures 6.6 and 6.7 using the known length of the observation vessel (16.8 m) in the photograph. From this estimate, the plume in this instance was approximately 150 m long from southwest to northeast and approximately 20 m in width.

Figure 6.6 Aerial photo of surface plume 20 minutes after disposal of dredged material at the site on March 20 2010 (photo: Terry Healy).

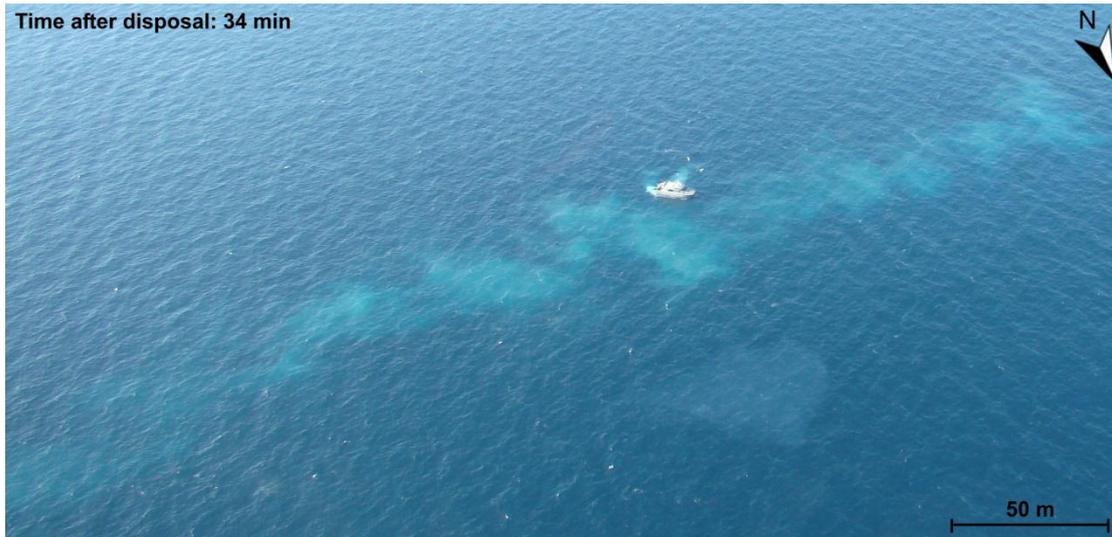
Figure 6.7 Aerial photo of surface plume 34 minutes after disposal of dredged material at the site on March 20 2010 (photo: Terry Healy).

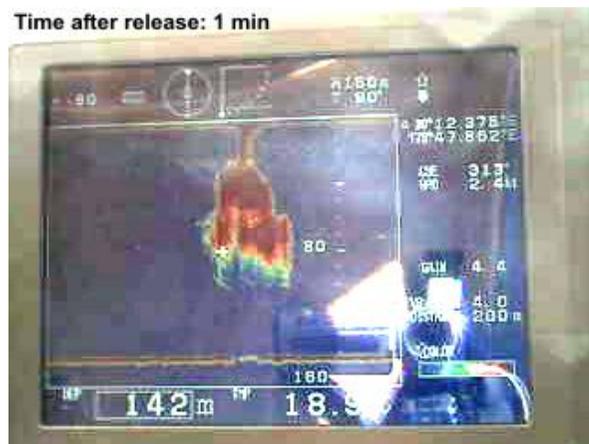
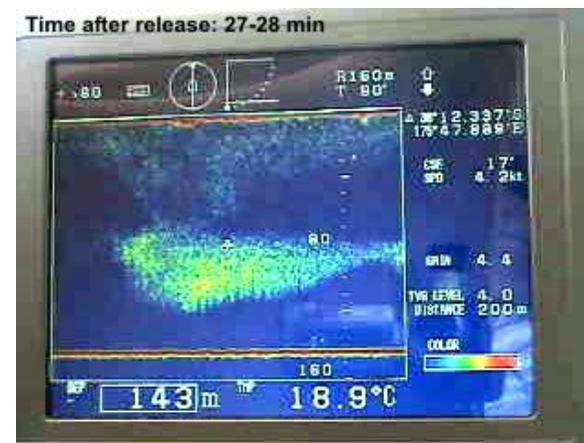
Figure 6.9 shows freeze-frame images from the echosounder monitor footage recorded during Survey 4. The images span from 1 - 28 minutes after disposal. The

echosounder image captured 1 min after disposal corresponds in time to ADCP transect 1 (Figure 6.8). Although the resolution of the ADCP backscatter data plot is significantly coarser, the shape of the area of lost data, somewhat like an upside-down wine glass, is very similar to that captured by the echosounder (Figure 6.9). By the time the ADCP transect was recorded, the density of material in the “stem” of the glass had decreased sufficiently to be registered by the ADCP system. Backscatter in that area was recorded at the maximum end of the range (107-112 dB). At the “bowl” of the glass, where there was a loss of data in the ADCP record, a very deep red colour was displayed in the respective echosounder image (Figure 6.9). The deep red colour similarly corresponded to the maximum end of the recordable range for the vessel sounder. It is therefore a reasonable assumption that density of material in the white area of the ADCP transect was too high to be registered by the system.

The remaining echosounder imagery, show detailed evolution of the descending material and the resultant plume. After 28 minutes, the majority of the material had either settled or dispersed so that only a small portion of the water column showed concentrations slightly above background levels.

Figure 6.9 Freeze frame images of video footage recorded of the echosounder monitor aboard the main survey vessel during Survey 4 on April 25 2010

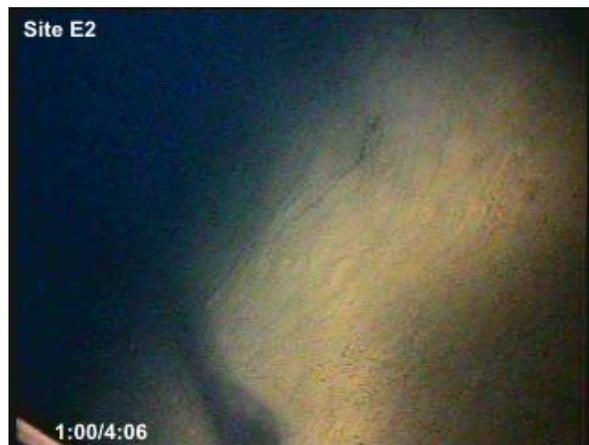
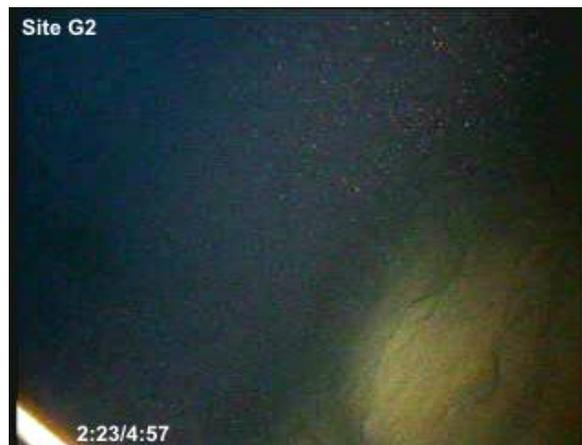
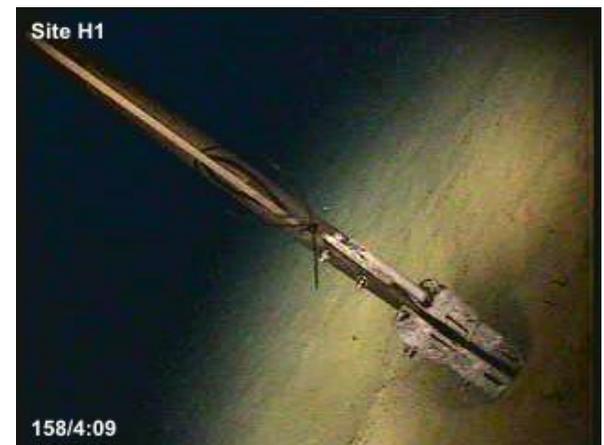
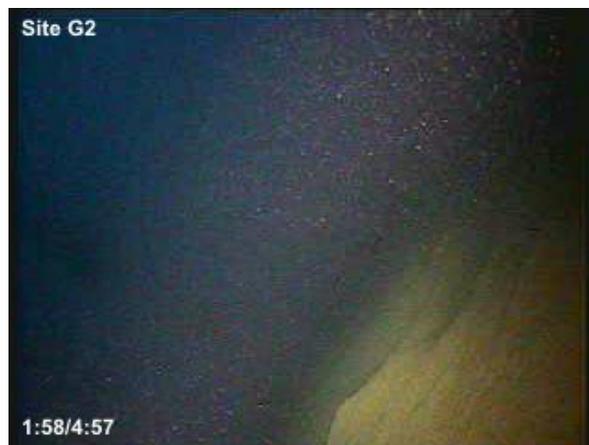
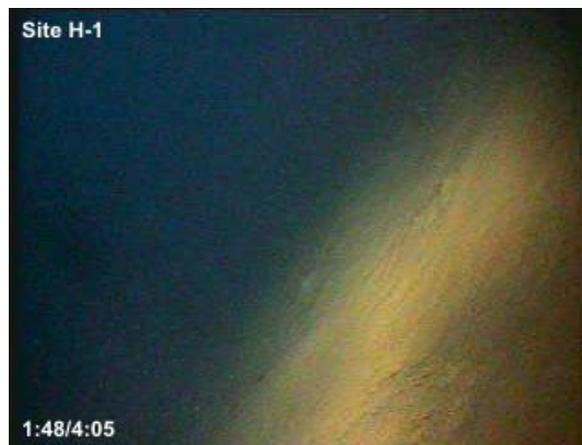
Figure 6.12 Freeze frame images of underwater video footage captured on July 26 2010 at sites: E2, G2, H-1, H1, and H2 following disposal operations.

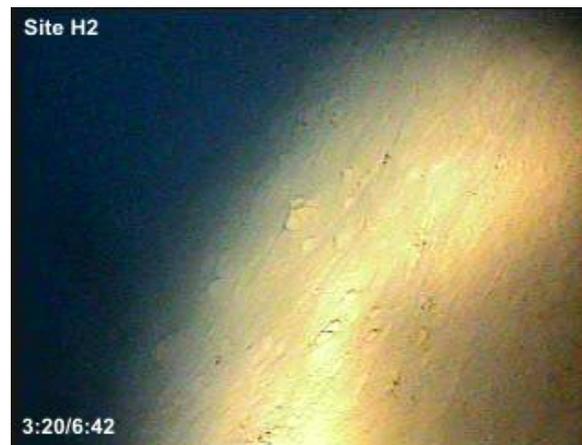
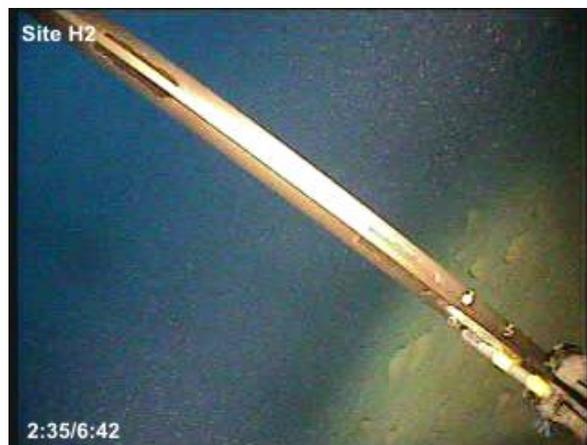
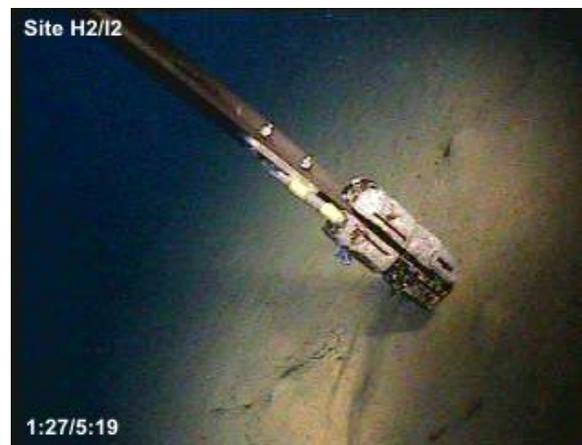
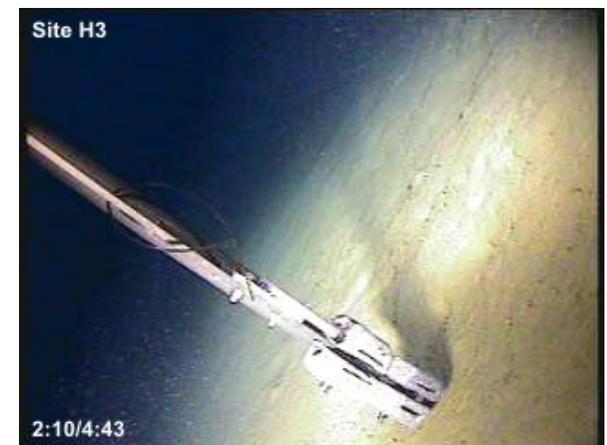
At the centre of the site (Site H2), where the dredged material was released, many blocks of dense material were observed (Figure 6.12 & 6.13). Typically, the blocks appeared exposed with no build-up of sediment around or covering them. However, the substrate in between blocks appeared smooth with very little scarring. This pattern seems consistent with typical disposal mechanics where the densest material (the blocks least disturbed in the dredging process) would descend rapidly to the seafloor and deposit very near to the release location. The turbulent jet of material (with the blocks mostly at the leading edge), would impact the seafloor with enough energy to erode the soft native materials leading to mixing with entrained disposed material. The entrained material may settle rapidly, but depending on particle size, would likely be dispersed radially outward from the point of impact and settle some distance away. The erosive conditions at the point of impact would therefore likely leave behind the dense blocks of material and in absence of blocks, patches of smooth sediment that have been wiped clean of trademark biological scarring that builds up over time. Initially, the blocks would have appeared darker than the surrounding sediment and in fact the darker colour of the dredged material was observed in cores retrieved very soon after disposal at Site H2 (see Report 1). However, after several months, oxidation would have changed the colour of the dredged material to one very similar to that of the native sediments, so it is not surprising that colour variations were not observed in the video clips.

Figure 6.13 Freeze frame images of underwater video footage captured on July 26 2010 at sites: H2, H2/I2, and H3 following disposal operations.

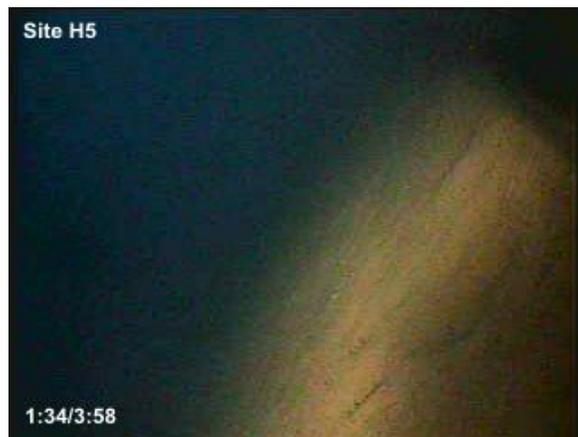
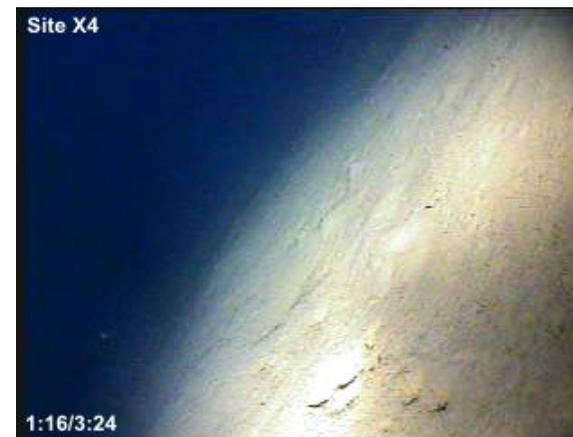
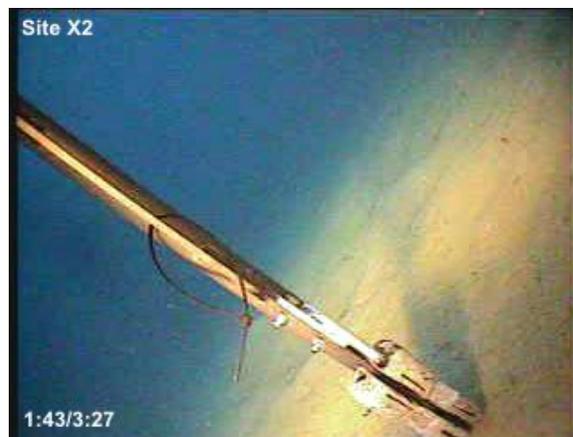
Figure 6.14 Freeze frame images of underwater video footage captured on July 26 2010 at sites: H5, I2, K2, and control sites X2, X4, and X6 following disposal operations.

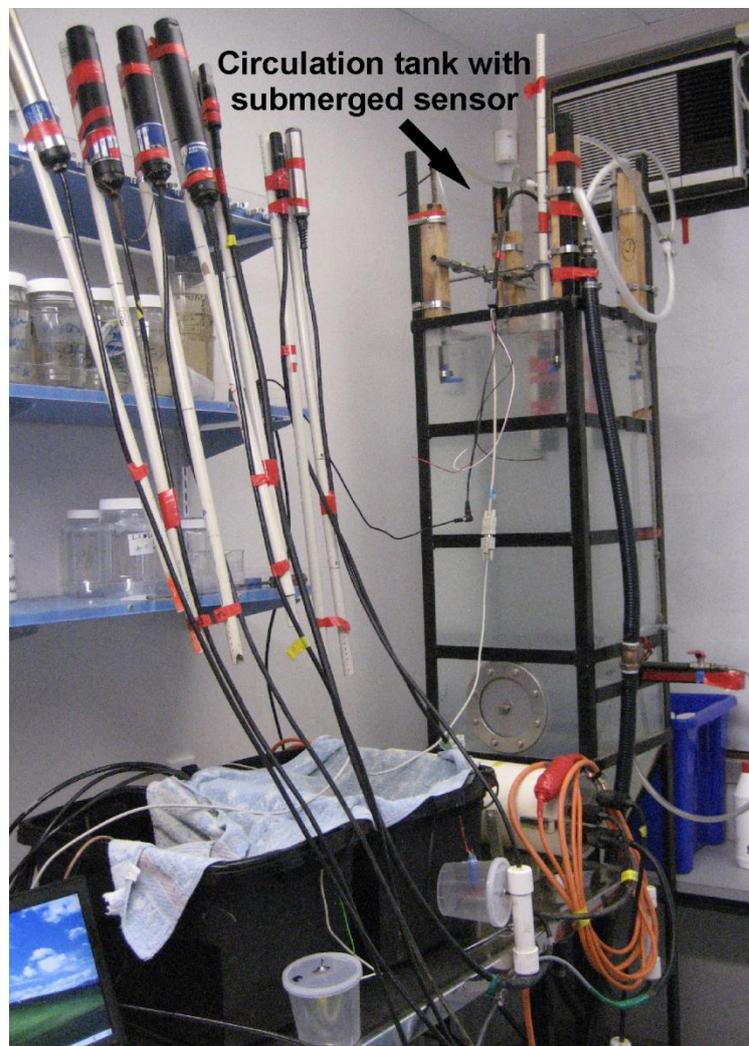
Turbidity sensor calibrations were undertaken prior to the first plume survey to determine scaling factors for converting raw sensor data to the equivalent suspended sediment concentration (SSC) (mg/L). Calibrations were undertaken using a suspended sediment calibration tank (see below) at National Institute of Water and Atmospheric Research (NIWA). Mud slurries composed of sediment collected from the marina basin at Pine Harbour was added to the calibration tank gradually to progressively increase the SSC within the tank. Following each increase in SSC, the tank was allowed to circulate for 15 min before time averaged readings were recorded for each sensor. A 1 litre water sample was collected from the centre of the tank prior to the addition of more slurry. The SSC (mg/L) of each dilution, determined by filtering each 1 litre sample (APHA, 1997), was plotted against the corresponding time-averaged readings for each sensor to establish the scaling factors for each sensor time series recorded during the 4 plume monitoring surveys.

During tests prior to calibration, it was observed that sensor readings varied depending on the station configuration for the same concentration (mg/L) sample (e.g. one sensor attached to the power source and logger compared to 2 sensors). Therefore, during calibrations the sensors were set-up as they would be deployed in the field. In most cases, one logger and power source were connected to 2 sensors.
