Environmental pollutants from the Scott and Shackleton expeditions during the 'Heroic Age' of Antarctic exploration

ABSTRACT. Early explorers to Antarctica built wooden huts and brought huge quantities of supplies and equipment to support their geographical and scientific studies for several years. When the expeditions ended and relief ships arrived, a rapid exodus frequently allowed only essential items to be taken north. The huts and thousands of items were left behind. Fuel depots with unused containers of petroleum products, asbestos materials, and diverse chemicals were also left at the huts. This investigation found high concentrations of polyaromatic hydrocarbons in soils under and around the historic fuel depots, including anthracene, benzo[b]fluoranthene, benzo[k]fluoranthene, chrysene, fluorene, and pyrene, as well as benzo[a]anthracene, benzo[a]pyrene, and fluoranthene, which are recognized carcinogens. Asbestos materials within the huts have been identified and extensive amounts of fragmented asbestos were found littering the ground around the Cape Evans hut. These materials are continually abraded and fragmented as tourists walk over them and the coarse scoria breaks

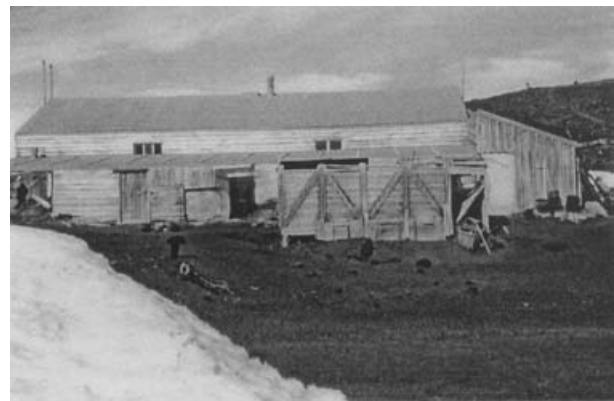
Fig. 5. Snow-free area round Cape Evans hut that contains several hundred pieces of asbestos on the surface of the ground.

2. Materials containing asbestos that litter the area around Cape Evans should be removed. Several hundred pieces larger than 1 cm² are on the surface of the ground in the snow-free areas around the hut. These materials continue to be fragmented and abraded as visitors to the site walk around the hut. It is not known how much additional asbestos exists under snow and ice, but as it melts the exposed asbestos should be removed. The larger pieces of asbestos can be easily collected, properly contained, and shipped out of the Antarctic for disposal. The smaller sized materials (less than 1 cm²) and materials below ground, however, will require significant effort to collect. The structure that contains the hut used for magnetic observations appears to be functioning. This structure has significant historic value and should remain at the site. Although the current wooden structure covering the hut functions very well to contain the asbestos-lined hut, Antarctica's severe weather is taking its toll on the wood (Blanchette and others 2002). Wind and salt will continually erode the plywood used in the building causing it to delaminate and deteriorate. This structure must be maintained and upgraded in the near future. A more stable and permanent containment building will be needed to insure that the large amount of asbestos in this historic hut remains confined to the building. A structure that can withstand severe storms (and possibly allow visitors to view the magnetic hut through Plexiglass or other similar material) is needed to prevent the possibility of an extremely large amount of asbestos material being broadcast into the environment should the containment structure be destroyed by katabatic winds or other extreme weather conditions.
