## Geotechnical Offshore Seabed Tool (GOST): CPTu measurements and operations in New Zealand

**ABSTRACT:** The Geotechnical Offshore Seabed Tool (GOST) was used in three field campaigns in on- and offshore areas in Tauranga, Bay of Plenty, New Zealand. Offshore measurements were performed along the main shipping channel in the Tauranga Harbor and onshore measurements were conducted at the locations of two landslides at Pyes Pa and Omokoroa. From each of these sites a sample static CPTu profile is described and reviewed. Additionally, a vibratory CPTu from the Pyes Pa landslide is presented. The CPTu results were used for subsurface sediments investigations at the tested locations.

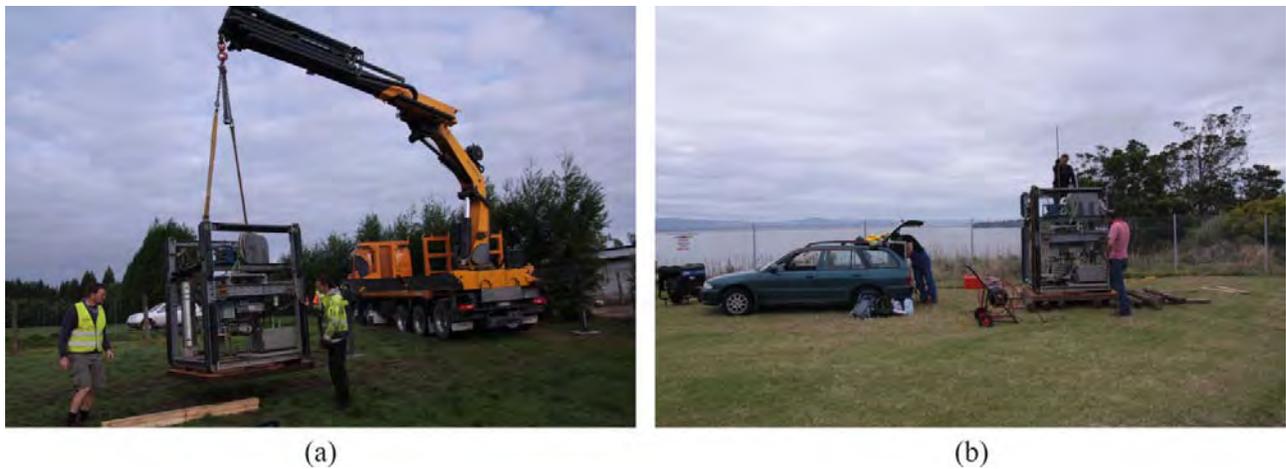
Figure 3. GOST during deployments at (a) Pyes Pa and (b) Omokoroa.

For onshore tests at the Pyes Pa and Omokoroa landslides, instruments were transported to the location and positioned by truck crane, and a mobile generator was used to provide power for the instruments. During two days, two static CPTu, two vibratory CPTu, two remolding tests and one dissipation test were conducted at both landslide locations (Figure 3). Of those, one static and vibratory CPTu performed at the Pyes Pa landslide and one static CPTu performed at the Omokoroa landslide are illustrated in this paper.
