**Location of Te Wahitapu Stream and other possible  
streams in 1877**

**30 April 2009**

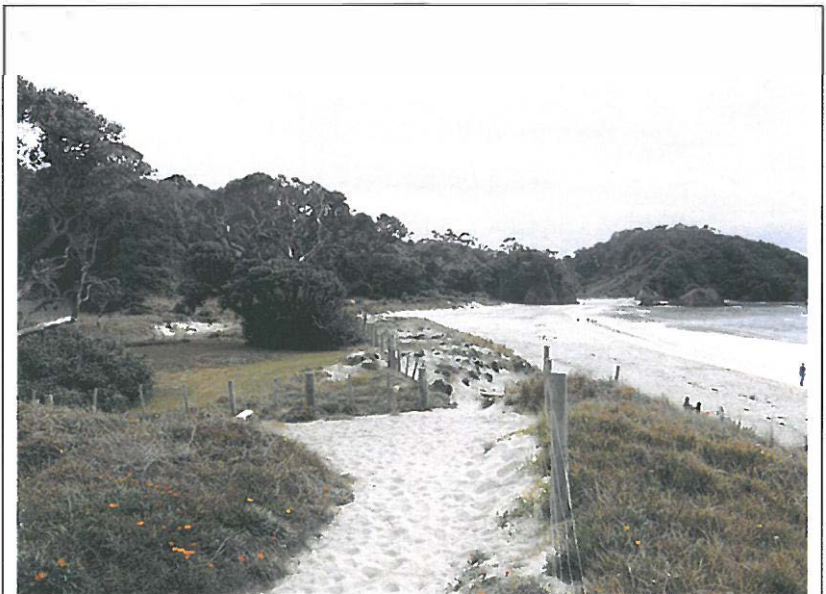
**Plate 1.** Northern end of Matapouri Beach looking towards the mouth of Te Wahitapu Stream

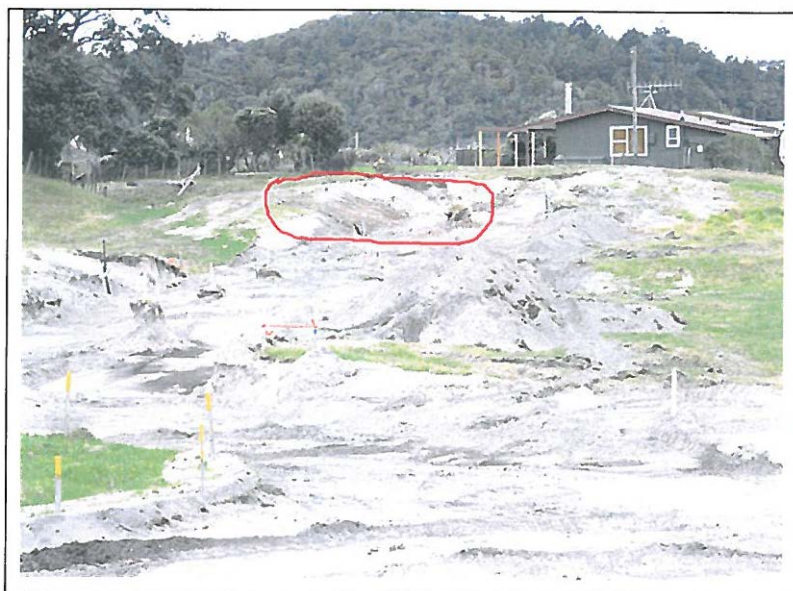
**Plate 3.** Earthworks through the hummocky topography shown in Plates 2A & B. Scattered gravels are evident throughout the deposit. The red outline was on the image provided and highlights coarse material.

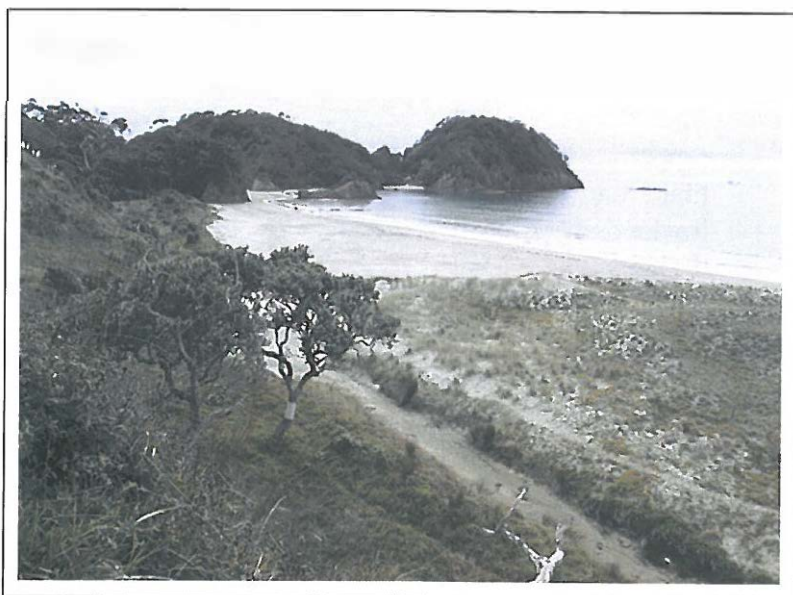
**Plate 4.** Mouth of the Te Wahitapu Stream looking NE. Migration northwards is limited by rock headland. Migration southwards has occurred as evidenced by the lowered dunes.
