# CURRENT STATE OF THE ROTORUA LAKES

**Professor David Hamilton, BSc PhD**

## **ABSTRACT**

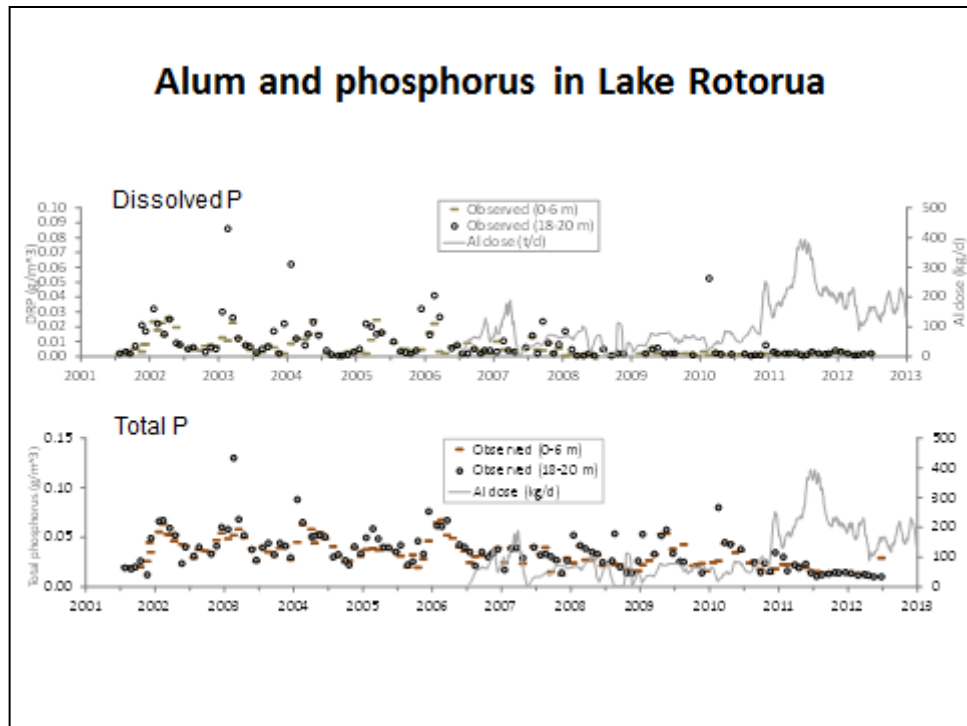
Slide 14

At the same time any increase in phosphorus loads are being offset by the alum dosing. **Slide 14** looks at dissolved phosphorus and total phosphorus concentrations in Lake Rotorua. There is a peak of alum dosing of nearly 400 kilos per day in 2011. The consequence of this was to sediment out the phosphorus, and concentrations decreased to about 15 milligrams per cubic metre. The average concentrations through the early 200's were about 40 milligrams per cubic metre and so they have more than halved over the period of alum dosing.

At the same time we looked very closely at the inflows to Lake Rotorua to ask if the inflows were the driver of the improvements in water quality. Not at all; in fact one of the challenges has been that with the climate of recent years the amount of phosphorus coming into the lake has, if anything, increased at the same time as the concentrations within the lake have decreased very substantially. We are obviously seeing the impact of the alum dosing.

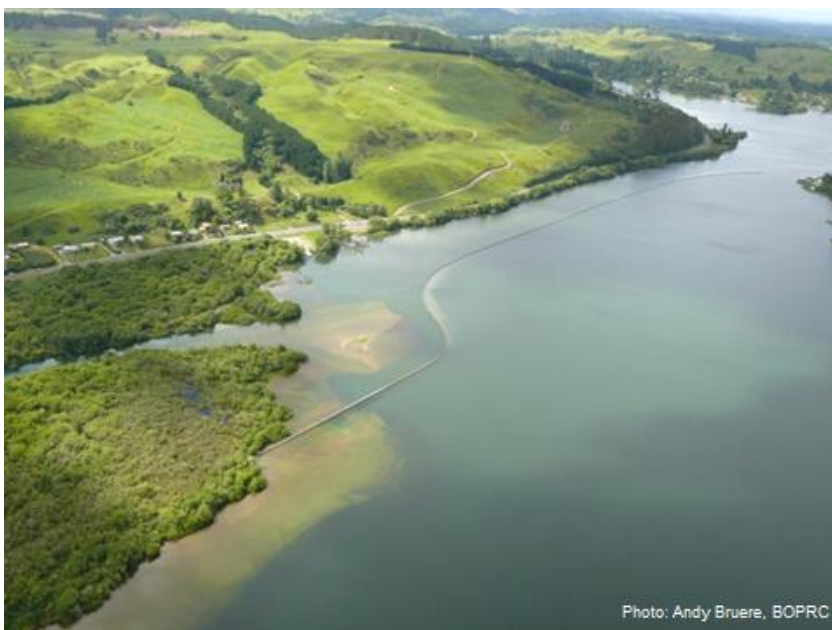
Slide 18

I cannot do justice to covering scientific aspects of the 12 (or 14) lakes in this region. **Slide 17** shows Rotoiti in the summer of 2003/4. We know that the Ohau Channel diversion wall was highly effective. **Slide 18** is the situation once the wall is in place. Water from the Ohau Channel is diverted by the wall down into the Kaituna System. One can see very clearly in **Slide 19** the sediment levels. Rotorua has moderate levels of suspended sediment that are reflected in the satellite image and they are transported

down the Kaituna Maketu system. The diversion is highly effective in taking that water away, and with it about 60% of the nutrient load from Lake Rotorua. The result has been quite a remarkable recovery of Lake Rotoiti. The final stage is to have oxygen persist in the bottom waters over the entire summer period.

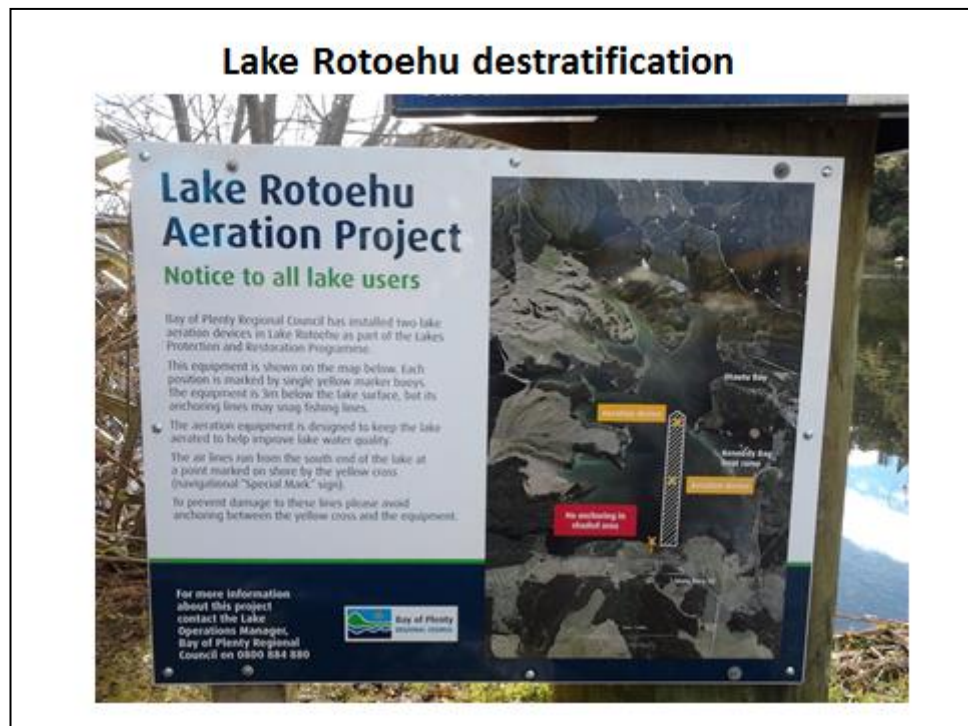
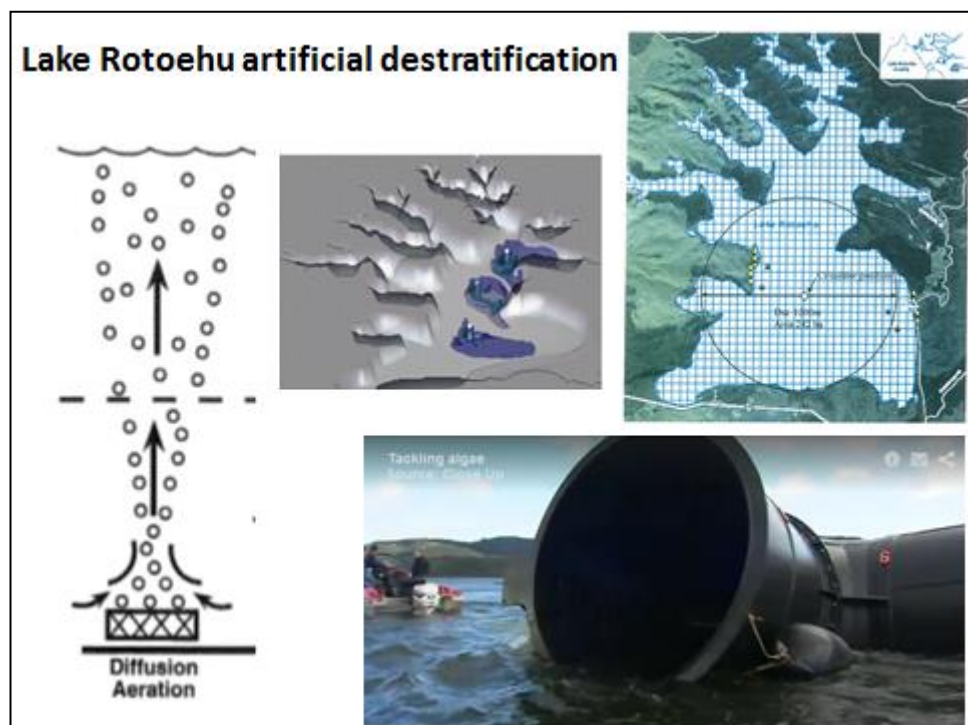
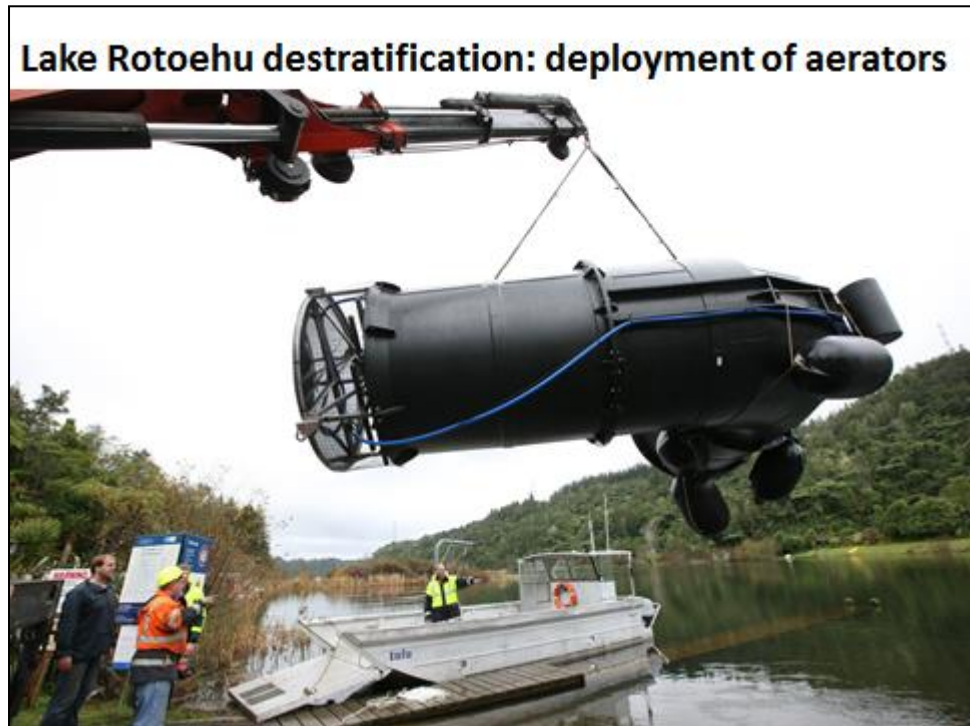
Slides 21, 22 and 23 show the large aeration device and the complimentary management programmes on the lake such as alum dosing and weed harvesting (Slide 24).
