Towards a Better Understanding of Coastal Cliff Erosion in Waitemata Group Rock; Auckland, New Zealand

A thesis submitted in partial fulfilment
of the requirements for the
Degree of
Master of Science in Earth and Ocean Sciences
at the
University of Waikato

Jessica Emily Bell

2007

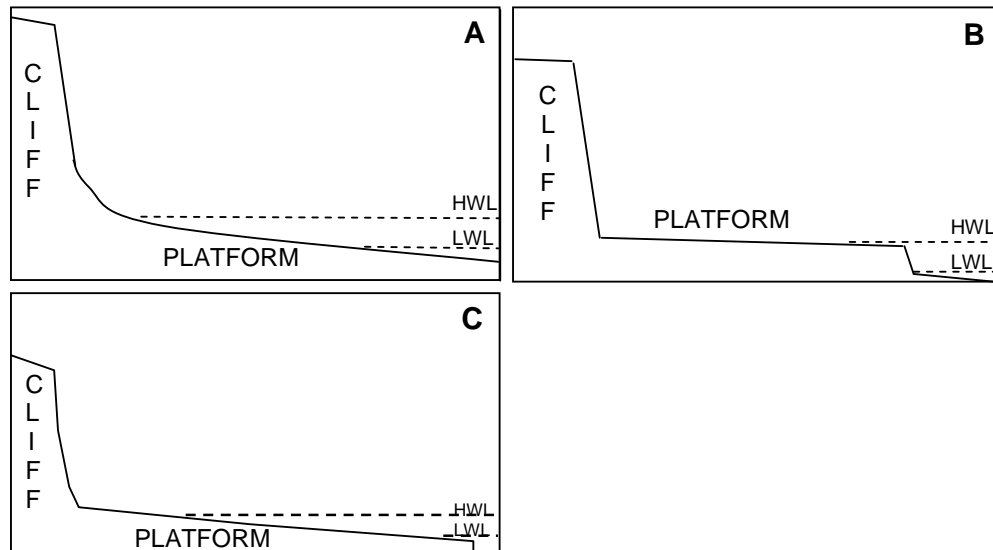
Figure 2.6: Schematic sketches of shore platform types. A is a sloping ‘Type A’ platform and B is a sub-horizontal ‘Type B’ platform which has a low tide cliff at its edge (modified from Sunamura, 1992). C is a broad intertidal platform (interpreted from Healy and Kirk, 1992)

Healy and Kirk (1992) defined platform morphology of New Zealand coasts into high-tidal benches (similar to Figure 2.6B) and broad intertidal platforms (Figure 2.6C). High-tidal benches are similar to the aforementioned Type B platforms but are classified for development at the high-tide level and occur in more indurated lithologies (Healy and Kirk, 1992). These benches have been noted to occur in the Waitemata Harbour where 2 - 3 m thick massive sandstone beds are exposed at the cliff (Healy and Kirk, 1992). Broad intertidal platforms develop in more porous, less-indurated rock than for high-tidal benches, and are gently sloped with a seaward

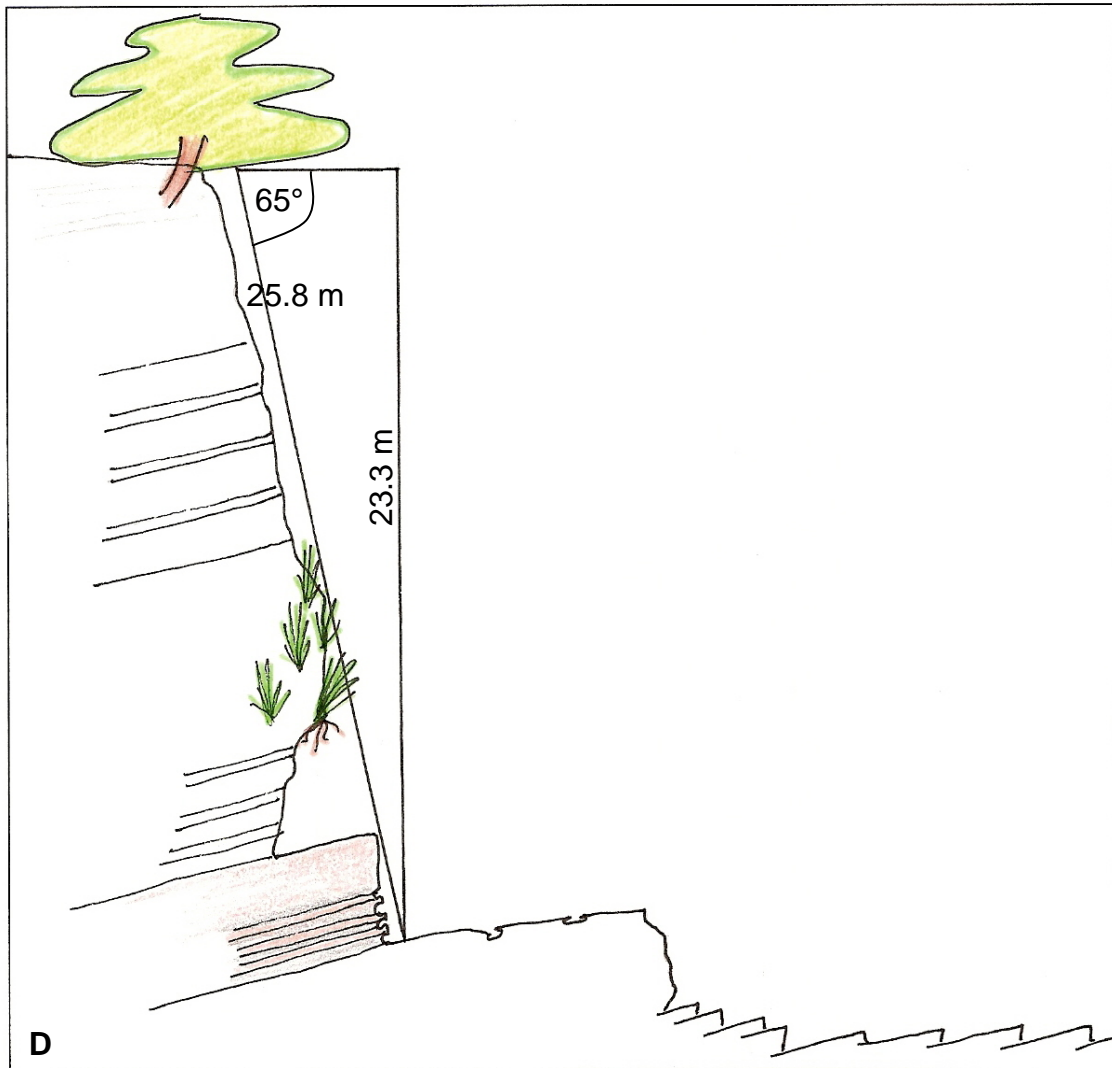
Figure 4.9: Photographs and sketch of the described Achilles Point cliff section. A: Cliff face. B: Bedding, note 3 joint sets leading to block fall in sandstone bed. C: Shore platform in Parnell Grit rock. D: Sketch of bedding and shore platform characteristics.

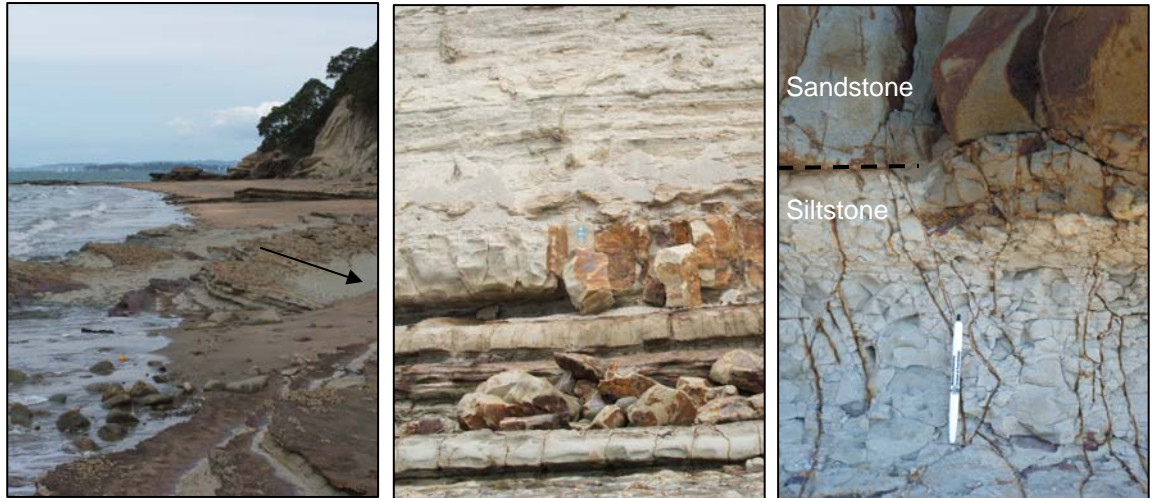
Figure 4.11: Photographs and sketch of the described Narrowneck Beach cliff section. A: Cliff profile and narrow shore platform; beds dip is marked by black arrow. B: Cliff face; flysch beds with fallen sandstone blocks. C: Close up of iron-stained joints; dashed line indicates boundary between sandstone & siltstone. D: Sketch of bedding and shore platform characteristics.

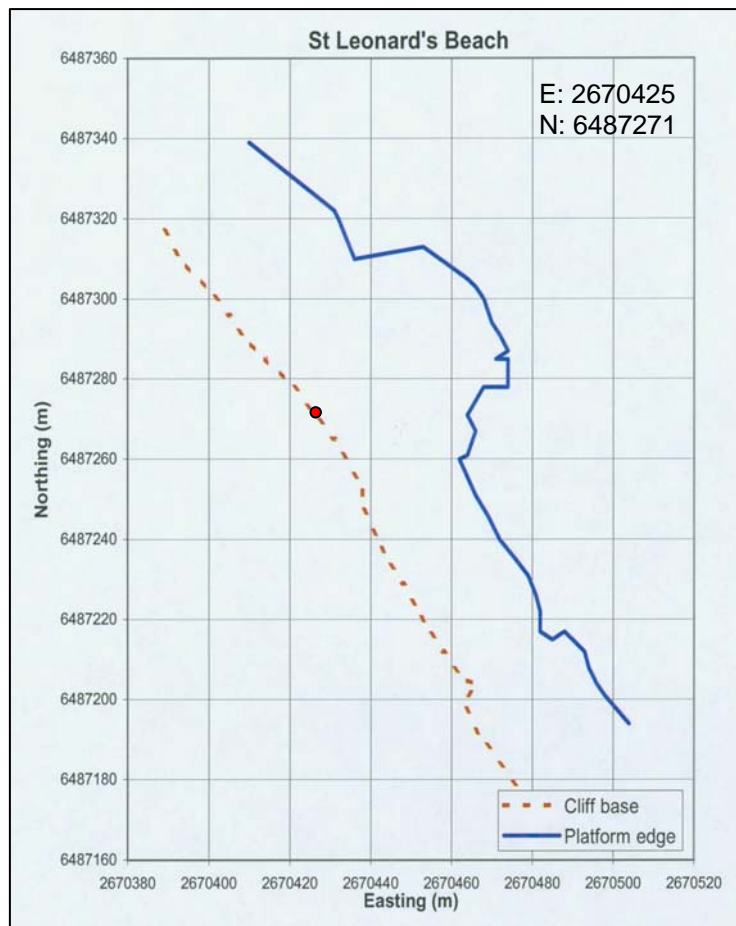
Figure 4.12: Shore platform plan morphology of St Leonard’s Beach.

The cliff site has a high prominent face with many faults. A few grasses and small shrubs are scattered across the cliff but are fairly sparse, Pohutukawa trees overhang the cliff top. Gully erosion is observed at the cliff top along weaker discontinuities which are probably faults. The cliff has predominantly equal amounts of siltstone and sandstone and beds are < 30 cm thick, except for the upper top 10 m of the cliff where there are 3 thick sandstone beds (~ 1 m thick each, light silvery grey, no orangey/yellow staining). The wind was observed to continually clean away small broken (mainly siltstone) fragments. The sandstone beds are laminated and some show convolutions. There is some waviness between the boundary of the lower siltstone and upper sandstone, and a sharp contact with the top of the siltstone and base of the upper sandstone. The sandstone beds tend to grade into upper siltstone. The sandstone beds in the shore platform have a massive base with a convoluted upper which also grades into siltstone (classic Bouma sequence). The shore platform has about three levels (a high narrow platform that is around the base of some of the cliff, a lower ledge which is stepped and strongly dipping, and a lowermost platform which has a sloping profile covered by varying amounts of rock and sand. The shore platform changes noticeably where a fault or series of faults cuts through.

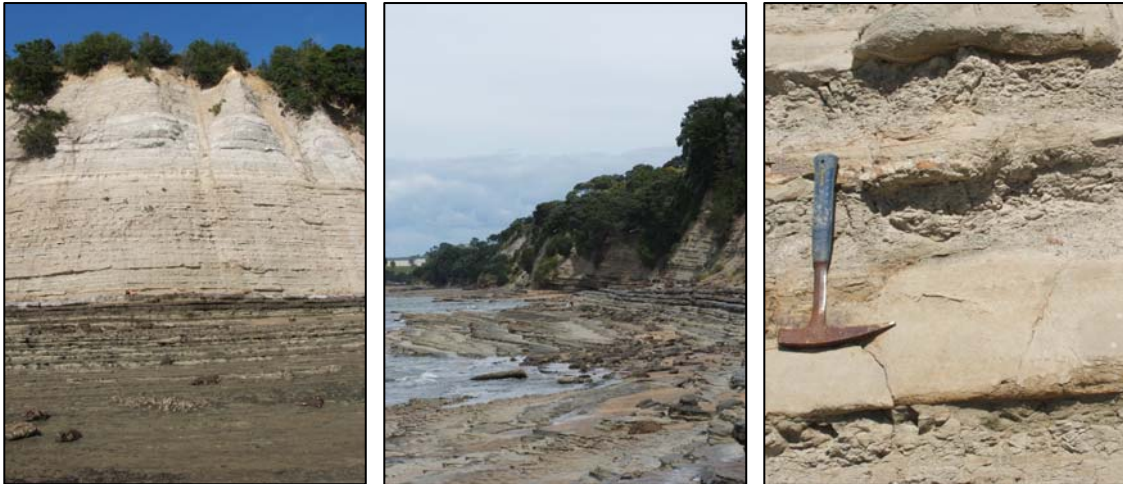
Figure 4.13: Photographs and sketch of the described St Leonard's Beach cliff section. A: Cliff face with upper gully erosion. B: Cliff profile and shore platform. C: Sandstone and siltstone beds; note sharp contact of sandstone base and grading into upper siltstone. D: Sketch of bedding and shore platform characteristics.

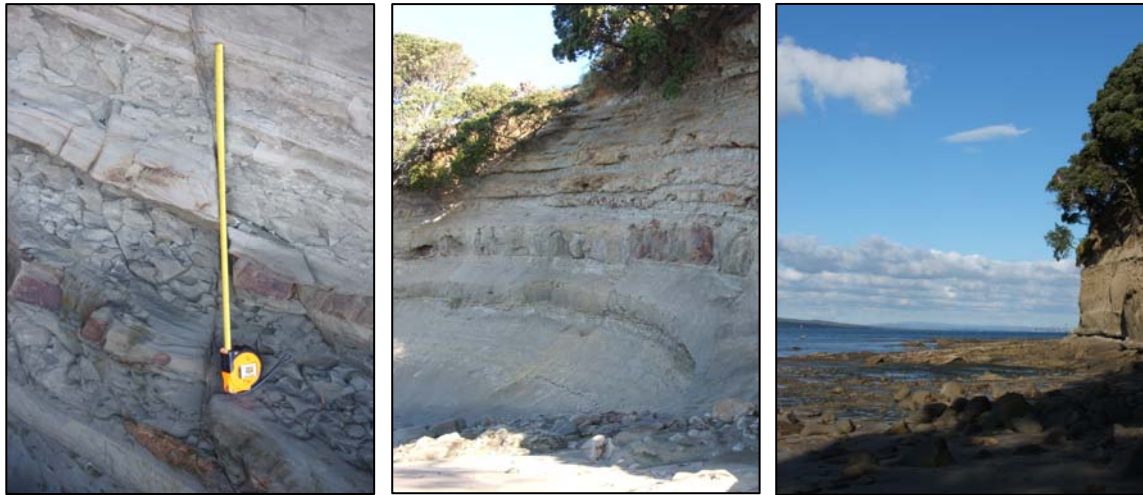
Figure 4.15: Photographs and sketch of the described Castor Bay cliff section. A: Close up of sandstone and siltstone beds; tape sits on fault plane. B: Cliff face; beds dip steeply seaward. C: Cliff profile and shore platform. D: Sketch of bedding and shore platform characteristics.

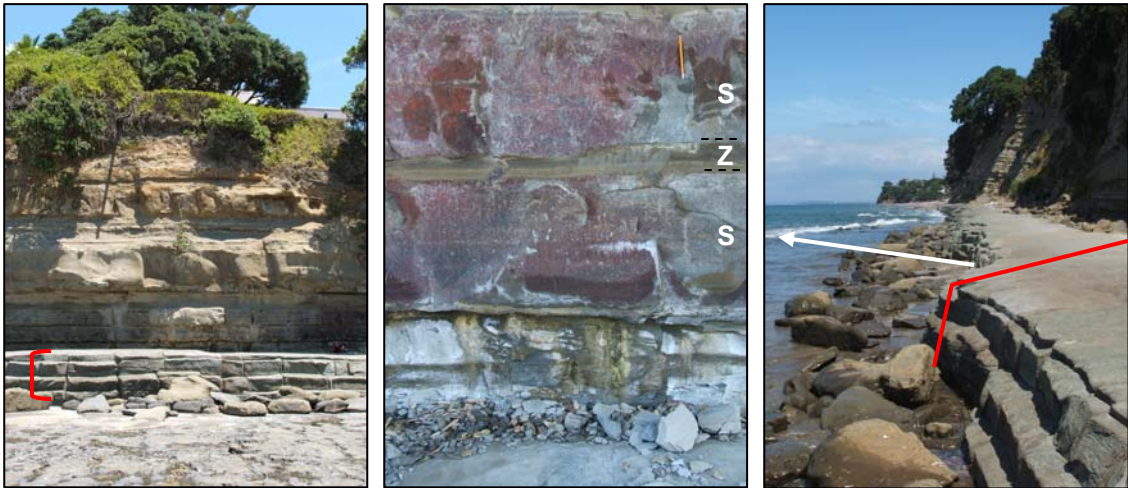
Figure 4.17: Photographs and sketch of the described Mairangi Bay cliff section. A: Cliff face with lower encased sewer pipe (red bracket) which acts as a sea wall. B: Dark iron-stained sandstone joint faces; thin siltstone bed is between dashed lines. C: Cliff profile and shore platform (extent is marked by white arrow); sewer pipe is marked by red line. D: Sketch of bedding and shore platform characteristics.

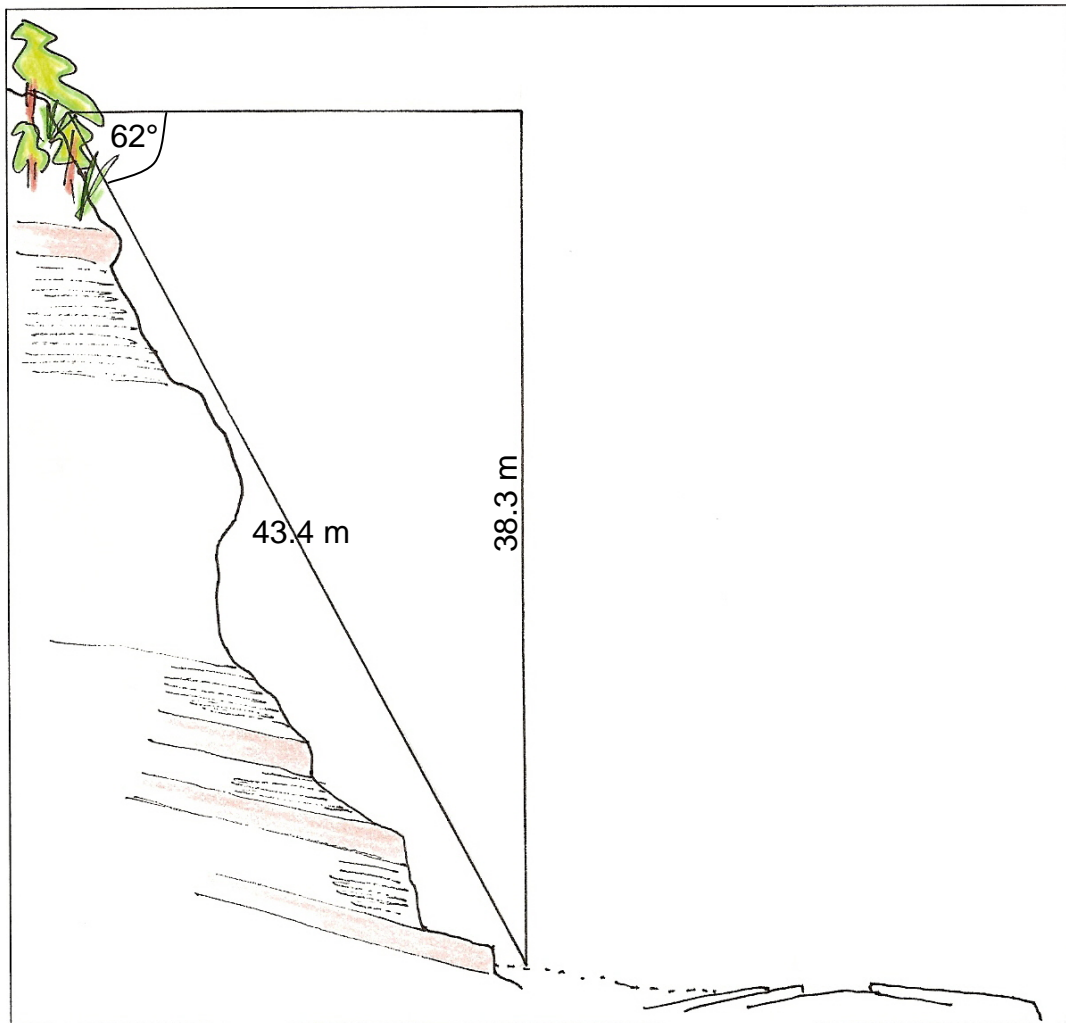
Figure 4.21: Photographs and sketch of the described Army Bay cliff section. A: Cliff face with very thick Parnell Grit mid-section (outlined by black line). B: Heavily jointed, seaward dipping beds. C: Cliff profile and shore platform; dashed line marks the cliff base and the arrow marks the direction from the described cliff base (dot) to the seaward margin of the platform (arrowhead). D: Sketch of bedding and shore platform characteristics.

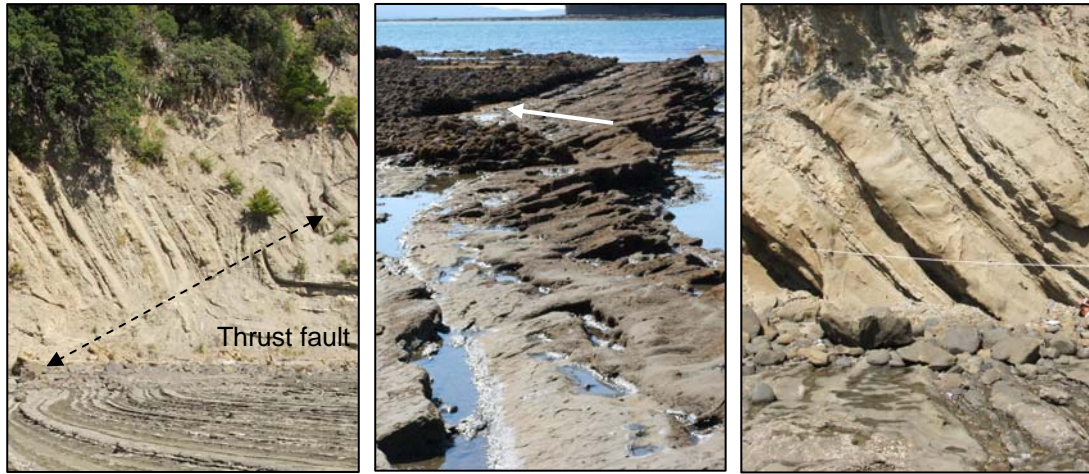
Figure 4.23: Photographs and sketch of the described Waiwera Beach cliff section. A: Cliff profile showing the intensely folded beds also evident in the shore platform. B: Shore platform with seaward dipping beds; dip direction is marked by the white arrow. C: Sandstone and siltstone beds of the described section; note undercutting of sandstone beds by siltstone. D: Sketch of bedding and shore platform characteristics.

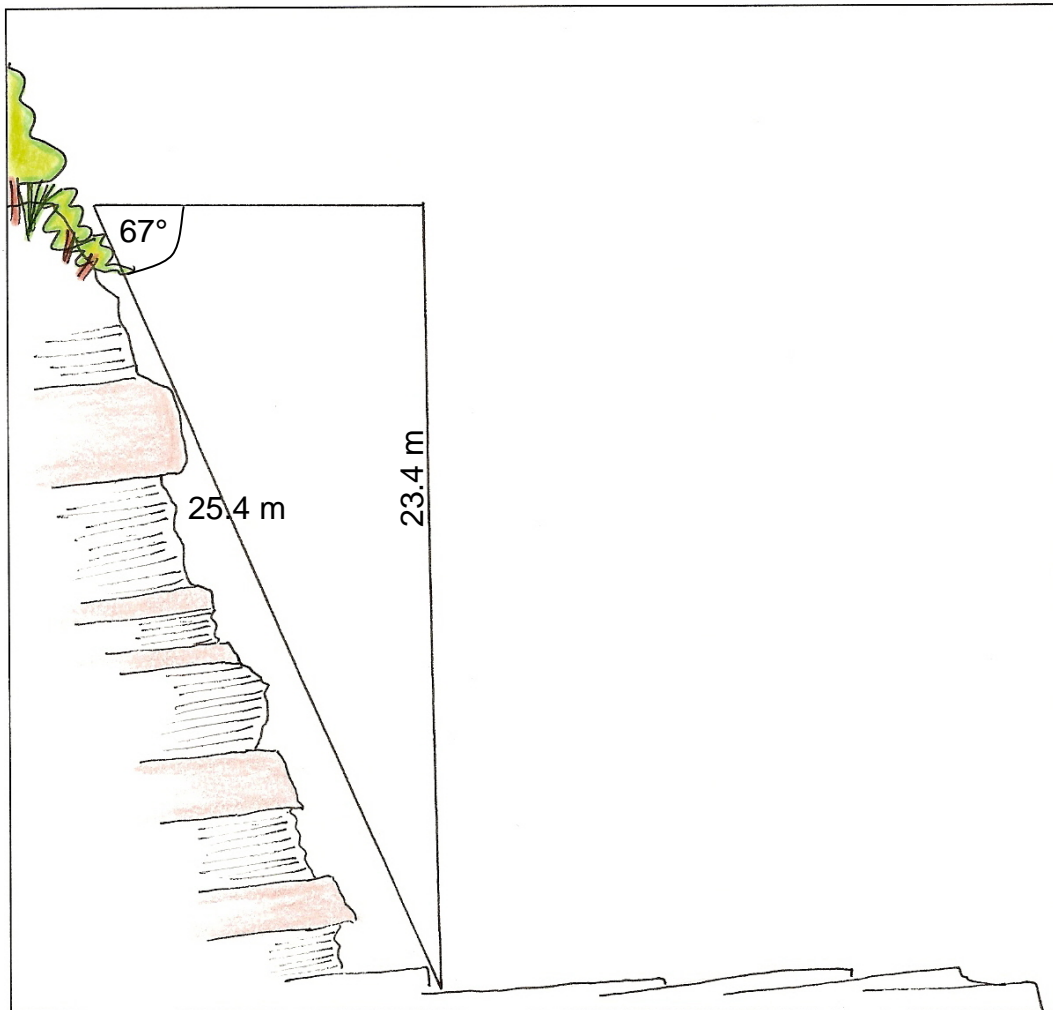
Figure 4.27: Photographs and sketch of the described Martins Bay cliff section. A: Cliff face with prominent thick sandstone bed mid-section (black arrow). B: Sandstone and siltstone beds; base of sandstone bed has a sharp contact (just above white tape measure) and the upper sandstone bed grades into siltstone. C: Shore platform with boulder-littered cliff base in the foreground. D: Sketch of bedding and shore platform characteristics.

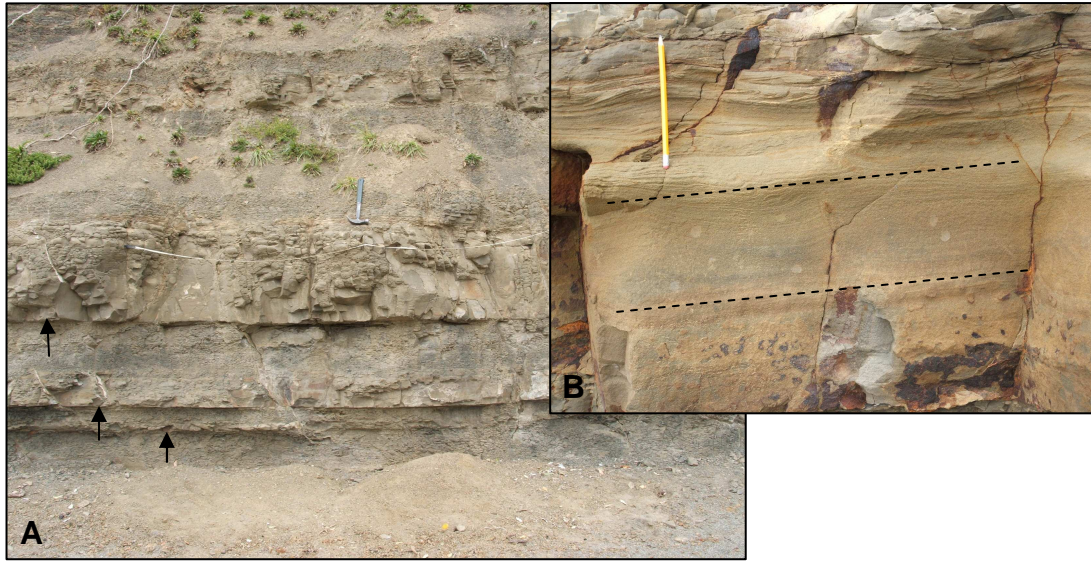
Figure 4.38: Sandstone beds of turbidite deposits. A: sandstone beds (base marked by arrows) grading upwards into siltstone from the Leigh Marine Reserve cliff site. Note hammer for scale. B: Sandstone bed transitioning from lower massive zone, to mid parallel laminated zone to upper convoluted zone at St Leonard's Beach; boundaries marked by dashed lines; 15 cm pencil length for scale.

Sandstone beds from turbidite units in Waitemata Group rock are recognized in the field as prominent beds of the cliff section that, most simply, do not contain clasts larger than sand-size (Figure 4.38). The sandstone is commonly light orange-yellow grey and beds range in thickness from thin (20 - 60 mm) to very thick (> 2 m) following the NZGS (2005) classification. Bed thickness varies between sites and within one cliff section. The sandstone beds are the basal portion of a turbidite unit and grade normally into finer grained sands then hemipelagic silt and mud, although the main bulk of the sandstone bed is often massive. The base of the sandstone unit is a sharp boundary (Figure 4.38A). At the majority of sites sandstone blocks are lined with limonite and at three sites had a hard calcite lining. More incoherent and/or weathered sandstone blocks and were covered in dust, and occasionally halite. The sandstone beds are porous (Simpson, 1987). Joints sets predominantly include a sub-horizontal bedding plane plus 2 - 3 sub-vertical joints at various orientations, perpendicular and parallel to the strike of the cliff face. Grain size was noted by de la Mare (1992), who carried out detailed grain analysis on Waitemata Group sandstones, as fine to medium sand and generally well sorted. Simpson (1987) measured that the sandstones contain up to 10 % clay and are non-calcareous. Fizzing from weak hydrochloric acid on joint surfaces at the sites of this research confirms calcite infill rather than calcareous sandstone material.

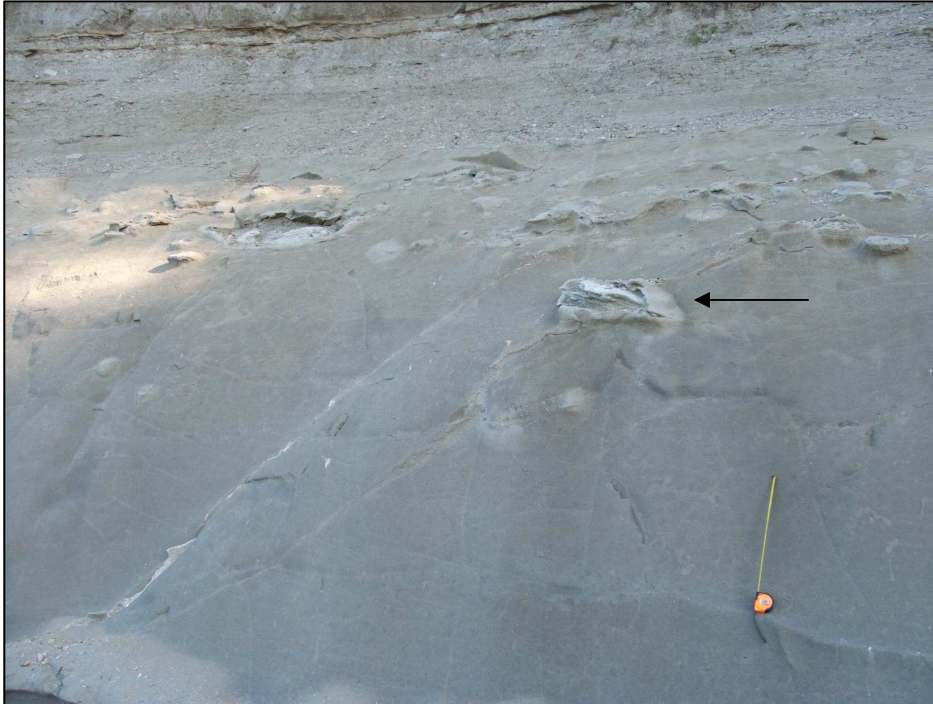
Figure 4.39: Sandstone bed of a densite deposit at Castor Bay. Note siltstone clasts in the mid to upper portions of the bed (marked by an arrow) and lack of joints. Tape measure indicates 80 cm.

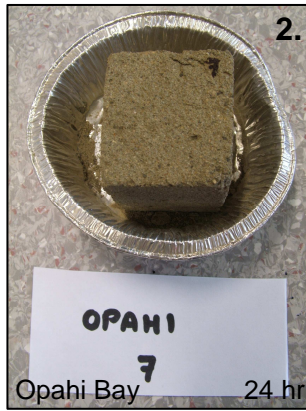
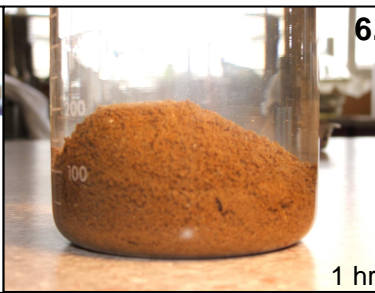
Note swelling at the corners of this block

Figure 5.4: Various stages of the modified jar slake test. The I_j' value is written at the top right corner of each photograph.

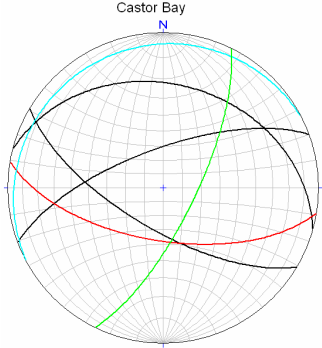
<p>No dominant mechanisms for failure. Because of the number of intersecting discontinuities there is opportunity for wedge failure. However, there are no intersecting discontinuities with respect to the cliff face and there is only one intersection between the fault plane and joint 68/211 which have orientations close to within 20° of each other.</p>
<p>Waiake Bay</p>

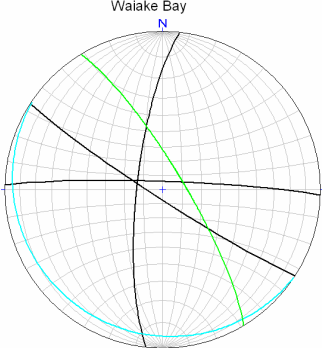
<p>There are three intersecting joints but these do not follow kinematic guidelines for failure. Otherwise, no notable mechanisms for failure.</p>
<p>Army Bay</p>

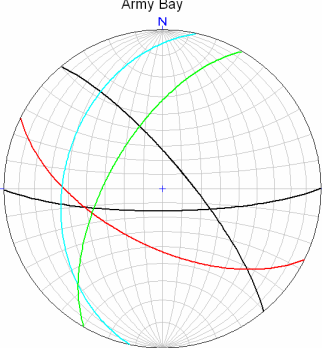
<p>Evidence for planar failure along bedding plane 37/282. The number of intersecting discontinuities may contribute to wedge failure however there are no intersections which have the kinematic specifications required for failure.</p>
<p>Waiwera Beach</p>

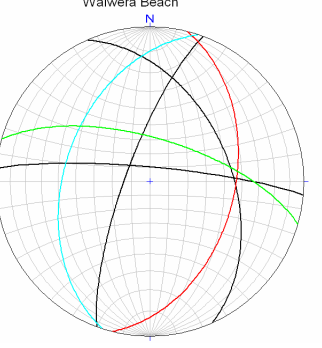
<p>Evidence for planar failure along joint surface 82/005, except the dip angle of the planar discontinuity, 82°, is more than the dip angle of the slope face, 67°. The number of intersecting joints gives a propensity for wedge-type failure.</p>

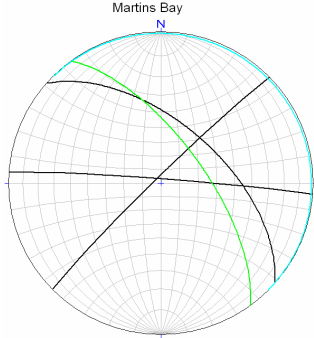
Evidence for planar failure along joint surface 58/041 and separately along the bedding plane. The bedding plane has a very low (01°) dip angle though so planar failure is unlikely. Potential for some wedge-type failures due to the number of intersecting discontinuities however no intersections follow the kinematic requirements for failure.
Leigh Marine Reserve

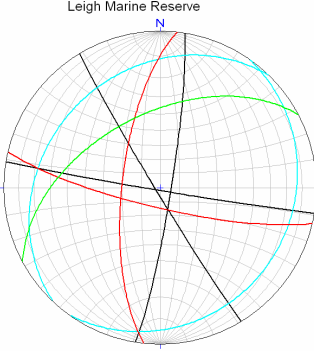
Evidence for planar failure along bedding plane 26/314, however the dip angle difference is $>20^\circ$, at 25° , and numerous intersecting discontinuities gives a propensity for wedge-type failure, particularly the bedding intersection with joint 88/239.

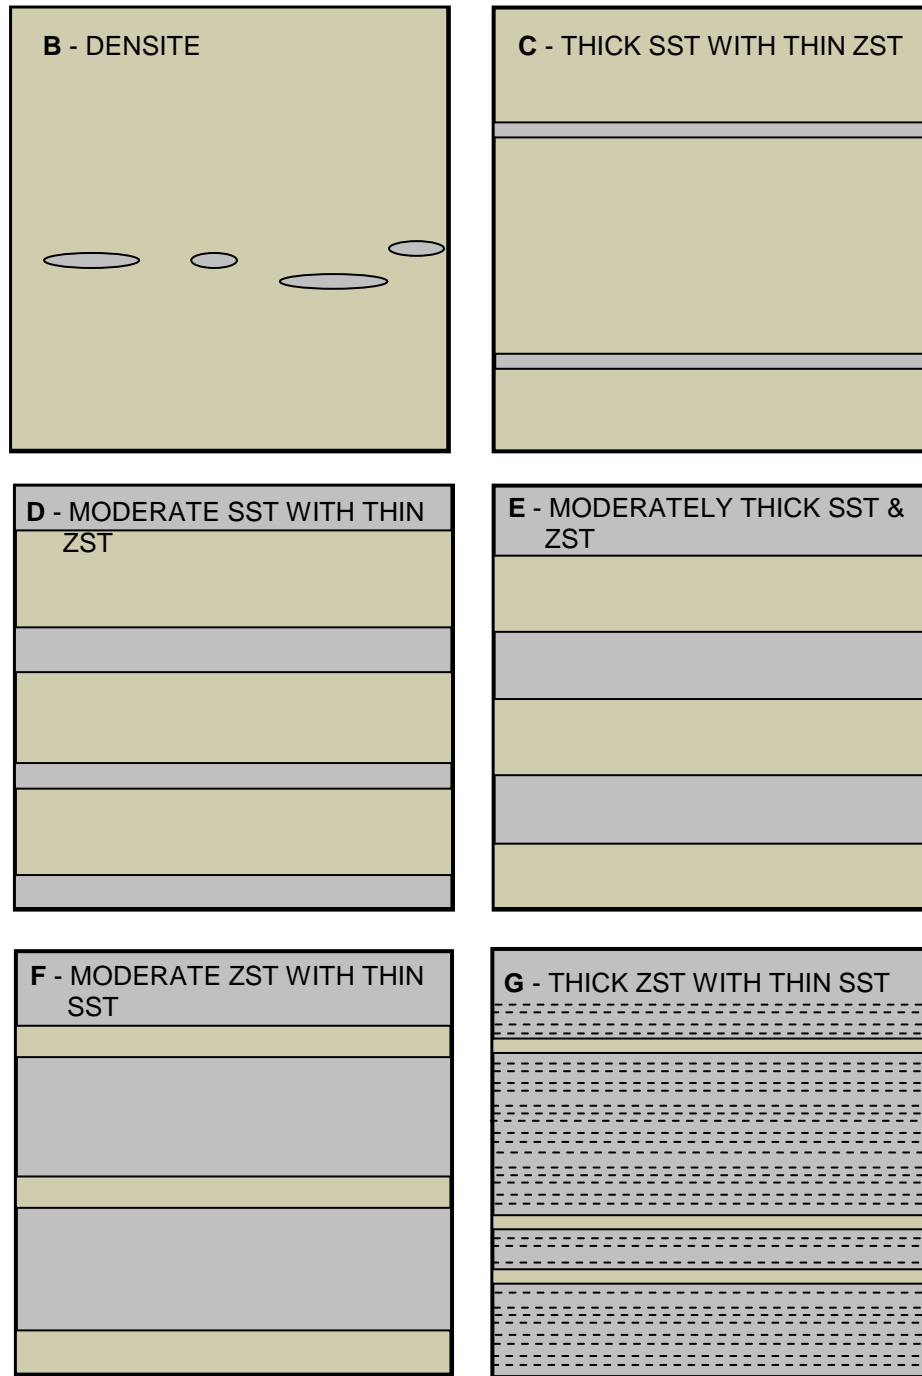
Figure 5.6: Relative thicknesses of sandstone and siltstone beds for each class (B-G). Class A is considered to be 100% sandstone. SST = sandstone (brown); ZST = siltstone (grey).

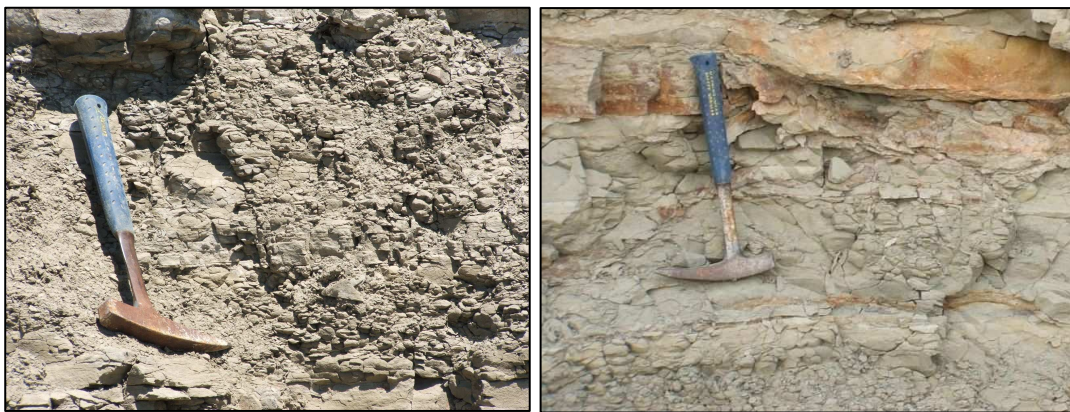
Figure 7.2: Highly-frittered siltstone is readily blown away by wind and washed away by rain as at Martins Bay (left) and Army Bay (right).

Siltstone beds are the weak, easily eroded material of Waitemata Group coastal cliffs, and therefore, their dominance in a cliff section will influence erosion rates and the mode of cliff recession. Physically, frittered siltstone rock can be easily removed by wind and rain from the cliff surface than more intact materials (Figure 7.2). In some locations, the siltstone does not fritter; erosion may still occur, albeit at a slower rate, through continual removal of the dusty surface but intact blocks do not appear to readily fall out (Figure 7.3).

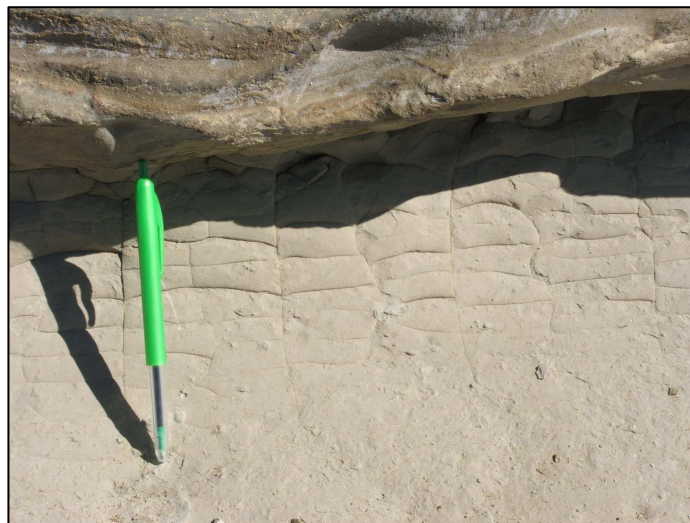
Figure 7.3: Siltstone is more competent at Cockle Bay; the regular closely-spaced joints are still exhibited but loose, curved siltstone fragments that are easily removed from the cliff face are not apparent.
