RECOGNISING THE NEGATIVE IMPACTS OF AQUATIC WEED MANAGEMENT: OKAWA BAY, LAKE ROTOITI CASE STUDY

ABSTRACT

We examine the impact aquatic weed decomposition has had on Okawa Bay's nutrient status and the cyano-bacterial blooms over recent summers, and Bay of Plenty Regional Council's response to reduce localised bloom development.

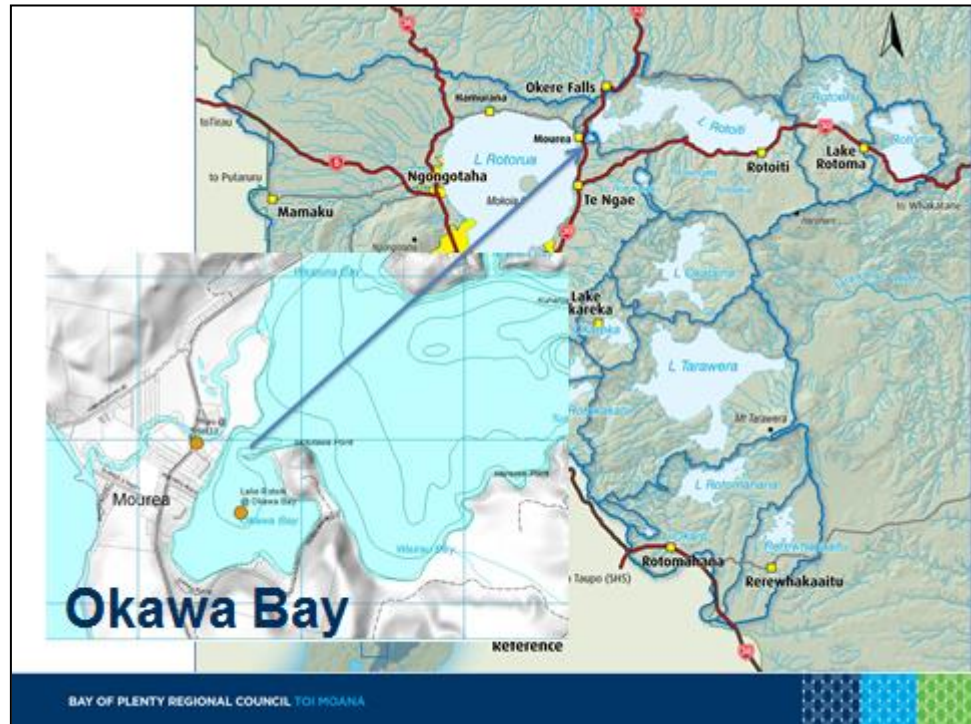
Slide 1 shows Okawa Bay on the western side of Lake Rotoiti, a 45 hectare embayment connected to the greater lake of Rotoiti. Its maximum depth is just over 5 metres, so it is quite a shallow embayment. There has been some action in recent times to improve water quality; sewage reticulation in 2006 and, of course, the Ohau diversion wall. This has improved the water quality of the greater Rotoiti lake and it has had a flow on effect into Okawa Bay.

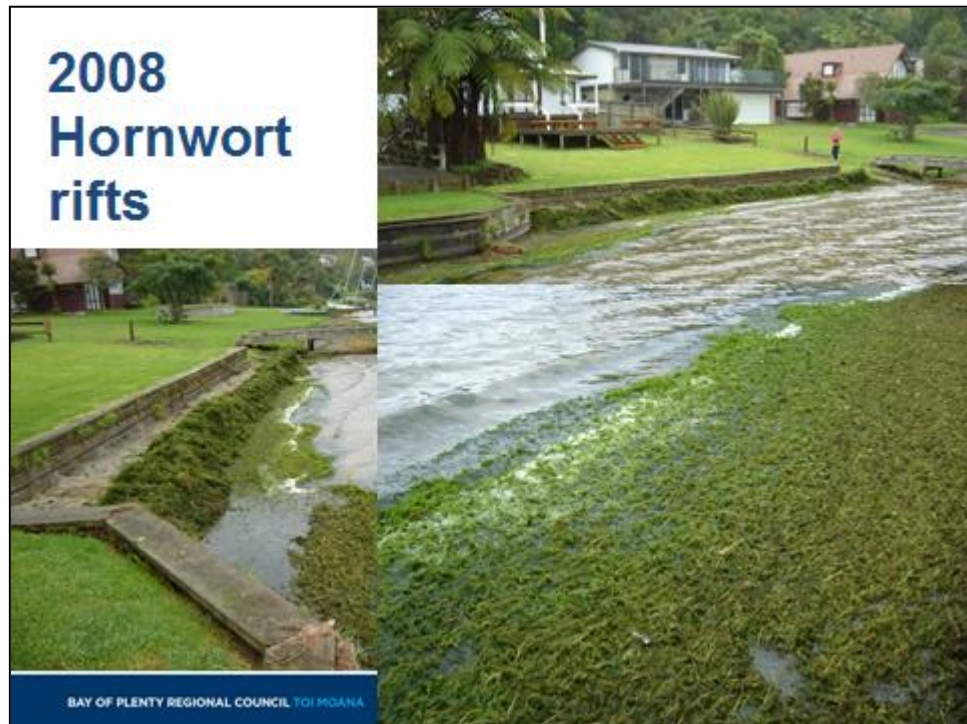
Slide 3

the Council into action and water clarity improved. As a result of this, there was a shift in algal dominance to macrophyte dominance up until 2008. The result was scenes like these large drifts of hornwort washing up on shore. **(Slide 3)** This picture was taken in the autumn of 2008 and the increased water quality encouraged the hornwort to really take off.
