Is There a Salty Solution to Sensitive Soil Sliding in the Bay of Plenty, New Zealand?

A thesis
submitted in partial fulfilment
of the requirements for the degree
of
Master of Science (Earth Sciences)
at
The University of Waikato
by
Thomas Robertson

2017

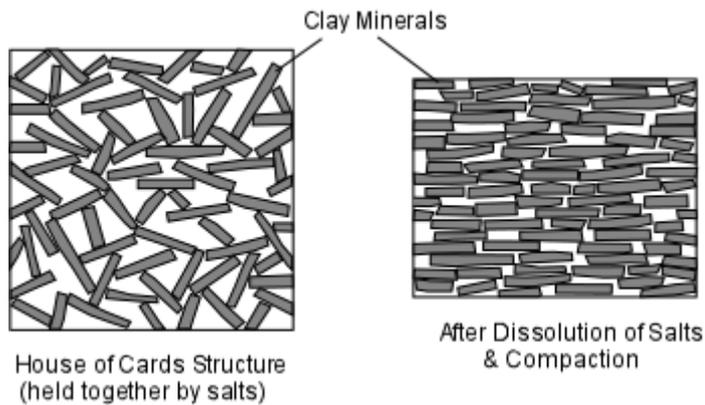
Figure 2.1. Salt precipitates in the pore spaces, allowing a ‘house of cards’ structure. Upon leaching, salts dissolve and this structure is lost. Figure source: <http://www.toulane.edu>

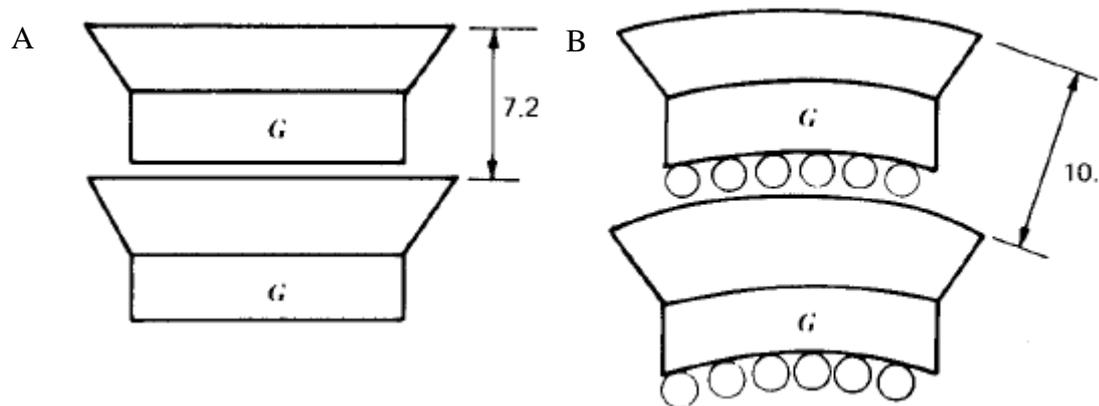
Figure 2.2A. A profile image of the proposed arrangement of a pair of halloysite units in its dehydrated form, with a basal space of 7.2\AA identified. The halloysite unit is made up of a aluminol sheet, denoted with the letter G, with an overlying silanol sheet on top of it. **2.2B.** An image idea of the shape of a hydrated halloysite unit, with the silanol sheet stretching to accommodate the water present in the intra-clay basal space source Joussein *et al* (2005).

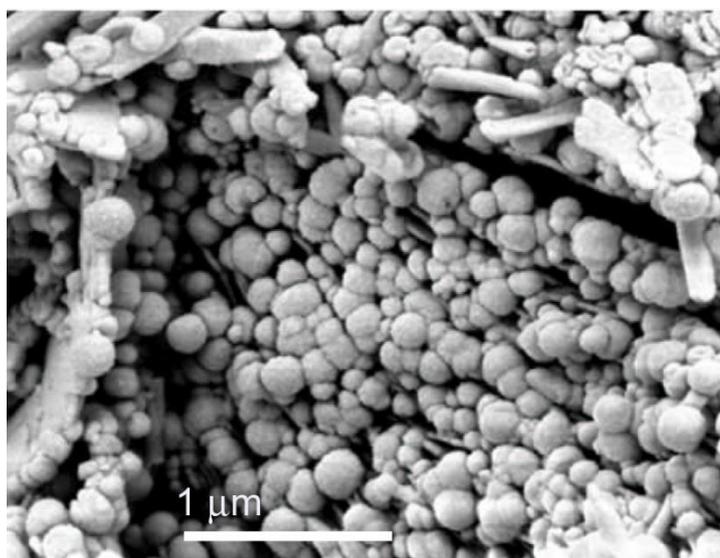
Figure 2.3. SEM imagery of spherical halloysite, with some tubular halloysite present within the image at a high magnification. Image sourced from <http://www.minersoc.org>.

As observed in Table 2.3 spheroidal and pseudo spherical halloysite have been found to occur in a variety of environments with the primary source of these spheroidal halloysite forms a result of weathering of volcanic ashes and pumiceous deposits. The spheroidal shape occurs as a product of deposition of halloysite from super saturated solutions of weathered volcanic glass derivatives (Sudo, 1953; Nagasawa & Miyazaki, 1975; Kirkman, 1977; Tazaki, 1979; Noro, 1986; Joussein *et al.*, 2005). An example of this spheroidal halloysite can be seen in figure 2.3.

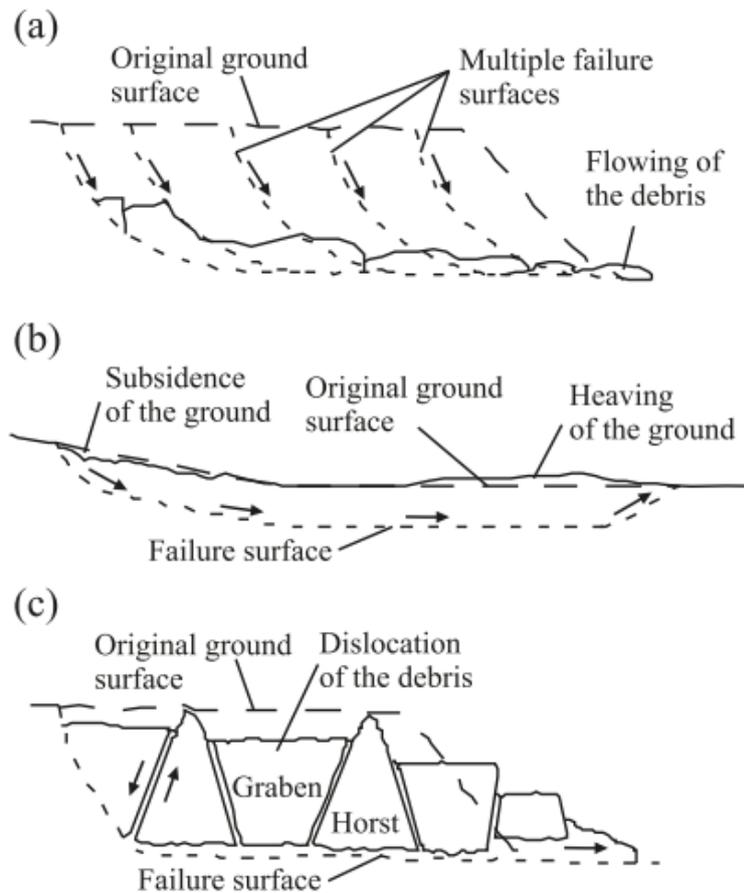
Figure 2.4. Three of the four main types of failure that occur in sensitive clays; (a) multiple regressive slide/flows, (b) translational progressive slides, (c) spreads (Locat *et al.*, 2011)

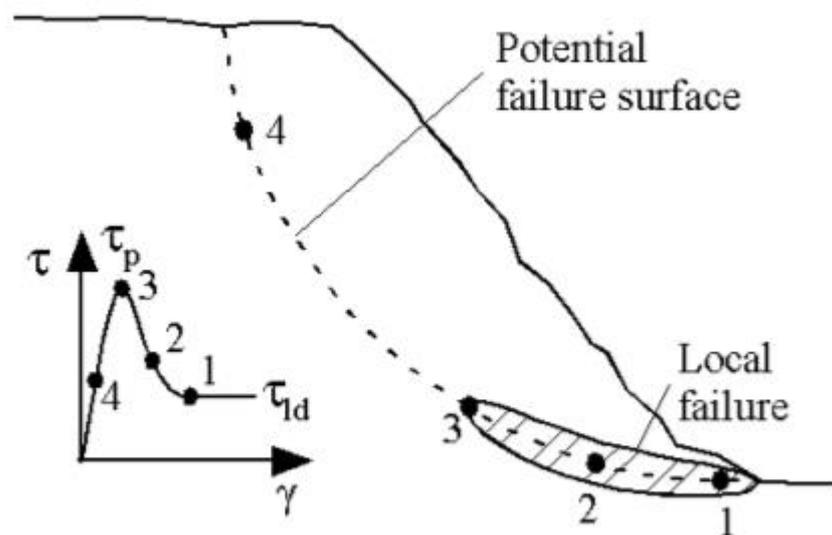
Figure 2.5. Progressive failure along a circular failure surface, related to the shear stress/strain curve. At points 1 and 2, the soil is becoming fully remoulded as a result of local failure, at point 3 there is a sharp strain increase, and at point 4 strain gradually increases from loss of underlying strength (Locat *et al.* 2011)

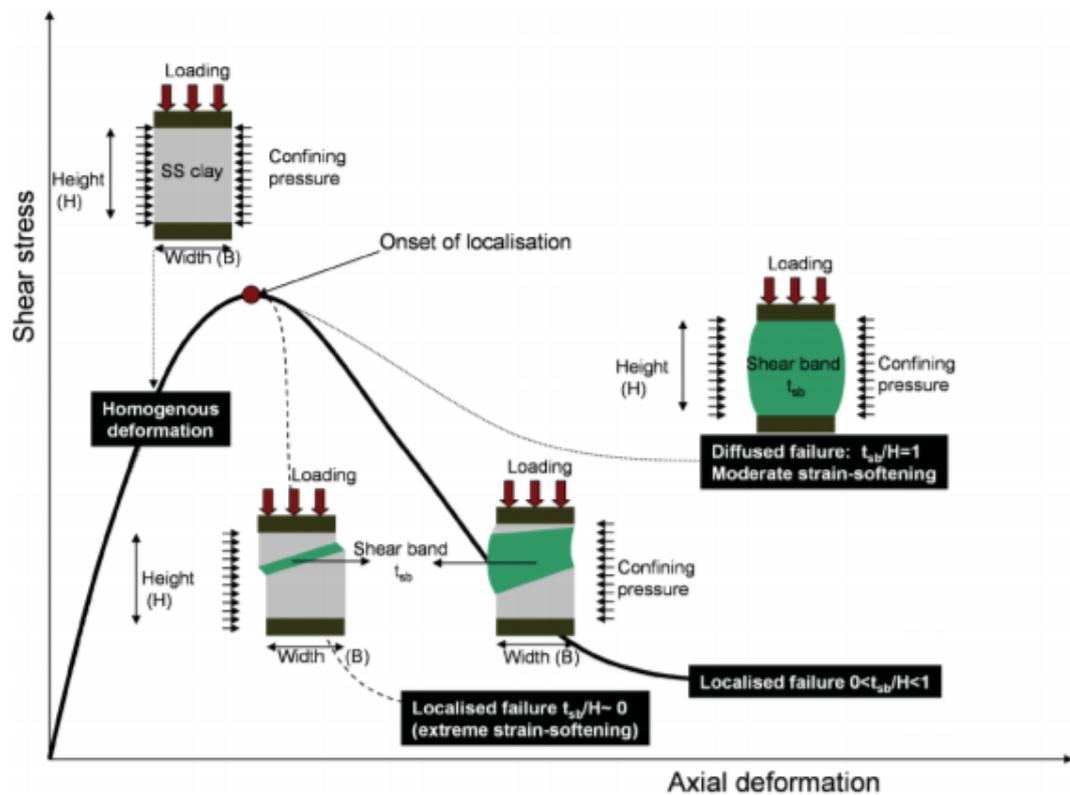
Figure 2.6. An idealised diagram of Thakur’s strain modelling, showing a shear band with decrease with increasing deformation rate. The shear bands thickness is dependent on post-peak strain softening of sensitive clays (Thakur, 2011).

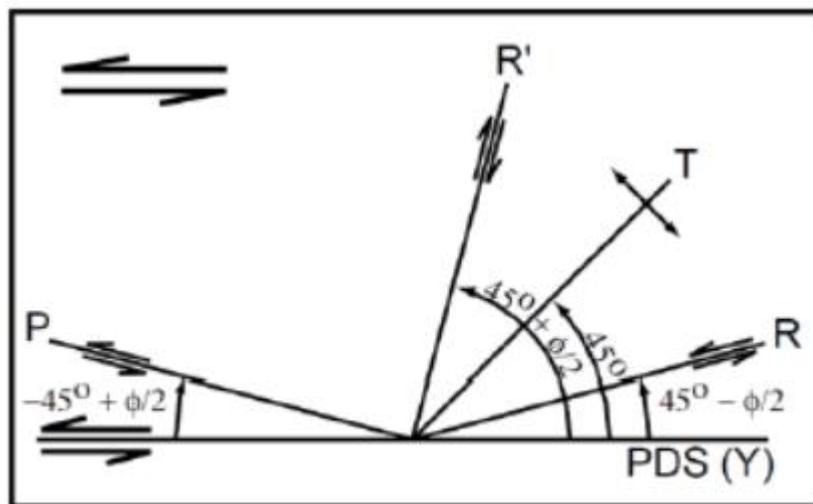
Figure 2.7. The relationship between the orientation of Riedel shears and thrust shears to the friction angle (Φ) of the material (Ahlgren, 2001 after Skempton, 1966)

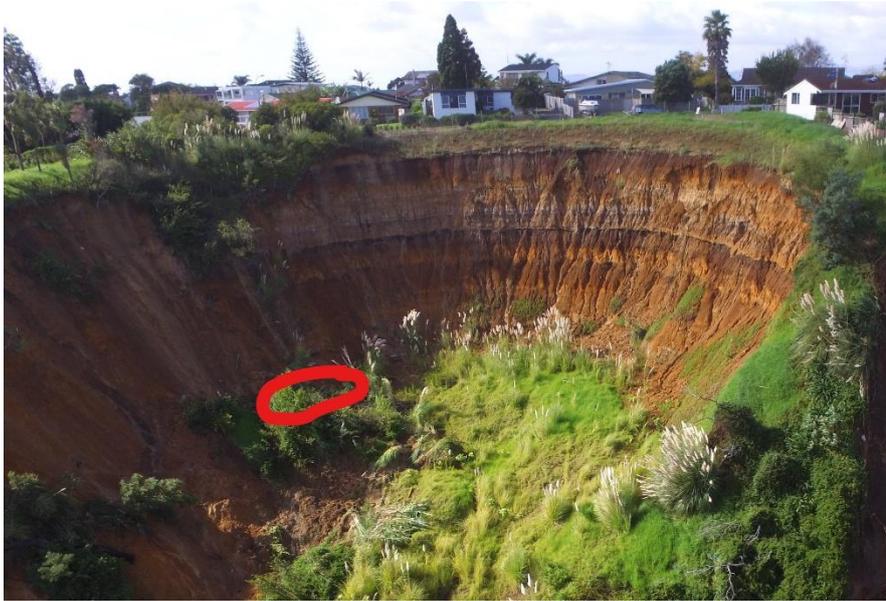
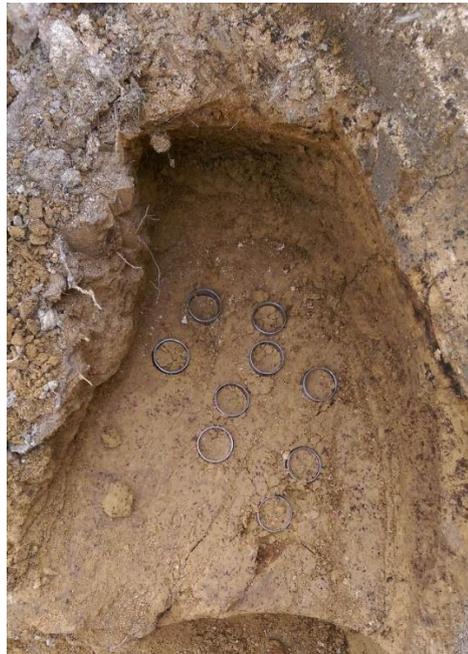
Figure 3.1. (A) The Bramley Drive landslide as seen from the edge of the shore platform via drone. The image highlights the former location of the sampling bench, indicated by the red circle, of which has since been covered by material from the upper slope. Image used with permission from the Western Bay of Plenty Council (WBOP, 2017). (B) After a bench was dug into the slope face at a sufficient distance to ensure that material would contain as little dehydrated halloysite possible soil cores were driven into the soil in a pattern as shown in the image, note large iron pans passing through the bench were avoided. Source Robertson, 2017.

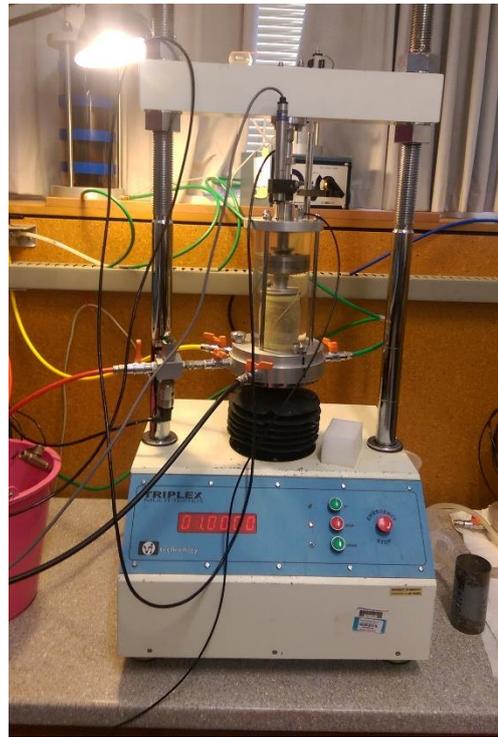
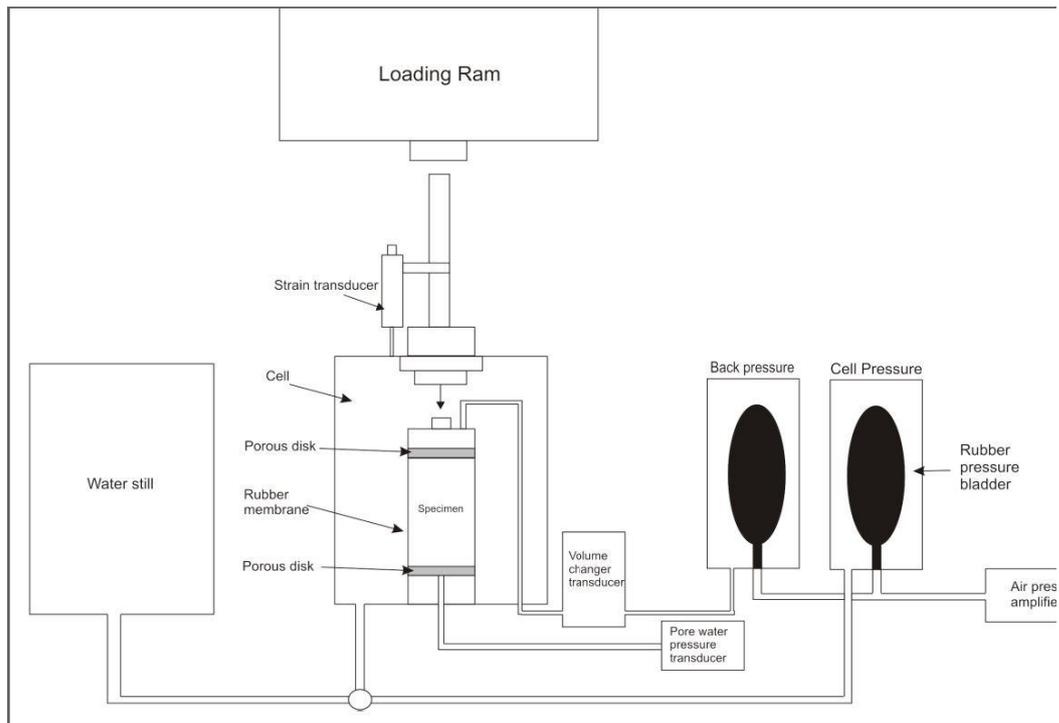
Figure 3.2. (A) The VJ Technology Triplex Multitester Tri-axial apparatus shown in use in the image above, was used during the course of this study. Bladders controlling cell pressure and water still are not shown in this image. (B) A simplified view of the tri-axial apparatus used during the course of this study Source: Cunningham, 2012.

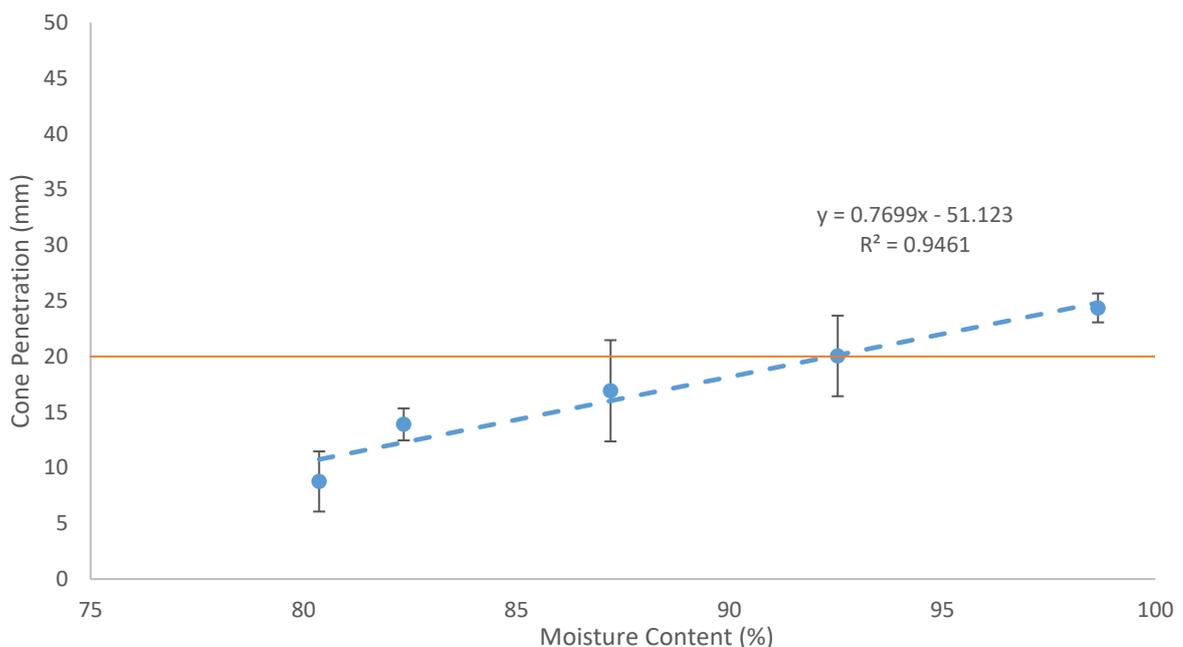
Figure 4.1. Results for the degree of cone penetration in mm at differing moisture contents for soil treated with distilled water. The orange line represents the point of

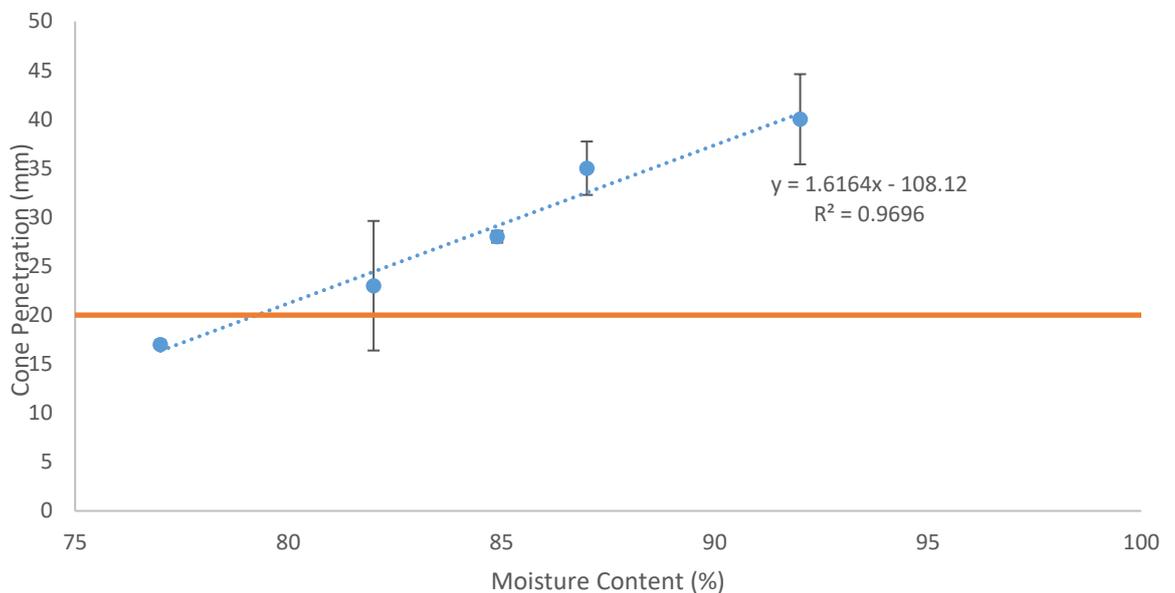
Figure 4.2 Results for the degree of cone penetration in mm at differing moisture contents for soil treated with KCL. The orange line represents the point of cone penetration that is regarded as the liquid limit. A line of best fit (dashed blue) was applied to the results, with the equation for this line and R^2 value displayed on the graph.

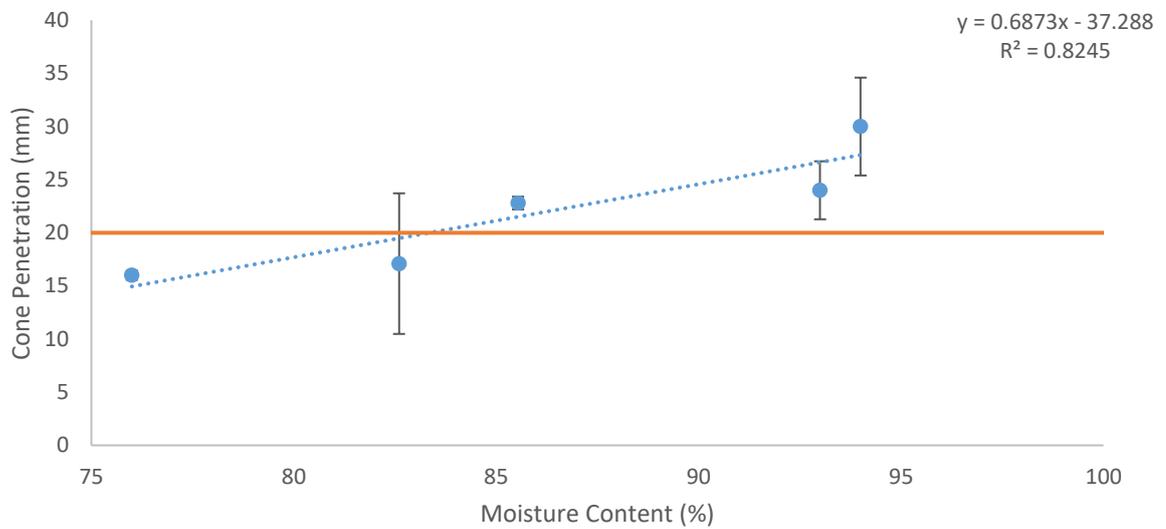
Figure 4.3. Results for the degree of cone penetration in mm at differing moisture contents for soil treated with KOH. The orange line represents the point of cone penetration that is regarded as the liquid limit. A line of best fit (dashed blue) was applied to the results, with the equation for this line and R^2 value displayed on the graph.

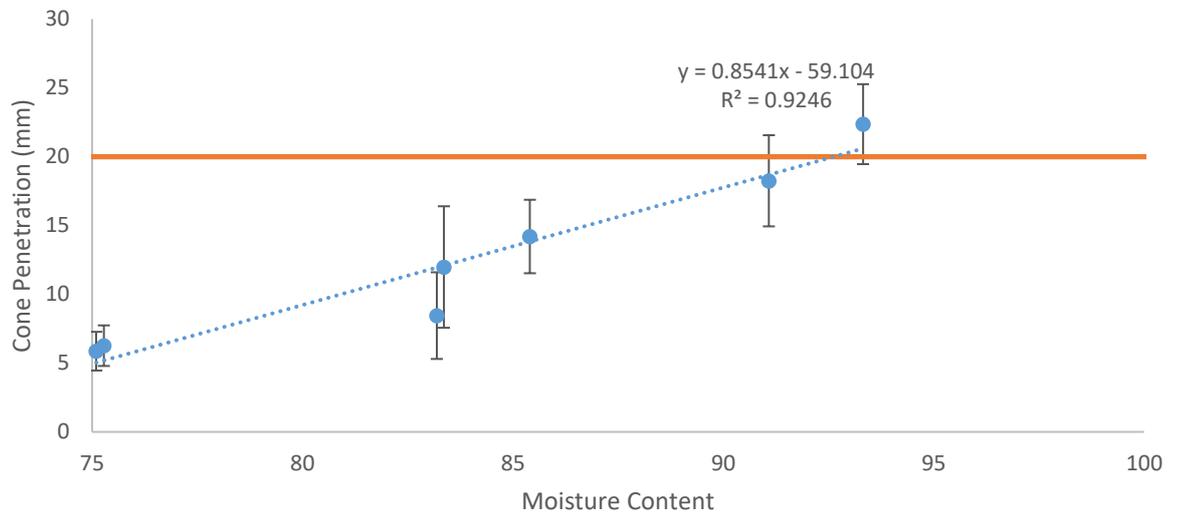
Figure 4.4. Results for the degree of cone penetration in mm at differing moisture contents for soil treated with K_2CO_3 . The orange line represents the point of cone penetration that is regarded as the liquid limit. A line of best fit (dashed blue) was applied to the results, with the equation for this line and R^2 value displayed on the graph.

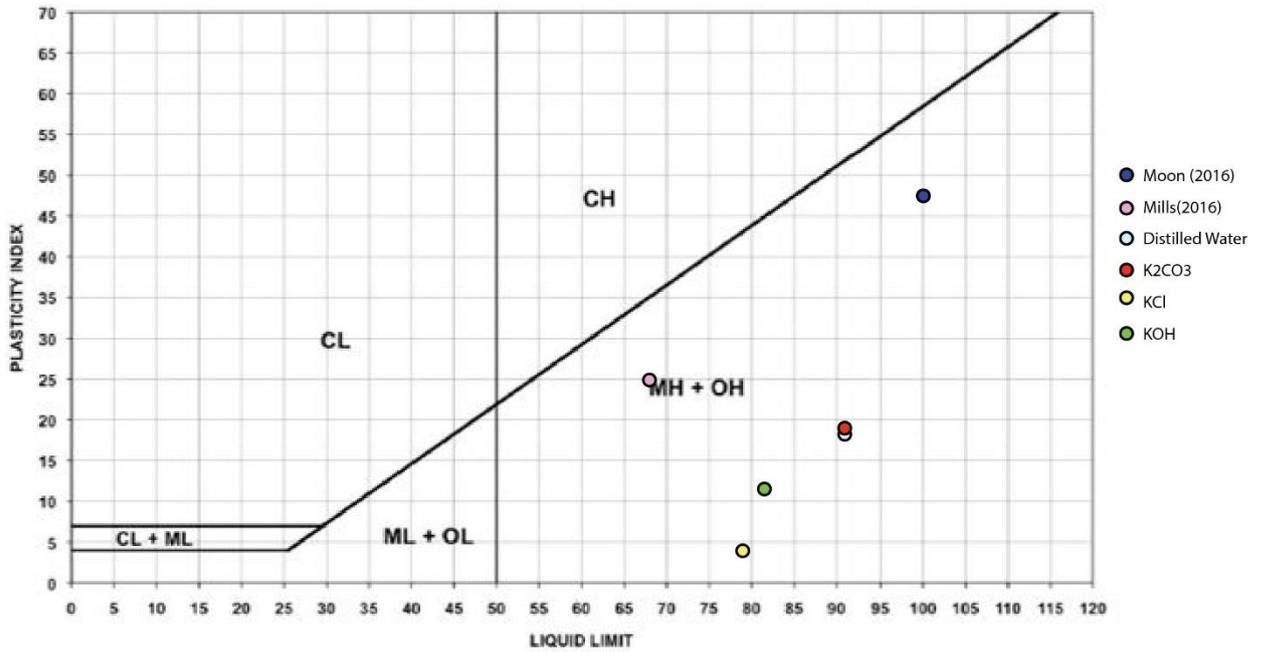
Figure 4.5. Adapted from Skempton & Northey (1952), the A-line chart above plots the relative Liquid Limit and Plasticity Indexes of the results gathered in this study, Mills (2016) study and Moons (2016) review. The colour of the dots correspond to the respective treatments as indicated on the left hand side of the diagram.

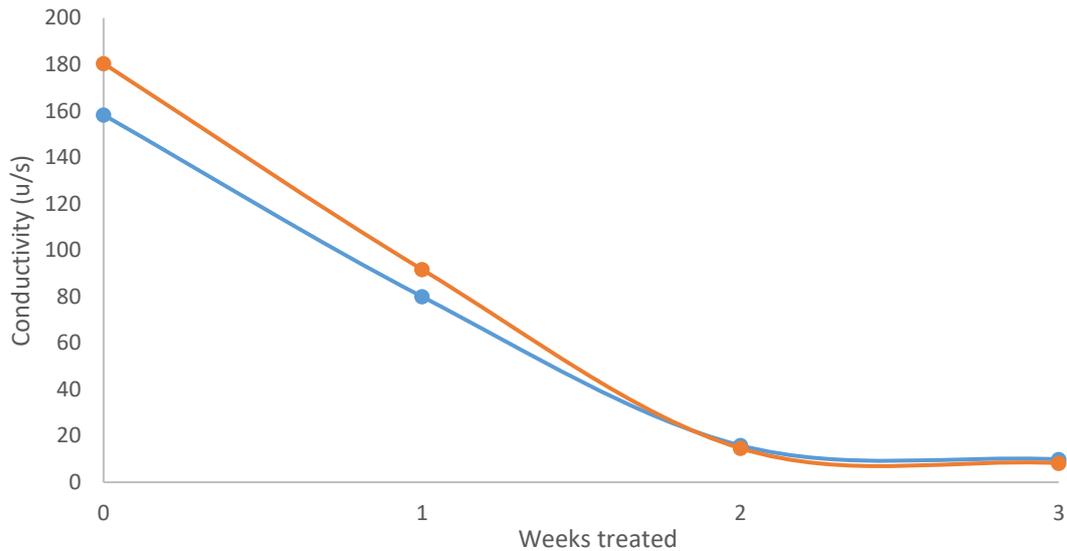
Figure 4.6. The chart above shows the changing conductivity of two separate sets of soil cores that were being treated independently, with each treatment having 4 soil cores within the solution. The conductivity was measured once a week every week prior to testing of the samples.

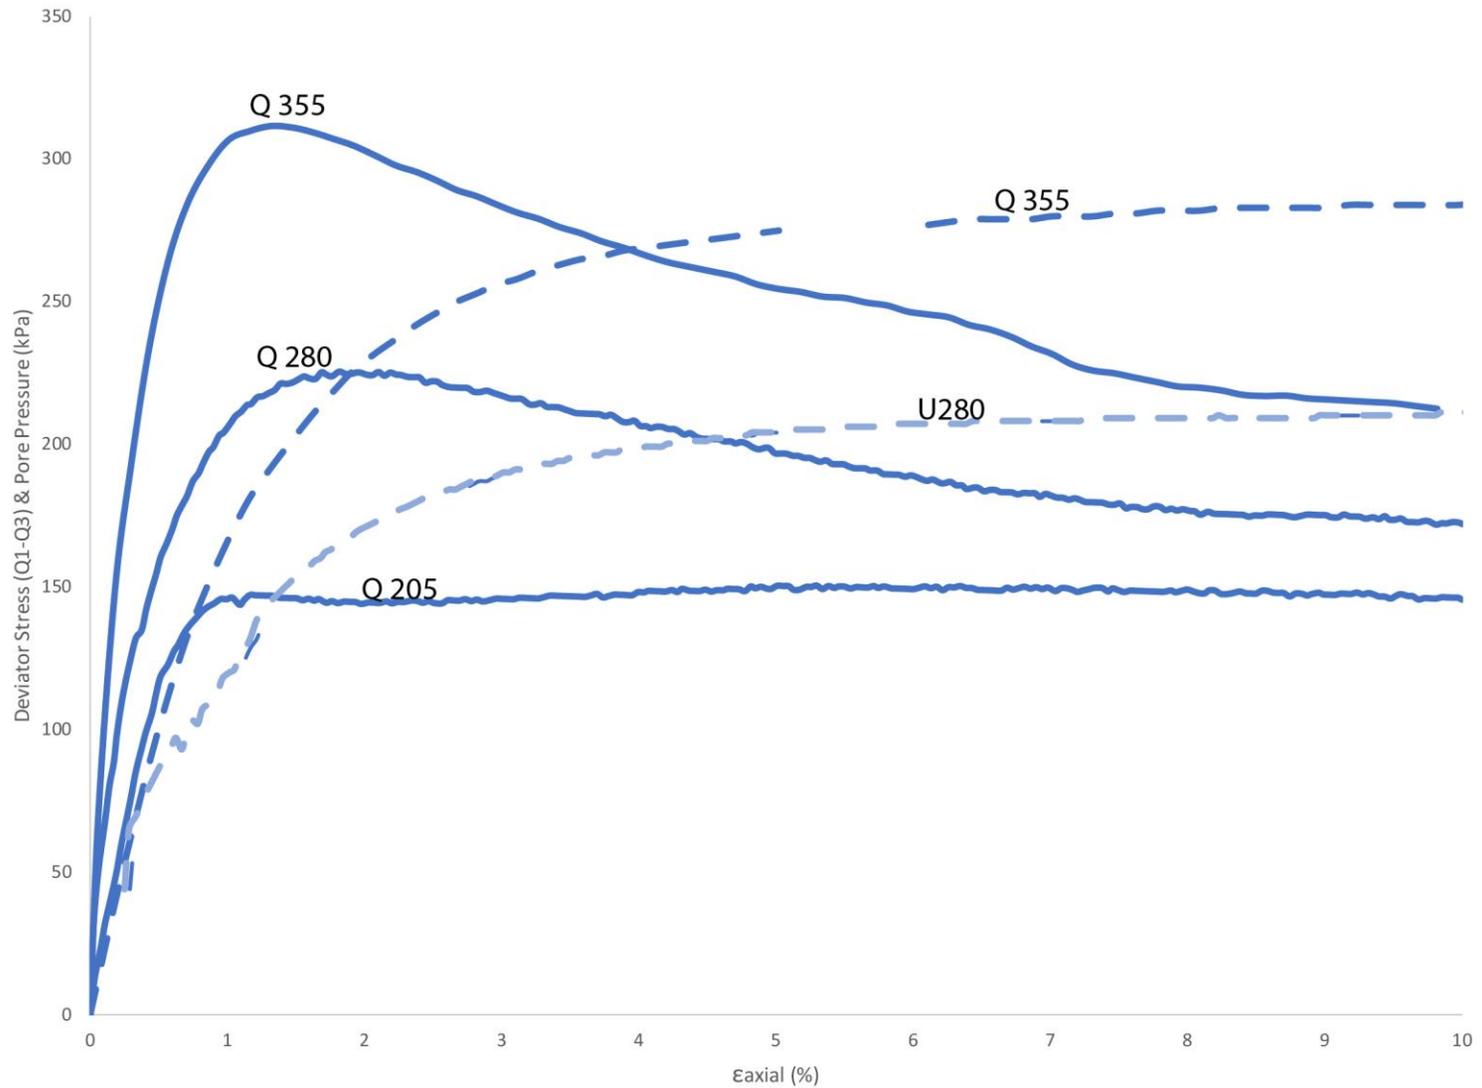
Figure 5.1. A stress versus strain plot derived for untreated soil core samples following tri-axial failure. Deviator stress (Q) is represented as the solid blue line, while pore water pressure (U) is represented by the dashed blue line. The results for specific confining pressures are presented on the graph.

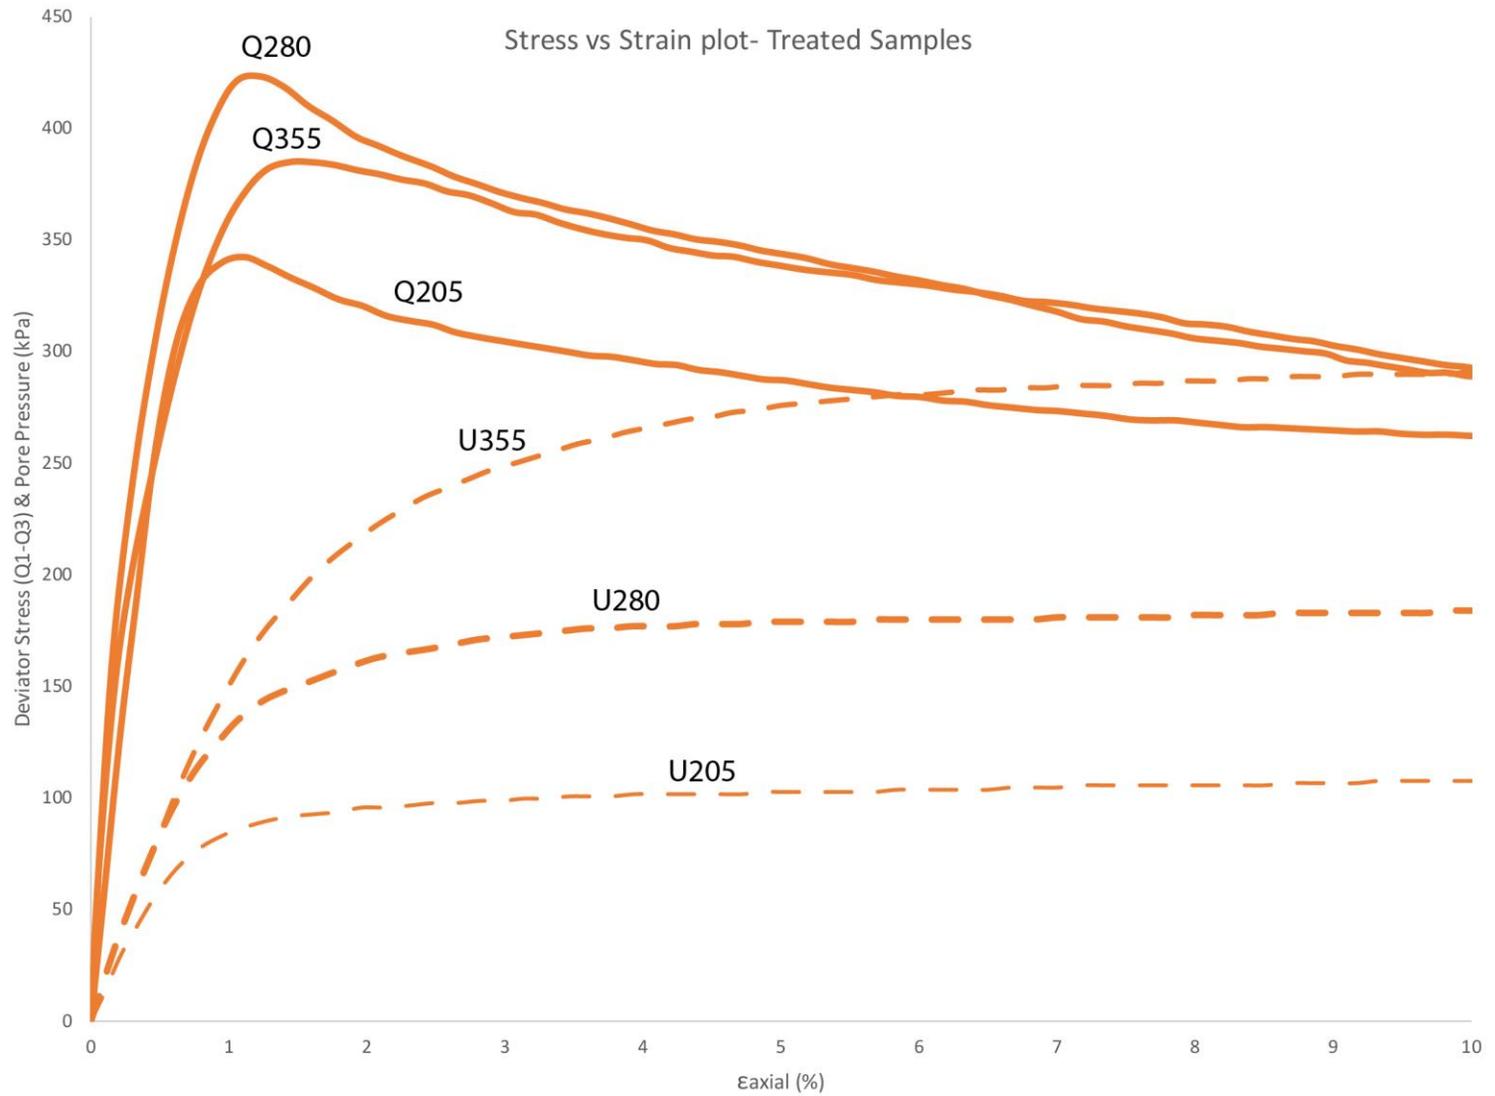
Figure 5.2. A stress versus strain plot derived for treated soil core samples following tri-axial failure. Deviator stress (Q) is represented as the solid orange line, while pore water pressure (U) is represented by the dashed orange line. The results for specific confining pressures are presented on the graph.

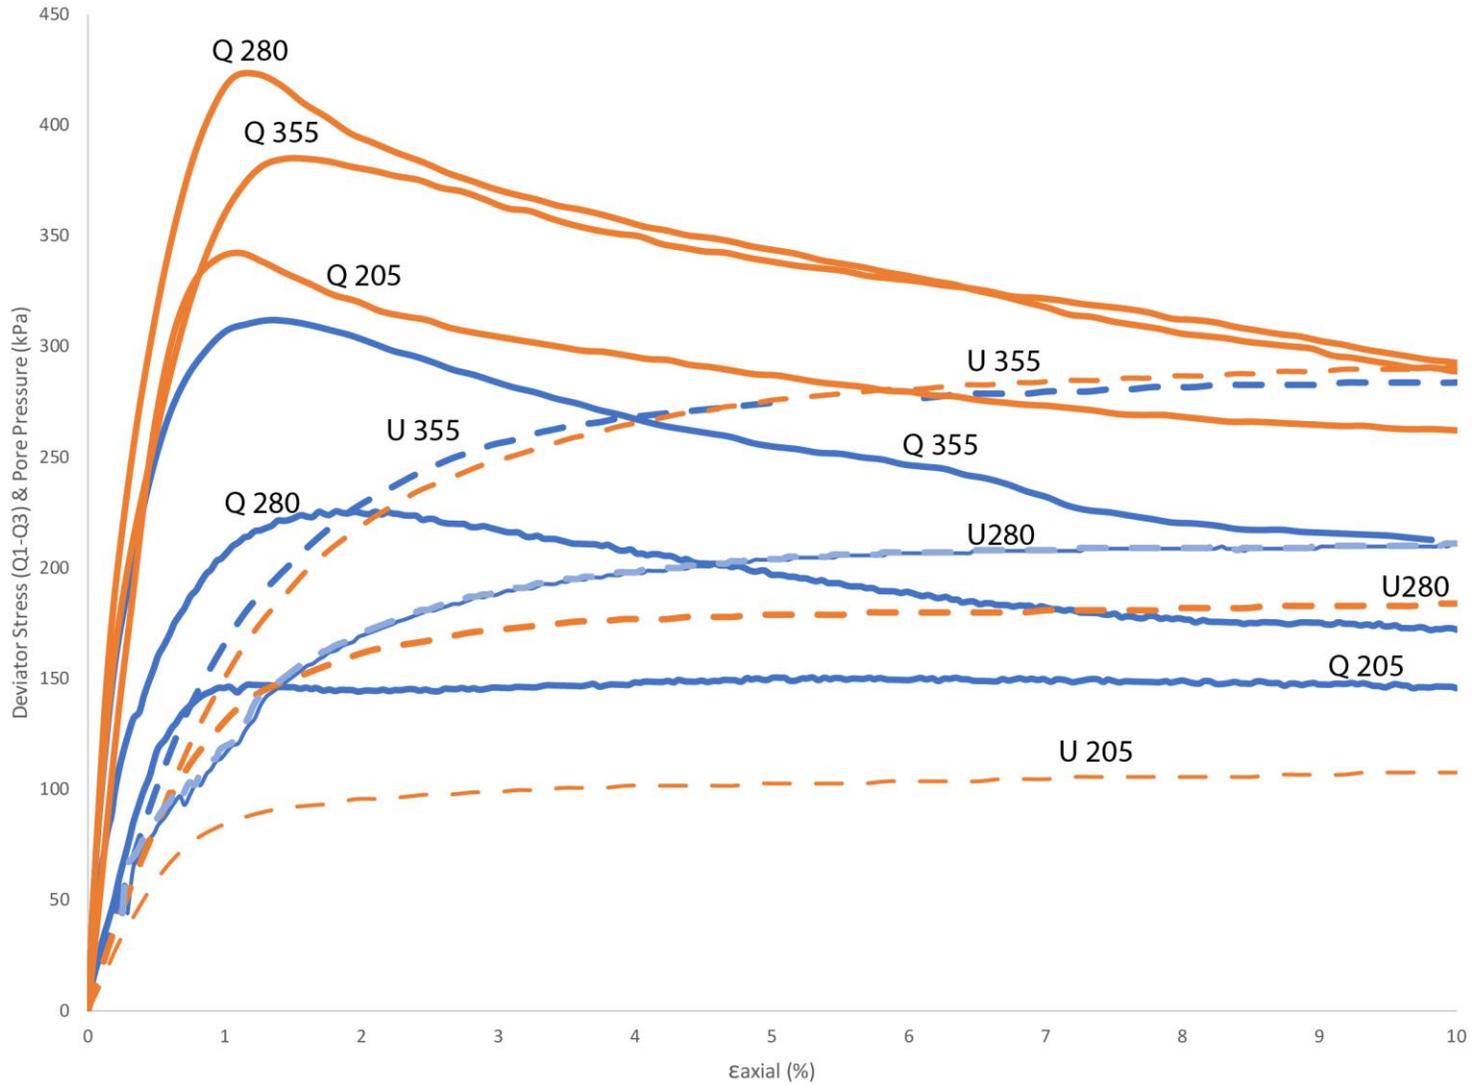
Figure 5.3. The graph above shows the stress versus strain plot for both untreated (blue) and treated (orange) samples plotted together on the same chart to allow for comparison of the results directly on the chart. Pore pressure (U) and deviator stress (Q) are shown by the dashed and solid lines respectively with respective confining pressures labelled.

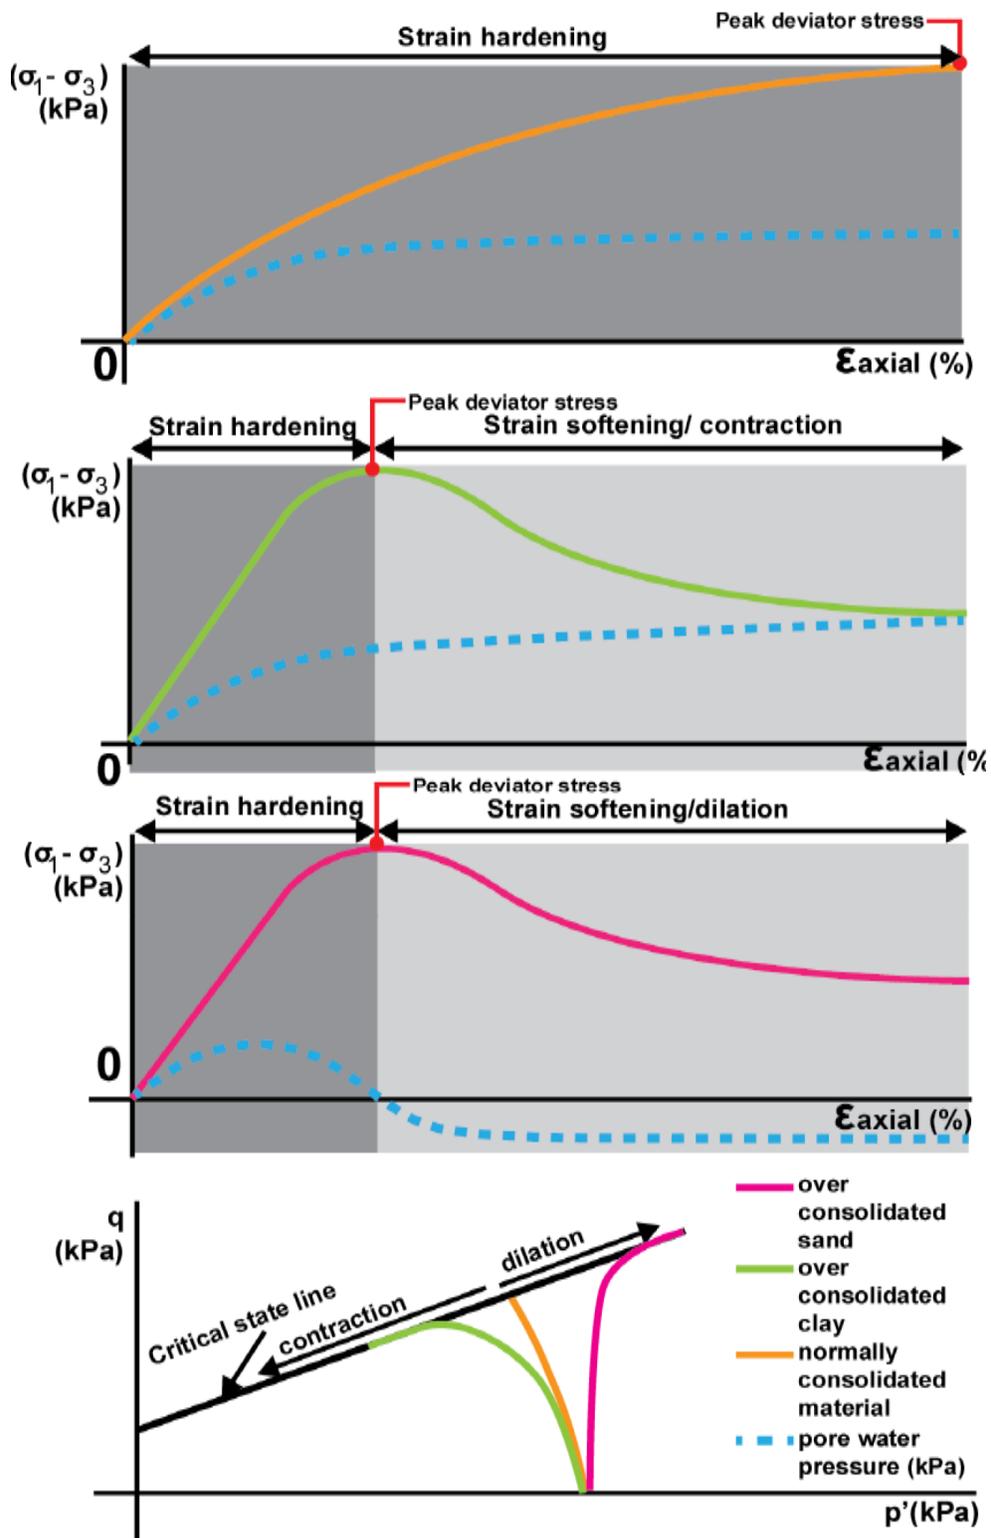
Figure 5.4. a-d (top to bottom). Schematics of the different behaviours expected for over consolidated sand (pink), over consolidated clays (green), and normally consolidated material (orange) for both q (deviator stress) vs axial, and p' vs q' (effective stress). Schematics are sourced from Mills (2016).

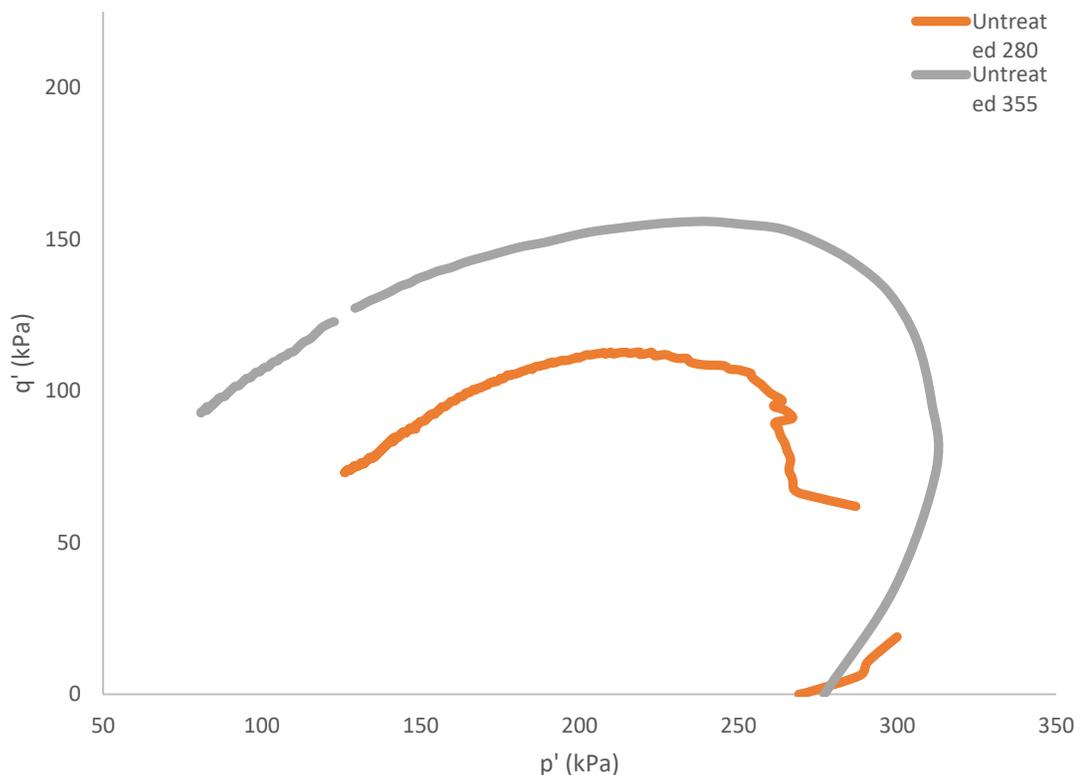
Figure 5.5. Stress path plots (p' - q') for our untreated soil sample at 280 and 355 kPa.

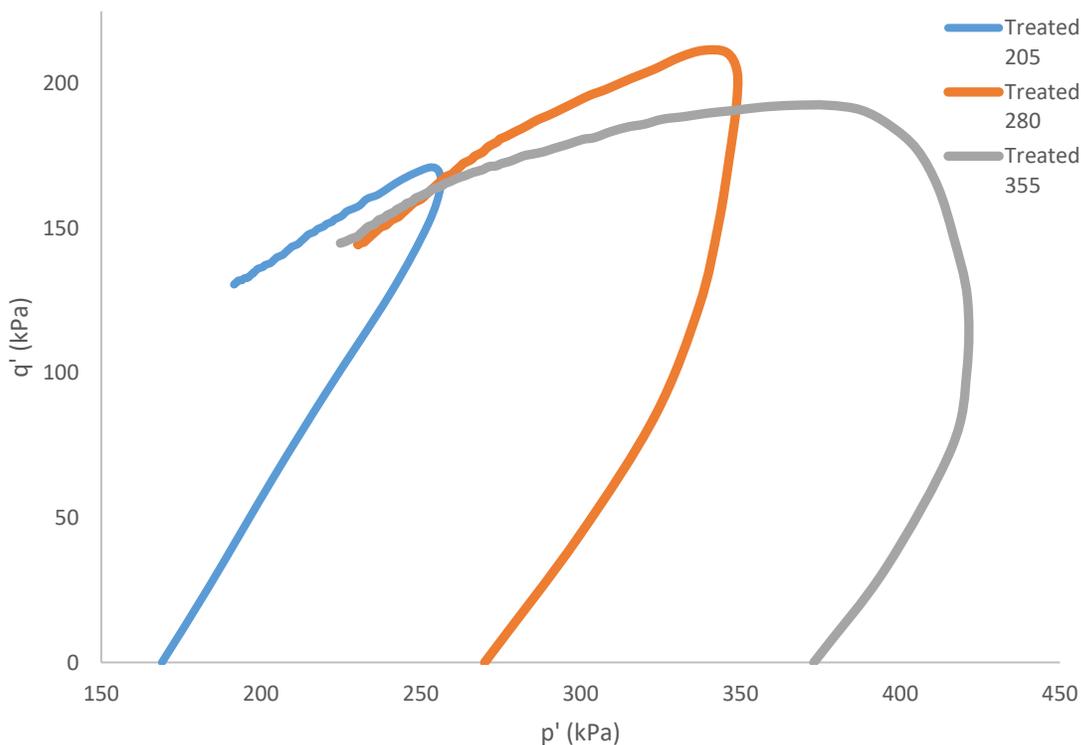
Figure 5.6. Stress path (p' - q') plots for treated samples at all 3 confining pressures.

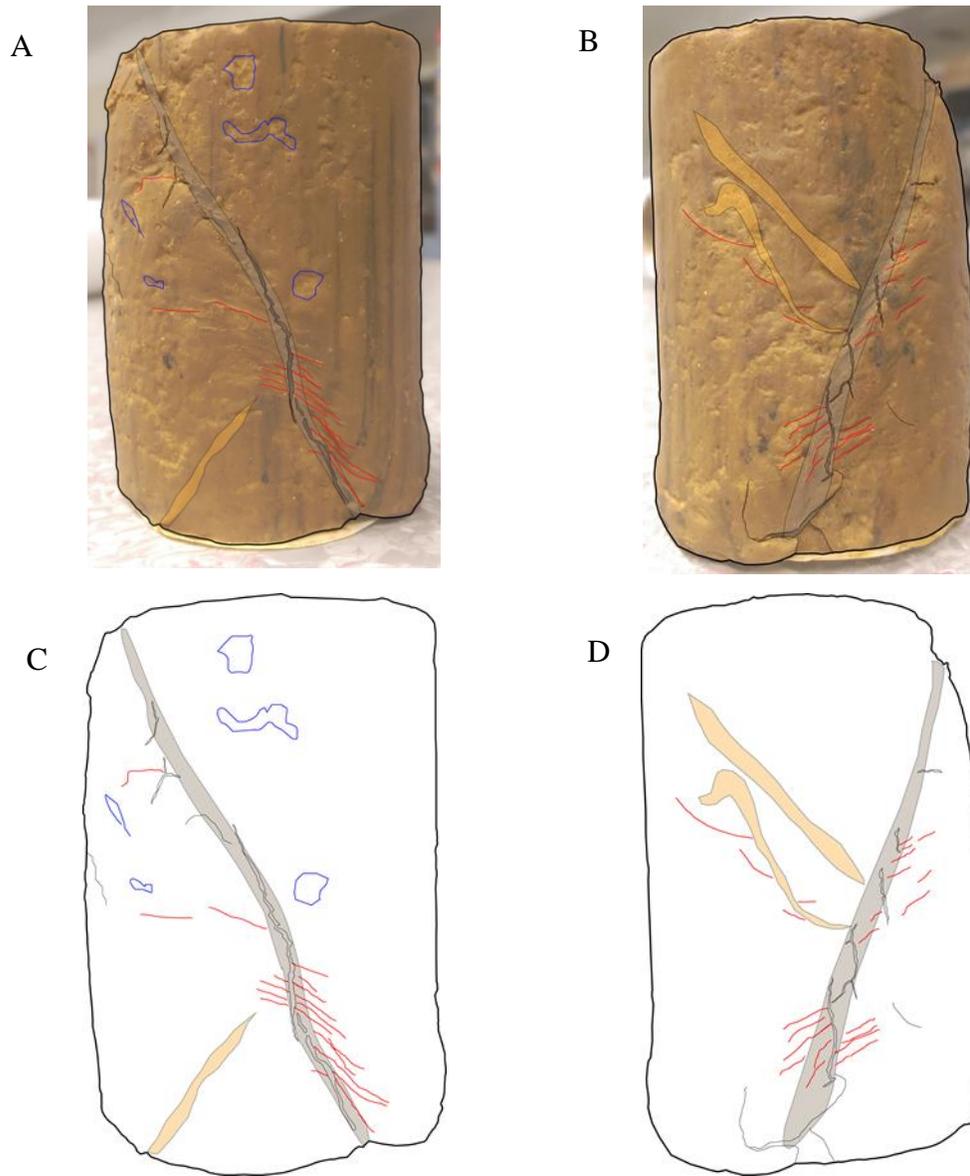
Figure 5.7. (A & B) Failed triaxial specimens for the untreated soil at 355 kPa, where grey denotes PSZ, Orange secondary shear zones, Red representing micro shears and blue depressions in the surface. (D & C) Failed tri-axial specimen sketches showing the drawn features with no overlying picture.

sketches due to the large number of them but can be observed towards the base of figure 5.7B, shown as noticeable black nodules.

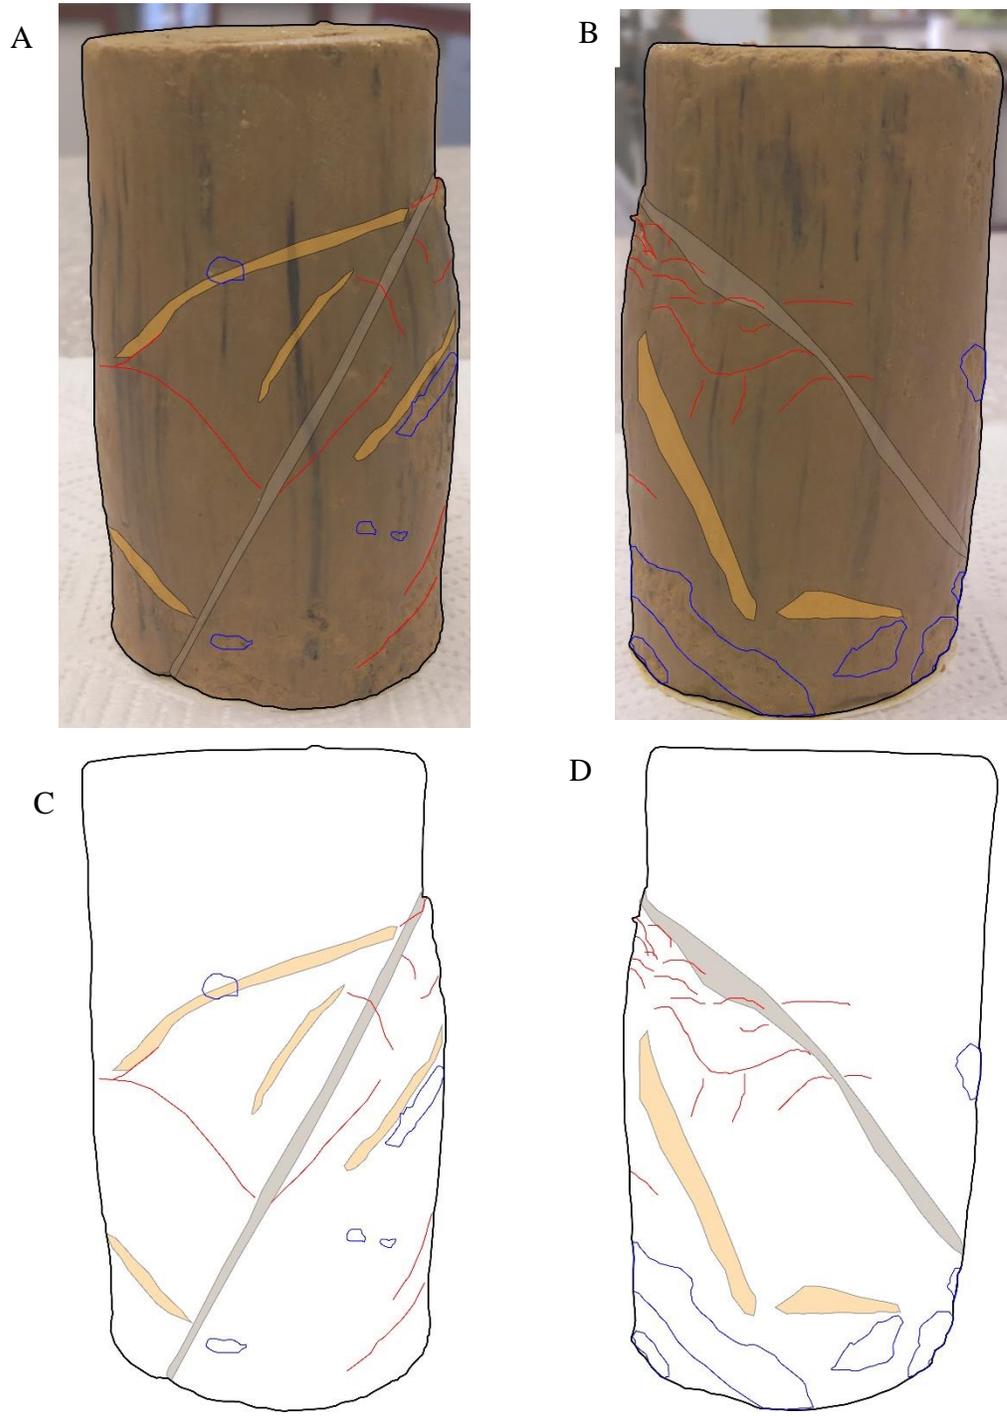
Figure 5.8(A & B) Failed triaxial specimens for the treated soil at 205 kPa, where grey denotes PSZ, Orange secondary shear zones, Red representing micro shears and blue depressions in the surface. (D & C) Failed tri-axial specimen sketches showing the drawn features
