Is There a Salty Solution to Sensitive Soil Sliding in the Bay of Plenty, New Zealand?

A thesis
submitted in partial fulfilment
of the requirements for the degree
of
Master of Science (Earth Sciences)
at
The University of Waikato
by
Thomas Robertson

2017

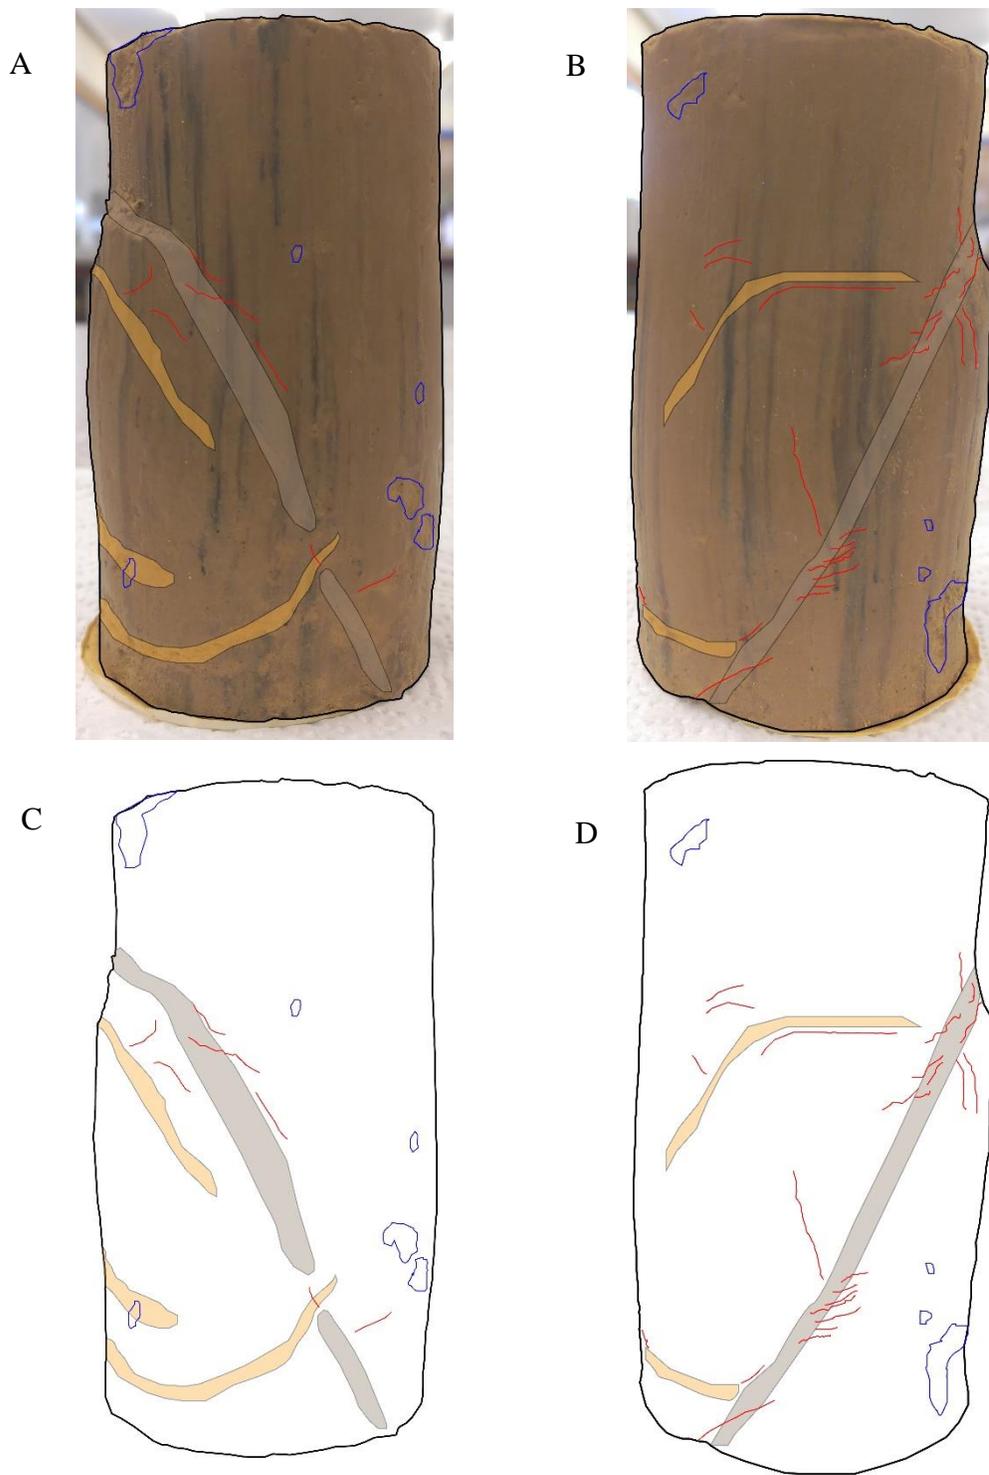
Figure 5.9(A & B) Failed triaxial specimens for the treated soil at 280 kPa, where grey denotes PSZ, Orange secondary shear zones, Red representing micro shears and blue depressions in the surface. (D & C) Failed tri-axial specimen sketches showing the drawn features

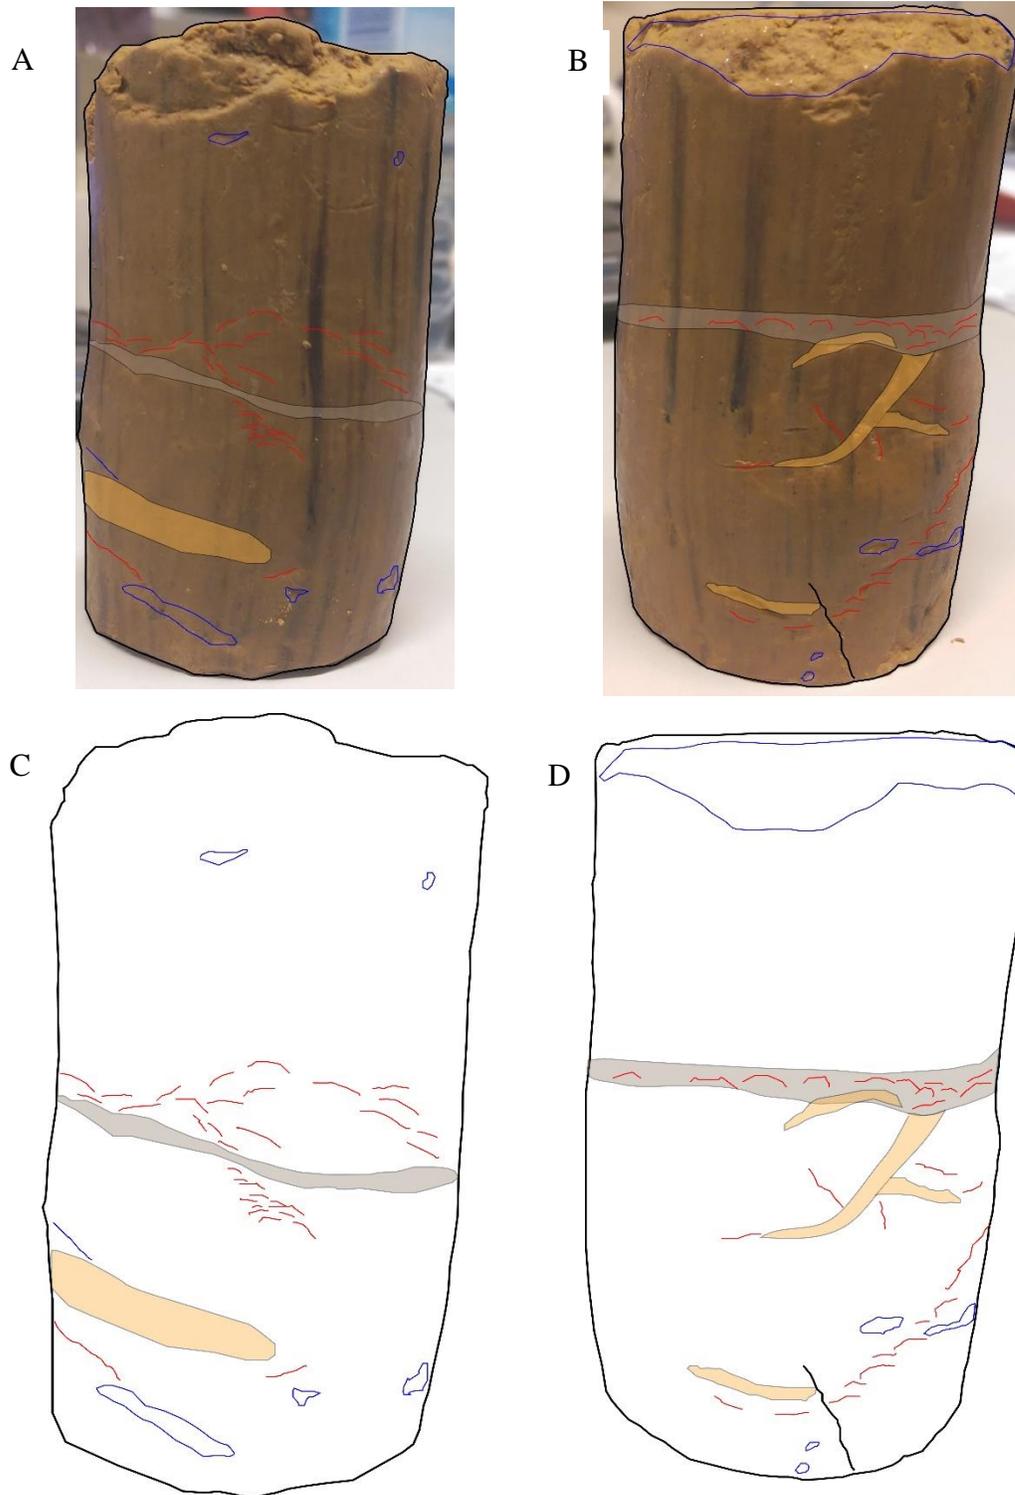
Figure 5.10(A & B) Failed triaxial specimens for the treated soil at 205 kPa, where grey denotes PSZ, Orange secondary shear zones, Red representing micro shears and blue depressions in the surface. (D & C) Failed tri-axial specimen sketches showing the drawn features

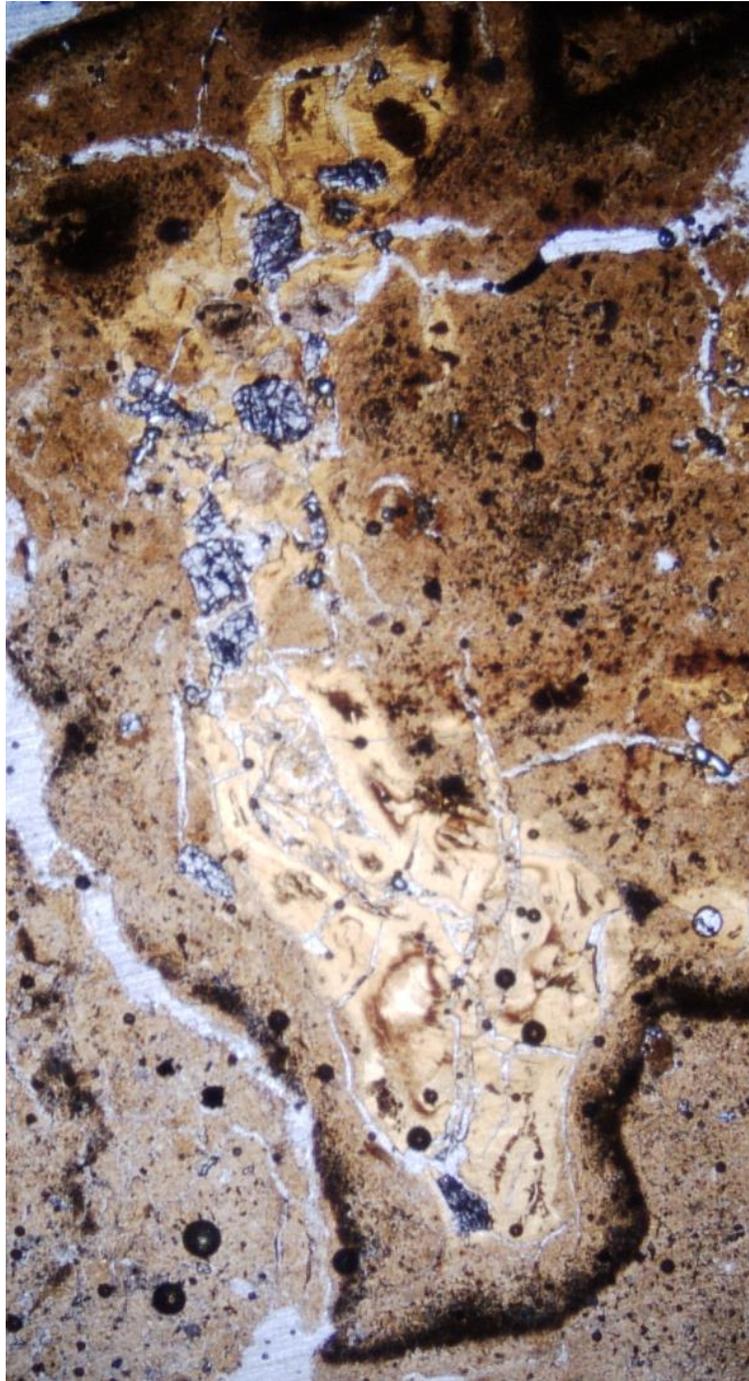
Figure 5.11. An amorphous unidentified object observed on the 205 kPa thin section, with inclusions within the crystal thought to be either quartz or zircon crystals.

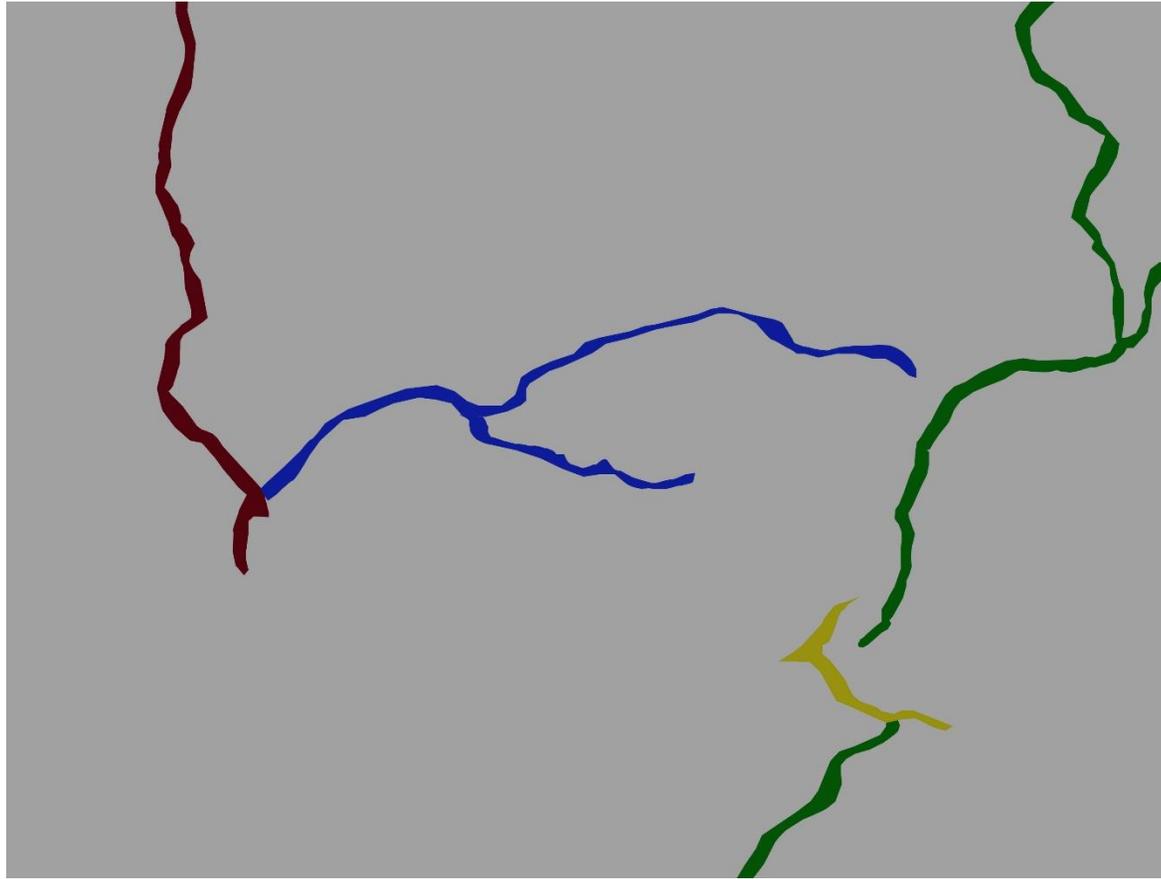
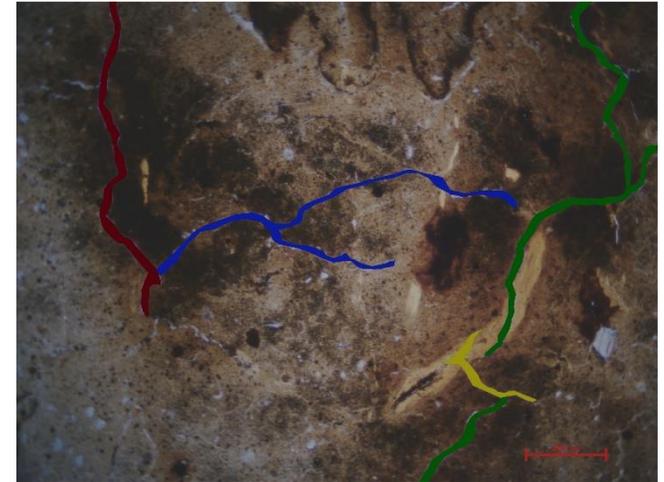
Figure 5.12. (A) Thin section at 205kPa with shears denoted on the sample. PSZ is represented as the green line, R'shear as blue, secondary conjugate shear as red and yellow as additional R shears. (B) Shears and shear direction overlain on thin section image.

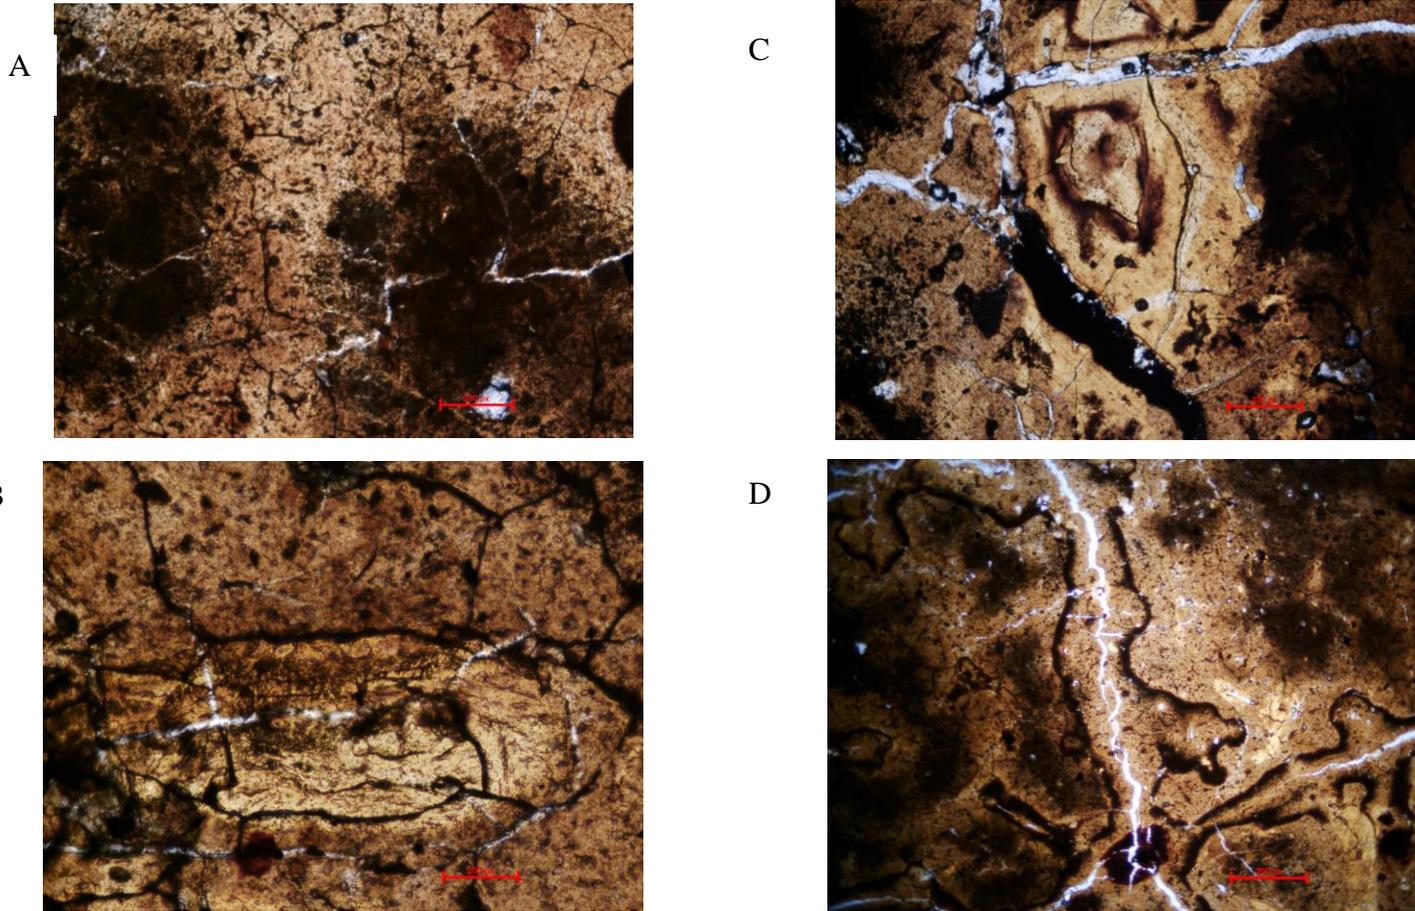
Figure 5.13(A) Relict or infilled fractures present in the 280 kPa thin section (B)Hypersthene crystal present in the 280 kPa thin section with shears passing through the crystal. (C)Infilling by an unidentified black substance in the shear zone of the 280 kPa thin section. (D) shear fracture passing directly through what is thought to be a magnetite crystal.

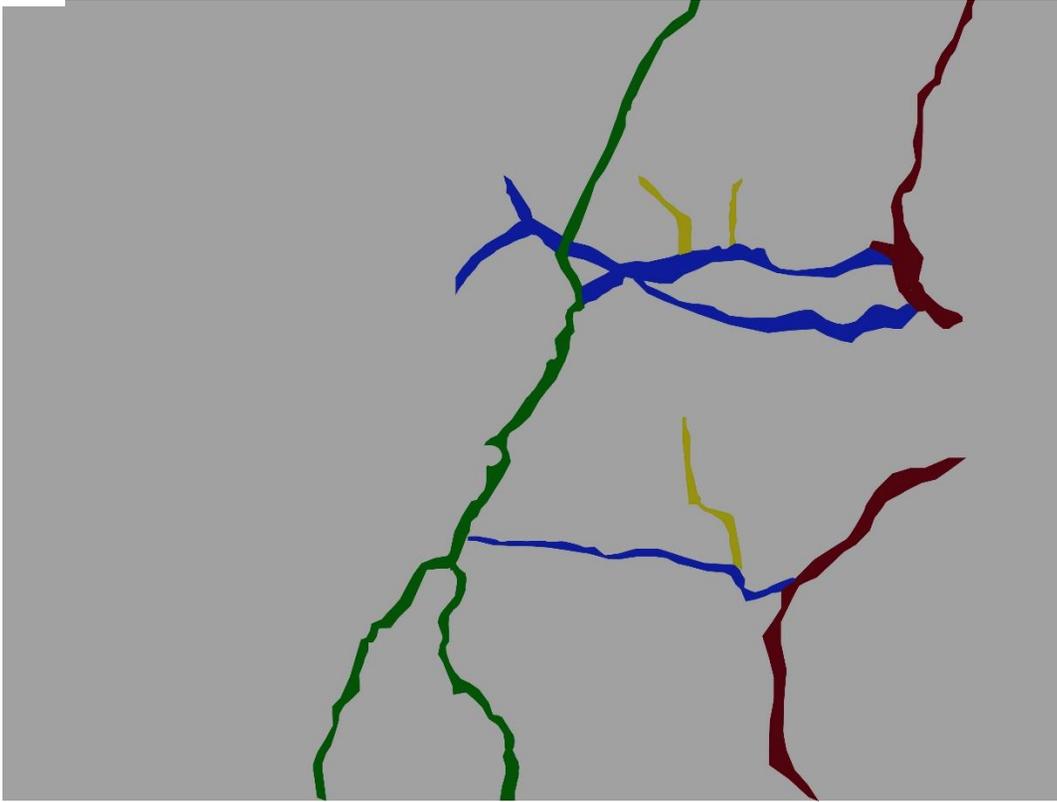
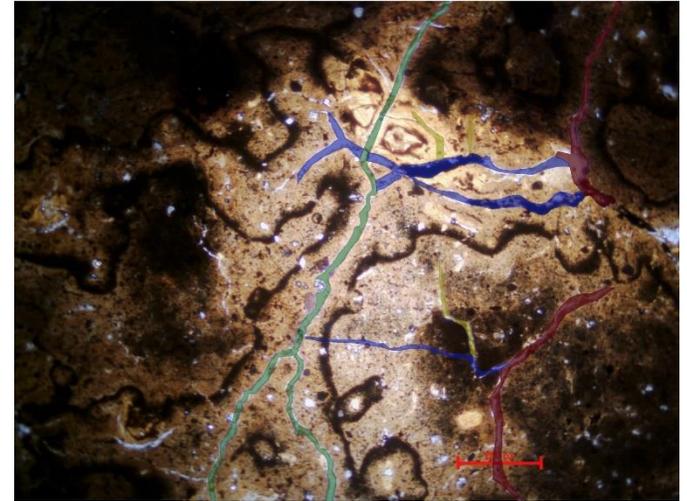
Figure 5.14 (A)Thin section at 280kPa with shears denoted on the sample. PSZ is represented as the green line, R'shear as blue, secondary conjugate shear as red and yellow as additional R shears. **(B)**Shears overlain on the slide are shown above.

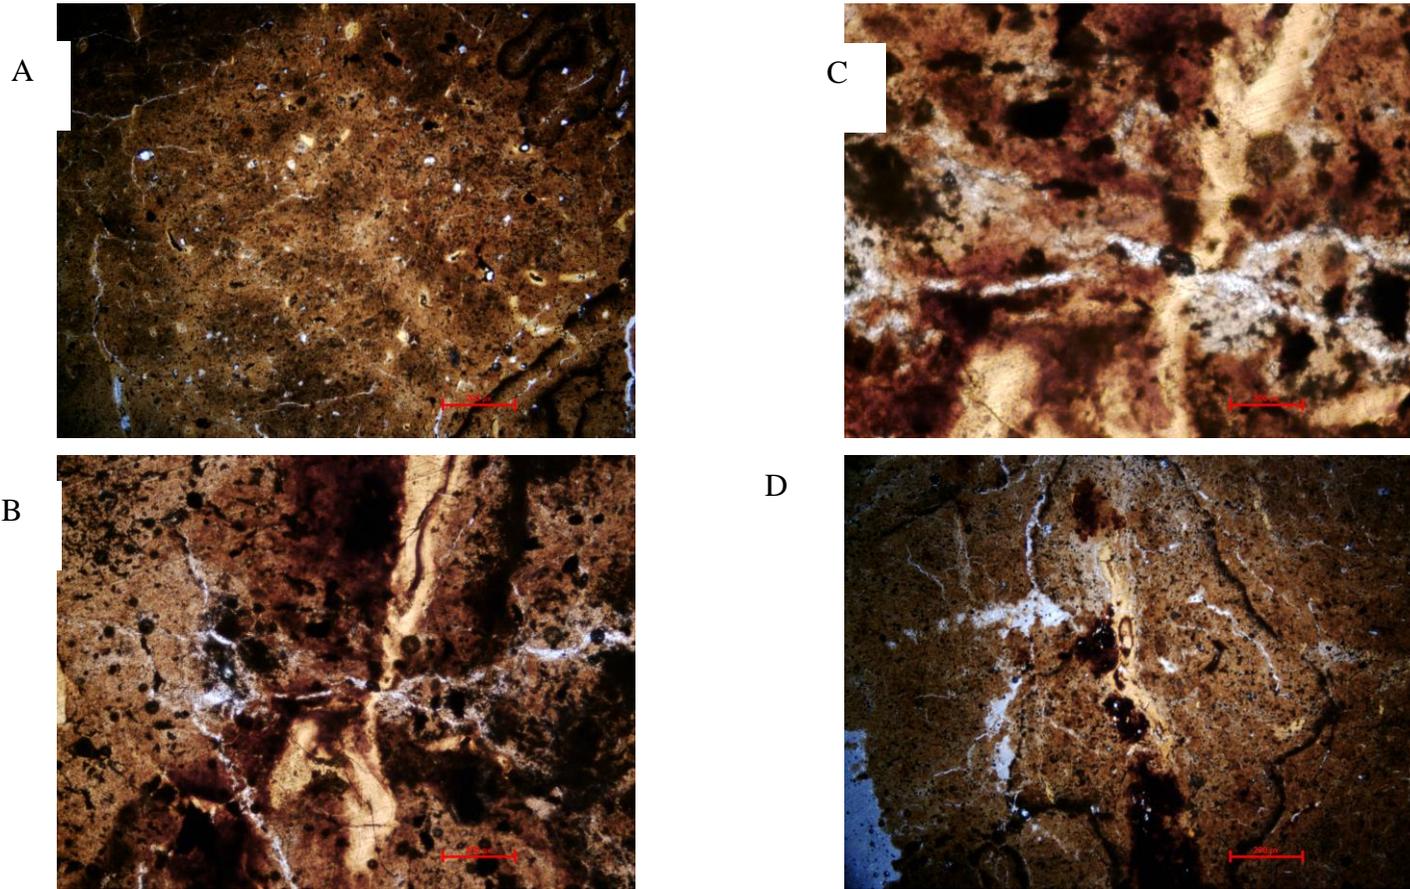
Figure 5.15. (A) Quartz crystals present in the 355 kPa thin section, crystals were much more distinct throughout the groundmass as this higher confining pressure. (B) A snapshot of the intersection of two shear fractures passing through an apparent weak point of a crystal, the intersection appears to have an indistinct black mass in the middle. (C) A higher magnification view of the fracture intersection shown in 5.15B shows a lithic wedged into the shear space between the two fracture. (D) Further dark infillings present in the 355 kPa thin section

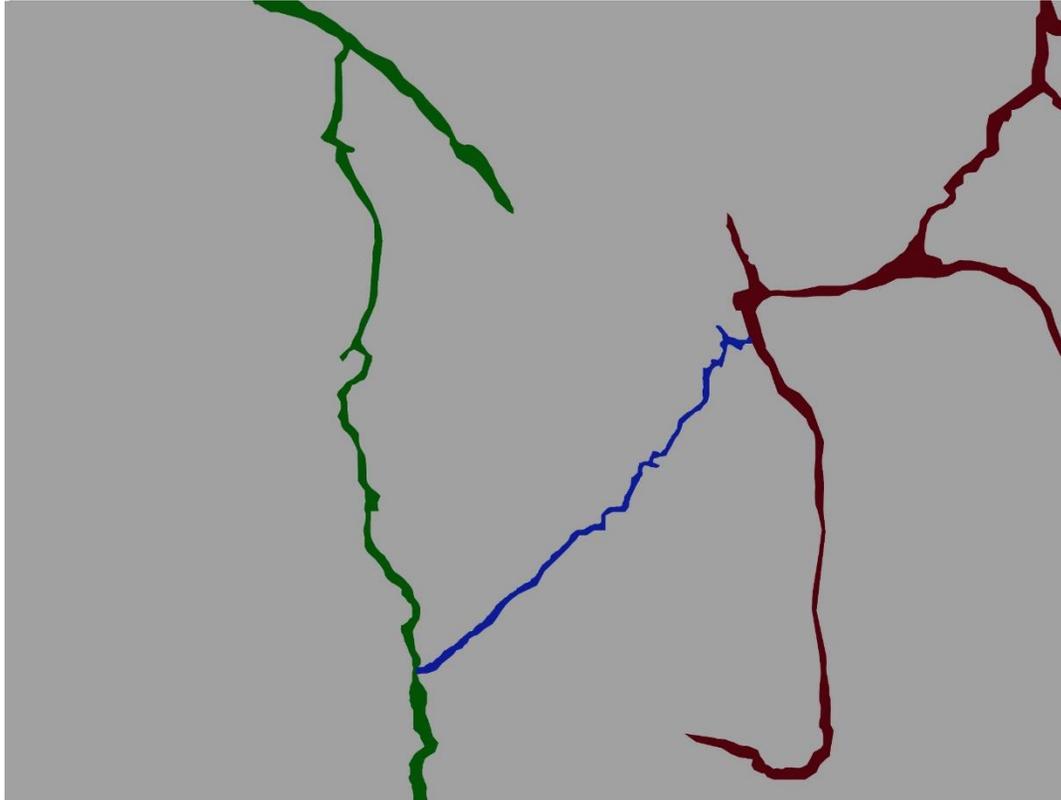
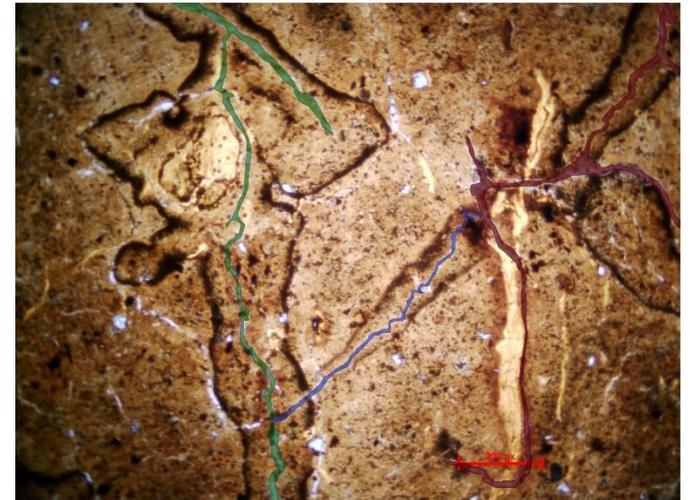
Figure 5.16. (A) Thin section at 355kPa with shears denoted on the sample. PSZ is represented as the green line, R'shear as blue, secondary conjugate shear as red. (B) Shears overlain on the slide image.

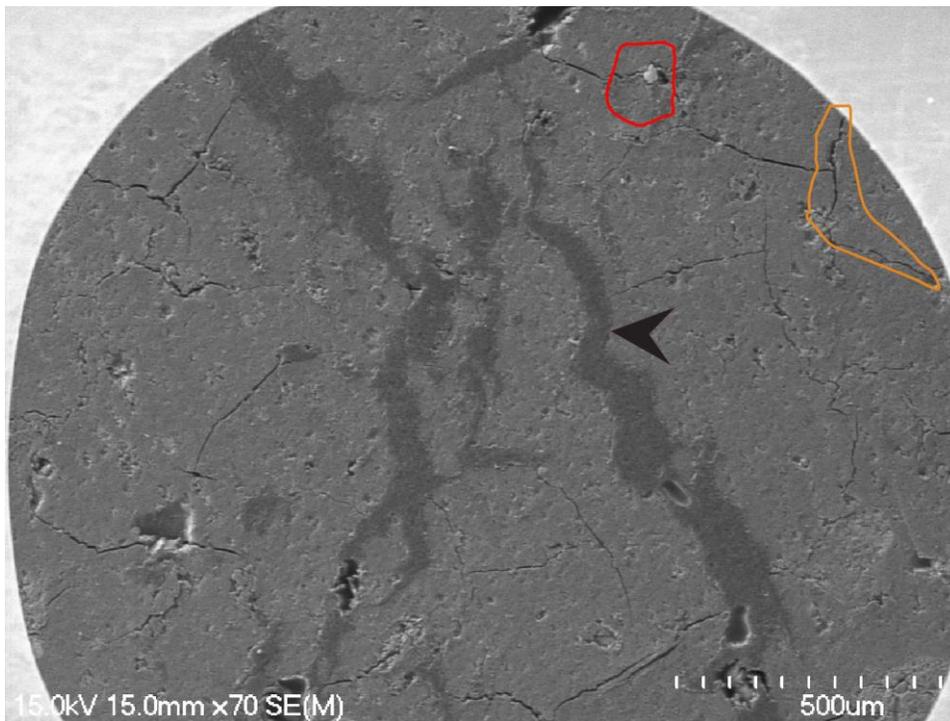
Figure 6.1. A normal SEM image of the 280 kPa thin section at the lowest possible magnification, desiccation cracks are denoted as circled in orange and indeterminate crystal circled in red.

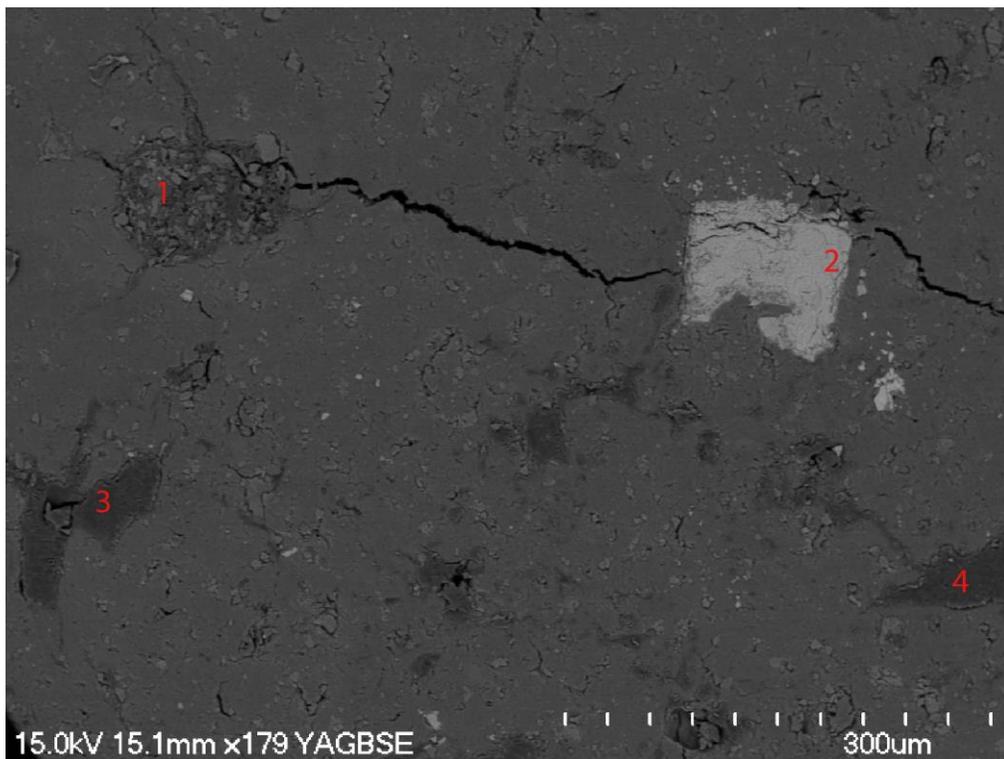
Figure 6.2. A BSE image taken of the 355 kPa thin section of 4 separate key features, each labelled in red for separate identification.

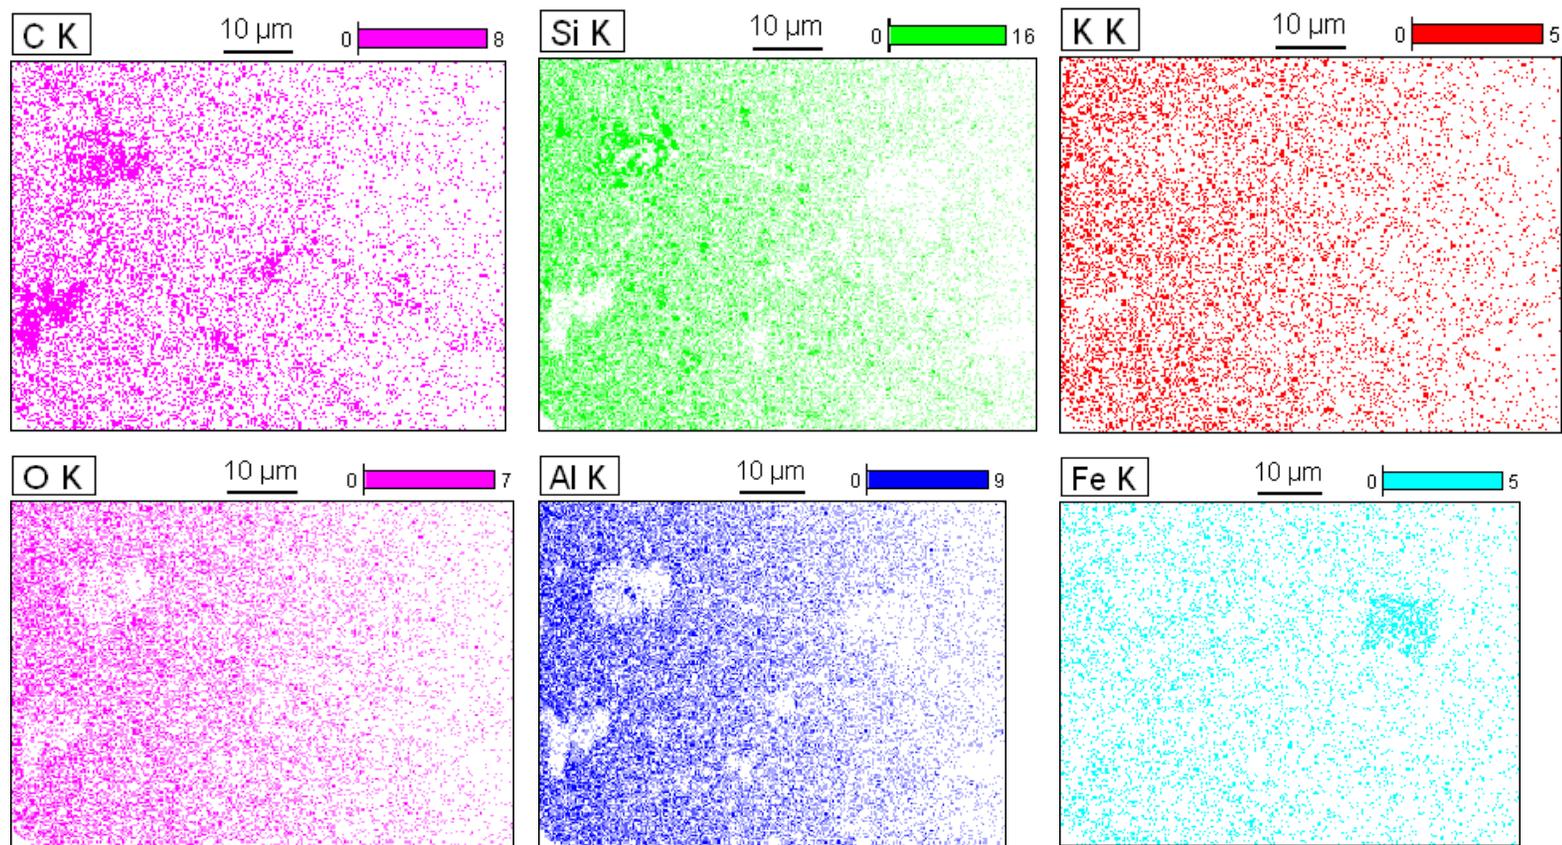
Figure 6.3. Element distribution graphs showing distribution of elements on the image of figure 6.2, elements are identified as points in differing colours with particular element identified in the top left of each image.

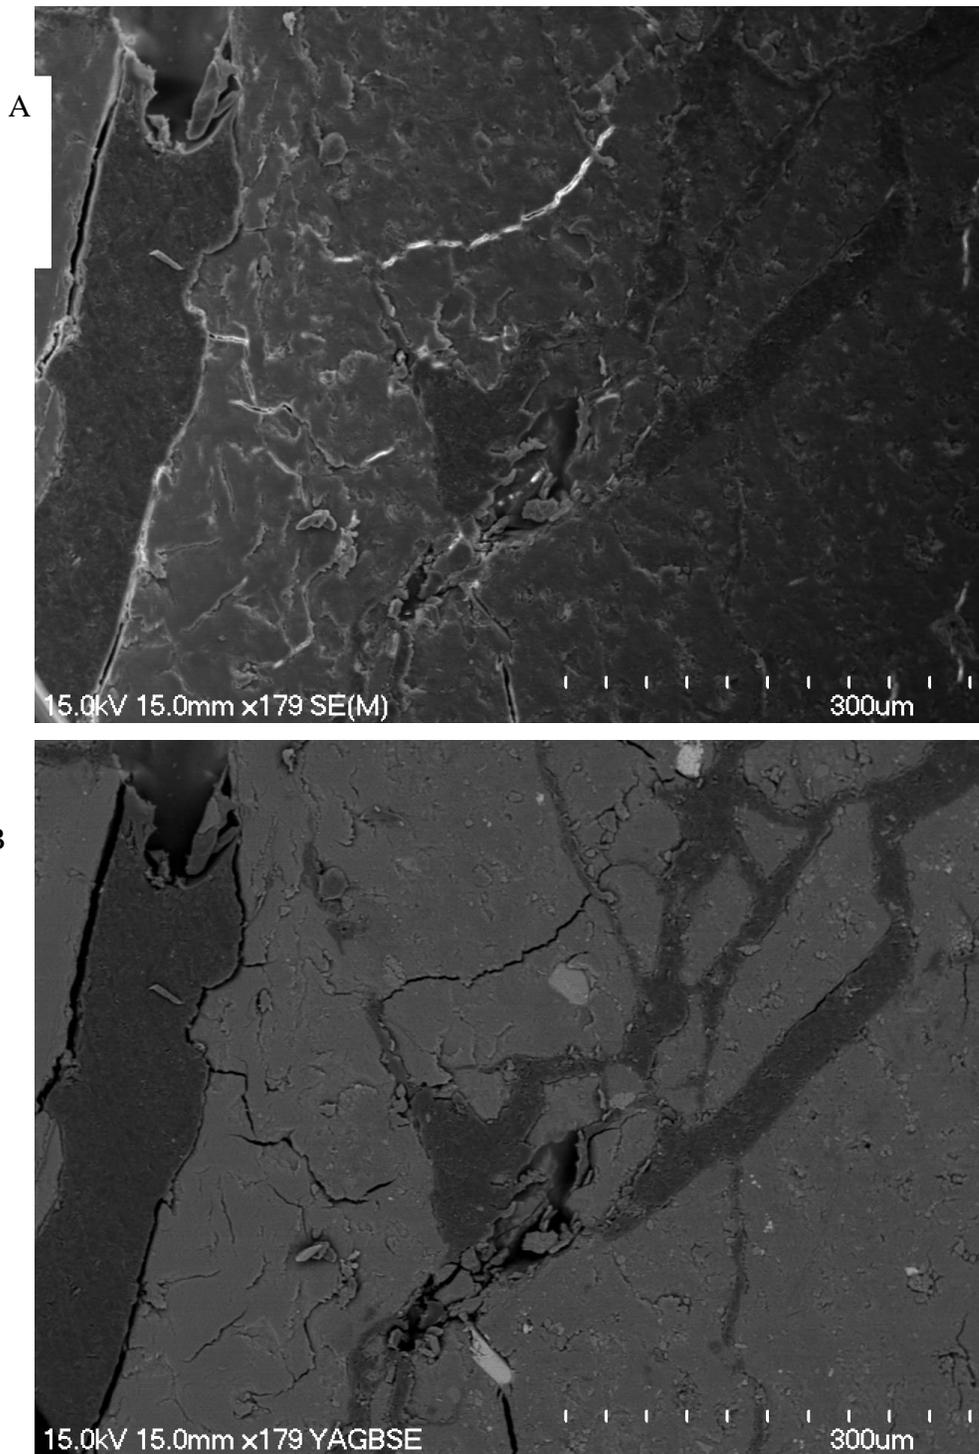
Figure 6.4. (A)An SEM image of the 280 kPa image showing infilled shears present within the thin section at 179 times magnification(B) A BSE image of infilled shears present on the 280 kPa thin section at 179 times magnification.

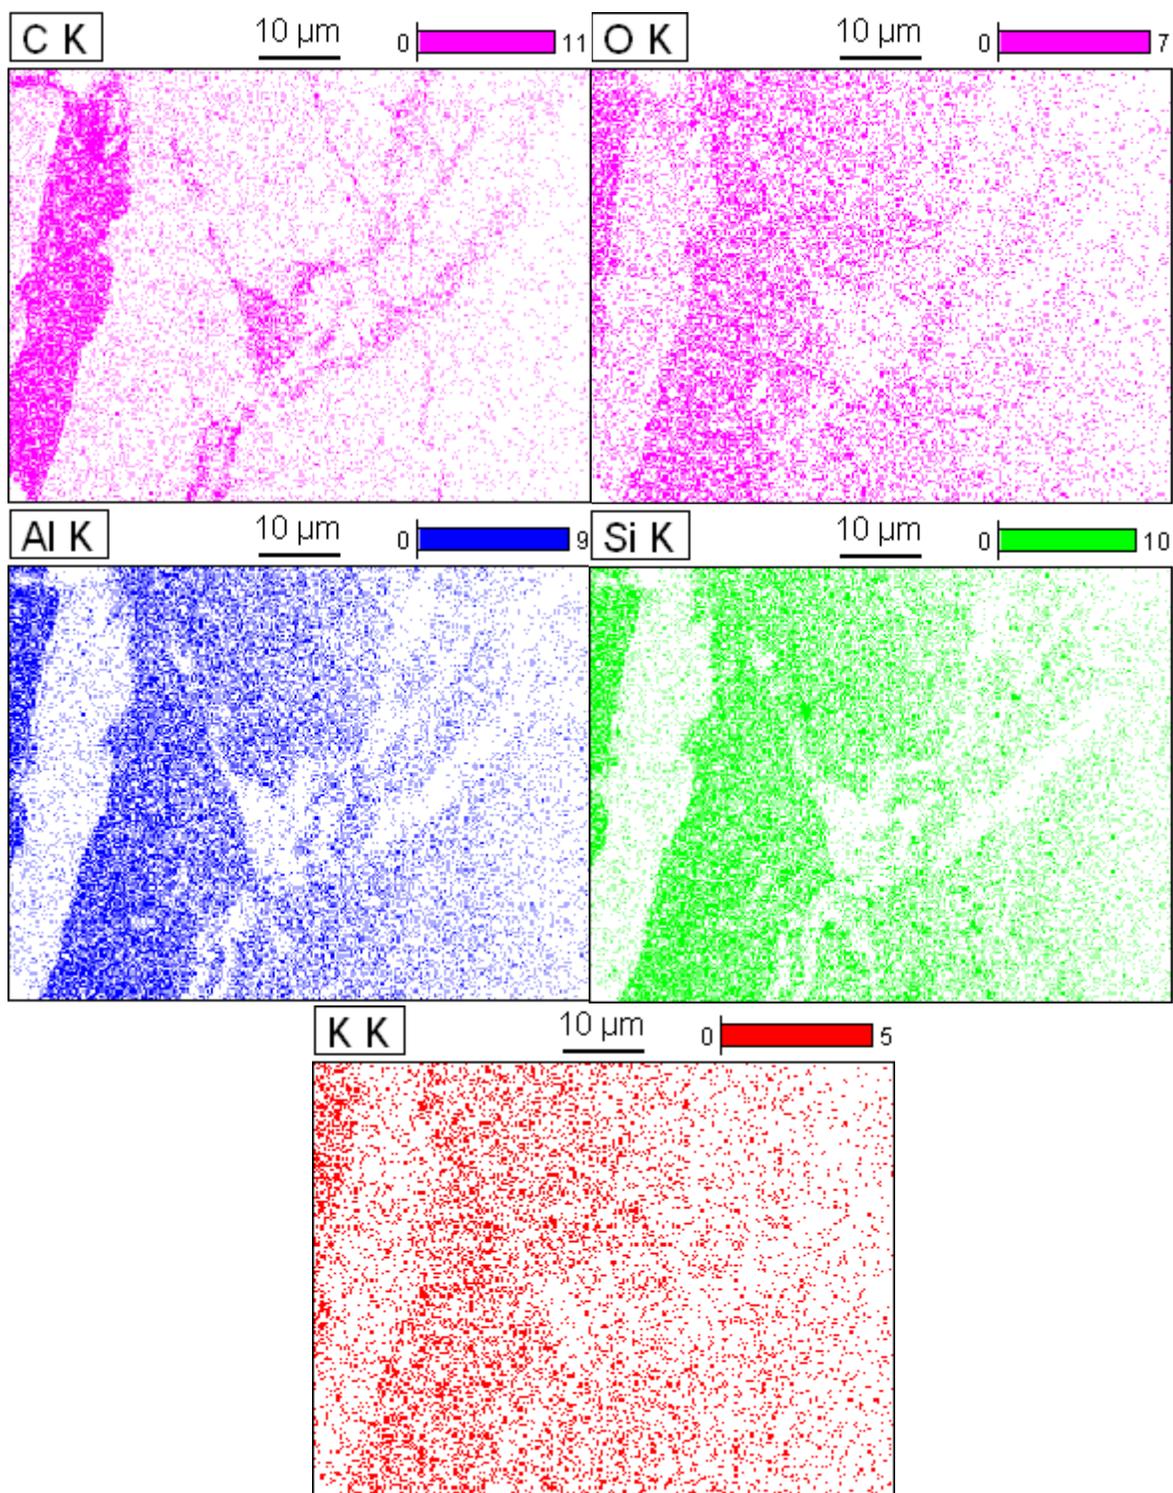
Figure 6.5. Element distribution maps for the images used in figure 6.4, with particular element for each distribution identified above each distribution box in the top left.

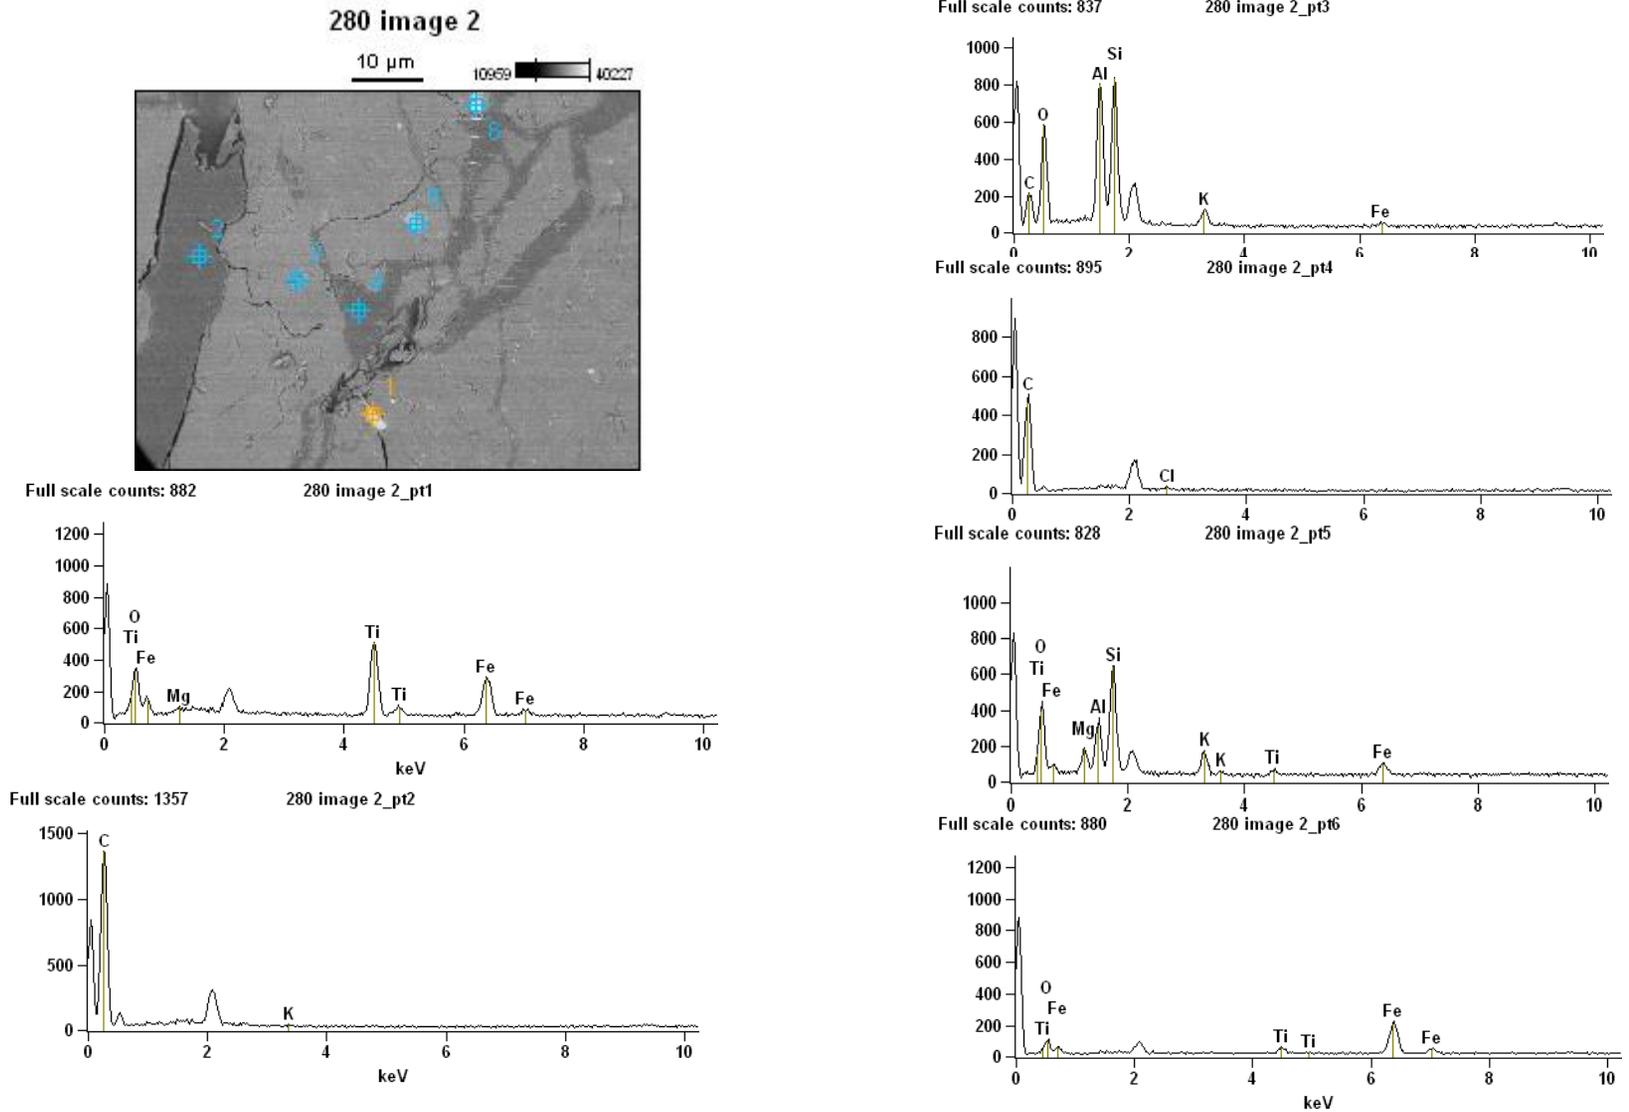
Figure 6.6. Point element distribution on the 280 kPa thin section, where specific points had element volumes graphed. Each point has its own graph produced as shown above, with particular point indicated in the title of each graph.

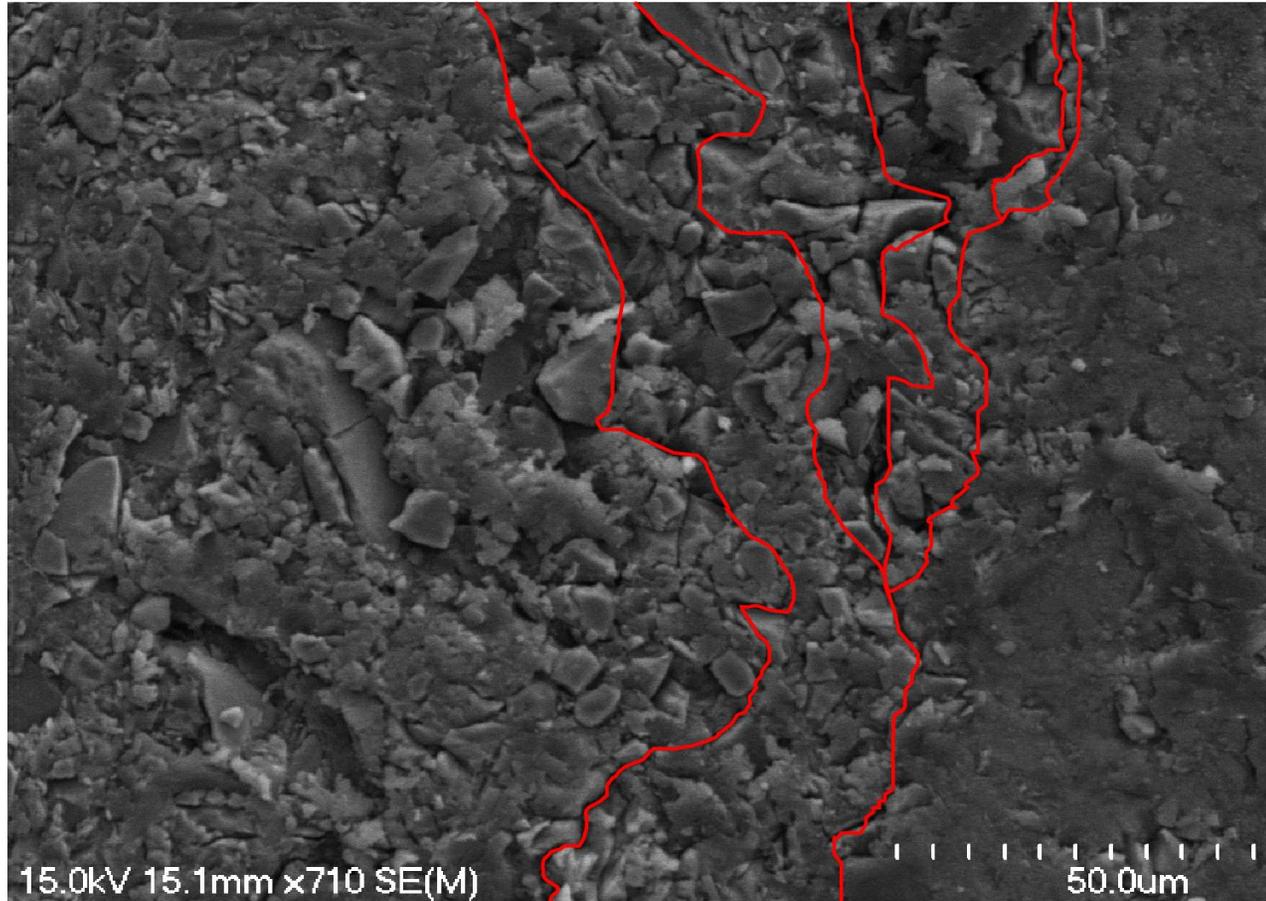
Figure 6.7. Taken at 710 times magnification of the 280 kPa thin section shear zone, propagation of alignments and fractures within the shear zone is indicated in the image above by the red lines.

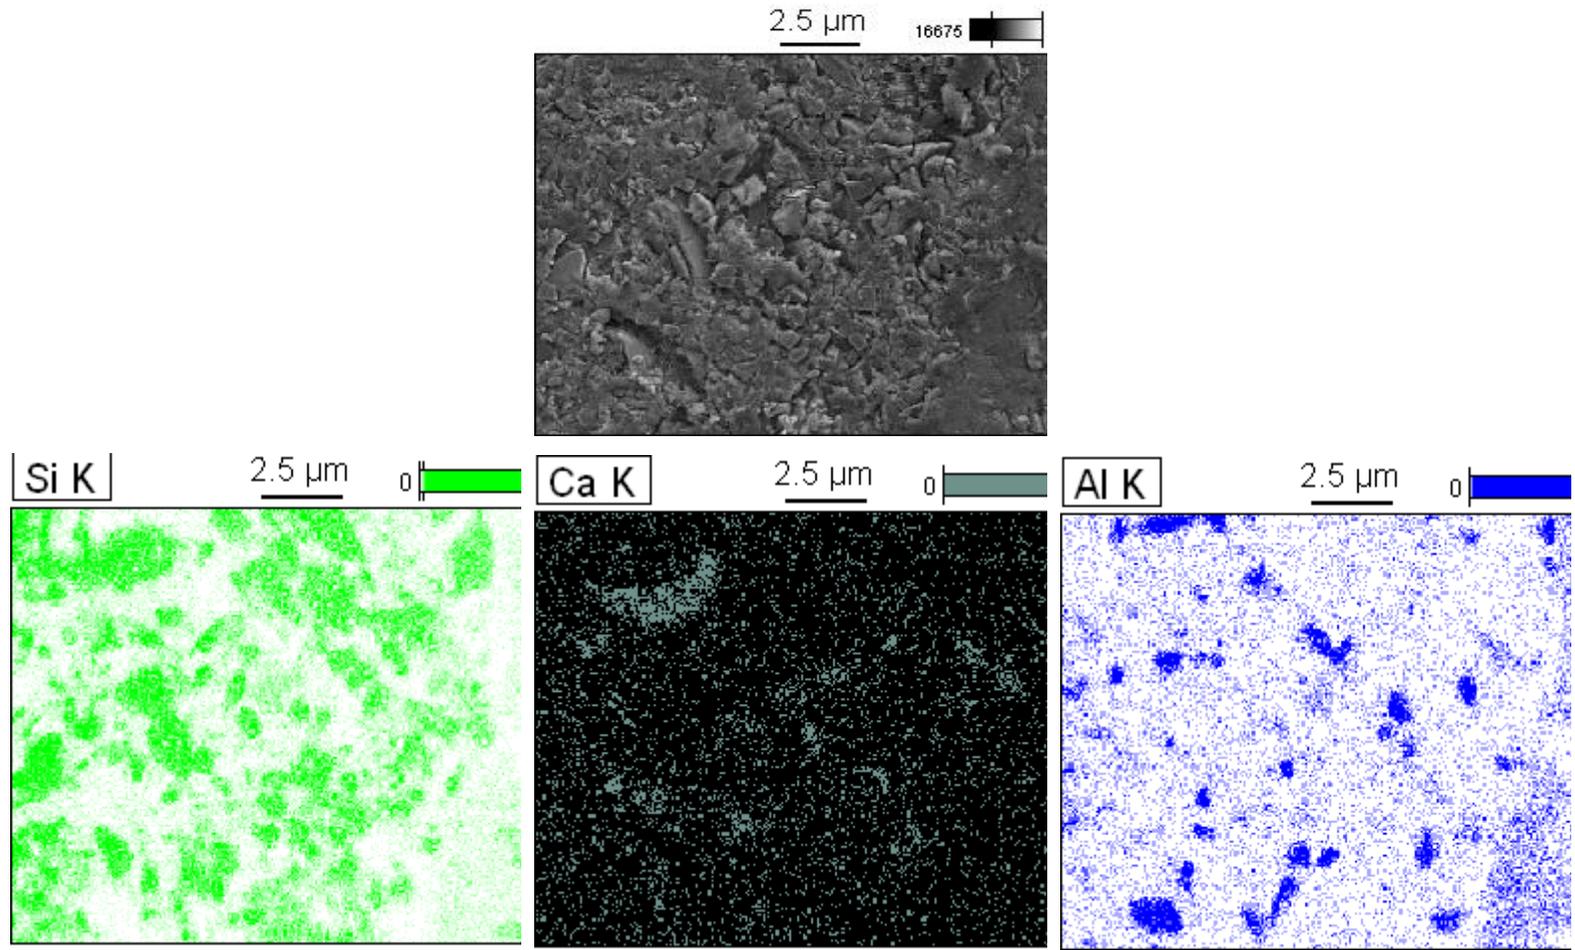
Figure 6.8. Element distribution maps for the image above taken for the shear zone of the 280 kPa thin section at 710 times magnification. Concentrations of calcium (middle image) can be seen above by the grey dots on a black background.

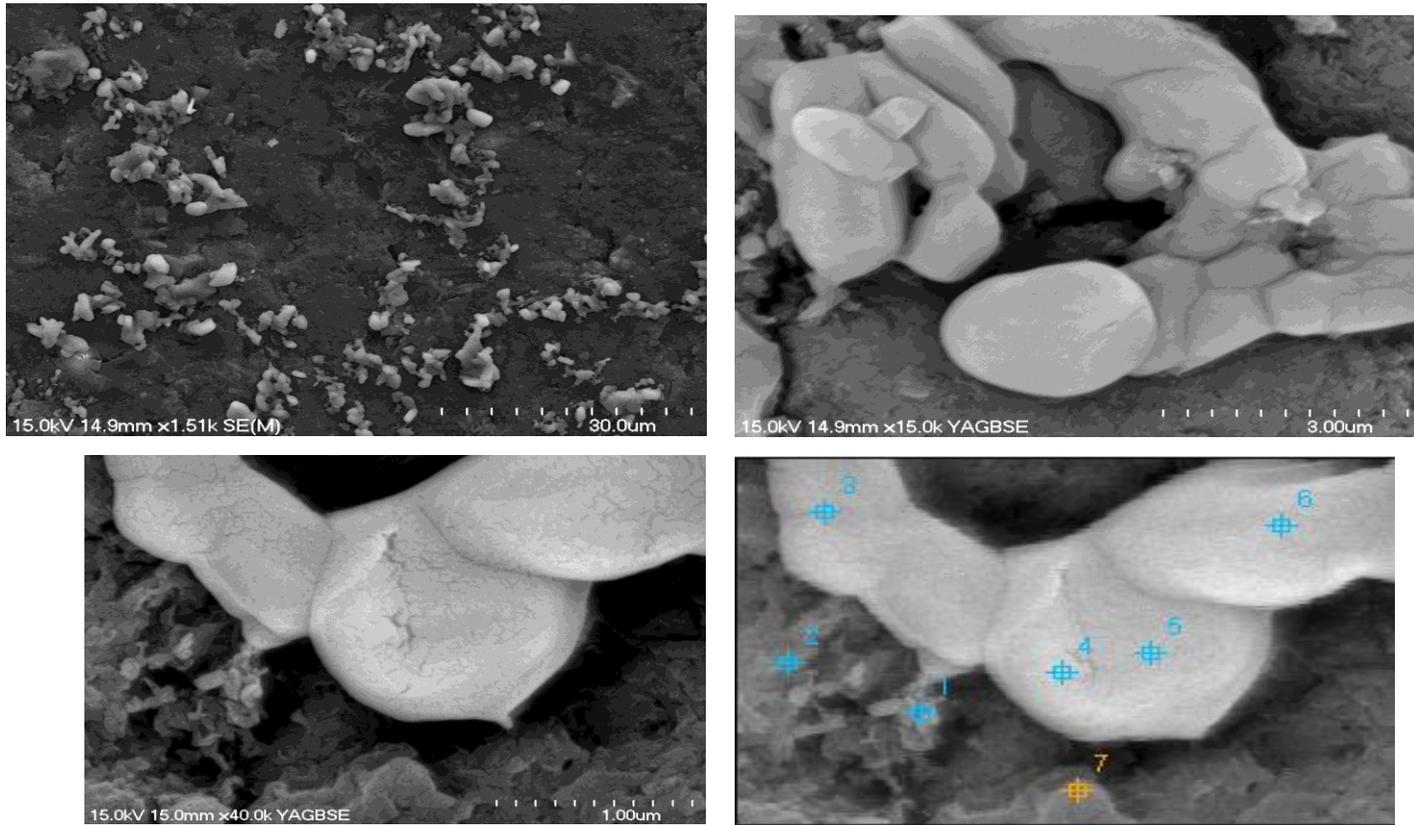
Figure 6.9(A) Taken at 1500 times magnification of the 280 kPa thin section in regular SEM bright circular nodules can be observed propagating on the clay shear surface, with plate like flecks present. **(B)** A BSE taken at 15,000 times magnification of one of the nodules, at this higher magnification it can be seen that these nodules are connected to each other and made up of numerous smaller nodules that have bonded together. **(C & D)** Taken as a BSE image at 40,000 times magnification an extreme close up of the nodule reveals the circular concave shape of the nodules, with desiccation cracks evident, the right hand image shows the points at which point element measurements have been mad
