Is There a Salty Solution to Sensitive Soil Sliding in the Bay of Plenty, New Zealand?

A thesis
submitted in partial fulfilment
of the requirements for the degree
of
Master of Science (Earth Sciences)
at
The University of Waikato
by
Thomas Robertson

2017

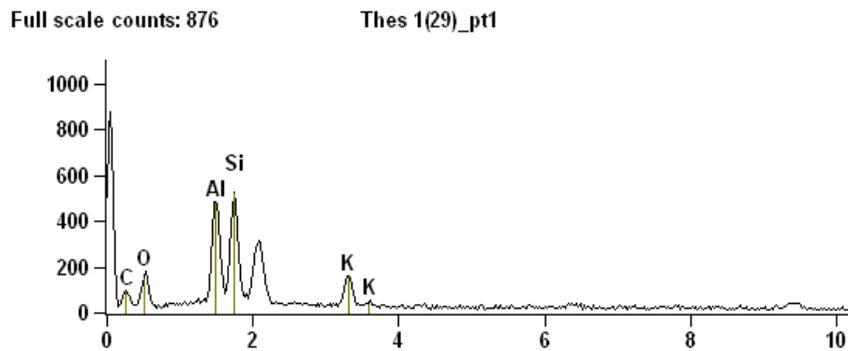
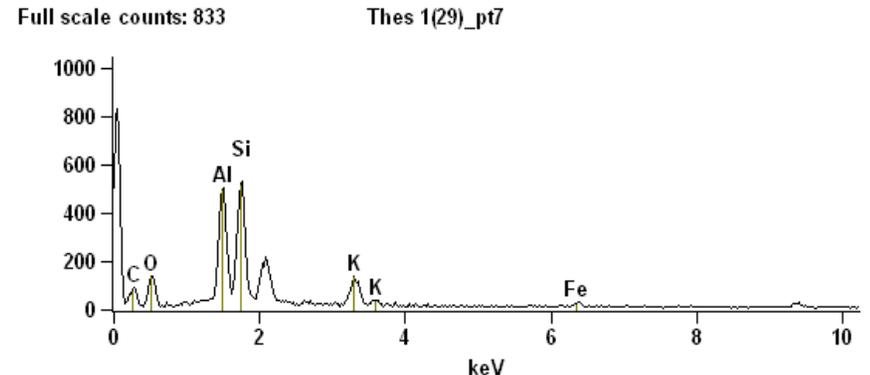
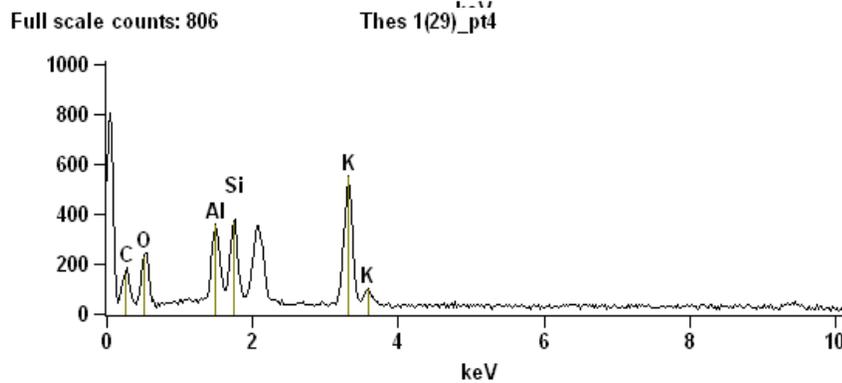
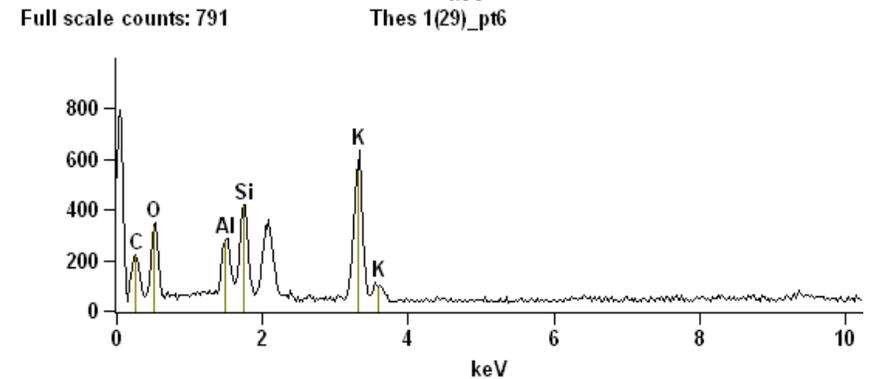
Figure 6.10. Point element analysis graphs for points 1,4,6 and 7 for image 6.9D. Points 1 and 7 show typical treated halloysite clay measurements with peaks measured for silicon and aluminium, whereas points 4 and 6 show peaks similarly for halloysite for silicon and aluminium, but differences are observed as there is a significant peak in potassium for these two points, with potassium measured as the highest proportion of element present at these points.

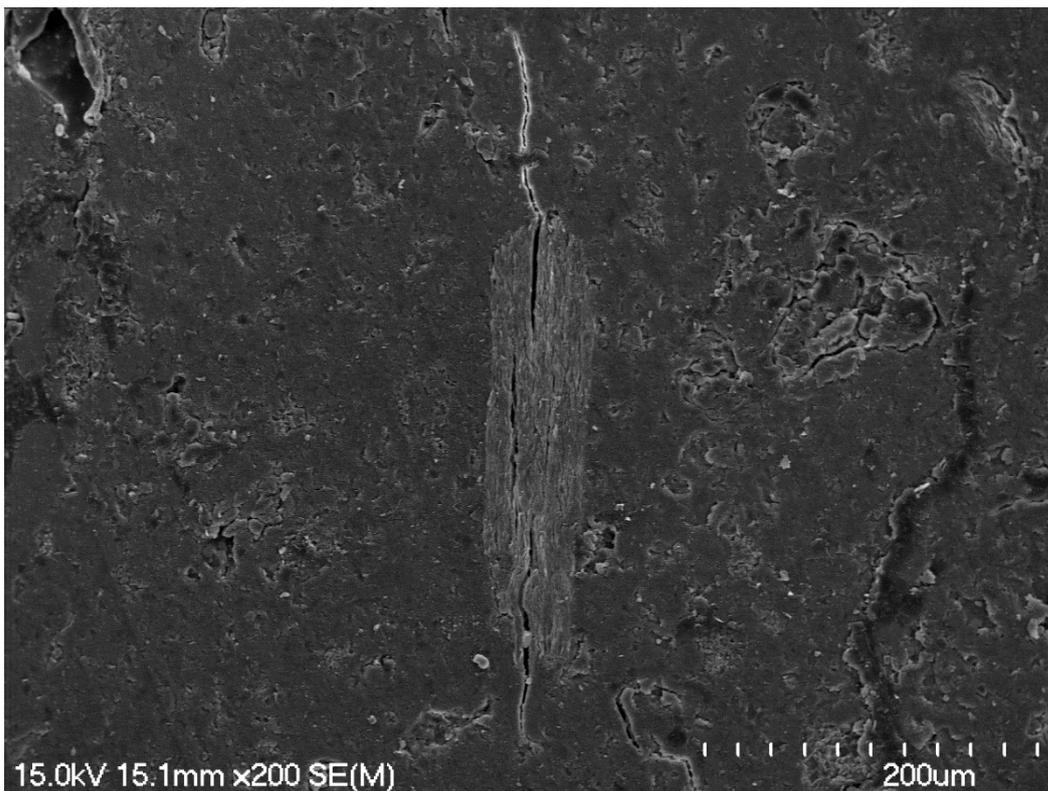
Figure 6.11. A possible orthoclase crystal with fracture propagating through the crystal at 200 times magnification taken in normal SEM

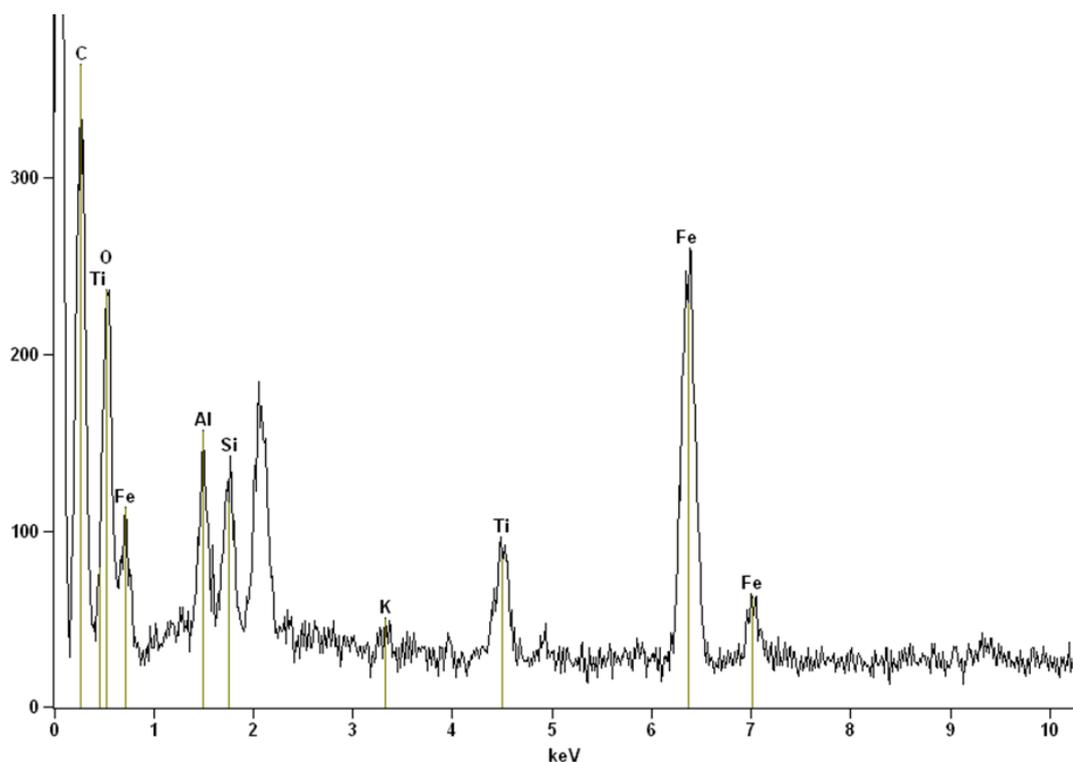
Figure 6.12. An element distribution graph for the crystal present in figure 6.14 with peaks measured for multiple elements.

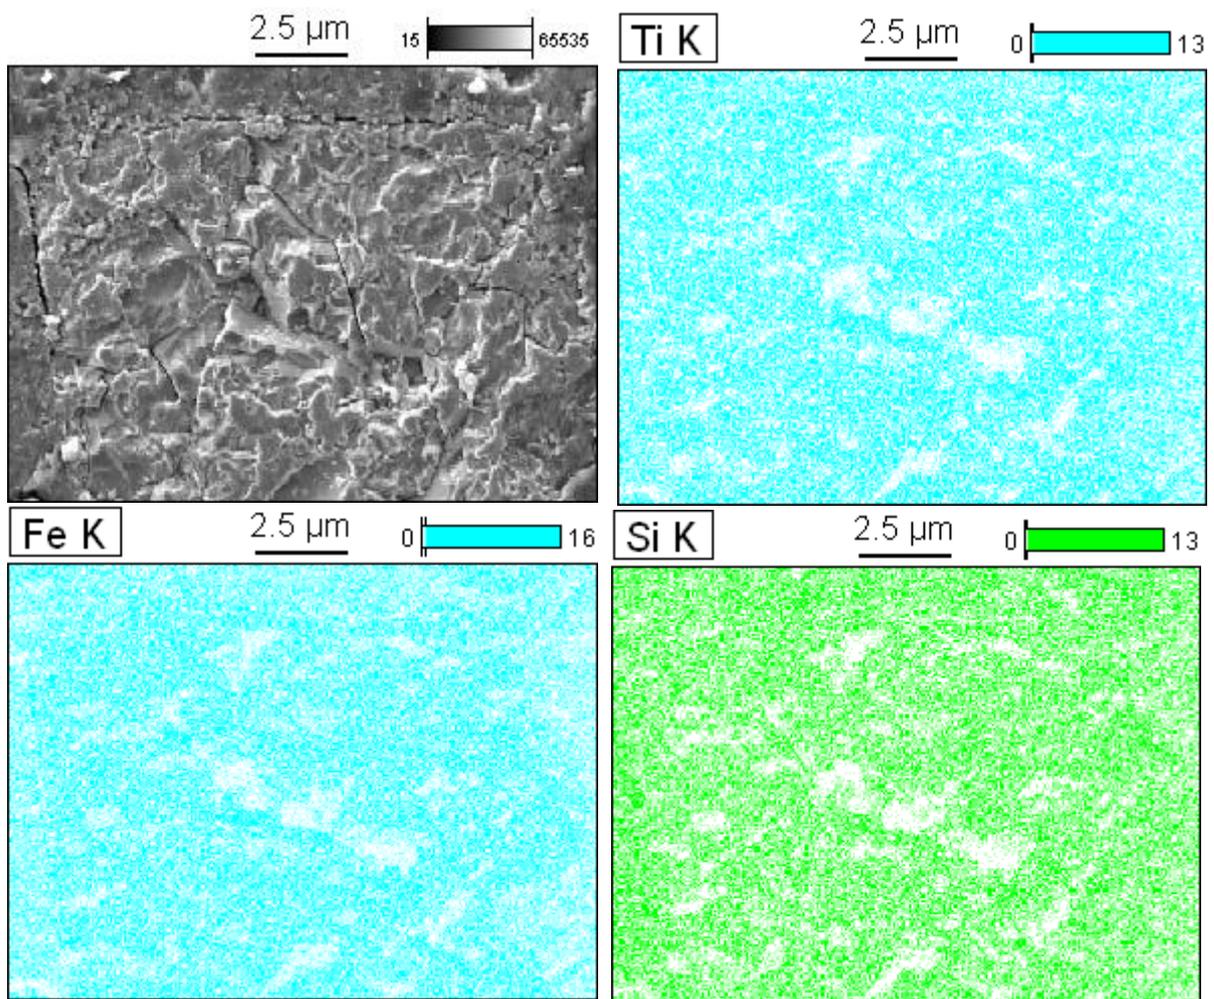
Figure 6.13. An element distribution map for titanium, iron and silicon present for the image shown in the top left corner.

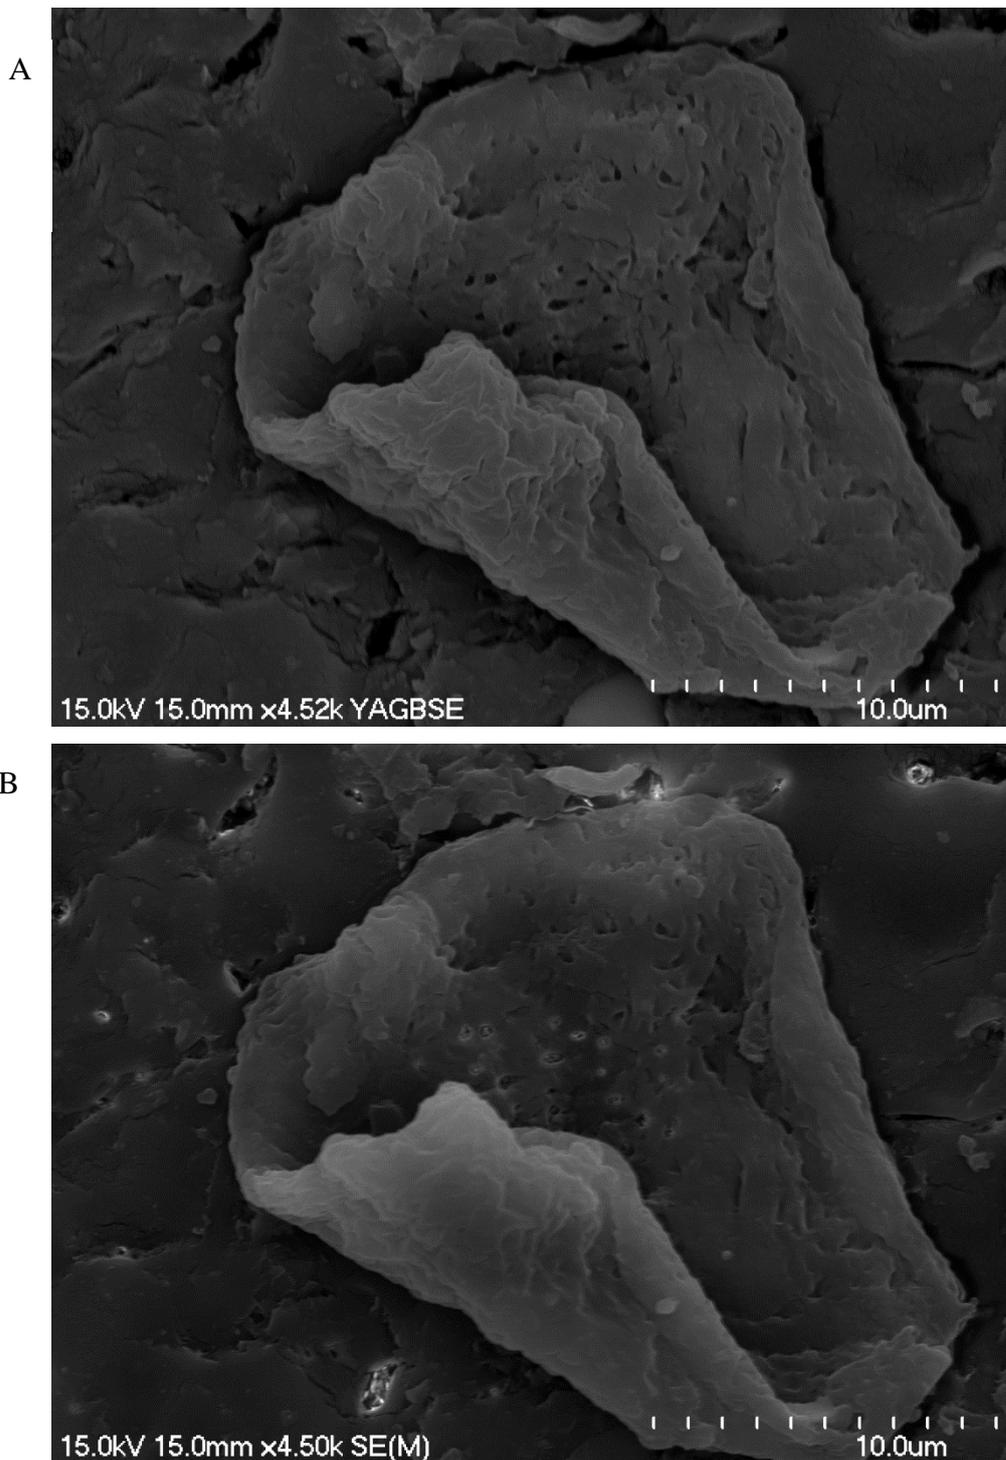
Figure 6.14(A) A BSE image of what is thought to be a weathered NaCl crystal found in the 355 kPa thin section. **(B)** An SEM image at 4500 times magnification of what is thought to be a NaCl crystal.

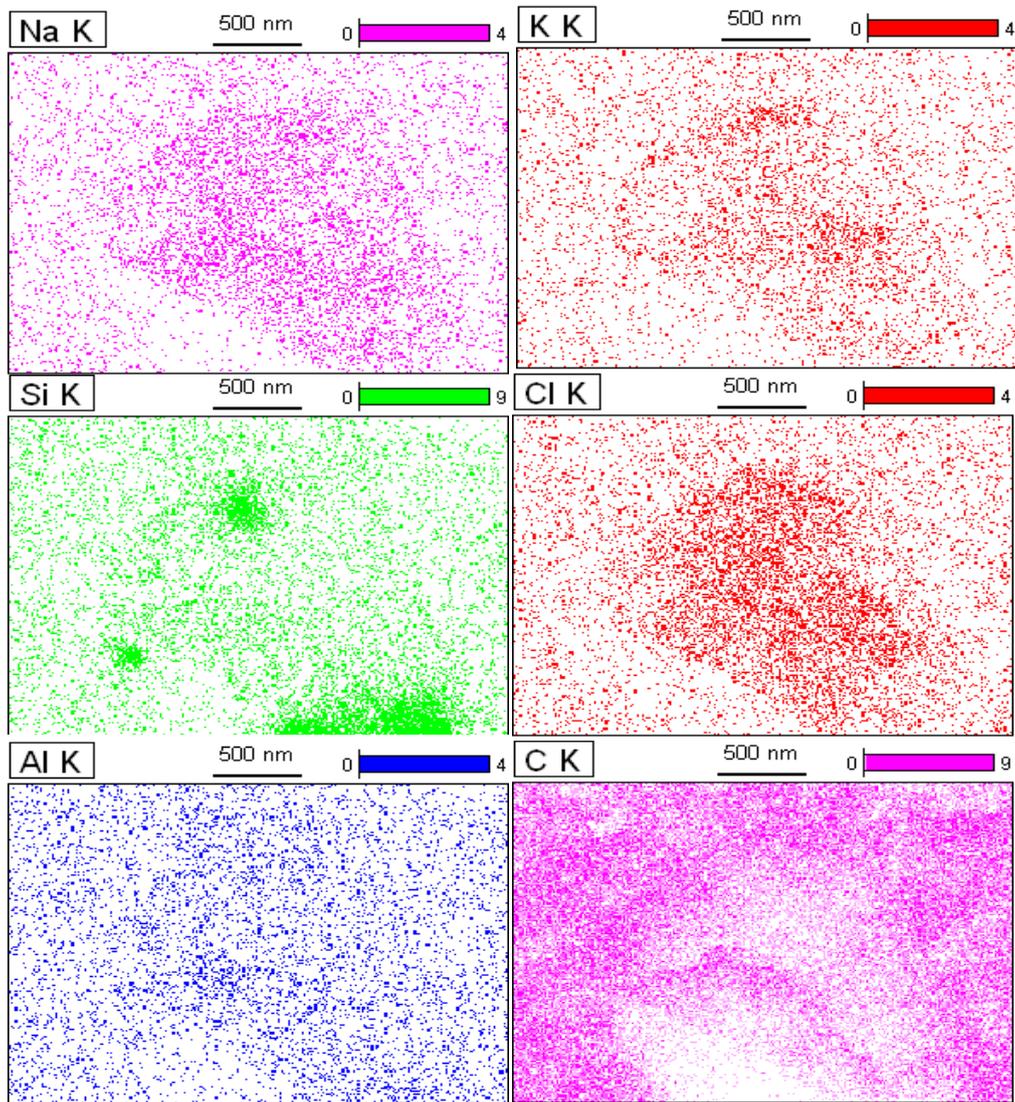
Figure 6.15. An element distribution chart for a variety of elements detected on the image of figure 6.14. Concentrations of Na and Cl are heavily evident on the crystal itself.

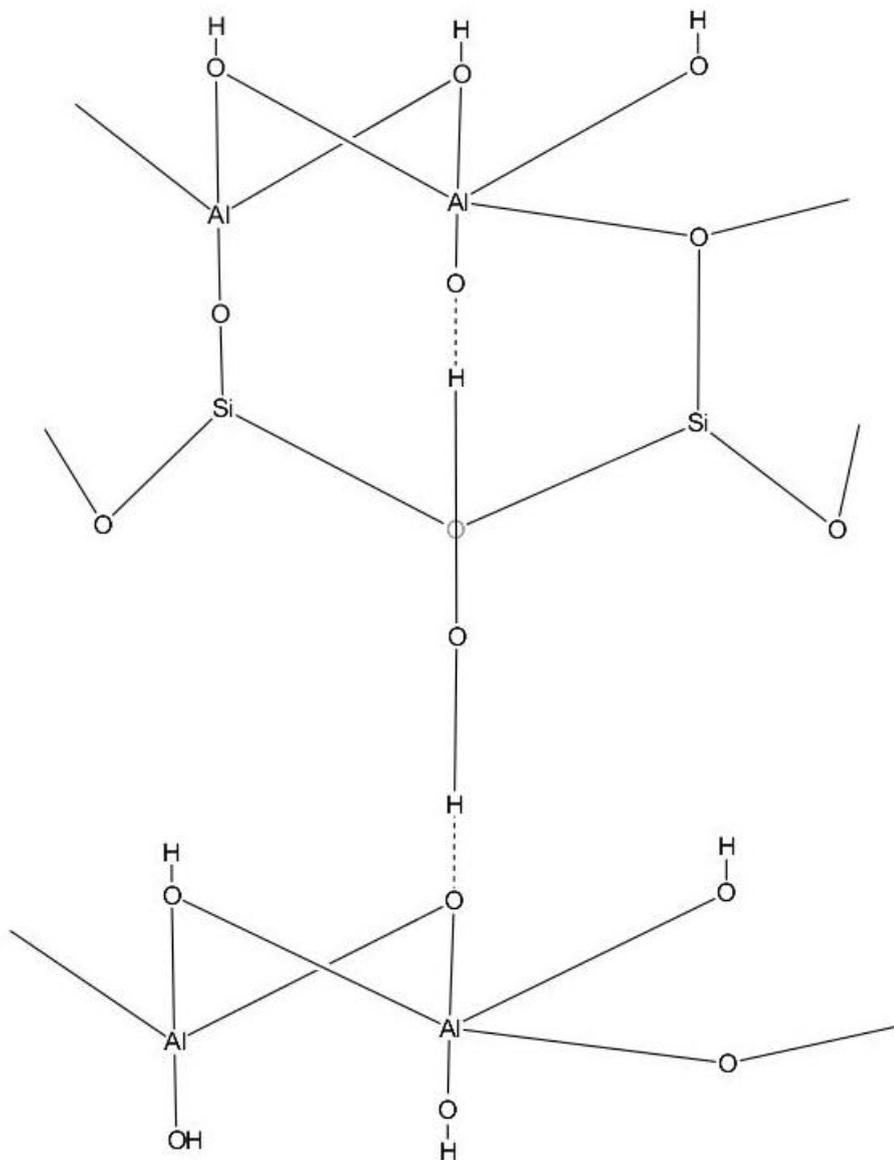
Figure 7.1. A concept sketch of how water intercalates into the halloysite crystal basal space. The H₂O unit forms temporary hydrogen bonds with the hydrogen deficient hydroxyl groups on the aluminol sheets and actively intercalates.

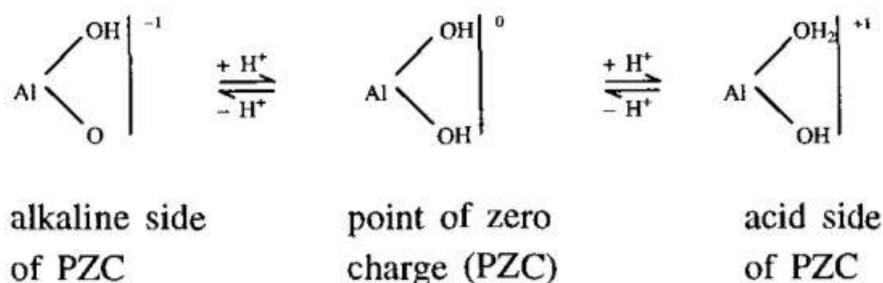
Figure 7.2. Sourced from Theng & Wells (1995), showing how the Aluminol sheet in halloysite changes its charge dependant on the soil pH.

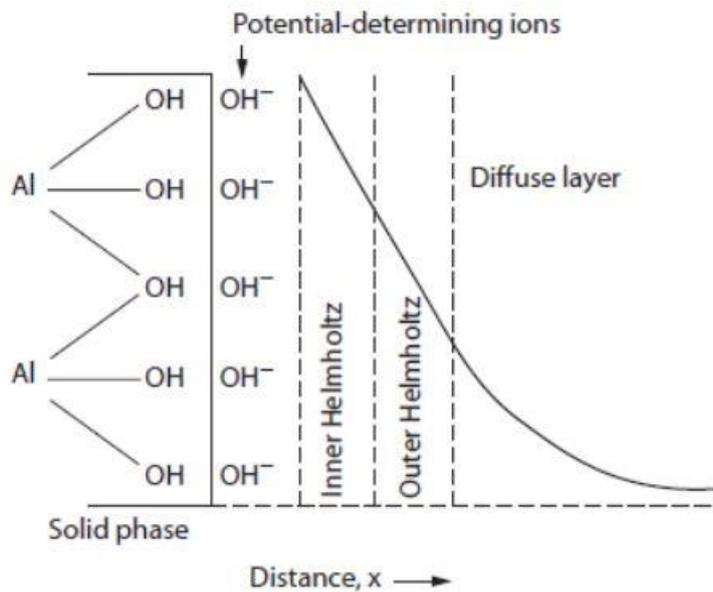
Figure 7.3. Sourced from Tan (2010), the diagram above represents the hypothetical inner and outer hemholtz layers that ions have to overcome to bond.

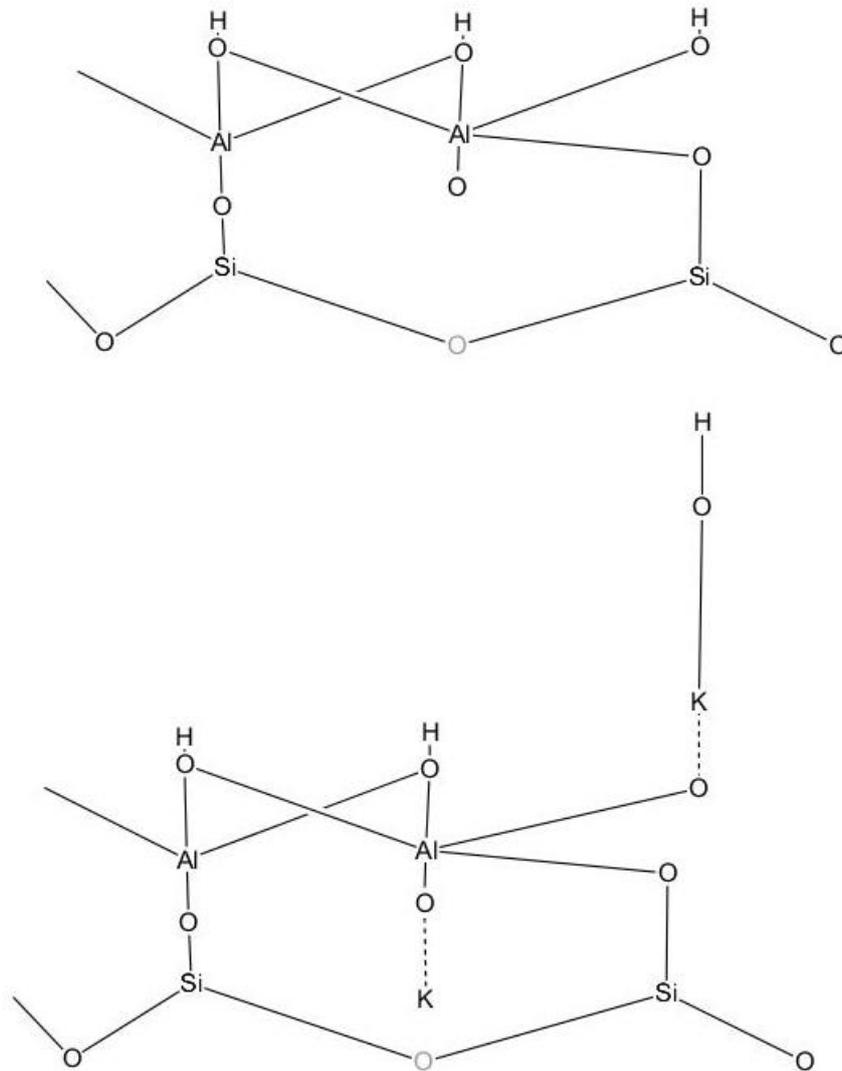
Figure 7.4. A hypothetical concept sketch of the chemical bonding and ionic bonding that will occur when KOH interacts with the aluminol sheet of halloysite.

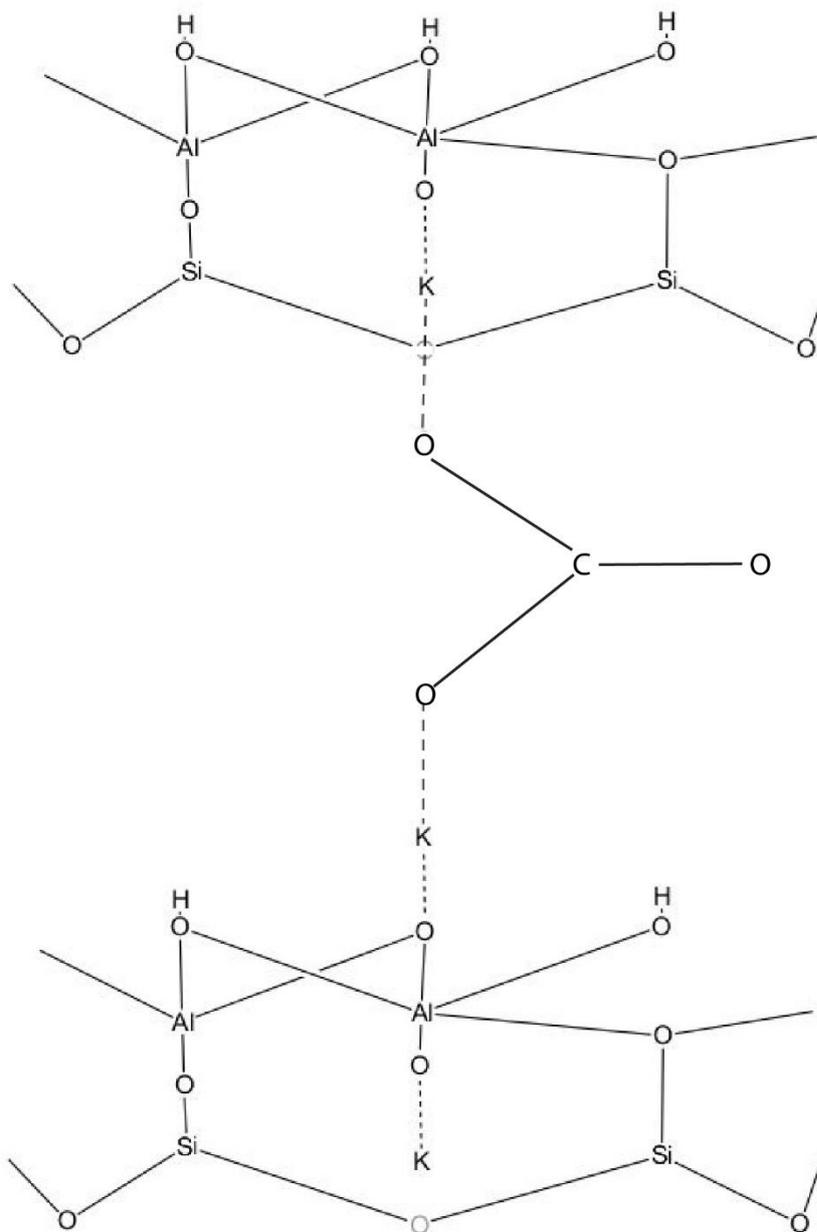
Figure 7.5. A hypothetical concept sketch of the way in which K_2CO_3 intercalates into the halloysite crystal lattice, and subsequently forms temporary ionic bonds with the hydrogen deficient aluminol oxygens.

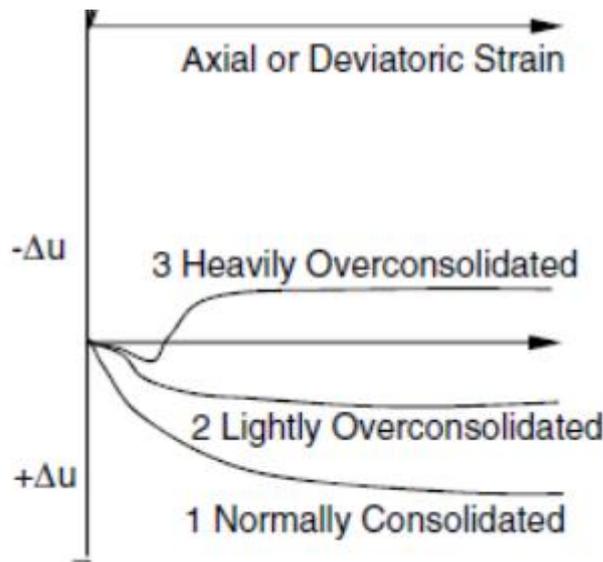
Figure 7.6. Sourced from Tan (2010), the figure above indicates whether pore pressures will become positive or negative under axial strain conditions for clays.
