THE UNIVERSITY OF
WAIKATO
Te Whare Wānanga o Waikato

Research Commons

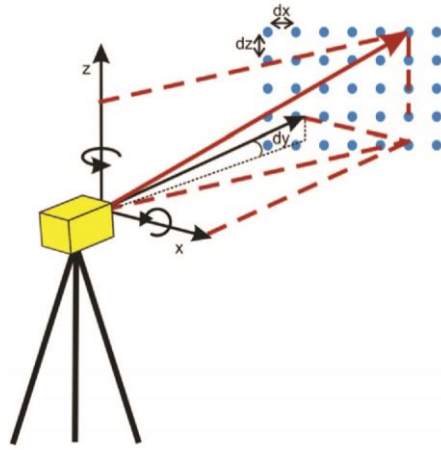
Figure 2.3 Terrestrial laser scanner capturing 3D position of data points (Kuhn & Prüfer, 2014, p. 157)

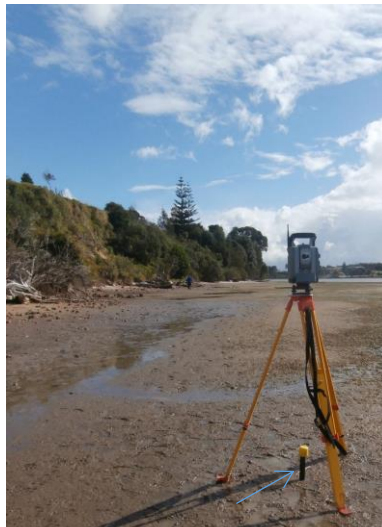
**Figure 3.12: Plummers Point centered peg**

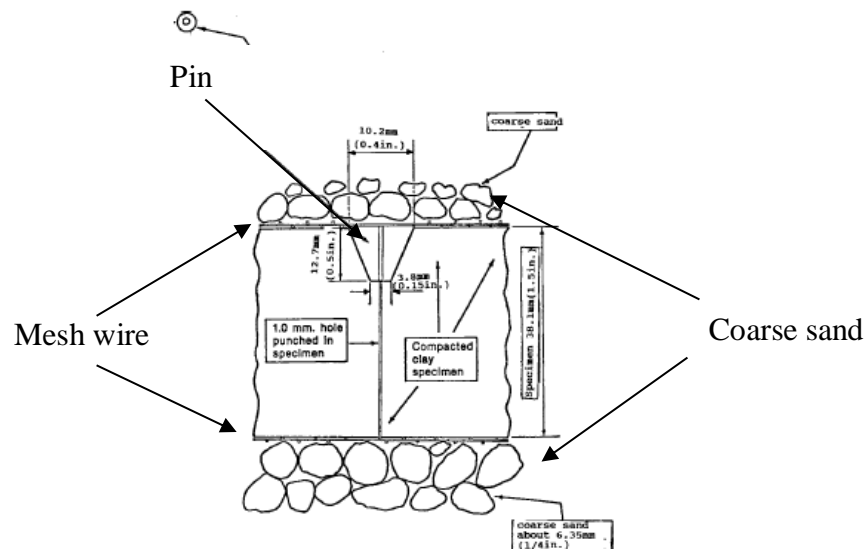
Figure 3.14: Cross section through pinhole test specimen (Sherard, 1976)

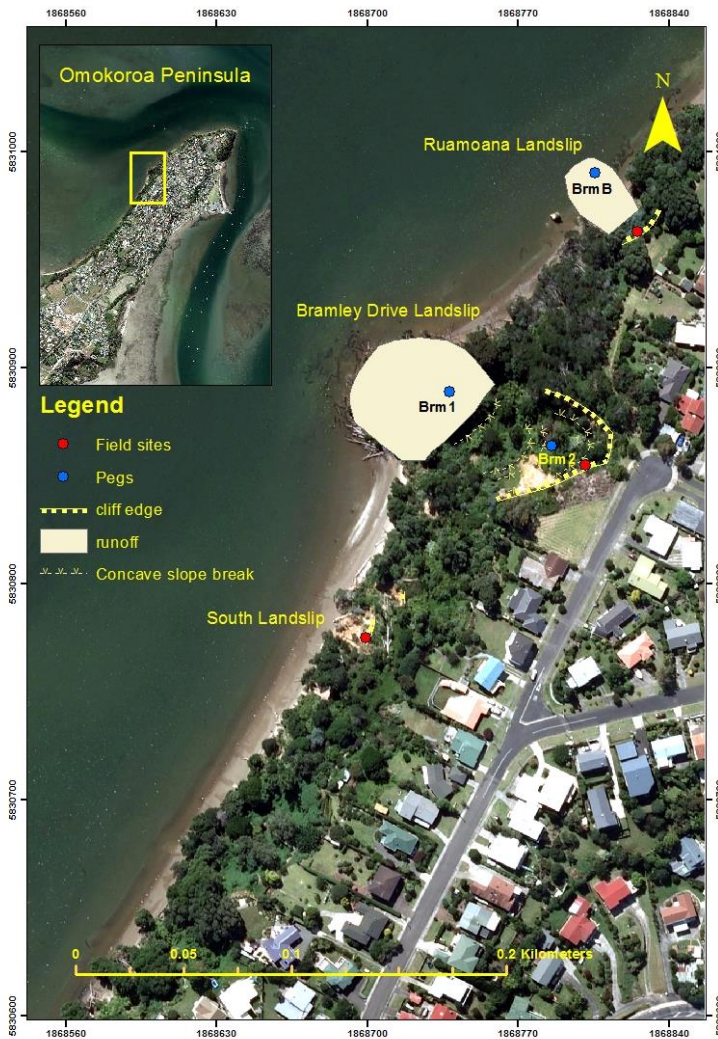
Figure 5.1: Location and Geomorphic Map of Ruamoana landslip, Bramley Drive landslip and South landslip

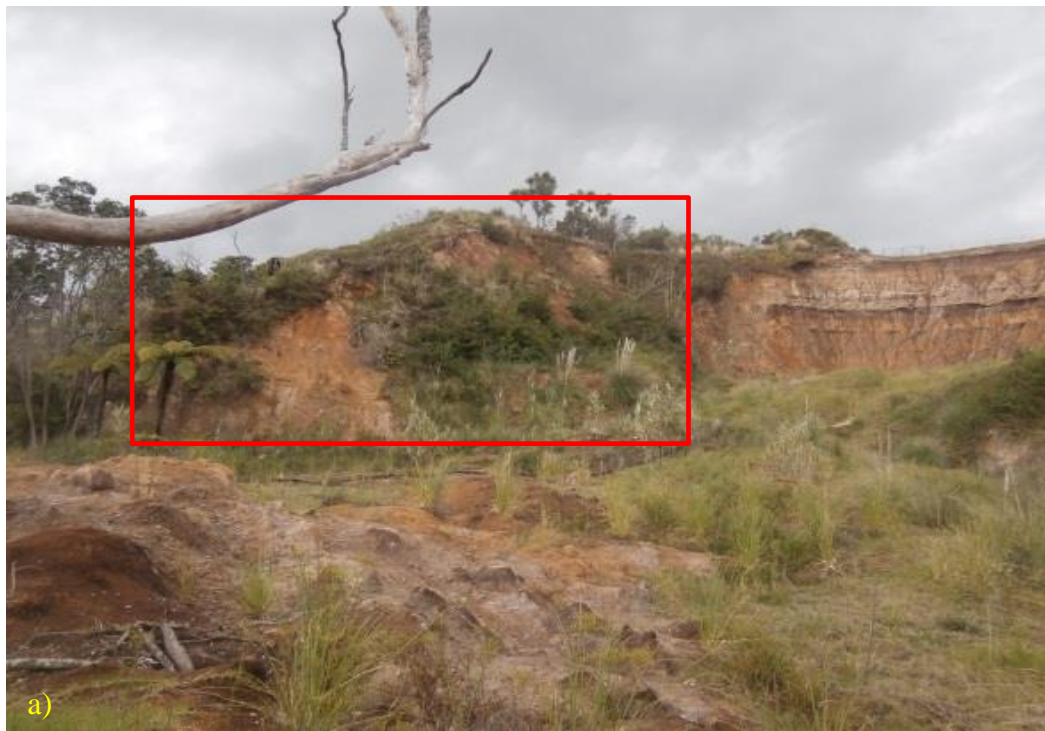
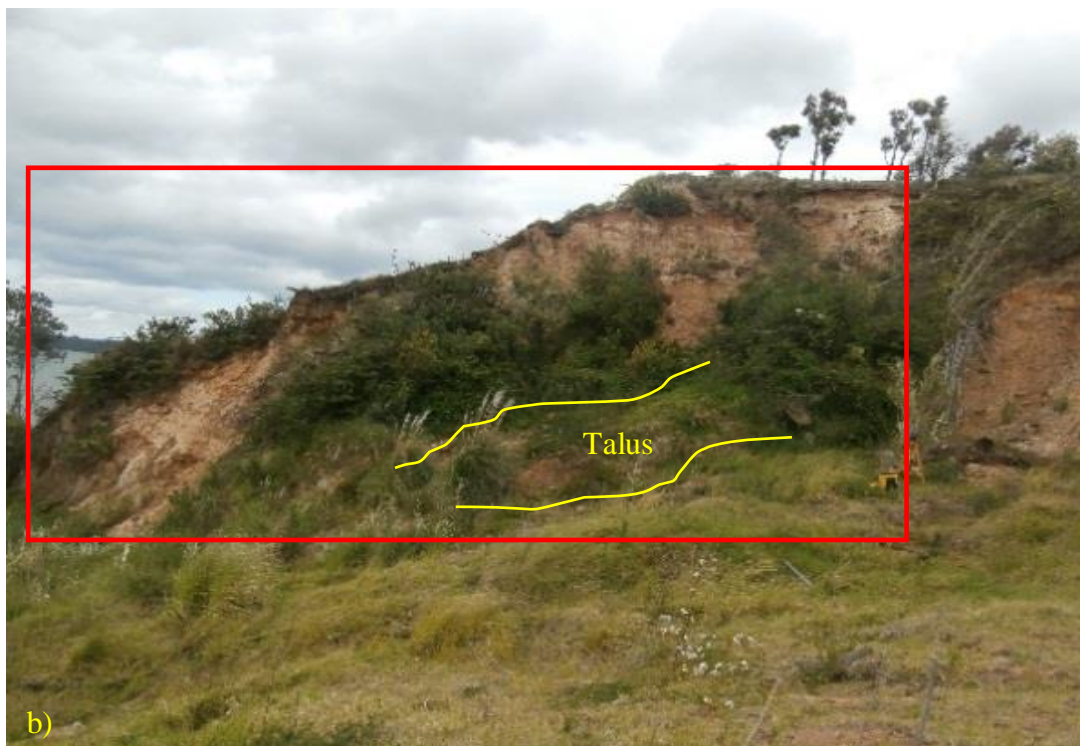
Figure 5.4: Erosion and deposition on western side of cliffs

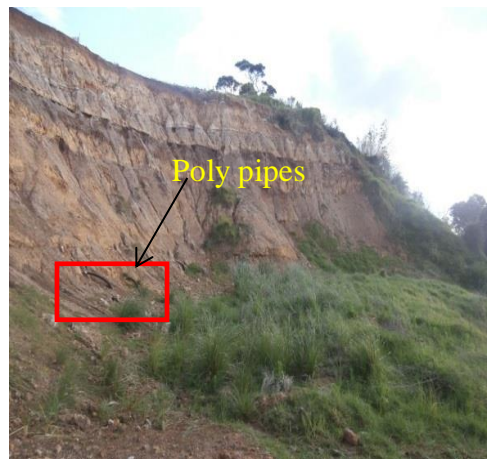
Figure 5.7: Poly pipes inserted into base of scarp

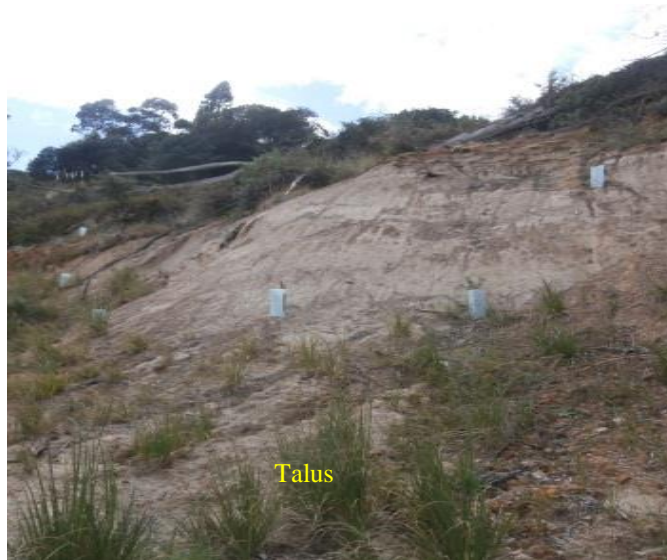
Figure 5.9: Steep Te Puna Ignimbrite cliffs

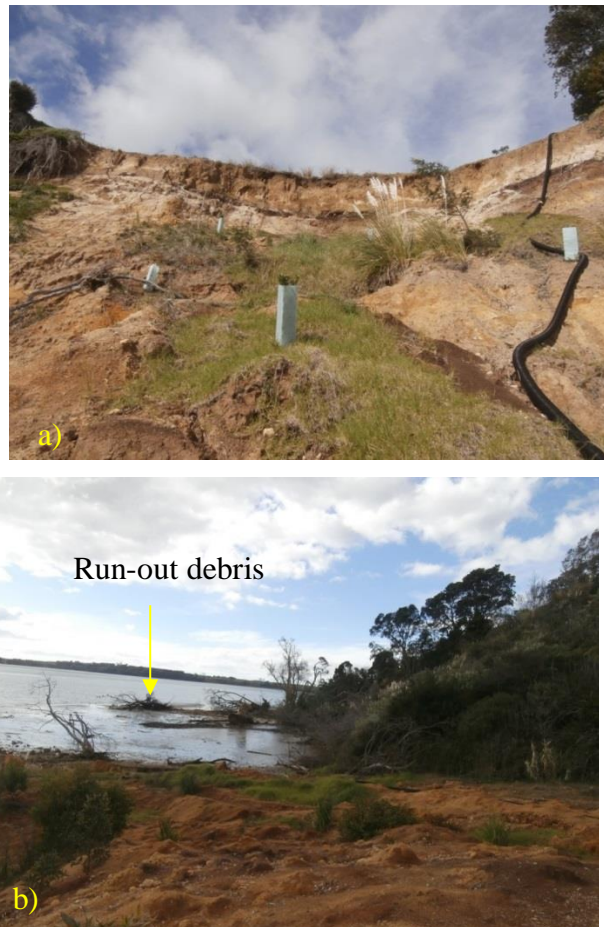
Figure 5.13: (a) Cliff scarp, (b) run off from landslip

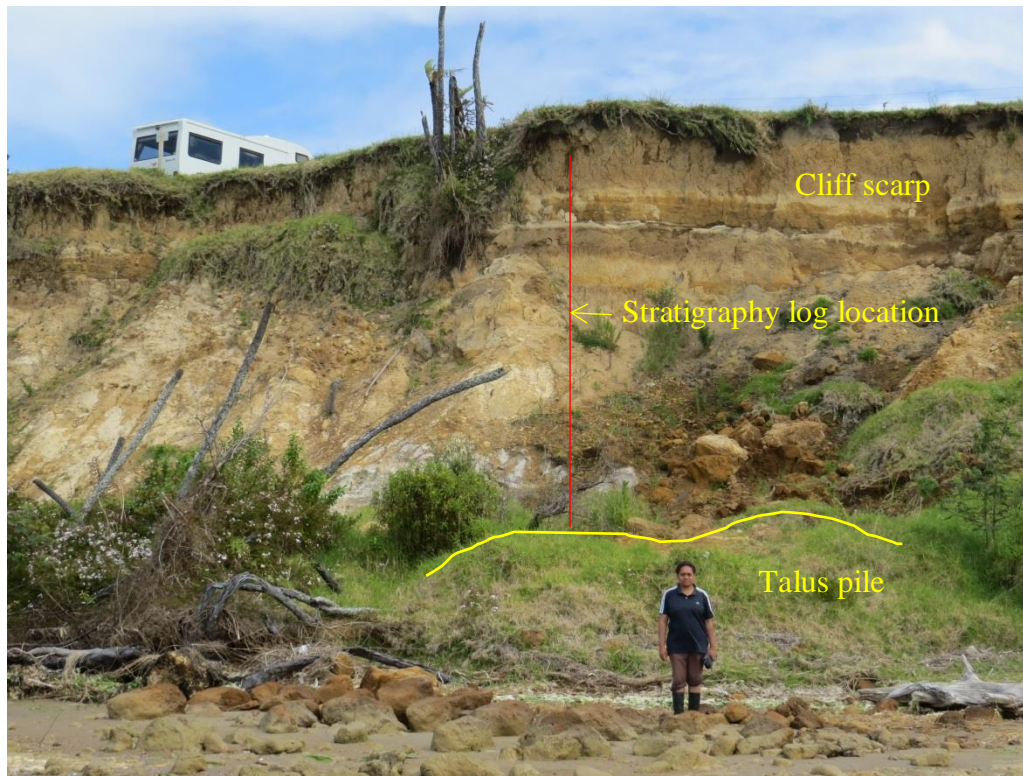
Figure 5.19: Main site cliff section at Plummers Point with location of log

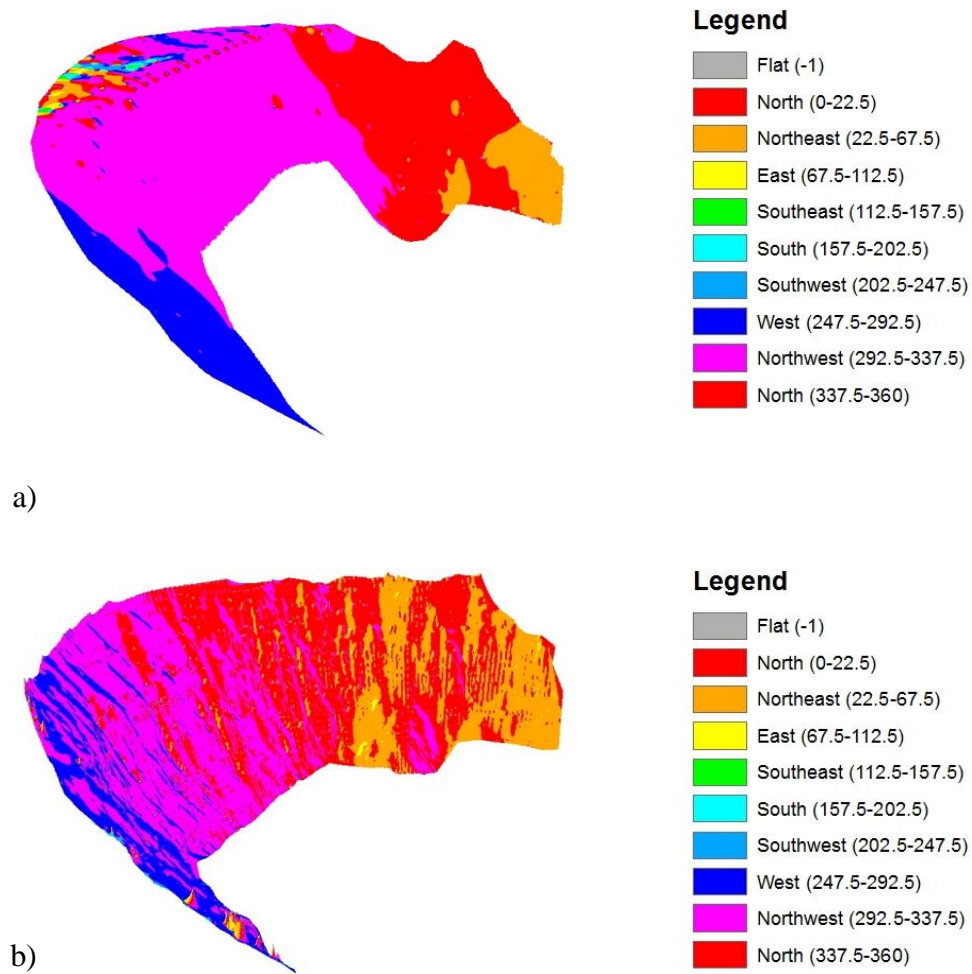
Figure 6.2: Aspect images showing the direction the cliff face is facing (a) 2011 aspect DEM, (b) November 2015 aspect DEM

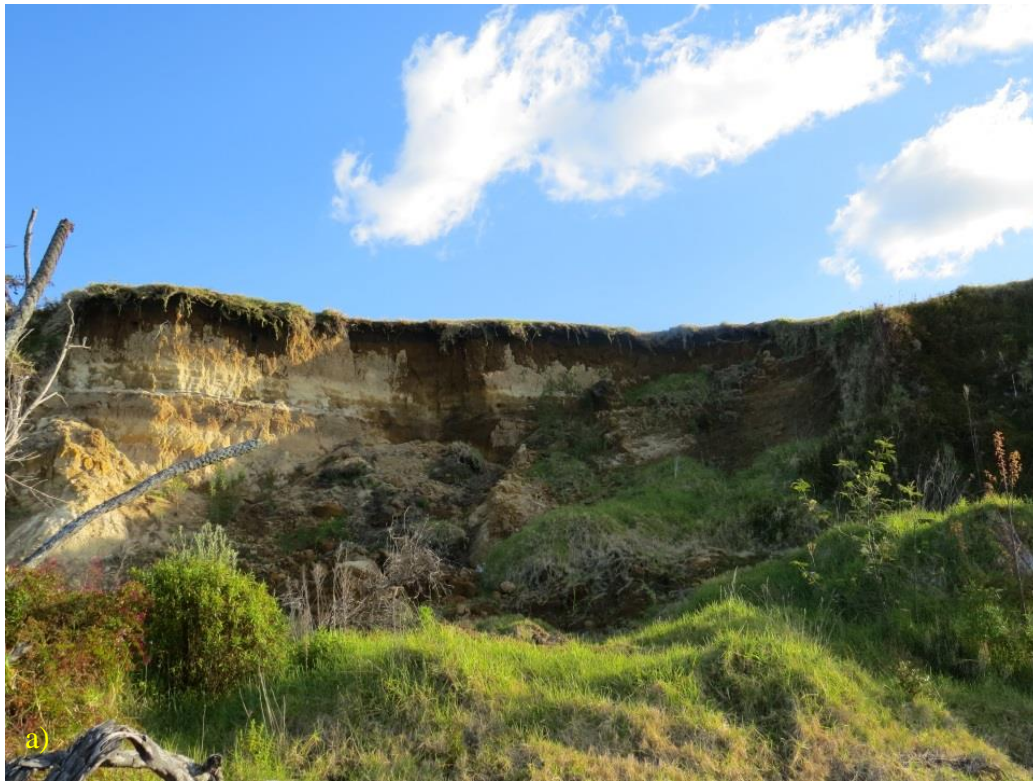
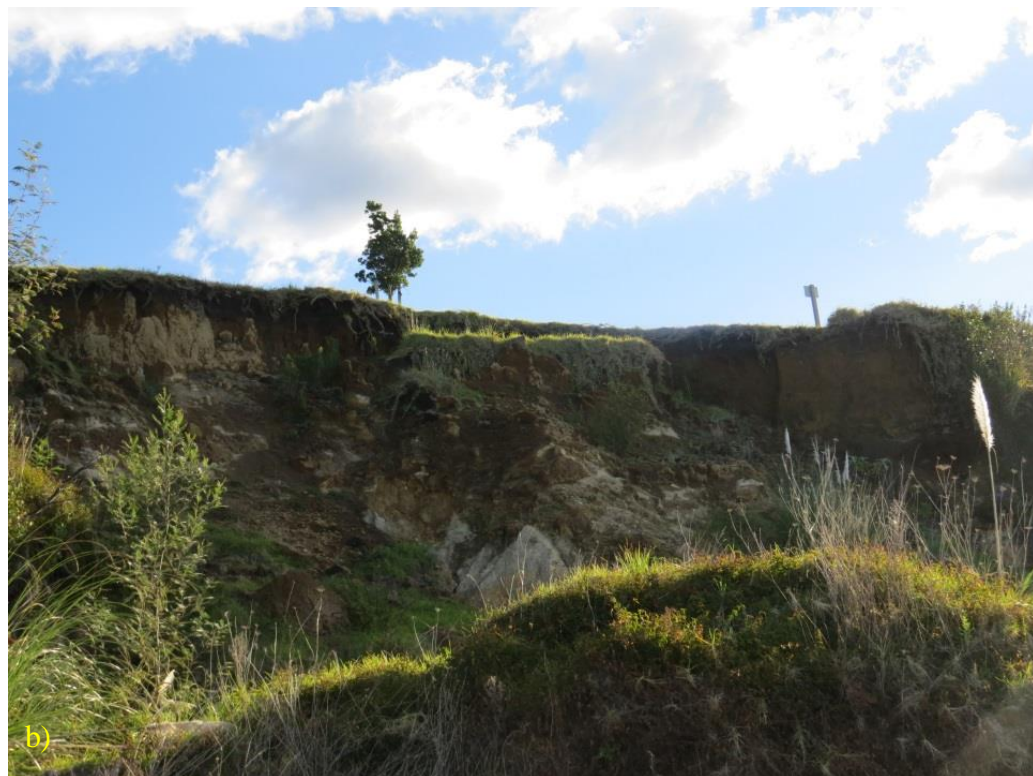
Figure 6.14: (a) Central face of cliff face (b) northern side of cliff face

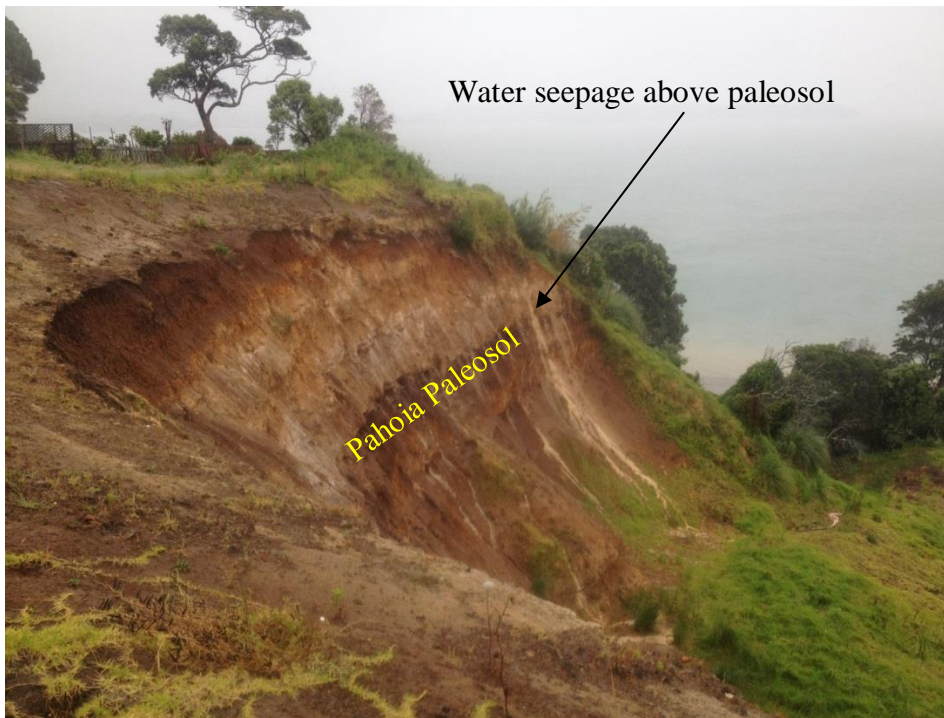
Figure 7.6: Water seepage above Pahoia paleosol layer at Bramley Drive (source: de Lange 2014)
