THE UNIVERSITY OF
WAIKATO
Te Whare Wānanga o Waikato

Research Commons

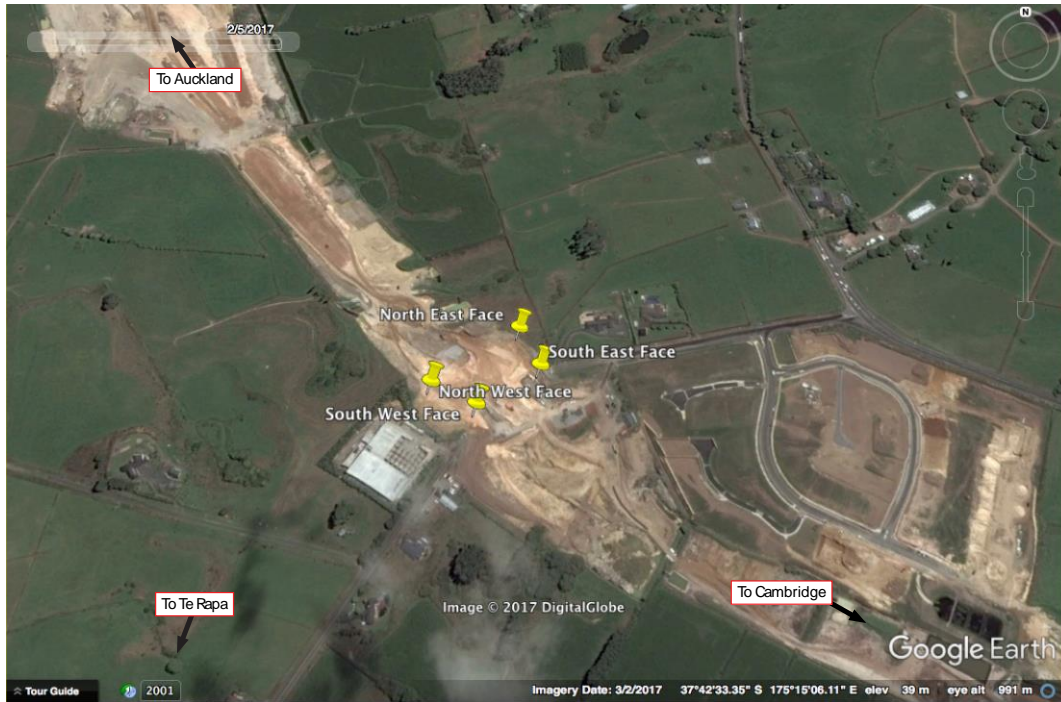
Figure 3.2 - A satellite image of the Kay Road field site. Detailed in the image are the four faces studied, along with directions of reference points. Image from Google Earth, 2017.

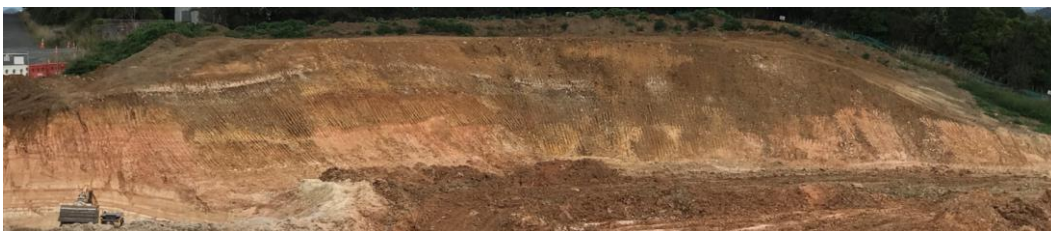
Figure 4.4 - Photograph of the NW face. Pictured to the far left (above digger) is the upper extent of the SW face.

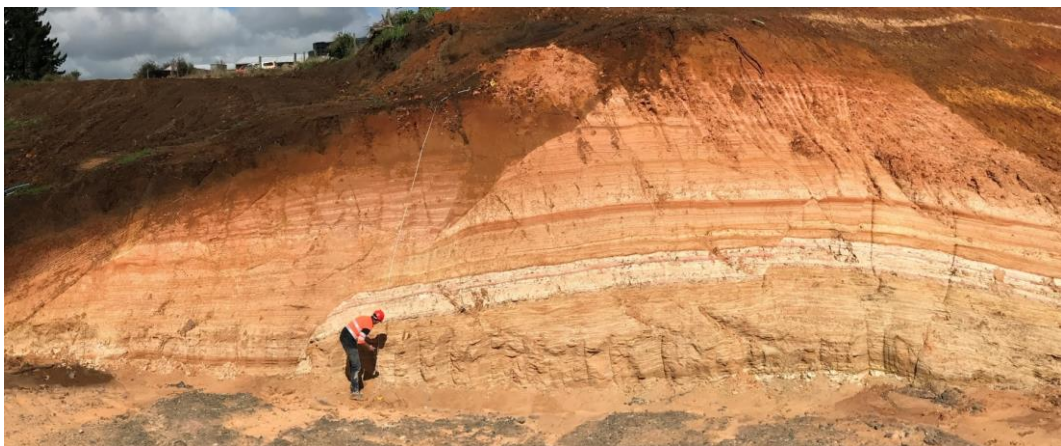
Figure 4.6 - Photograph of the SW face.

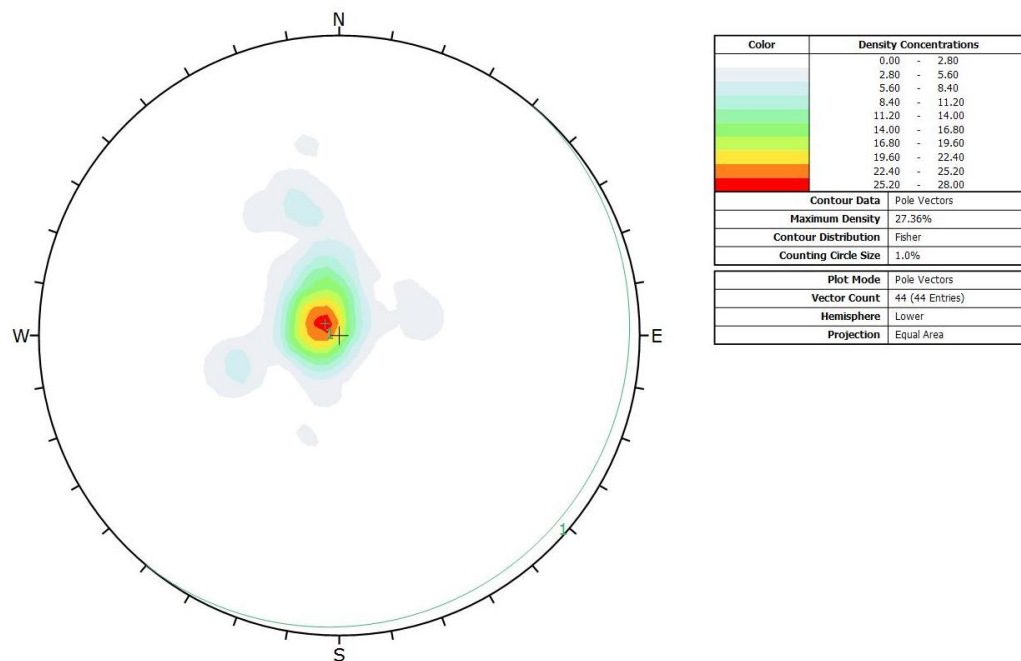
Figure 4.13 - Stereonet illustrating structural information of beds obtained in the NW field area.

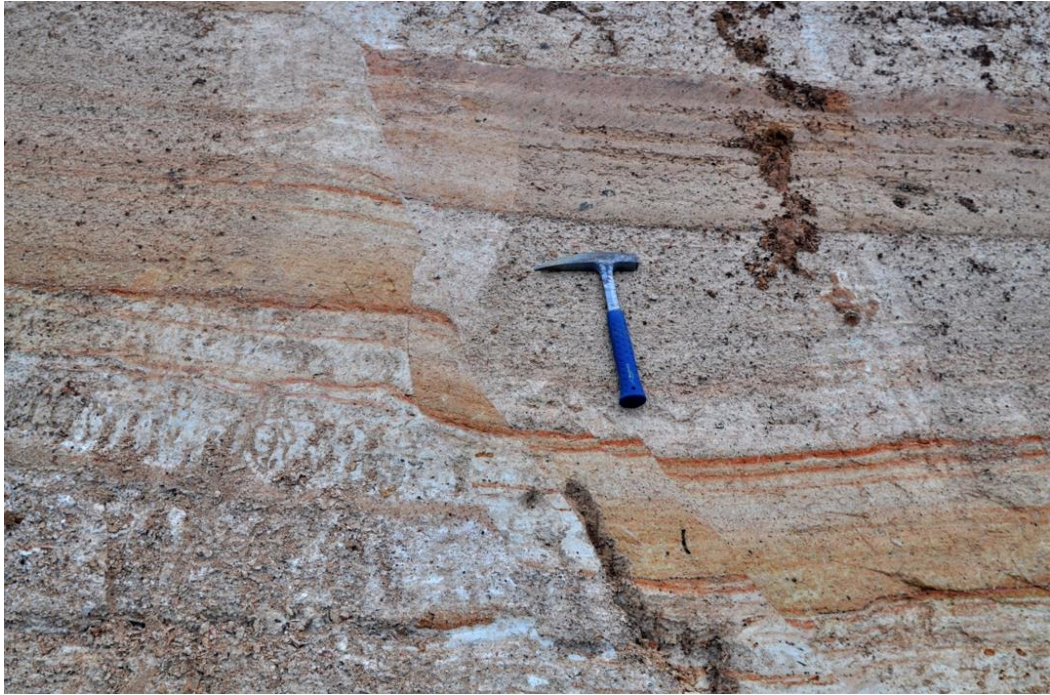
Figure 4.16 - Image showing offset within the Walton Sub-group in the SE of the Kay Road field area. As shown in the image, the block to the right (southern block) appears to be down-thrown, a result of normal faulting within the Walton Sub-group. Also shown in Figure 4.16 is clear banding, a phenomenon observed throughout the Walton Sub-group in the field area.

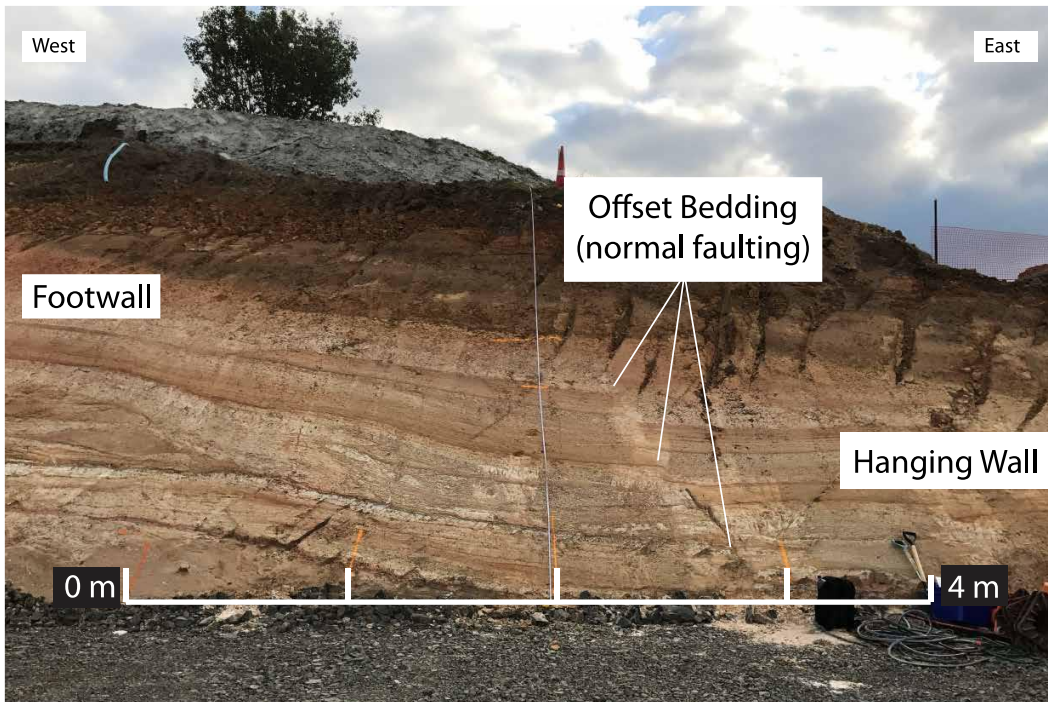
Figure 4.19 - Image showing deformation of the Walton Sub-Group within the South Eastern face. Pictured to the right is a spade for reference. The total height of the face was 8 m high.

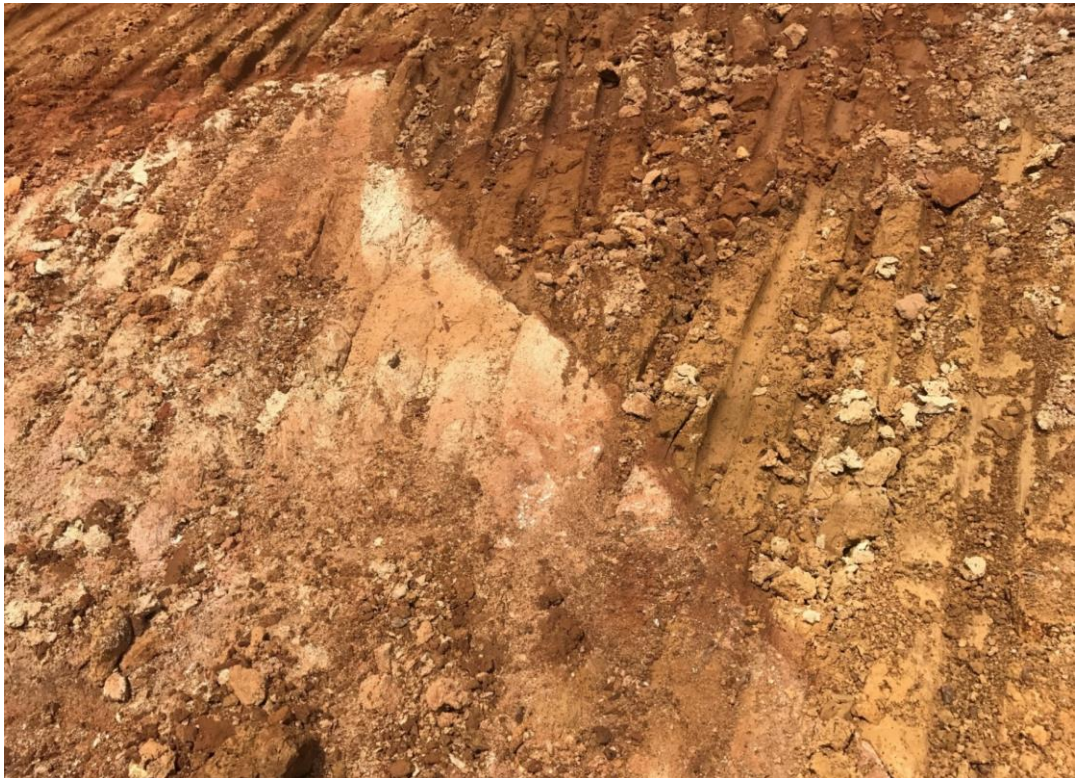
Figure 4.20 - Clear boundaries with white cementations found around the boundary of this structure.

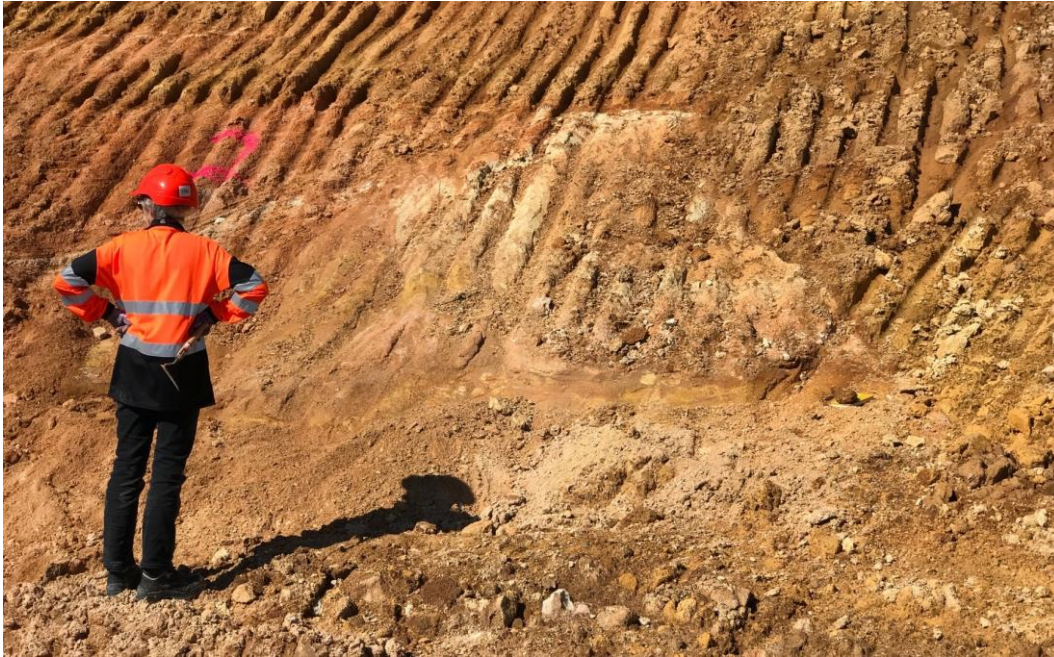
Figure 4.21 – An Intrusion structure observed on the NW face. As shown in the image, clear boundaries between the intrusion structure, overlying Kauroa bed to the right and overlying Karapiro formation to the left exist.

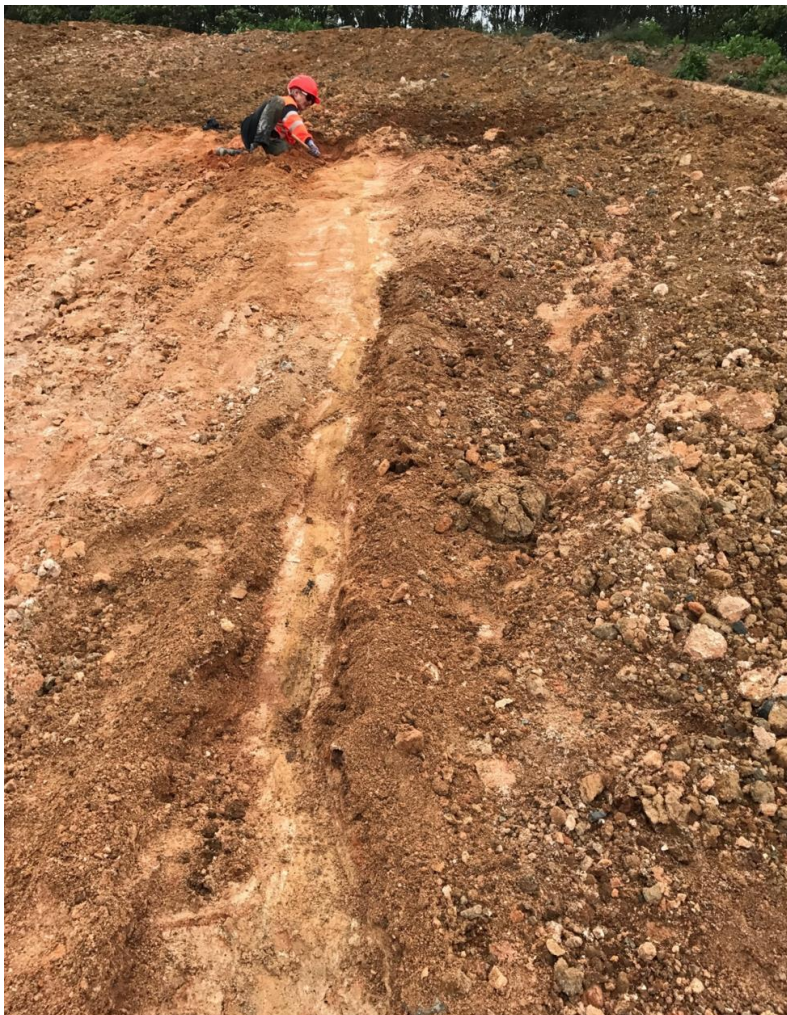
Figure 4.23 - What appears to be a clay intrusion structure within the Walton Sub-group unit.

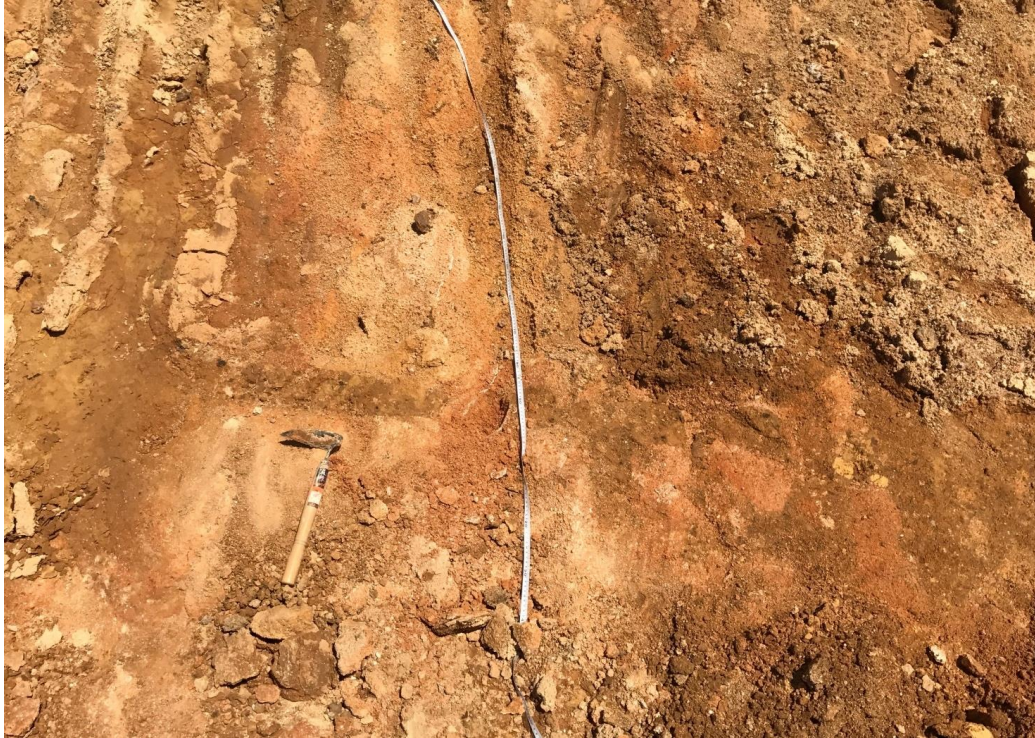
Figure 4.24 – The base of an observed intrusion structure in the NW face of the Kay Road field area. A lateral channel is shown at the base of this structure, branching toward the right of the image.

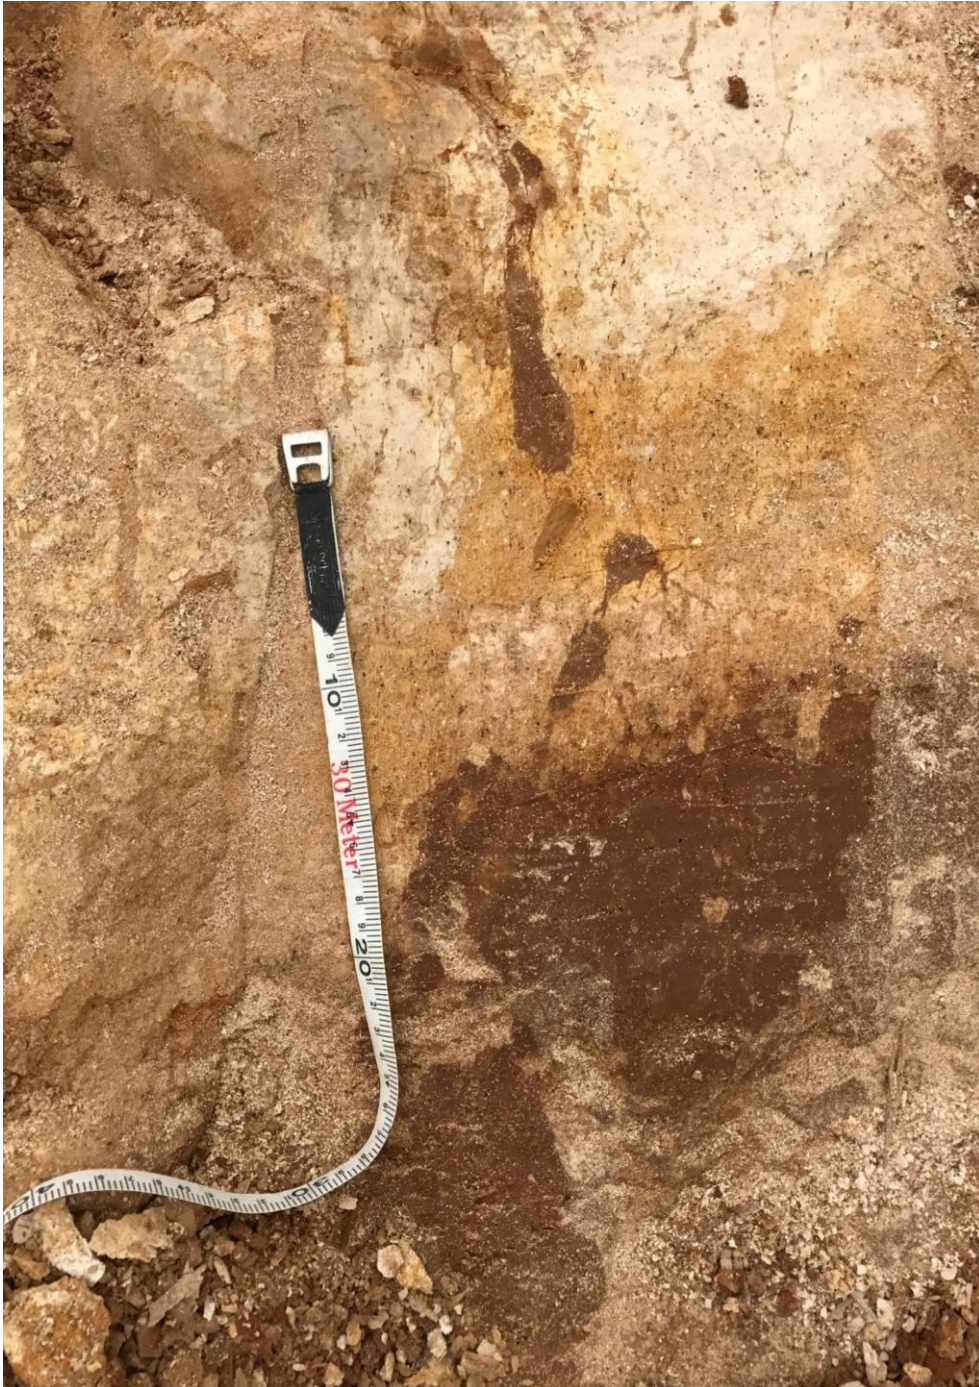
Figure 4.25 – An intrusion like structure found proximal to weathered tephra units in the field. As shown, this intrusion structure is significantly smaller than that pictured in Figures 4.20 to 4.24.

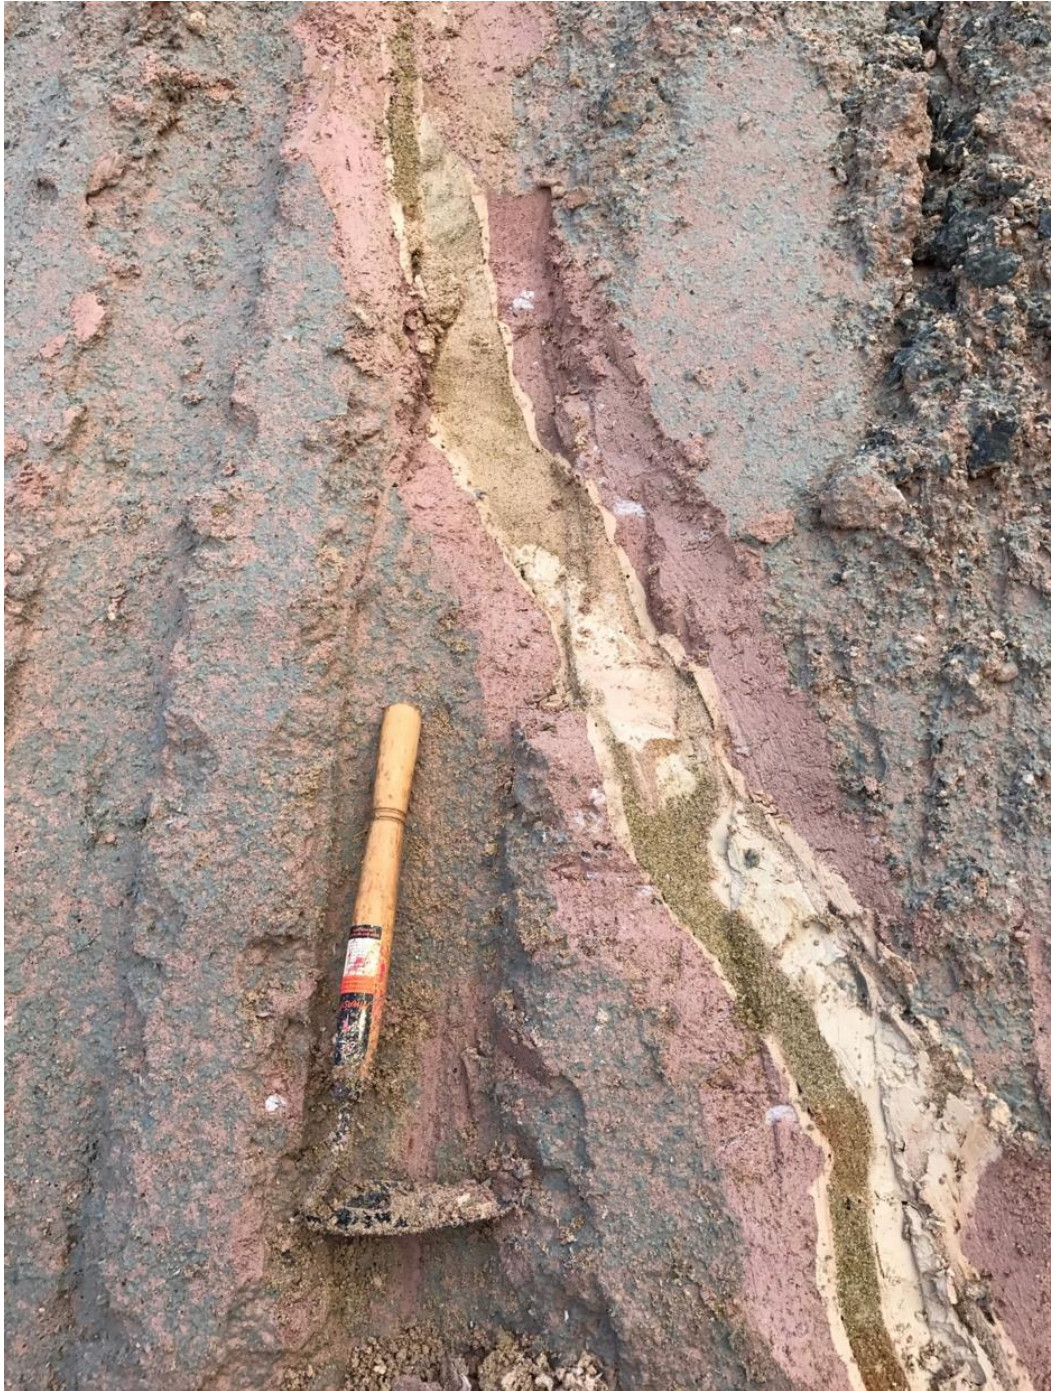
Figure 4.27 - An intrusion structure found on the western face of lower units within the Walton Sub-group. Shown in the image are clear boundaries between the brownish-green sand and white silt channels within the structure.

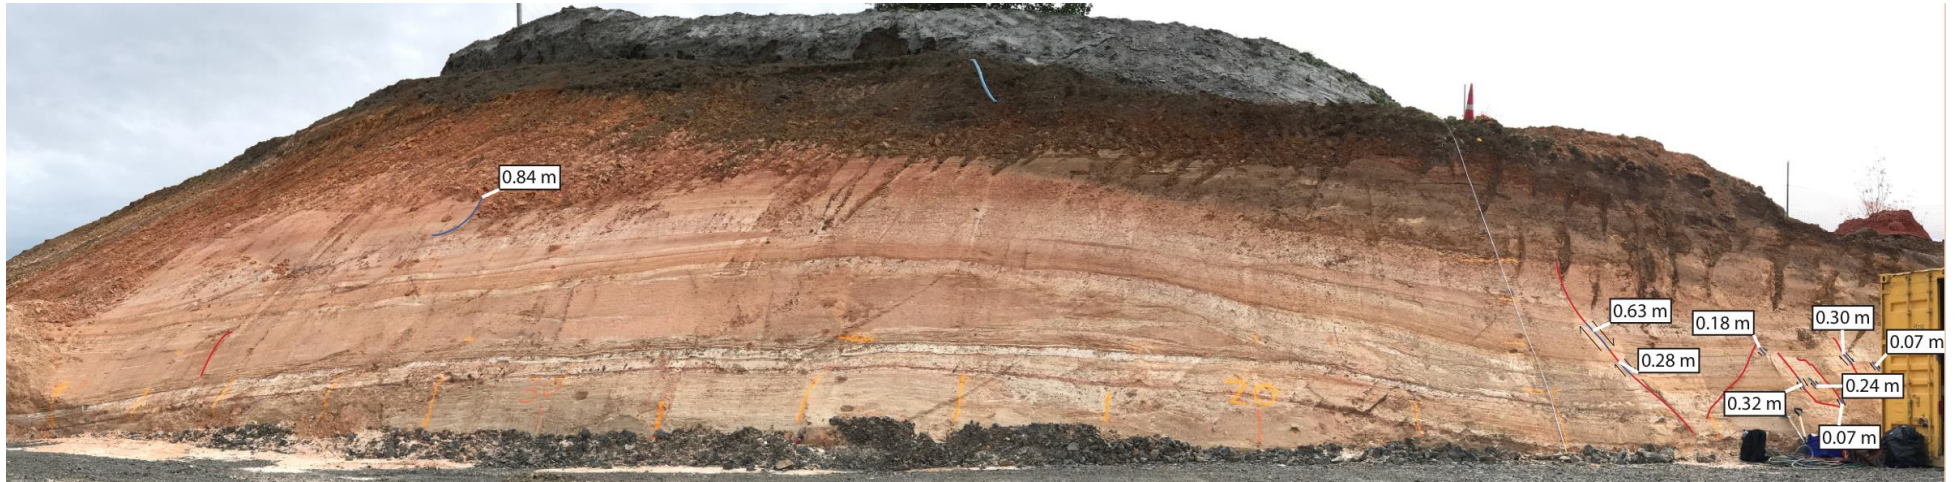
Figure 4.46 - Figure showing displacement within the SE face. As shown in this image, displacement was concentrated in the southernmost (right of image) portion of the SE face.

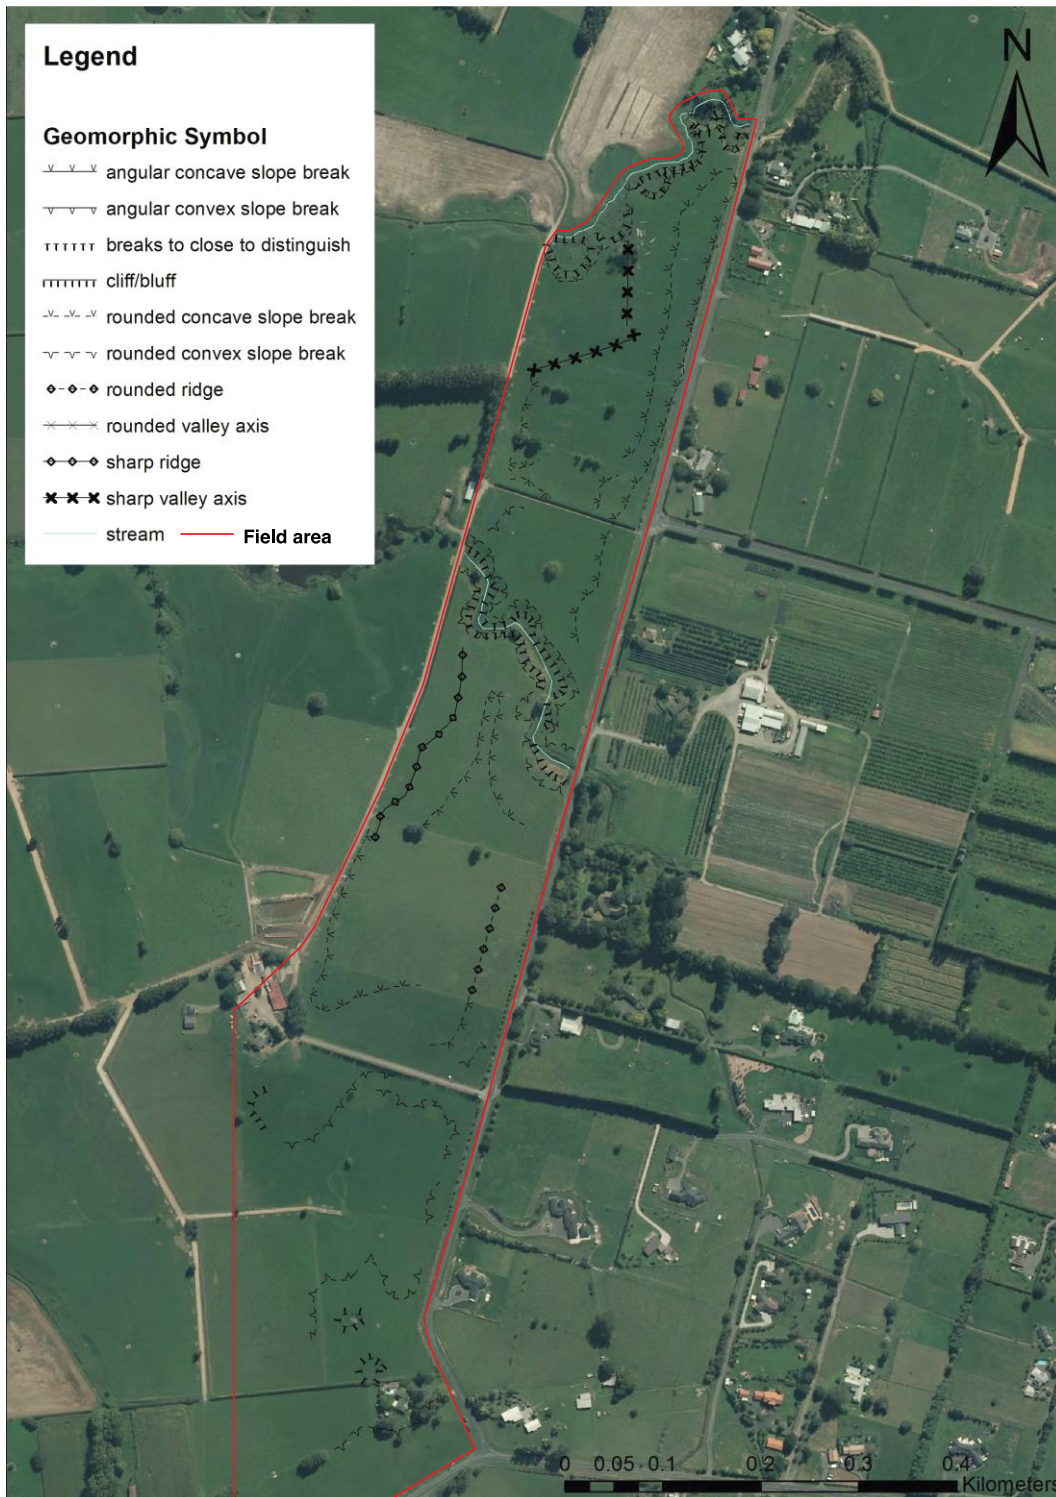
Figure 5.3 - Satellite image of the Osborne Road field area with geomorphic mapping symbols.

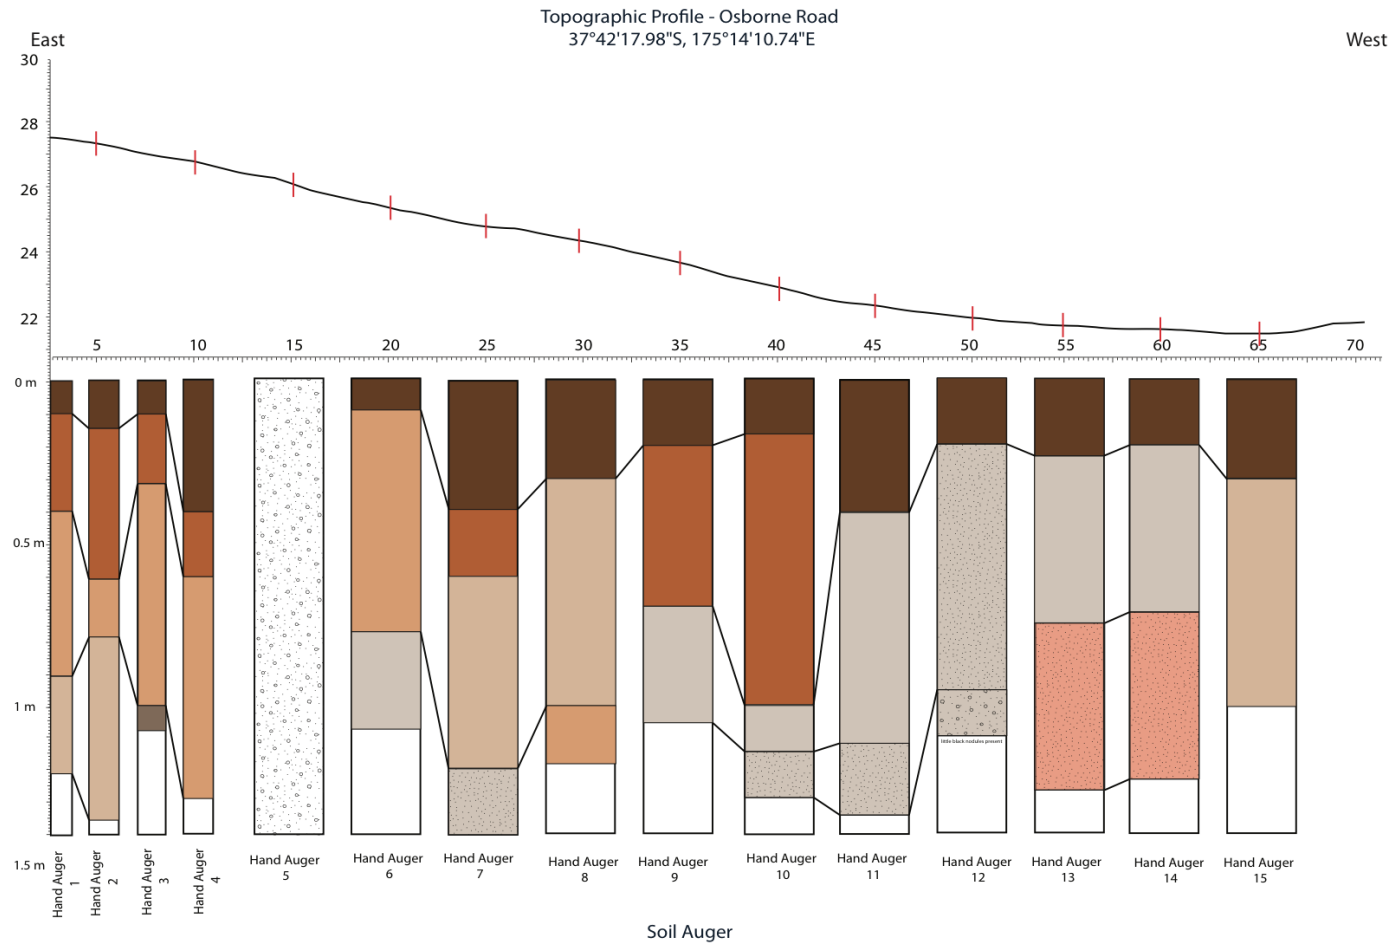
Figure 5.7 - Fence section of soil auger descriptions taken from the initial Osborne Road soil auger sampling transect. Shown in the top of this figure is the topographic relief of the Osborne Road field site (east to west). The middle of the transect illustrates horizontal distance across the profile, whilst the Y axis shows elevation on the top half, and soil auger sampling depth on the lower half. A description of the units shown in Figure 5.7 is depicted below in Figure 5.8.

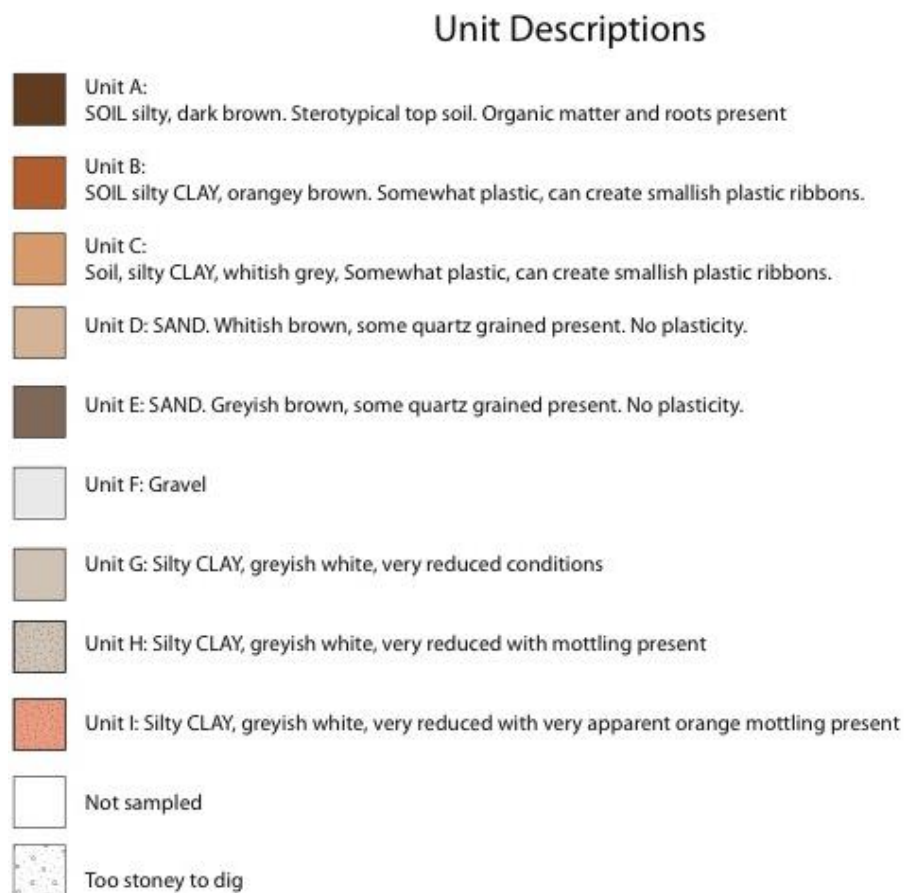
Figure 5.18 - Legend of units found within the Osborne Road field area that have been used in Figure 5.19.

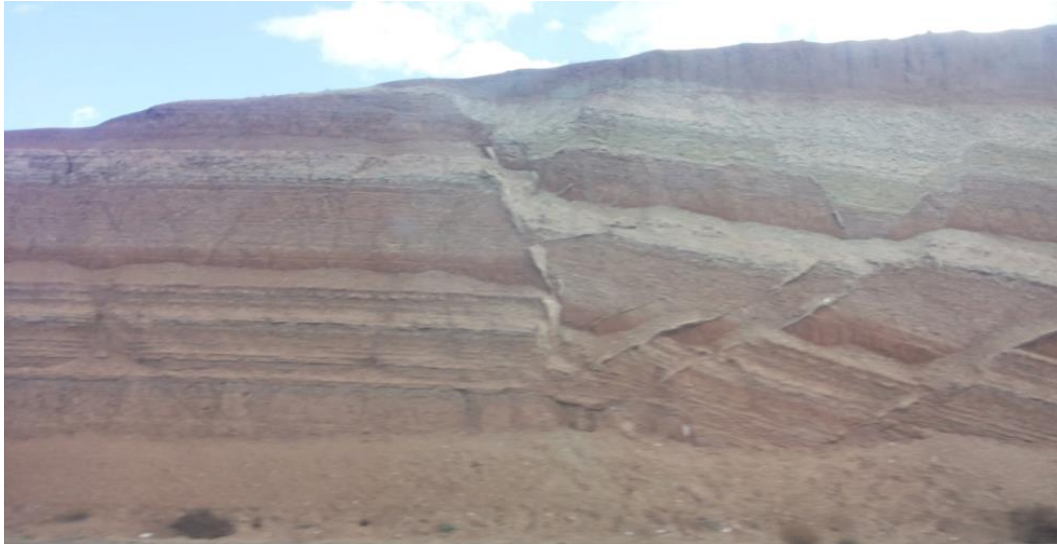
Figure 6.5 - Normal faulting within Neogene sediments between Zanjan and Ardabil, Iran. Image taken from van der Boon (2013). As shown in this image, a steeply dipping normal fault is observed, with associated low angle faults pictured to the right of the image.

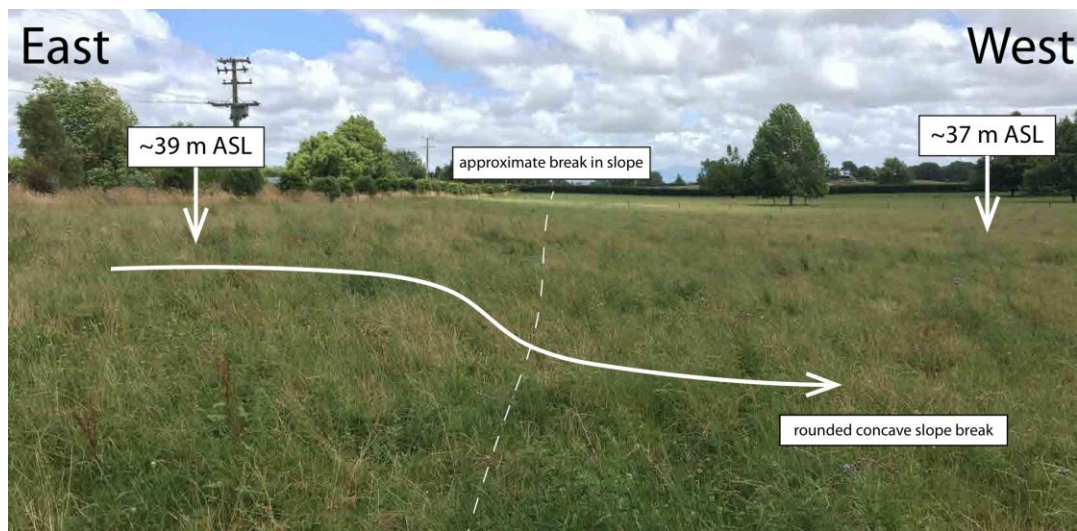
Figure 6.9 - Annotated schematic of the Osborne Road field area. As shown in this image, the field area is dominated by a rounded concave slope break, with the eastern portion of the Osborne Road field area sitting higher than the western side of the field area.
