**Potassium acetate treatment as a potential means
for stabilising extra sensitive, halloysite-rich soils
in the Bay of Plenty, New Zealand — A novel
approach to an old issue.**

A thesis

Doctor of Philosophy in Science

The University of Waikato

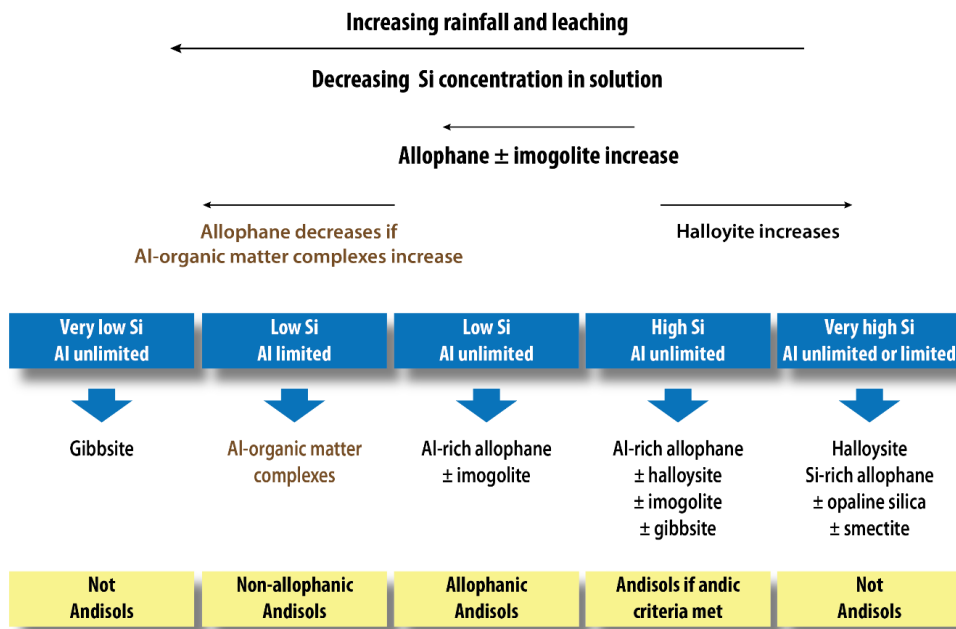
Figure 2.5 Relationship between environmental conditions and the formation of allophane, halloysite, and other minerals, as predicted by the silicon-leaching model and the availability of aluminium. From Hewitt et al. (2021).

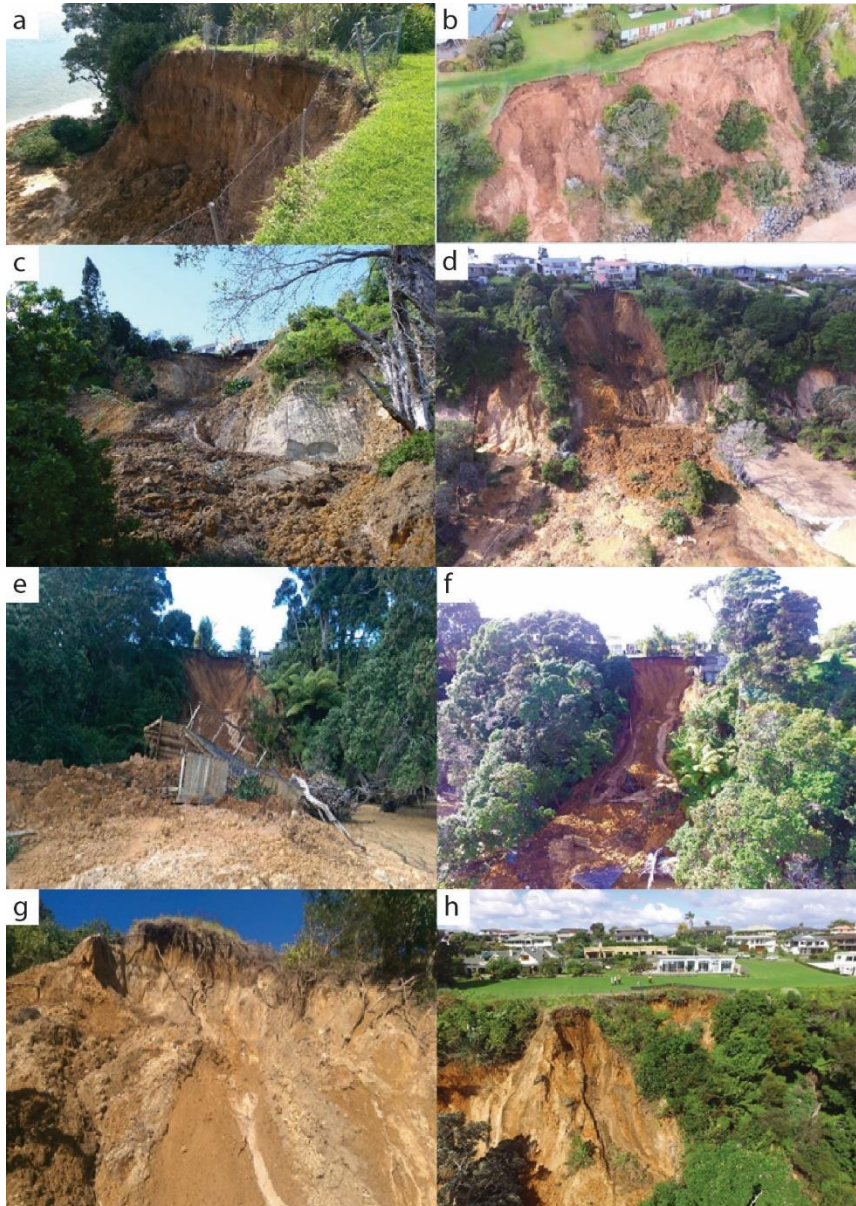
Figure 3.4(a) An aerial image of the Ruamoana Place landslide following the 2017 cyclone events within Ōmokoroa (as supplied by the WBoP District Council). **(b)** The same Ruamoana Place landslide was taken from the ground near the landslide scarp a few weeks after the landslide event. **(c)** The McDonnell Street landslide, as seen from the beach below, which failed a few days after the primary cyclone event. **(d)** Aerial drone imagery of the McDonnell Street landslide taken within 24 hours of the mass wasting event. **(e)** The Kowhai Grove landslide, as seen from the beach below the landslide a few days after the event had occurred; note the semi-intact deck carried down by the landslide debris. **(f)** The Kowhai Grove landslide photo was taken from aerial drone imagery soon after the landslide. Note the large amount of visible water exuding from the landslide scarp (supplied by WBoP District Council). **(g)** The Waterview Terrace landslide as seen from the beach below the landslide scarp. **(h)** The same landslide scarp at the Waterview Terrace taken from above via drone imagery (supplied by the WBoP District Council).

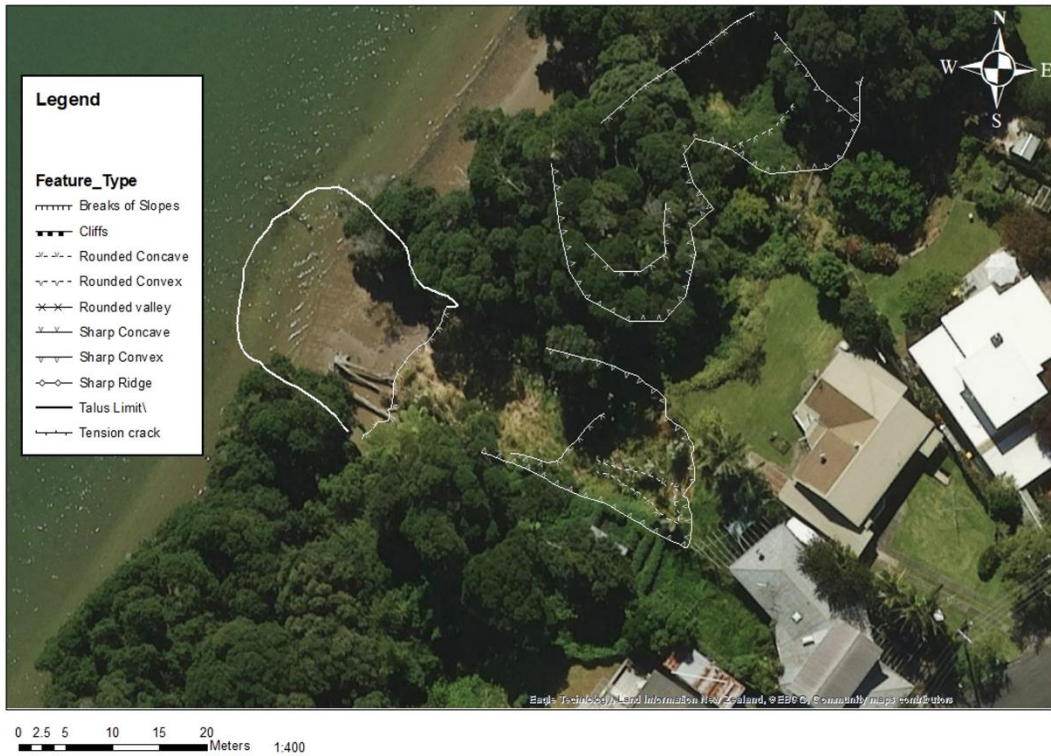
Figure 3.6. An annotated aerial image of the 2017 Kowhai Grove landslide provides a geomorphological context to the landslide. Standard geomorphological ESRI symbols are used and are shown in the legend.

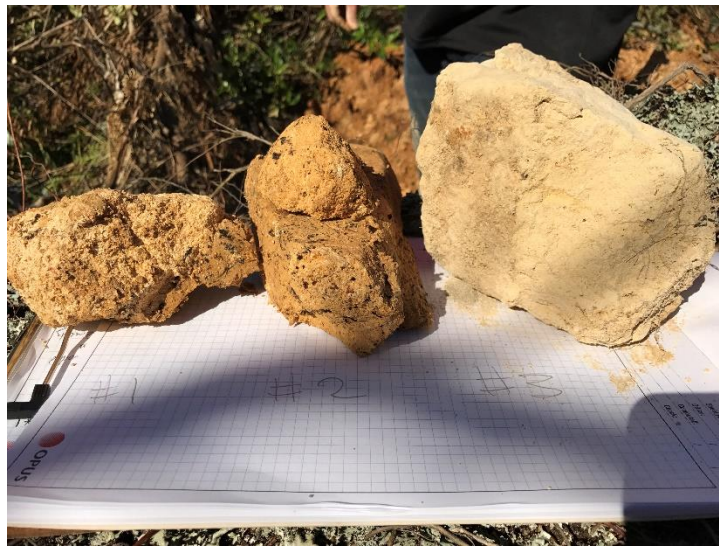
Figure 3.8. Samples of soils found within the Waterview Terrace landslide scarp. From left to right, the soil is representative of Pahoia Tephra, a slightly more weathered Pahoia Tephra, and Te Puna Ignimbrite

Material within the scarp bowl was soft, with the soil having extensive manganese oxide concretions and/or nodules throughout (Figure 3.8). The soil appeared to be a clayey SILT, with some sands. Samples exhibited a dilatant response but retained some strength upon mechanical remoulding. Blocks of Te Puna Ignimbrite also appeared within the lower portion of the scarp (Figure 3.8). These blocks were almost entirely SILT with some sands to sandy SILT, with dilatant behaviour observed.

The Pahoia Tephra present within the scarp itself was inconsistent in thickness on either side of the bowl, with a slightly thicker lens of clayey SILT present on the left (southwest) face of the bowl, being much lighter in colour (brownish-grey) (see left soil sample in Figure 3.8) than the material present on the right face (northeast). This material was much darker (see centre soil sample in Figure 3.8), almost exhibiting an orange-brown complexion. Further, the Pahoia Tephra material in the right face was much stiffer and appeared to have a higher clay content, with the soil barely dilating. Additionally, material from the right edge appeared to have pumiceous inclusions within the chunk, accompanied by orange mottling (likely iron oxides).

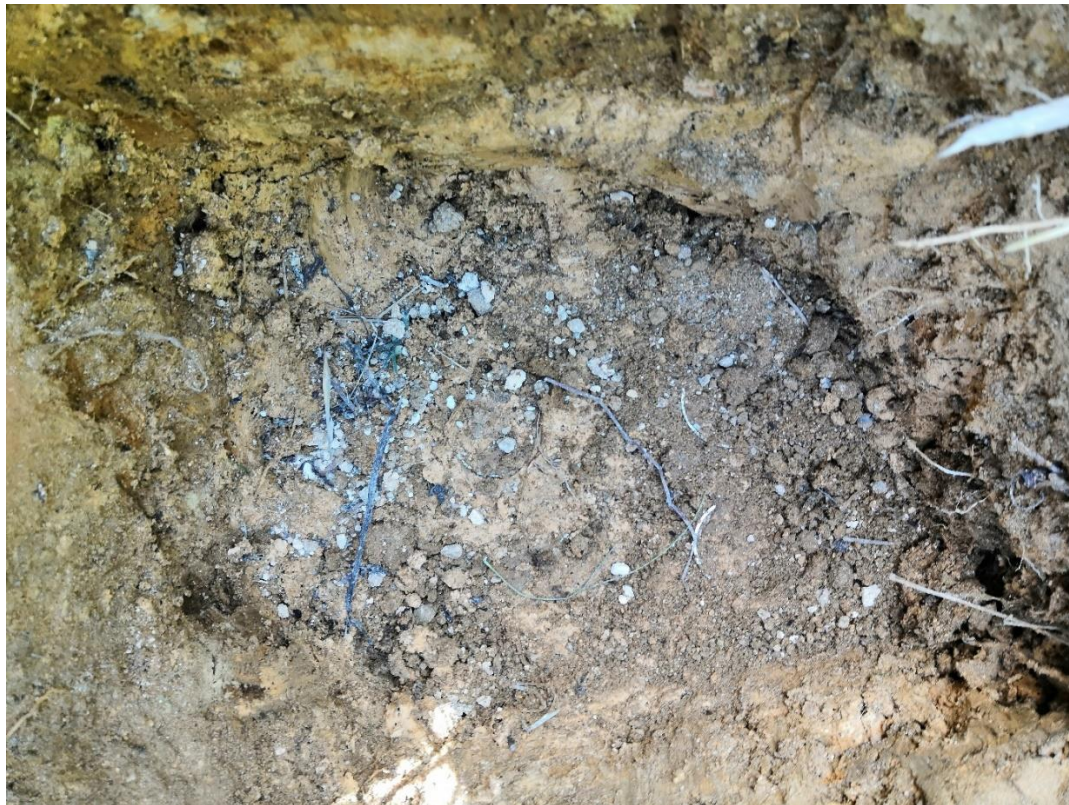
Figure 3.10. An image of a small test pit dug into the Kowhai Grove landslide scarp. Some features of note in this are stark colour change (top right of image) where the soil transitions from the dark brown clayey SILT to an underlying light greyish brown clayey SILT. Sensitive material is hard to distinguish within this image due to the uniformity in which the soil appears. The only visible evidence is the slight smearing of clays between the wall and the base of the test pit, as the pit begins to go into the sensitive layer. Some detritus has fallen into the pit from around the edges.

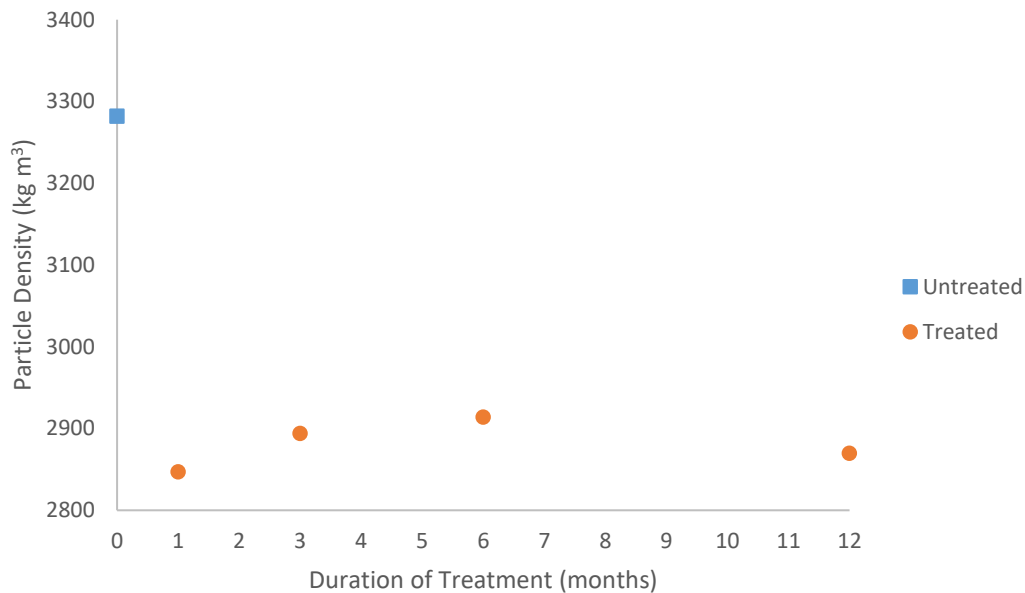
Figure 6.1. Particle density for untreated (blue square) and treated (orange dots) samples plotted against their respective soaking times in months. A large drop off exists between untreated and treated, while treated samples were within 100 kg m⁻³ of one another.

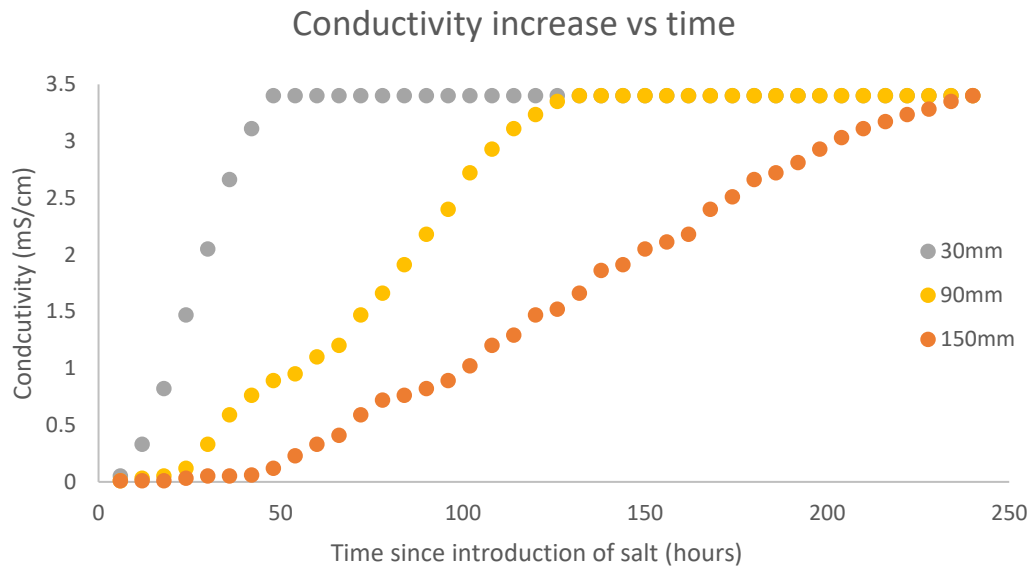
Figure 6.4 Conductivity measured at 30mm (grey points), 90mm (yellow points) and 150mm (orange points) from the salt well. Conductivity is measured in mS/cm. The ion plume was detected reasonably quickly at 30 mm (48 hours), while it took 240 hours for the full strength to be observed at 150mm.

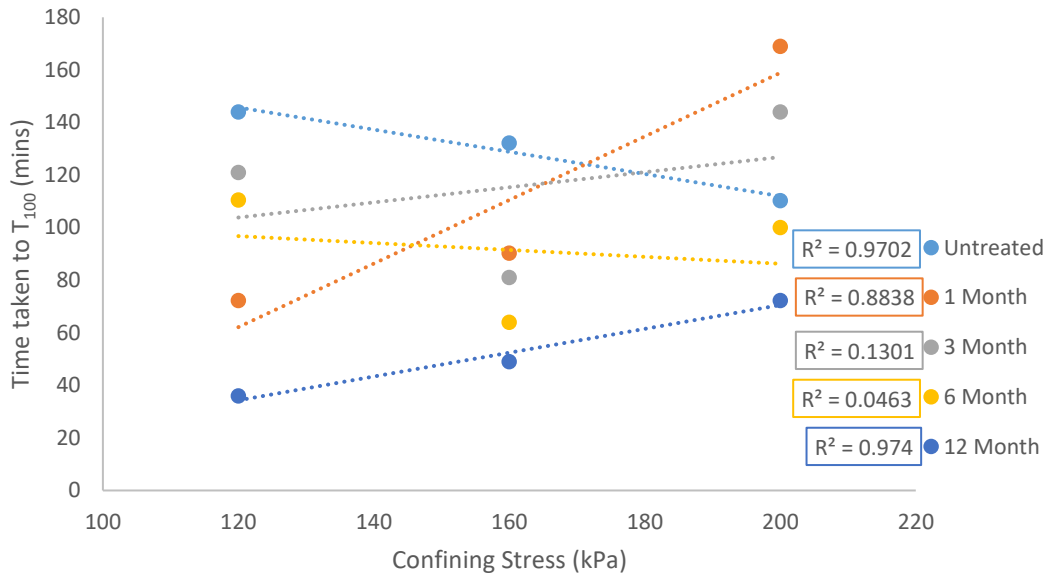
Figure 6.6. Time taken to reach T_{100} for samples at their respective soakage lengths. Some strong correlations do exist (untreated, 1 month, 12 months), though samples at the 3 and 6 months show no correlation at all.

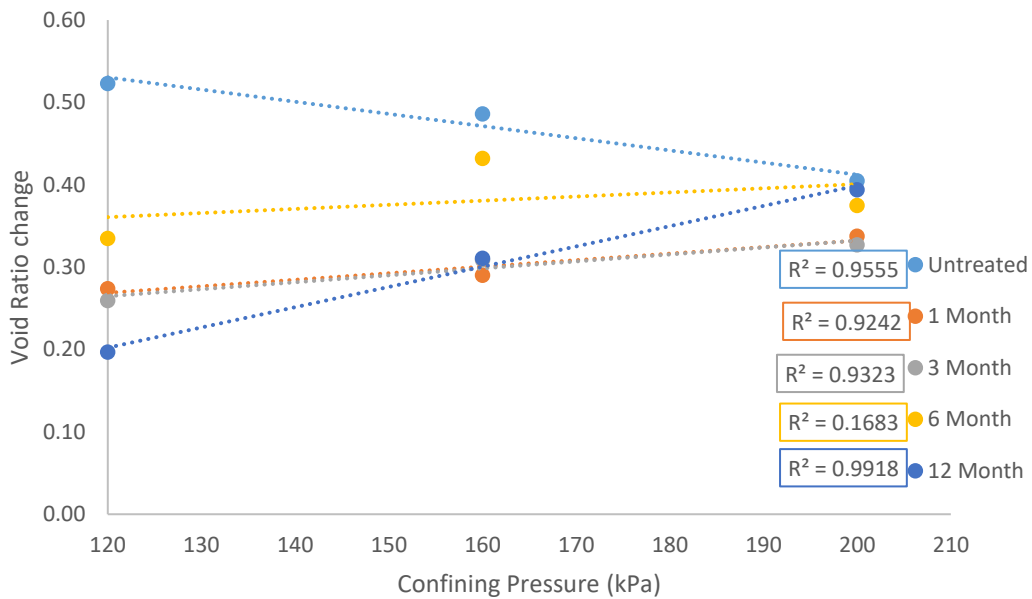
Figure 6.7 Void ratios change for treated and untreated samples plotted against confining pressure. Strong correlations were observed for nearly all samples, with the 6 months samples the only showing little to no correlation.

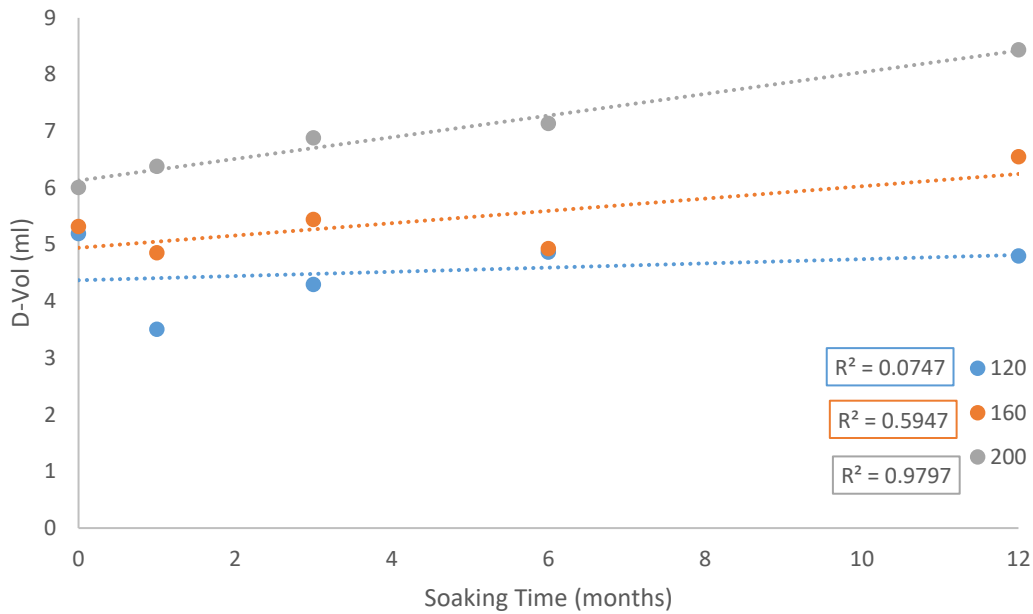
Figure 6.8 . A scatter plot showing the volume of liquid expelled during consolidation (D-Vol) plotted against soaking time. From the data no correlation appears to exist for samples at the lowest confining stress (120 kPa), while 160 kPa showed some correlation ($R^2 = 0.59$) and 200 kPa showed a strong relationship. Note untreated samples were tested at 150 kPa and 225 kPa as opposed to 160 and 200 kPa.

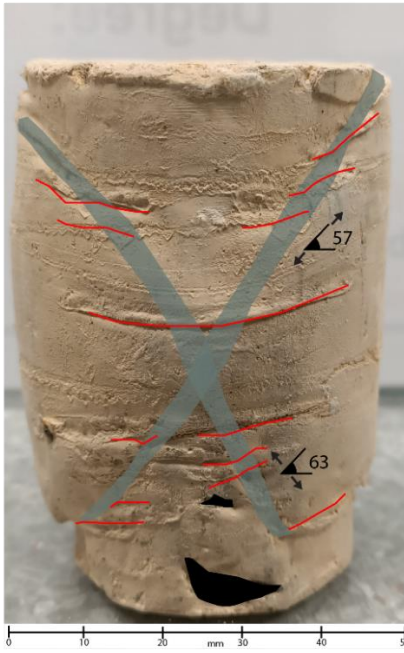
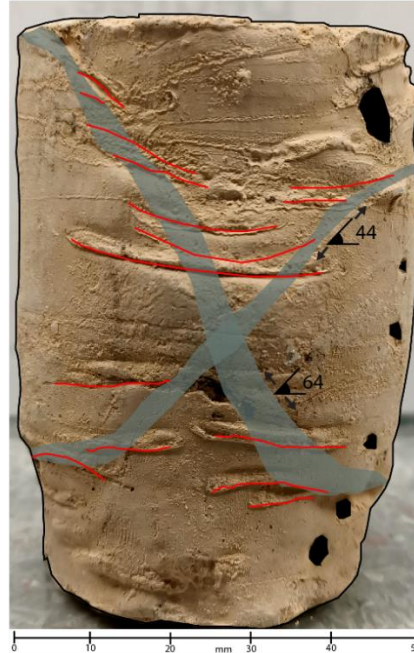
Figure 6.24(a)The sheared core for an untreated 150 kPa sample, primary shear zone's (shaded grey areas) stretch at 57 and 63° angles in an x style failure. Various minor shears are present throughout, generally associated with the primary shear zone. **(b)** The sheared core for an untreated 150 kPa sample, primary shear zone's (shaded grey areas) stretch at 44 and 64° angles in an x style failure. Various minor shears are present throughout, generally associated with the primary shear zone. **(c)** the outline of the sheared core in 6.23 (a). **(d)** The outline of the sheared core in 6.23 (b)

At 150 kPa (Figure 6.24) the PSZ appears to have progressed along 2 paths resulting in an intermediate-wedge style failure, with 2 blocks measuring around 70 mm (left block Figure 6.24a and c) and 85 mm (right block Figure 6.24b and d) displaced. Blocks were displaced along the two PSZ, with one stretching from the top right of the sample (Figure 6.24a) to around 8.5 mm above the base of the sample on the left at an average angle of 57° , while the other from 11 mm below the top of the left side of the sample to 13 mm above the bottom right of the sample at an angle of 63° . On the reverse side of the sample the smaller displaced block, had a PSZ that appeared shallower (44° , r-l) starting 19 mm below the top of the sample and finishing 19 mm above the bottom left. While the larger displaced block was slightly steeper than the reverse side (64° l-r), finishing approximately 12.5 mm above the sample base. The 'top' block of the sample also exhibited a slightly larger post failure diameter than the base (52 mm top, 45 mm base). Minor shears for the most part remained relatively radial with little inclination along PSZ's. The exception being some slight dragging in the PSZ direction at the very tops of samples along the larger displaced block

less oriented along the PSZ on side B with shears generally appearing radially between 0
– 5° in a clockwise orientation

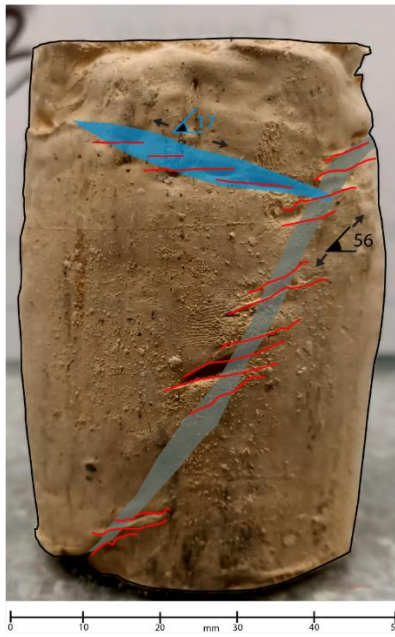
Figure 6.26. (a) the sheared core for the 120 kPa confining stress 1 month sample. A primary shear zone extends from the top right of the sample to the bottom left at 68°. A secondary shear zone is present, with shearing occurring at a 40° angle. (b) the outline of the major shear features.

Samples sheared at 1 month treatment (Figure 6.26) exhibit shear and wedge failure, with PSZ's becoming more distinct as confining stress increases. At 120 kPa only one side was able to be photographed due to damage to the reverse side of the sample occurring during removal of membrane. With a shear-wedge failure style, the PSZ at 120 kPa descends r-l at an orientation of 68°, terminating 21 mm above the base. The PSZ itself is thick and relatively undistinguished, with a slight bulging block forming at the base of the PSZ. Minor shears are present, trending along the PSZ at angles 5–25° anticlockwise. An SSZ is present, intersecting around 14 mm above the PSZ termination running at an angle of 40° l-r. This SSZ isn't clear throughout the sample though occurring approximately 15 mm and terminating 15 mm from the edges of the sample. As per the untreated samples, the top of the sample following failure was thicker than the base.

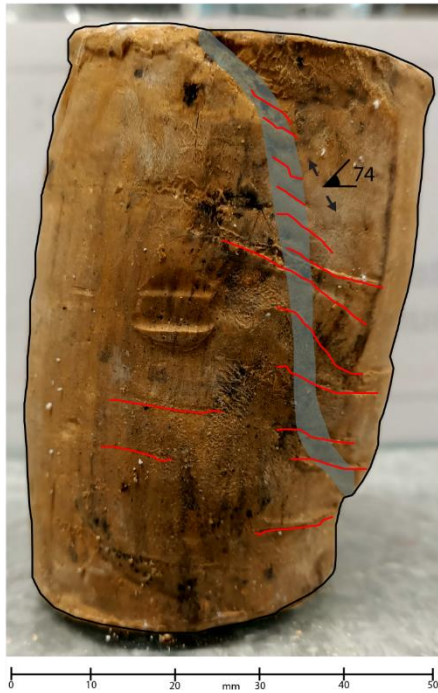
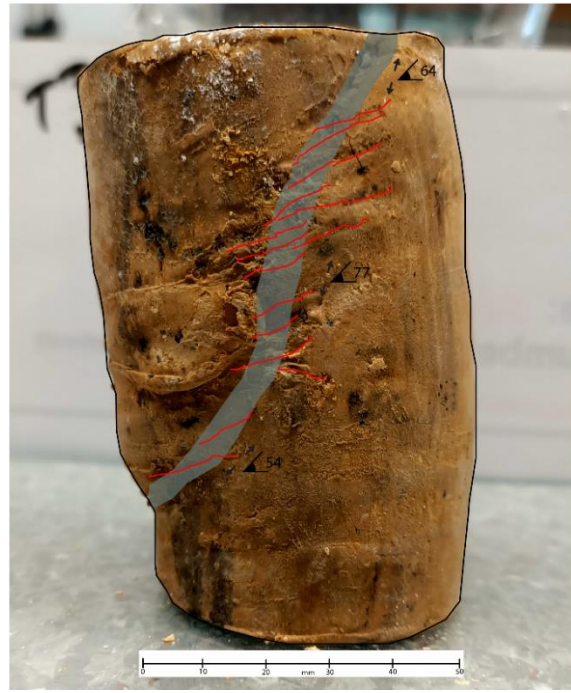
Figure 6.27(a,c) (a) The major shear features present in the 1 month treated 160 kPa confining stress sample. A primary shear zone stretches from left to right at 74°, with minor shears generally associated with the shear zone. The outline of the shear features are shown in (c). (b,d) The major shear features on the revers side of the 1 month 160 kPa treated core. The primary shear zone has 3 differing angles noted as these change throughout failure. Minor shears are associated with the primary shear zone. The outline of shear features is shown in (d).

At 160 kPa (Figure 6.27) a shear-wedge failure is seen, with side A showing a steep PSZ at an angle of 74°, with the top edge of the PSZ daylighting approximately 20 mm from the very left edge of the sample, extending l-r, terminating 15 mm above the bottom of the samples. The wedge is displaced outwards in a bulge, but hasn't sheared over the base of the sample, failing outwards as opposed to both out and down. Side B has the PSZ descending right to left, 10 mm in from the right edge, terminating at a similar height above the sample base on a slightly shallower 65° inclination. Minor shear structures are observed in both side a and b extending across the PSZ at angles between 10 – 20°. On side A the minor shear structures are relatively evenly spaced, while side b has a concentration of around 20 – 50% of the full length of the PSZ. The top of the sample was slightly greater in diameter than the base following shear. The sample also appears to have buckled slightly during the shear formation, with the sample no longer vertical, instead exhibiting just over 4° of deformation towards the wedge side of the sample

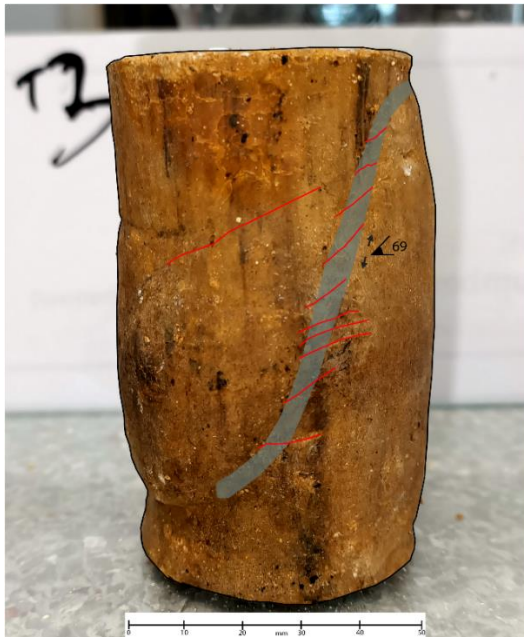
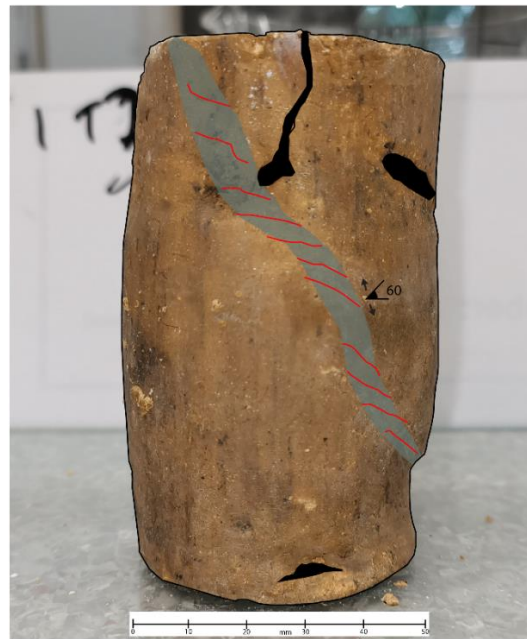
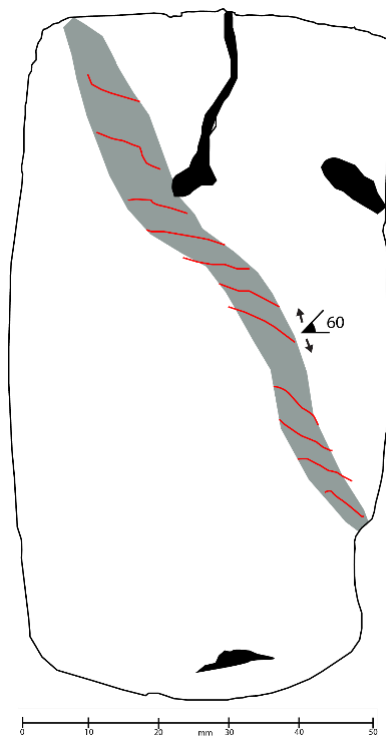
Figure 6.28(a,c)An annotated image of the 200 kPa confining stress, 1 month treated, soil core. A singular primary shear zone is present, with shear seen to occur at an angle of 69°. Minor shears are associated with the primary shear zone. The outline of the shear features are shown in (c). **(b,d)** The reverse side of the failed 200 kPa, 1 month, core. The primary shear zone has a shallower angle (60°), with some pieces of the sample noted as missing (black zones).

At 200 kPa a shear-wedge failure (Figure 6.28), with some intermediate failure is seen. The PSZ on side a stretching 4 mm below the top r-l, terminating 12.5 mm above the sample base on a 69° angle. The reverse, side b, exhibited a failure surface daylighting 5 mm from the top left edge of the sample, terminating 16 mm above the sample base l-r at a shallower 60° angle. The sample had minor shears observed along the failure surfaces

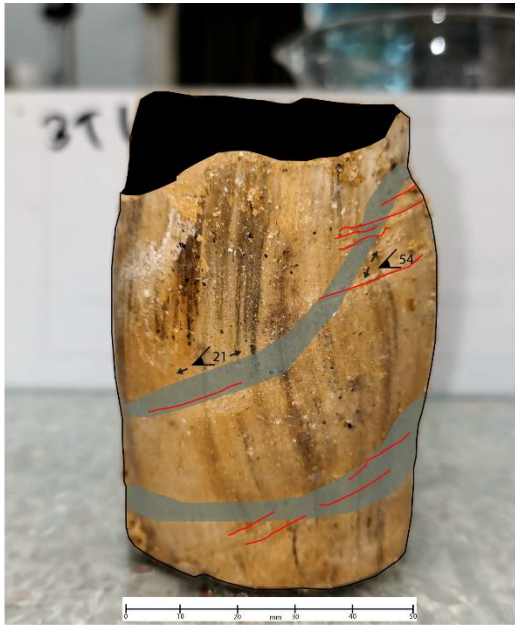
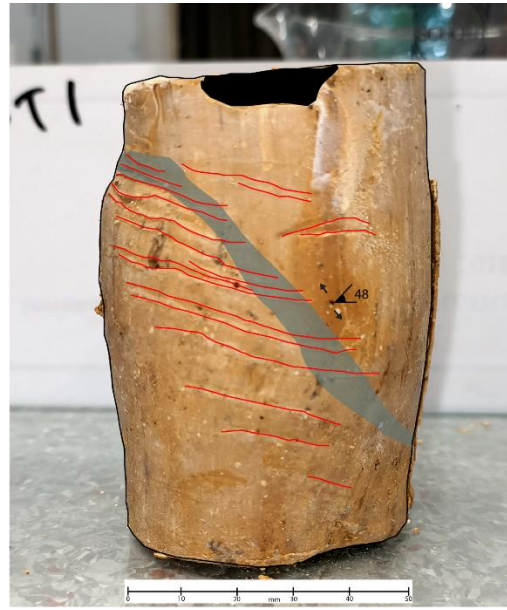
Figure 6.29. (a,c) An annotated image of the 3 month treated, 120 kPa, soil core. Two primary shear zones appear to be present in an apparent barrel/wedge failure style. Some of the damage to the core is noted (black area). The outline of shear features is shown in (c). (b,d) The reverse of the 3 month treated sample, with a singular, 48° primary shear zone noted, minor shears are present throughout. The outline of shear features are shown in (d).

Samples treated for 3 months (Figure 6.29) exhibited all four major failure modes, with 120 kPa samples showing shear-wedge failure, some intermediate, with side a exhibiting a PSZ and SSZ, with the PSZ descending from r-l at 54° in the upper portion, before shallowing out to 21° halfway through the PSZ. This PSZ occurring 12 mm below the top of the sample, terminating 25 mm above the base, with an SSZ occurring radially 8 – 12 mm above the sample base. The reverse, side B exhibits just the PSZ on a shallower 48° inclination extending l-r 8 mm from the top, terminating 14 mm above the base. Side B displays no SSZ, but has much larger minor shears present, with these exhibiting a 15 – 25° inclination in the clockwise direction. Samples show a slight intermediate failure with a slight bulging 1/3 of the way down the sample.

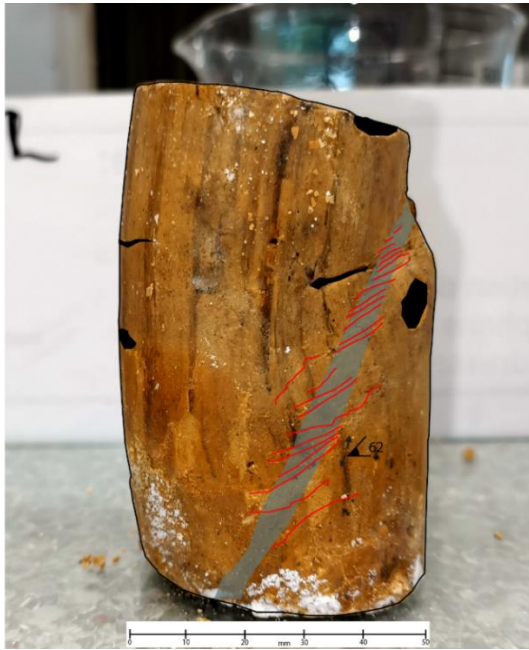
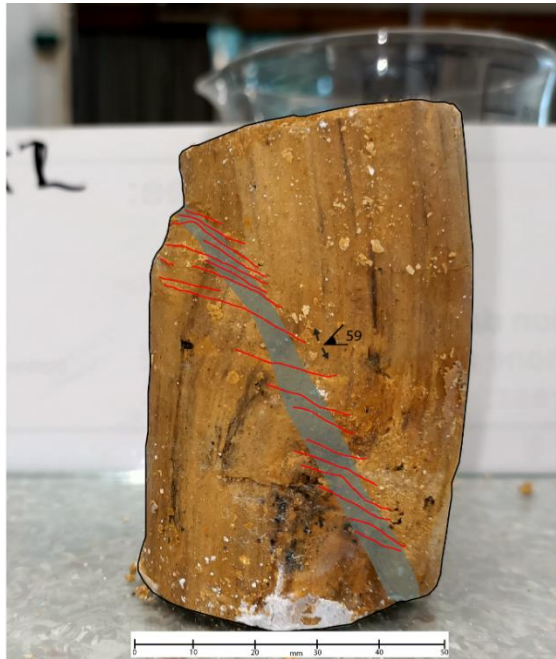
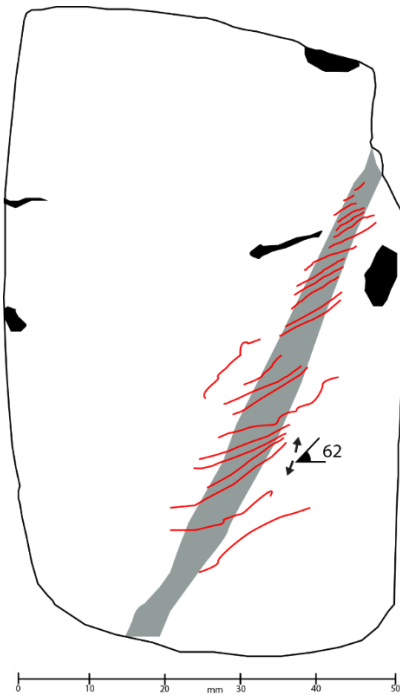
Figure 6.30. (a,c)The annotated image of the 160 kPa, 3 month treated, soil cores. A singular primary shear zone exists with failure occurring at 62°. Minor shears are present along the primary shear zone. The outline of shear features is shown in (c). (b,d) The reverse of the failed core, with the same singular primary shear zone noted, though the angle of failure was slightly shallower (59°). The outline of the image is shown in (d).

At 160kPa confining stress samples (Figure 6.30) showed shear-wedge failure, with the core appearing to stretch and bulge in certain orientations. A single PSZ is present on both side A and B of the sample with it stretching roughly 10 mm from the top to the base of the sample at angles of 62° and 59° respectively. Extensive minor shears are observed either on, or close to the PSZ indicating clear localisation of stresses during shear. As observed with previous treated samples, the failed wedge did not extend over the edge of the sample, instead the wedge above the shear zone has bulged outwards with the resultant top edge closest to the shear zone dropping lower to accommodate the bulging of the sample outwards.

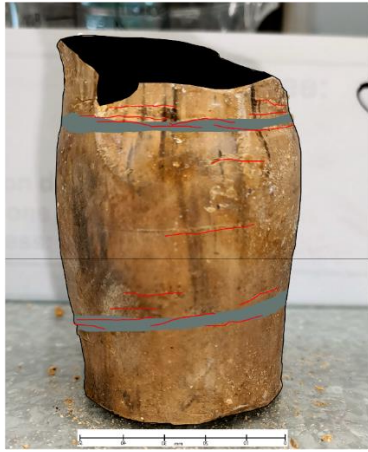
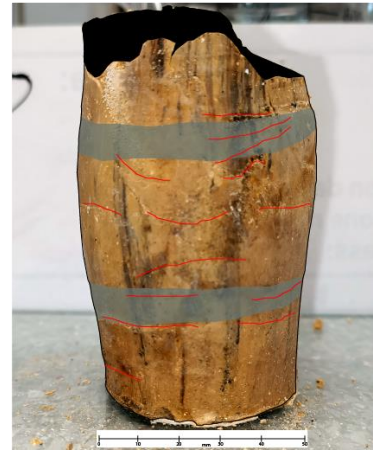
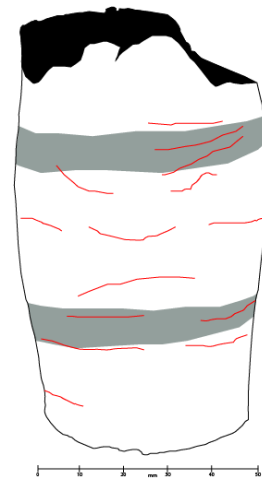
Figure 6.31(a,c) An annotated image of the 12 month treated, 200 kPa, soil cores following failure. Note in this instance barrel failure with a bulging of the material between the two primary shear zones. Some damage to the core has occurred and is shown by the black shaded area. The outline of the features is shown in (c) (b,d) The reverse side of the failed soil core with similar features noted as in (a). Note outlines of the failed core are shown in (d).

Barrel failure is seen at the highest confining pressure (Figure 6.31), with two PSZs seen denoting the boundaries of the sample bulging. A number of minor shears are present throughout the sample though these seem to extend radially around the sample with no significant directional inclination, though side A has these concentrated along the PSZ. Due to sample damage the top of the sample is too damaged to make a clear judgement on whether it is larger than the base, though the base appears to have remained a size similar to that of which it started.

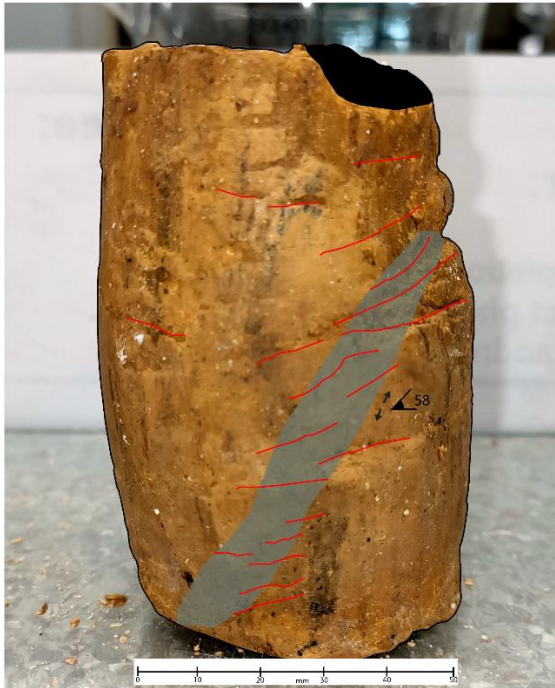
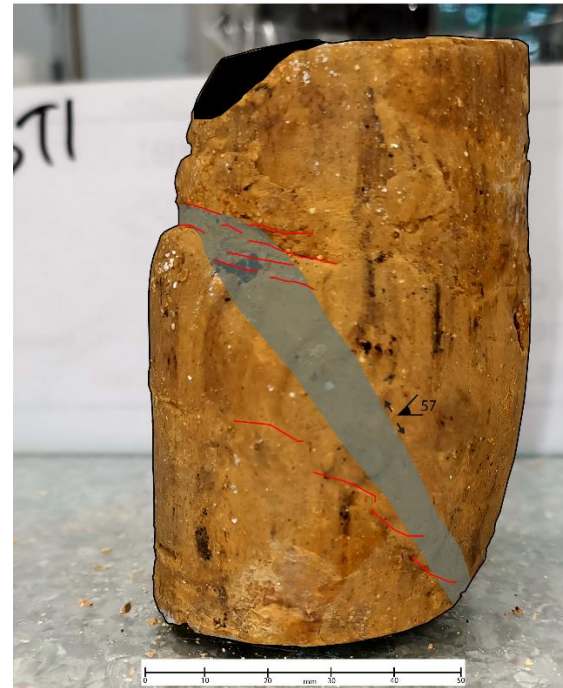
Figure 6.32(a,c) An annotated image of the 120 kPa confining stress, 6 month treated, soil core. A singular primary shear zone, of wedge failure style is shown with a shear angle of 58°. The outline of major features is shown in (c). **(b,d)** The reverse of the 120 kPa, 6 month, soil core. Similar features are noted with a 1° difference in shear angle (57°) noted. As previous the outline of features is shown in (d).

Shear failure is seen at 120kPa (Figure 6.32) for samples treated for 6 months, with a relatively thick PSZ, descending at inclinations of 53° and 57° (Side A and B, respectively). The PSZ is concentrated noticeably below the top of the sample, similar to the failure seen for 120 and 160kPa samples treated for 3 months. Minor shears concentrate along the PSZ inclined between 15 – 35°. As observed with previous treated samples instead of a brittle failure, and the entire upper wedge clearly descending over the bottom wedge, as occurred for untreated samples, the upper wedge has bulged outwards to accommodate the movement.

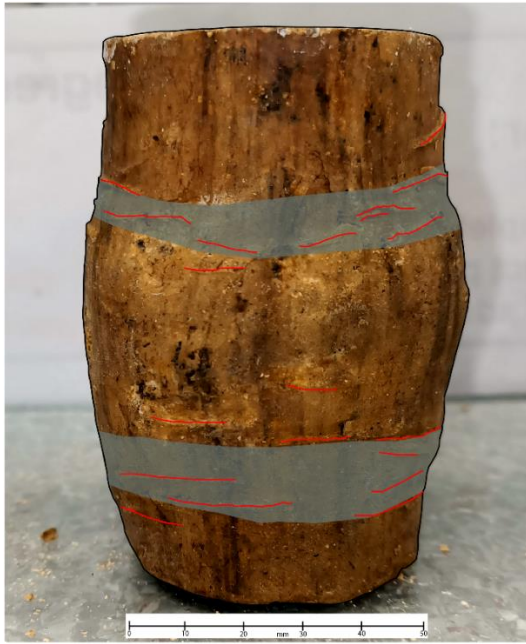
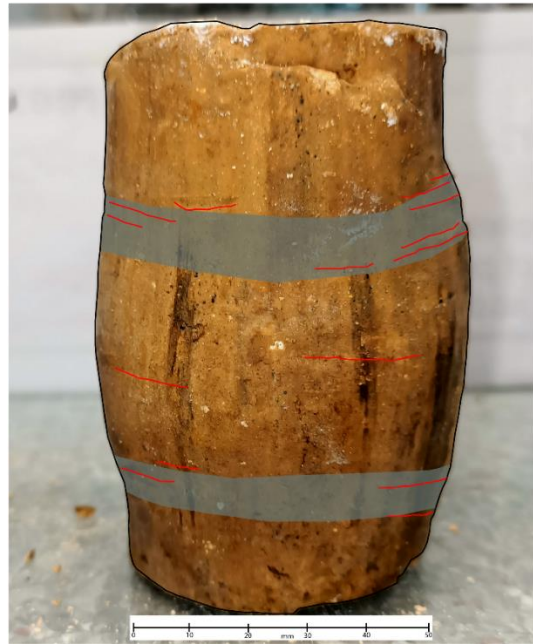
Figure 6.33 a,c) Annotated images for the 6 month, 160 kPa confining stress sample, with a barrel failure style noted. Minor shears also appear to stretch along the sample in a similar barrel style. Outline of major features is shown in (c). (b,d) the reverse of the 160 kPa failed core, with outline of major features shown in (d).

Barrel failure is seen at 160 kPa (Figure 6.33) and 200 kPa (Figure 6.34), with two key PSZ's observed demarking the boundaries of the failed material. Both samples showed that the upper portion of the sample above the PSZ had larger diameters than the material below the bottom PSZ. Barrelling at the 160 kPa confining pressure was more pronounced, with much smaller, more localised, minor shears observed, with a peak diameter of 83 mm measured. At 200 kPa, barrelling was smaller by comparison, peaking at 74 mm, though minor shears for the 200 kPa sample were much larger.

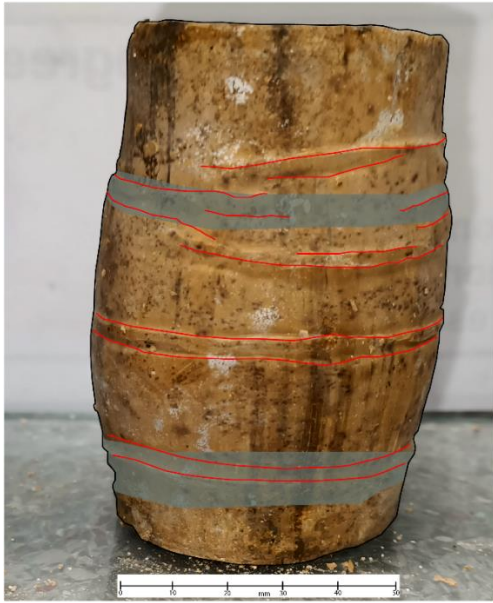
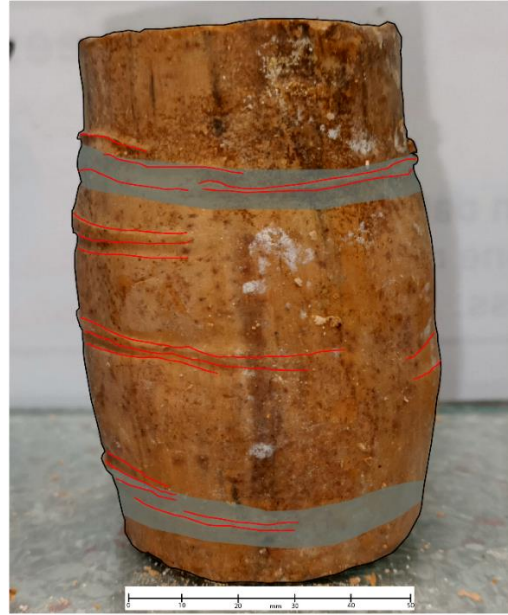
Figure 6.34 .(a, c) the annotated image of the 200 kPa failed cores, failure style is similar to 160 kPa with barrel failure style noted, the outline of the failure features are shown in (c). (b, d) the reverse of the 200 kPa barrel failure, with the outline shown in (d).

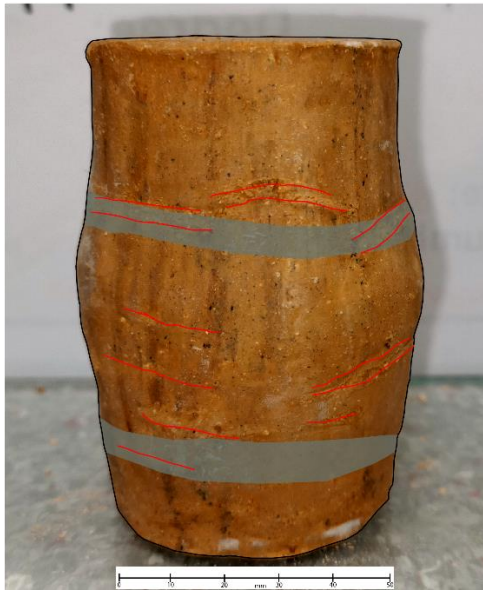
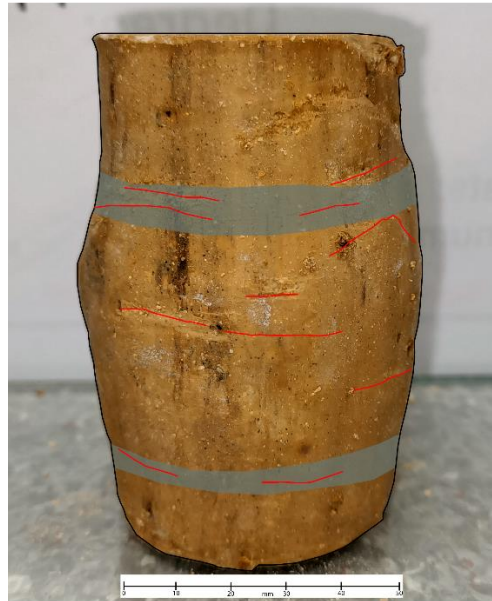
Figure 6.35. (a,c)An annotated image of the 120 kPa, 12 month treated, soil cores. Barrel style failure is observed , with the outline of shear features shown in (c). (b,d) the reverse side of the 120 kPa sample, with the outline shown in (d).

Samples tested at 12 months treatment time exhibited barrel, intermediate as well as shear/wedge failures. At 120 kPa confining stress (Figure 6.35) barrel failure is apparent, with two PSZ bands observed 30 mm from the top of the sample and 12 mm from the bottom of the sample. These were accompanied by minor shears extending radially around the sample. These minor shears were found throughout the barrelled portion of the material, with a slight concentration of shears at the top of the sample compared to the bottom. Similar to other treated samples, the base below the shear zone was slightly smaller in diameter than the material above the sheared zone.

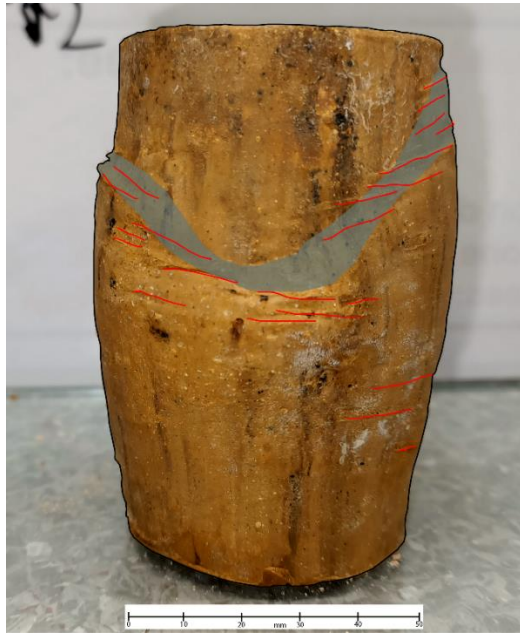
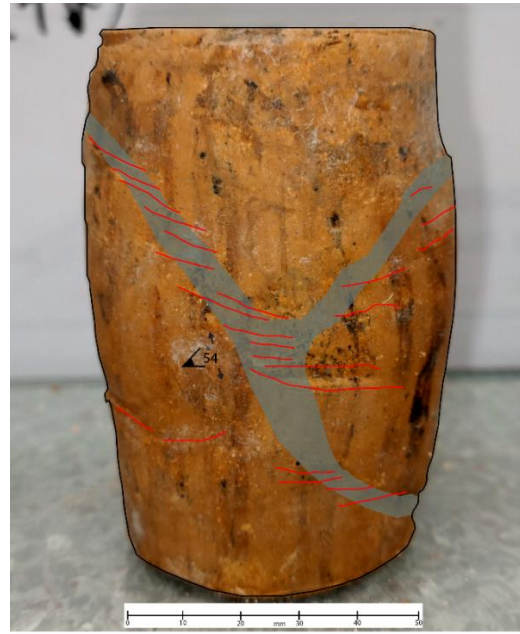
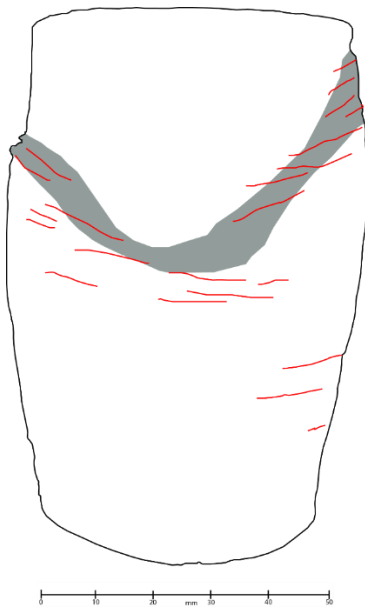
Figure 6.36 (a,c) An annotated image of the wedge style failure observed for the 160 kPa confining stress, 12 month treated soil cores. An outline of shear features is shown in (c). **(b)** The reverse side of the 160 kPa core, with a 54° angle of failure measured. An outline of shear features is shown in (d).

- Figure 6.36 (a,c) An annotated image of the wedge style failure observed for the 160 kPa confining stress, 12 month treated soil cores. An outline of shear features is shown in (c). (b) The reverse side of the 160 kPa core, with a 54° angle of failure measured. An outline of shear features is shown in (d). 118

Wedge-intermediate failure was observed on samples at 160 kPa confining stress (Figure 6.36), with irregular PSZ's noted for side A and B. For side A the PSZ descended in a semi-circle from 3 mm below the top right edge, descending to 40 % of the sample, before ascending to the left edge 28 mm below the top edge. This PSZ does not descend into the lower portion of the sample, instead creating an intermediate style failure. Minor shears are present throughout, though these for the most part are concentrated along the PSZ. Side B on the other hand displays wedge-intermediate failure, with the samples divided into three portions by the PSZ. The PSZ descends from 12 mm below the top of the sample on the left edge at a 54° angle, descending to 4 mm above the base. The PSZ intersects at around the halfway point of the sample with another PSZ descending from the right edge of the sample, starting 24 mm below the top edge on a shallower 47° inclination. Minor shears are present throughout both sides A and B, with the bulk of these concentrated within the PSZ.

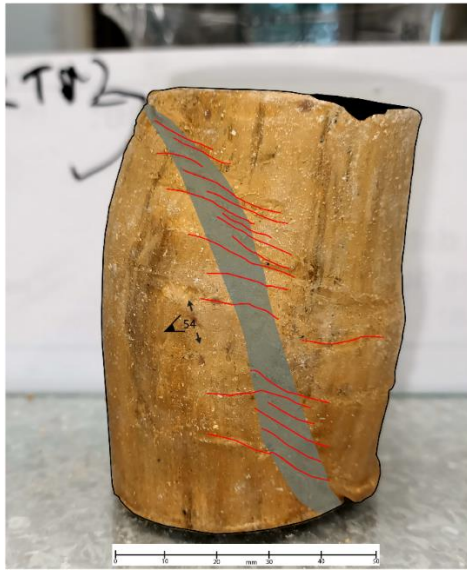
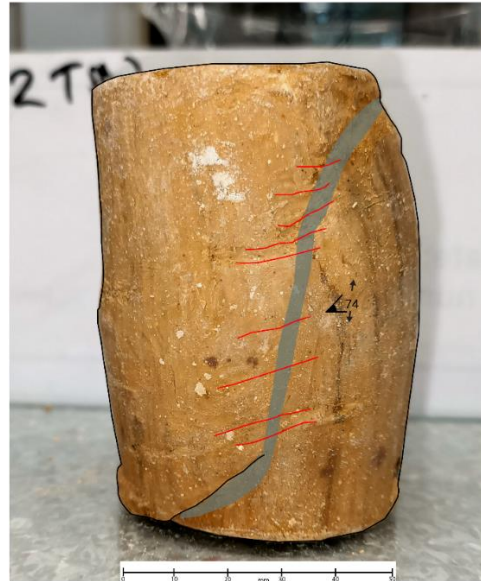
At 200 kPa confining stress (Figure 6.37) the sample exhibits shear-wedge failure with a distinctive PSZ descending from 8 mm below the top edge on both samples at angles of 54° (side A) and 74° (side B). The sample appears to have sheared with an edge visible in sheared material of side B. It is worth noting though that the sample appears to have slightly bulged as seen in previous treated sample cores, as well as a clear lean is present on the samples. Minor shears are concentrated along the PSZ tending on a slightly shallower angle (25 – 37°)

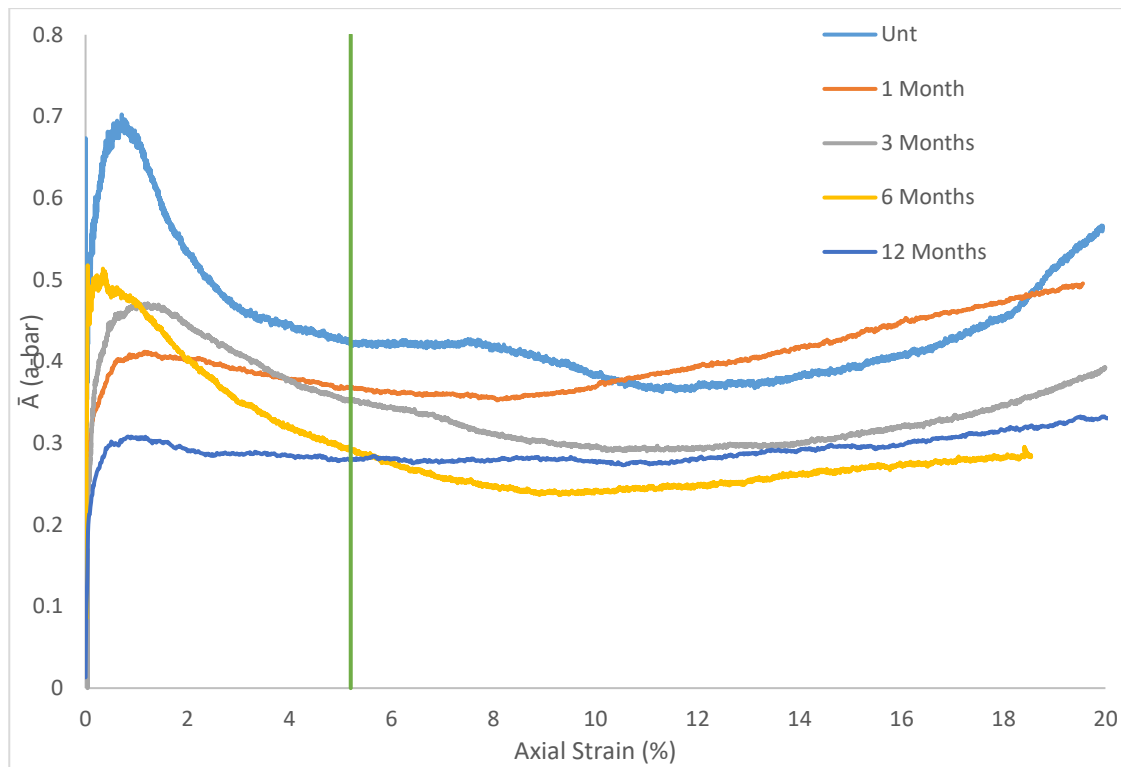
Figure 7.11. \bar{A} paths for soils under shear at 120 kPa confining stress. No samples show an \bar{A} in excess of 0.75 at any point during the stress path. It is worth noting \bar{A} increases as the soils strain soften following failure. The solid green vertical line represents the average axial strain at failure across all samples.
