An Ecological Perspective on ‘Undisturbed’ Lake Catchments in the Rotorua District

William Shaw

Principal Ecologist and Director, Wildland Consultants Ltd, Rotorua
willie.shaw@wildlands.co.nz

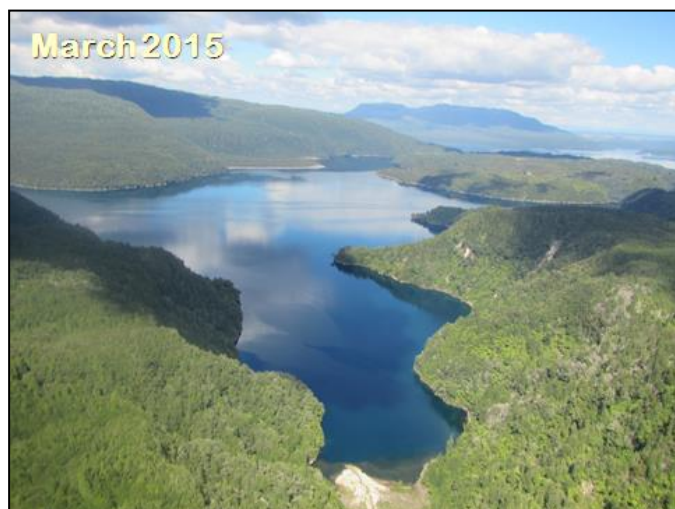
This is a photograph taken four days ago of Lake Ōkataina and this is how we picture our lakes: beautiful, natural, and unchanging stable systems. There is, however, quite a lot happening in this image: a fresh delta (due to recent sediment deposition), relatively recent landslides, and some kamahi dieback higher on the slopes.

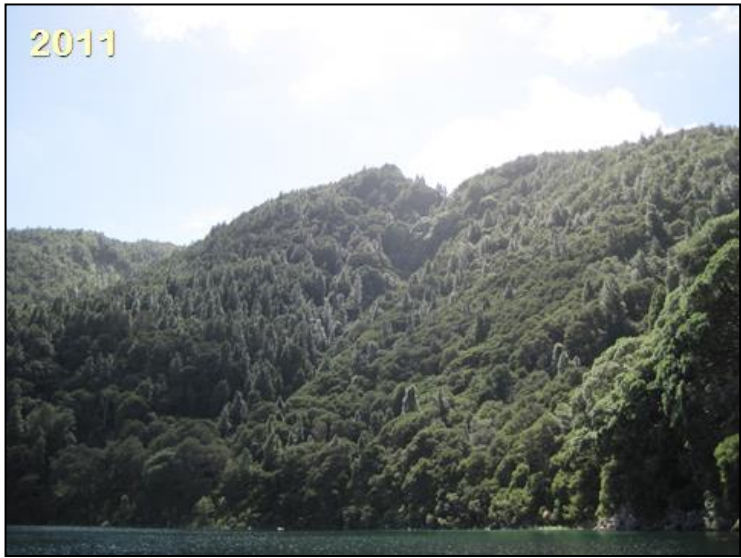
This is almost entirely secondary forest that has developed following fire, which has affected a large part of the Ōkataina catchment, with pohutukawa close to the lake shore.

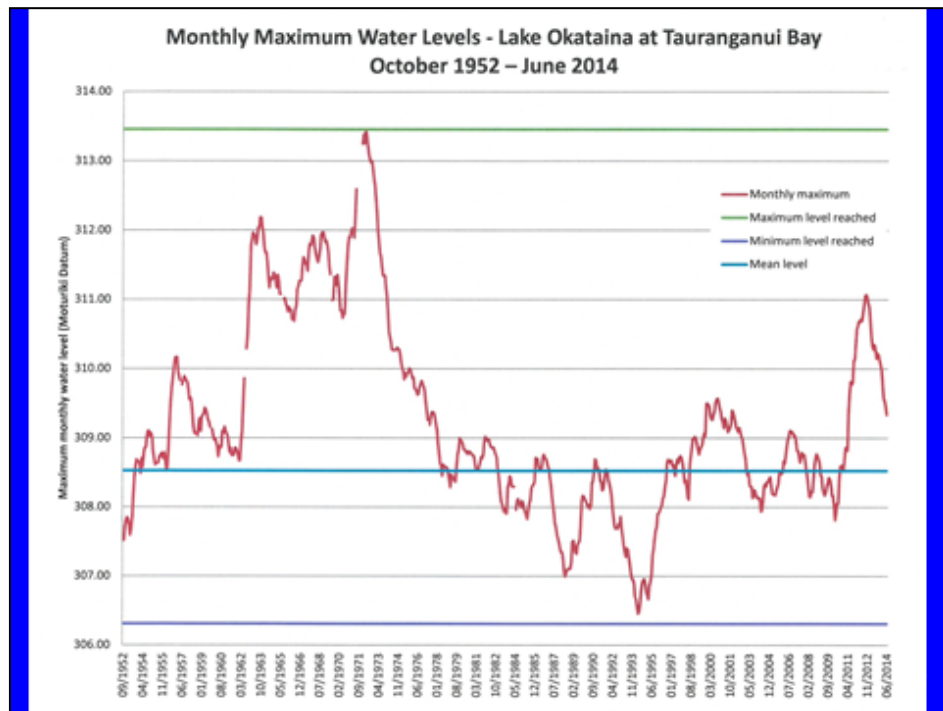
Slide 12 is a plot of lake levels for Ōkataina over the last 62 years, and is very interesting. The lake level peak in 1956/57 was regarded as being a really high peak in some of our lakes. There were much higher peaks following that though, particularly in 1971/72, with a very steep slope on the lake level plot for that event. The lake obviously rose relatively rapidly over quite a period of time and there was then probably a major event which rapidly pushed the lake level up to a very high level. In 2012, only three years ago, the lake attained the highest level recorded since 1972.

The overall natural range recorded over the last 62 years is seven metres, which is huge, and is about the same as the natural range for Lake Waikaremoana (where I have worked for many years monitoring shoreline vegetation processes for Genesis Energy).

Vegetation dynamics relative to lake levels are summarised in a short paper by Roger Cameron in 1957 who studied high lake level effects at Rotomā. You will recall the peak shown in **Slide 12** on the lake level graph for 1956/57, which was not really that high, but the Rotomā margin was submerged and forest died there during that summer. Cameron cored those trees and found that they were about 45 to 50 years old. There were larger trees of 200-300 years old but these were c.0.6 of a metre above the 1956 flood level and he considered that the 1956 lake level was the highest since an even higher flood in 1905 or earlier. There was no indication of higher floods in recent centuries. It is notable that only 0.6 of a metre above the trees that died in 1956/57 Cameron found the shoreline vegetation to be quite stable. We now know that within 20 years of that high level on Rotomā there was a far higher level at Ōkātina.
