**The Fault in our Hill:
Characterisation of the Rangitawa Tephra,
and Insight into Tectonic
Influences at Hillcrest Road.**

A thesis submitted in partial fulfilment
of the requirements for the degree

Master of Science

The University of Waikato

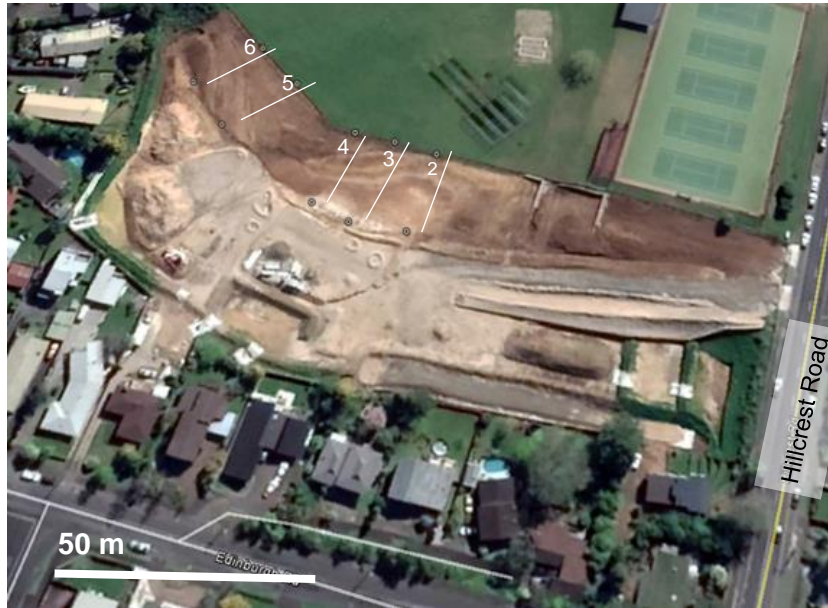
Figure 4.1 Aerial view of the cutting and expresses the extent of earthworks at 59 Hillcrest Road, Hamilton. White lines indicate soil profiles 2 to 6.

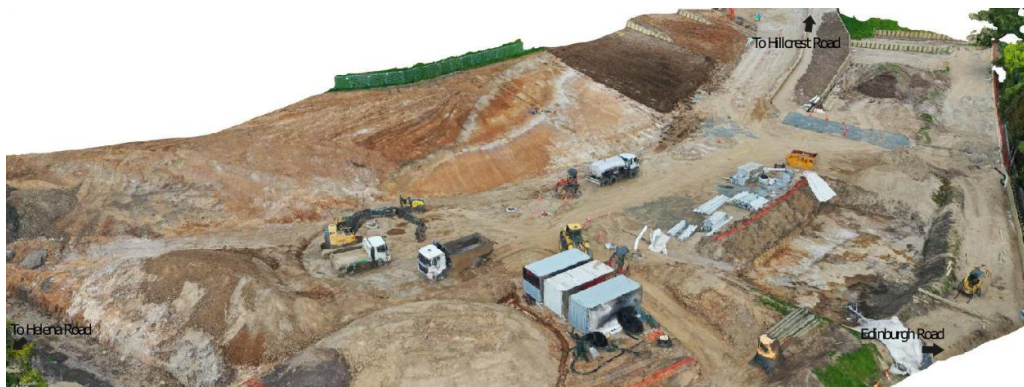
Figure 4.2 Still from drone footage of the site at 59 Hillcrest Road, Hamilton. Viewing toward east-northeast.

Figure 4.1 is a satellite image from Google Earth providing an aerial view of the field area and expressing the scale of earthworks for this project. **Figure 4.2** provides a drone photo facing northeast toward the cutting exposing a birds-eye view of the cutting and stratigraphy of the hill beneath Hillcrest Road and the university.

All units also dip sharply and disappear into the base of the field area between profiles 4 and 5 (**Figure 4.2**) which could be inferred as another splinter off the fault zone resulting in further deformation and offset in the field area. This cannot be determined for certain, however, as the material exposed after the units disappear is fill from previous earthworks at the site so any other evidence of a fault in that particular area is masked and must be left under 'potential fault plane. Other normal faults are present across the Hamilton Basin. One example is the 8.4 metre and 3.04 metre displacements at Kay Road (Campbell, 2017). The deformation at Kay Road was believed to stop before the Rangitawa Tephra was deposited, constraining the activity on the fault to be older than 0.34 ka (Campbell, 2017). At Rototuna (in 2015), faults found dipped over a range 51 – 84°, with an average dip direction of 89°. At Kay Road steeply dipping faults were also identified, with an average dip of 57.3°, and an average dip of 73° and dip direction of 55° (northeast), aligned southwest-northeast (Moon *et al.*, 2019). Within the Hamilton Basin, reverse and strike-slip faults have also been suggested (Campbell, 2017; Spinardi, 2017) but there is no evidence in this site to suggest these forms of faulting are present.

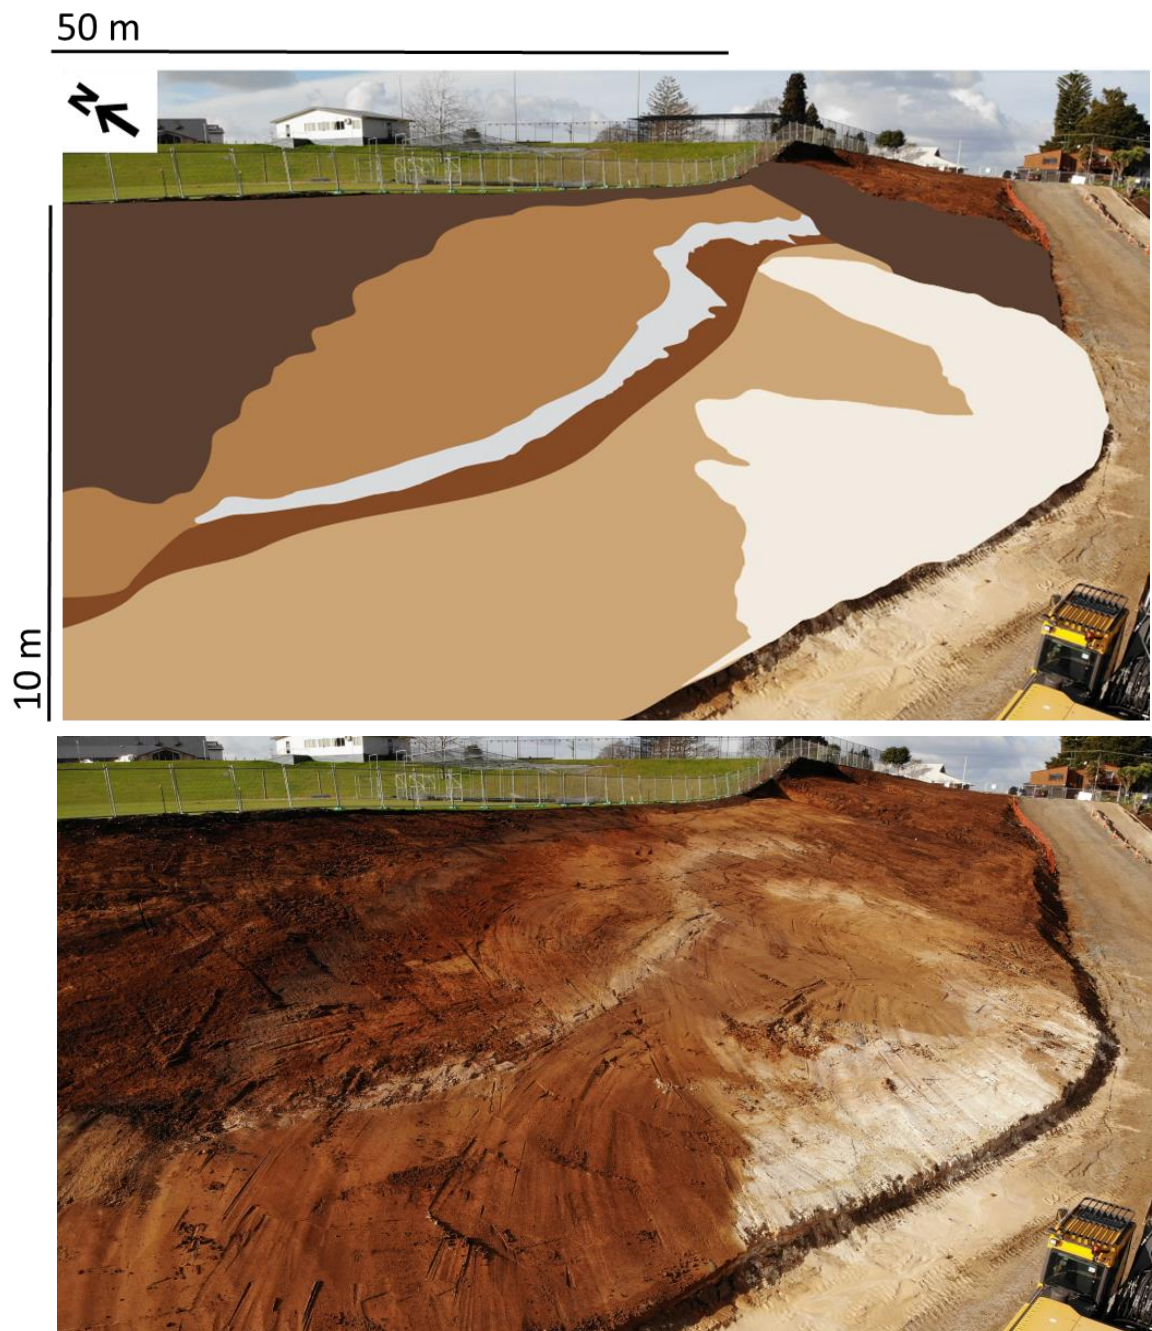
Figure 4.5 Inkscape annotation of cutting presenting stratigraphic relationships at 59 Hillcrest Road, Hamilton. Facing east-northeast.

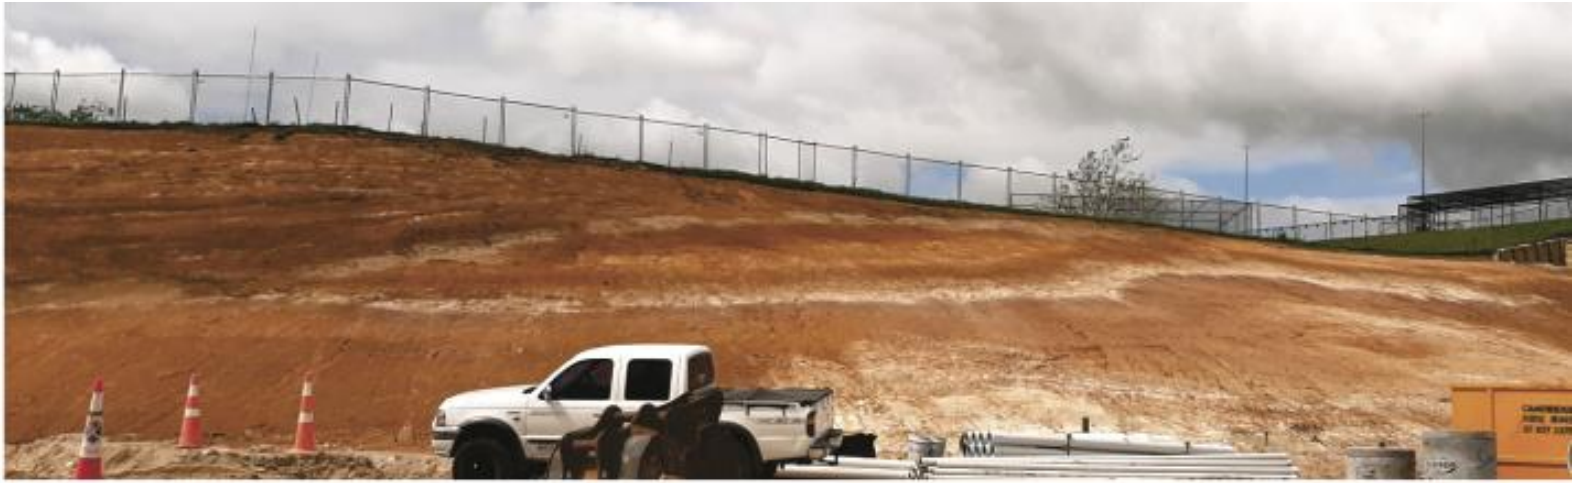
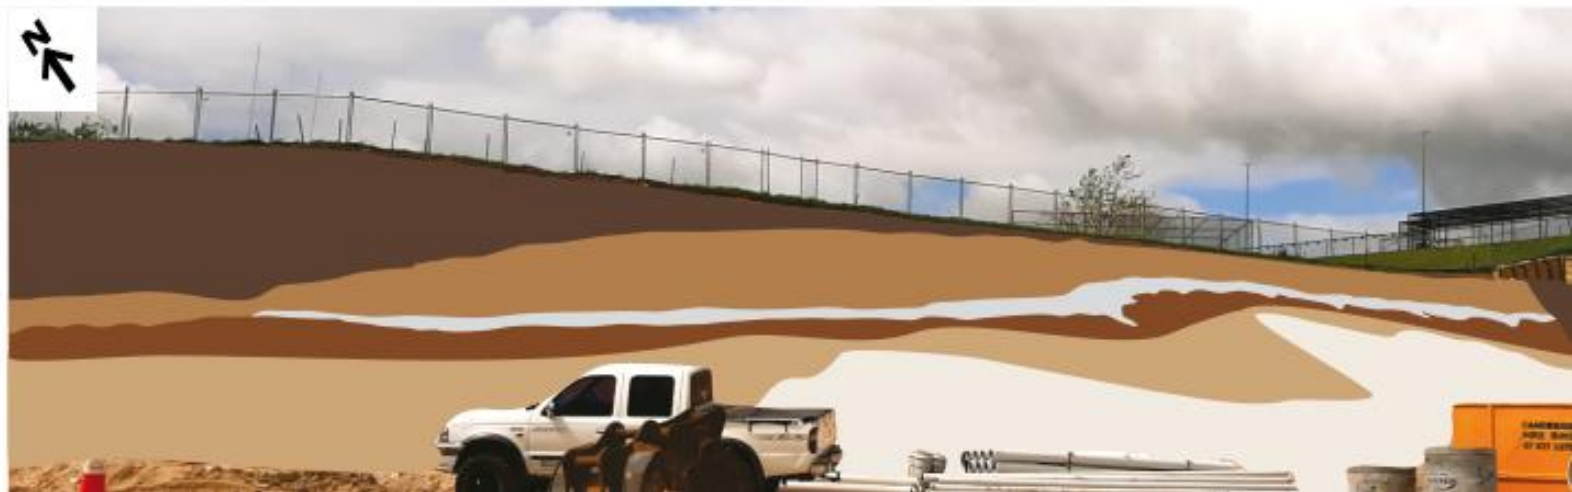
Figure 4.6 Inkscape annotation of cutting at 59 Hillcrest Road, Hamilton showing stratigraphic relationships. Facing northeast.

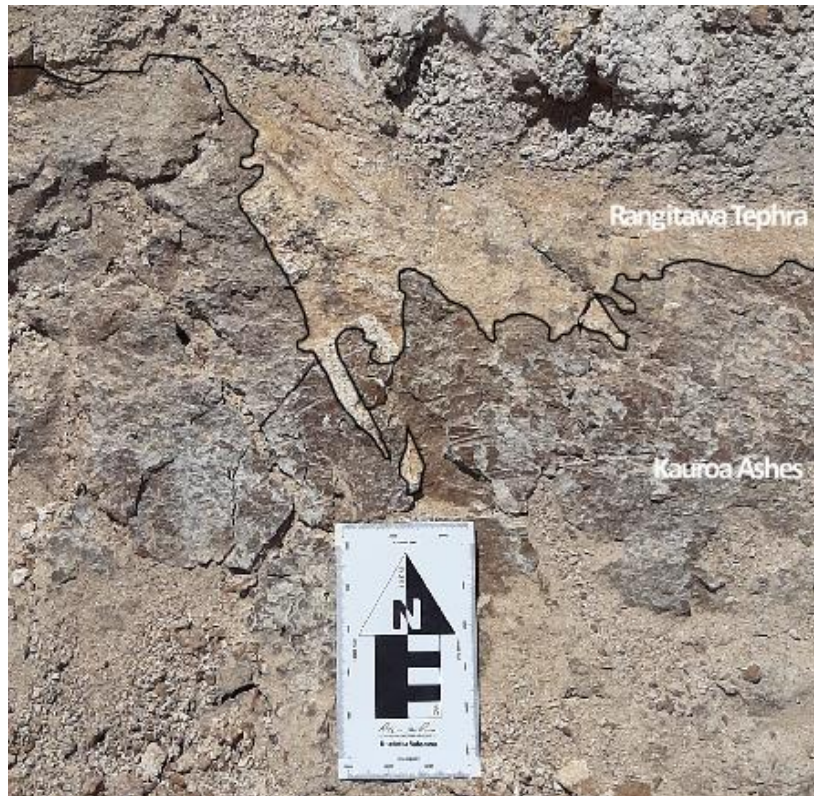
Figure 4.10 Centimetre-scale deformation at the Rangitawa Tephra unit base contact with Kauroa Ash Formation.

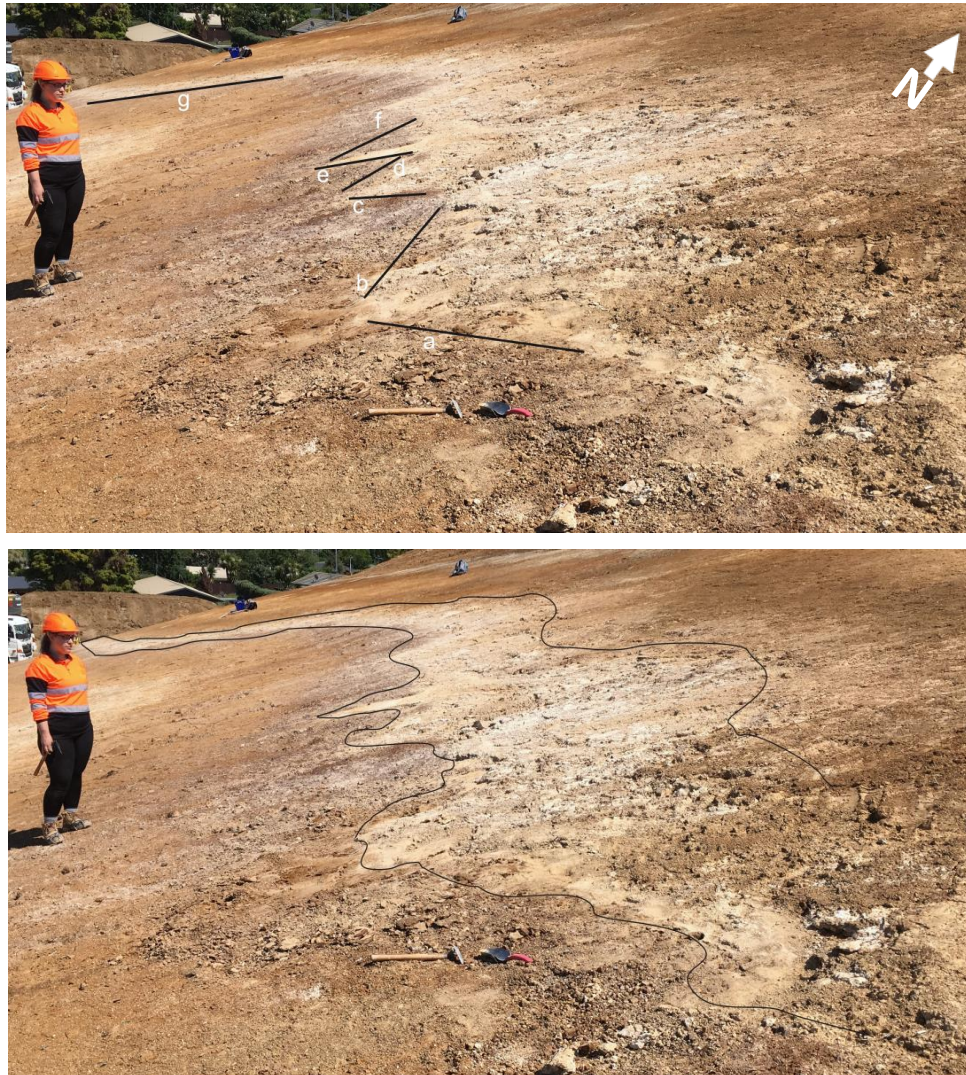
Figure 4.11 Deformation at the base of the Rangitawa Tephra unit. Table 4.8 for measurements of each section (a-g).

Position	Length (m)
a	2.50
b	1.32
c	1.13
d	1.16
e	1.40
f	1.50
g	5.98
Mean	2.14 +- 1.63
Mean exc. (g)	1.5 +- 0.46

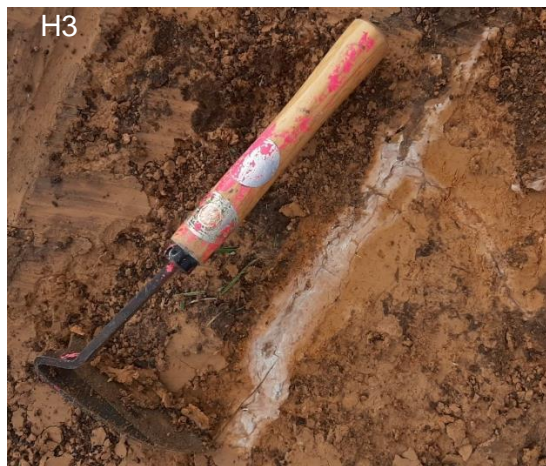
Figure 4.12 Infilling of light grey silty material into clayey soil. Source could not be determined. Niwashi for scale. Running directly upwards at profile 2. (H3/4 Profile 2).

structure at 190 cm depth along profile 2 within the Hamilton Ash Formation (H3 bed). The intrusion appeared to run both vertically into an orb of silty material and horizontally from this orb. **Figure 4.13** the same material is observed penetrating two centimetres into the upper Kauroa Ash Formation. A similar structure up close is presented in **Figure 4.14**. This picture was taken at 230 cm depth along profile 3 in the Hamilton Ash Formation (H4). The source of this material was not identified but is theorised to be caused by weathering processes along discontinuities, or injection of material from within the site.

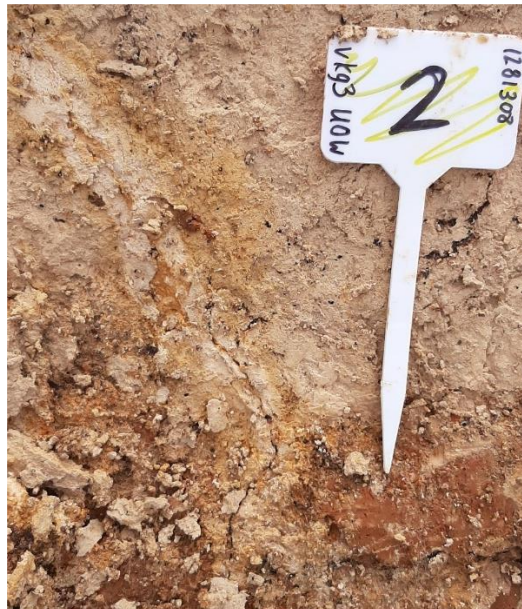
Figure 4.13 Infill of light grey and weathered silty textured material, and dark reddish-brown clayey material penetrating 2 centimetres downwards into the top of the Kauroa Ash Formation.

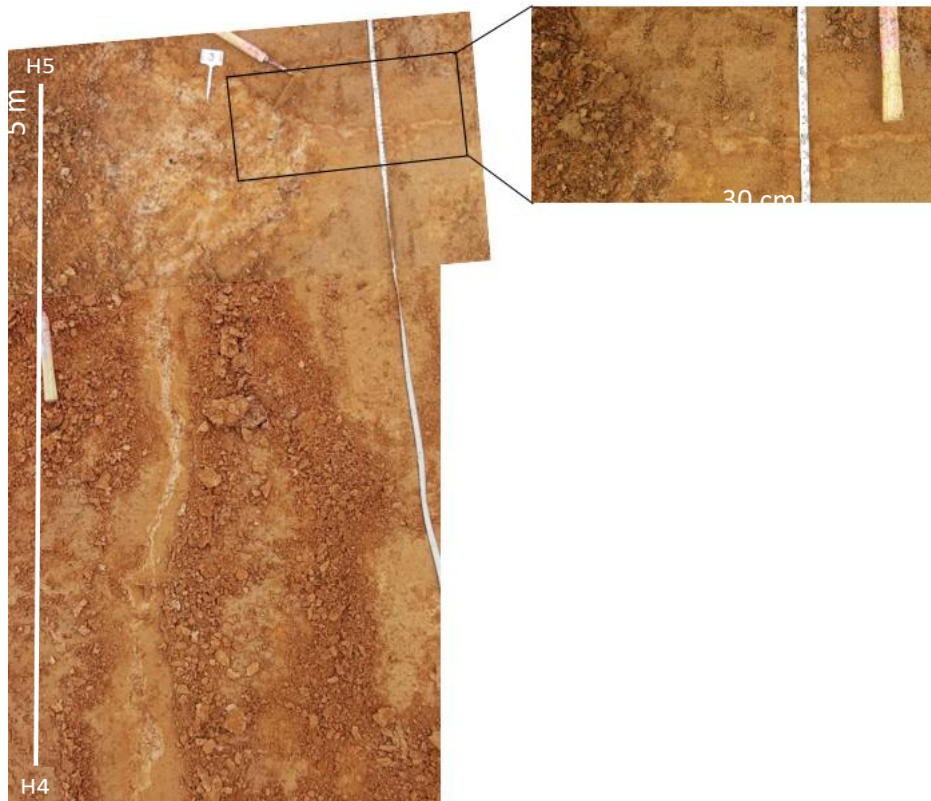
Figure 4.14 Light grey-brown silt-textured intrusion into the Hamilton Ash Formation (H4/5 profile 3). Composite figure of multiple photographs. Niwashi and tape measure for scale.

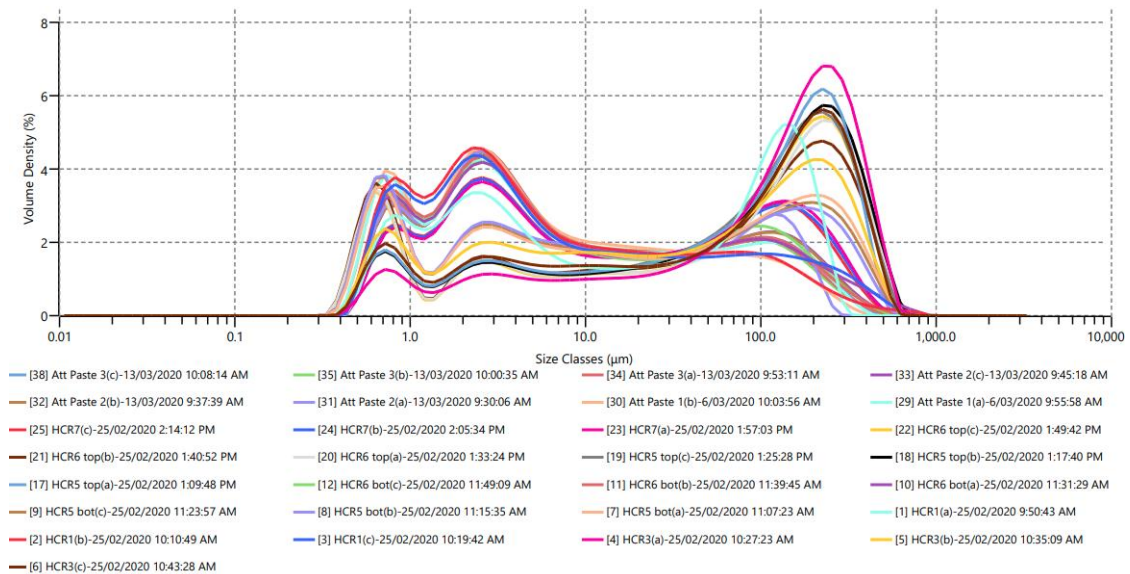
Figure 5.1: Particle-size distribution graph for all Hillcrest Rangitawa Tephra samples. Shows bimodal distribution of extra-fine silt, and extra-fine sand fractions.

average of medium silt. 1) Very fine to fine silts as present in HCR1, HCR5 Bot, HCR6 bot, HCR7, and Atterberg Pastes 1, 2, and 3. 2) Very-fine sand as present in HCR3, HCR5 Top, and HCR6 top.

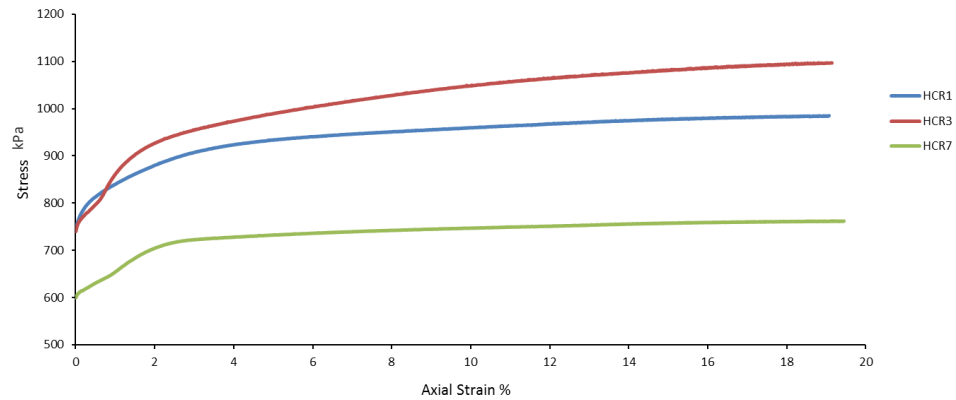
Figure 5.9 Axial Strain (%) versus Axial Stress (kPa) relationship for samples HCR1, HCR3, and HCR7 from Hillcrest Road.

graph, rather the stress continues to increase until the test ended. Ultimate strain for HCR1 is 19.25 % at 985.65 kPa. HCR3 19.32 % strain at 1098.96 kPa. HCR7 19.62 % at 762.98 kPa, all of which are when the test was ended. Rather than failing in a brittle way, the material appears to be deforming in a ductile-plastic manner.

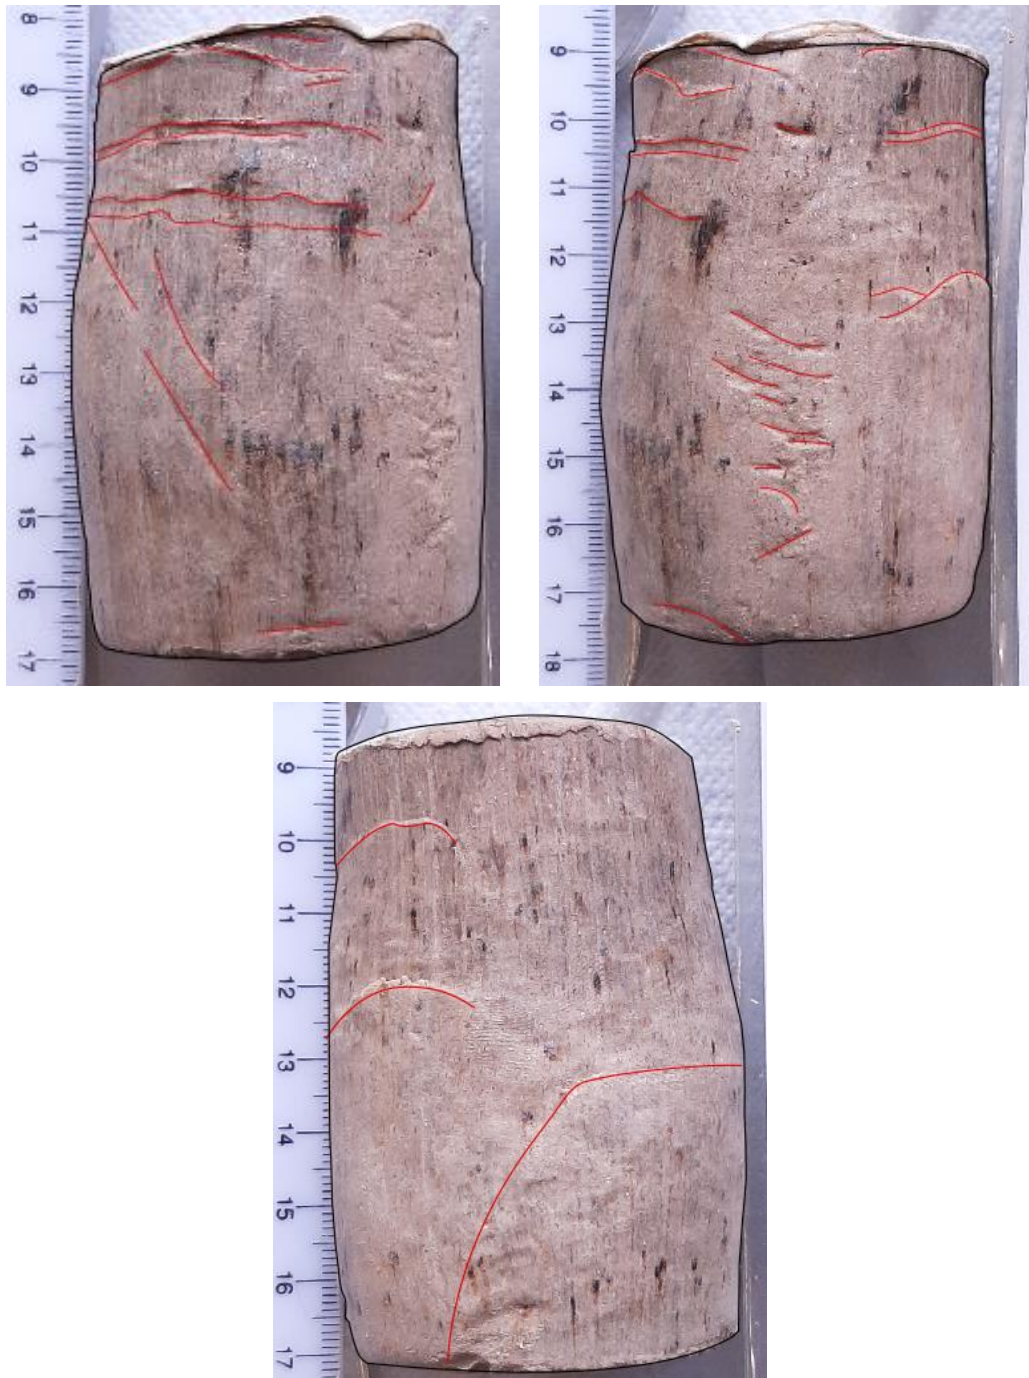
Figure 5.15 HCR1 Failed Triaxial core annotated figures. Tested at 100 kPa under undrained, consolidated conditions.

Photographs of the failed samples (HCR1, HCR3, and HCR7) presented in **Figures 5.14- 5.16** indicating the failure modes contributing to deformation. Selby (1993) provides four failure modes for triaxial specimens – a) brittle - shear failure, b) brittle to ductile - wedge failure, c) ductile - intermediate failure, d) ductile-plastic - barrel failure. **Figure 5.14** presents the various modes. The samples tested are assigned a failure mode based on Selby (1993) (**Figure 5.14**).

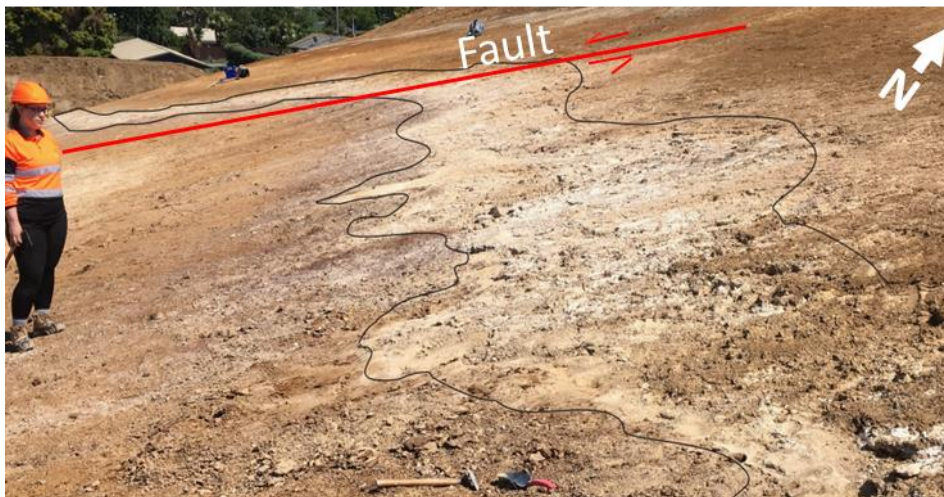
Figure 6.2 **From Figure 4.11** Deformation at the base of the Rangitawa Tephra unit with inferred normal fault (red) superimposed.
