Twelve Years on: Christchurch's Recovery from the 2010/2011 Canterbury Earthquakes

ABSTRACT

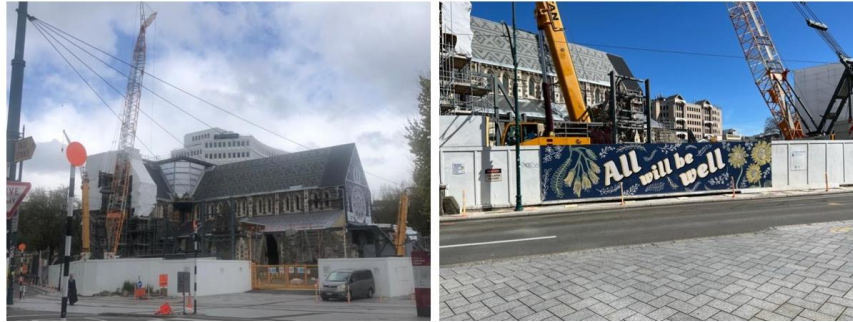
Figure 3. The repairs of Christchurch Cathedral: (a) Construction activities on the facade of the Cathedral (Courtesy of Lianyan Li), (b) Construction activities on the sides of the Cathedral (Courtesy of Beth Mayer).

interviews with P4, P3, and P6, this research confirmed that decision-making played an essential role in restoring buildings in Christchurch CBD. For example, Cathedral has been put aside for an extended period of time due to disagreement among different stakeholders. The decision-making on Cathedral even takes much longer to settle numerous coordinating issues and determine a satisfactory restoration plan. Surprisingly, the restoration of the surrounding buildings was also impacted by the status of the Cathedral. Stakeholders are more cautious about repairing their buildings if the adjacent landmark building remains unrepaired. The influence of adjacent buildings became a crucial impeding factor in the decision-making process. It is worth noting that the reinstatement of Christchurch Cathedral has started recently, though it might take another several years to complete all construction activities, as is indicated in Figure 3.

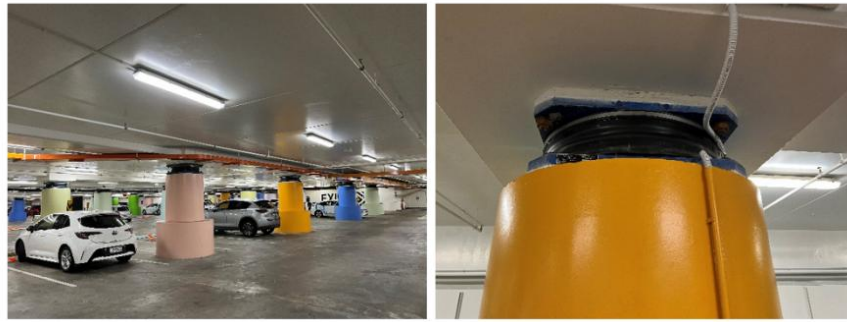
Figure 4. Christchurch Art Gallery: (a) Base-isolators in the underground parking garage (Courtesy of Beth Mayer), (b) Amplification details of base-isolators (Courtesy of Beth Mayer).

Through the interviews, most participants believed the legislative changes were effective in embracing the enhanced building resilience in the long term. Specifically, the seismic hazard factor for the Canterbury region was increased from 0.22 to 0.3 after the earthquakes to account for increased seismic activity within an estimated 10-20 year period after the February 2011 earthquake [37]. This regulation informs the higher seismic safety for new or future retrofitted buildings and affects the design and construction of most public and commercial buildings, particularly in Christchurch CBD. Also, P6 confirmed the concept of redundancy received more attention after the earthquake. For example, base-isolation was broadly adopted in newly constructed buildings to ensure sufficient redundancy against future disasters, such as the Art gallery (see Figure 4). With redundancy better conveyed to construction practices, buildings are more capable of satisfying functional requirements in the event of a disruption, degradation, or loss of functionality [38]. However, how to add redundancy to components that are most likely to fail in the building based on its design has not reached a uniform agreement so far.

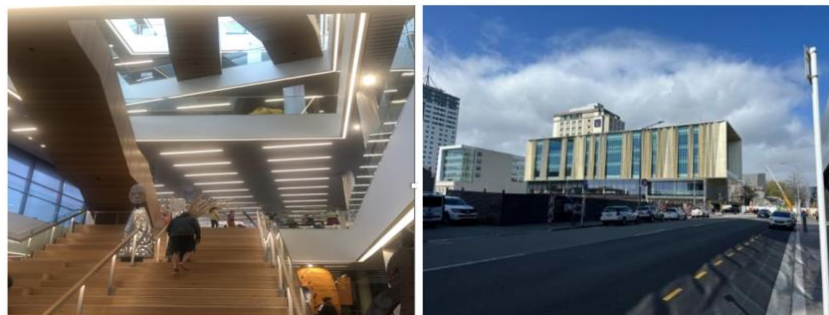
Figure 5. Tūranga Library: (a) Interior of the library (Courtesy of Lianyan Li), (b) Global view (Courtesy of Beth Mayer).

One of the Anchor projects that used low-damage design is the new Christchurch central library Tūranga (see Figure 5), which was constructed with modern low-damage technology by incorporating a dual seismic resisting system, primarily consisting of an integrated, self-centring mechanism in the form of hybrid concrete shear walls that can rock to isolate the building from peak earthquake accelerations [41].

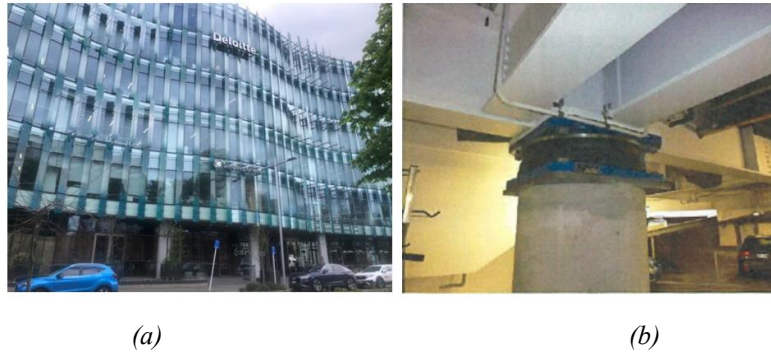
Figure 6. 151 Cambridge Terrace: (a) Global view (Courtesy of Lianyan Li), (b) Base-isolator (Courtesy of Mark Willard).

Through interviewing with P3, P4, P6, and P8, participants consistently believed that the use of base-isolation systems was more prevalent in newly constructed buildings compared to other low-damage designs. Two typical buildings during the observational tours are 151 Cambridge Terrace and Awly building. Both buildings used a base-isolation system, as indicated in Figure 6 and Figure 7. 151 Cambridge Terrace is the first building in New Zealand to incorporate Triple Pendulum base isolation bearings into its design, making it one of the most earthquake-resilient buildings in the country. Specifically, its bearings were supported on concrete columns from the concrete foundation. The supporting structure is a steel frame throughout, except for the beams framing the parking ramp that provides access to the lower level.

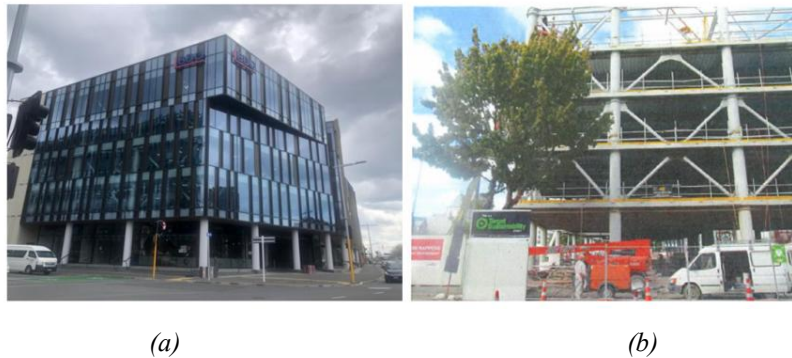
Figure 7. Awly Building: (a) Global view (Courtesy of Lianyan Li), (b) Hybrid structure during construction in March 2016 (Courtesy of Mark Willard).

Located on the southwest corner of Durham Street North and Armagh Street, Awly building is the first building in the post-earthquake city to achieve a 5-star rating from the New Zealand Green Building Council (NZGBC) [42]. Unlike 151 Cambridge Terrace, it adopted a hybrid structure to satisfy specific seismic requirements (see Figure 7). It is equipped with base isolators to reduce swaying and shaking and limit damage to the building. Meanwhile, it is coupled with diagonal seismic bracing, visible through the high-performance façade, for lateral stability.
