# **SHORE PLATFORM OBSERVATION AT TATAPOURI AND MAHIA PENINSULA, NEW ZEALAND**

A thesis  
submitted in partial fulfillment  
of the requirements for the degree  
of  
Master of Science  
in Earth Sciences  
at  
The University of Waikato  
by

**Murray Te Aho**

**2007**

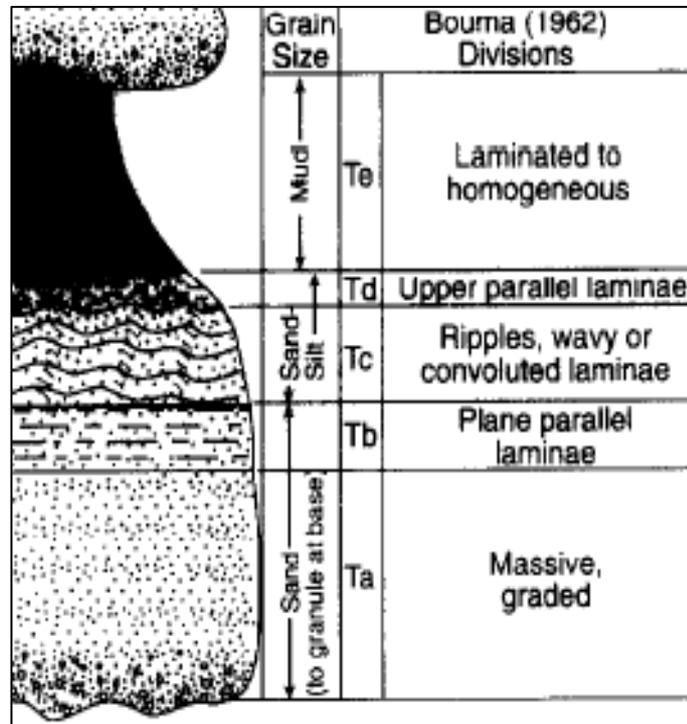
**Figure 2.1** A Bouma sequence (Shanmugam 1997).

The Bouma sequence, is a ‘graphic approach to facies interpretation’ deposited by turbidity currents (Shanmugam 1997). The classic Bouma sequence (figure 2.1) is broken down into intervals. Each interval (i.e. Ta, Tb, Tc, Td, and Te) of the entire sequence is a product of turbidity currents (Shanmugam 1997).

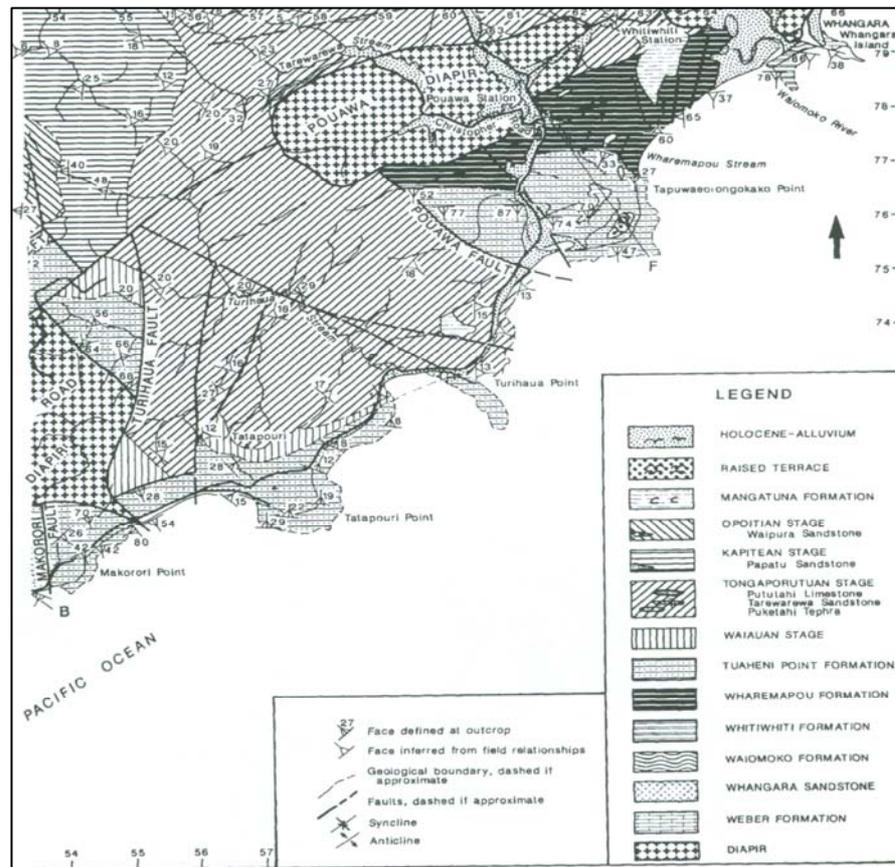
**Figure 2.2** Cenozoic geology of Tatapouri and active fault systems. Neff & Bottrill (1992).

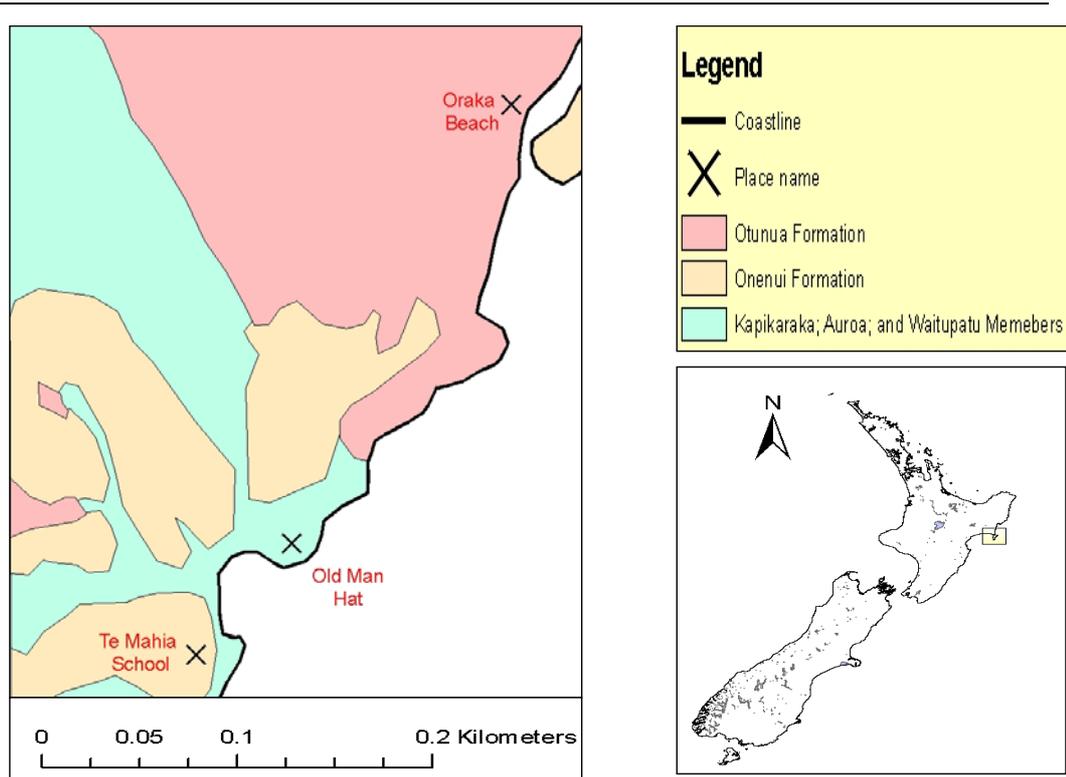
**Figure 2.3** Geology of Mahia peninsula Adapted from Webb (1979). The total distance for the study area is approximately 1.3 km. Note the Kapikaraka and the Waitupatu Members are not exposed along the section of coastline within the field and is outside the scope of this thesis.

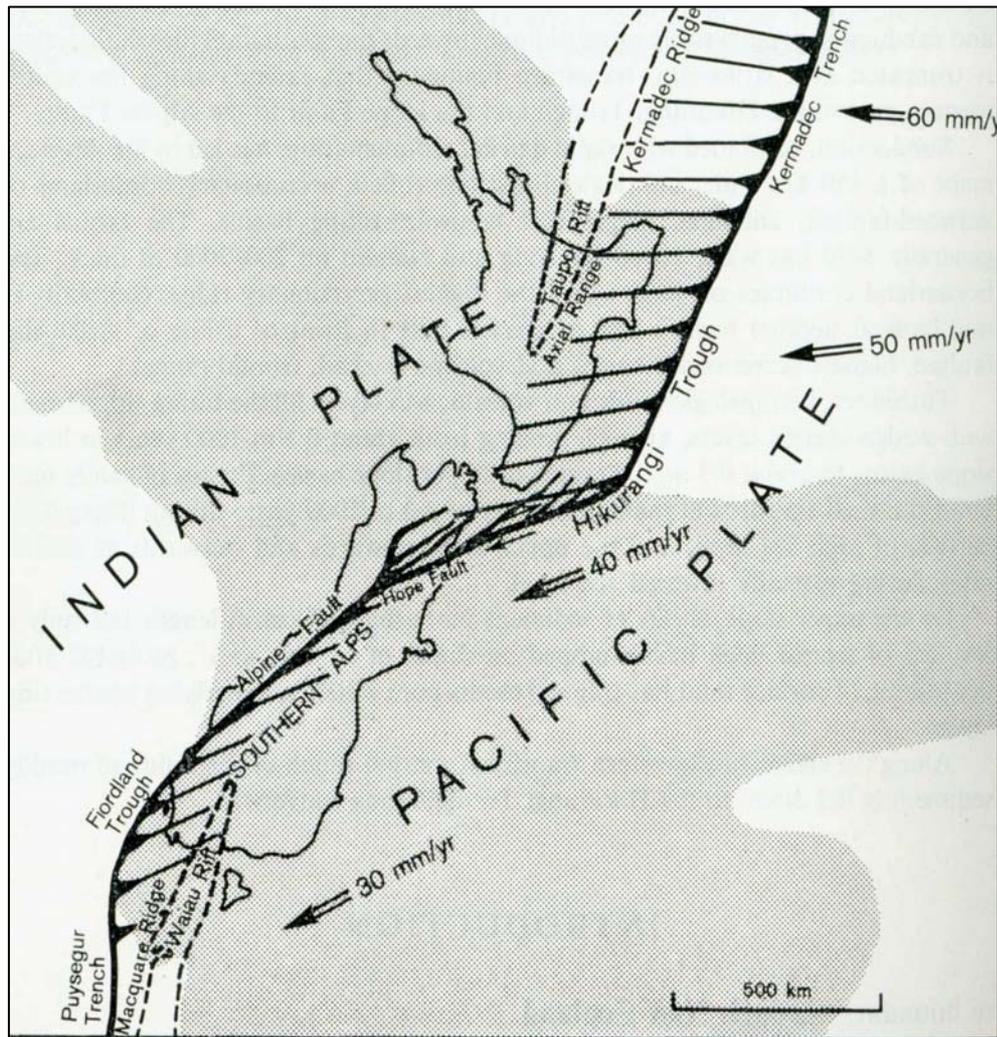
**Figure 2.4** Major elements of the Indian – Pacific Plate boundary in the New Zealand Region. Note: Stippling represents continental crust and arrows show relative motion of Pacific Plate with respect to the Indian Plate. Lines represent direction of motion of underthrusting plate. (Adapted from Walcott, 1978a, b) cited in Lewis, (1980).

The Hikurangi Trough is located approximately 80 km East from the Mahia Peninsula where the Pacific Plate is being subducted beneath the Australian Plate (figure 2.4). The Pacific Plate is moving towards the Australian plate in the Gisborne region at a rate of 45-50 mm/yr<sup>-1</sup> (Walcott, 1987; Aitken, 1999) cited in Dunn (2001). The rate of movement for Mahia Peninsula shows a similar rate to the Gisborne region. Most of the soft sediments are coming from off shore sediment sources.

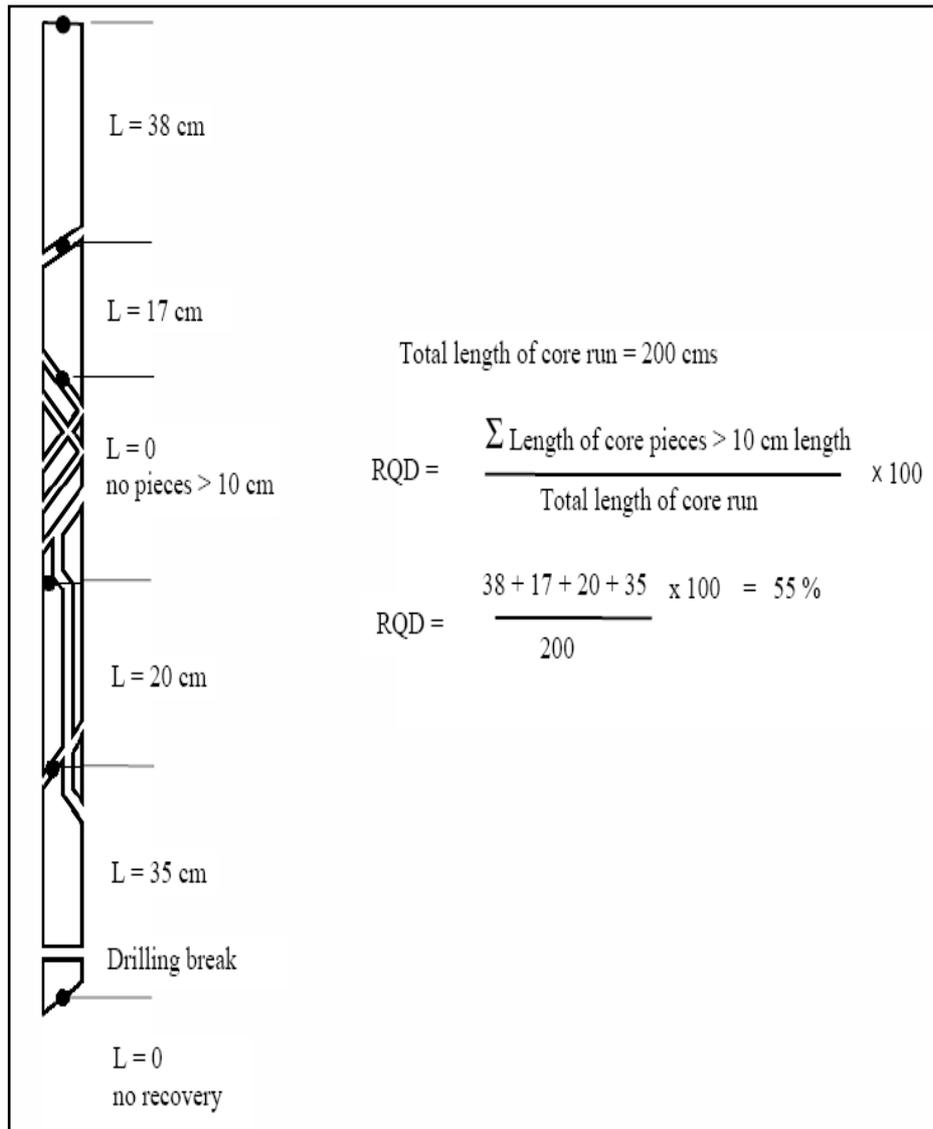
**Figure 2.8** Procedure for measurement and calculation of RQD (Deere *et al.* 1989).

The correct method used to measure RQD is illustrated in figure 2.8. Unfortunately no drill core data was available so Equation 2.1 (Priest & Hudson, 1979) was used to work out RQD.

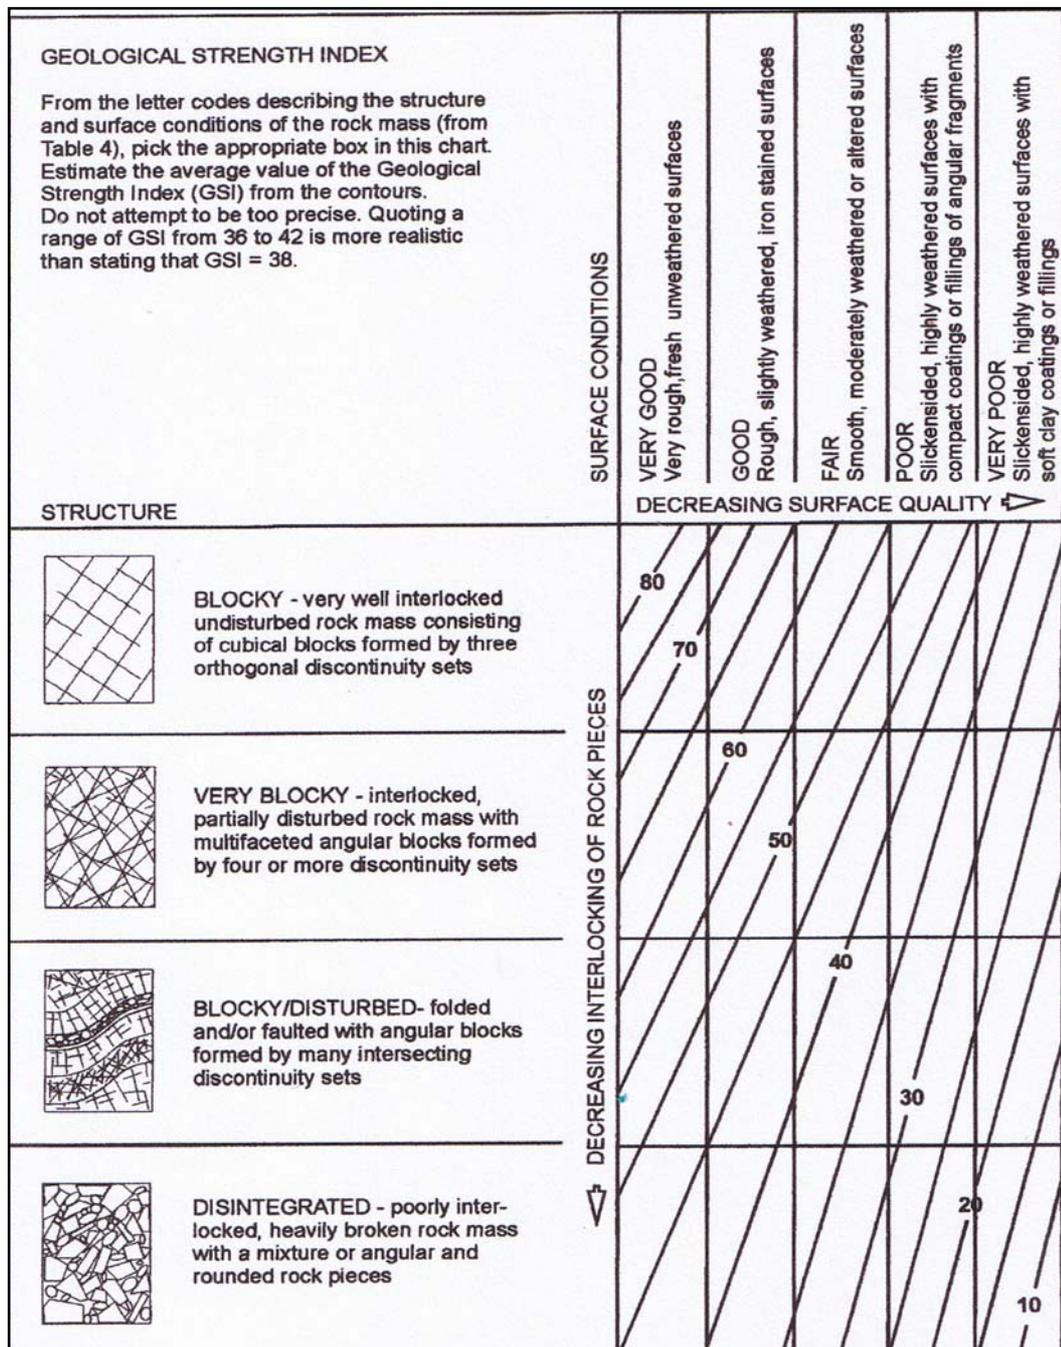
**Figure 2.9** Estimation of GSI (Hoek *et al.* 1997). Marinos & Hoek (2001, page 154).

The GSI estimates the reduction in strength of a rock mass based on different geological conditions and relies on field descriptions for assigning a rating number (Hoek *et al.* 1998). Figure 2.9 shows five ‘surface conditions’ ranging from ‘very good’ through to ‘very poor’ and four ‘structure categories’ ranging from blocky through to disintegrated (Hoek *et al.* 1998).

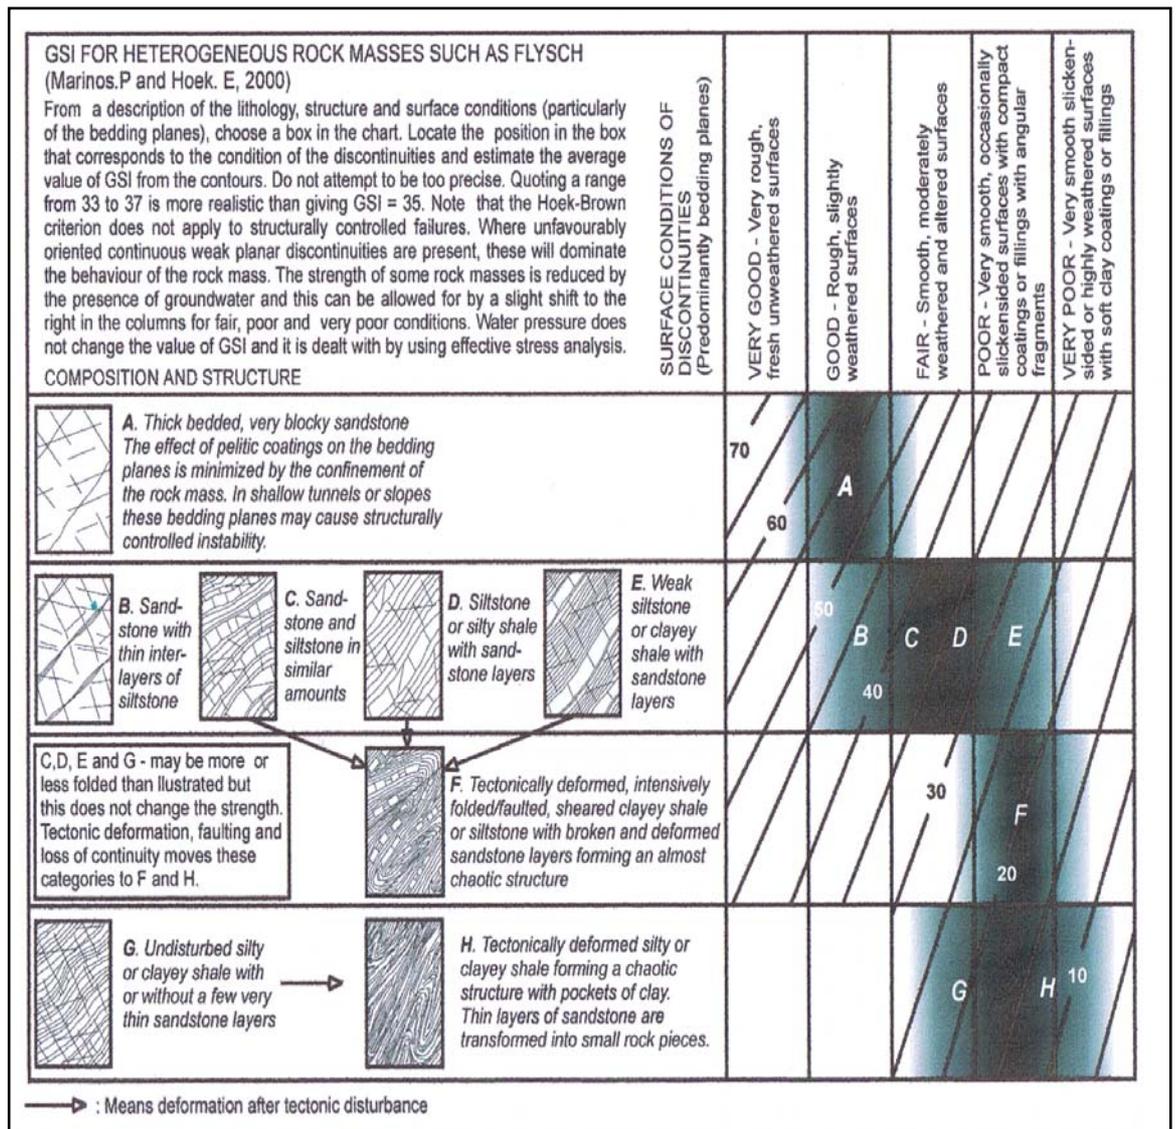
**Figure 2.10** GSI estimates for heterogeneous rock masses such as Flysch (Marinos *et al.*, 2001). Marinos & Hoek (2001, page 9).

Hoek *et al.* (1998) and Hoek 1999 cited in (Bradshaw 2004) introduced two additional rock mass categories called foliated/laminated rock mass structure and massive or intact rock into the GSI system. Due to the anisotropic and heterogeneous nature of the foliated/laminated rock mass structure category, Marinos and Hoek (2001) also proposed a special GSI chart only for the classification of the heterogeneous rock masses such as flysch (figure 2.10).

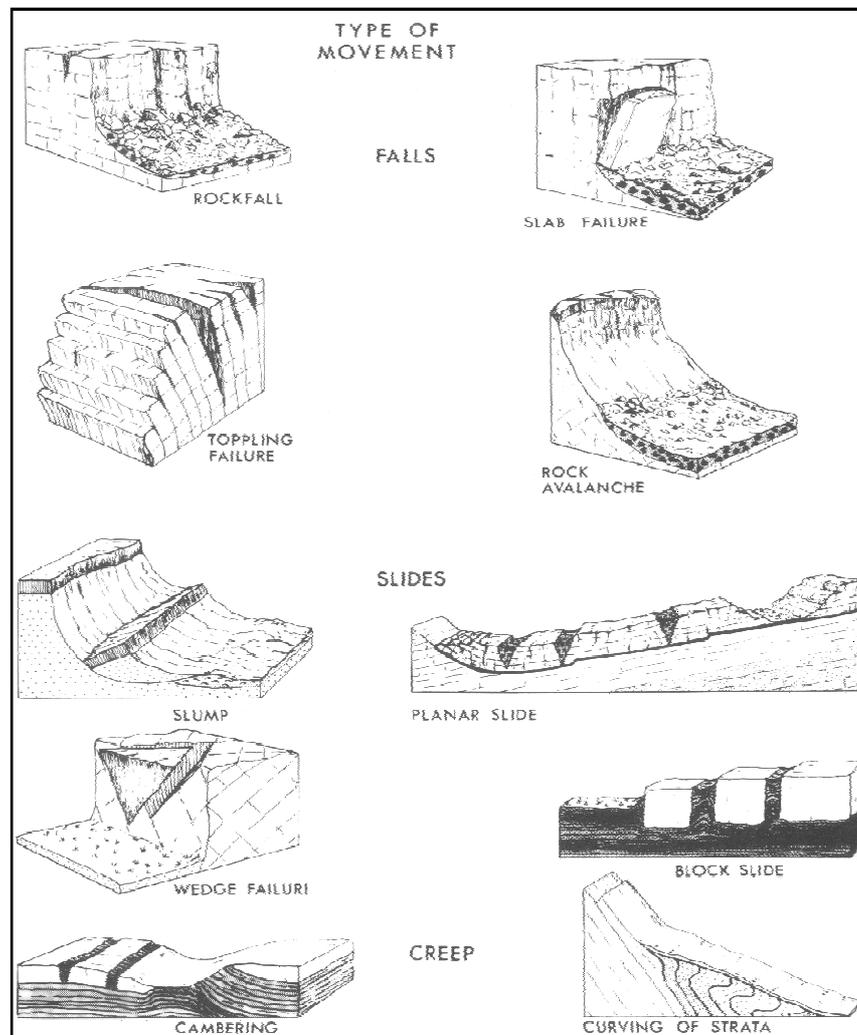
**Figure 2.12** Different forms of slope mass failure (Selby, 1993).

Many different classification criteria are in use for describing mass wasting, ranging from the earliest classification from Sharpe 1938, to more recent work from Varnes in 1958 and 1975, Hutchinson in 1988 and Sassa in 1989 (Selby, 1993). Ten types of mass wasting process that may occur in the field are summarized in figure 2.11. Based on classification of Varnes in 1975 in both study areas, the main mass wasting processes are slides (block, and planar), wedge failure, and rock fall.

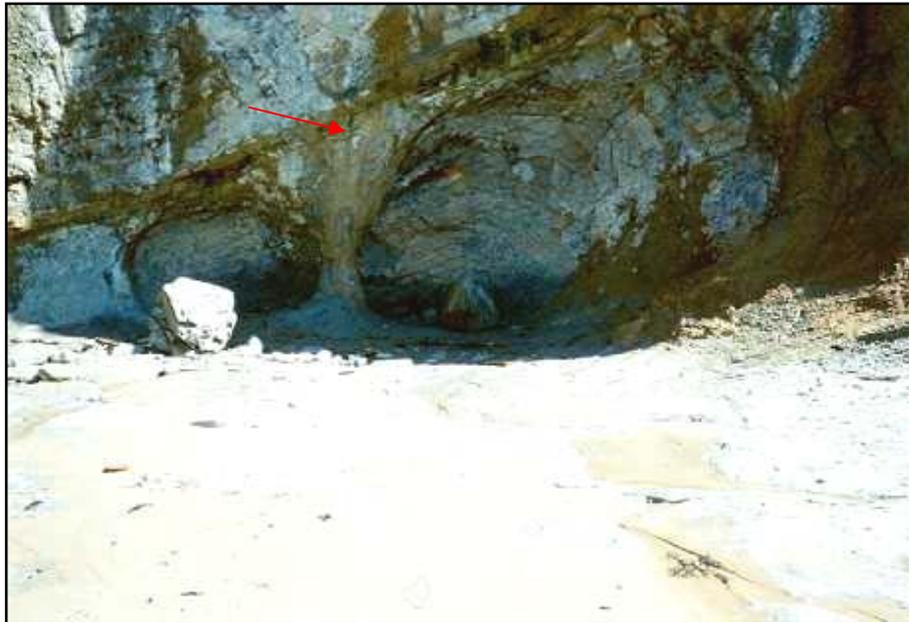
**Figure 2.12** This photo is looking at a cliff notch located on the Mahia Peninsula. The arrows are pointing at notable water seepage coming out of the cliff face.

A clear indicator of cliff erosion is the presence of a notch (figure 2.12), a laterally extending hollow at the base of the cliff with width being greater than depth (Sunamura 1992). Beach material can aid as an abrasive tool which plays an important role in notch development (Sunamura 1992). The rate of notch growth depends on: the strength of the cliff-forming rocks; the energy level of waves arriving at the cliff base; and the amount of abrasive material set in motion by waves (Sunamura 1992).

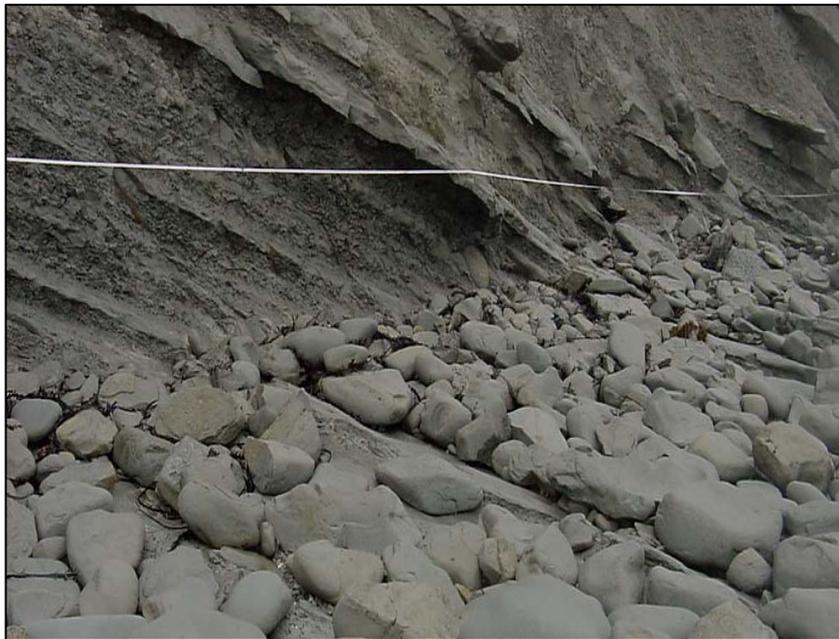
**Figure 3.1** The photo below shows a typical flysch sequence at Tatapouri (Scanline 2). The colour of the rock is darker than normal because it was raining at the time when this picture was taken. The scanline (the white measuring tape) covered a distance of 50 meters in length.

Scanlines were employed to estimate Rock Quality Designation (RQD). This involves stretching a tape measure (50 meters in length) over the face of the rock surface (figure 3.1), and measuring the distance between each individual discontinuity along the scanline (Priest and Hudson 1976). RQD was then estimated by using equation 2.1

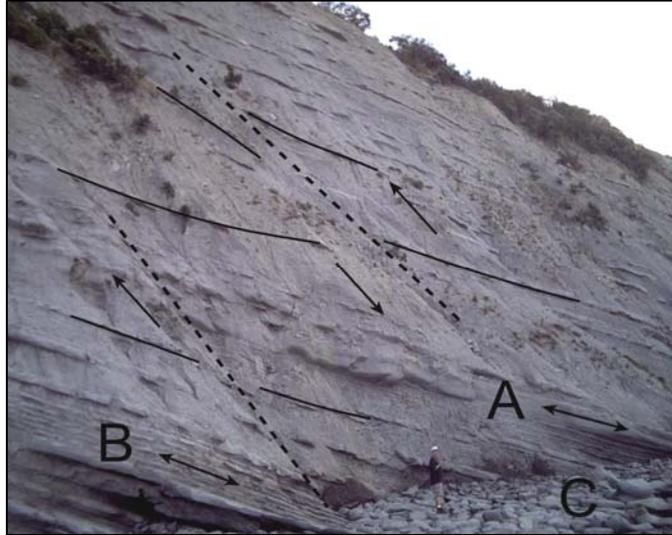
**Figure 4.1** The dashed lines represent regions of known faulting. The solid line represents the bedding that has been uplifted and the arrows show the direction of movement. A & B shows the same flysch units, note the thickness difference. C) Rockfall debris. The person in this photo's is approximately 1.79 meters tall.

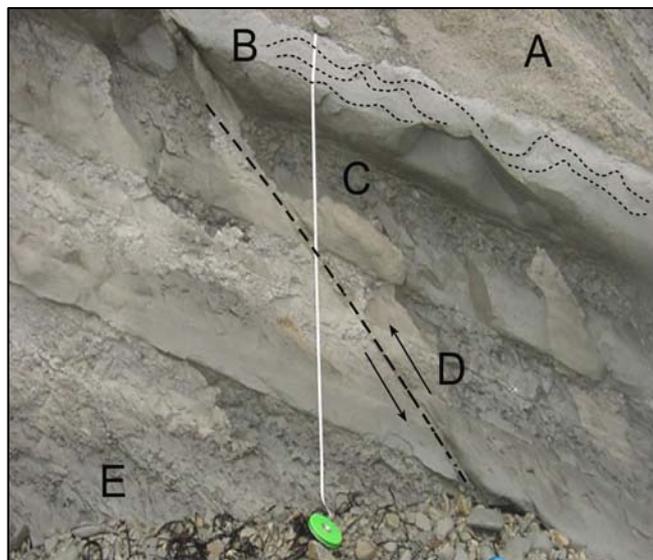
**Figure 4.2** Shows complex geology setting for Tatapouri. (A) Shows convolute lamination, dish and flame structures. B) Alternating thick sandstone. C) Crushed alternating siltstone. D) Field evidence of localised displacement. E) Highly convoluted siltstone. Measure tape in the picture covers a distance of 1.75 meters.

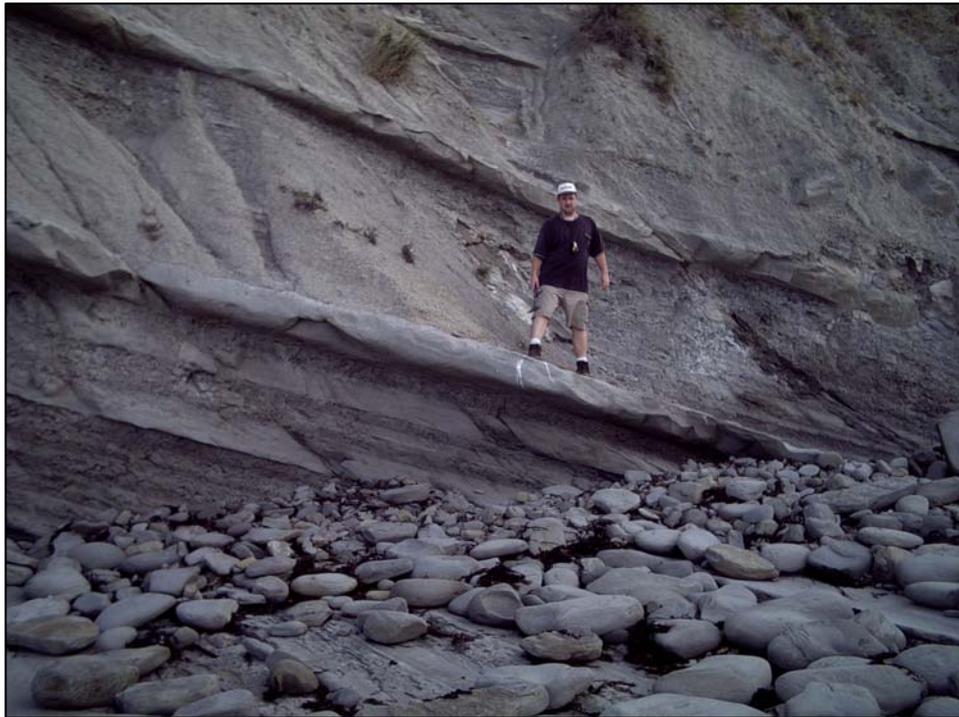
**Figure 4.3** In this picture it shows a person standing on top of a thick sandstone bed at Tatapouri. The person in this photo is approximately 1.79 meters tall.

The Tatapouri sandstones are bedded (figure 4.3) with an range of thickness from (0.03 - 0.8 m). The spacing of adjacent discontinuities is extremely close spacing (< 20mm), with very tight apertures and very low persistence (< 1m). The exposed joint surfaces were covered in rock fragments and grit from the erosion of overlying rock material at the time of field work. The discontinuities were dry at the time of the field survey, but showed evidence of water flow (rust staining). Traces of Fe stains were also noticed on the face of the sandstone and between the cracks.

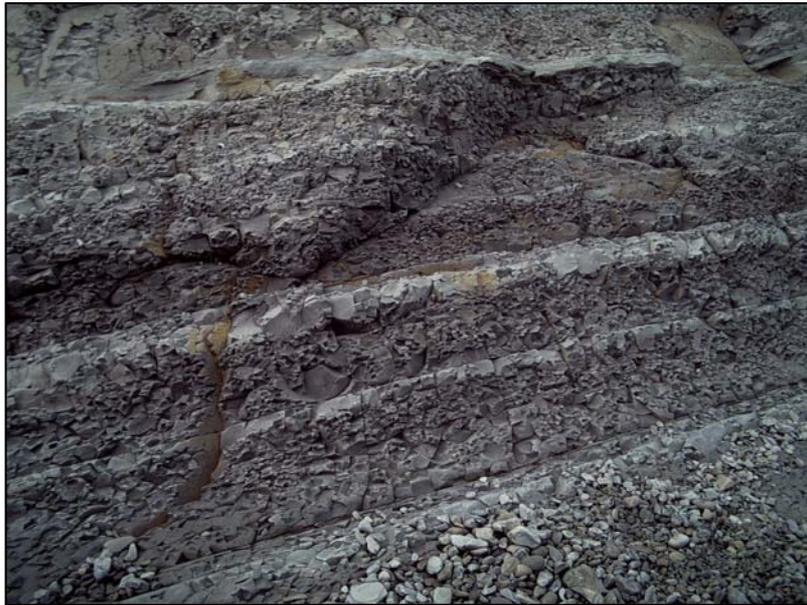
**Figure 4.4** In this picture it shows friable siltstone beds at Tatapouri.

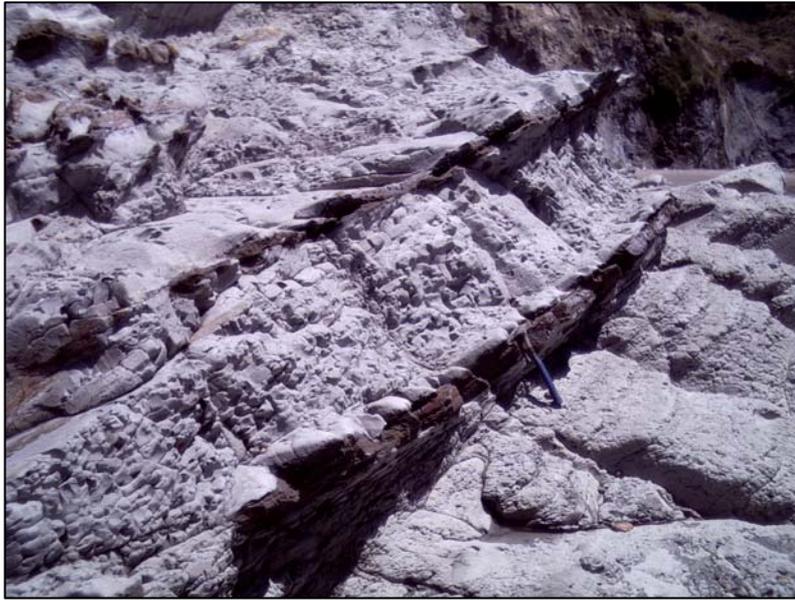
**Figure 4.5** This photo is looking at a section of coastline in Auroa Formation where water is seeping out of the cliff face along a distinct discontinuity boundary zone. This photo was taken at Mahia Peninsula.

The rocks at Mahia Peninsula can best be described as a flysch sequence. The field area itself can be split into two different Formations (e.g. Auroa and Otunua). The Auroa Formation is composed of tuffaceous sandstone and siltstone (figure 4.5). At multiple points along the coastline from Oraka Beach to the bottom cliff of Te Mahia School, signs of water staining and water seepage from the cliffs were observed (figure 4.6).

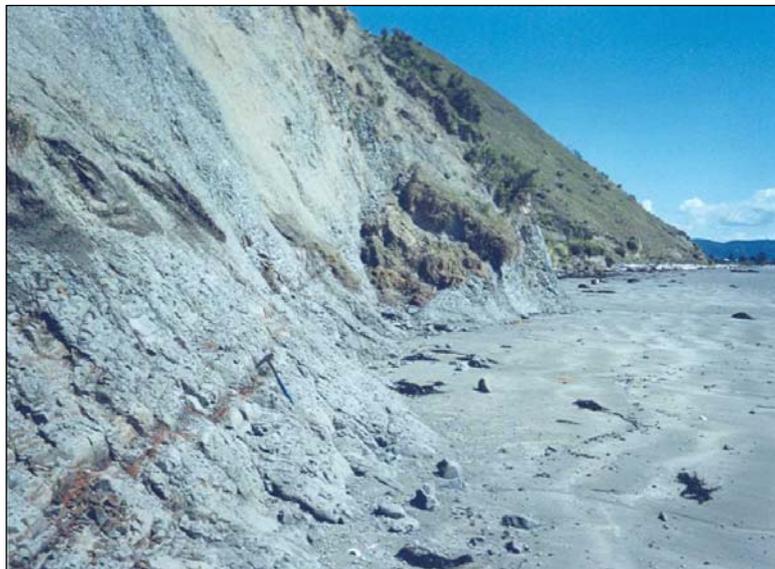
**Figure 4.6** This photo is looking toward Oraka Beach, located on the Mahia Peninsula. A zone of water pooling along a discontinuity produces water staining within the sandstone and muddy siltstone sequence. The iron rust stain shows the boundary of the discontinuity along this section of the coastline.

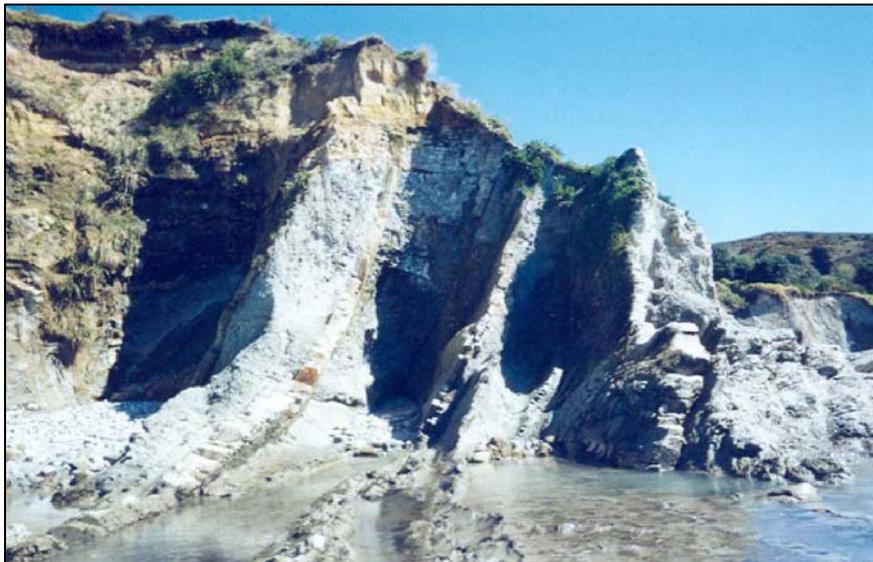
**Figure 4.7** This photo is looking at spectacular geological structures caused by tectonic uplift. This photo is located near Old Man Hat on the Mahia Peninsula. Note a loss of beach sediment in this section of coastline.

The whole area has been uplifted, resulting in intense folding structures in several locations (figure 4.7). Figure 4.8 shows water seeping out along a discontinuity zone. This may create a potential weak zone within the cliff and may result in failure. Signs of mass wasting were also visible. It was noticed that the upper parts of the cliff face were more prone to erosion and slips than the bottom section of the cliff.

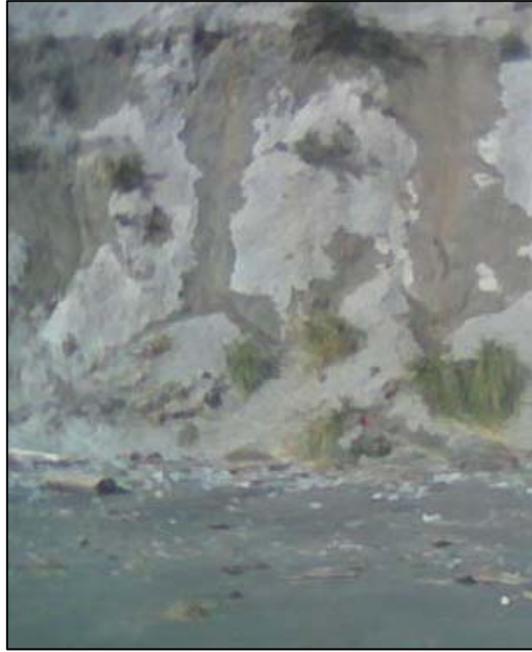
**Figure 4.8** This photo is looking at a section of coastline where water is seeping out of the cliff face along a distinct discontinuity boundary zone. This photo was taken at Mahia Peninsula.

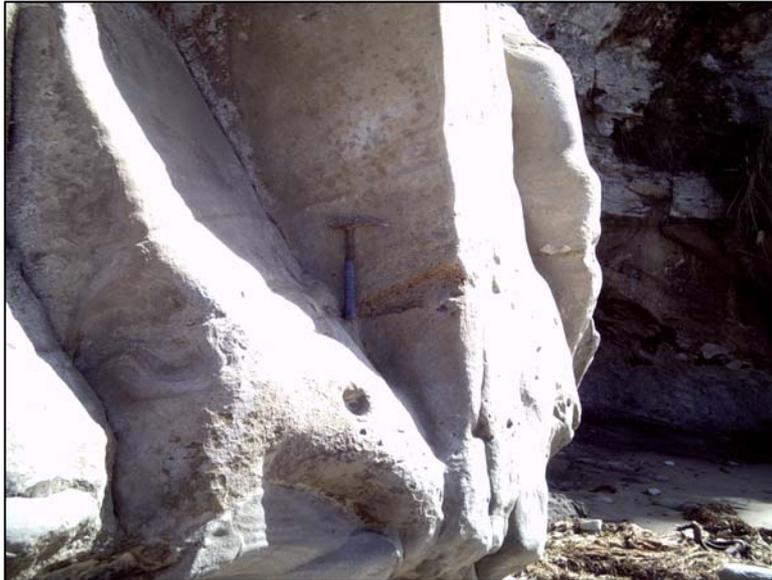
**Figure 4.9** This photo shows a thick tuffaceous sandstone which belongs to the Auroa Formation (Web 1979). The geological hammer in this picture is about 30 cm long.

The sandstone units within the study area are a part of the Auroa Formation (Web 1979). It is composed of tuffaceous sandstone (figure 4.9). The main feature of this rock unit is the presence of lapilli grains. It can be described as light greyish brown in colour. The sorting of the grains ranged moderately sorted to poorly sorted (Gardiner and Dackombe 1983) from mSL (medium sand, lower limit) to mSU (medium sand, upper limit) grains according to the size grade scales of Wentworth (1922). The sediment strength of the sandstone was assessed as “indurated” (coarse-grained sediment, broken only with sharp pick blow), (GSEWP 1977).

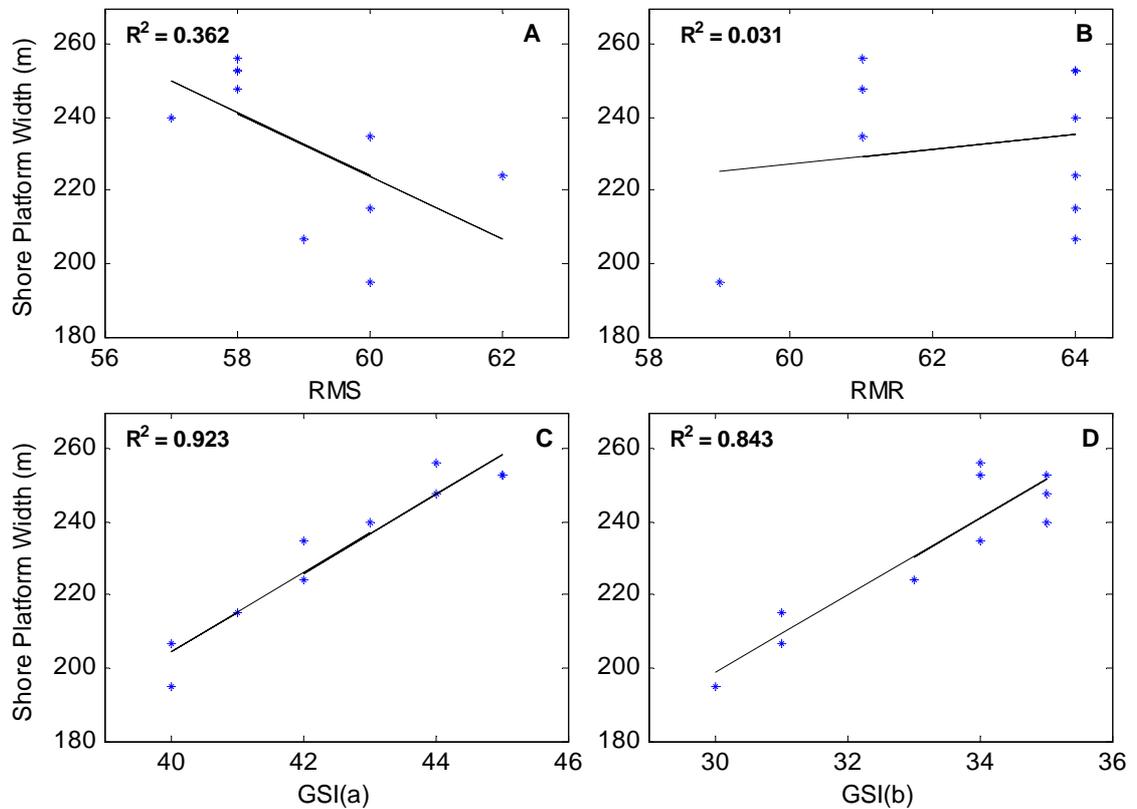
**Figure 5.1** Graphs A - D show different rock mass classification systems plotted against shore platform width for Tatapouri sandstone.

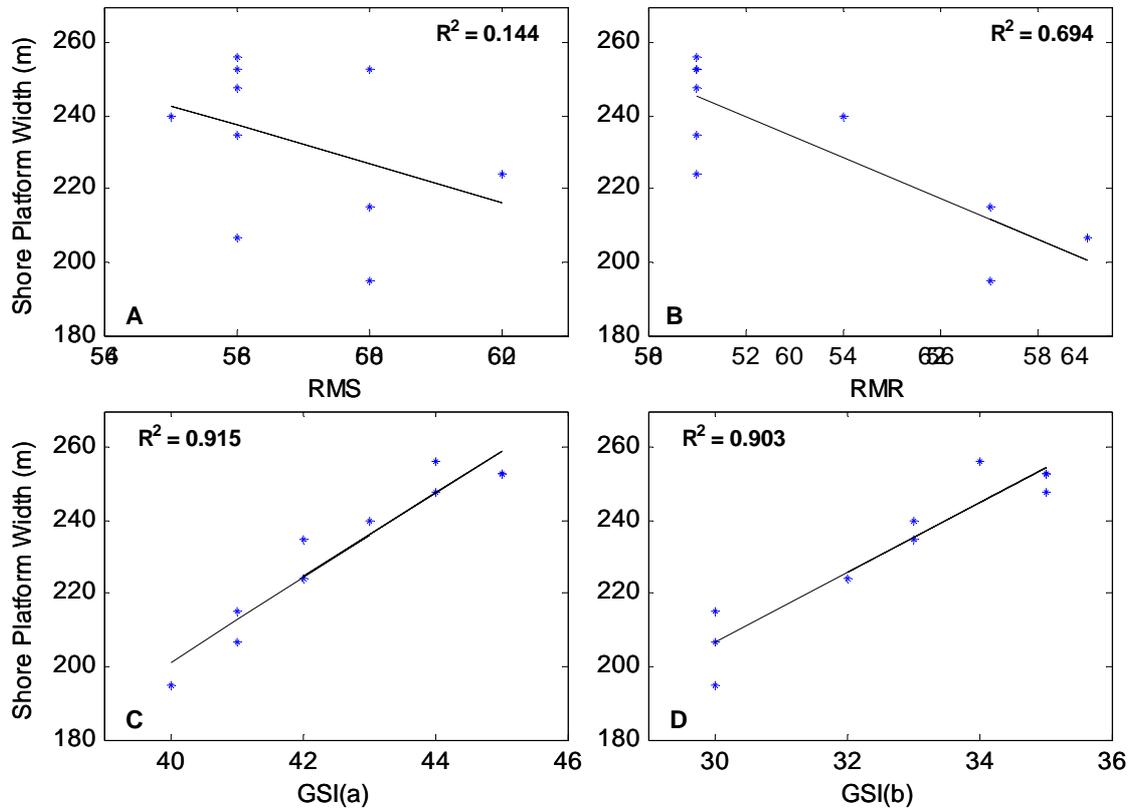
**Figure 5.2** Graphs A - D show different rock mass classification systems plotted against shore platform width for Tatapouri siltstone.

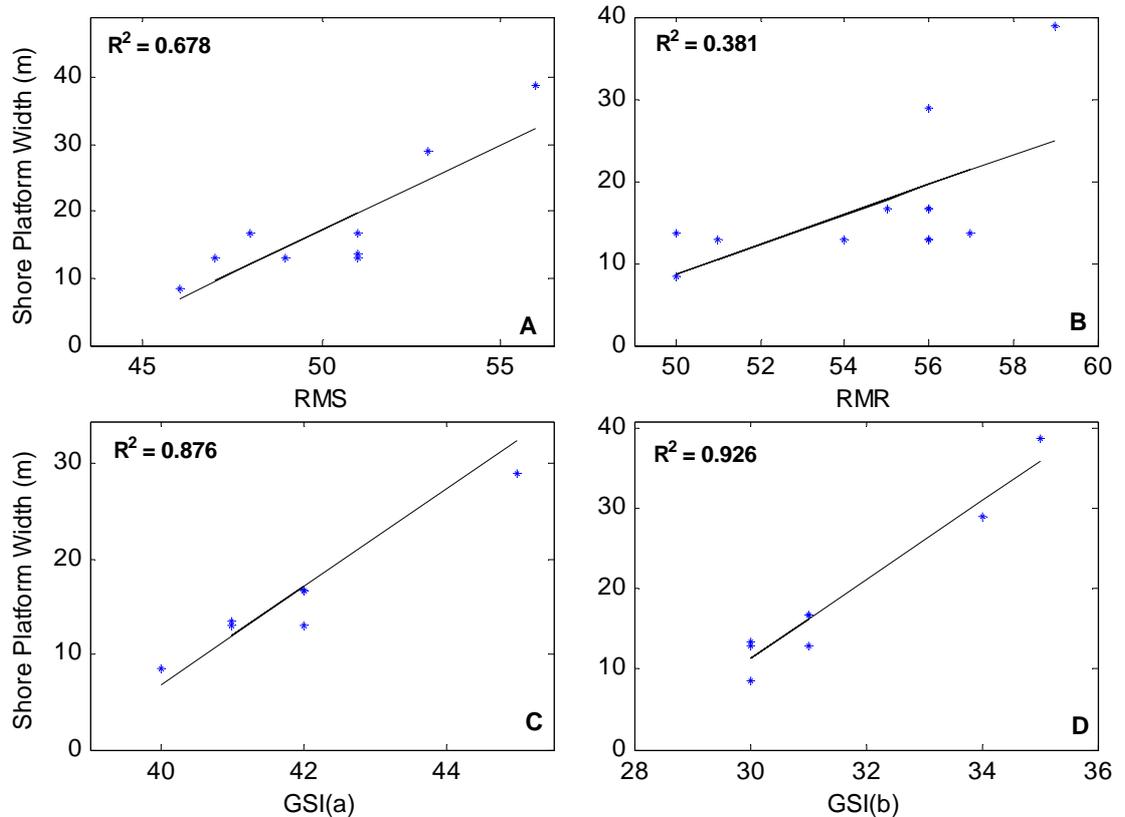
**Figure 5.3** Graphs of rock mass classification vs shore platform width for Mahia Peninsula sandstone.

Figure 5.3 plots rock mass classification versus shore platform width for Mahia Peninsula sandstone graphs. This shows  $R^2$  values from 0.38 for RMR, to 0.93 for GSI (b). All graphs show increases in platform width with increased rock mass strength. Graphs C & D show that the GSI (a) and GSI (b) classification system seem to produce better  $R^2$  results than RMS & RMR.

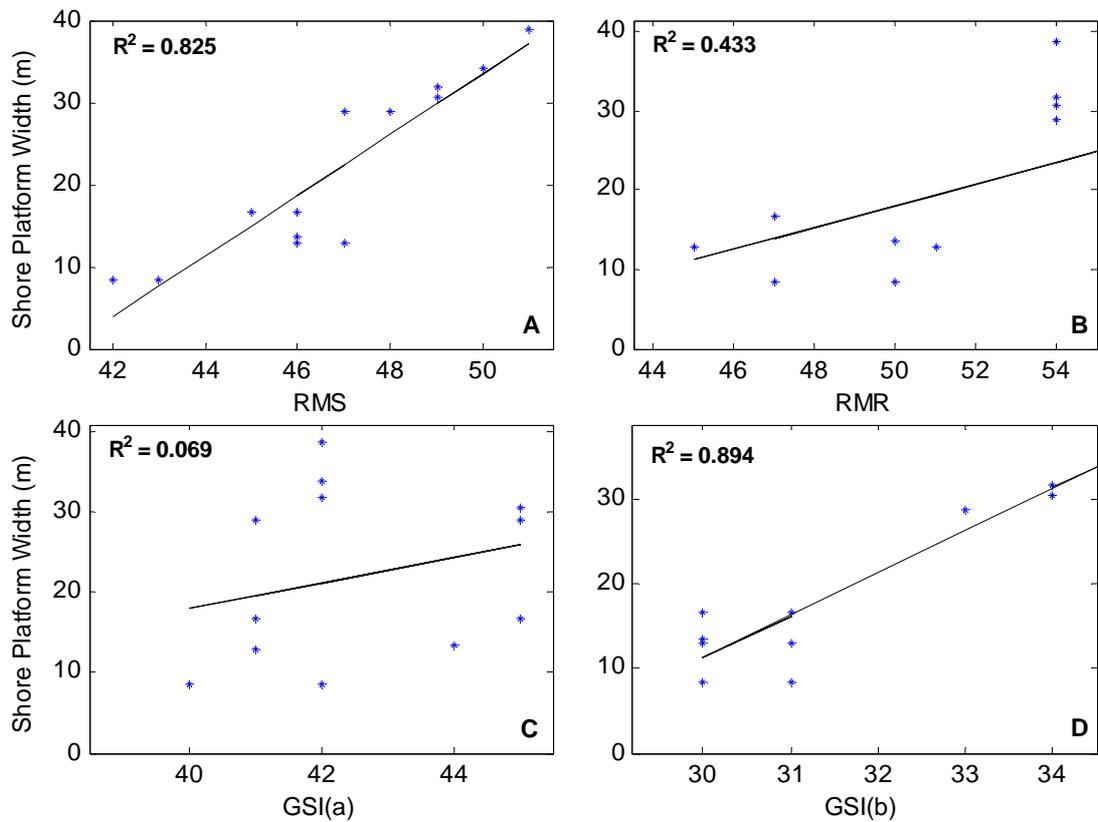
**Figure 5.4** The graphs above for Mahia siltstone shows a low R-square results for GSI (a) and RMR while over all good results for GSI (b) and RMS.

Figure 5.4 plots rock mass classification versus shore platform width for Mahia Peninsula siltstone graphs. This shows  $R^2$  values from 0.06 for GSI (a), to 0.89 for GSI (b). The graphs for Mahia Peninsula siltstone show similar trends as for the sandstone, that is, as RMS, RMR, GSI (a) and GSI (b) increase; so too does the width of shore platform. However, the GSI (a) shows a very poor relationship.

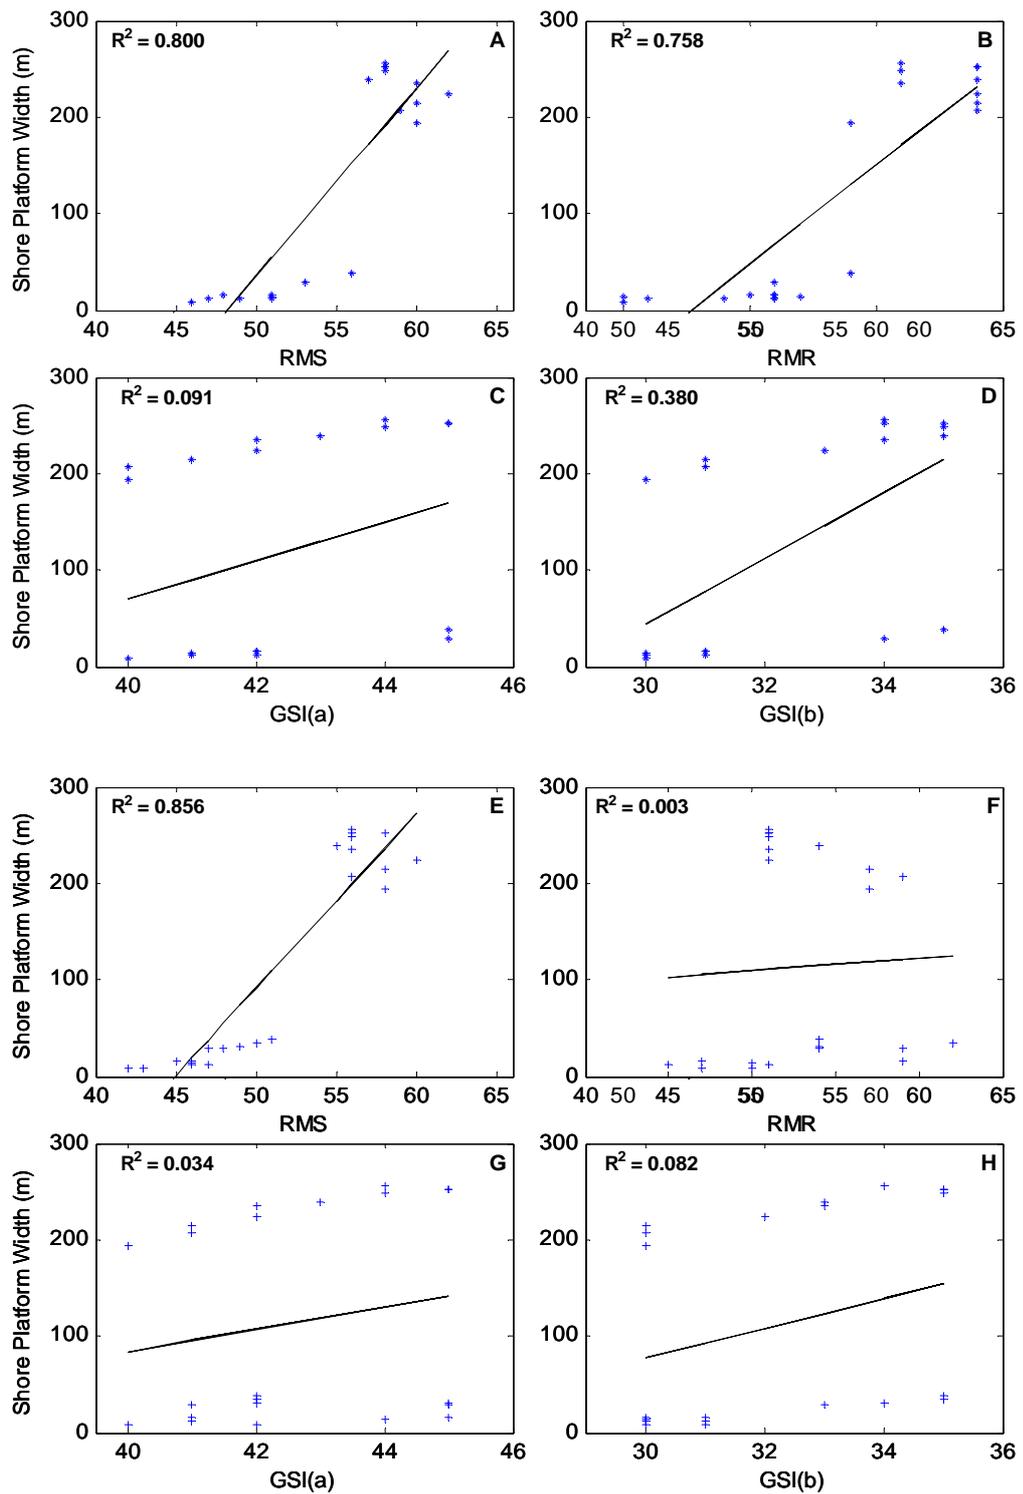
**Figure 5.5** Graphs of rock mass classification vs shore platform width Graphs A – D are results for Tatapouri and Mahia Peninsula sandstone. Graphs E – H are results for Tatapouri and Mahia Peninsula siltstone.

Figure 5.5 shows Tatapouri and Mahia Peninsula sandstone (graph A - D) & siltstone (graph E- H) are plotted together.

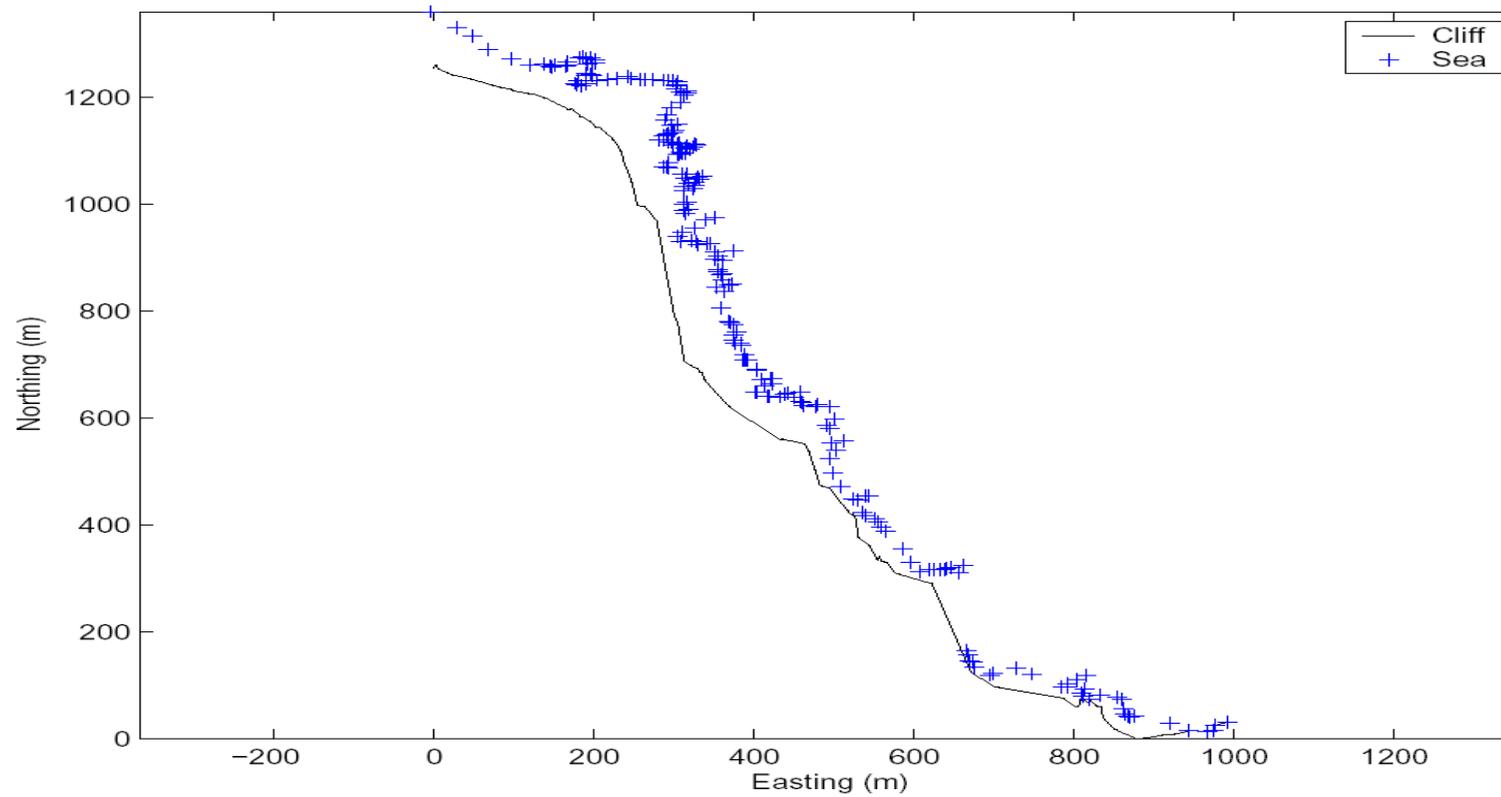
**Figure 5.7** GPS data showing the location of the cliff base at Mahia Peninsula, represented by the black line, and the width of the shore platform edge, represented by the blue crosses.
