# **SHORE PLATFORM OBSERVATION AT TATAPOURI AND MAHIA PENINSULA, NEW ZEALAND**

A thesis  
submitted in partial fulfillment  
of the requirements for the degree  
of  
Master of Science  
in Earth Sciences  
at  
The University of Waikato  
by

**Murray Te Aho**

**2007**

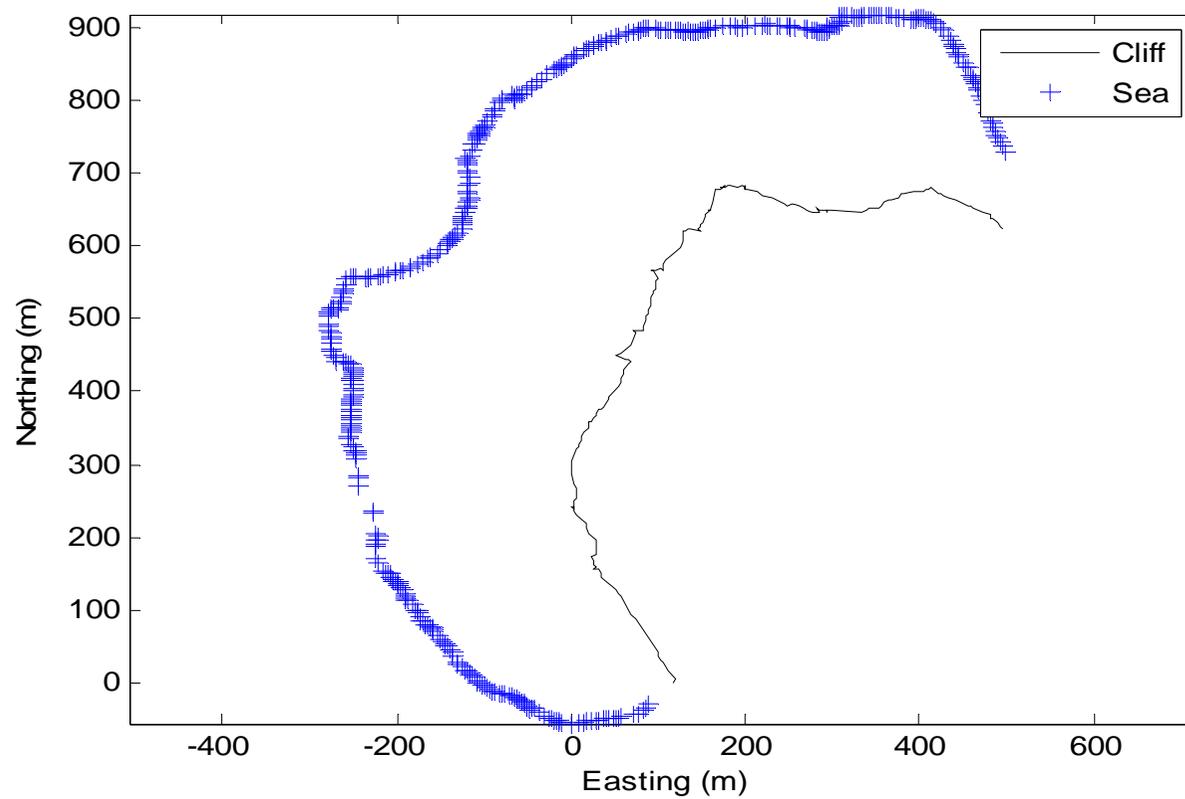
**Figure 5.8** GPS data showing the location of the cliff base at Tatapouri, represented by the black line, and the width of the shore platform edge, represented by the blue crosses.

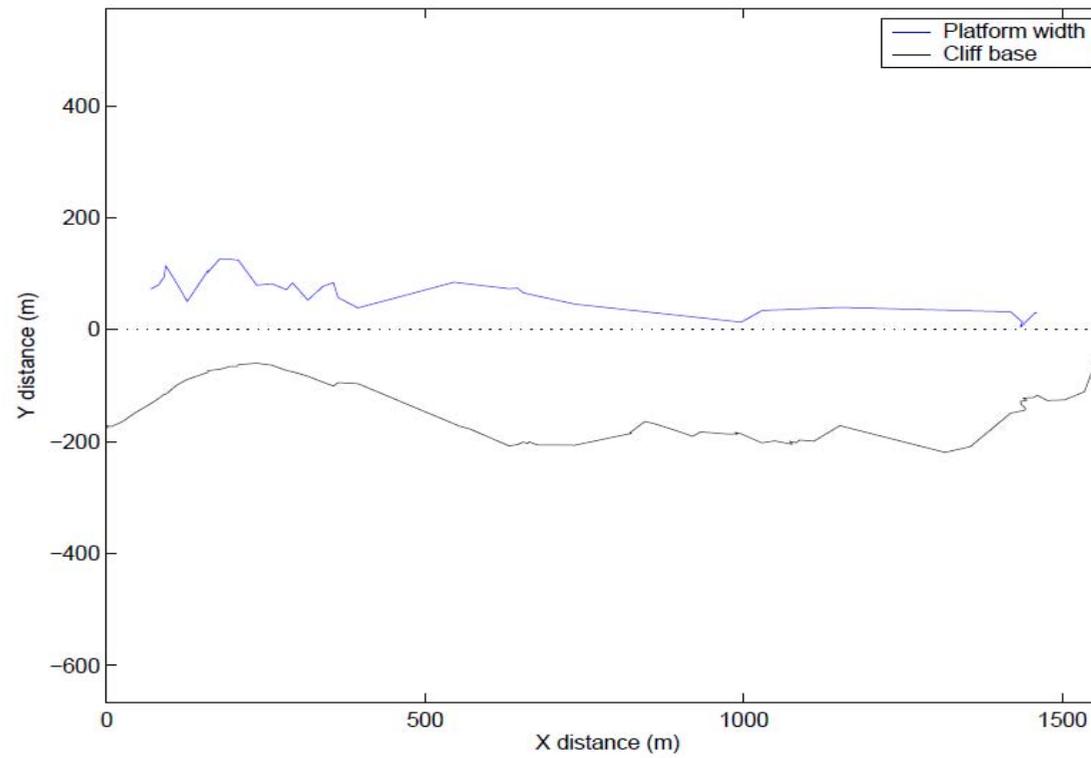
**Figure 5.9** Transformed data showing platform width compared to the base of the cliff for Mahia Peninsula.

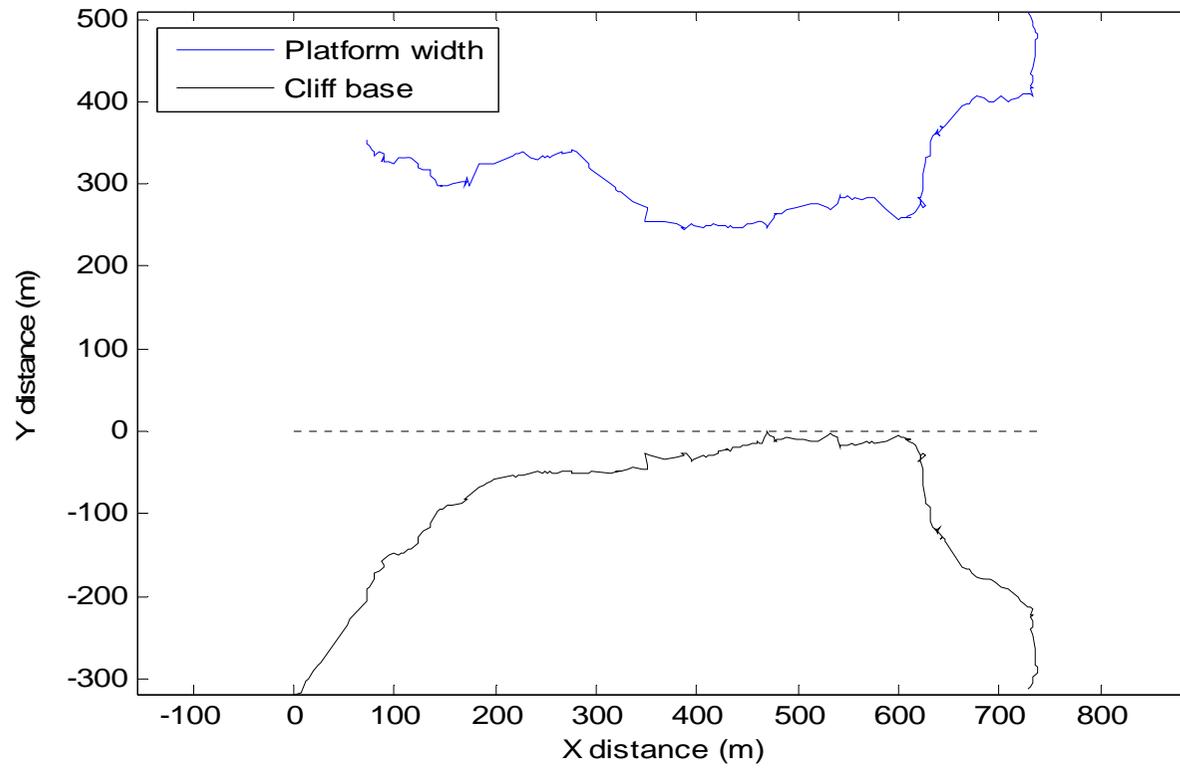
**Figure 5.10** Transformed data showing platform width compared to the base of the cliff for Tatapouri.

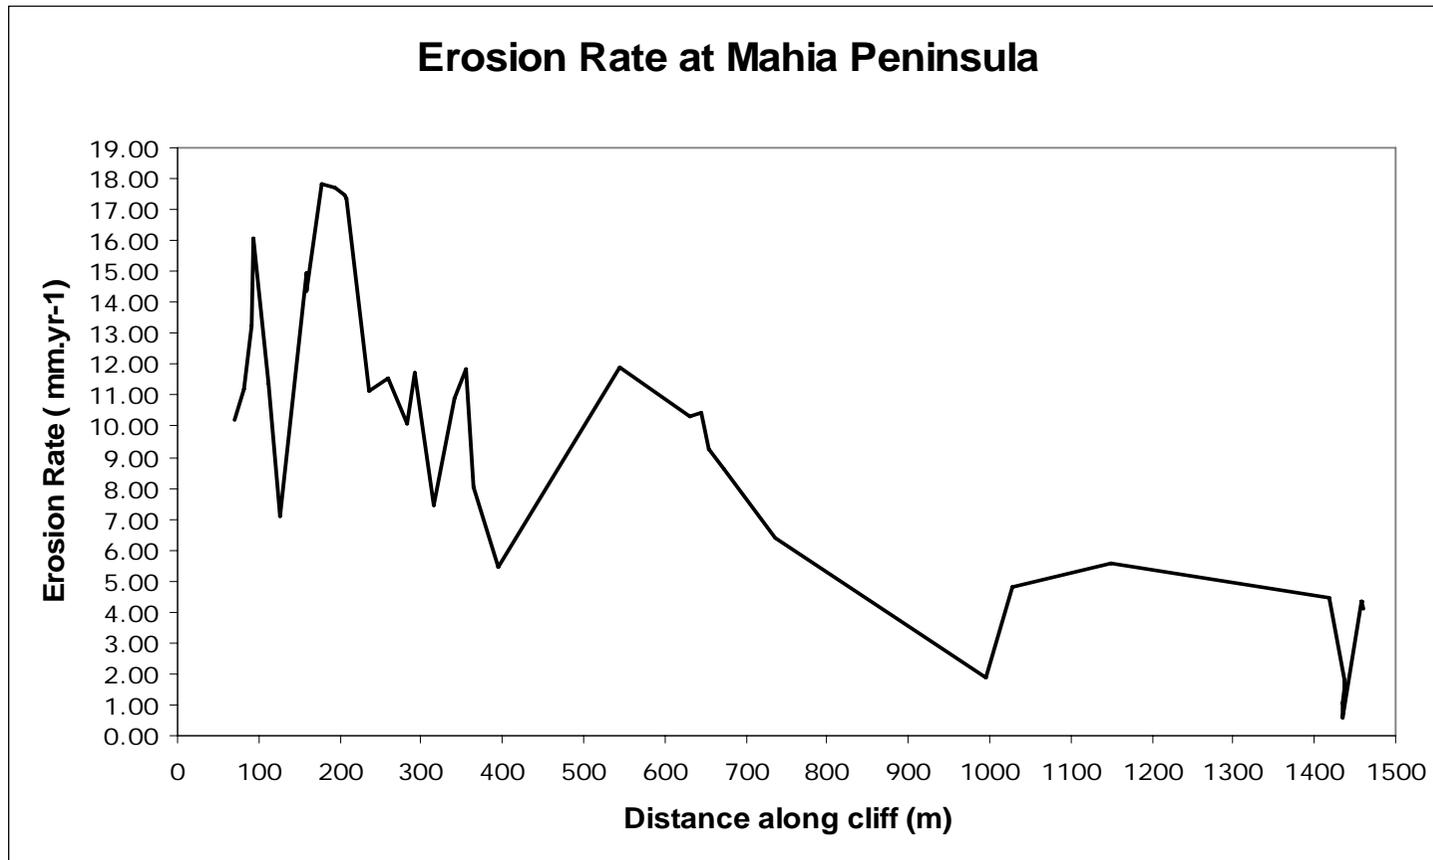
**Figure 5.11** Transformed data from Easting and Northing to erosion rates versus distance along the cliff at Mahia Peninsula.

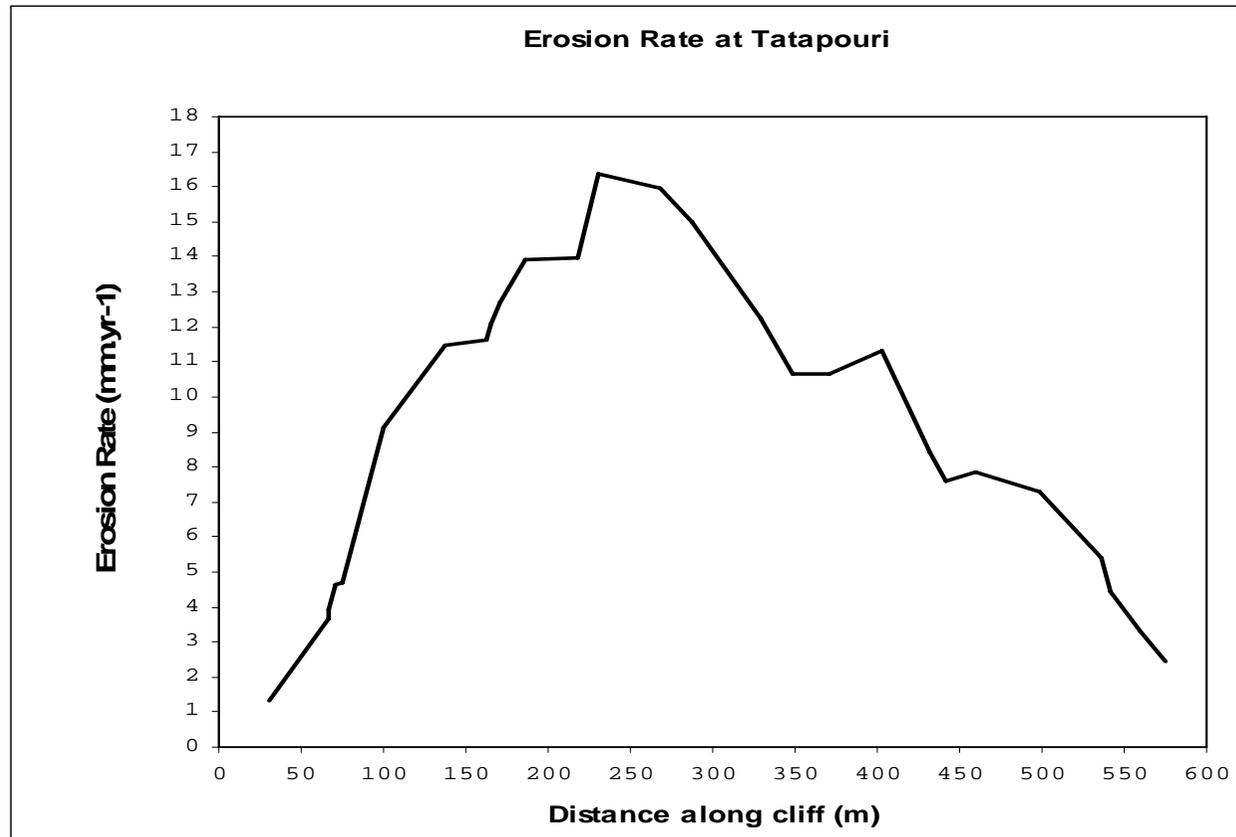
**Figure 5.12** Transformed data from Easting and Northing to erosion rates versus distance along the cliff at Tatapouri.

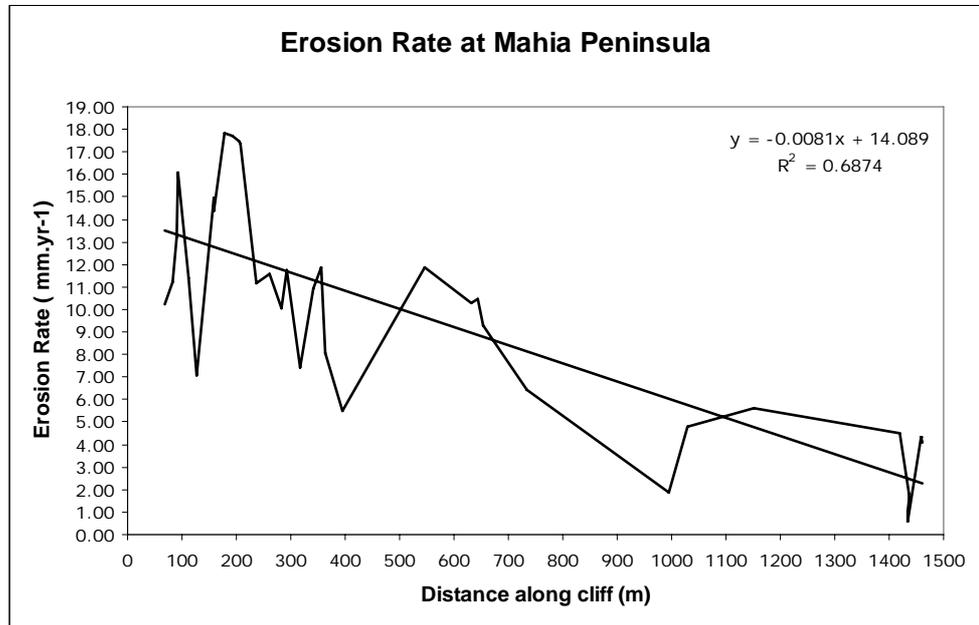
Graph A show erosion rate at Mahia Peninsula

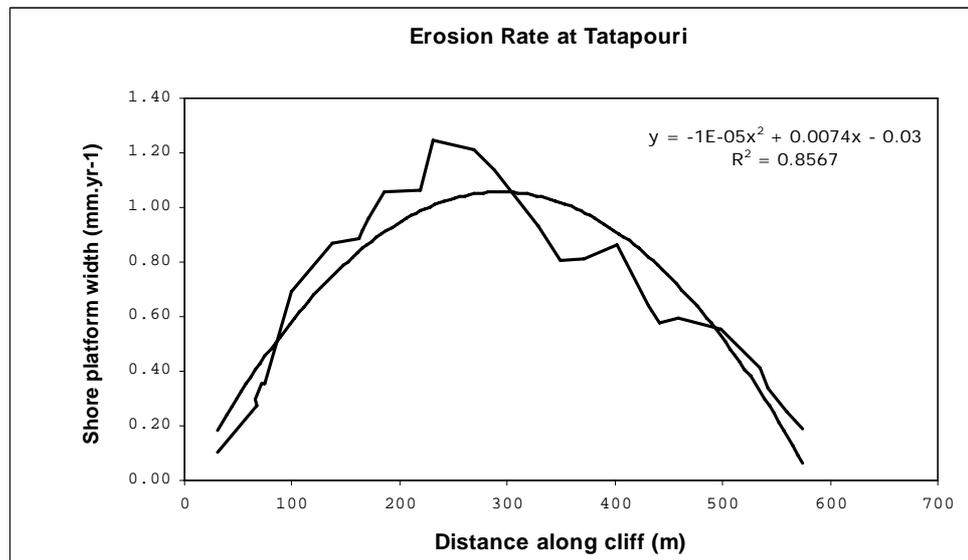
Graph B show erosion rate at Tatapouri
