Exclusion and Removal of Pest Fish from Lake Ohinewai – Fact Sheet

Linking lake restoration with end users for positive environmental outcomes

Lake Ohinewai

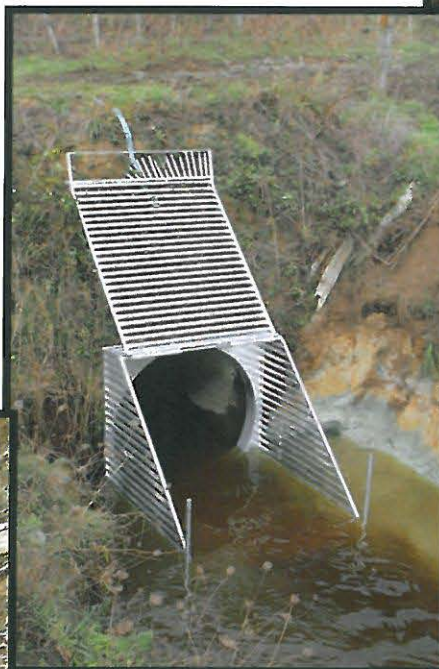
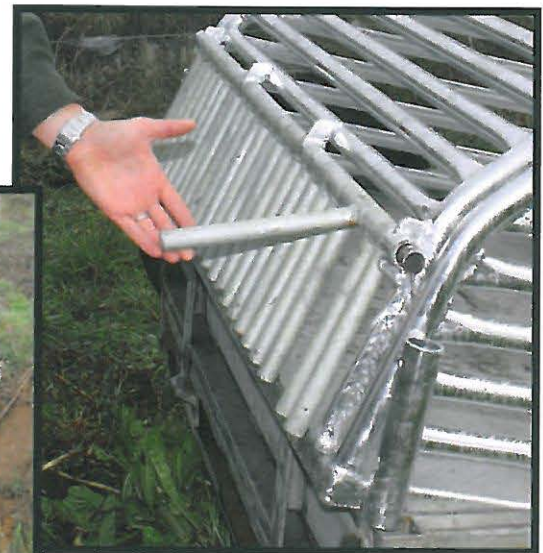
Figure 1. Pest fish exclusion barrier installed on the Lake Ohinewai outlet. The barrier is designed to allow one-way passage of pest fish species out of the lake. Photos: Adam Daniel

A one-way barrier was installed across the outlet allowing fish within the lake to exit, but preventing adult fish from entering (Figure 1). The barrier did not prevent juvenile fish from entering the lake, but it was hoped that exclusion of adult koi carp would reduce disturbance of the lake bed and assist recovery of the lake.

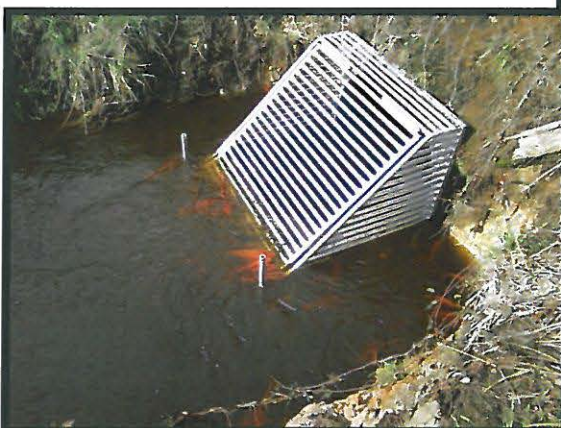
Installation of the one-way barrier and associated fish removal efforts from Lake Ohinewai have reduced the koi carp population from an estimated 373.6 kg/ha in January 2011 to 10.4 kg/ha in December 2014, a 97% reduction in koi carp biomass.

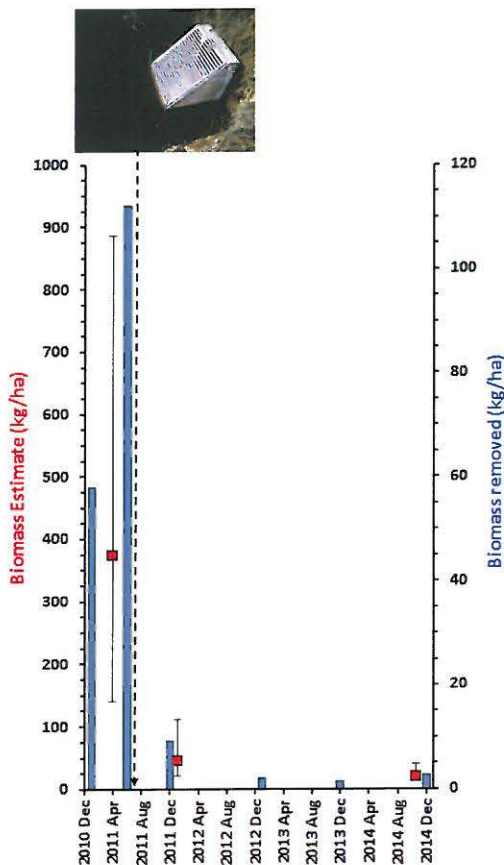
Figure 2. Pest fish (koi carp, catfish, goldfish) biomass estimates (red squares \pm 95% CI) and removals (blue bars) from Lake Ohinewai. The one-way barrier was installed on the lake outlet in mid-2011.

A total of 3494 kg of pest fish was removed from Lake Ohinewai, including 3003 kg of koi carp, 233 kg of catfish and 257 kg of goldfish. Pest fish removals were undertaken on six occasions between December 2010 and December 2014. In addition, mark-recapture programmes were conducted on three occasions in order to estimate the remaining biomass (Figure 2). Removal methods used included boat electrofishing, fyke netting, automated feeder-traps and beach seining.

The single largest factor responsible for the decline in the koi carp population appears to be the installation of the one-barrier on the Lake Ohinewai outlet. An estimated 208.6 kg/ha (55.8%) of koi carp were removed by this passive method in a six month period.
