Session Two : The Issues

WEEDS AND THE ROTORUA LAKES

Dr John Clayton

Principal Scientist - Freshwater Ecology, NIWA, Hamilton
John.Clayton@niwa.co.nz

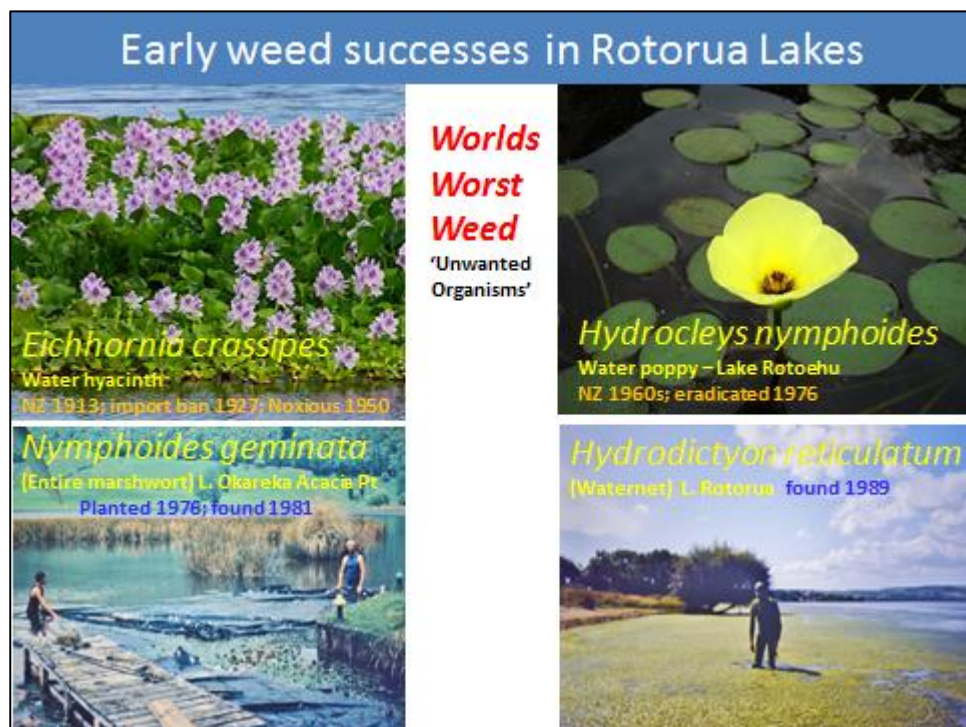
Slide 4

Several great successes in the Rotorua Lakes area are worth noting. (**Slide 4**) Water hyacinth was first identified in New Zealand in 1913, but its potential impact on waterbodies was recognised, so it was banned from import in 1927 and declared a noxious weed in 1950. At this time water hyacinth was already spreading and forming floating rafts on Lake Rotorua, but fortunately early control works enabled eradication.

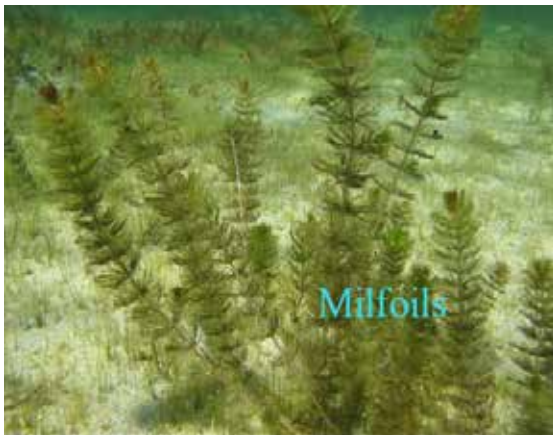
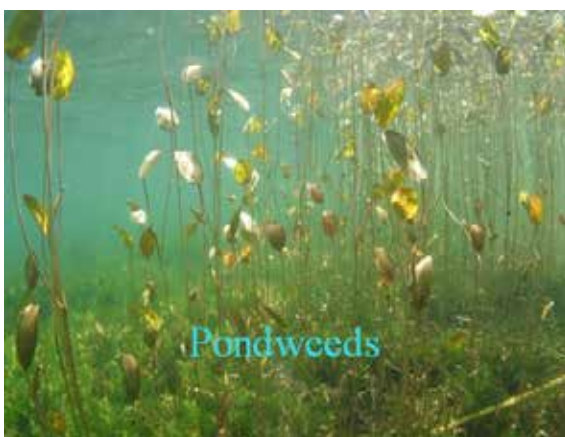
Slides 5, 6 and 7

In shallower water, native milfoils and pondweeds (**Slides 4-6**) are common. In deeper waters (**Slide 7**) charophytes (comprised of several *Chara* and *Nitella* species) can form undulating carpets down to 15 metres; and in some clear South Island

lakes they can reach 30-40 metres. There are many different species of *Chara* and *Nitella*.

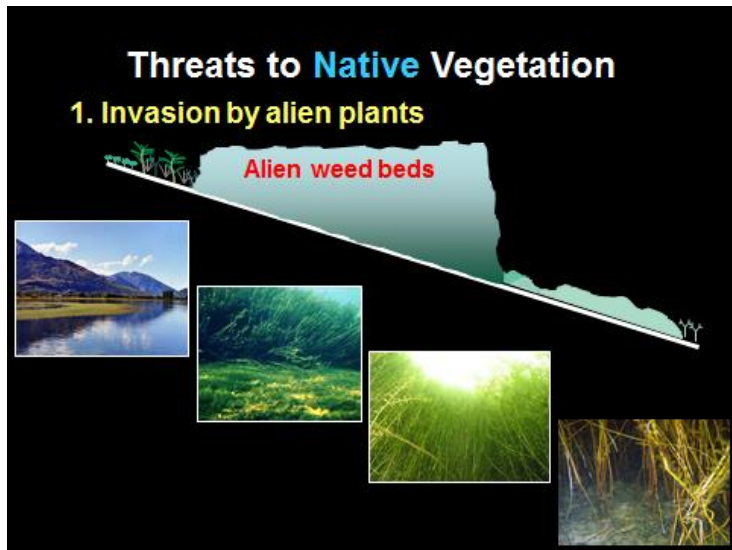
Slide 8

Alien plants are a major threat to native vegetation. **Slide 8** shows what can happen when alien plants invade and displace the native plants. Generally native plants may survive in shallow water where wave action or fluctuating water levels create a disturbance zone. Likewise, if the water is clear, native plants can still occupy the deep water zone.

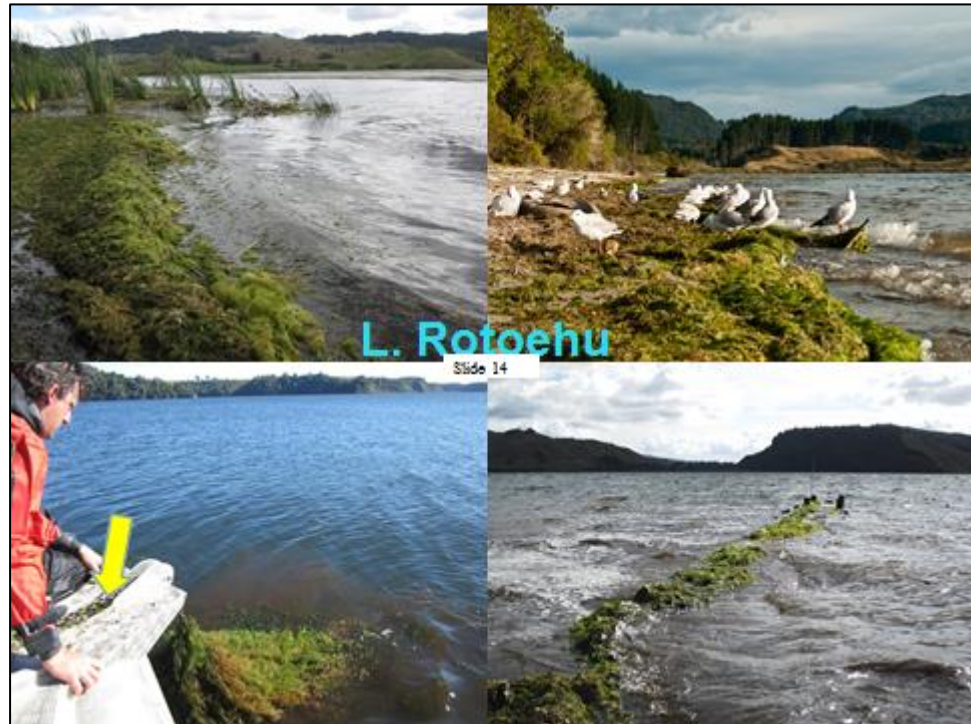
Slide 16 shows the extent of hornwort drift around the Lake Rotoehu shoreline; while the photo at bottom left (Hamish Lass from Bay of Plenty Regional Council) shows how easily hornwort can be spread by a boat anchor. Clearly, it is very difficult not to spread weed. Although 'Check, Clean and Dry' messages are widely displayed, it is obvious how easy it is for this weed to be spread.

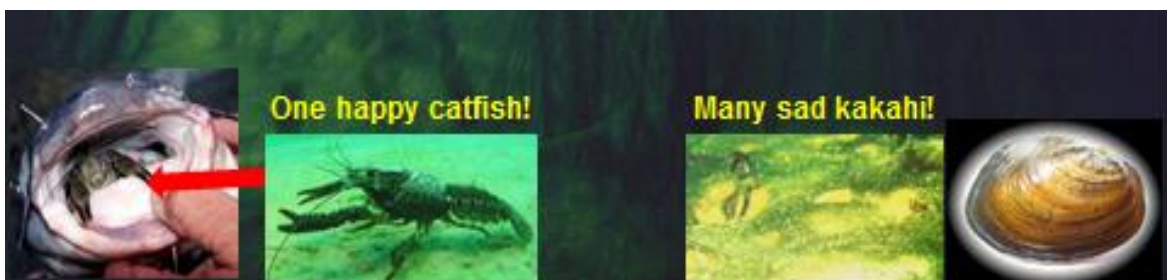
Slide 17 is a picture taken in Lake Rotokakahi where organic matter has built up. Some mussels are visible at the surface, but many are partially 'buried', struggling to keep their

siphons open as they slowly sink into sediment. Crayfish mostly avoid weed beds growing on soft organic sediment. If catfish become established in these lakes; it will be the cat fish mouths that any remaining koura will end up (Slide 20 – bottom left).

Another problem is the reduction in animal biodiversity. Dense weed beds are often associated with low oxygen levels and pH can fluctuate wildly from photosynthesis. Furthermore, organic accumulation often leads to low density sediments beneath invasive weeds that can impede or prevent kakahi and koura survival. As sediment becomes more organic, kakahi sink below the sediment surface and drown in the soft silt.

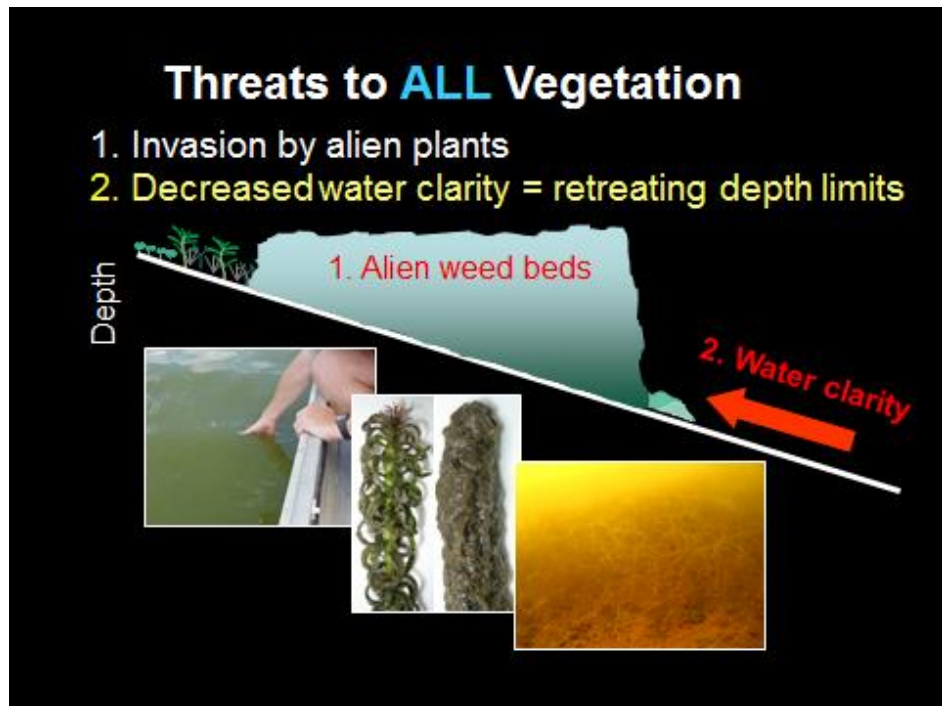
Slide 18

As nutrients increase there tends to be more algae suspended in the water and detritus also accumulates on plant surfaces thereby reducing plant health. Declining water clarity also decreases the depth that submerged plants can grow. **(Slide 18)**

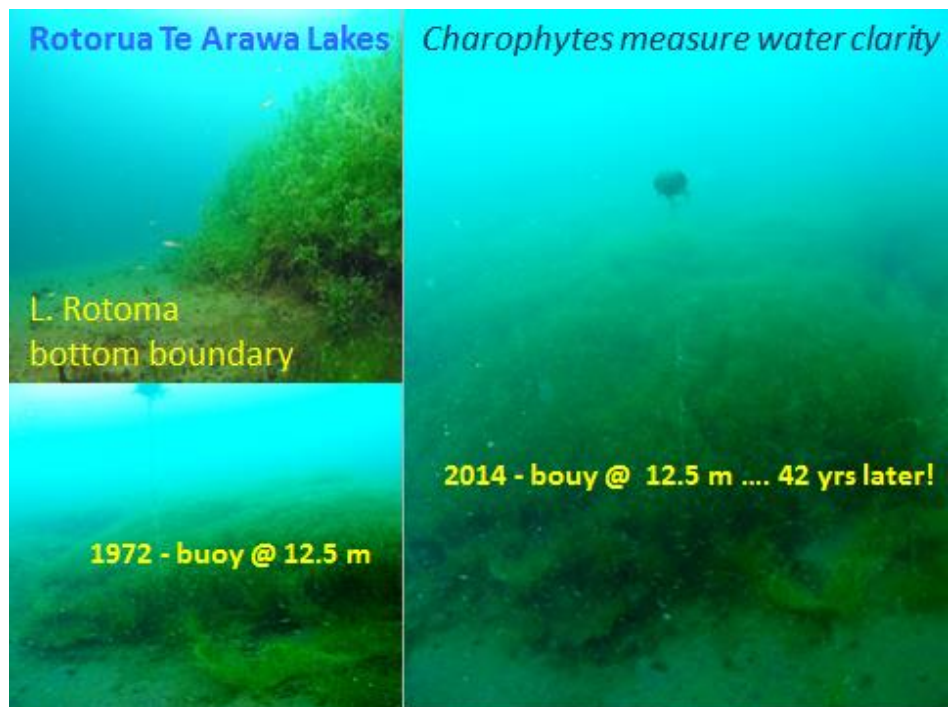
Slide 19

Lake Rotoma is a good example of a clear lake. It has some well-formed deep charophyte boundaries **(Slide 19)**. Charophyte bottom depth boundaries represent an annually

integrated light limiting compensation point for sustainable plant growth. These boundaries can be used to measure changes in water clarity or lake level. In 1972, I placed a submersed float on a nylon line attached to a brick. Periodic inspections up to 2014 have demonstrated that over a 42 year period that bottom boundary has been stable, which therefore supports a relatively consistent water clarity. Lake Rotoma has had periods of lake level fluctuation and during these times the bottom plant boundary has responded proportionally, but with a notable lag phase.

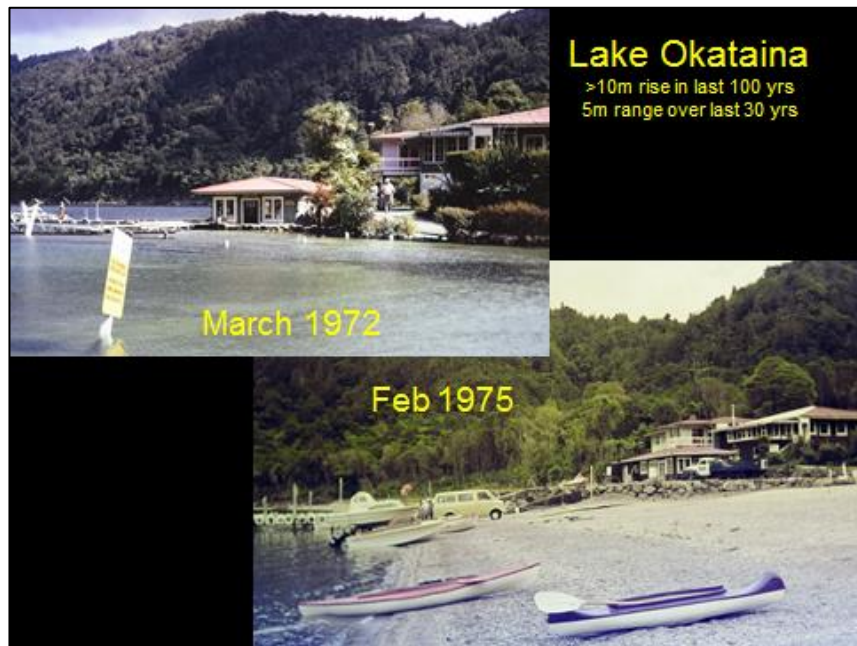
Slide 20

Lake Okataina is the best example of a lake with no outlet. As a consequence the lake level rises and falls in direct proportion to rainfall. During an earthquake the lake level has also been known to drop. **Slide 20** shows a 5 metre water level fluctuation over a 3 year period. The lake level reached up to the store windowsills in 1972, dropping 5 metres over the next 3 years.

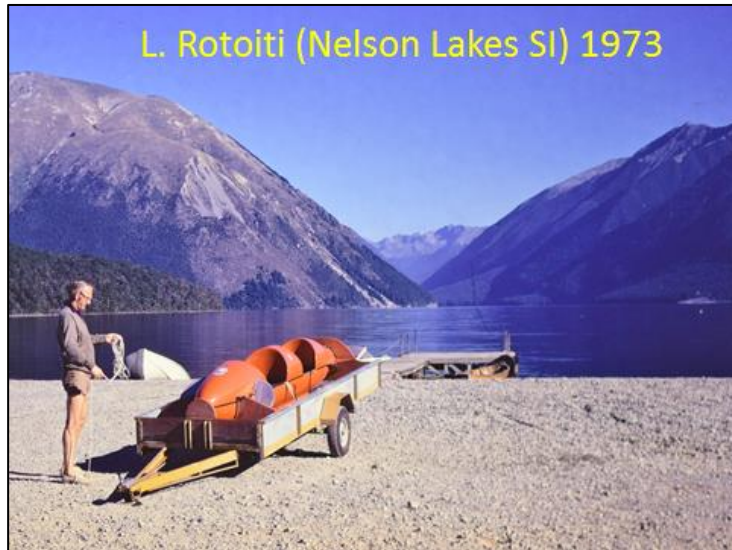
Slide 22 shows the use of a two man underwater submarine, which the Auckland University bought in 1973. We surveyed the underwater vegetation in Lakes Rotoiti & Rotoroa in the Nelson Lakes National Park and several of the Rotorua Te Arawa Lakes.

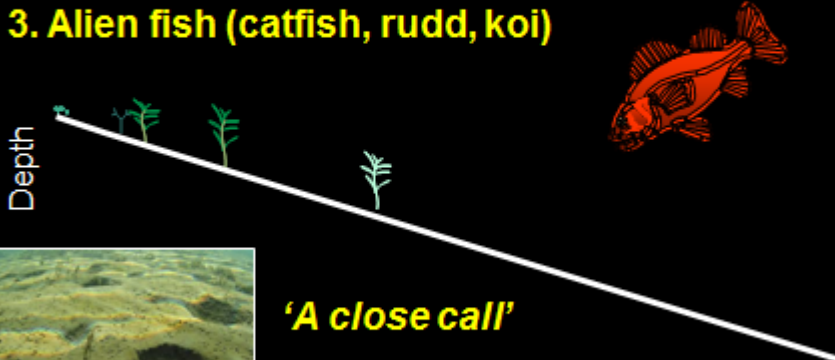
Slide 24 (over) returns to the threat of alien fish. There has already been one close call in Lake Rotoiti when in 2003 I found several 'craters' scalloped into Te Weta Bay sediments (see Slide 24 – 'L Taupo craters', caused by catfish). The University of Waikato was notified and they attempted electrofishing, but unfortunately this was not successful. However, 7 years later there was a dead catfish washed up in Okawa Bay. Luckily that

'Craters' – Te Weta Bay, L. Rotoiti (Sept 2003)
Electrofishing 2004 – none found
Catfish (dead) 7 yrs old – Okawa Bay (Jan 2009)
Otolith analyses indicated - Waikato origin

catfish was a male. It may well have been a very different outcome if this had been a fertile female! It is almost inevitable that sooner or later catfish will establish in the Rotorua Lakes, but we must do everything possible to prevent them establishing and this applies to other alien biota too.
