# Faulting within the Hamilton Basin: Recent Progress

Dr Vicki Moon (*PEngGeol*), Dr Willem de Lange

# Introduction

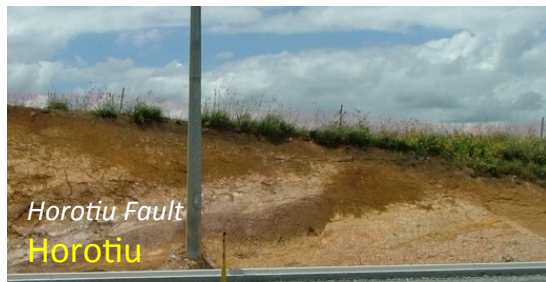
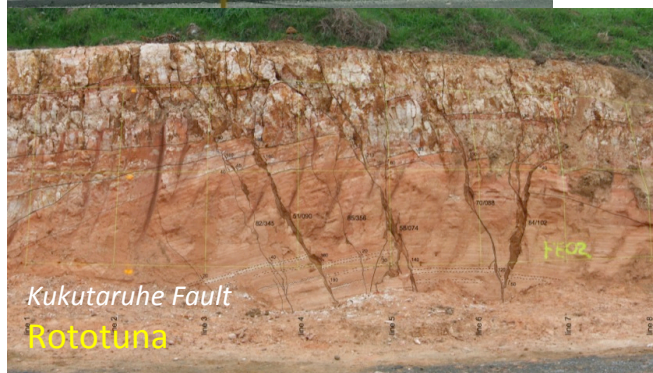
2015 – 5 known & potential fault zones

1. Taupiri Fault
2. Horotiu Fault
3. Kukutaruhe Fault
4. Te Kourahi Fault
5. Te Tatua O Wairere Fault

- Geothermal systems
- Basement outcrop

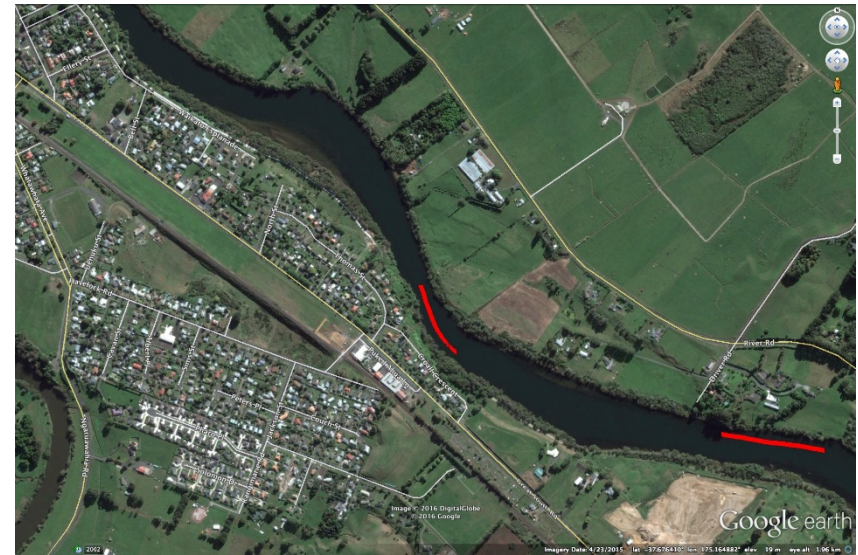
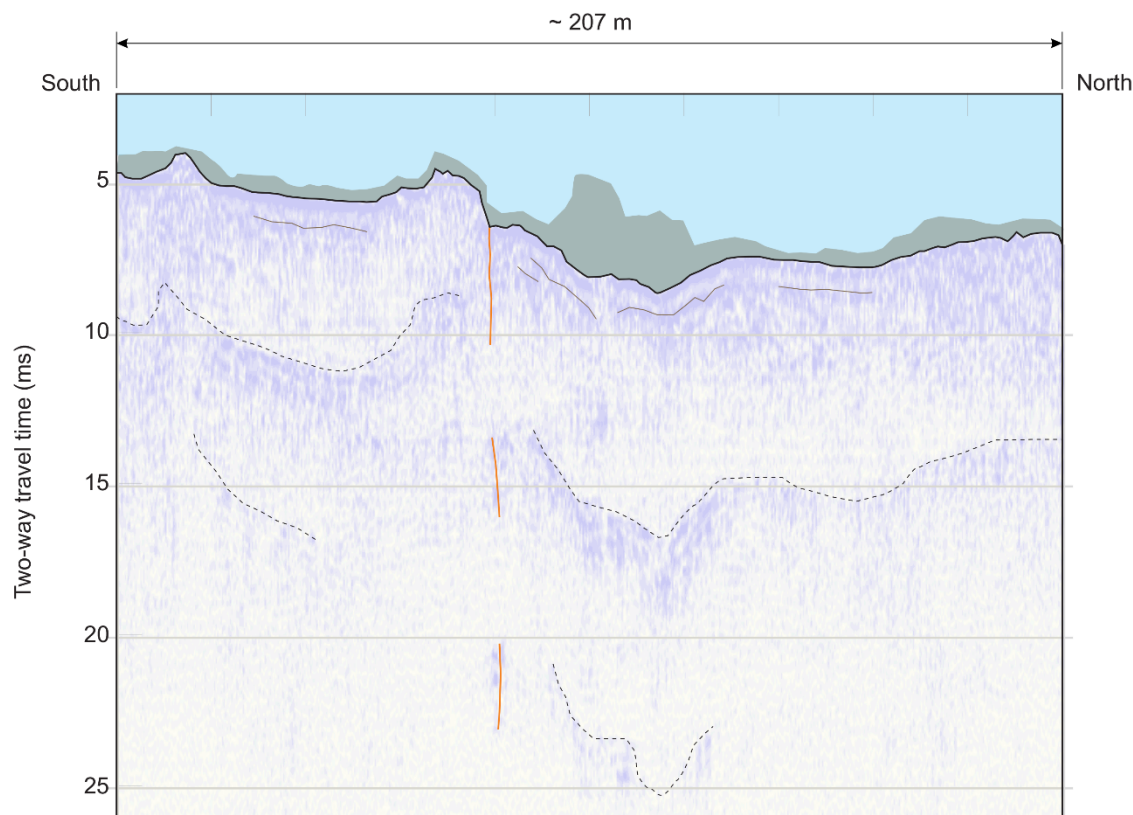
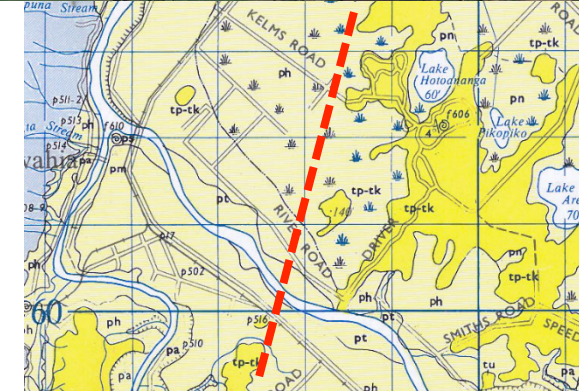
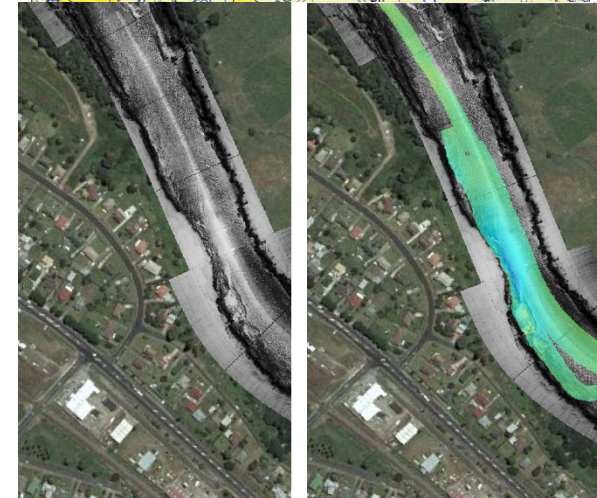
# Taupiri Fault

- Known major boundary fault zone flanking Hakirimata Ranges
- We hoped to find a fault at this location if CHIRP methodology worked

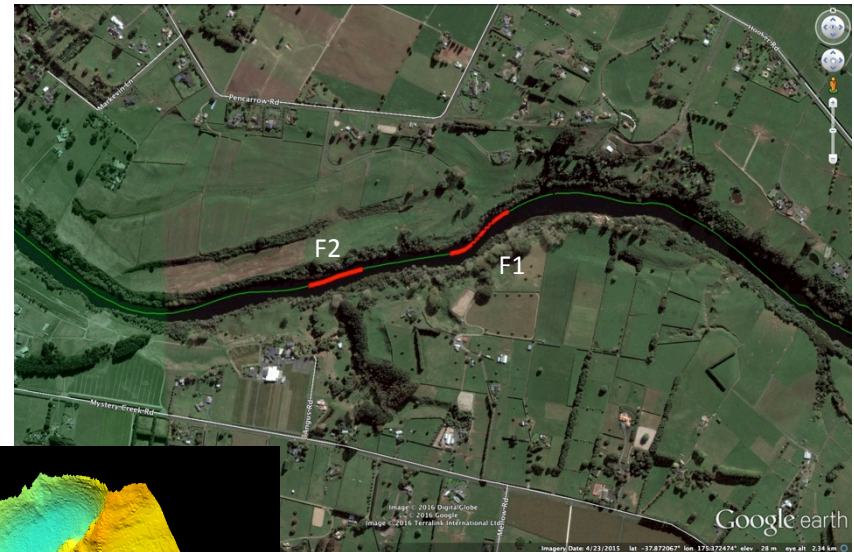
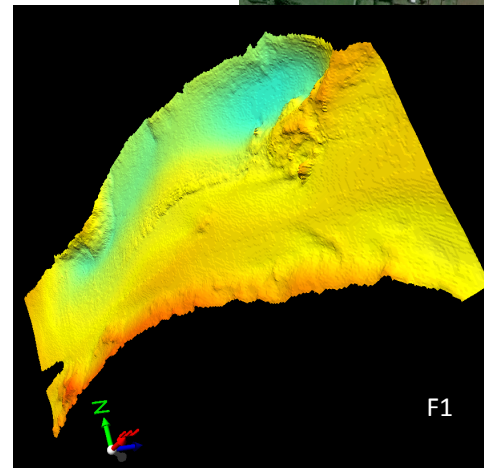
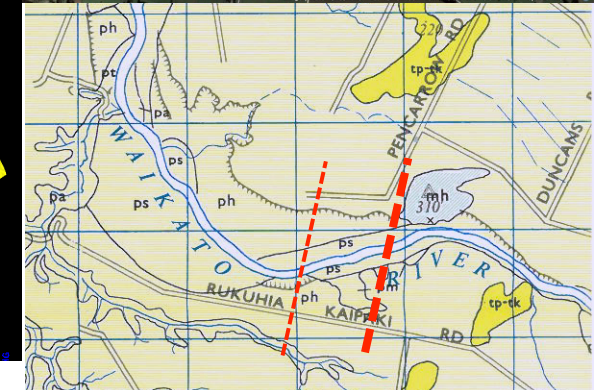
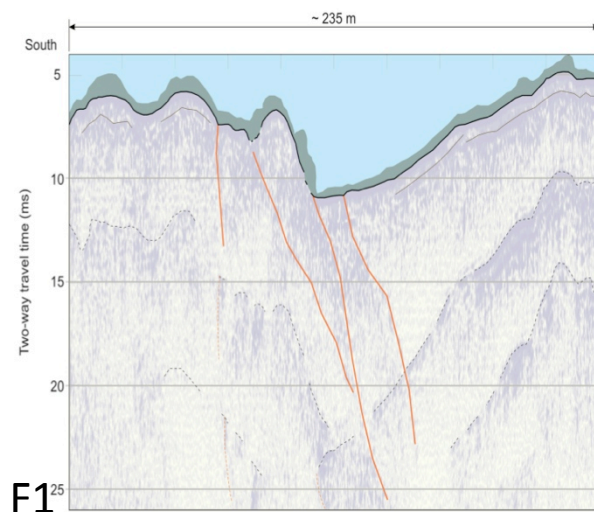
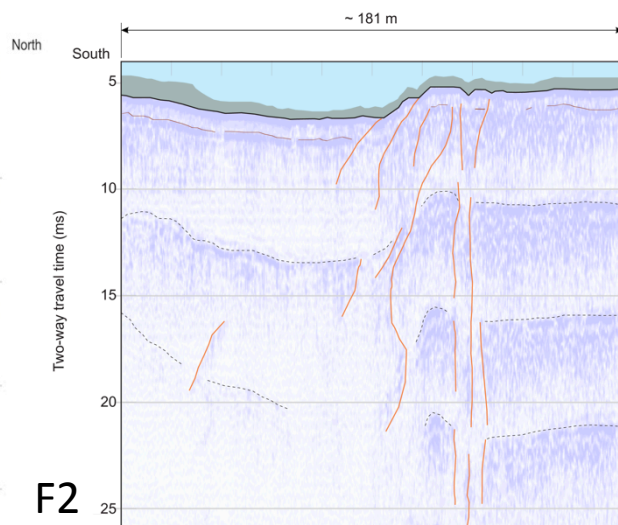
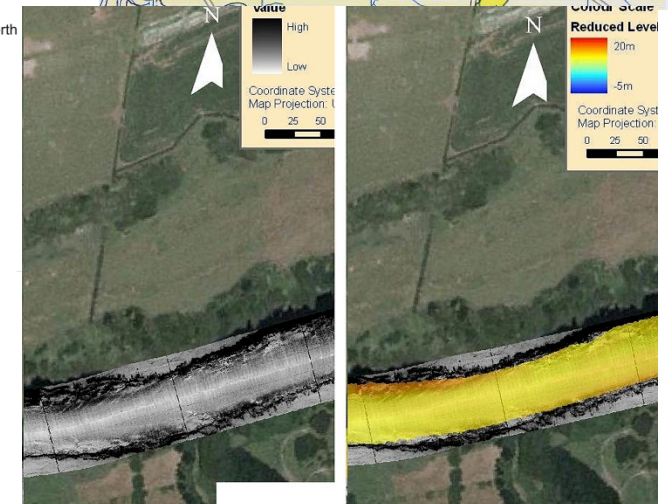
# Mystery Creek

- Outcrop of basement greywacke suggested possible faulting
- CHIRP located 2 faults downstream of greywacke
- MBES data revealed “Scour hole” & rock outcrop in river bed

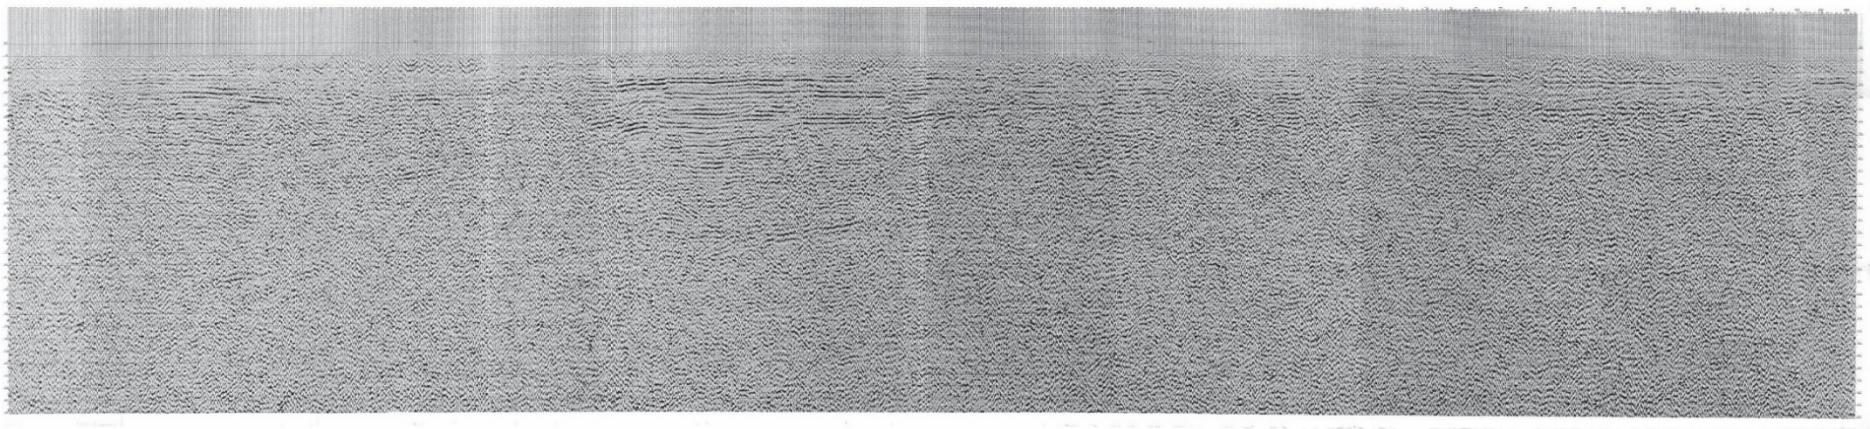
## Line 2 - original

- These lines are available as high-resolution tiff images of original data.
- They are not high-quality processed files.

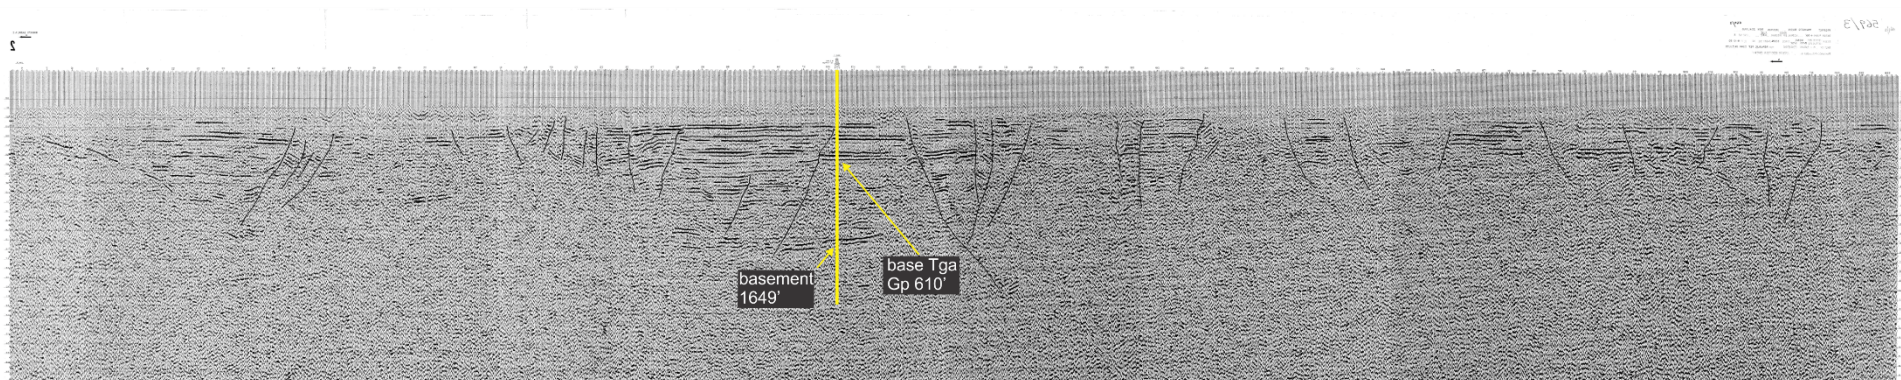
# Line 2 - interpreted

- These lines are available as high-resolution tiff images of original data.
- They are not give high-quality processed files.
- However, if you stare at them long enough can interpret structure.
- Have a borehole that allows calibration of two key levels:
  - bottom of Tauranga Group sediments
  - top of basement greywacke

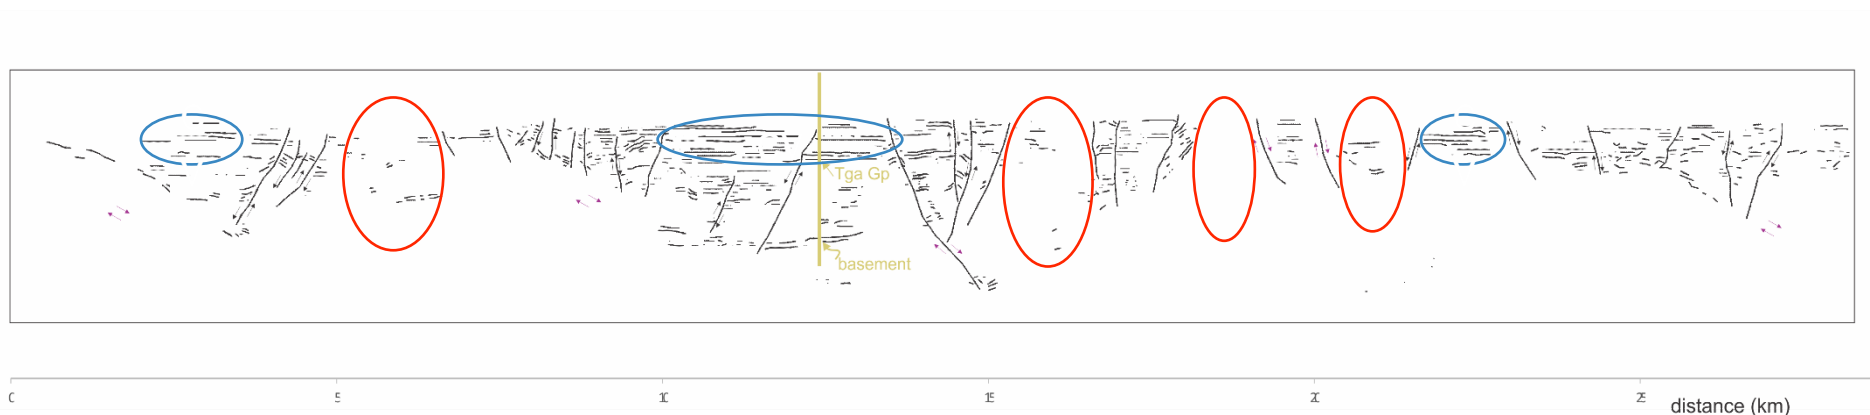
# Line 2 - interpreted

- The Tauranga Group shows as flat-lying basin infill in many areas, but is horribly distorted in others.
- There are big chunks where cannot see much as traces unreadable.
- Can see:
  - numerous steeply-dipping normal faults
  - two different orientations

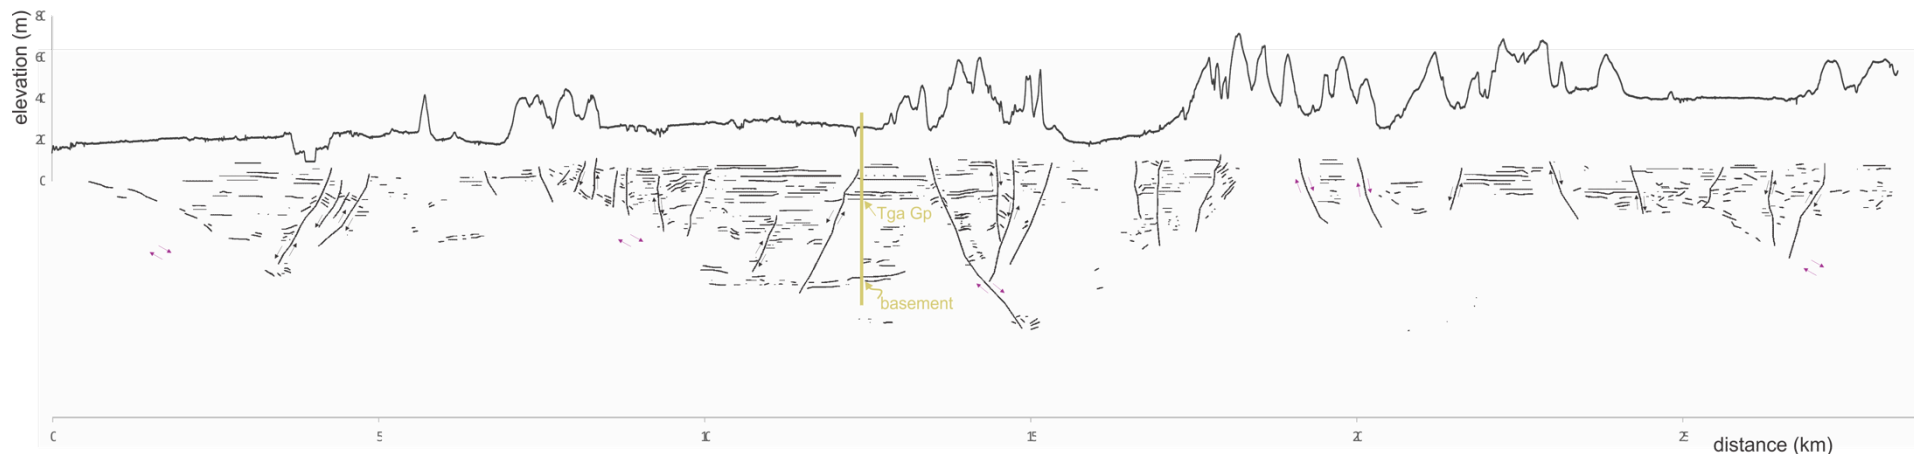
# Line 2 - interpreted

- Ground surface profile aligned on top:
  - note considerably greater vertical exaggeration
- See considerable agreement between faults and surface geomorphology:
  - faults coincide with hills
  - river nestles against faulted zone
  - even many small lumps and bumps in surface reflect underlying faults

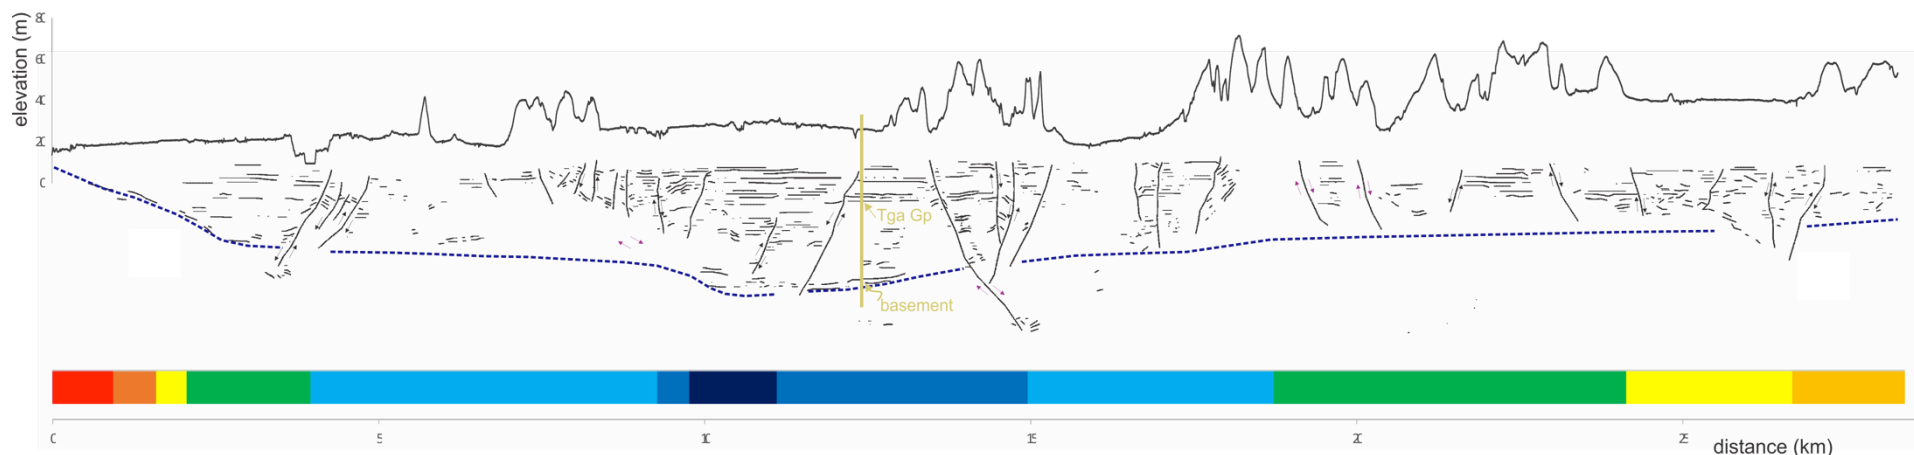
# Line 2 - interpreted

- Adding in gravity (colour band) allows rough basement profile to be extended from identifiable points.
  - basement dips down from north to deepest point below north Hamilton
  - rises steadily towards south (about  $3^\circ$ ) slope
  - thin or non-existent Tertiary rocks to south

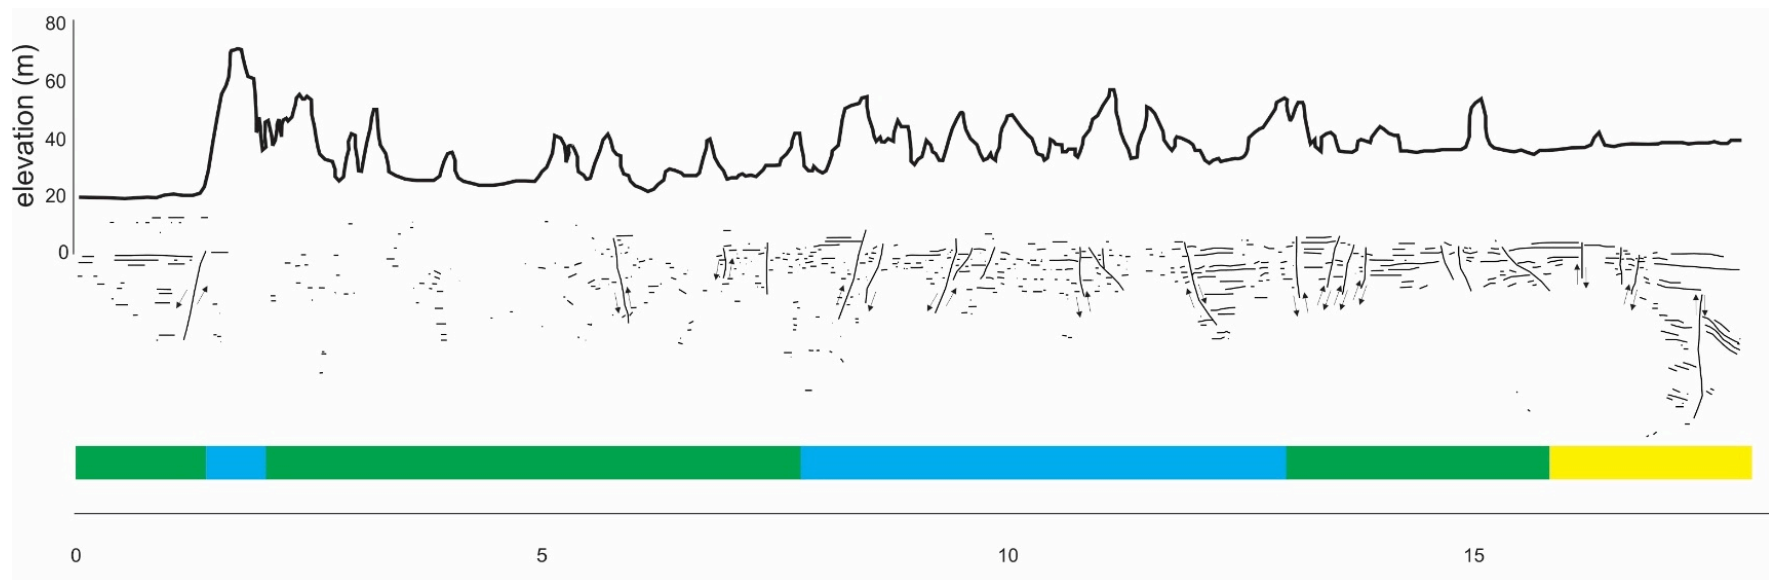
# Line 16

- Line of poorer quality – zones unreadable
- See similar series of faults, also closely related to geomorphology
- More suggest reverse fault (compressional) movement.

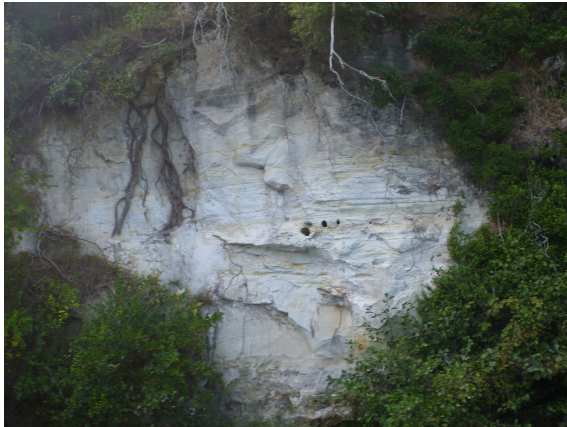
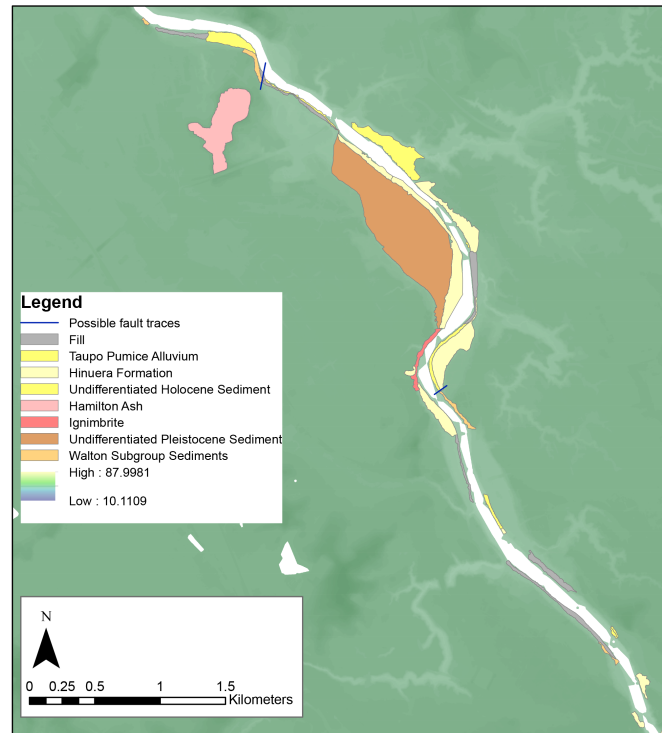
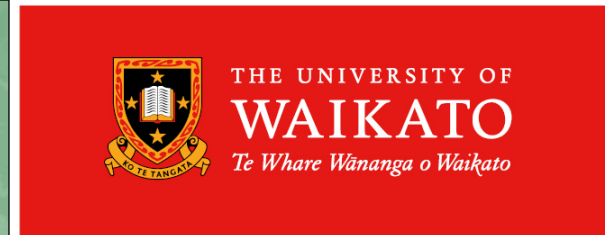
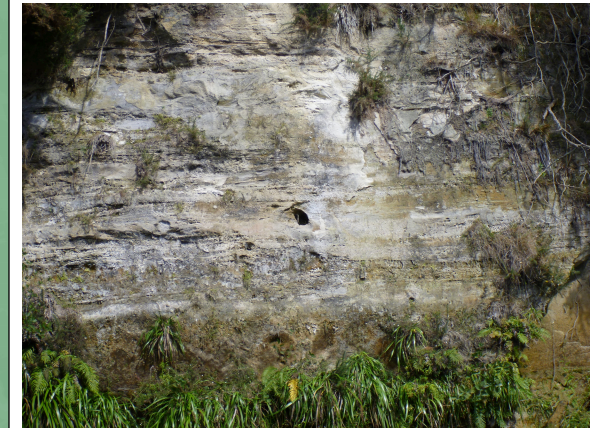
# Riverbank mapping

- Geological mapping along riverbanks from Narrows to Horotiu.
- Surprisingly difficult. Still work in progress - Francesca making thin sections to confirm identifications.
- One definite fault identified (Stubbs Road).
- Others inferred from geology.

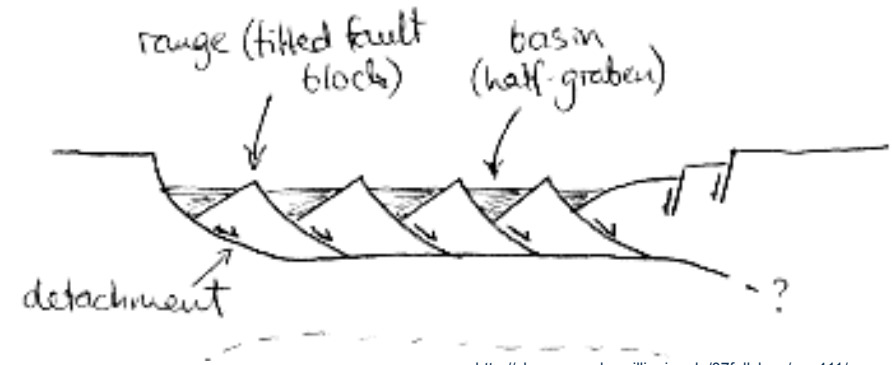
# Hill morphology

- Many hills show steep slope to SE, gentler to NW
  - More dissected to NW
- Fits listric model

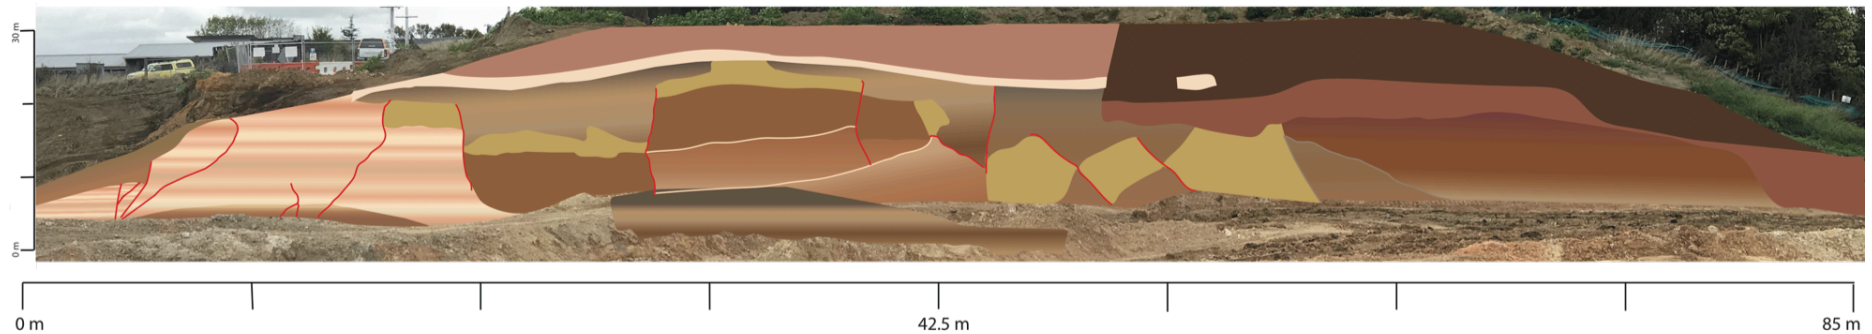
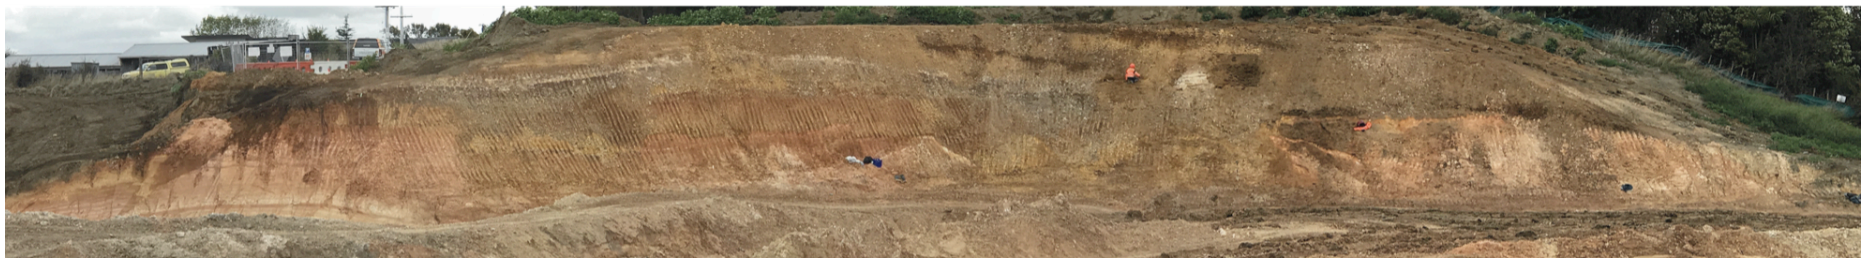
# Kay Road

- Complex fault zone
- Mostly steeply dipping normal faults.
- Some lower angle (thrusts?)
- Greater than 5 m throw on individual faults

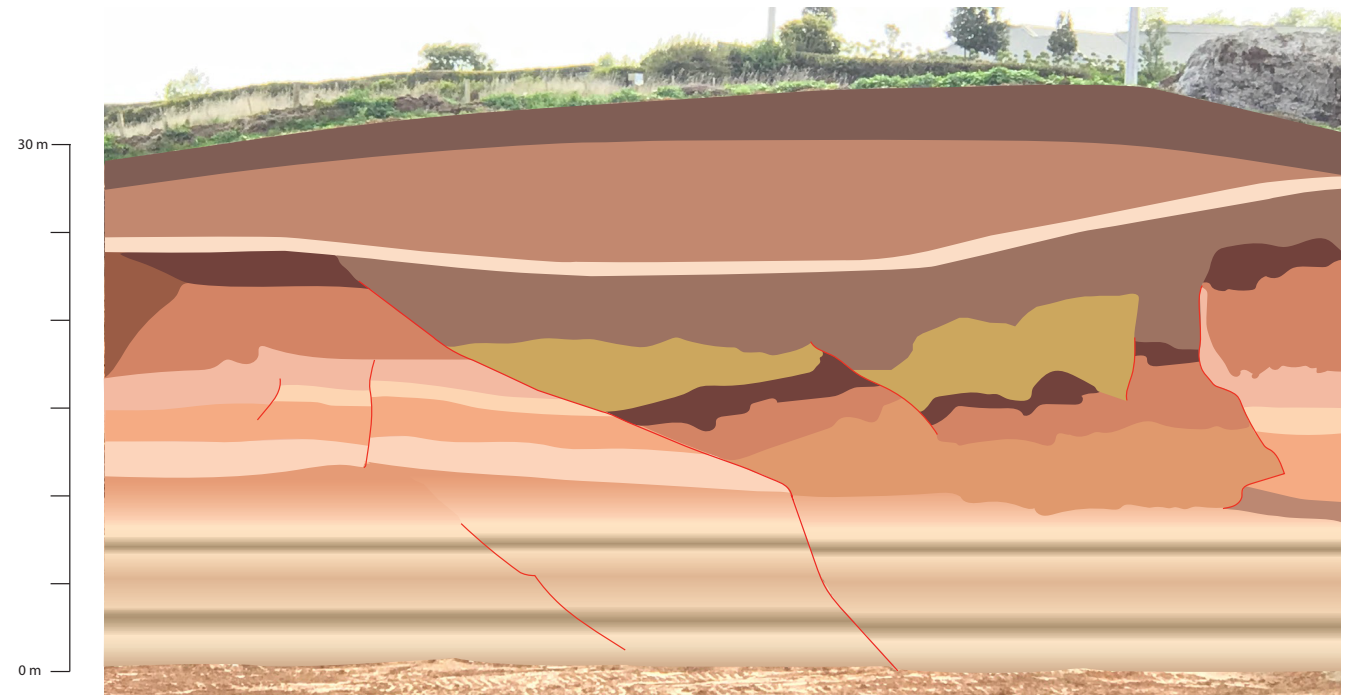
# Kay Road

- Key point is that Rangitawa Tephra (lowest layer of Hamilton Ashes) is **undisturbed**.
- This layer is ~350,000 years, indicating that these faults are inactive in terms of NZ definition.

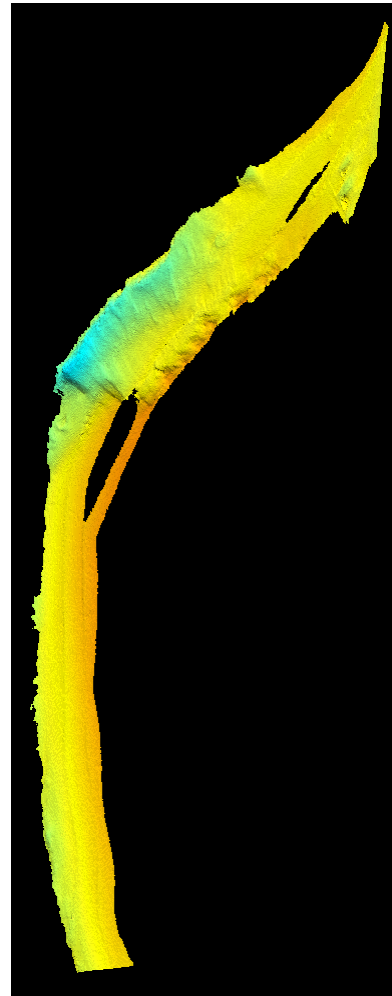
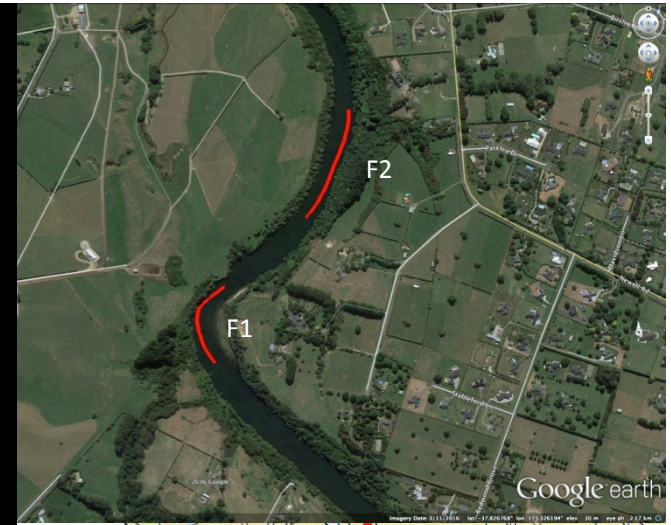
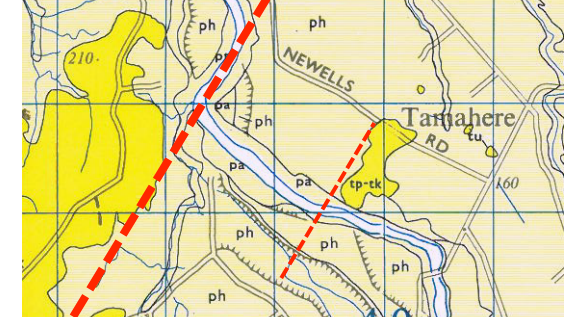
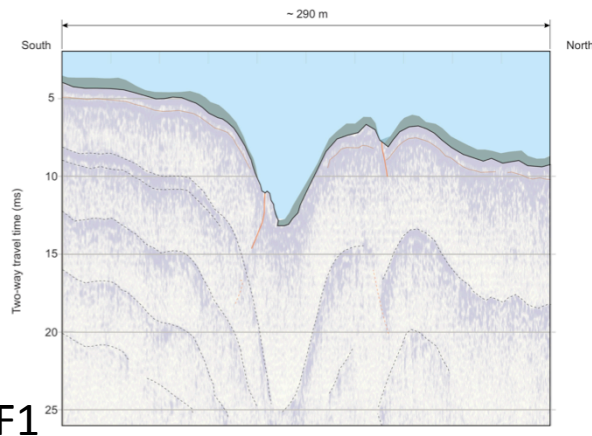
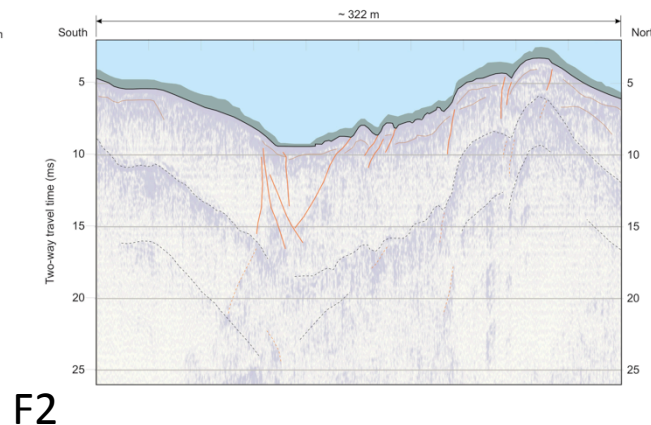
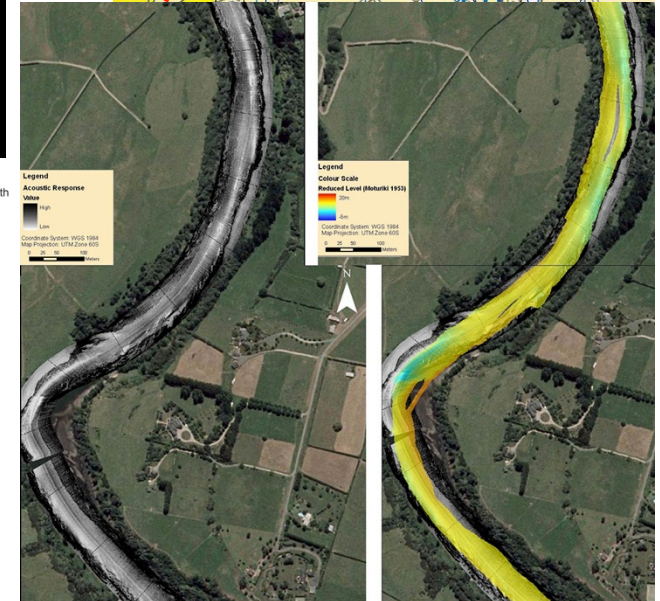
# Stubbs Rd

- Scour hole within river with offset scarp
- Multiple traces on sub-bottom profile

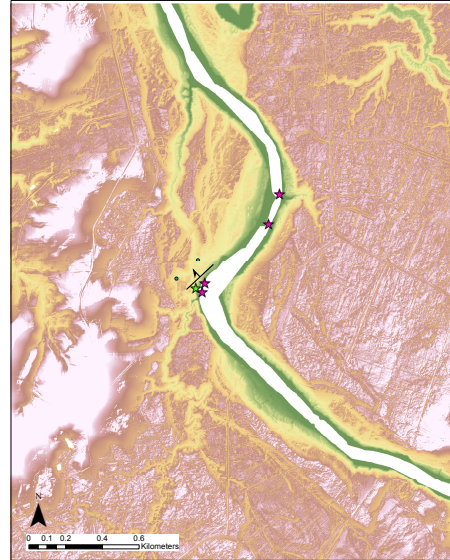
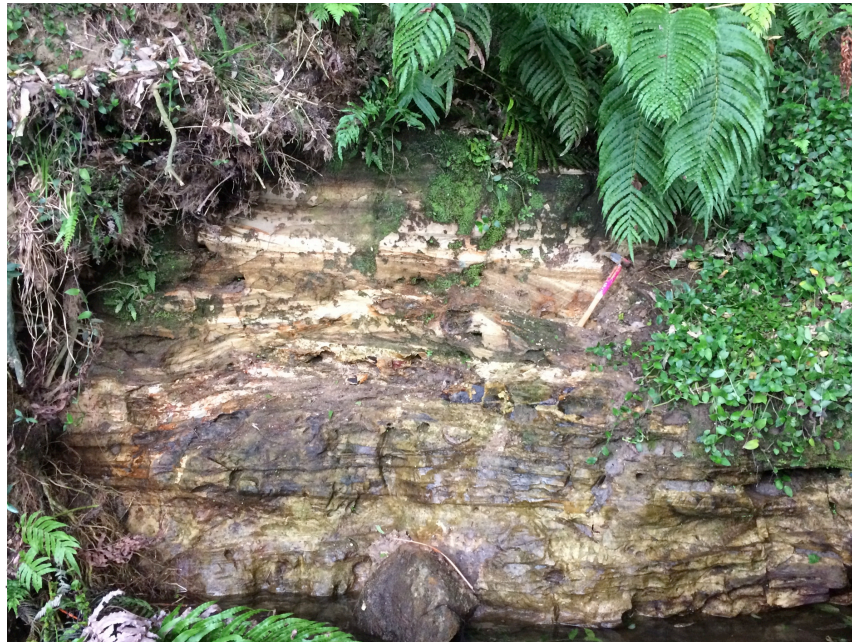
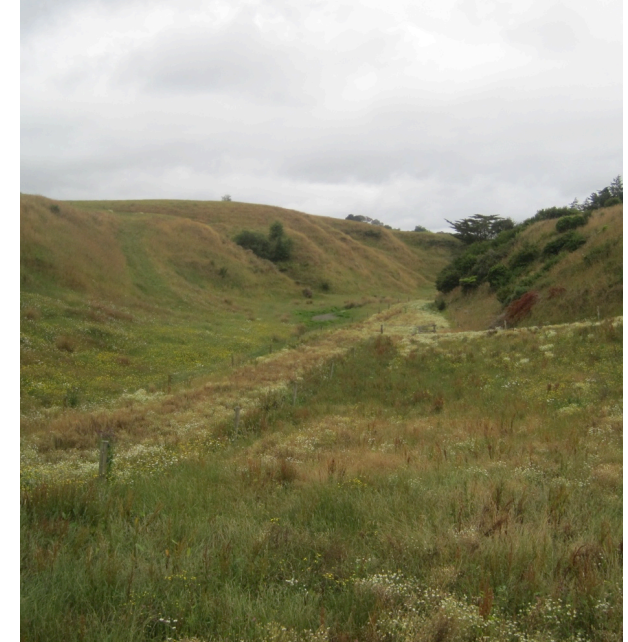
# Stubbs Rd

- Inconsistent terraces flanking river
- Abandoned river channel(s) & impoundment?
- LiDAR & resistivity survey of terraces indicate faulting
- Fault identified in riverbank mapping

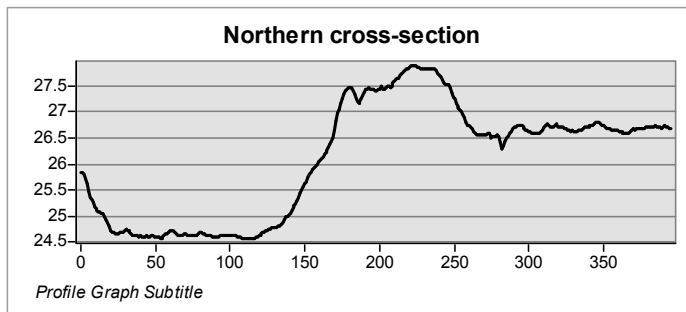
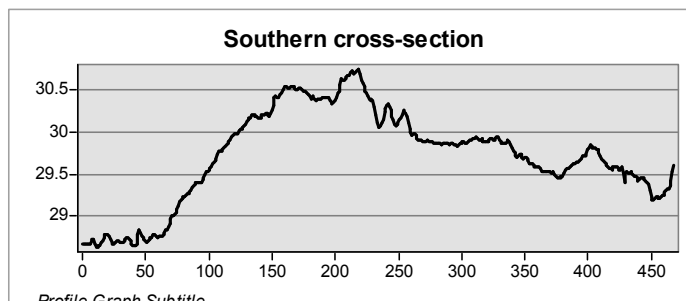
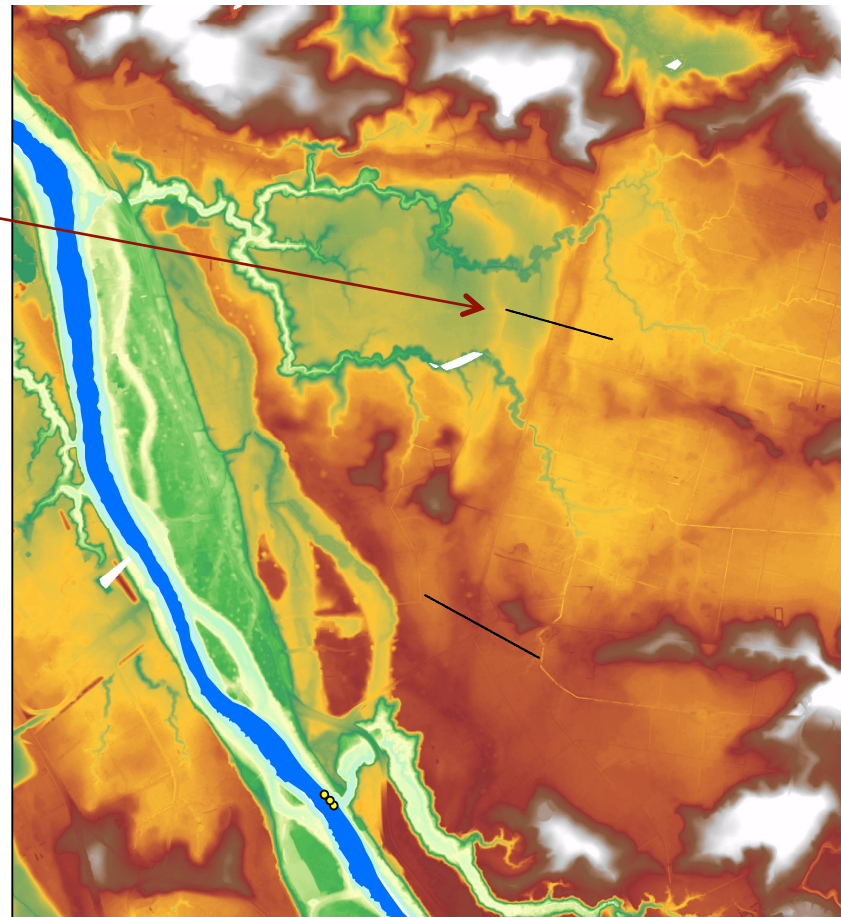
# Osborne Road

Osborne Rd located on upthrown side of fault

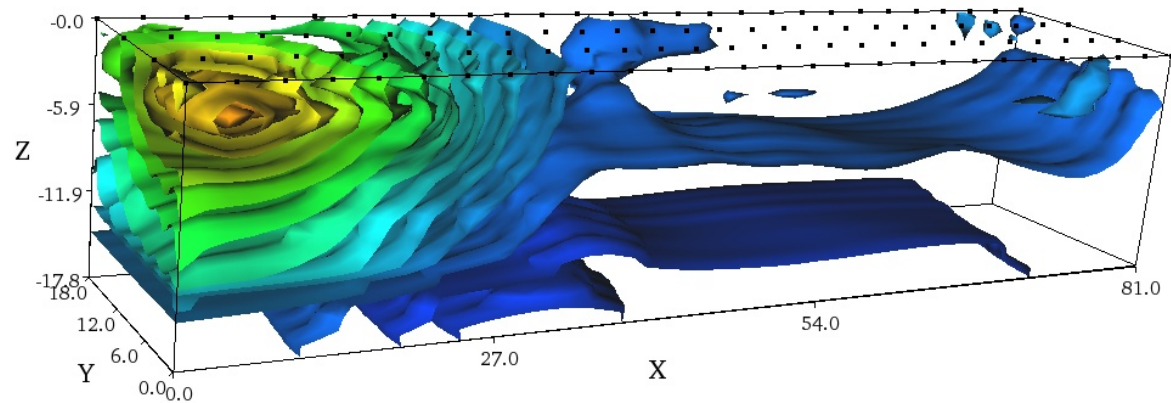
3D Resistivity Contour Plot

# 3D resistivity

- Appears to be a small fault that displaces 16 ka Hinuera Surface.
- Possible location for trenching.

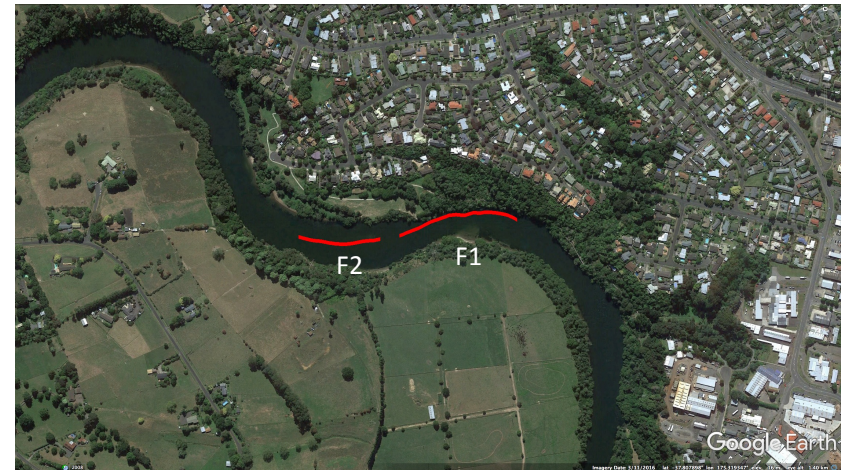
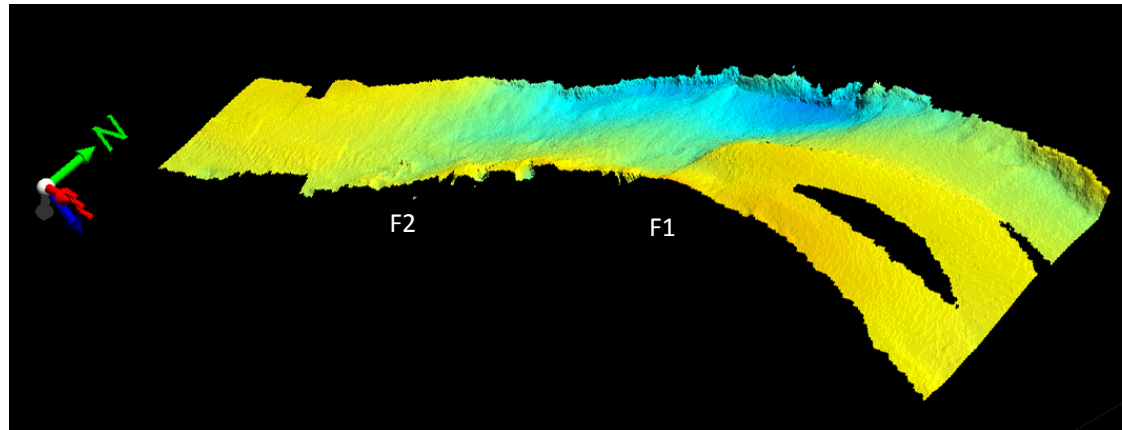
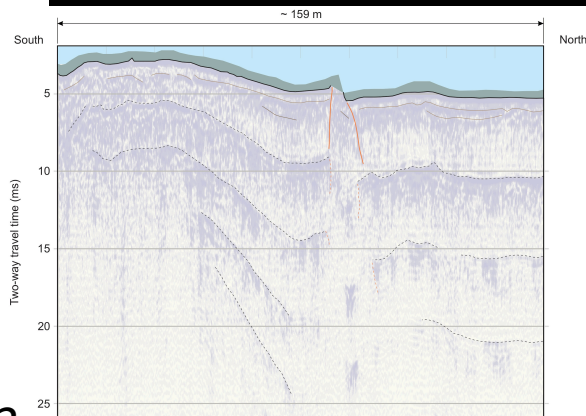
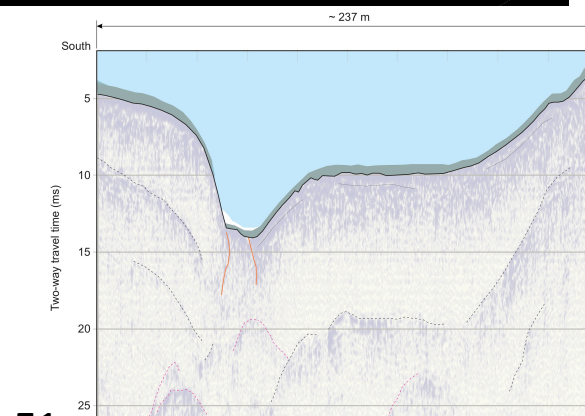
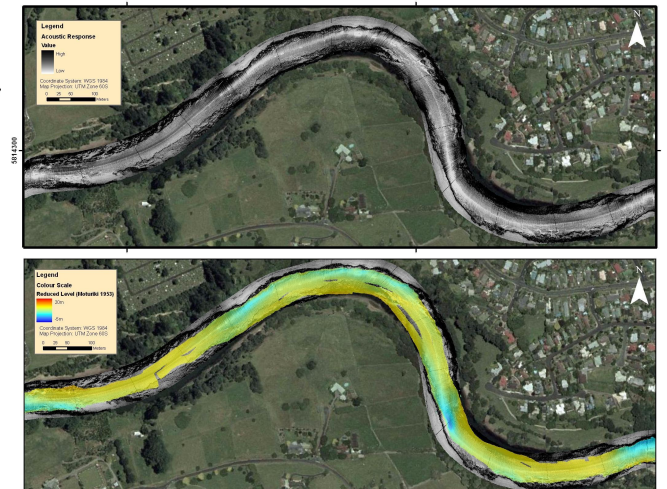
# University / Ruakura

- Multiple faults evident within river bed near Hammond Park
- Abandoned river channel on left bank

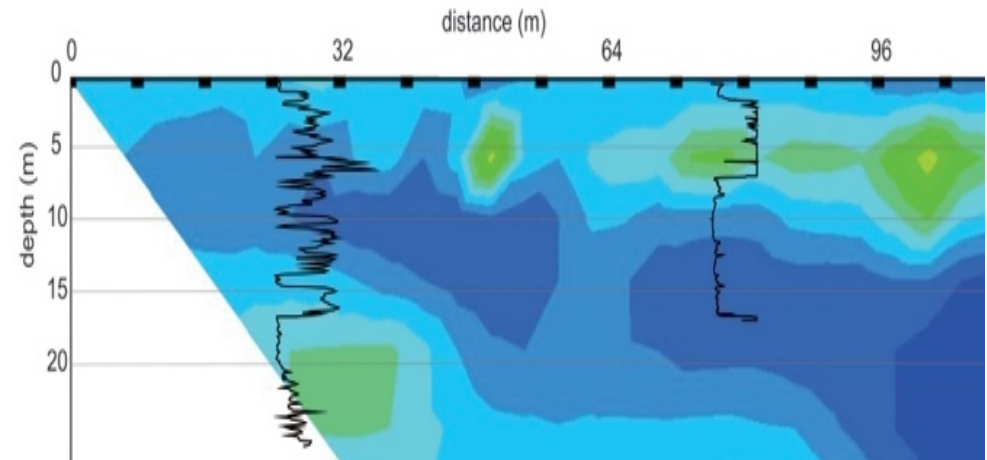
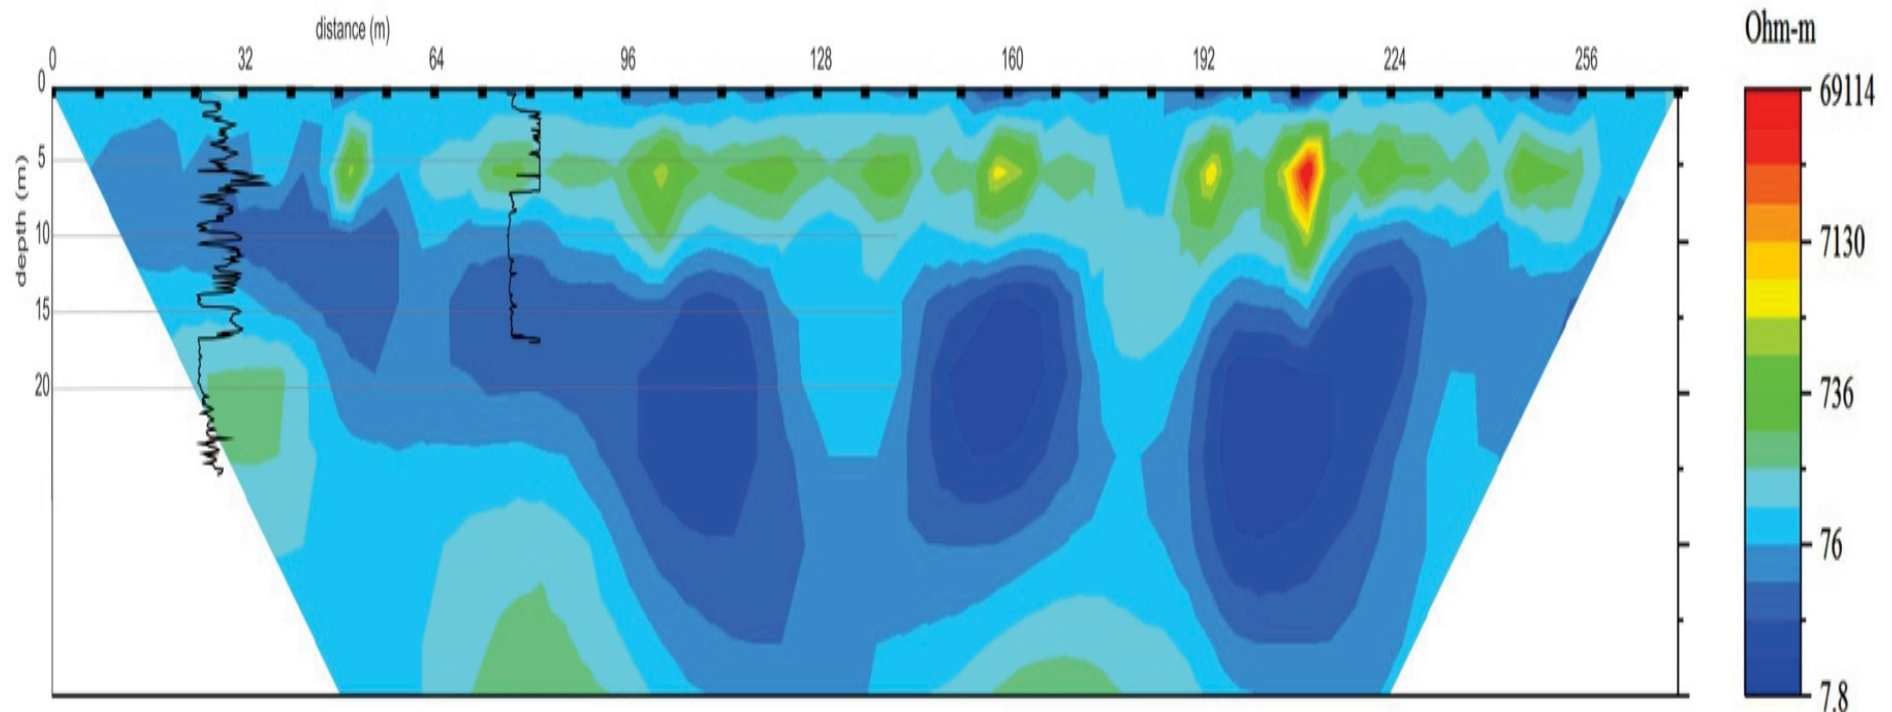
# University / Ruakura

- Have CPT and resistivity data from Inland Port.
- CPT traces correlate with resistivity
