# Faulting within the Hamilton Basin: Recent Progress

Dr Vicki Moon (*PEngGeol*), Dr Willem de Lange

# Introduction

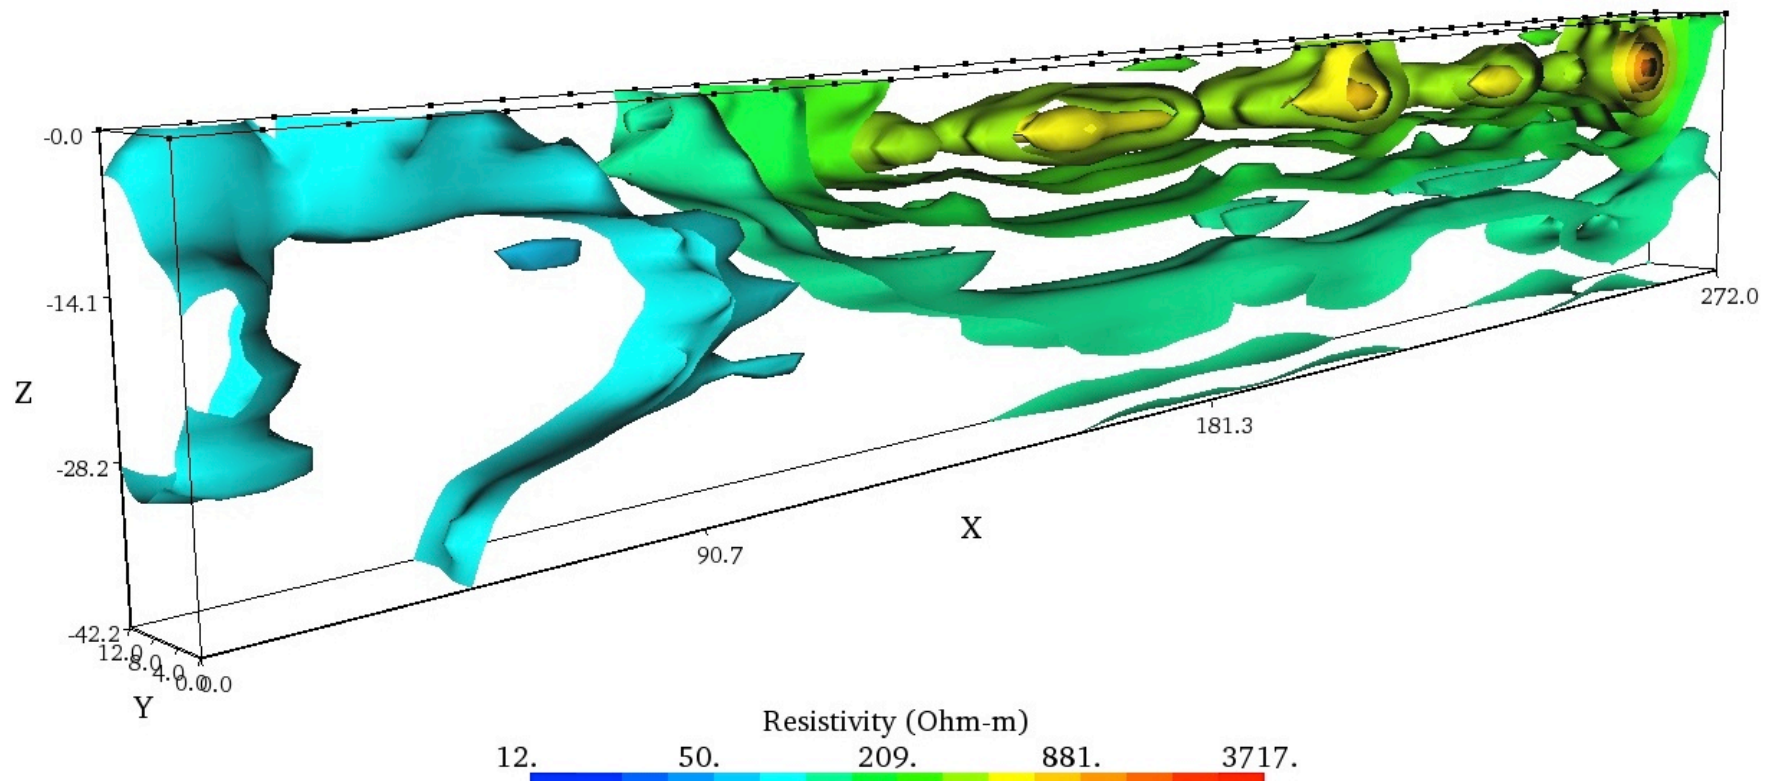
# 3D resistivity

- 3D reconstruction shows fault within Hinuera sediments

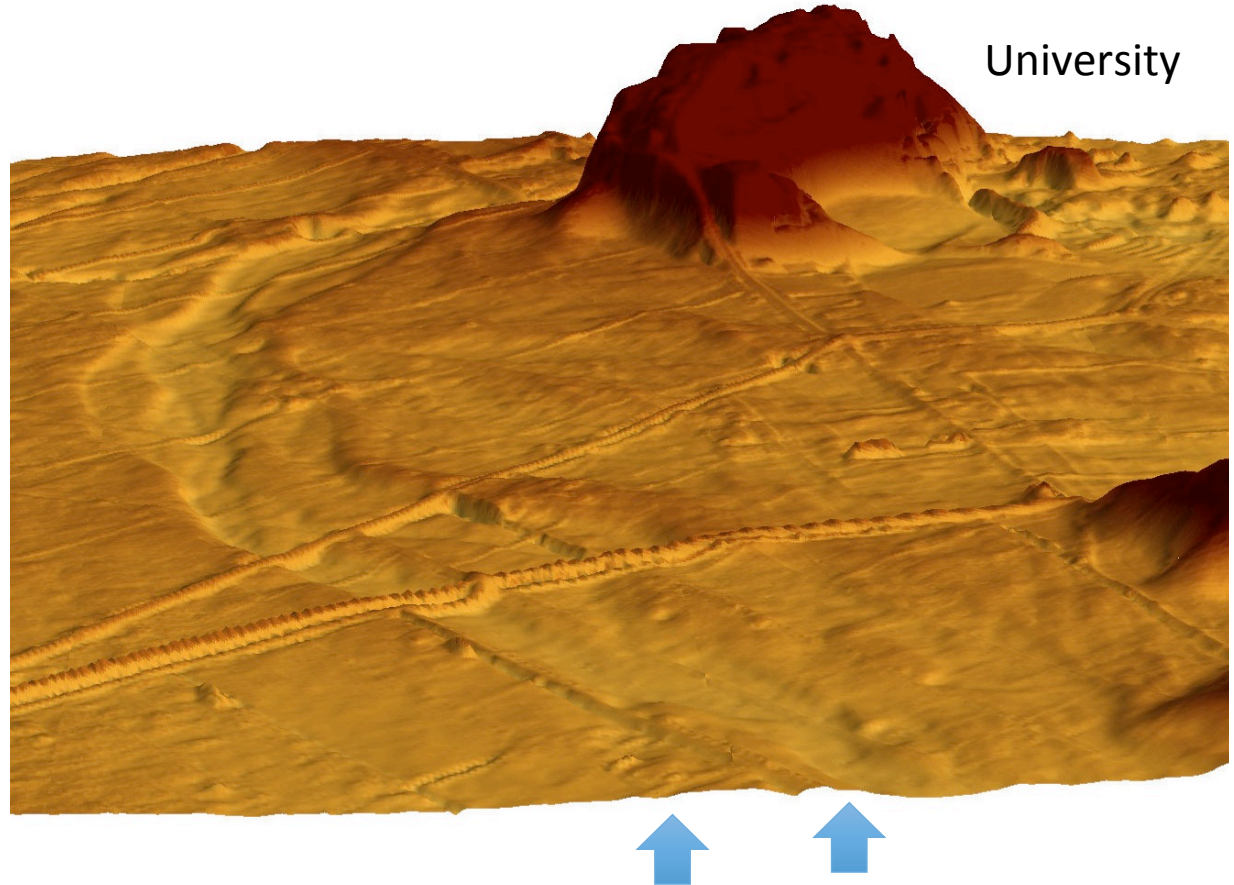
Vertically exaggerated  
LiDAR image looking  
south

- Can trace a possible fault zone through geomorphology.
- Needs ground truth to be sure.

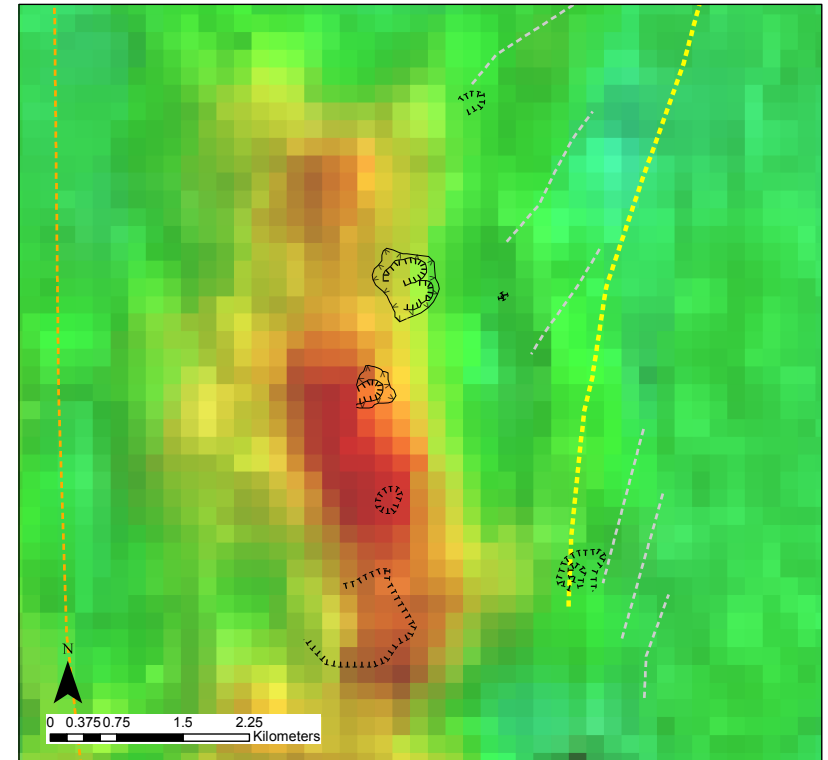
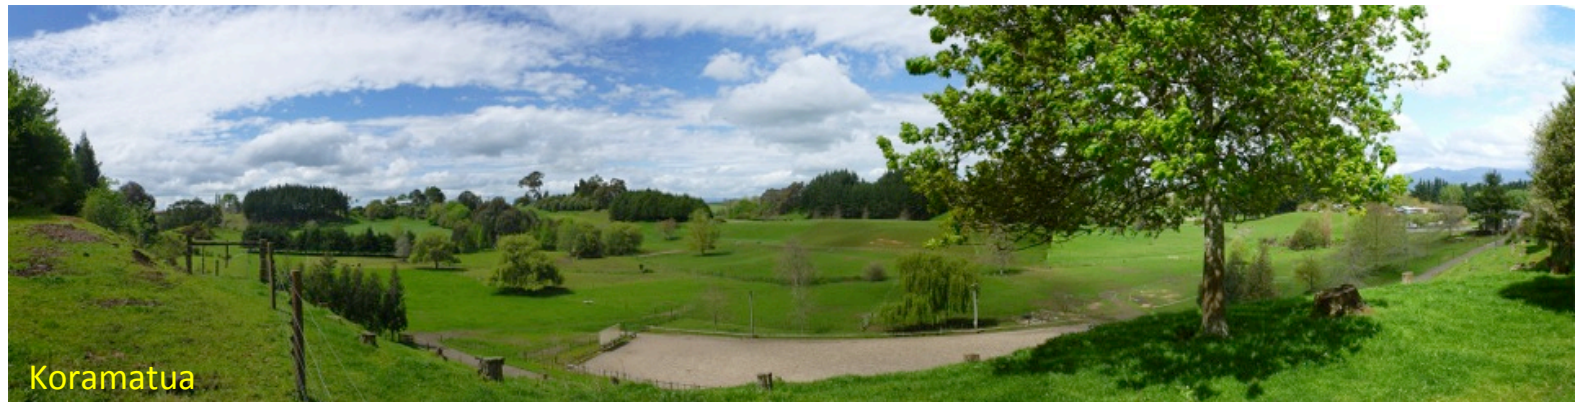
# Volcanic field

- Small volcanic field recognised on maps in 1960s.
- Removed from more recent maps, but present in:
  - Geomorphology
  - Aeromagnetics
- Age?

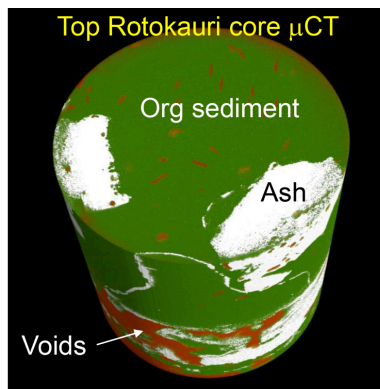
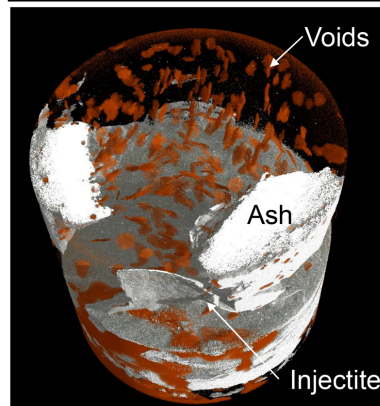
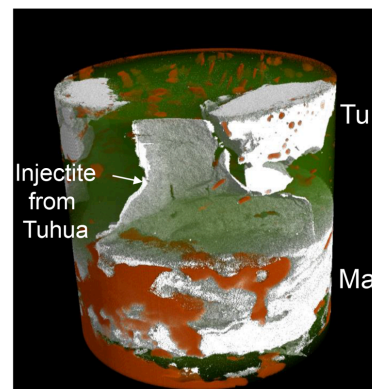
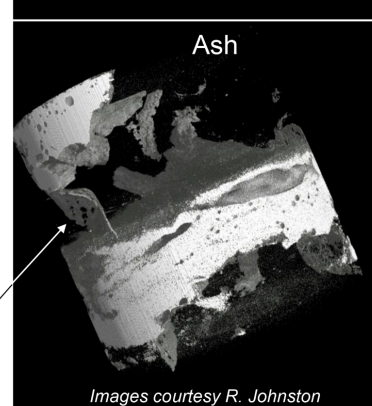
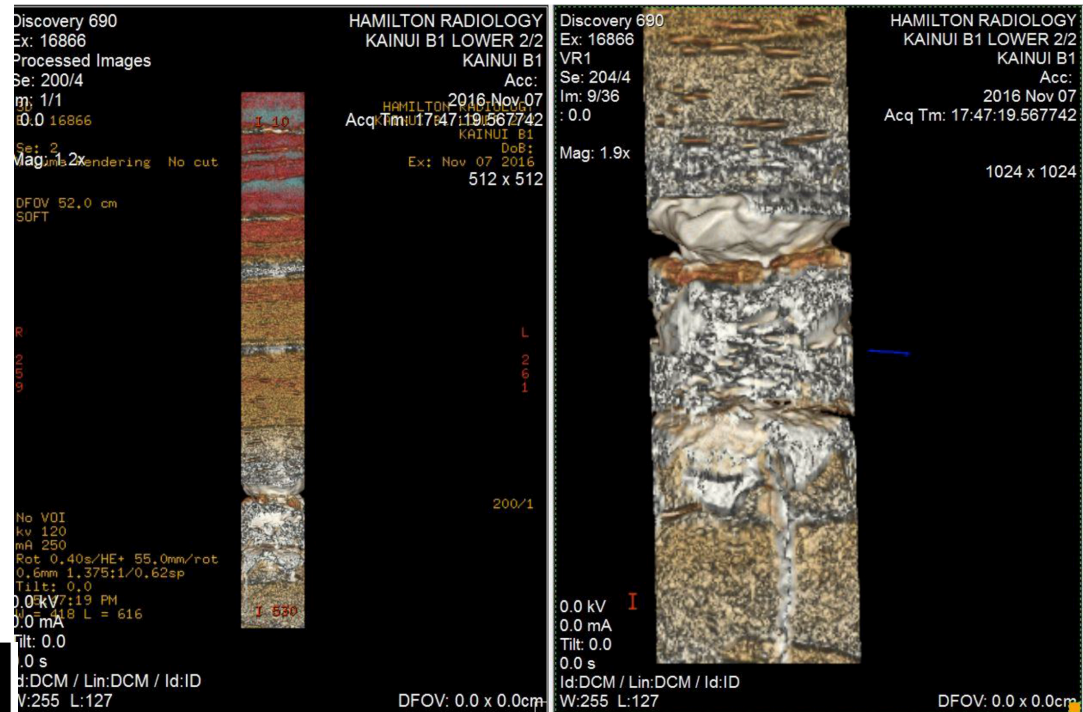
# Tephra seismites

- CT & micro-CT can identify seismites & may provide dates for the events causing liquefaction

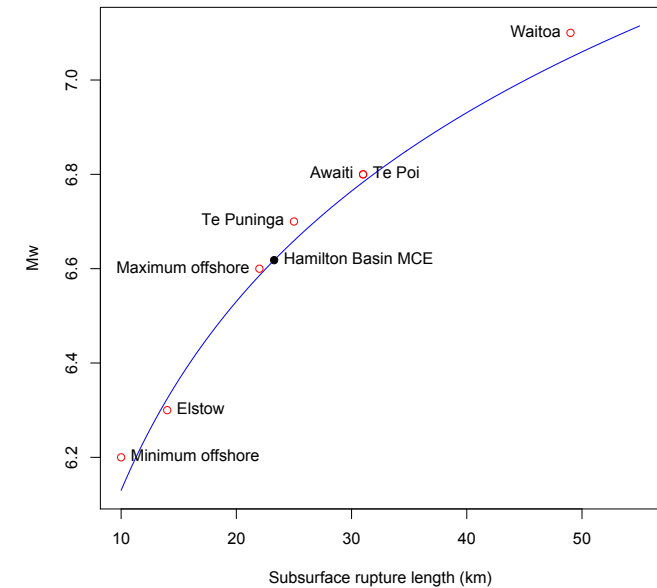
Magnitude versus rupture length - Kerepehi Fault

- Following methodology of Persaud *et al* (2016) for Kerepehi Fault, we can estimate maximum earthquake (MCE) magnitude ( $M_w$ ) & Modified Mercalli (MM) shaking intensity
  - MCE  $M_w = 6.6$
  - MCE maximum MM = 9 to 10
    - This is higher than expected MM intensity for Hamilton due to an event on the Kerepehi Fault
    - Current seismic risk for Hamilton Basin gives annual probability of 0.0025% for  $MM \geq 9$

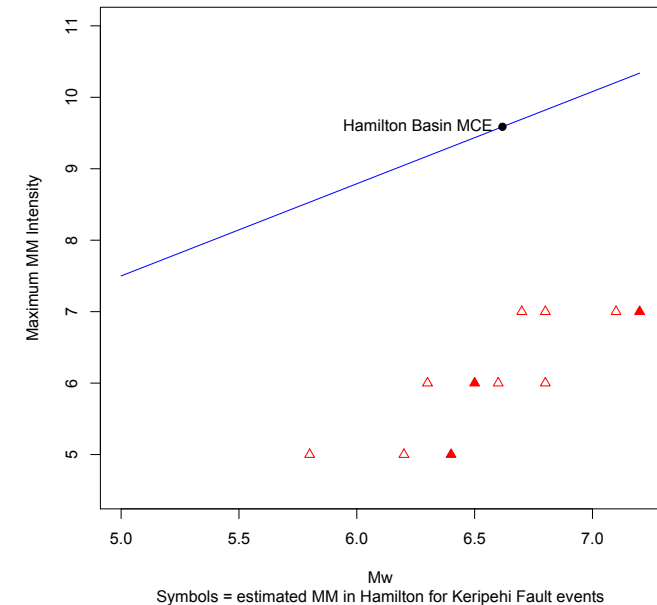
Modified Mercalli Intensity versus moment magnitude - New Zealand

Symbols = estimated MM in Hamilton for Kerepehi Fault events
