## Article

# Heat Treatment, Impact Properties, and Fracture Behaviour of Ti-6Al-4V Alloy Produced by Powder Compact Extrusion

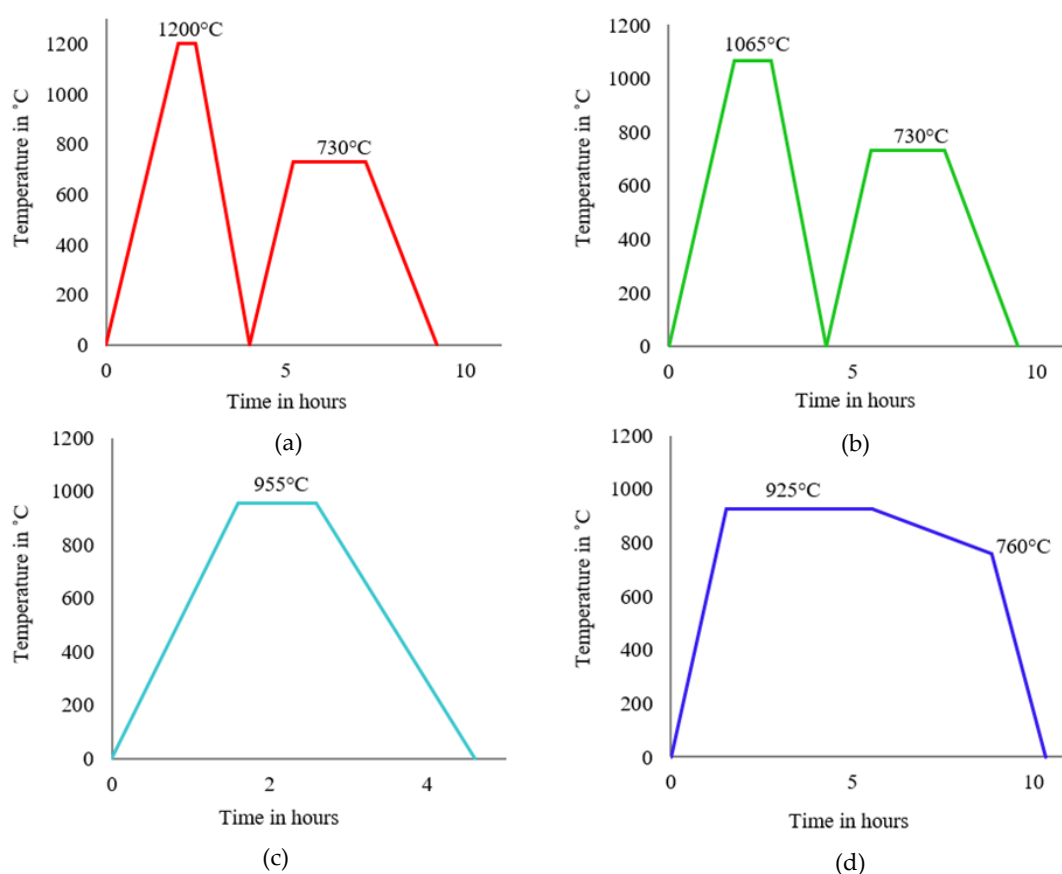
**Figure 1.** Schematic showing time-temperature cycles for annealing treatments (a) 1200 °C/30 min, FC, 730 °C/2 h; (b) 1065 °C/1 h, FC, 730 °C/2 h; (c) 955 °C/1 h, FC; (d) 925 °C/4 h, CFC@50 °C/h to 760 °C, FC. Note: FC—furnace cooling and CFC—controlled furnace cooling.

Extruded rods were produced as described in Table 1 and were then subjected to different heat treatments (see Figure 1). The annealing heat treatments were carried out in the same vacuum furnace used for sintering to avoid additional oxygen pickup. The functionality of this particular furnace does not allow for the removal of rods at high temperature; therefore, natural furnace cooling (FC) was used rather than air-cooling. For all annealing treatments, variations such as annealing temperature, isothermal hold time, ageing temperature, and cooling rate were incorporated. A heating rate of 10 °C/min was used for every heat treatment, followed by an isothermal hold. Cooling to 200 °C from any temperature above the  $\beta$  transus was reached in two hours once the furnace was turned off. The thermal cycle used for the four annealing treatments can be seen in Figure 1. The first treatment involved a high  $\beta$  anneal, followed by two hours of ageing in the  $\alpha/\beta$  region. A more standard  $\beta$

annealing temperature (a few degrees higher than the  $\beta$  transus temperature) was used in the second treatment, followed by the same ageing scheme as in the previous case. The third case involved FC from the  $\alpha/\beta$  region without any ageing step. Similarly, the final treatment was also  $\alpha/\beta$  annealing, where there was well-controlled cooling from 925 to 760 °C, followed by FC.

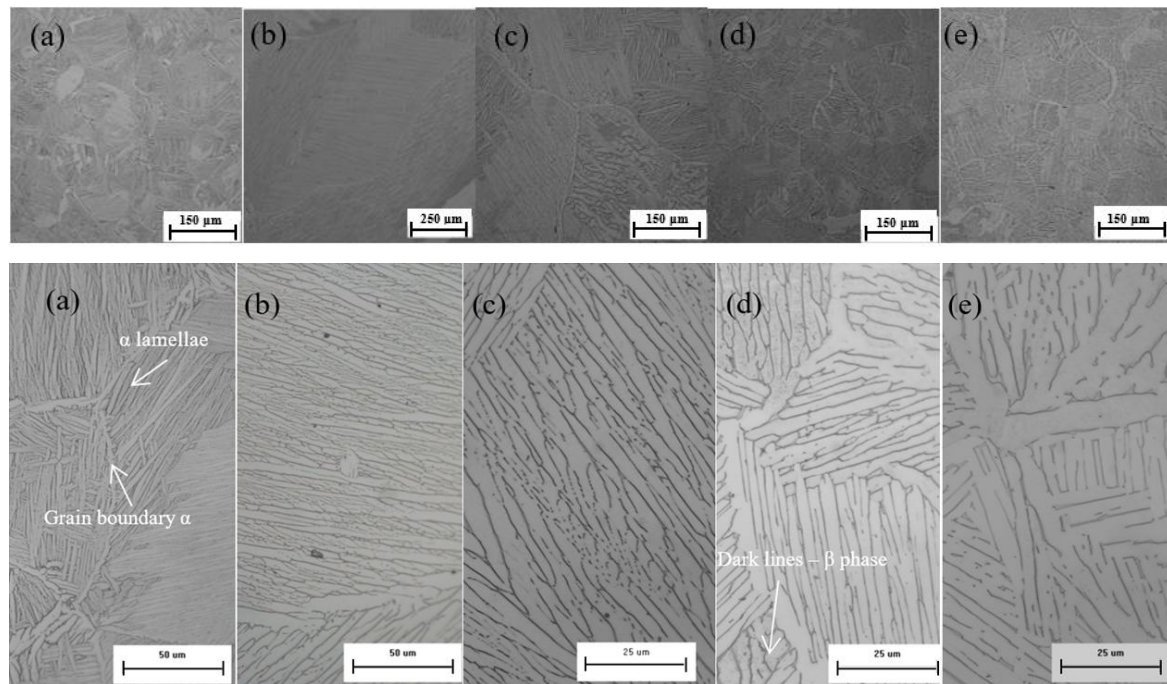
**Figure 2.** Optical micrograph of powder compact extrusion (PCE)-produced Ti-6Al-4V alloy: (a) as-extruded: fine lamellar microstructure; (b) 1200 °C/30 min, FC, 730 °C/2 h: coarse lamellar microstructure with a complex structure of  $\alpha$  lamellas; (c) 1065 °C/1 h, FC, 730 °C/2 h: basketweave structure with partially broken up  $\beta$  phase; (d) 955 °C/1 h, FC: fine lamellar microstructure with complex grain and colony structure; (e) 925 °C/4 h, CFC@50 °C/h to 760 °C, FC:  $\alpha$  laths, interfaces, and the grain boundary layer morphology. Note: the bottom row of images shows the same features at high magnification.

The microstructure of as-extruded material had a typical Widmanstätten/lamellar appearance which formed as a result of diffusion-controlled growth of the  $\alpha$  phase as the material air-cooled from the  $\beta$  phase after exiting the extrusion die (see Figure 2a). Annealing above the  $\beta$  transus followed by ageing at 730 °C for two hours led to the formation of a coarse lamellar-type microstructure. Furnace cooling from a relatively high temperature (1200 °C) resulted in larger  $\alpha + \beta$  colonies containing very coarse  $\alpha$  lamellas, as shown in Figure 2b. In general, there were fewer colonies per grain, with some grains having a more complex colony morphology. The amount of retained  $\beta$  phase also varied from grain to grain. Most of the grains were well defined by a fine grain boundary  $\alpha$  with uniform thickness.

The standard  $\beta$  annealing treatment (1065 °C/1 h, FC, 730 °C/2 h) gave a microstructure containing a small, but very complex colony structure within larger grains. It is apparent that transformation from  $\beta$  to  $\alpha$  led to a typical basketweave structure in most areas; however, there were a few areas that contained significant thick  $\alpha$  plates separated by fine discontinuous dark lines corresponding to retained  $\beta$ , as shown in Figure 2c. This type of variation significantly affected the volume fraction of each phase along with the general morphology present within the same grain or colony. Overall, the grain size after this heat treatment was significantly larger (in the mm range) compared to material after a non-standard high  $\beta$  anneal and ageing treatment (1200 °C/30 min, FC, 730 °C/2 h). The combination of a high annealing temperature and an isothermal hold time were thought to be the reasons for the fast grain growth kinetics, resulting in very large grains with a significant variation in colony,  $\alpha$  lath, and lamellar interfaces.

Furnace cooling from 955 °C produced a homogeneous lamellar microstructure containing small  $\alpha/\beta$  colonies, with complex orientations (Figure 2d). This microstructure had a high  $\beta$  phase content as the lamella packages were well defined by continuous and uniformly thick darker lines. Other than the  $\beta$  phase, the grain boundary  $\alpha$  phase was thicker compared with that observed in previous annealed and aged microstructures. There were a few colonies which had a lighter appearance, and which showed less clear features. An investigation of these areas at high magnification indicated that these features contained some retained  $\beta$  phase in the form of a very fine discontinuous line or dots.

This annealing treatment gave a similar homogeneous microstructure to that described for the previous case, with a few new key features. This microstructure had an even more complex colony arrangement containing a partly broken up  $\beta$  phase between each lenticular lamellar plate as shown in Figure 2e. Overall, the  $\alpha$  morphology at the  $\beta$  boundaries was similar, but there were a few areas containing complex triple joints along with discontinuous grain boundary layers. There was also less retained  $\beta$  compared with that shown in the previous microstructure, which was evident from the thinner interfacial  $\beta$  (Figure 2e). It is clear that very slow controlled cooling from 975 °C to 760 °C at a rate of 50 °C/h followed by standard furnace cooling was responsible for  $\alpha$  coarsening and a reduction in the  $\beta$  phase fraction.

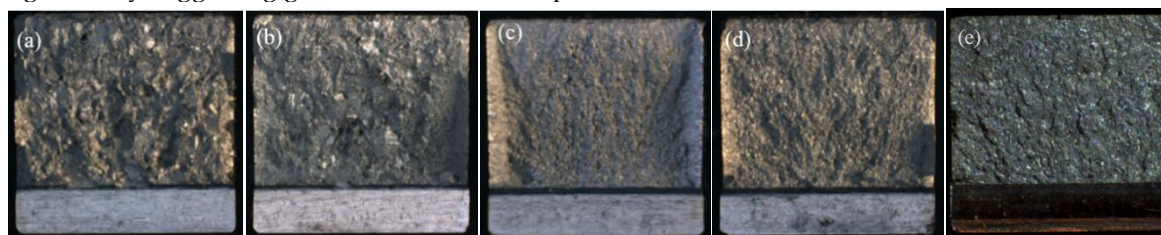
**Figure 3.** Fracture appearance of broken impact specimens: (a) 1200 °C/30 min, FC, 730 °C/2 h; (b) 1065 °C/1 h, FC, 730 °C/2 h; (c) 955 °C/1 h, FC; (d) 925 °C/4 h, CFC@50 °C/h to 760 °C, FC; (e) as-extruded.

The optical fractographs of impacted specimens for each heat treatment are shown in Figure 3. It is very apparent that fracture surfaces of both  $\beta$ -annealed and aged conditions were very rough with shiny facets and thin shear lips (Figures 3a,b). The general fracture appearance of  $\alpha + \beta$  heat-treated material (955 °C/1 h, FC and 925 °C/4 h, CFC@50 °C/h to 760 °C, FC) were very similar. Here, the fracture surface was much smoother, with larger shear lips of more uniform thickness around the outer edges, as shown in Figures 3c,d. For as-extruded material (VS-E3') shown in Figure 3e, the typical fracture surface was rather flat and featureless, and there were no shear lips around the outer edge, clearly suggesting greater brittleness compared to heat-treated materials.

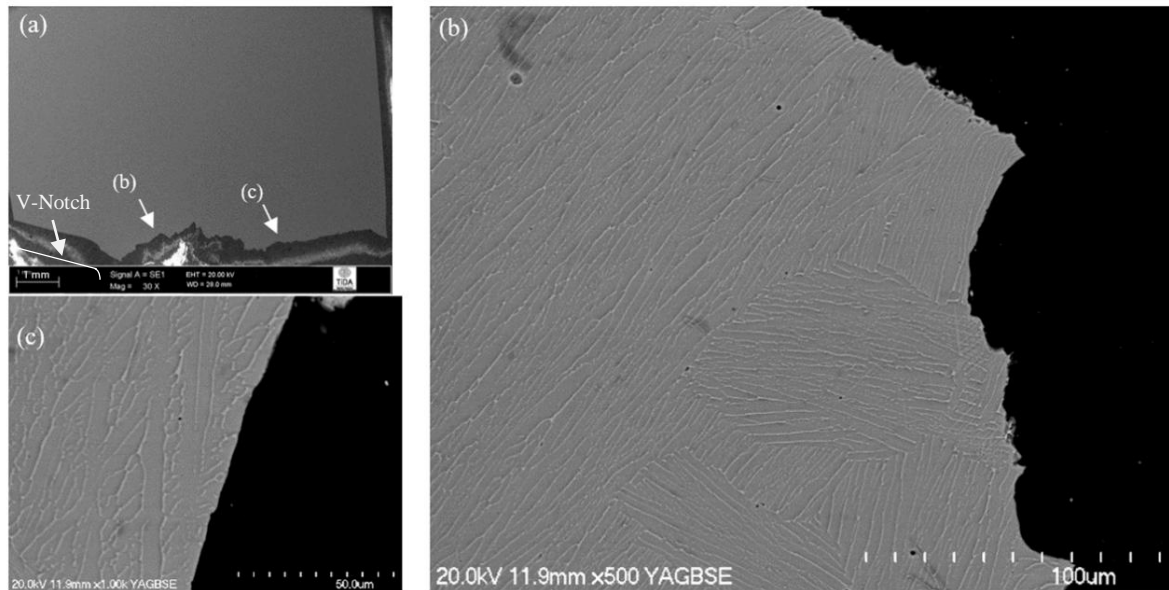
**Figure 4.** Crack propagation behaviour of 1200 °C/30 min, FC, 730 °C/2 h heat-treated material: (a) overall crack path; (b) crack path in first half; (c) crack propagation in second half (relative location of image (b) and (c) is marked on (a)).

The crack path profile for  $\beta$ -annealed and aged (1200 °C/30 min, FC, 730 °C/2 h) microstructure could be divided into two parts (Figure 4a). A rough and regularly deviating crack profile was observed in the first half of the fracture profile (Figure 4b), whereas, after reaching the middle of the sample, the crack propagation mechanism changed. From here onwards, the crack followed a straight line (clear sign of brittle fracture) (Figure 4c). Overall, the fracture mode was predominantly transgranular as there were no signs of cracking around the grain boundaries. At an early stage of crack propagation, the individual  $\alpha + \beta$  colonies and thick  $\alpha$  lamellas provided some resistance to crack advancement, along with the grain boundary  $\alpha$  layer. In the remaining half of the fractured test-piece, the propagating crack ruptured all the microstructural features randomly, which suggests that an unstable fracture occurred. Overall, the large aspect ratios of the  $\alpha$  lamellas and resulting colonies were more resistant to fracture. This is most likely because this microstructural feature increased the crack length and, therefore, the surface area or surface energy, giving a larger toughness.

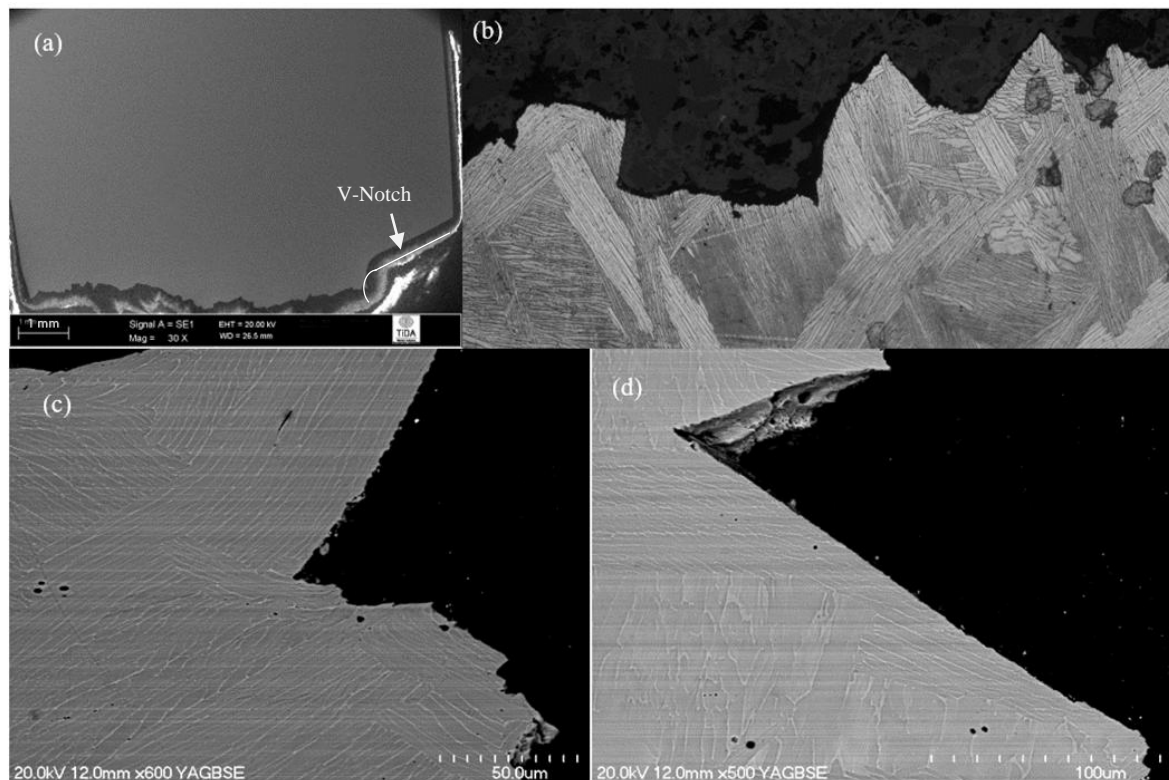
**Figure 5.** Crack propagation behaviour of 1065 °C/1 h, FC, 730 °C/2 h heat-treated material: (a) overall crack path; (b) transgranular fracture with relatively sharp crack deflection; (c, d) microstructural features causing a significant change to crack path.

The crack profile for material heat-treated 1065 °C/1 h, FC, 730 °C/2 h suggests a predominantly transgranular fracture mode in which the angle of crack front deviation was very sharp (as displayed in Figures 5a,b). The high-magnification SEM fractographs clearly indicate that the main sources of crack deflections were the entrance points to a new colony or, in some instances, a relatively thick individual  $\alpha$  lamella arrested the crack, as shown in Figures 5c,d.

Generally, after entering each colony, cracks ruptured individual lamellas at a variety of angles to obtain the path of least resistance, and the thick grain boundary  $\alpha$  layer played a negligible role in causing any change to the crack front. Overall, it can be concluded that relatively small colonies with large aspect ratio  $\alpha$  lamellas (basketweave) did not further improve the crack propagation resistance compared with material heat-treated at 1200 °C/30 min, FC, 730 °C/2 h. Hence, the average impact toughness values for this heat treatment category were in close agreement.

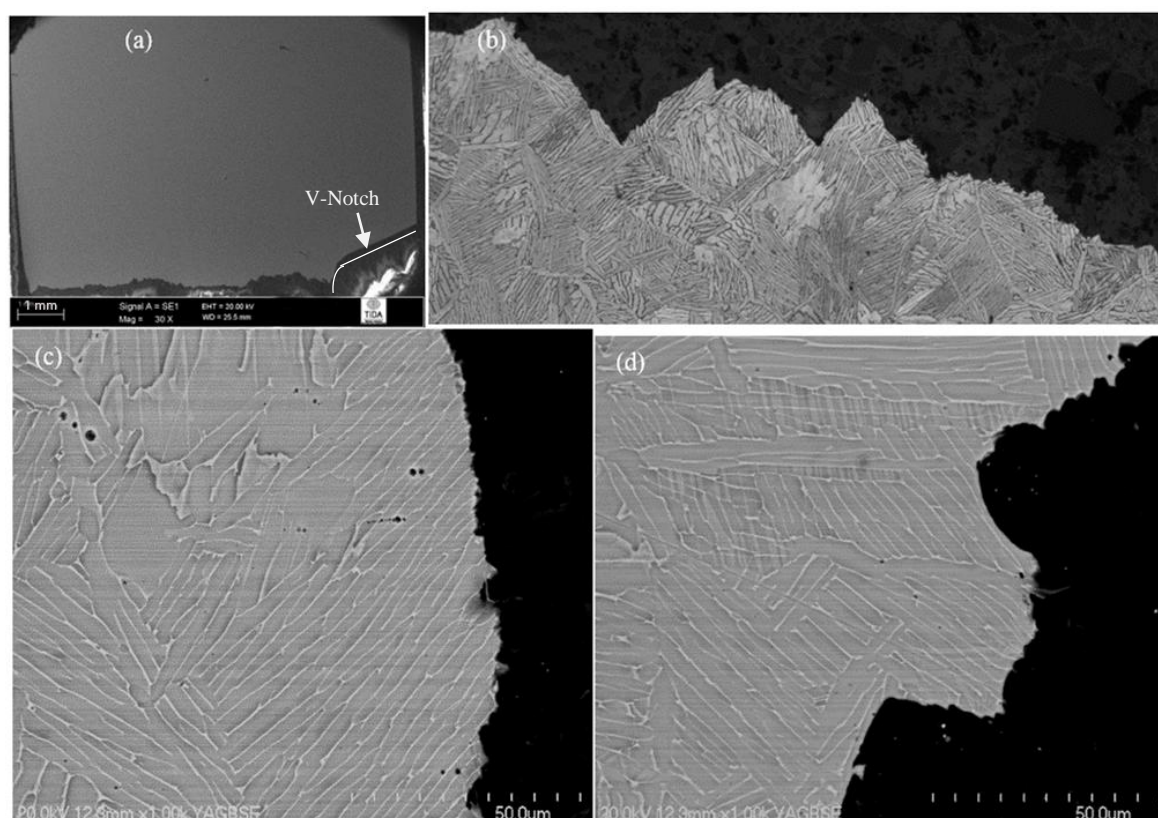
**Figure 6.** Crack propagation behaviour of 955 °C/1 h, FC heat-treated material: (a) overall crack path; (b) transgranular fracture; (c, d) individual  $\alpha$  lamellar plates and retained  $\beta$  phase matrix providing sufficient hindering to crack growth.

The crack propagation behaviour of material furnace cooled from 955 °C (shown in Figure 6) was drastically different from that described in the previous two cases ( $\beta$ -annealed and aged). Overall, the crack path shown in Figure 6a highlights the fact that the amplitude of crack front deviation was relatively small, while changes in the crack path were much more frequent. This suggests that individual microstructural features caused significant resistance to crack propagation, while the crack spread through the interior of grains (as clearly observed in the optical fractographs in Figure 6b). Confirmation of this can be seen in the higher-magnification images shown in Figures 6c,d. From these images, it is clear that a crack was not only deflected by the differently orientated colonies, but each  $\alpha$  lamellar plate and retained  $\beta$  phase matrix diverted the crack propagation paths to possibly retard crack propagation by blunting the crack tip. Additionally, the interaction of the crack with grain boundary  $\alpha$  had a minor contribution to crack propagation resistance. In general, it can be concluded that a relatively thick retained  $\beta$  interface and individual  $\alpha$  lamellar platelets in this microstructure were much tougher than those in  $\beta$ -annealed and aged material. Overall, each individual microstructural feature hindered the crack growth and, as a result, the best impact toughness values were obtained for this particular microstructure compared to the other heat treatments.

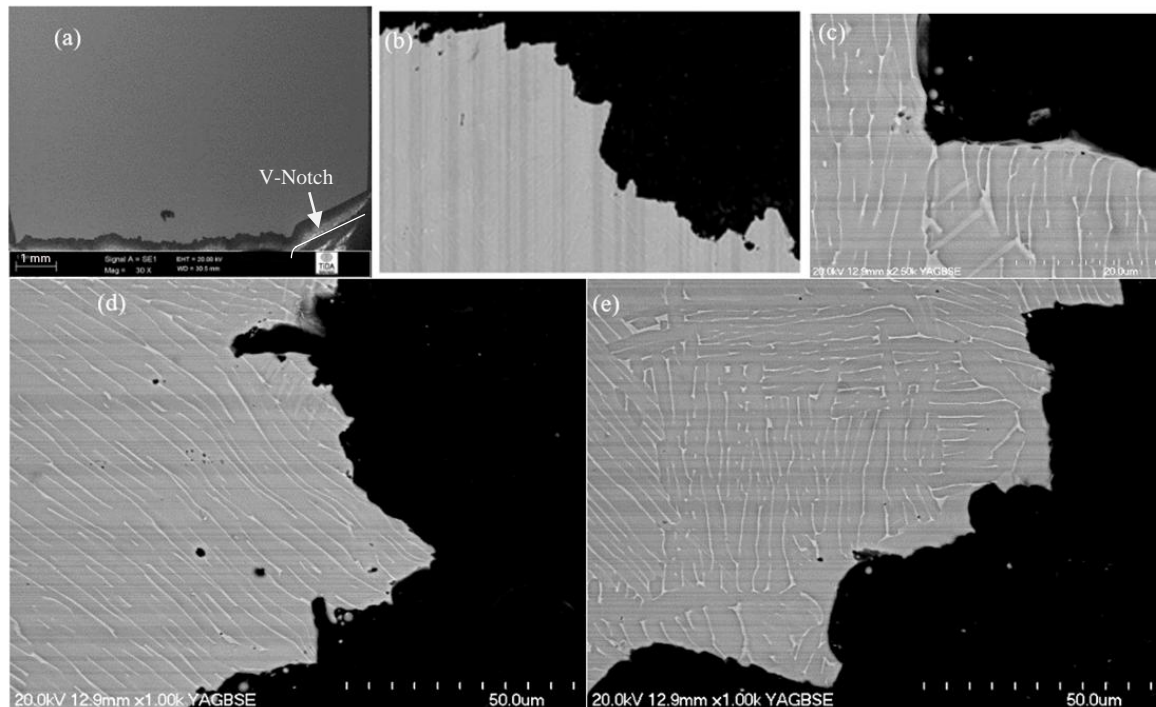
**Figure 7.** Crack propagation behaviour of 925 °C/4 h, CFC@50 °C/h to 760 °C, FC treated material: (a,b) overall crack path; (c) interaction with  $\beta$  phase; (d,e) different forms of  $\alpha$  phase providing sufficient resistance to crack growth.

The general crack path in material annealed using 925 °C/4 h, CFC@50 °C/h to 760 °C, FC shown in Figures 7a,b was comparable to that described in the previous case (where the material was cooled

from 955 °C). From high-magnification SEM fractographs (Figures 7c–e), it was clear that various forms of  $\alpha$  phase, i.e., the thick  $\alpha$  present in a more rounded form, individual lamellas, and those at colony interfaces, were responsible for changes in crack direction. The retained  $\beta$  phase also provided some resistance to crack propagation. However, in this case, there was only sufficient blunting at the crack tip when there was a head-on encounter by the crack with a non-uniform thickness  $\beta$  strip. An example of such behaviour is presented in Figure 7c, where the crack deviated towards the path of least resistance after interacting with the  $\beta$  phase. Most of the time, cracks ripped apart these  $\beta$  interface strips and, therefore, a local deflection of the crack after passing each individual lath was absent. Overall, transgranular fracture was the major failure mode as there was no indication of cracking around grain boundaries.

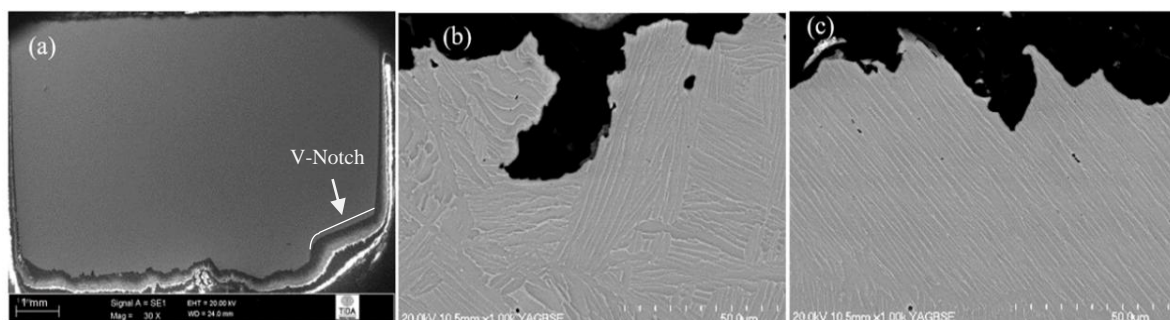
**Figure 8.** Crack propagation behaviour of as-extruded Ti-6Al-4V alloy: (a) overall crack path; (b) major deviation caused by colony interface; (c) limited resistance provided by retained  $\beta$  phase matrix.

For as-extruded material, an examination of the fracture surface of broken impact specimens (Figure 8) showed that the amplitude of the crack deflection was relatively lower than that for 925 °C/4 h, CFC@50 °C/h to 760 °C, FC annealed and 955 °C furnace-cooled samples. However, a phenomenon of frequent changes in crack path was still very active (see Figures 8b,c).

The zigzagging of the crack profile here was mainly due to the presence of small colonies and a relatively fine morphology of the individual  $\alpha$  and  $\beta$  phases. The size of the shear lips was similar to that observed in  $\beta$ -annealed and aged (730 °C) samples, as well as in 955 °C quenched and aged samples. Overall, an energetically favourable fracture path in this sample was crack deflection, as the crack entered individual colonies and cut through the  $\alpha$  lamellas and interfacial and grain boundary  $\alpha$  layers at a range of angles.

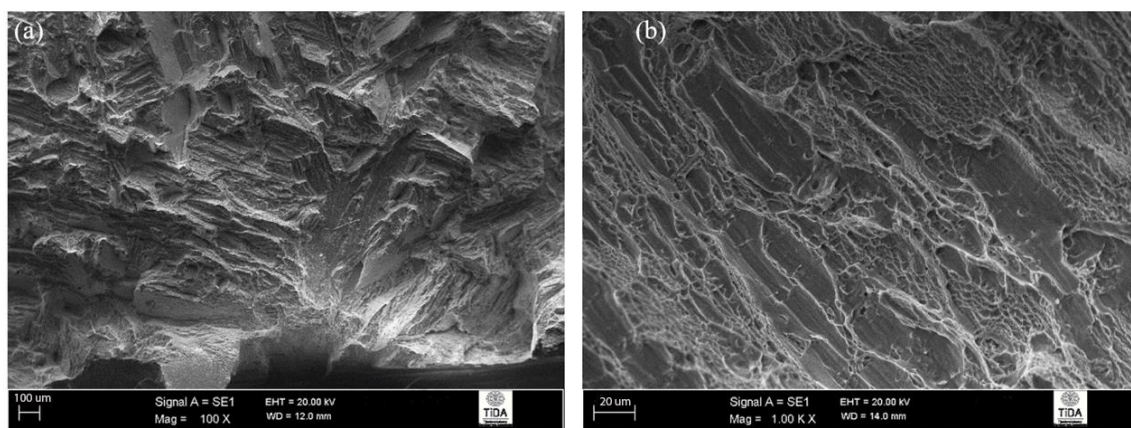
**Figure 9.** Fracture surface of 1200 °C/30 min, FC, 730 °C/2 h heat-treated Ti-6Al-4V alloy: (a) cleavage fracture; (b) ductile dimples.

After annealing at 1200 °C followed by ageing at 730 °C, the failure mode was mostly cleavage (see Figures 9a,b). There were just a few areas where crack propagation was trans-lamellar, and some ductile dimpling was evidence of a limited amount of ductile fracture. These observations correlate with the earlier crack path investigation studies, and the cleavage seen here derived from cracks travelling along crystallographic planes with a preferred orientation relating to colony interfaces.

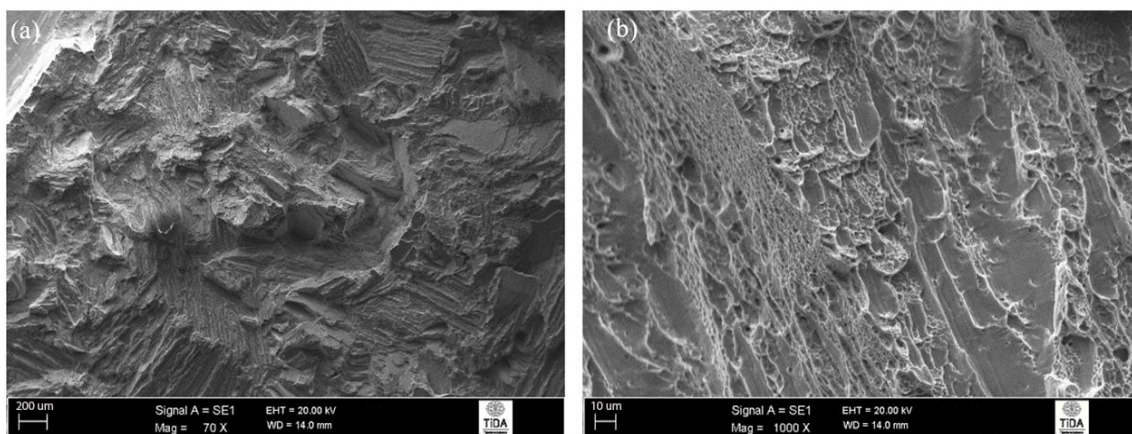
**Figure 10.** Fracture surface of 1065 °C/1 h, FC, 730 °C/2 h heat-treated Ti-6Al-4V alloy: (a) transgranular fracture marks; (b) signs of ductile fracture.

The features present in the fracture surface of standard  $\beta$ -annealed and subsequently aged samples (Figures 10a,b) included well-defined transgranular fracture features, some cleavage facets, and sufficient dimples to be comparable to those in high  $\beta$ -annealed and aged samples. The size of the spallings (areas where a crack travelled through the lamellas) were very similar to the colony size, and this confirmed the observations made regarding the path taken by the crack.

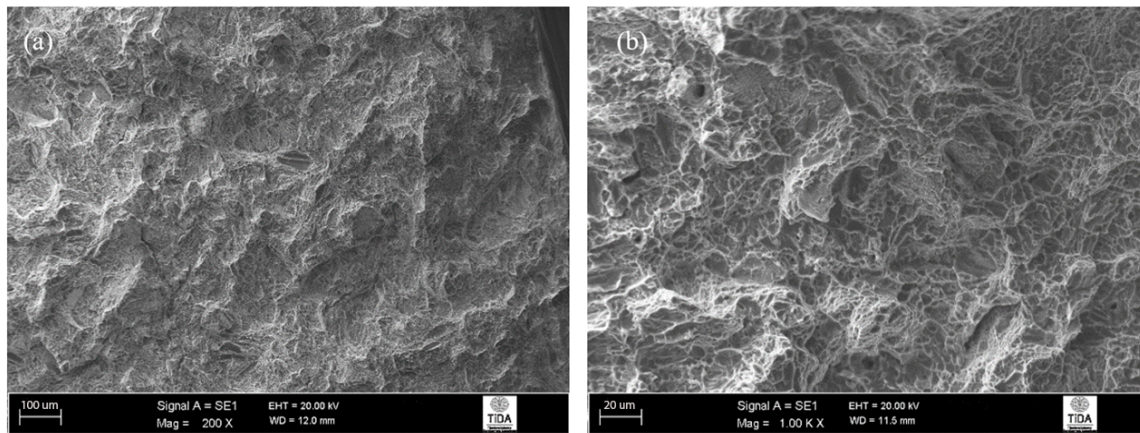
**Figure 11.** Fracture surface of 955 °C/1 h, FC heat-treated Ti-6Al-4V alloy: (a) general appearance; (b) evidence of ductile fracture.

Fractographs of fractured impact specimens given a 955 °C/1 h, FC heat treatment are shown in Figure 11, and these showed a typical ductile fracture that one would expect from a Ti-6Al-4V alloy. Here, the presence of many ductile dimples and ductile tearing ridges suggests that the predominant mode of failure was ductile. There are no signs of trans-lamellar fracture, which suggests that  $\alpha$  platelets provided sufficient resistance to crack propagation. In other words, the individual  $\alpha$  lamellas and  $\beta$  phase matrix were plastically deformed, giving a fracture surface that consisted mostly of ductile fracture features.

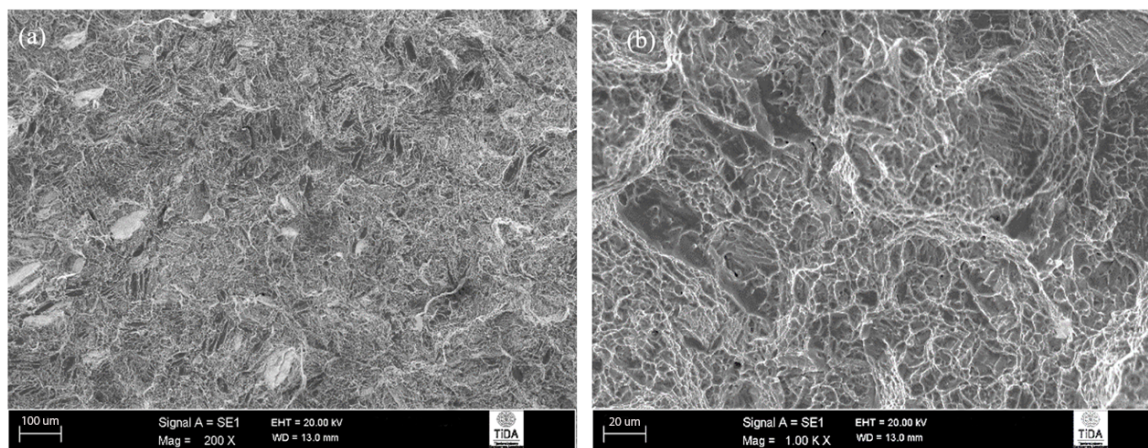
**Figure 12.** Fracture surface of 925 °C/4 h, CFC@50 °C/h to 760 °C, FC heat-treated Ti-6Al-4V alloy: (a) general appearance and the occasional presence of cleavage facets; (b) ductile dimpling.

The fracture surfaces of Ti-6Al-4V heat-treated using 925 °C/4 h, CFC@50 °C/h to 760 °C, FC looked rather ductile at first sight. However, the presence of well-built cleavage facets on the fracture surface cannot be ignored (as shown in Figure 12a). A comparison of this fracture surface with that for the previous case (where material was subjected to 955 °C/1 h, FC) suggests that, in this case, the cleavage fracture features were evidence of brittle behaviour along with smaller-sized dimples (compare Figures 11 and 12). Despite this fact, the mean impact toughness values from each of these  $\alpha + \beta$  annealing treatments was the same.

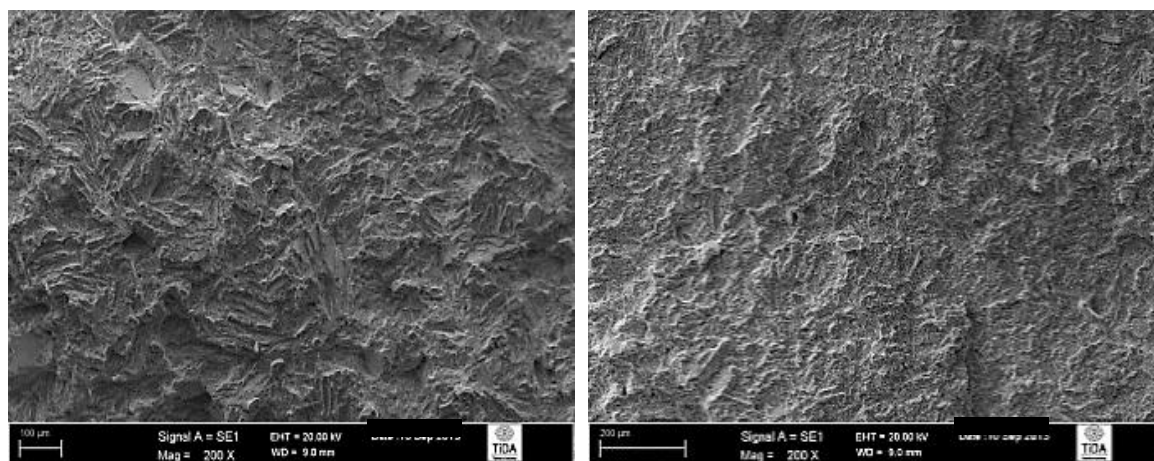
**Figure 13.** Typical fractographs of as-extruded Charpy impact specimens: (a) cleavage and transgranular fracture; (b) relatively flat surface with brittle fracture.

For as-extruded material, the fracture area containing ductile dimples or other signs of ductile fracture was significantly smaller than the area represented by cleavage and transgranular fracture in all surfaces investigated. Hence, it was very evident that brittle fracture was the predominant mode of failure here. Figures 13a,b show high-magnification fractographs that contain a significant number of cleavage facets along with large plane spallings (or transgranular features).

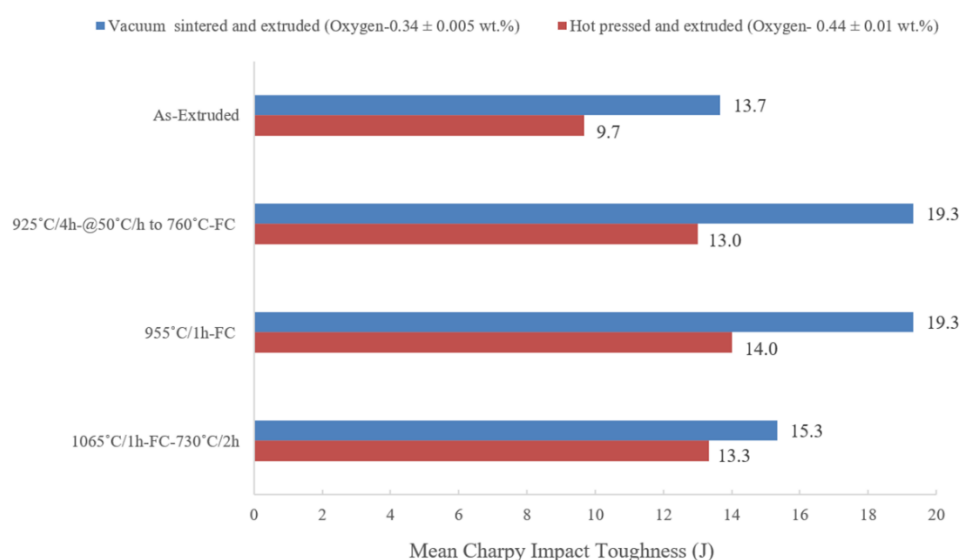
**Figure 14.** A comparison of mean Charpy impact toughness of heat treated Ti-6Al-4V alloy prepared via two different processing routes with different oxygen contents [23].

From Figure 14, it is also apparent that the heat-treated material described in this paper, with 0.1 wt.% lower oxygen, has (on average) a 2–6.3 J higher impact energy compared to hot-pressed and extruded material, depending on the respective microstructure/heat treatment. From the literature, it is clear that the presence of oxygen is favourable for some properties, whereas it is detrimental for others [1–3]. Generally, high oxygen content in the titanium lattice increases the yield strength, ultimate tensile strength, Young's modulus, fatigue strength, and hardness, but compromises the ductility, impact strength, and fracture toughness. The main reason for a high dependency of the mechanical properties of titanium and titanium alloys on oxygen content can be explained by the interaction of oxygen atoms with the hydrostatic fields of both edge and screw dislocations and the alteration it brings to twinning and prismatic slip.
